**The January 17, 1995 Kobe Earthquake
An EQE Summary Report**

April 1995

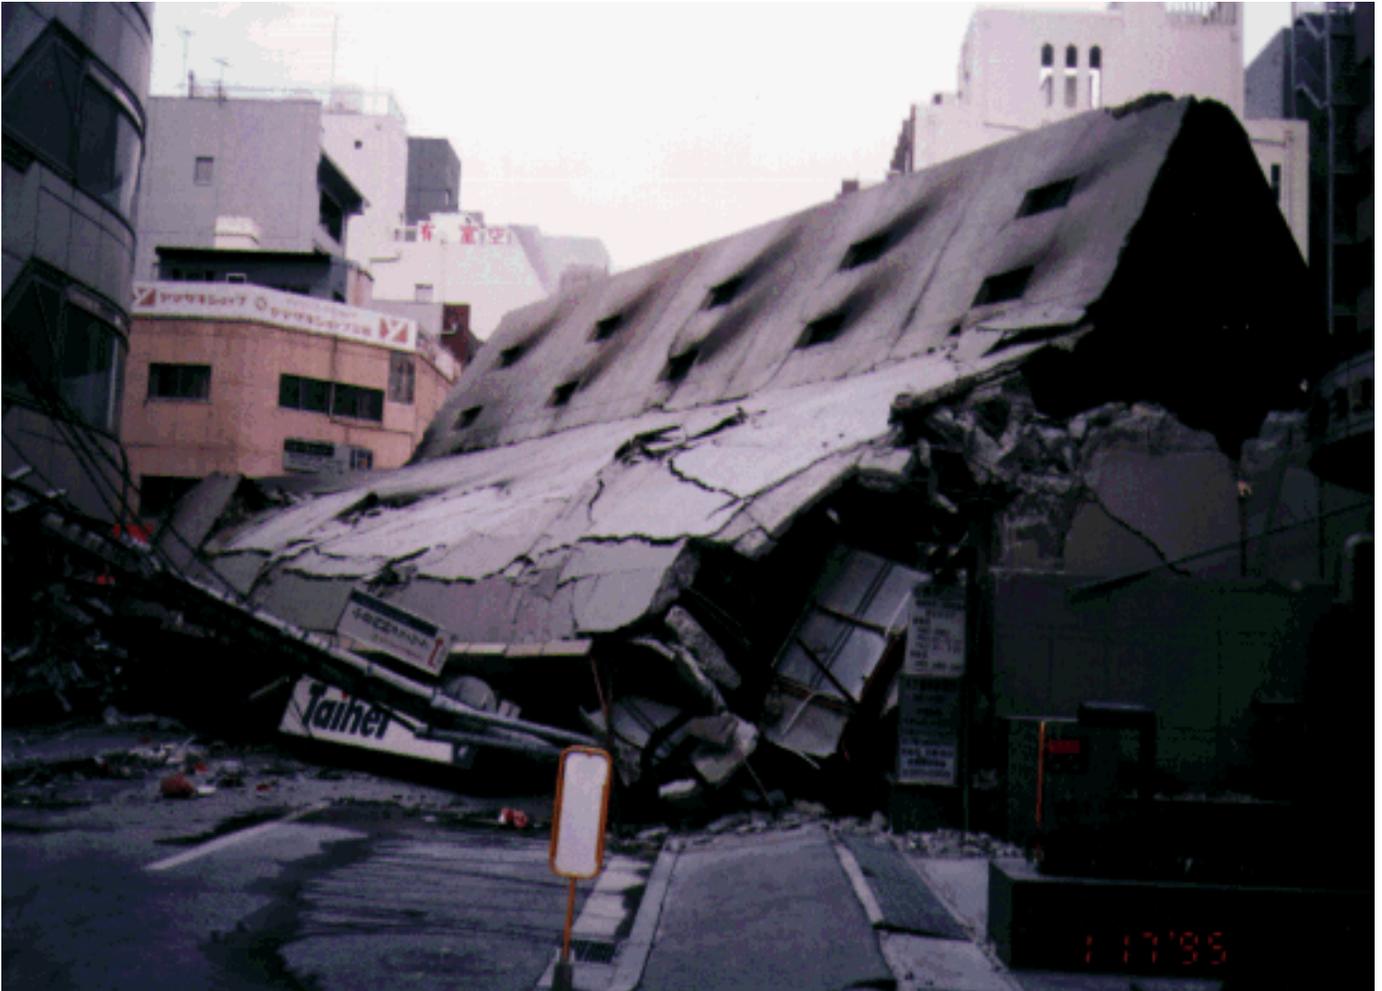
This collapsed concrete building in Kobe completely blocked the street.

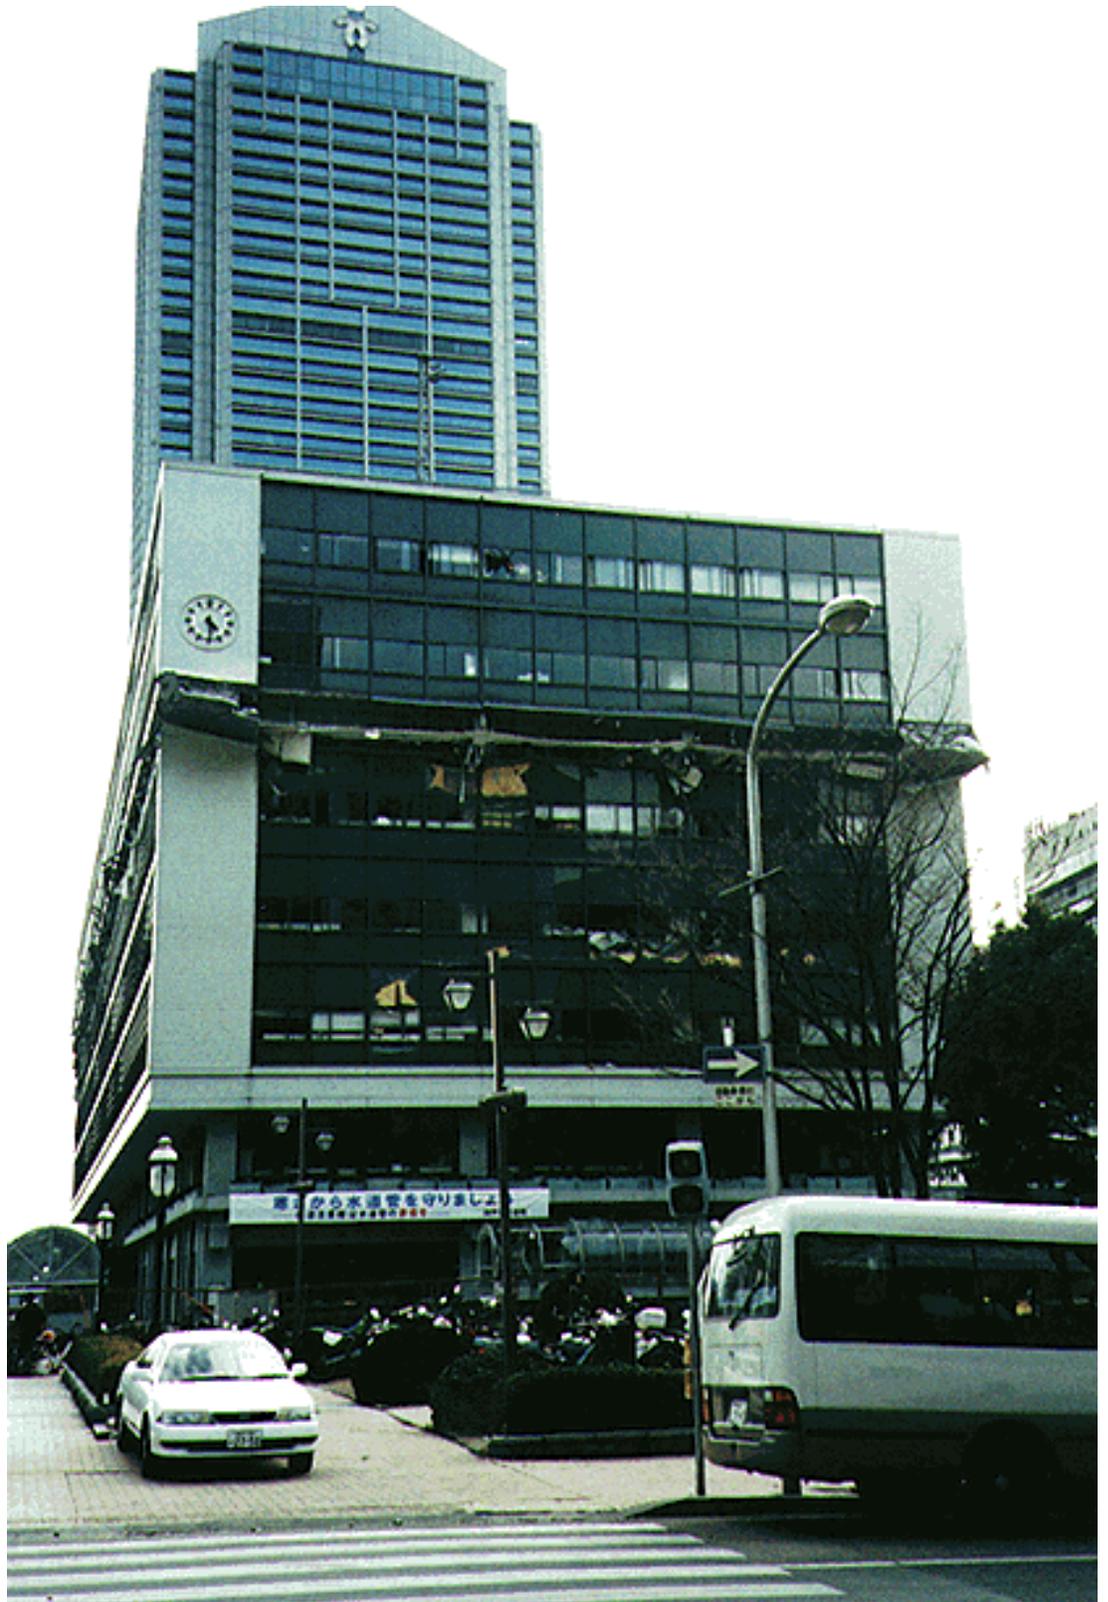
Kobe City Hall, Sannomiya District. In the foreground is the old City Hall with a mid-story collapse. Behind it is the new City Hall, which exhibits signs of only minor damage.

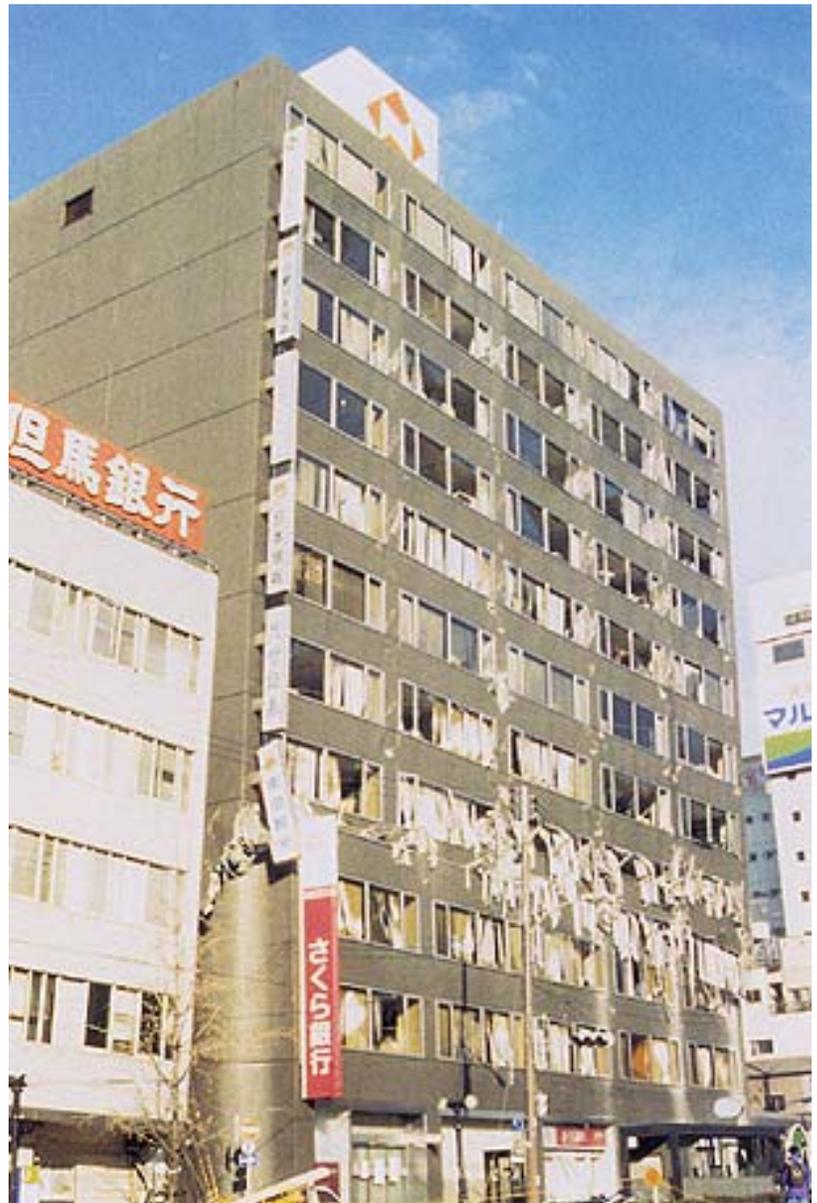
Top: Mid-height collapse of a concrete-frame building.

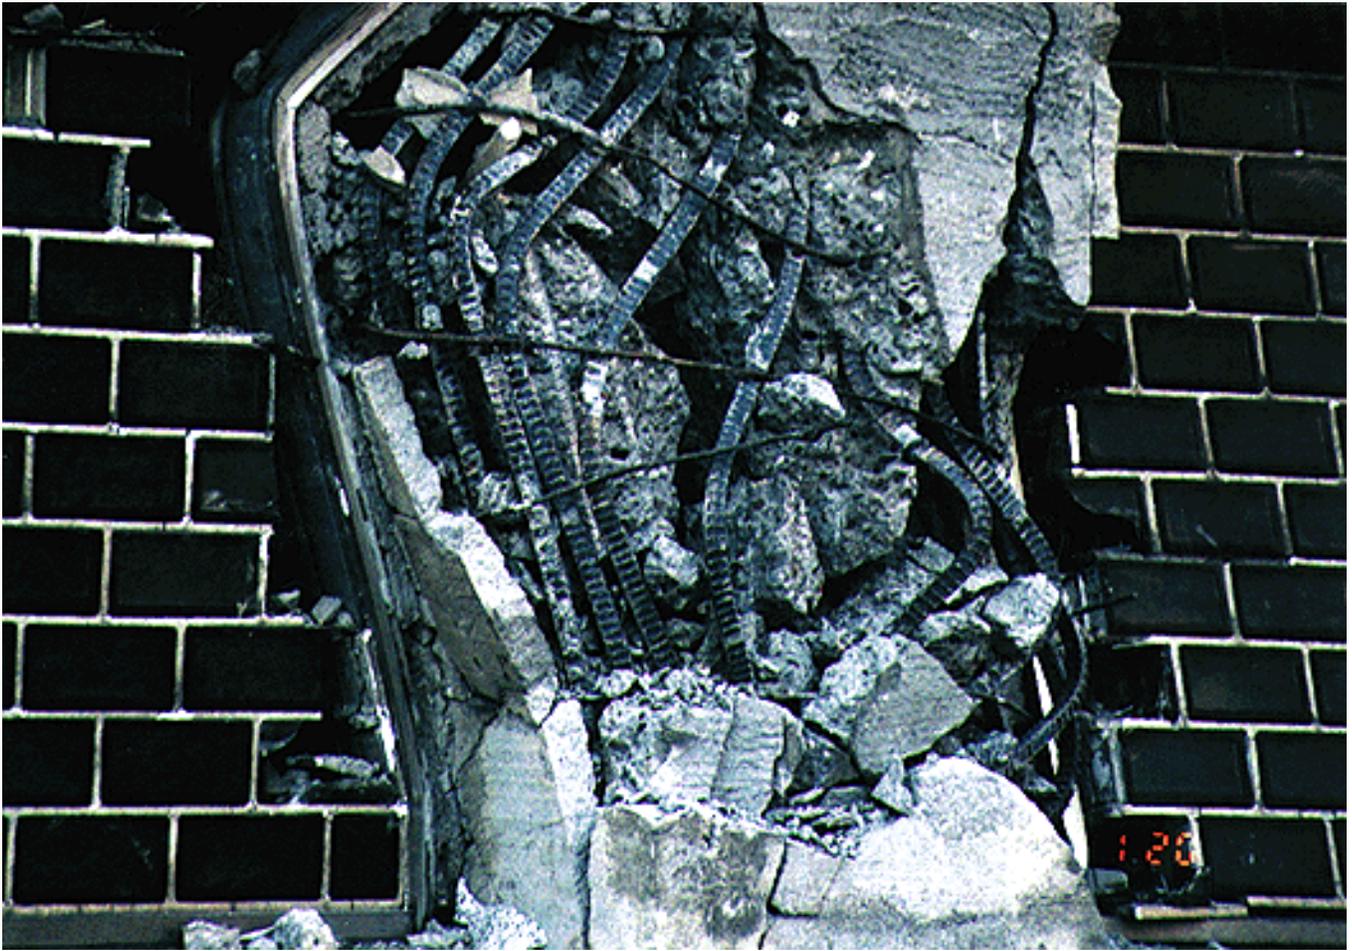
Top: Badly damaged reinforced concrete column. Note the heavy longitudinal reinforcement, with scant shear reinforcement.

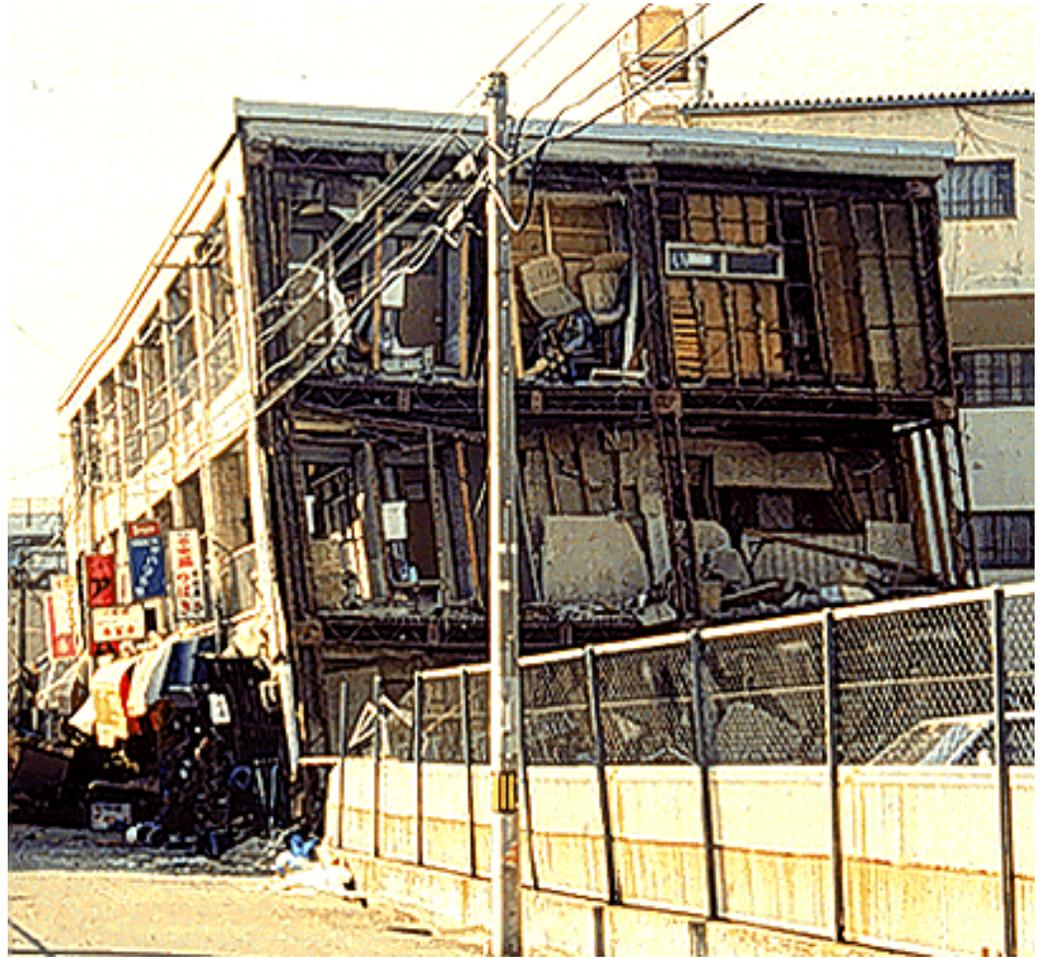
Top: A steel building in the Nagata Ward. The building was probably very close to collapsing in the earthquake. High flexibility of the building probably contributed to the failure of the cladding.

Bottom: Collapsed housing was responsible for most of the deaths in the earthquake.

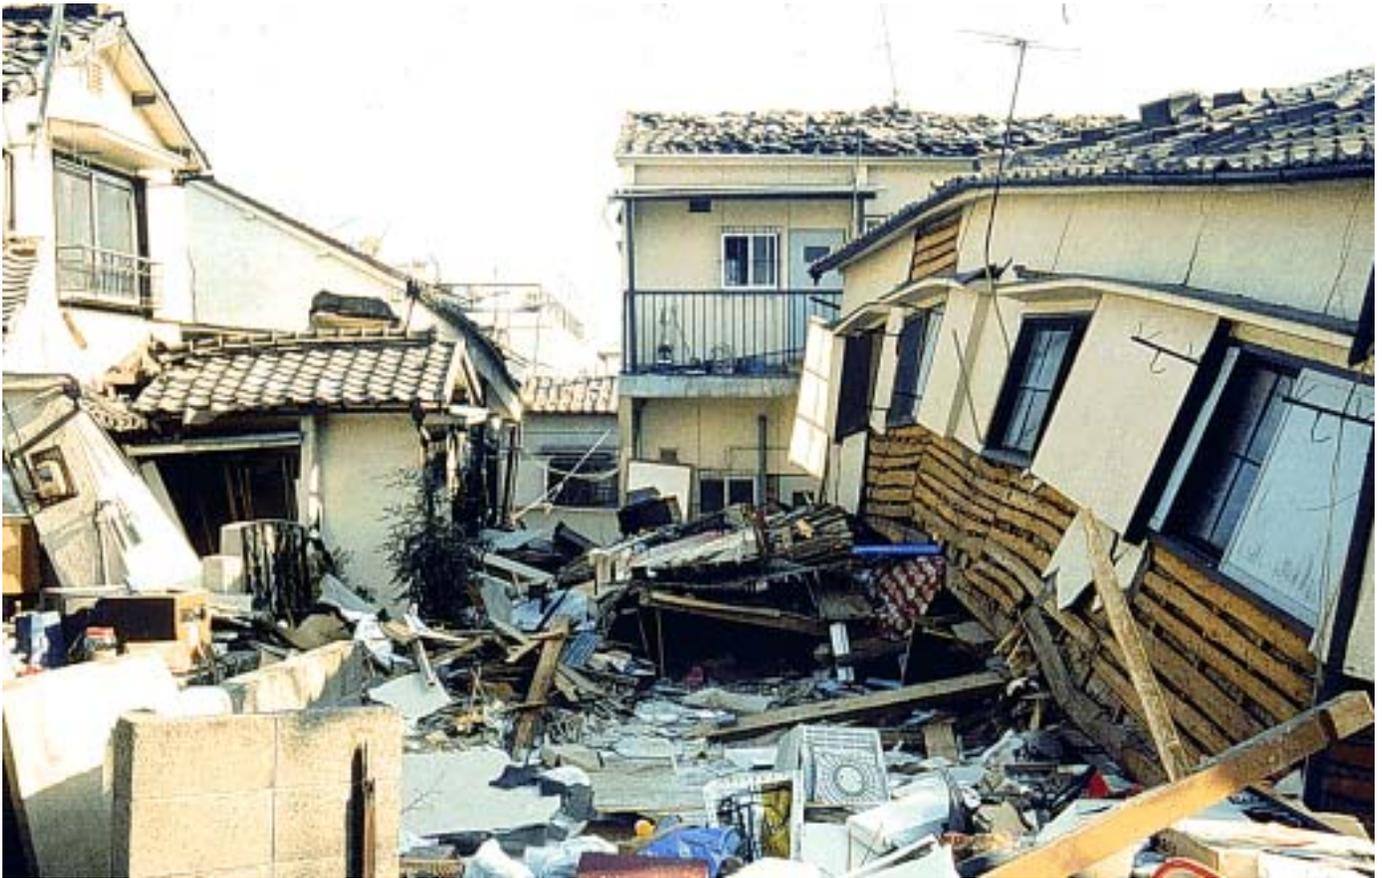
Top: These three-year-old houses collapsed from excessive loads imposed by heavy tile roofs. A similar house on the block with a lightweight roof had minimal damage (see bottom photo).

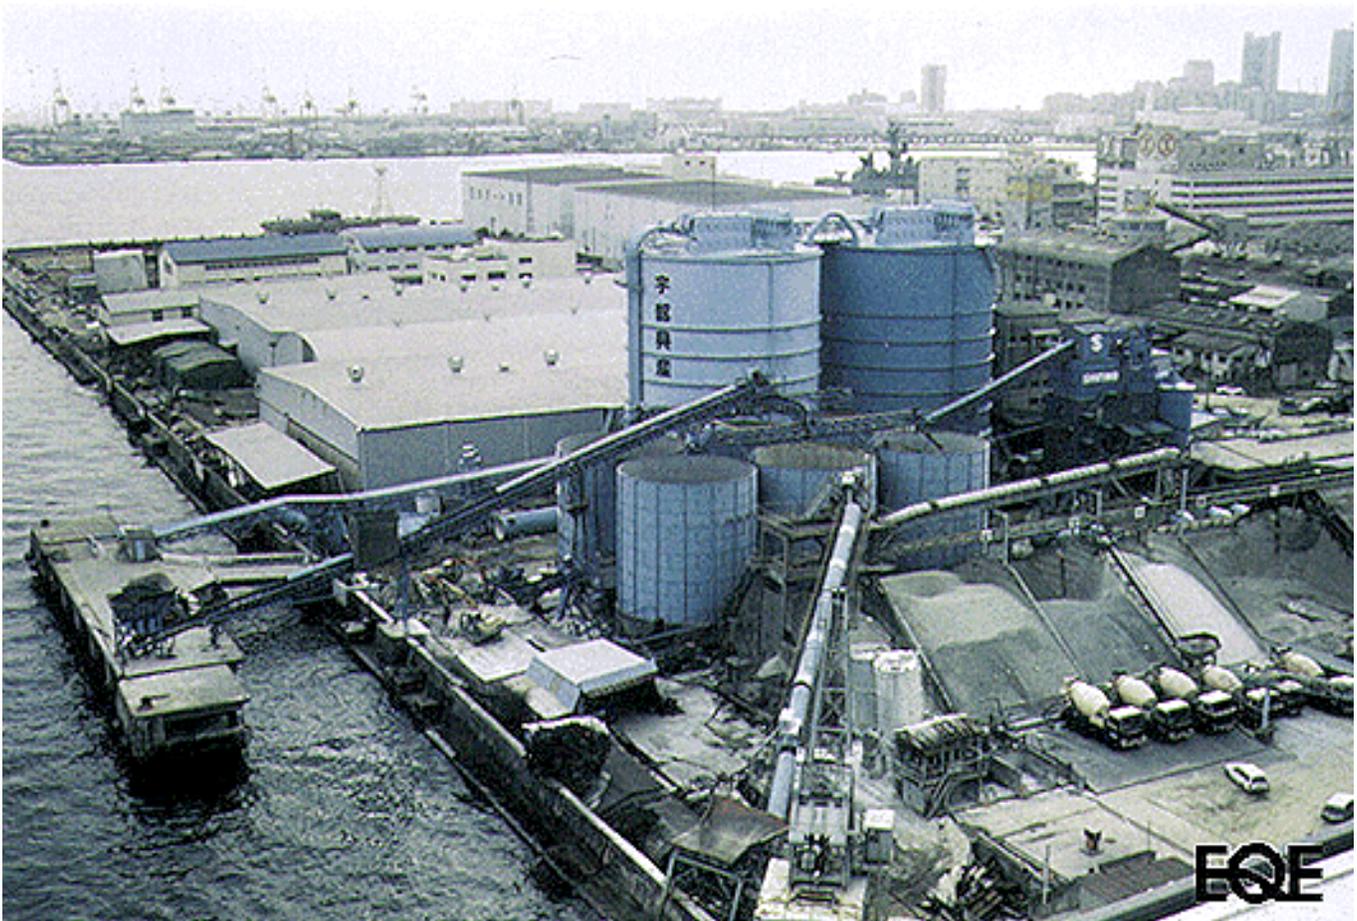
A damaged concrete plant on reclaimed land east of Rokko Island. The conveyors are severely damaged, and several tanks have toppled.

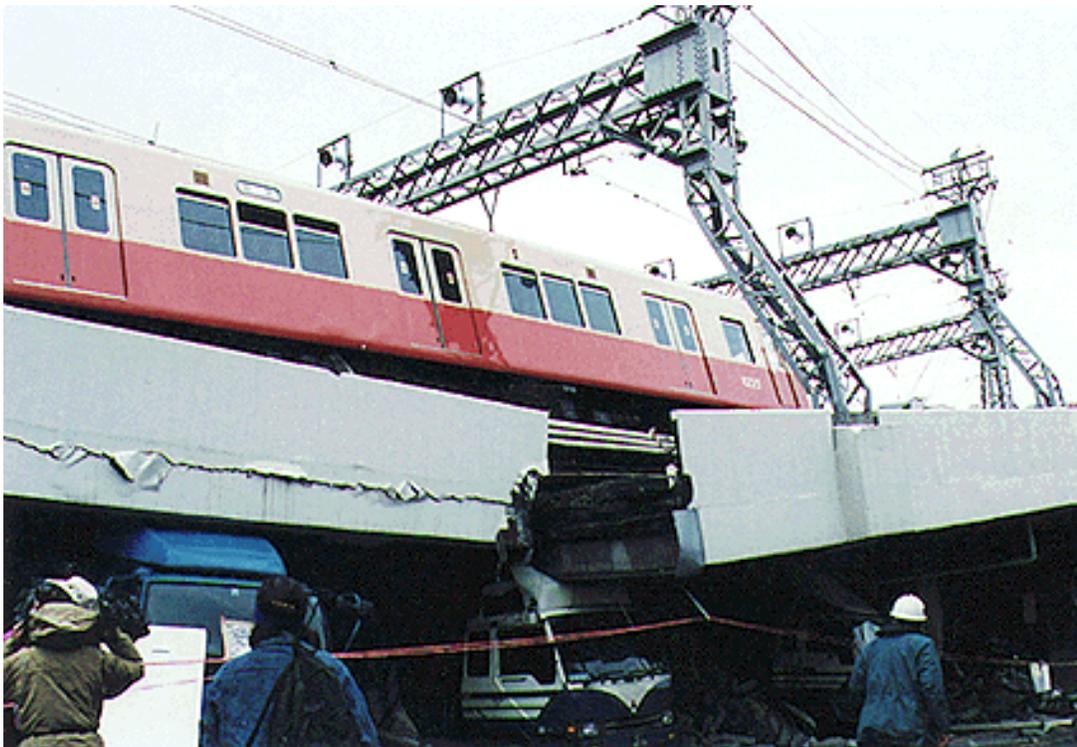
The Rokkomichi Station (built in 1972) of the JR West line was virtually destroyed.

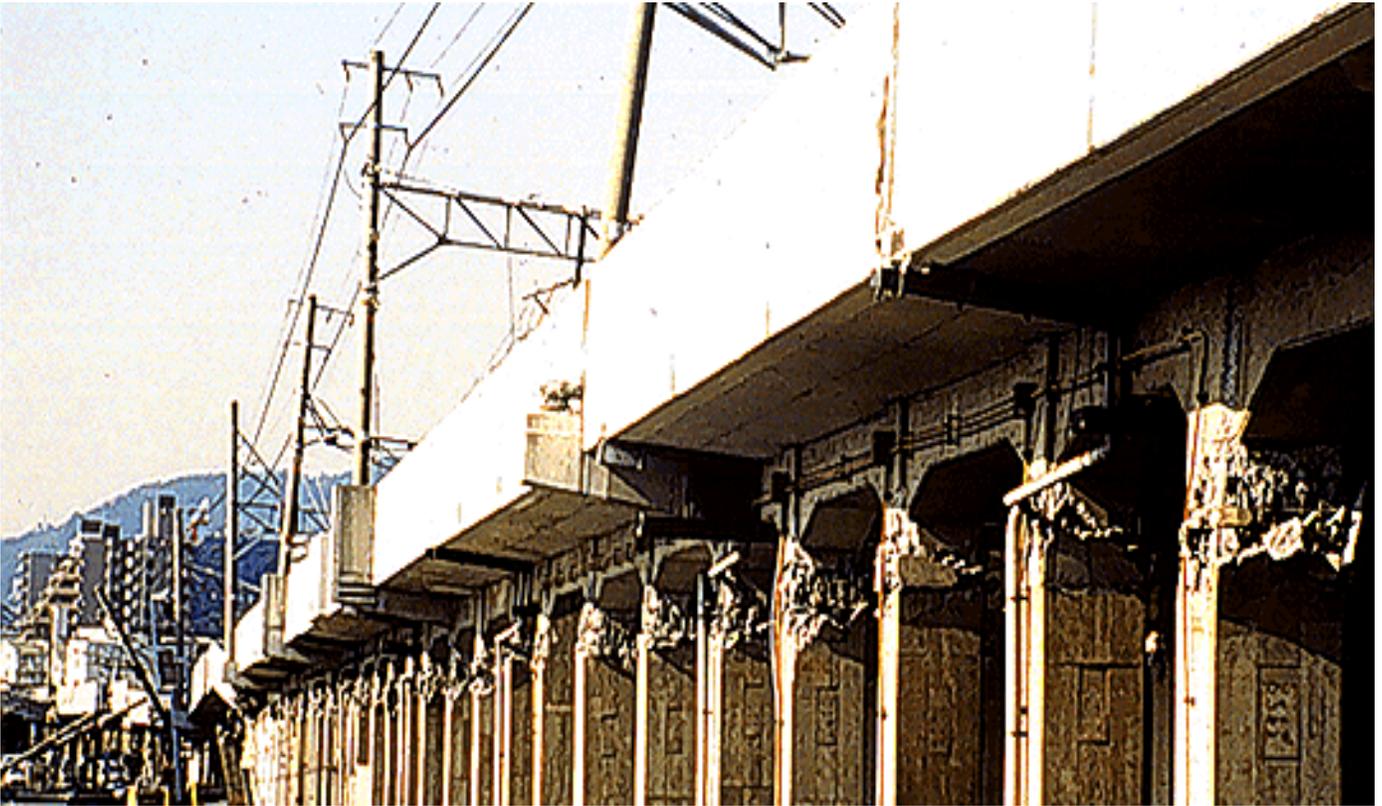
Top: A section of the severely damaged Shinkansen (Bullet Train) elevated roadway. The structure is very stiff and very strong, but had inadequate shear reinforcement.

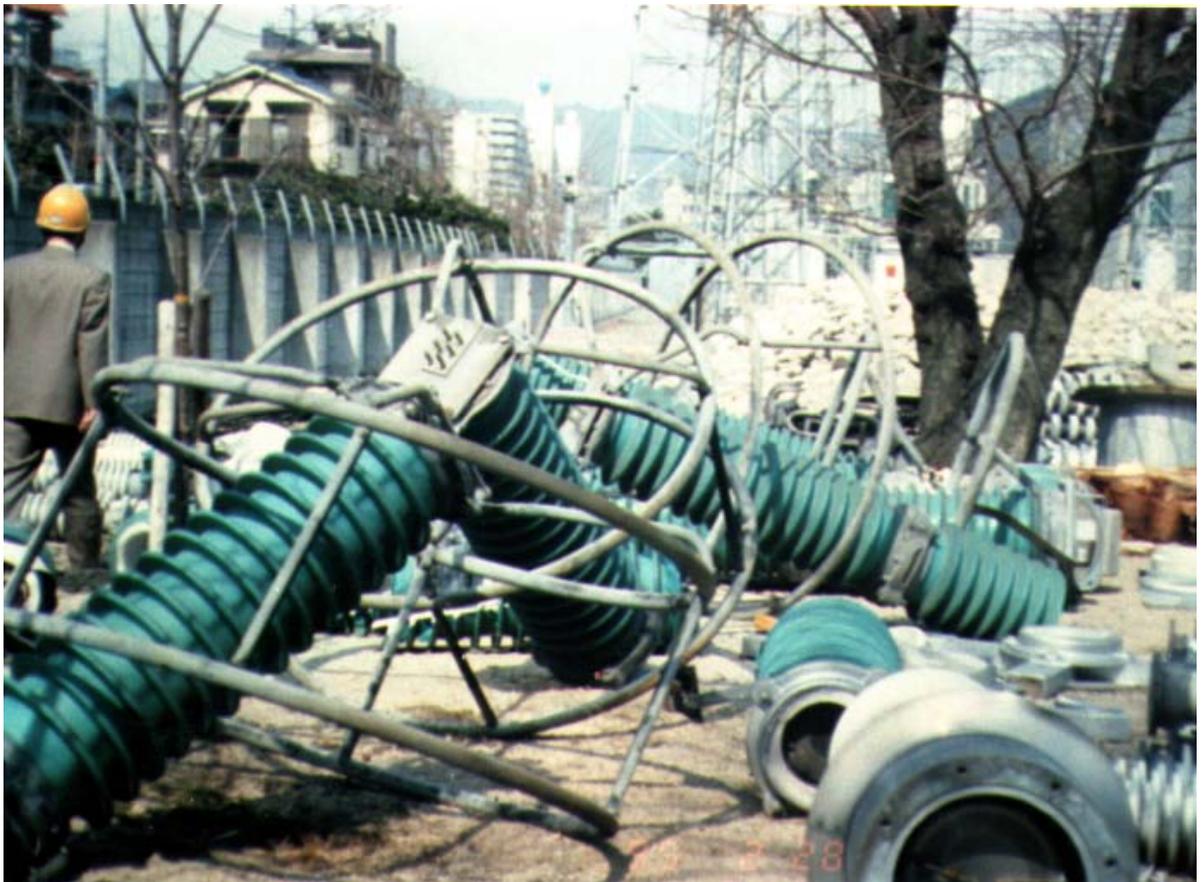
Broken arresters at the Itami Substation.

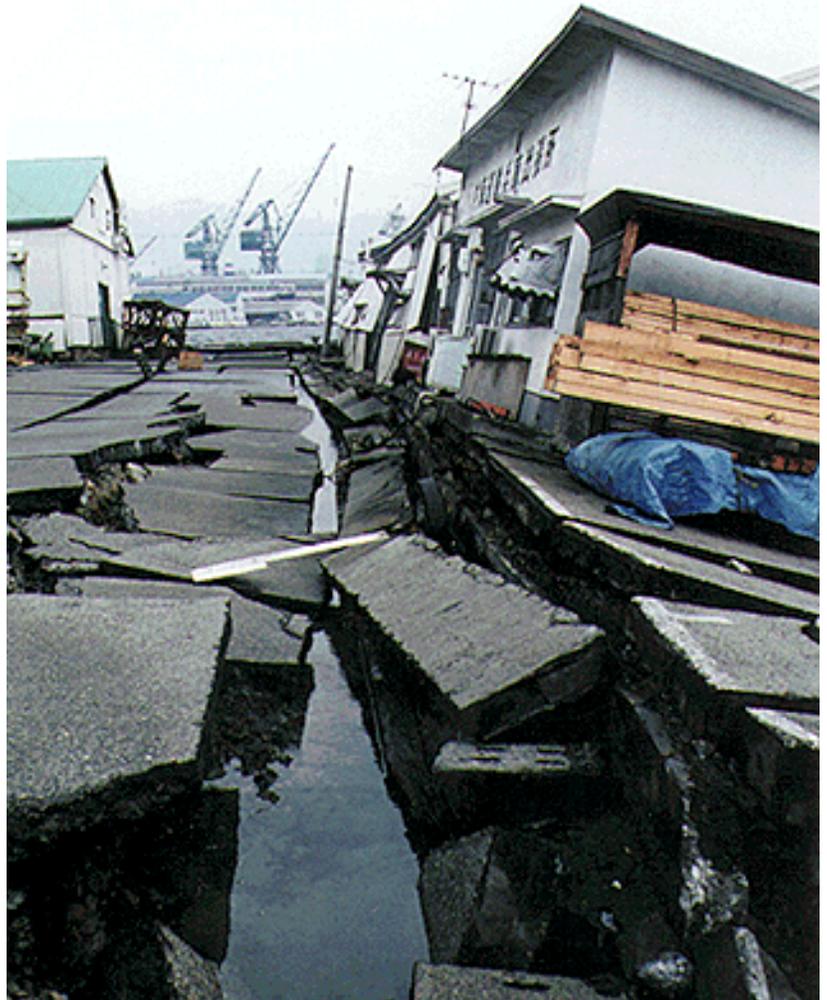
Completely destroyed pier at the Port of Kobe.
