Earthquake Damage to the Electric-Power Infrastructure- Substation

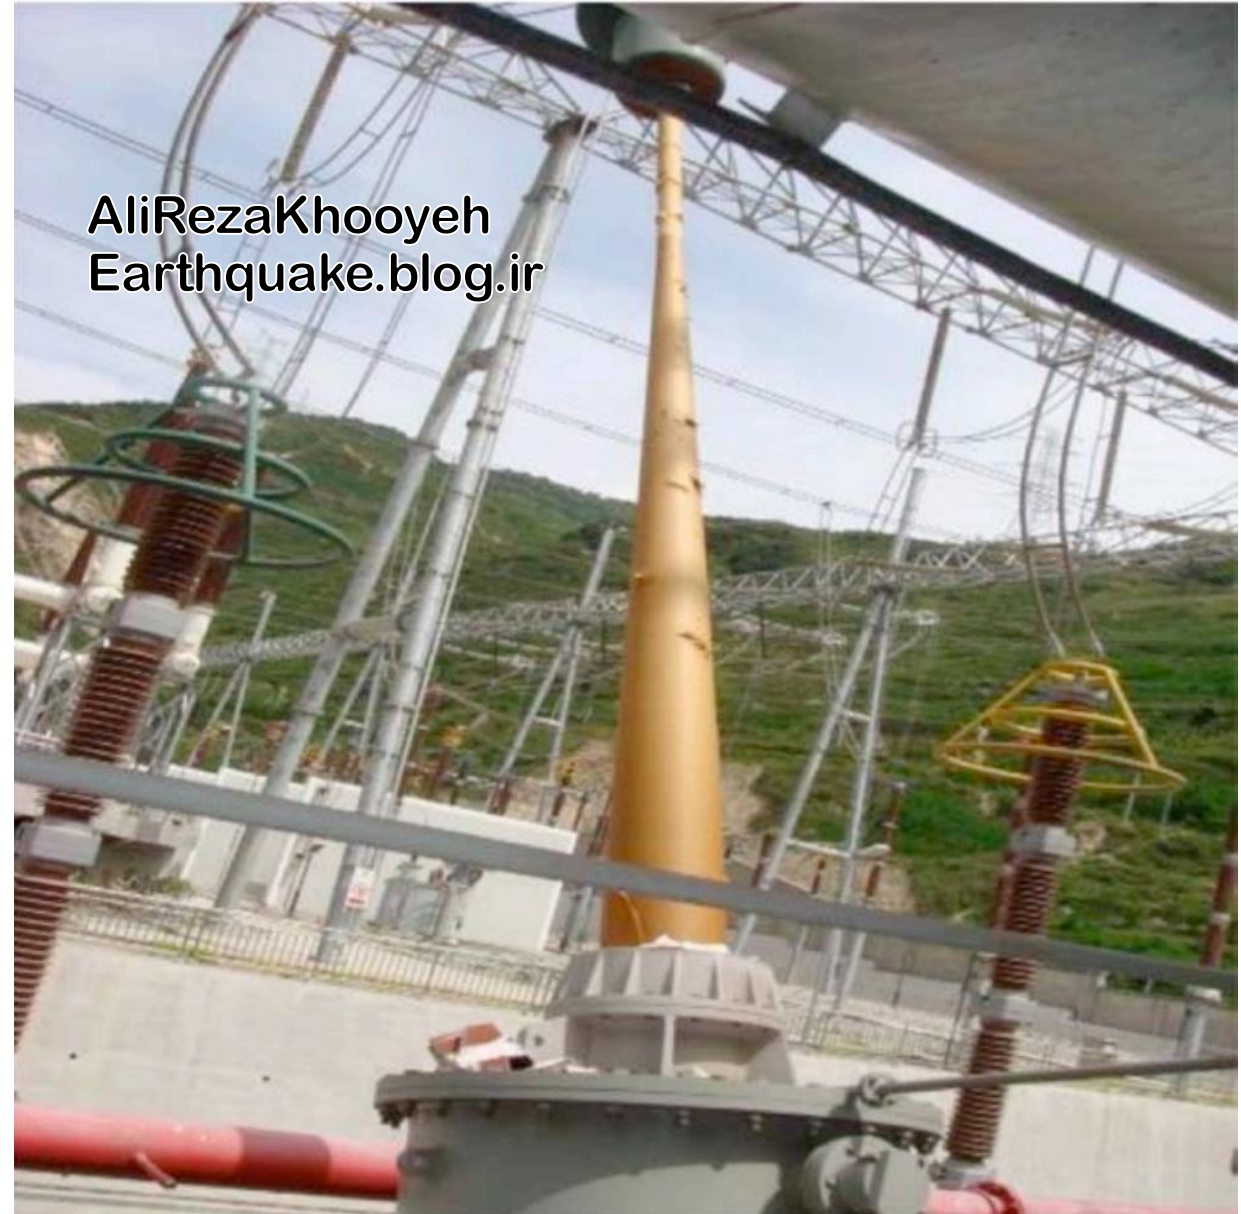
Bushing, 500 kV Transformer

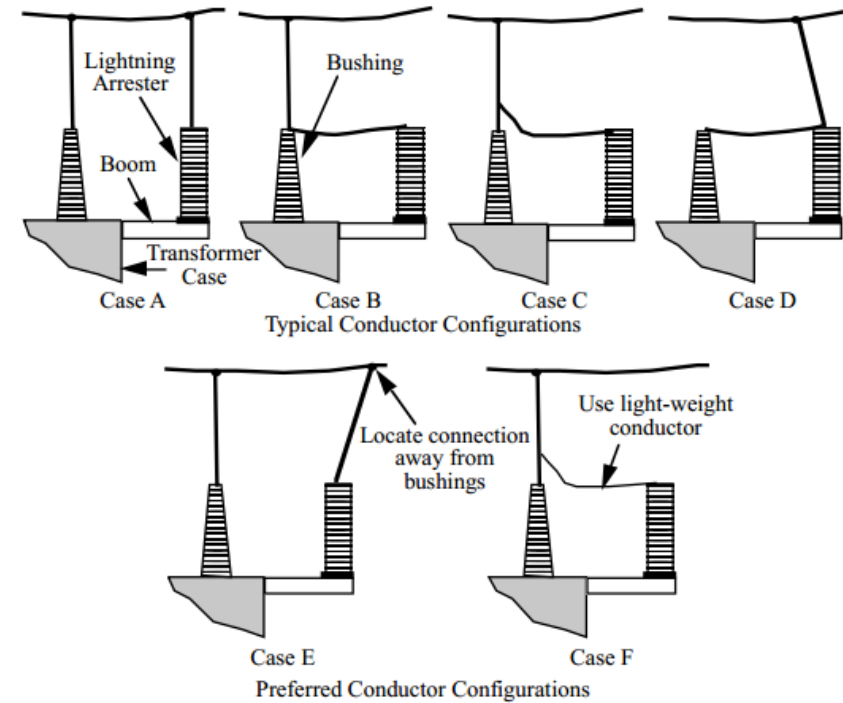
- One of the most common items to fail in substations has been transformer-supported surge arresters. In coastal California, where lightning is very rare, damaged surge arresters are removed and the transformer put back into service. One of the risks associated with such failures is that, in falling, the surge arrester can damage the transformer bushing by striking or pulling on it and damaging the conductor bonding post.
- This figure illustrates several different methods of configuring the conductor and preferred methods.

Variations in surge arrester conductor configurations.

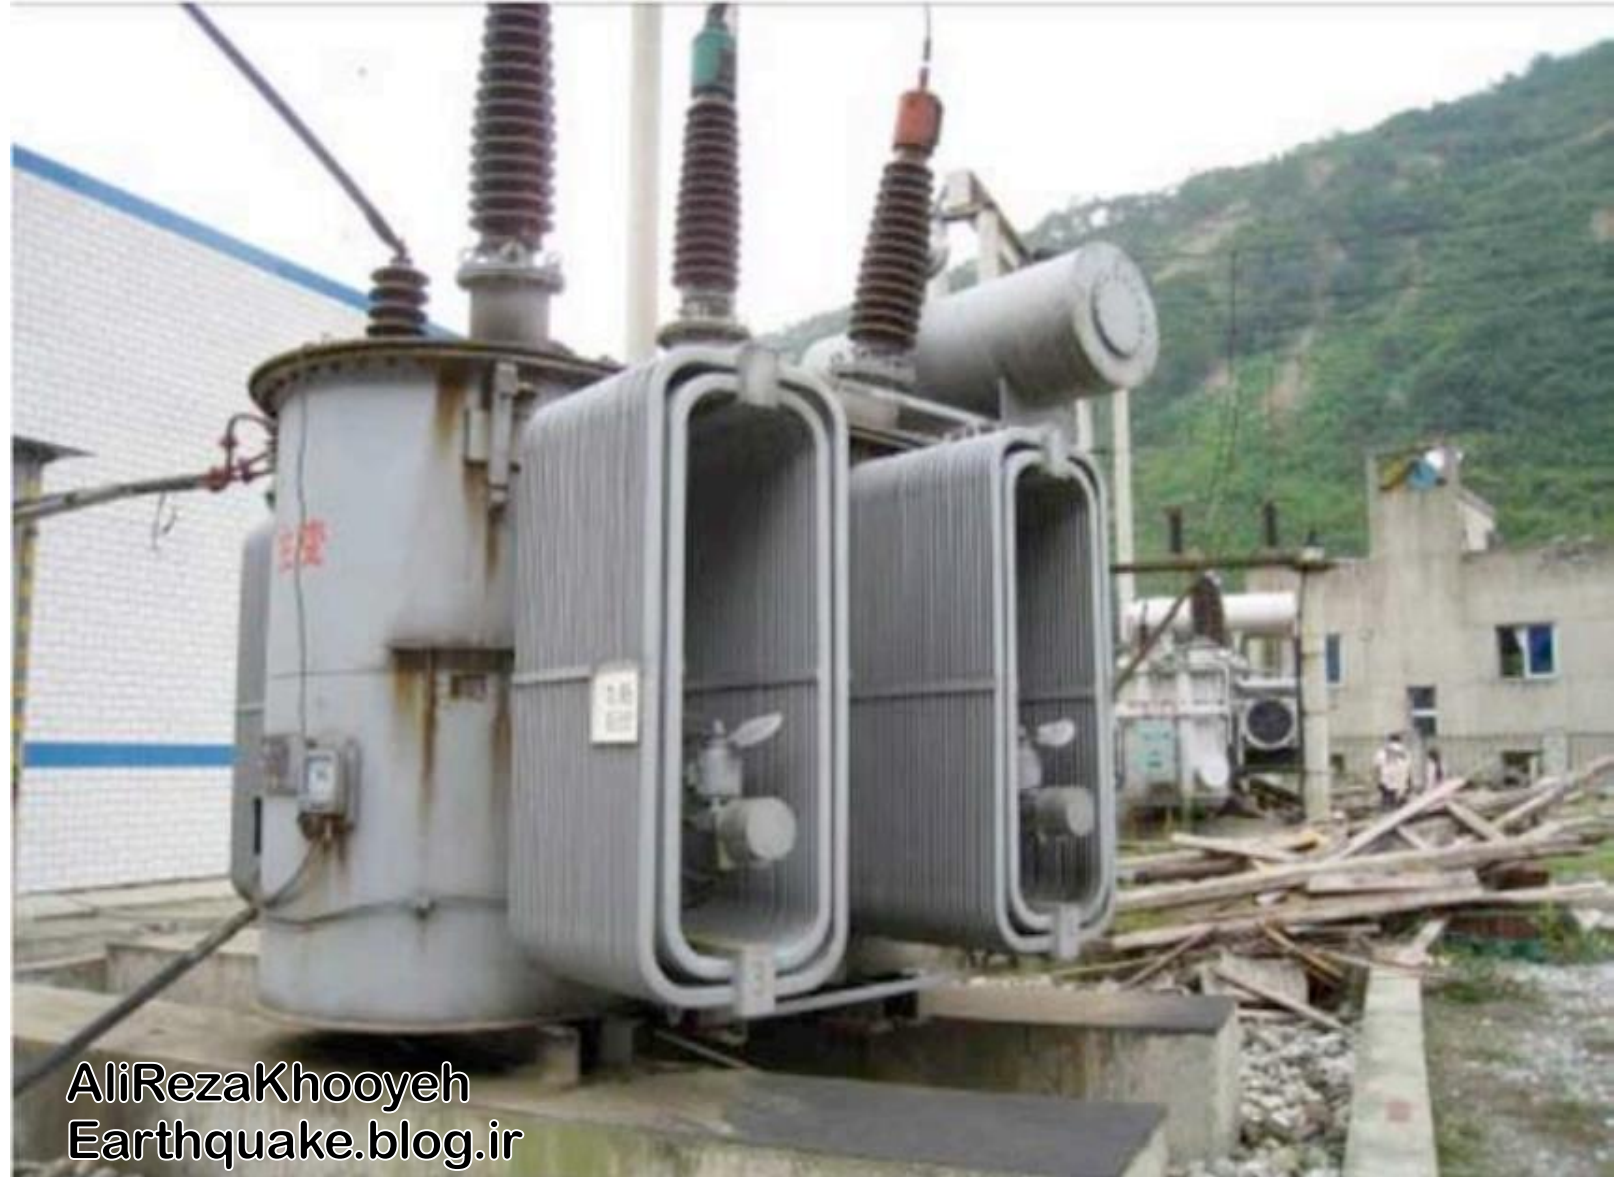
Skid-Mounted Transformer

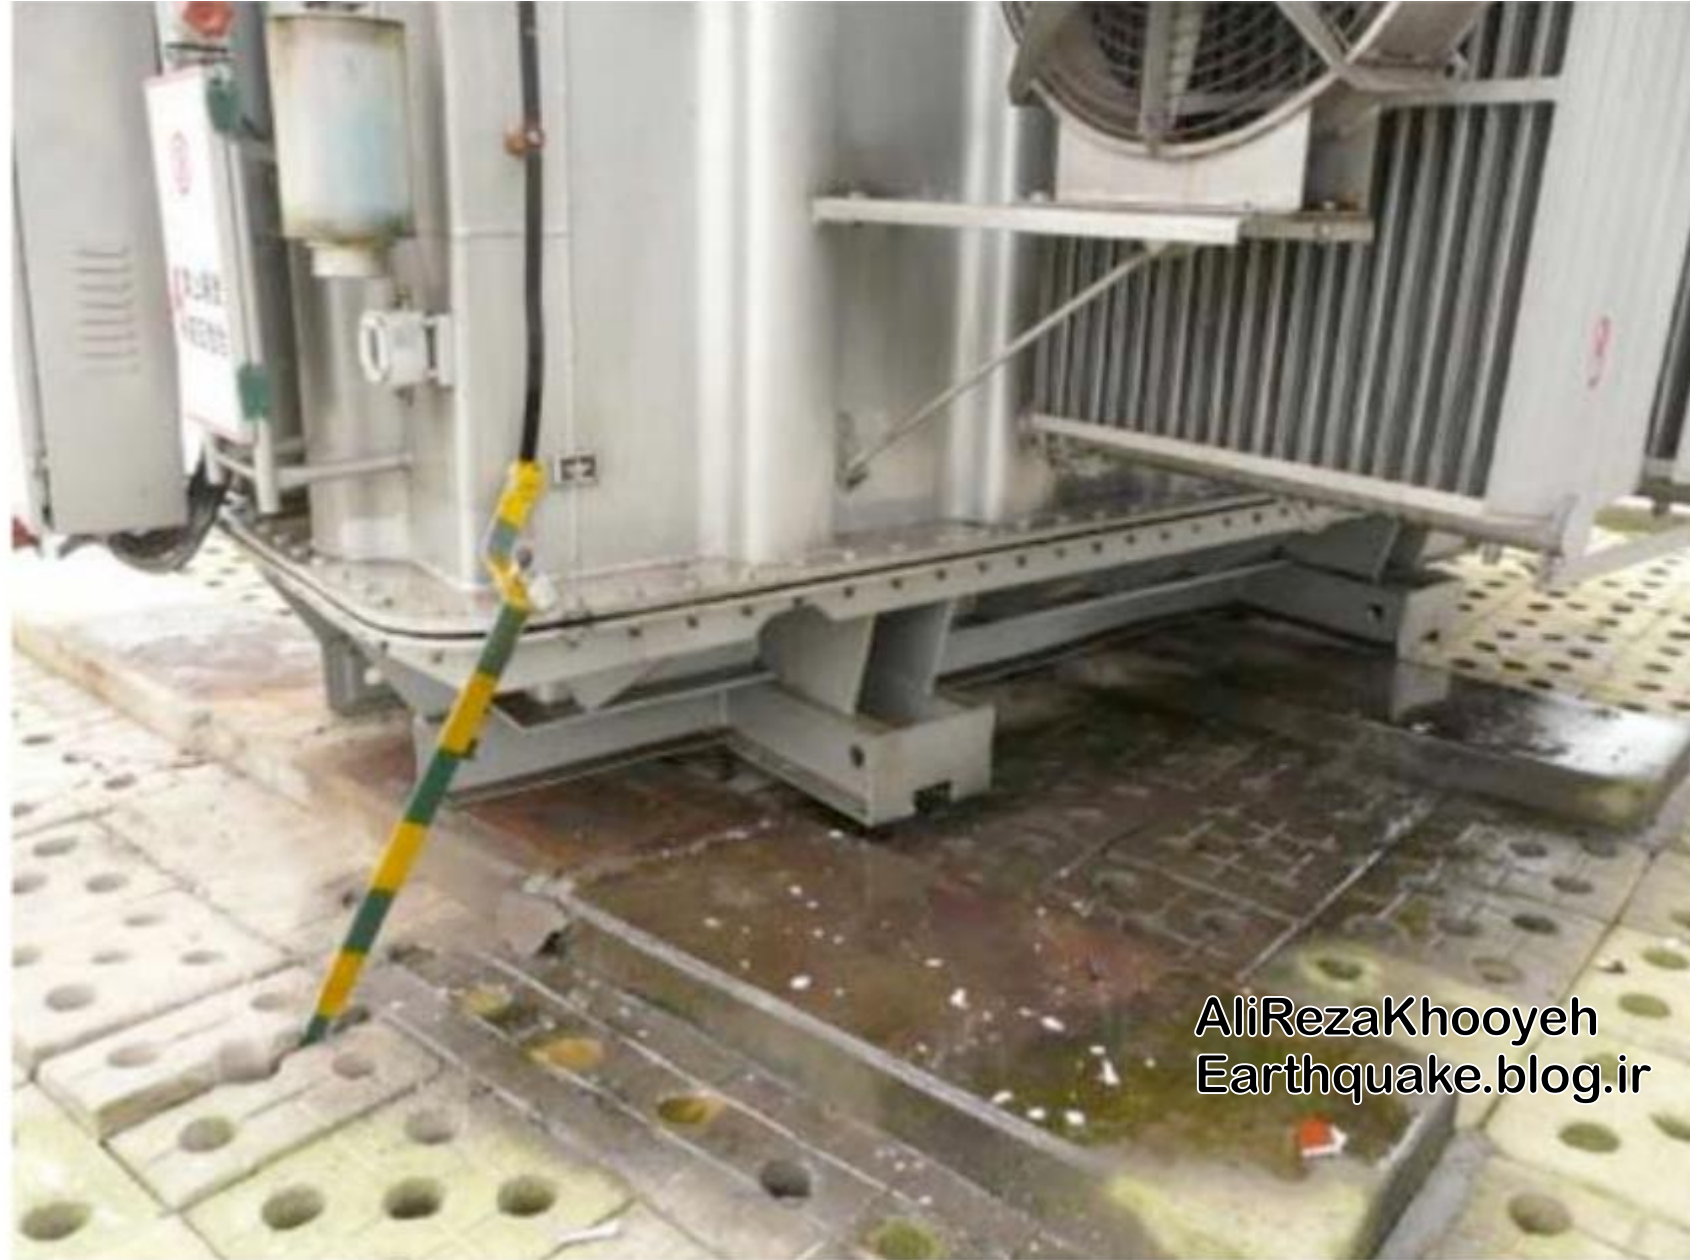
Skid-Mounted Transformer

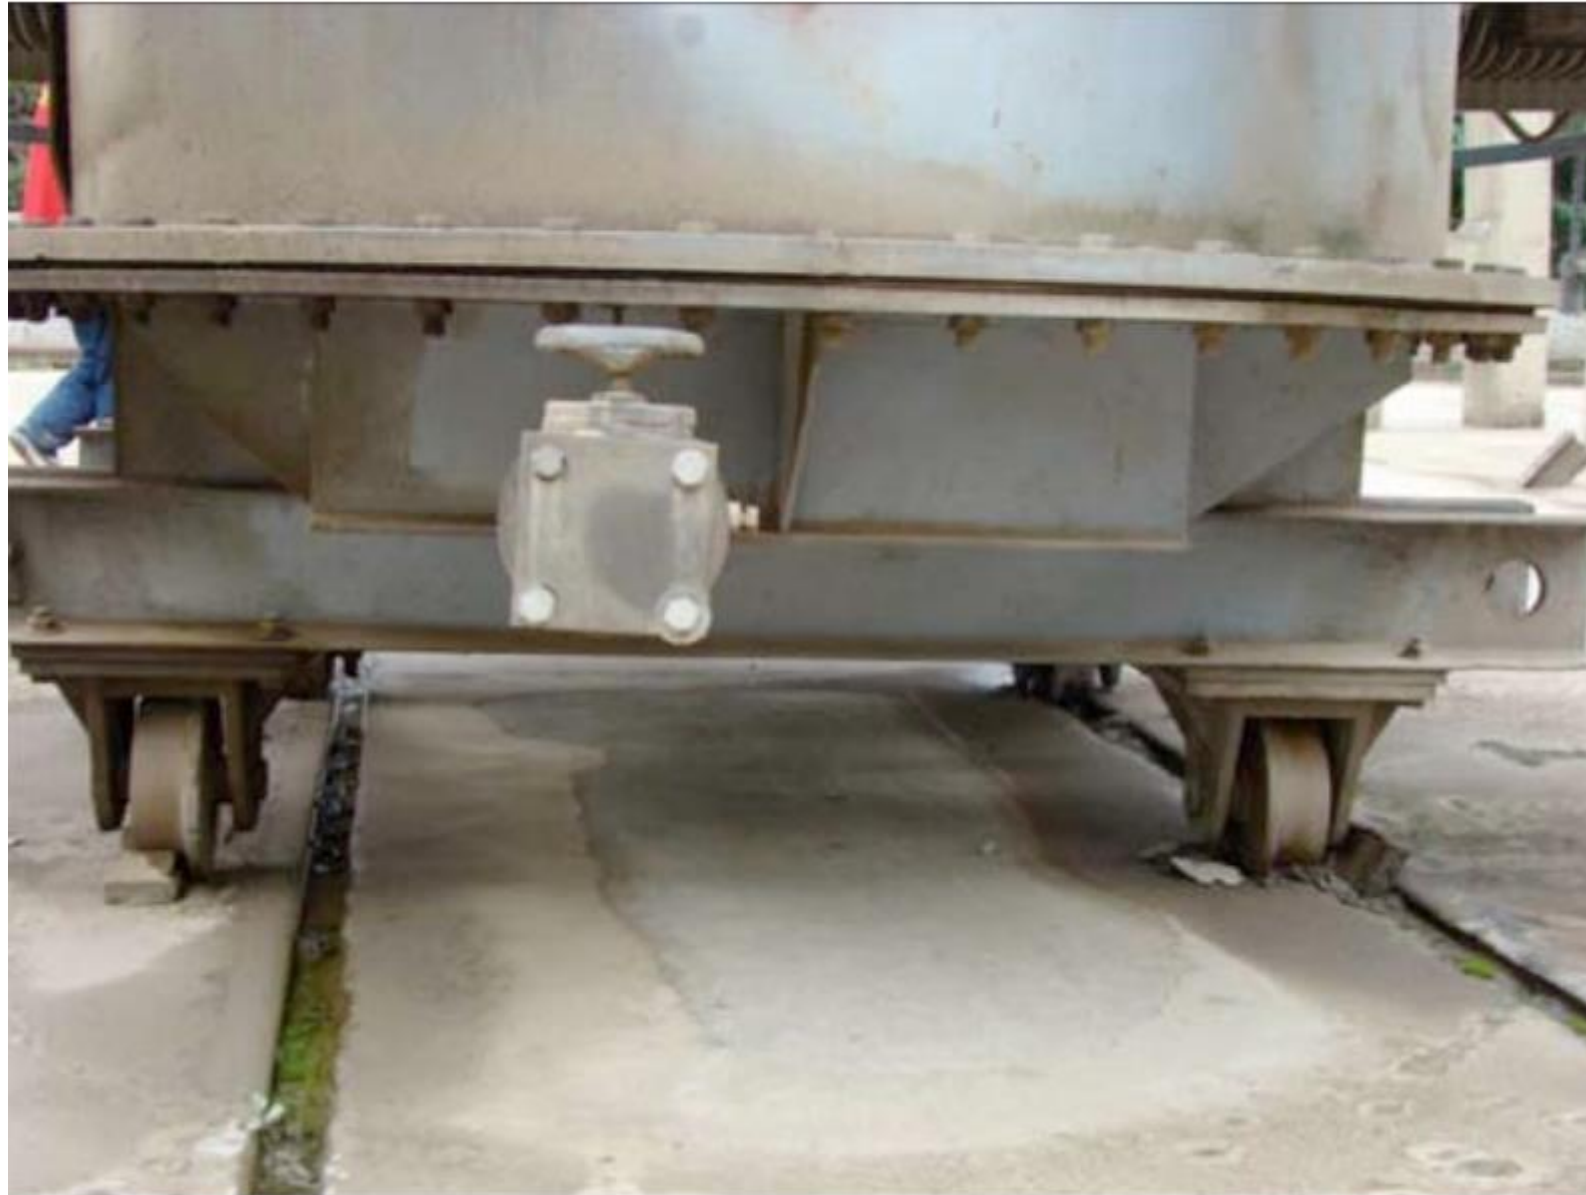
Wheel-Mounted Transformer

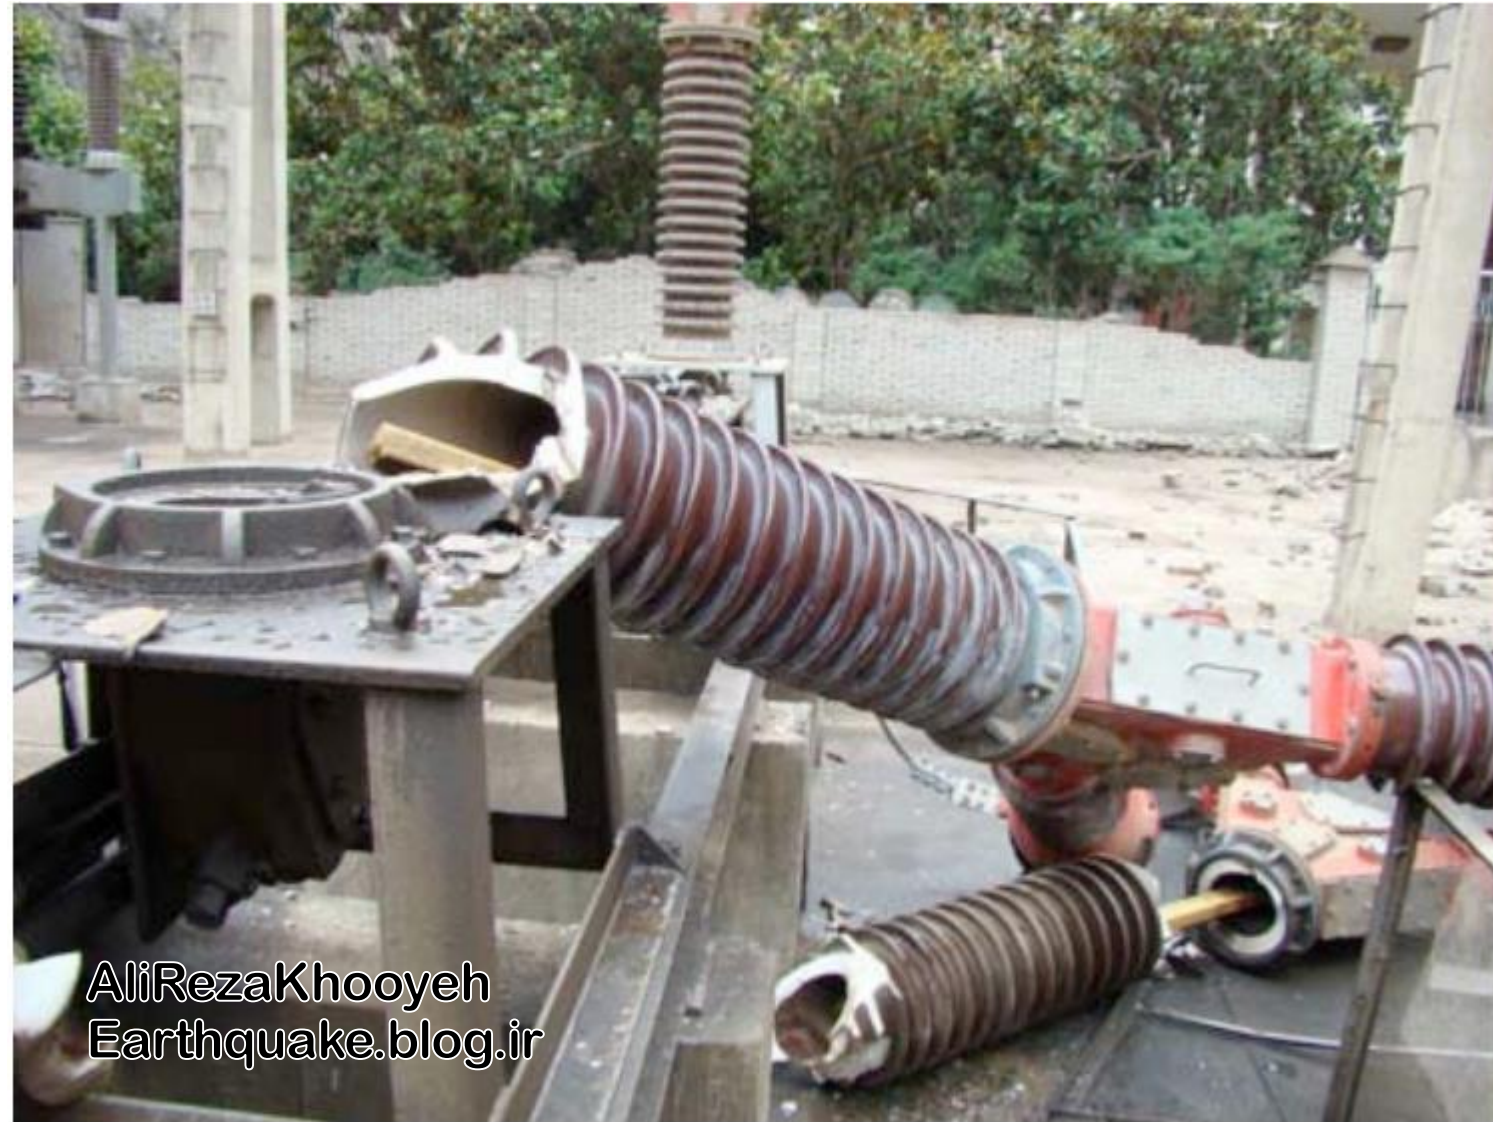
Damaged Live Tank Circuit Breaker (110 kV)

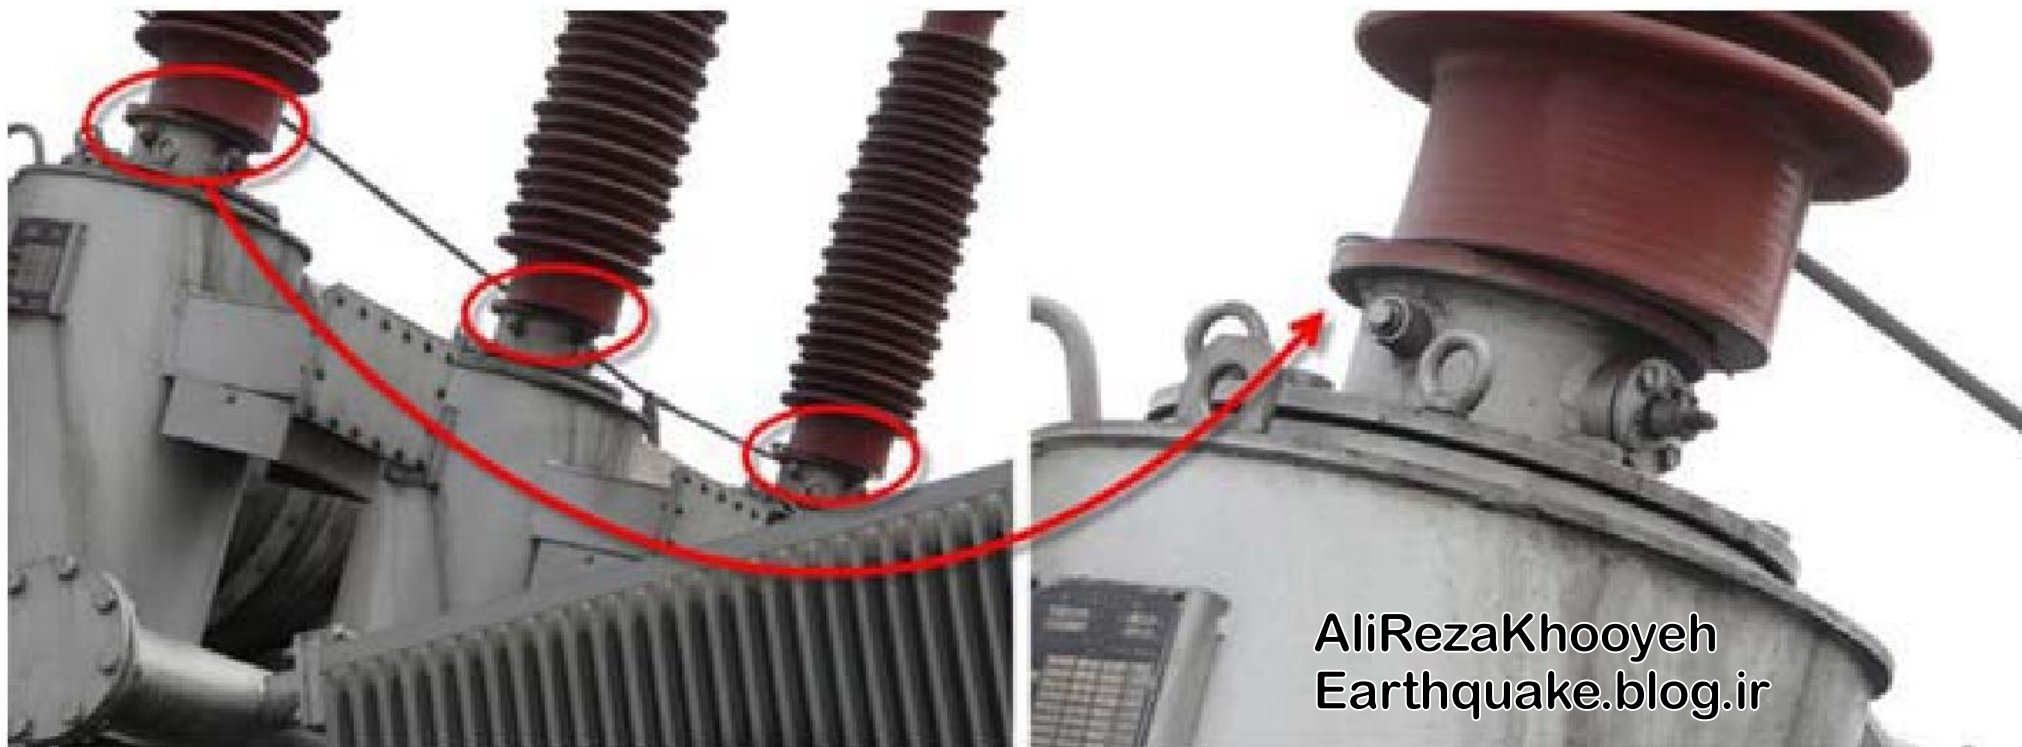
Slippage at the bottom of porcelain bushing and subsequent oil leakage falling off the foundation on the ground if displacement exceeded the foundation dimensions,

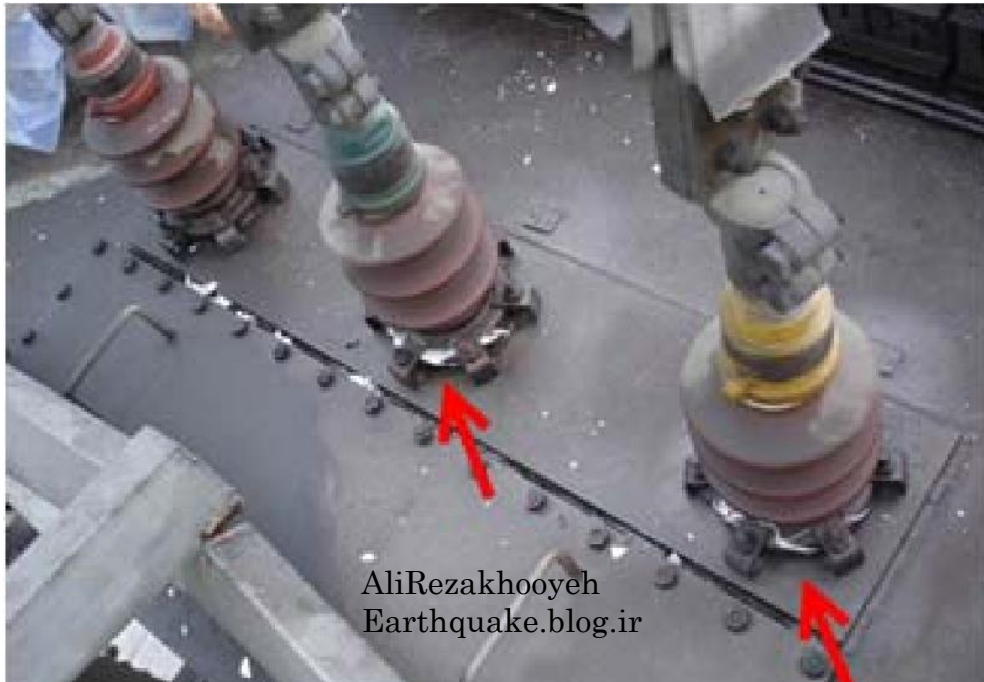
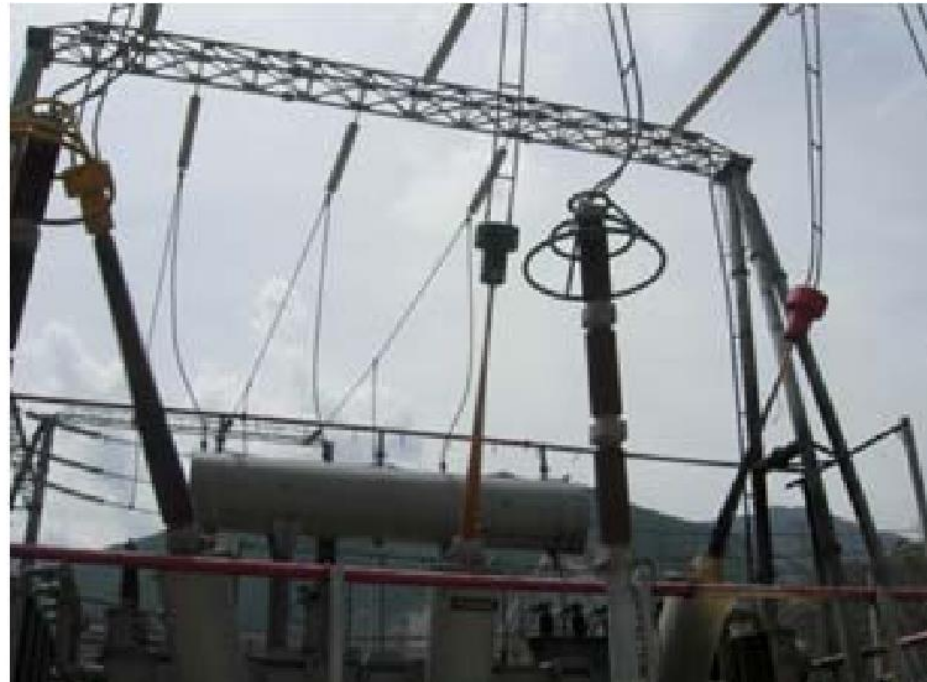
Fracture at the porcelain bushings
slippage of an anchored transformer on
its foundation,

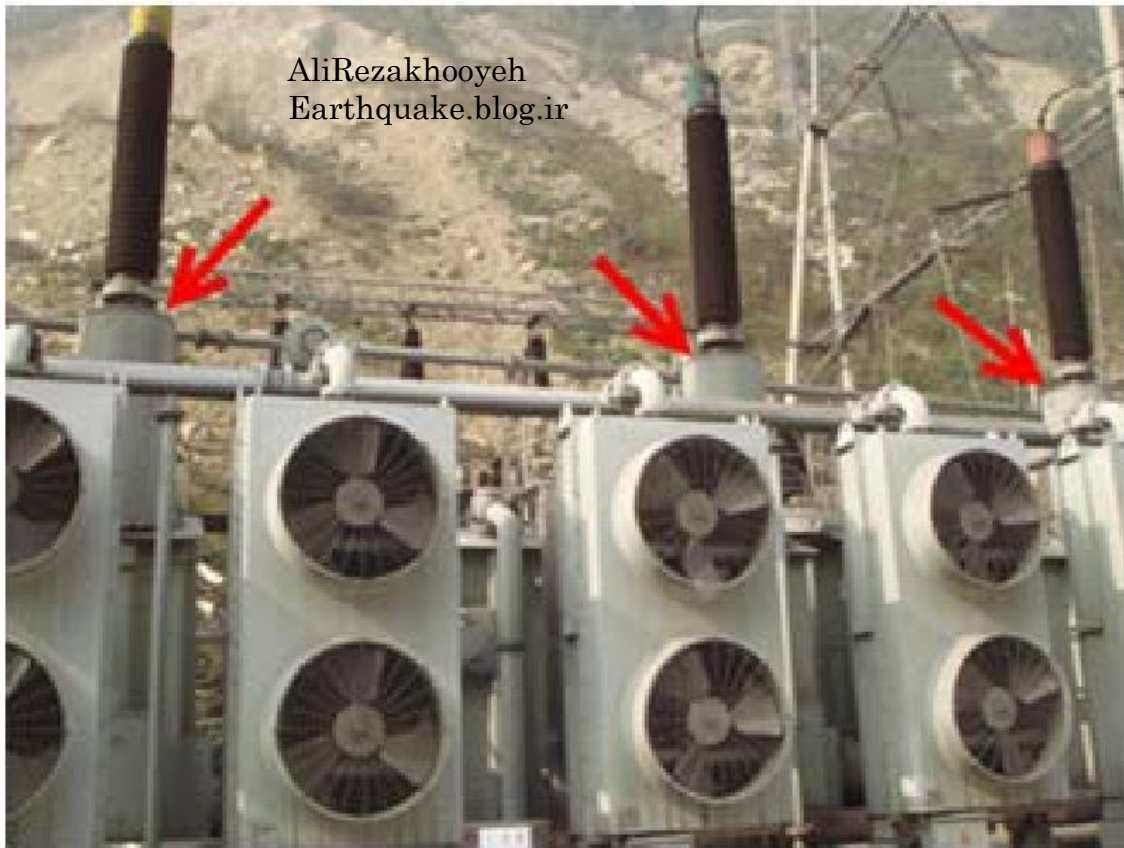
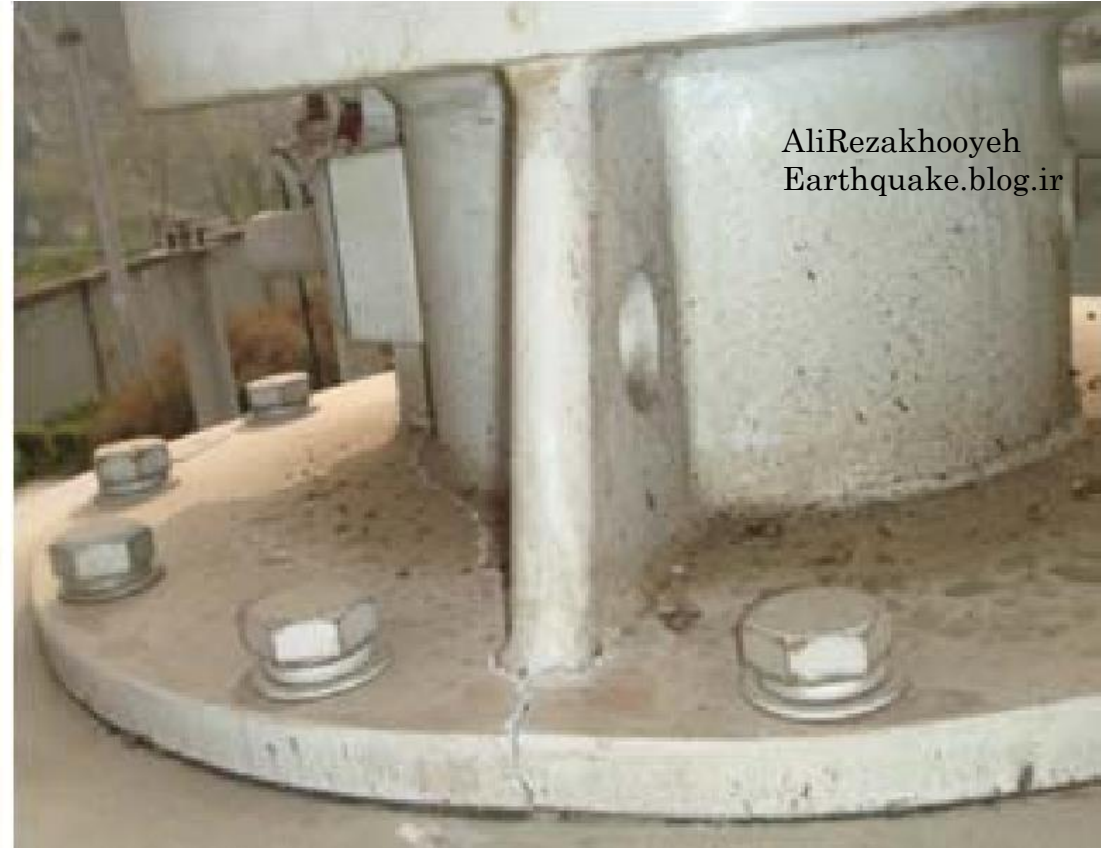
Fracture at the bottom of cast-aluminum flange collapse due falling on the ground

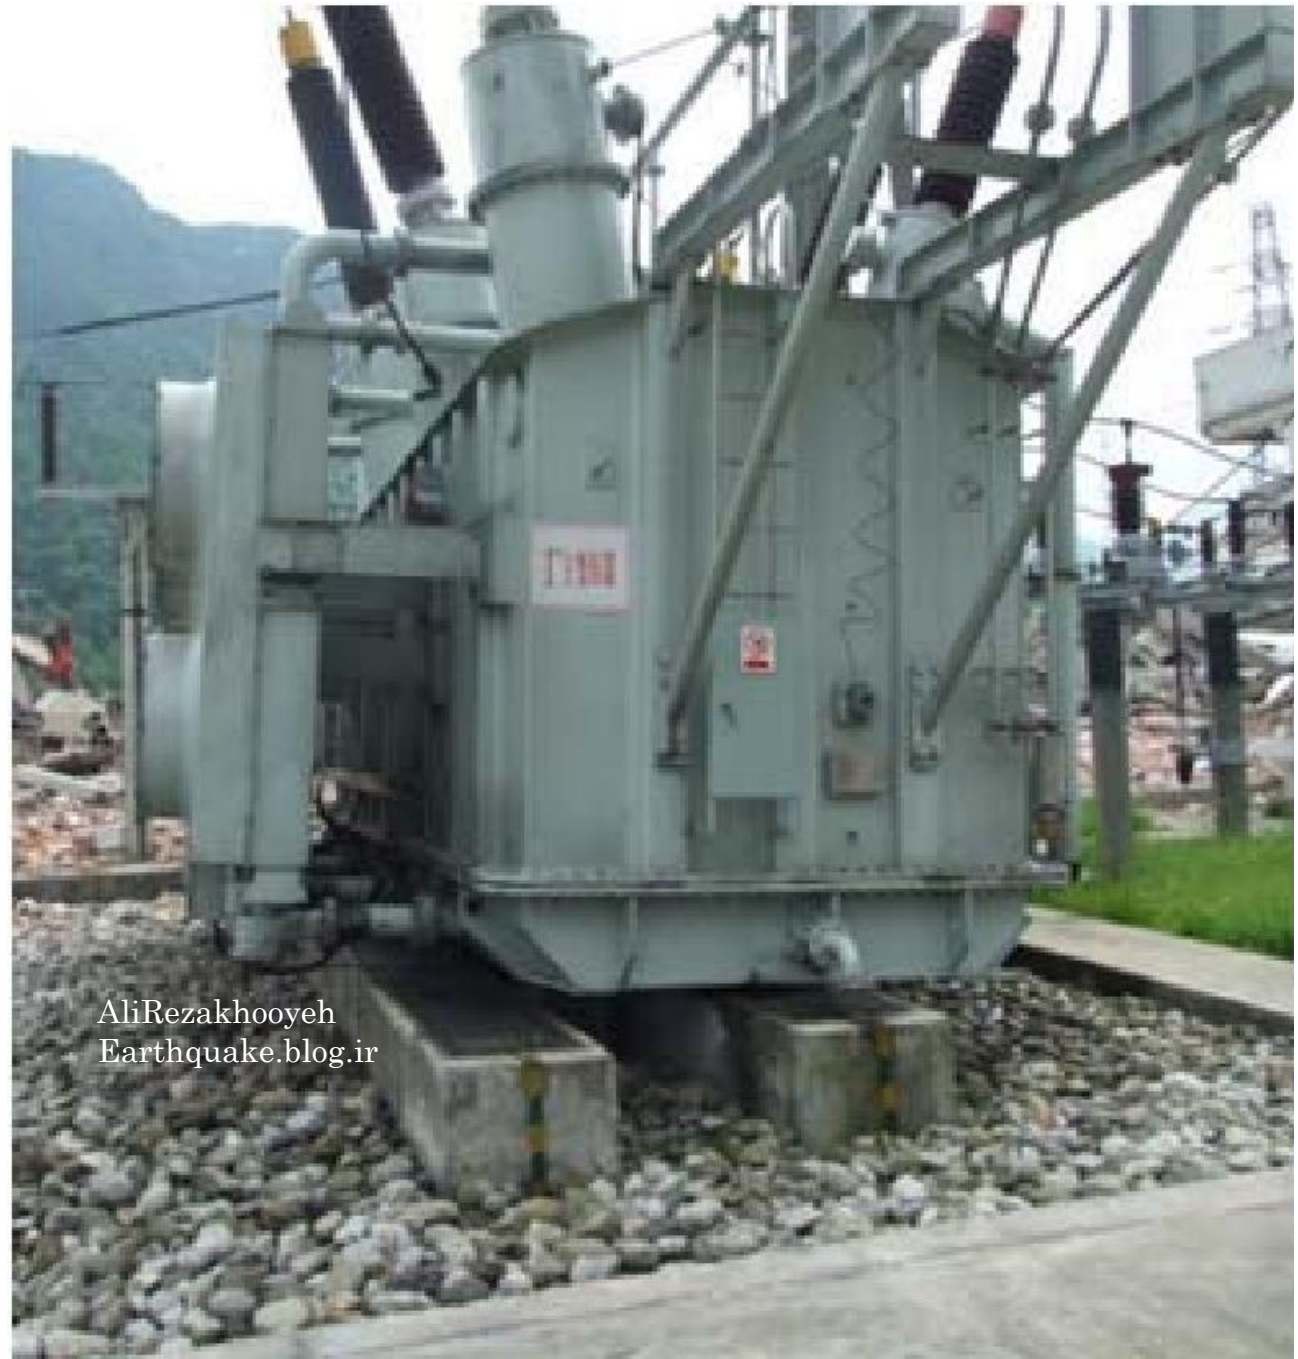
Slippage of a 220kV transformer

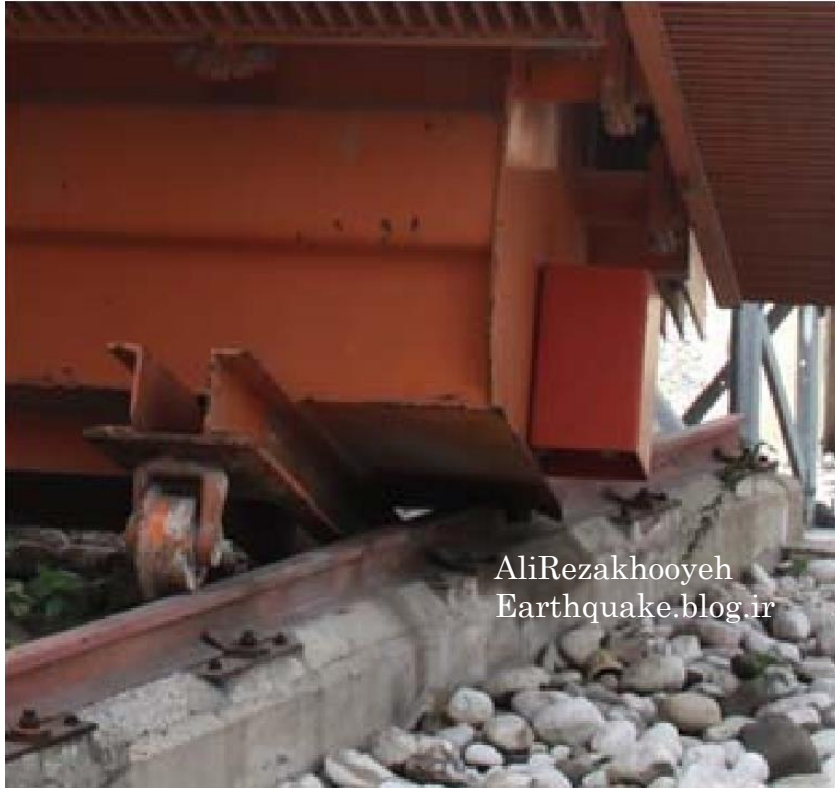
Oil leakage from the tank of the transformer

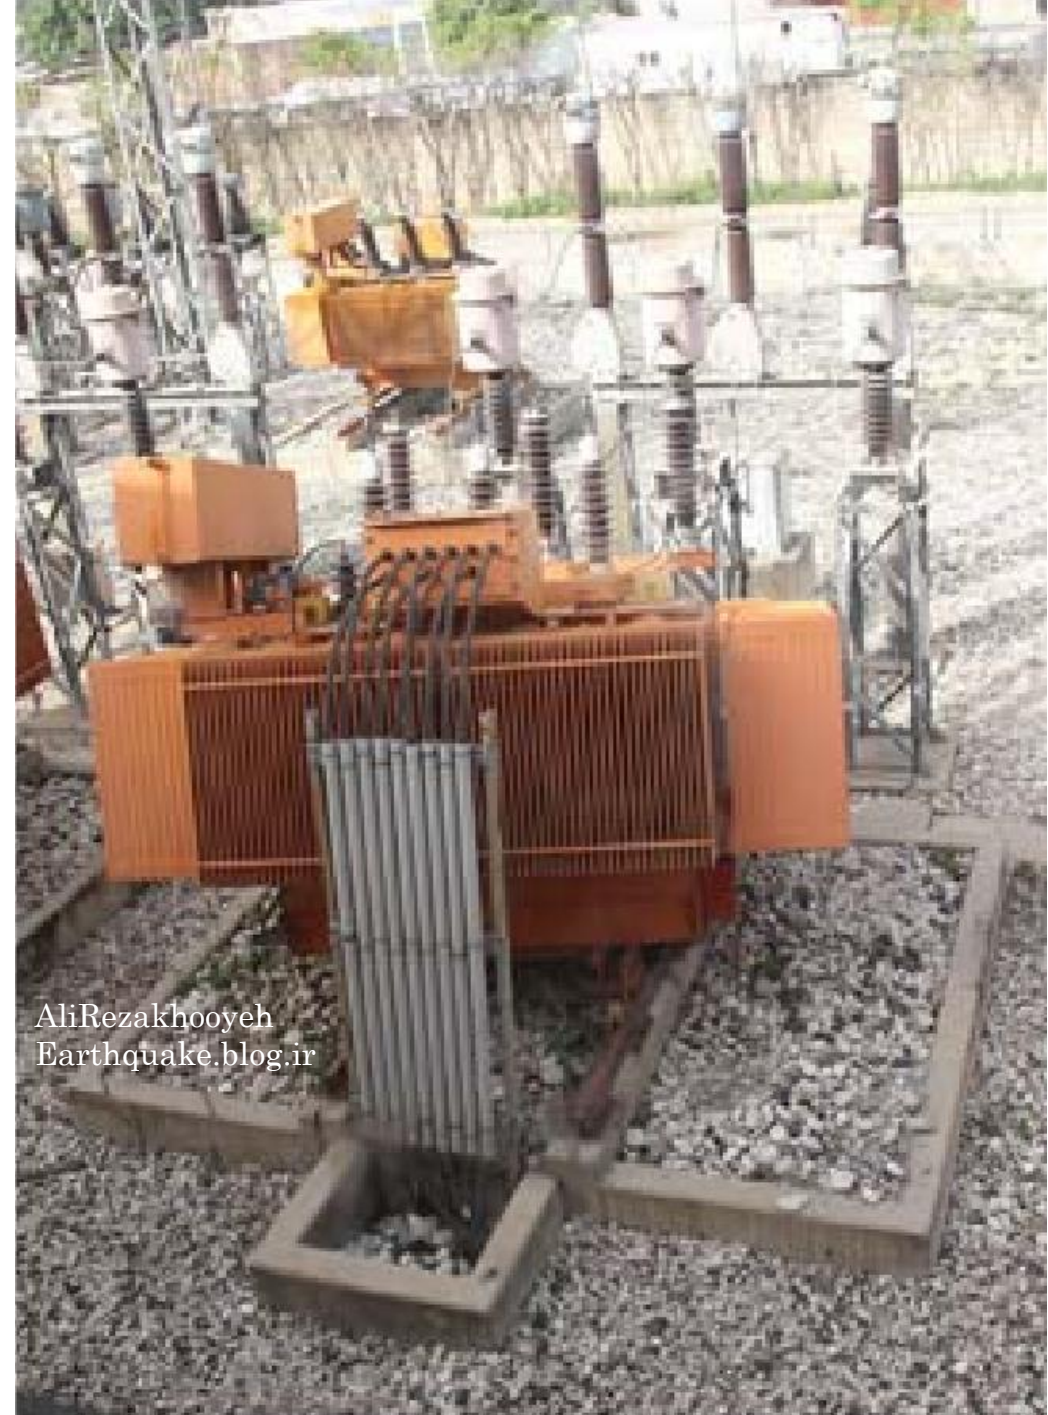
transformer in Haiti
earthquake (left image – top view and right image - oil
leakage from the tank of the transformer).

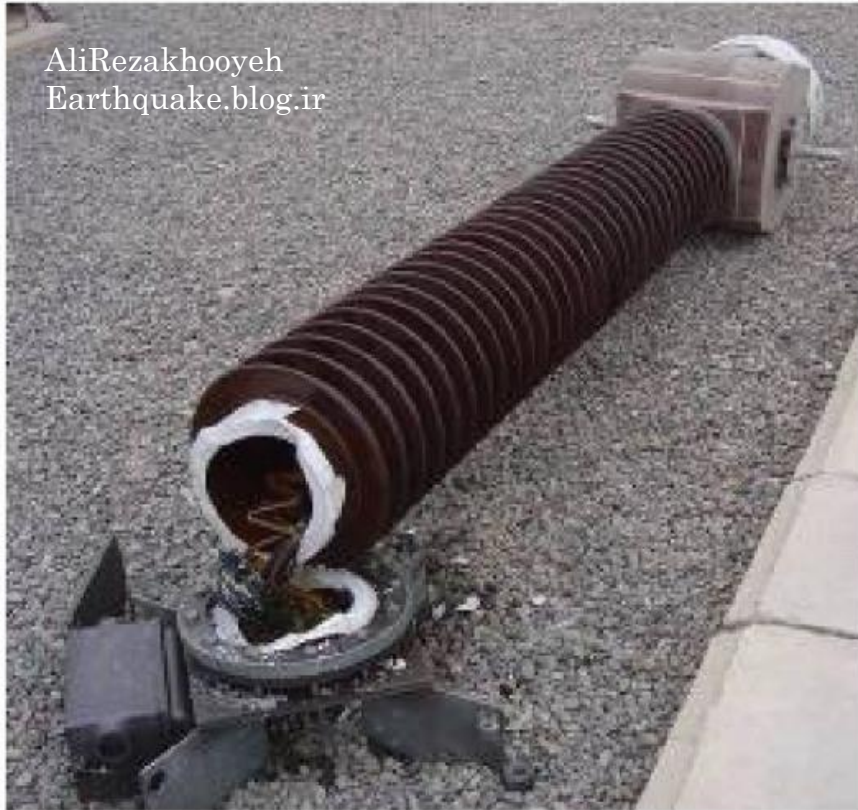
Figure 2: A broken CT

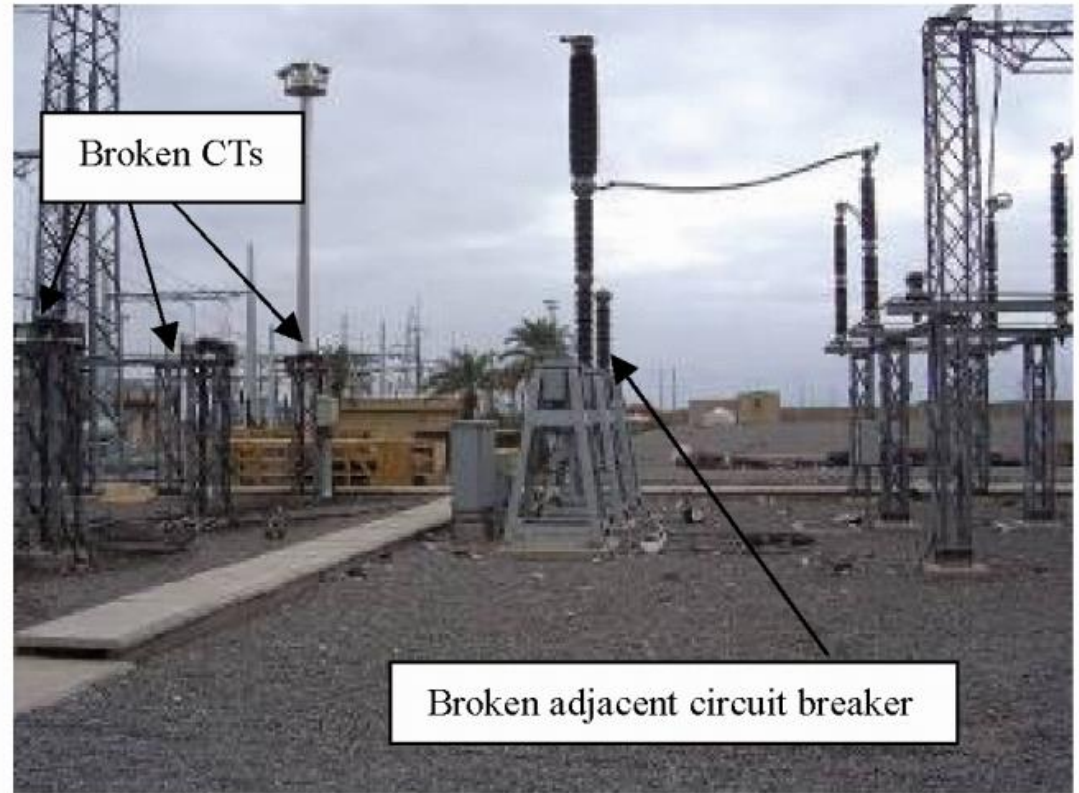
Figure 3: Fallen adjacent equipments

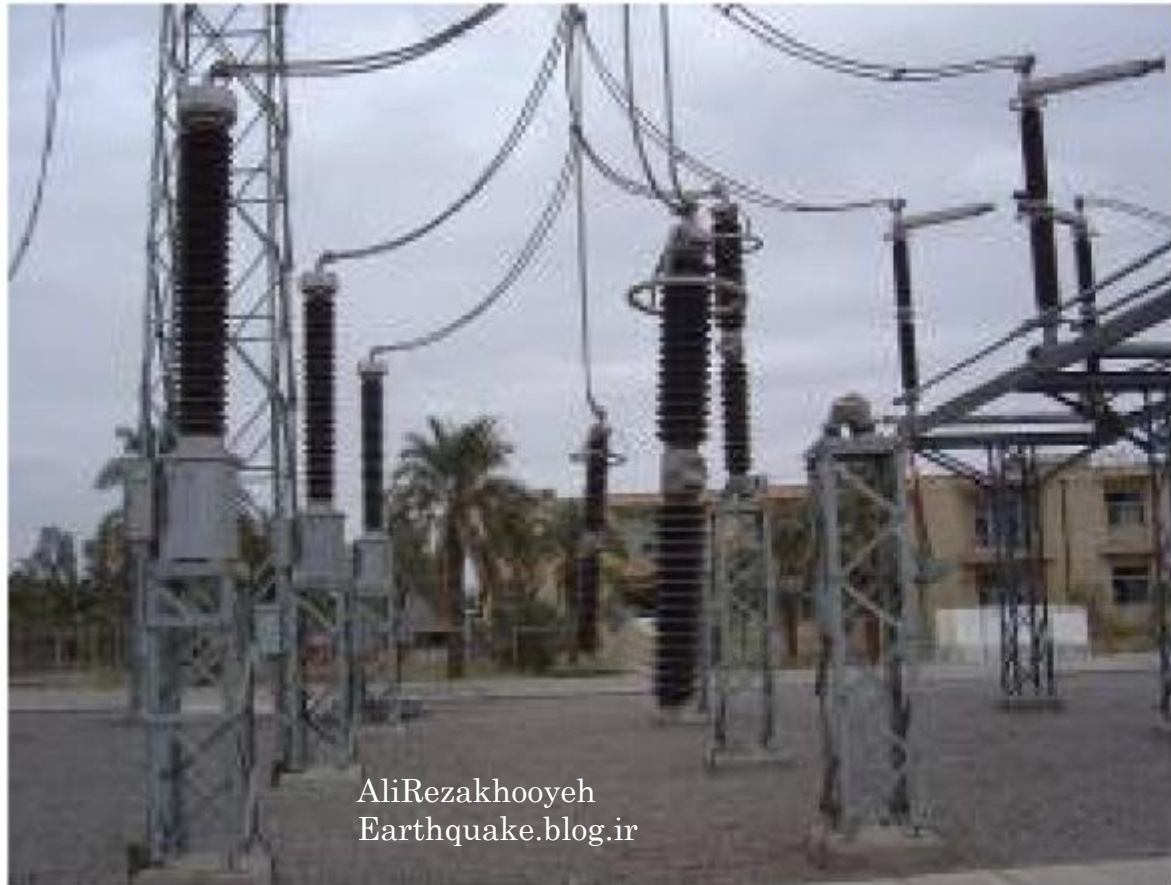
Figure 8: Broken surge arresters

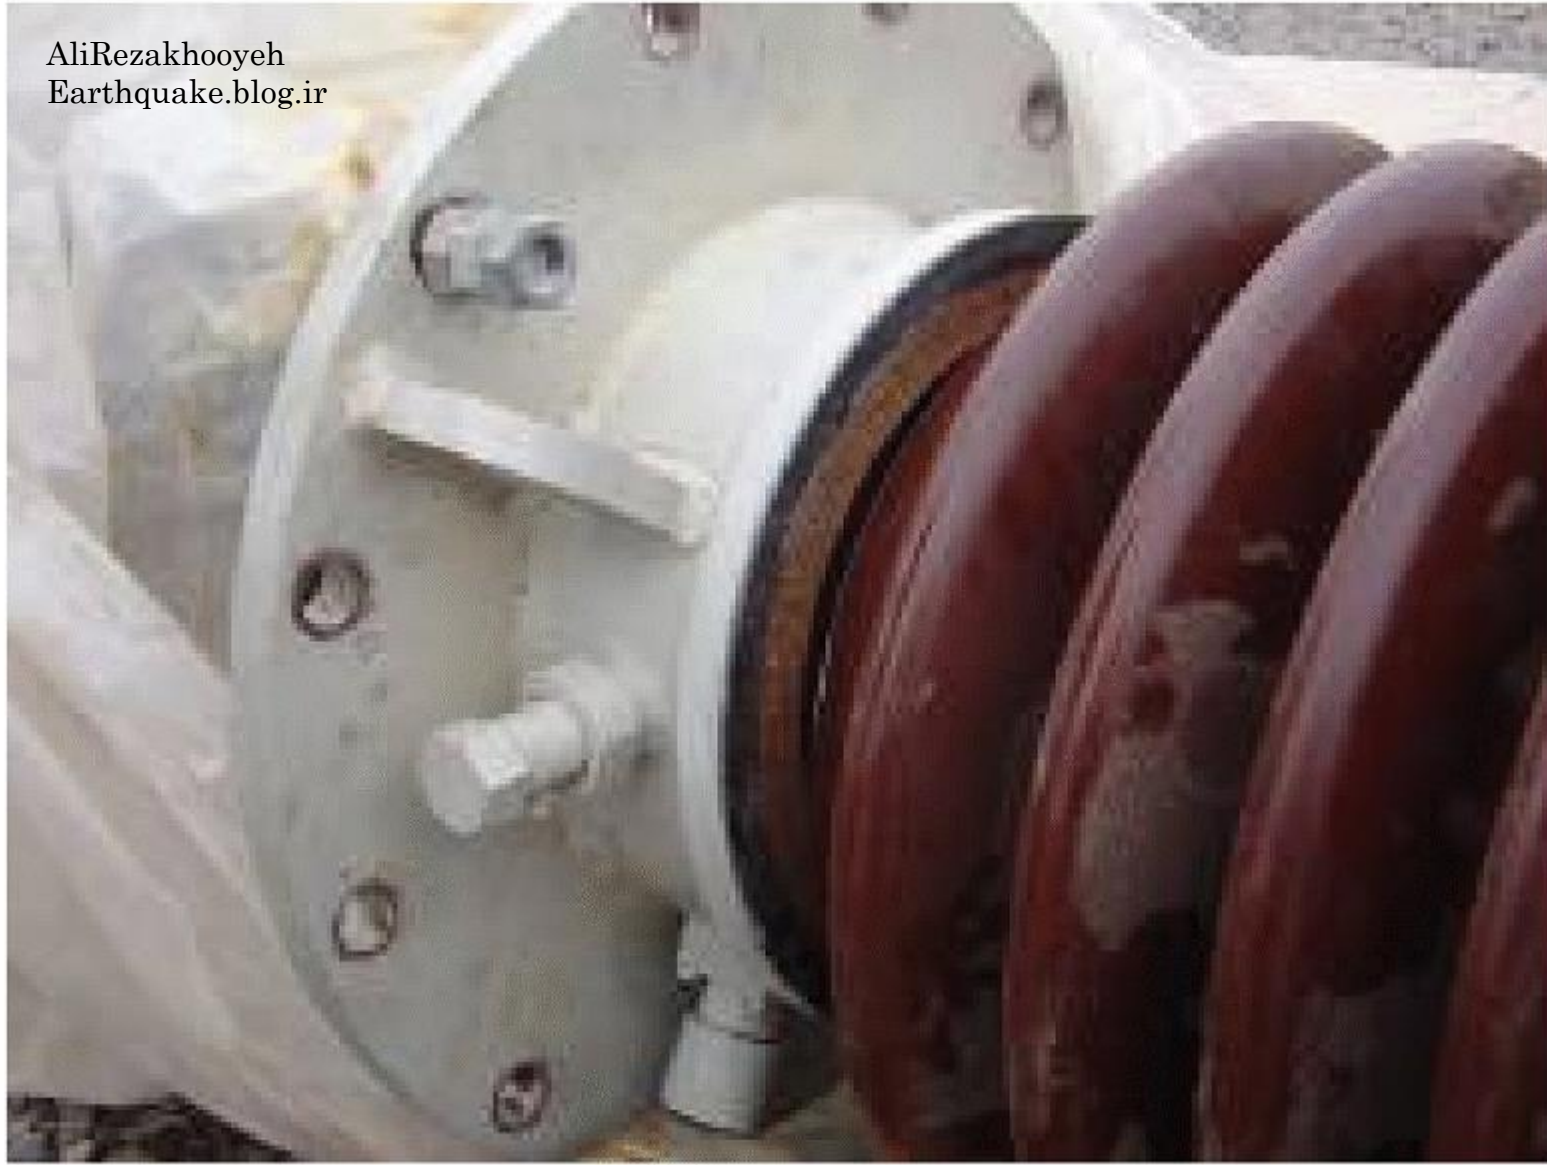
Figure 11: Cracked bushing
