Earthquake Damage to the Electric-Power Infrastructure- Substation

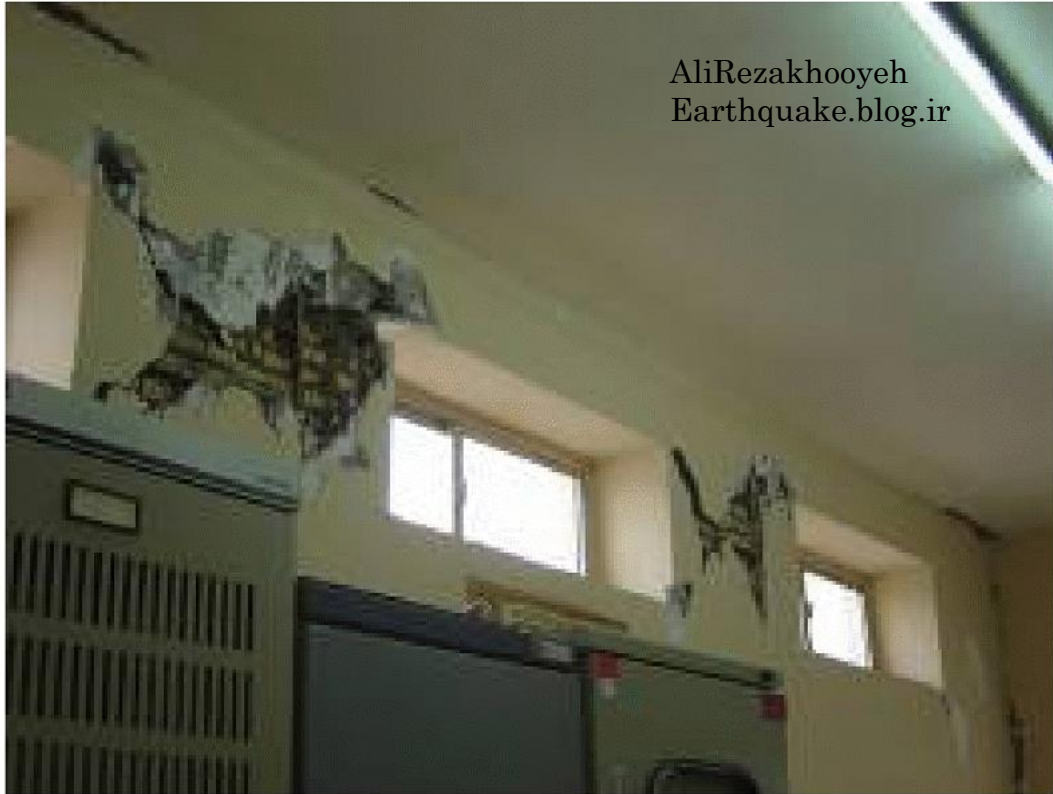
Figure 12: Damages to control building

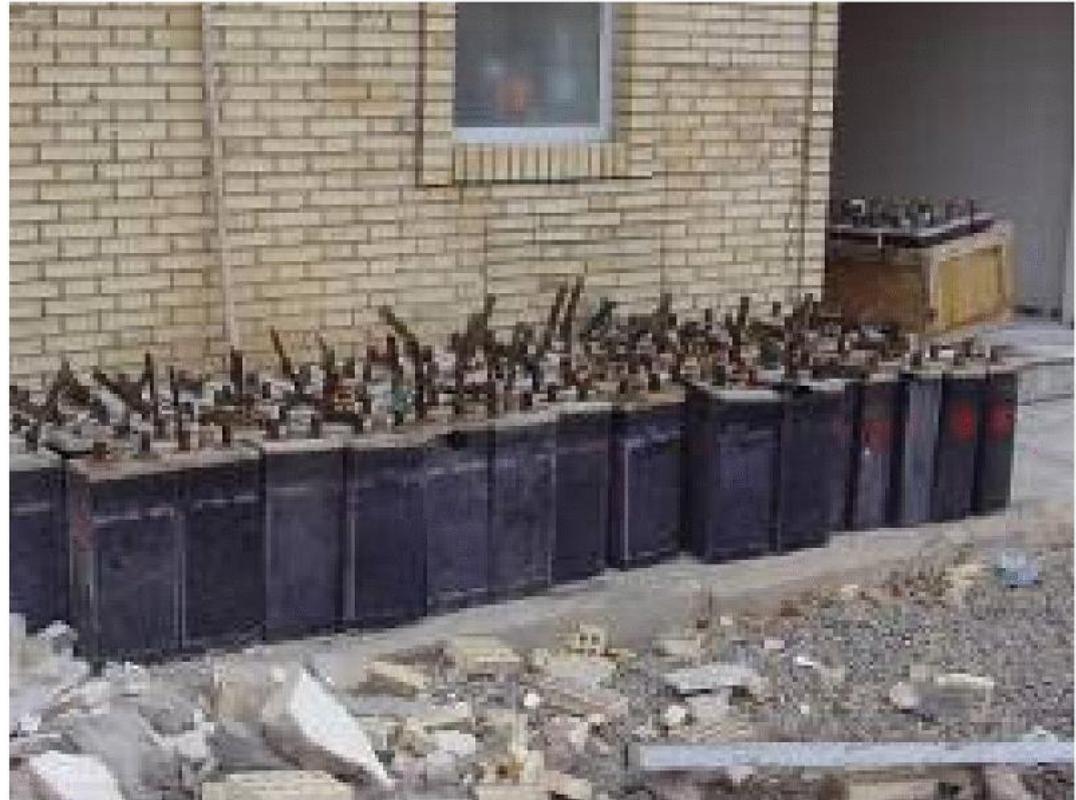
Figure 13: Damaged batteries

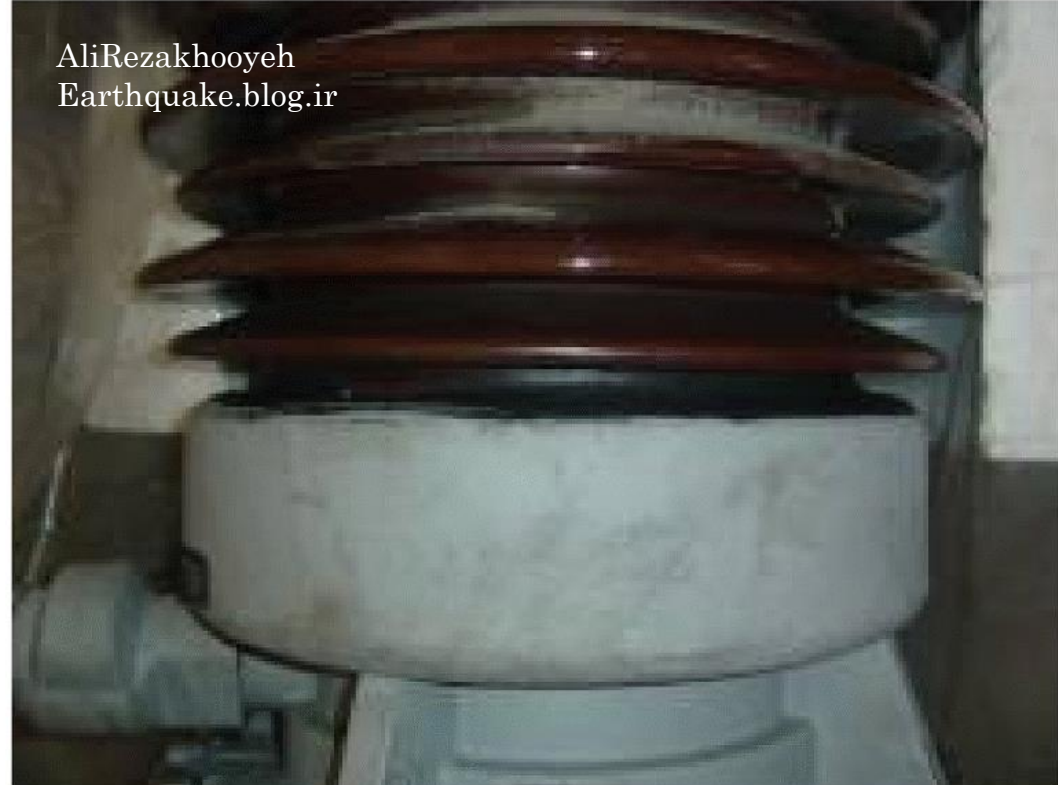
Figure 15: Damaged bushing

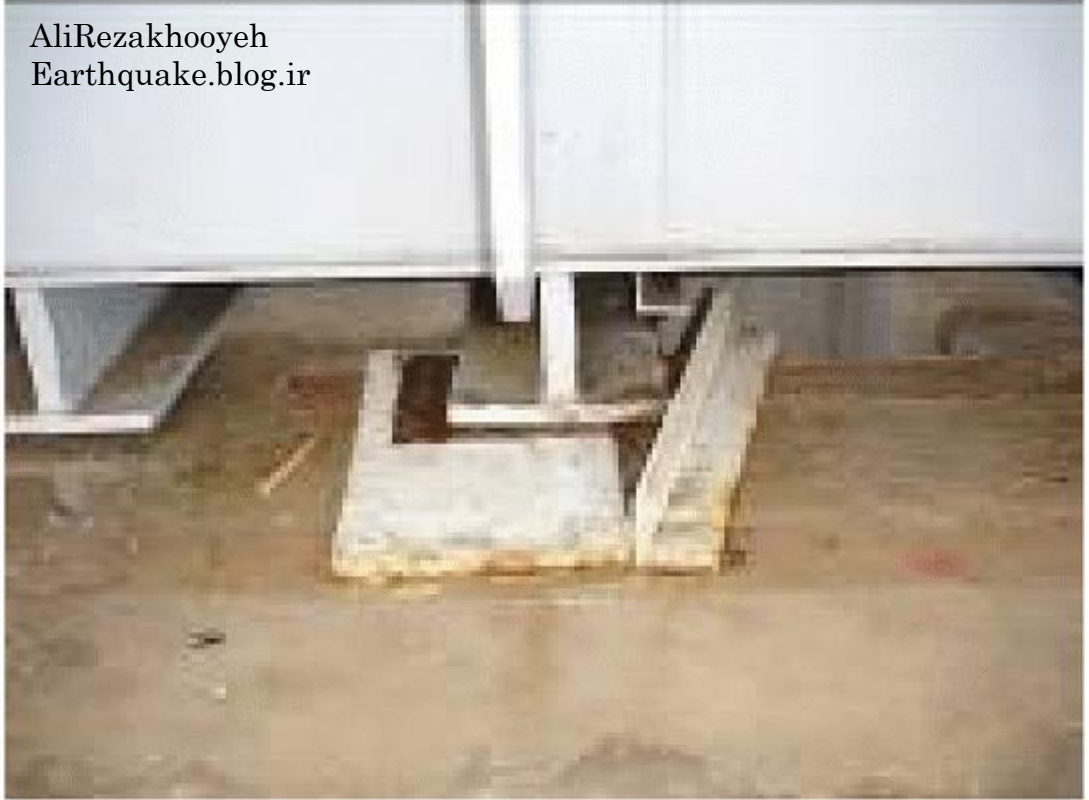
Figure 18: Trans sliding

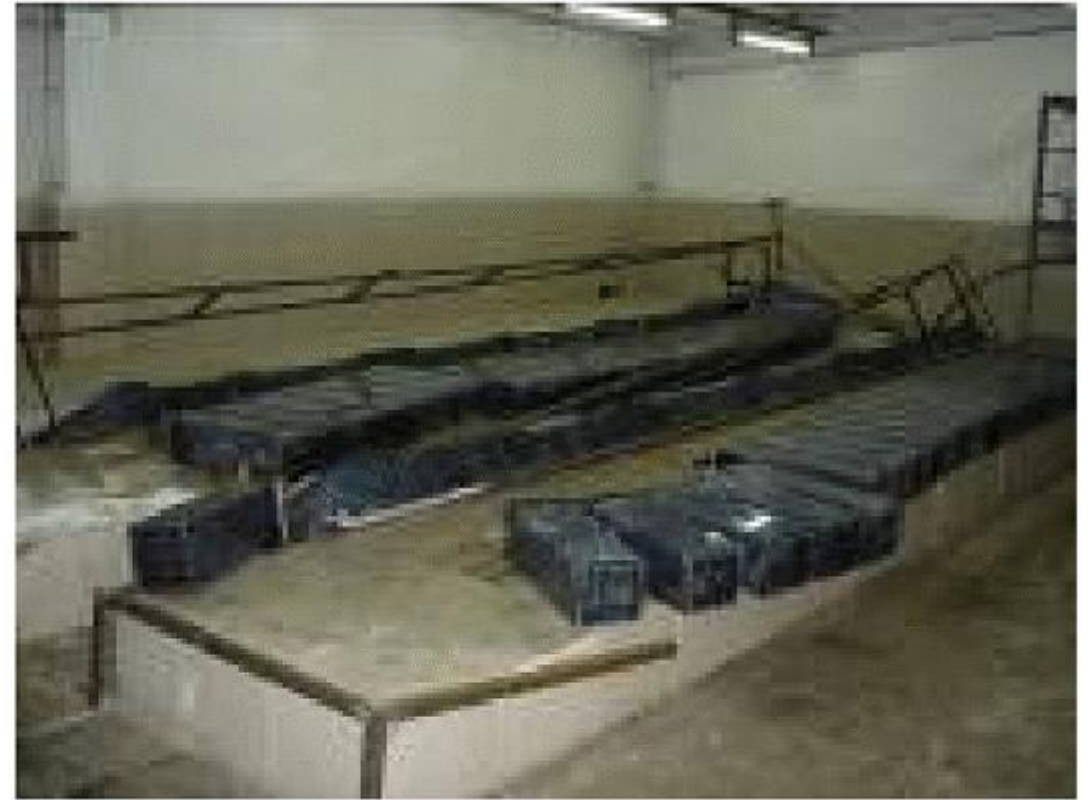
Figure 19: Damaged batteries

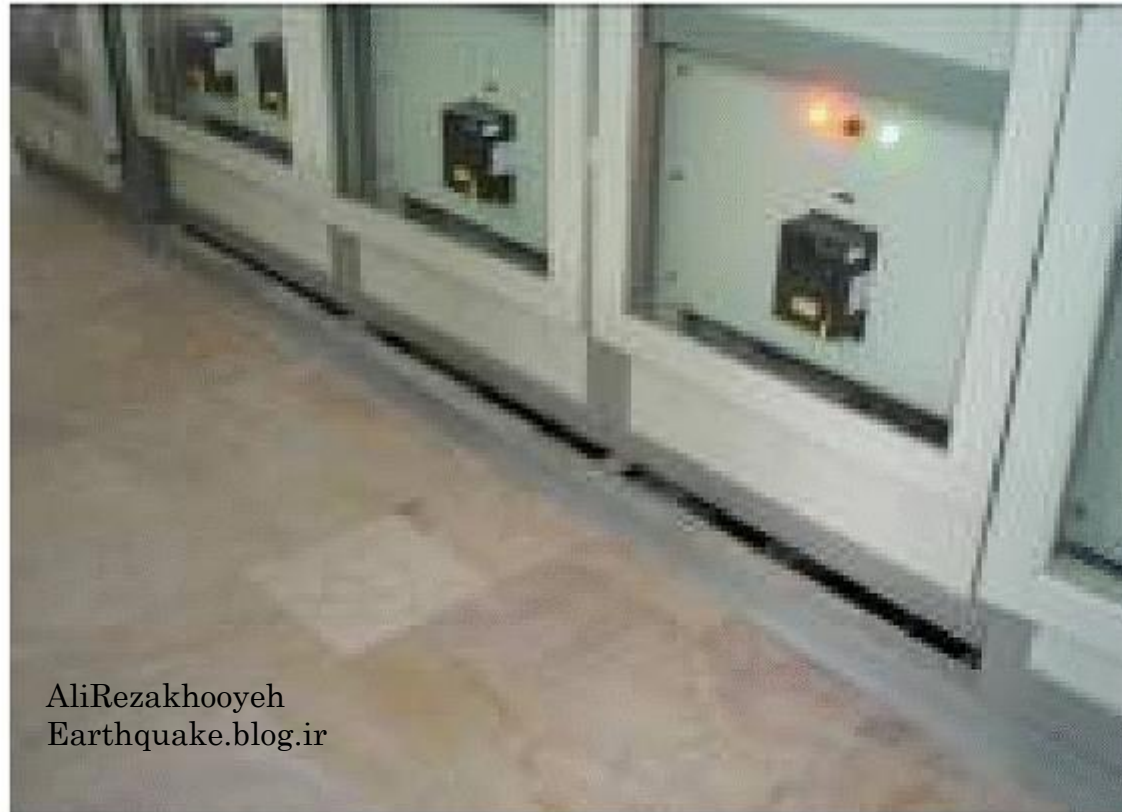
Figure 20: Panel sliding

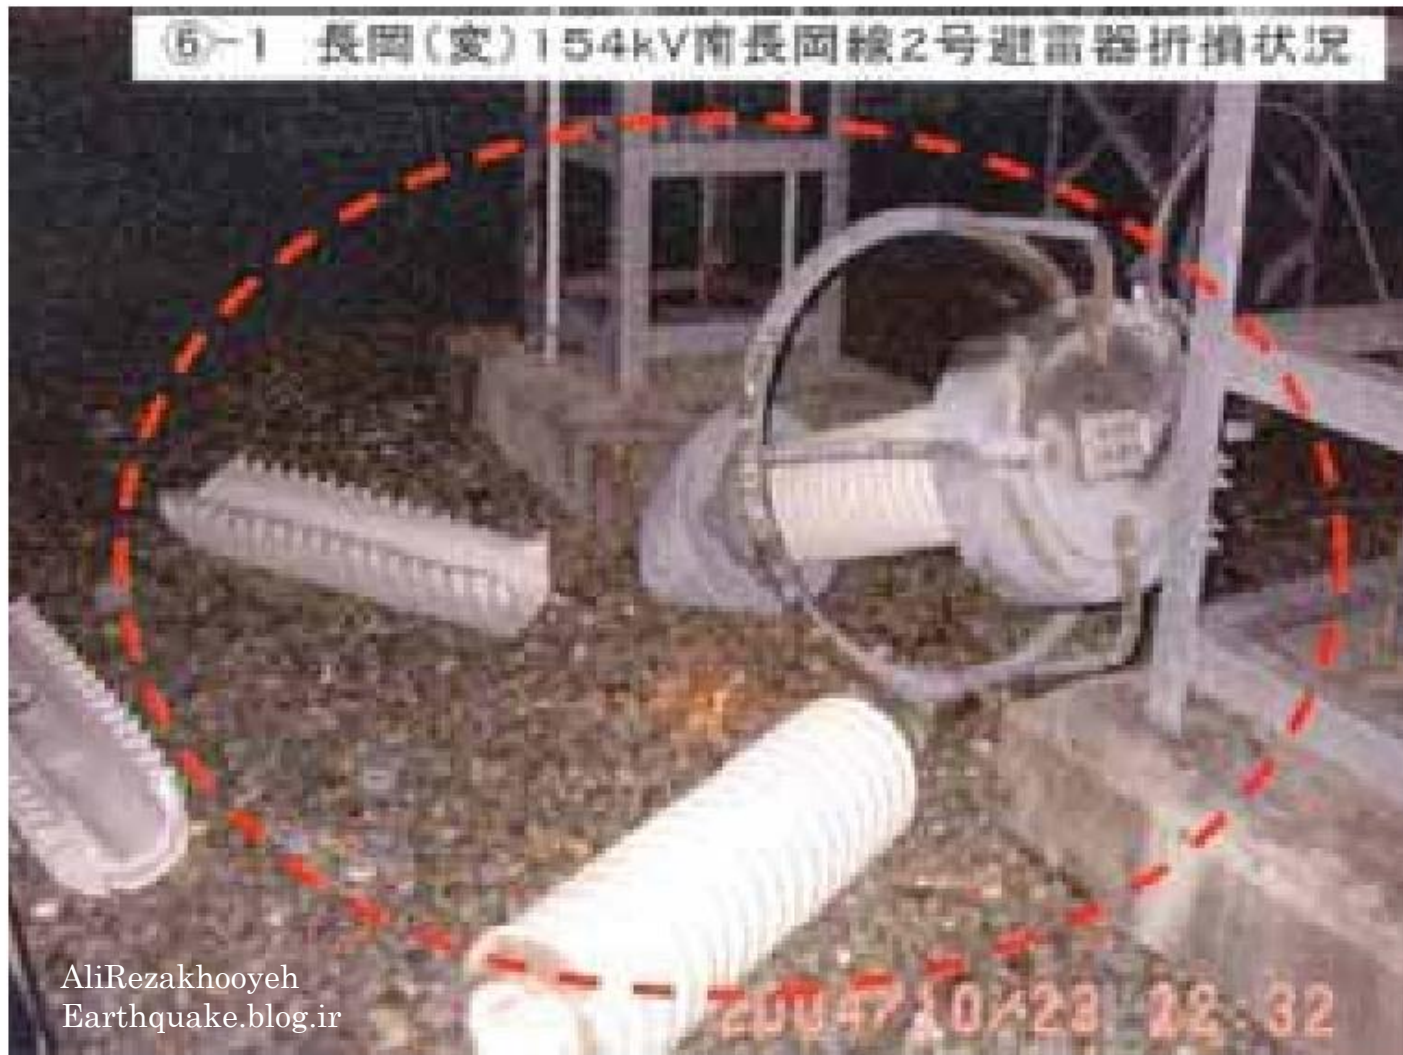
Figure 1 Lightning arresters of all three-phases were broken in Nagaoka Sub.
(JSCE, 2004)

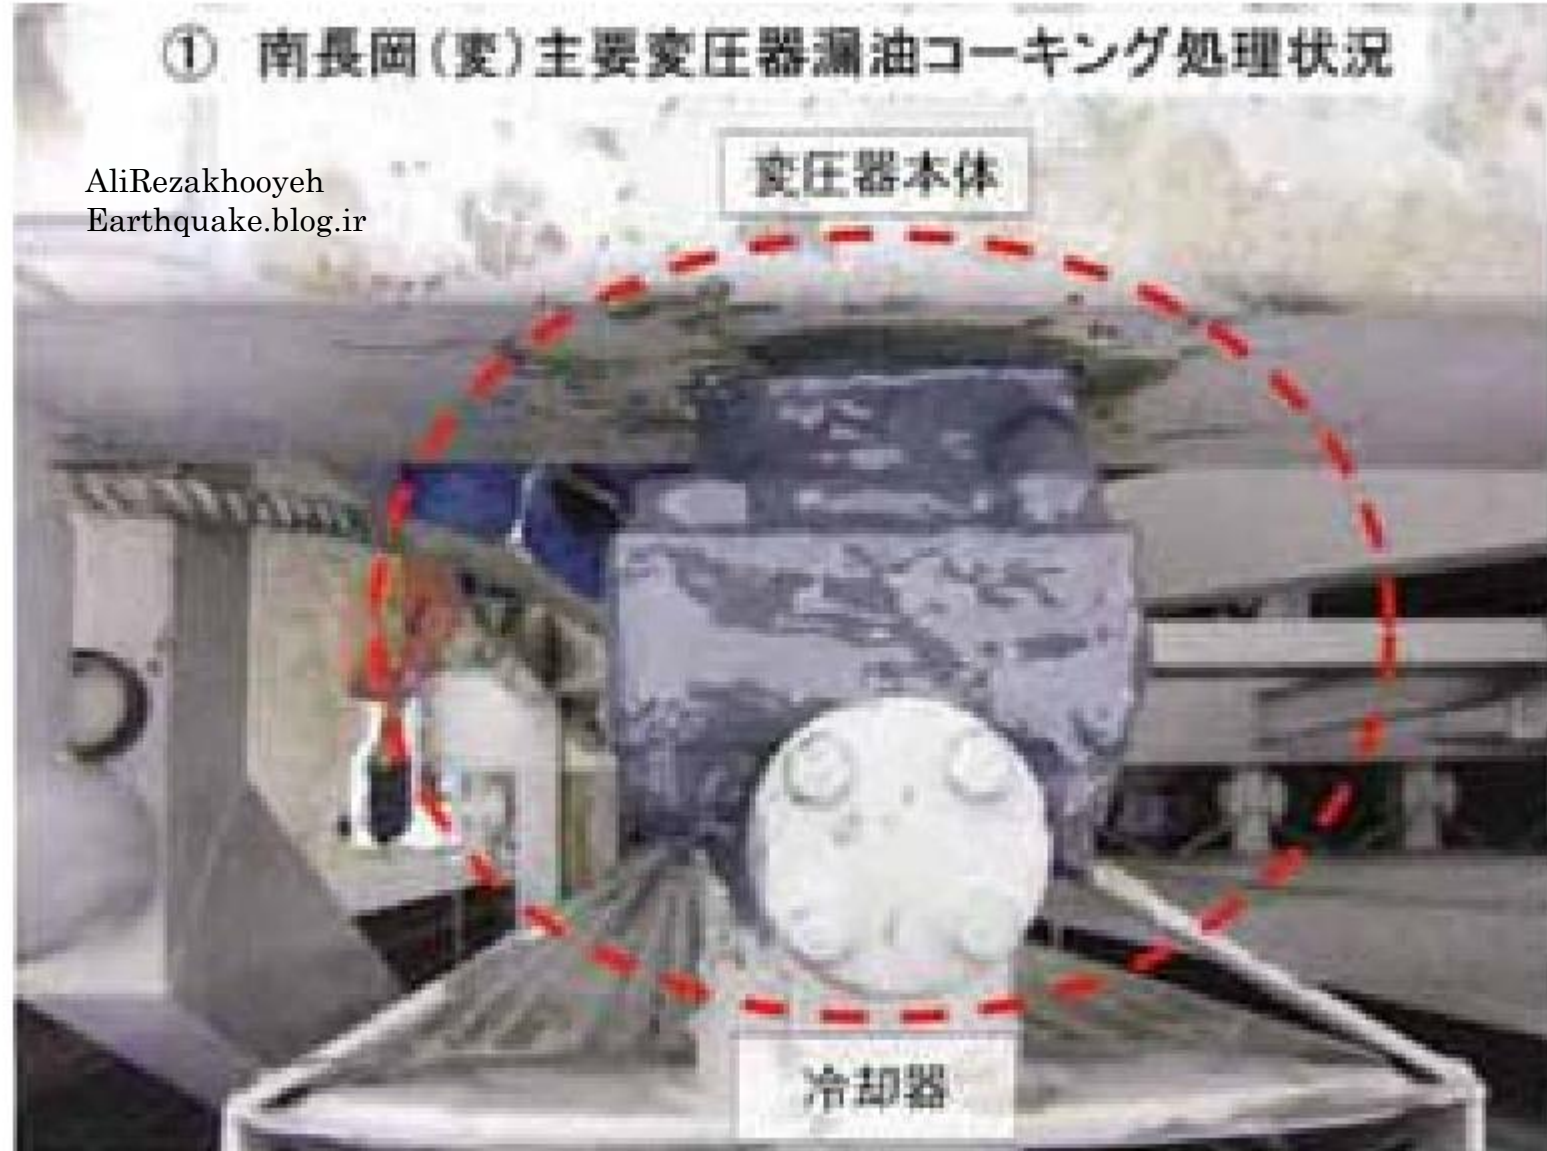
Oil leakage from joint between transformer and condenser in Minami Nagaoka Sub. (JSCE, 2004)

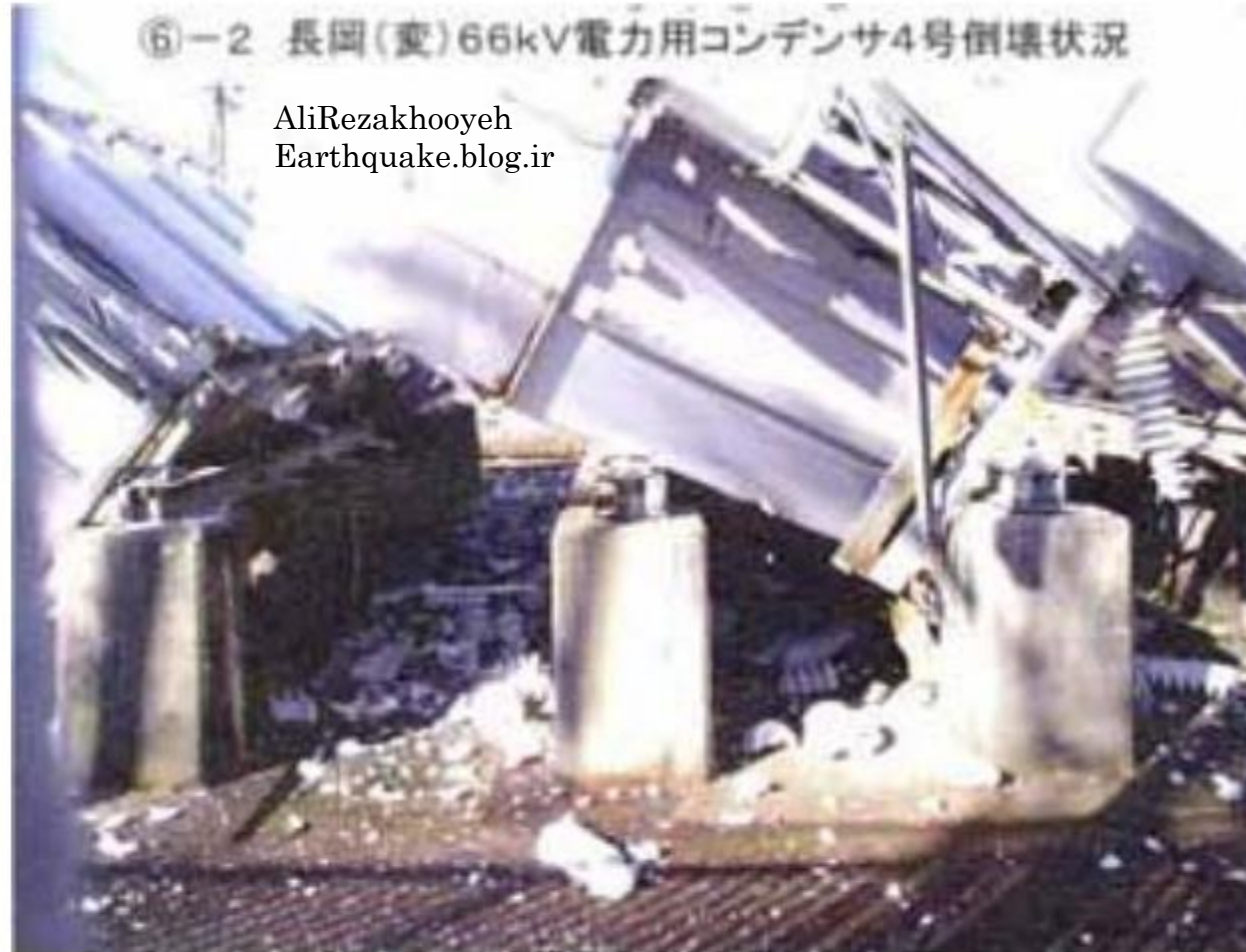
Figure 3 Failure of condenser in Nagaoka sub.
(JSCE, 2004)

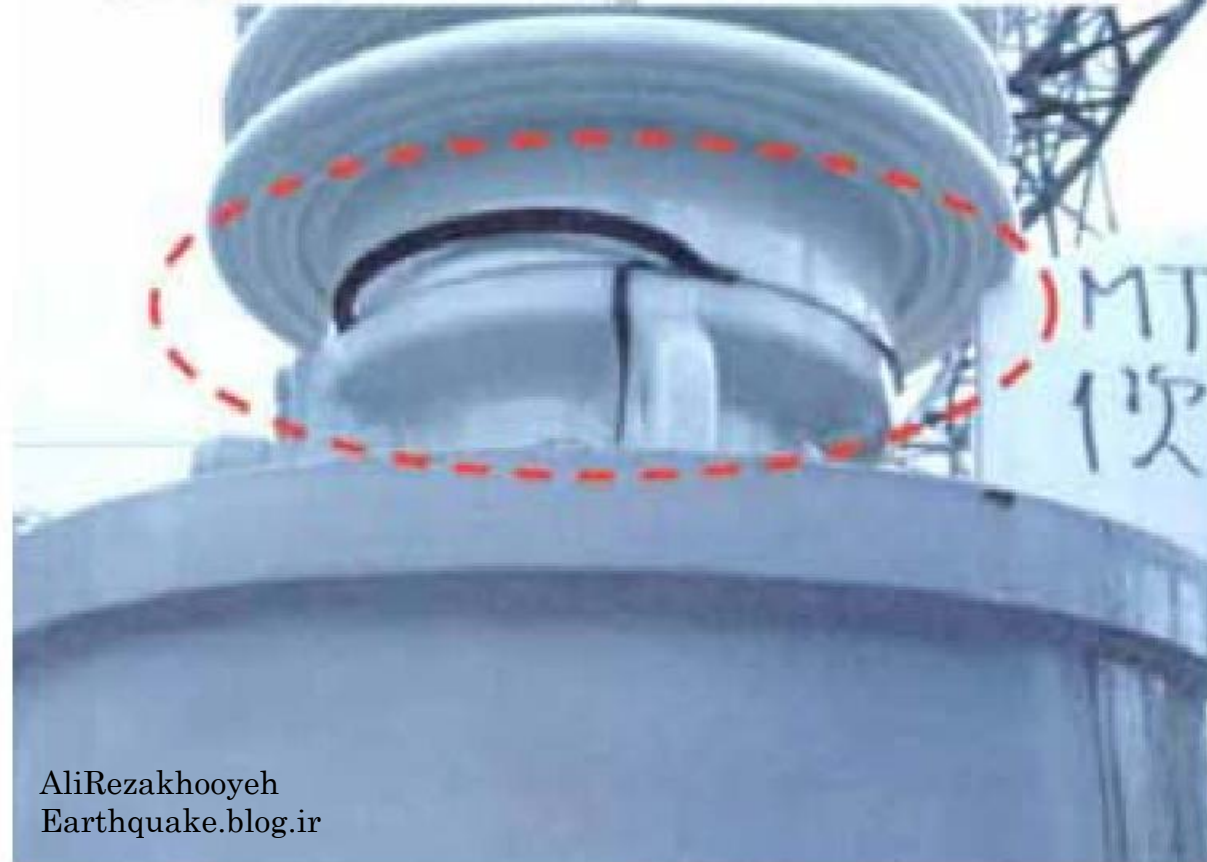
③ 魚沼(変)主要変圧器3号一次ブッシング下部漏油状

Figure 4 Extrusion of gasket and oil leakage
in bushing of 154 kV transformer in Uonuma Sub.
(JSCE, 2004)

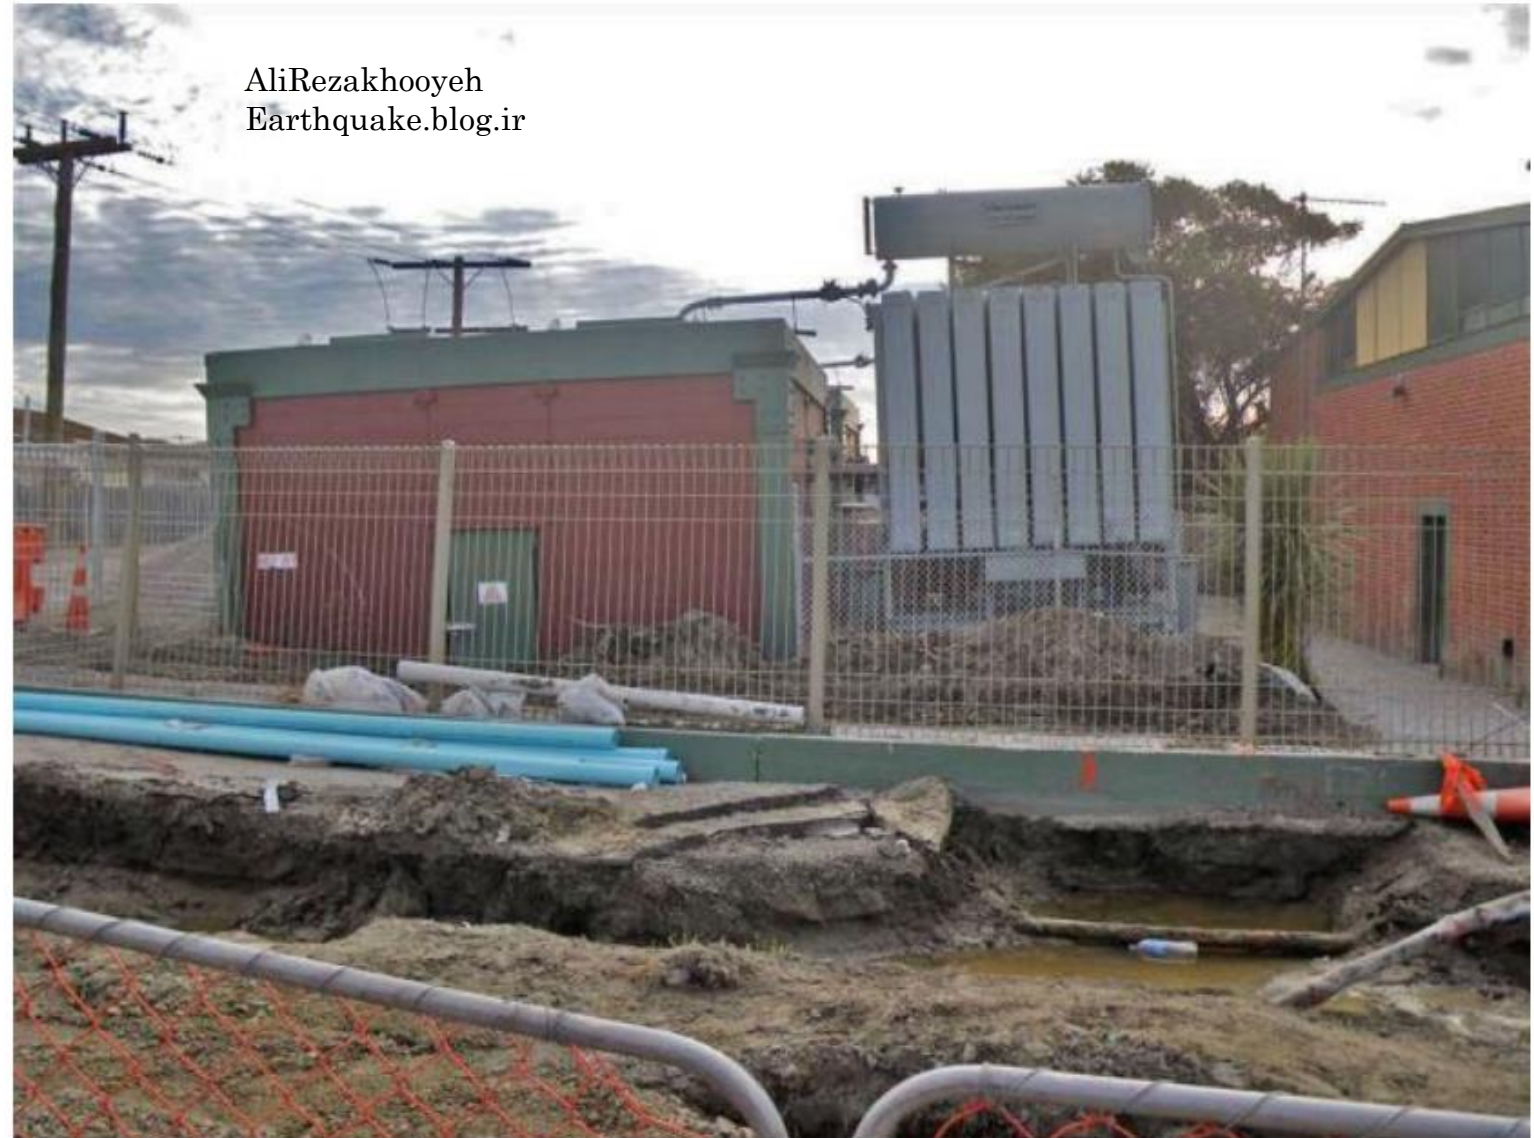
Liquefaction damage (New Brighton Substation)

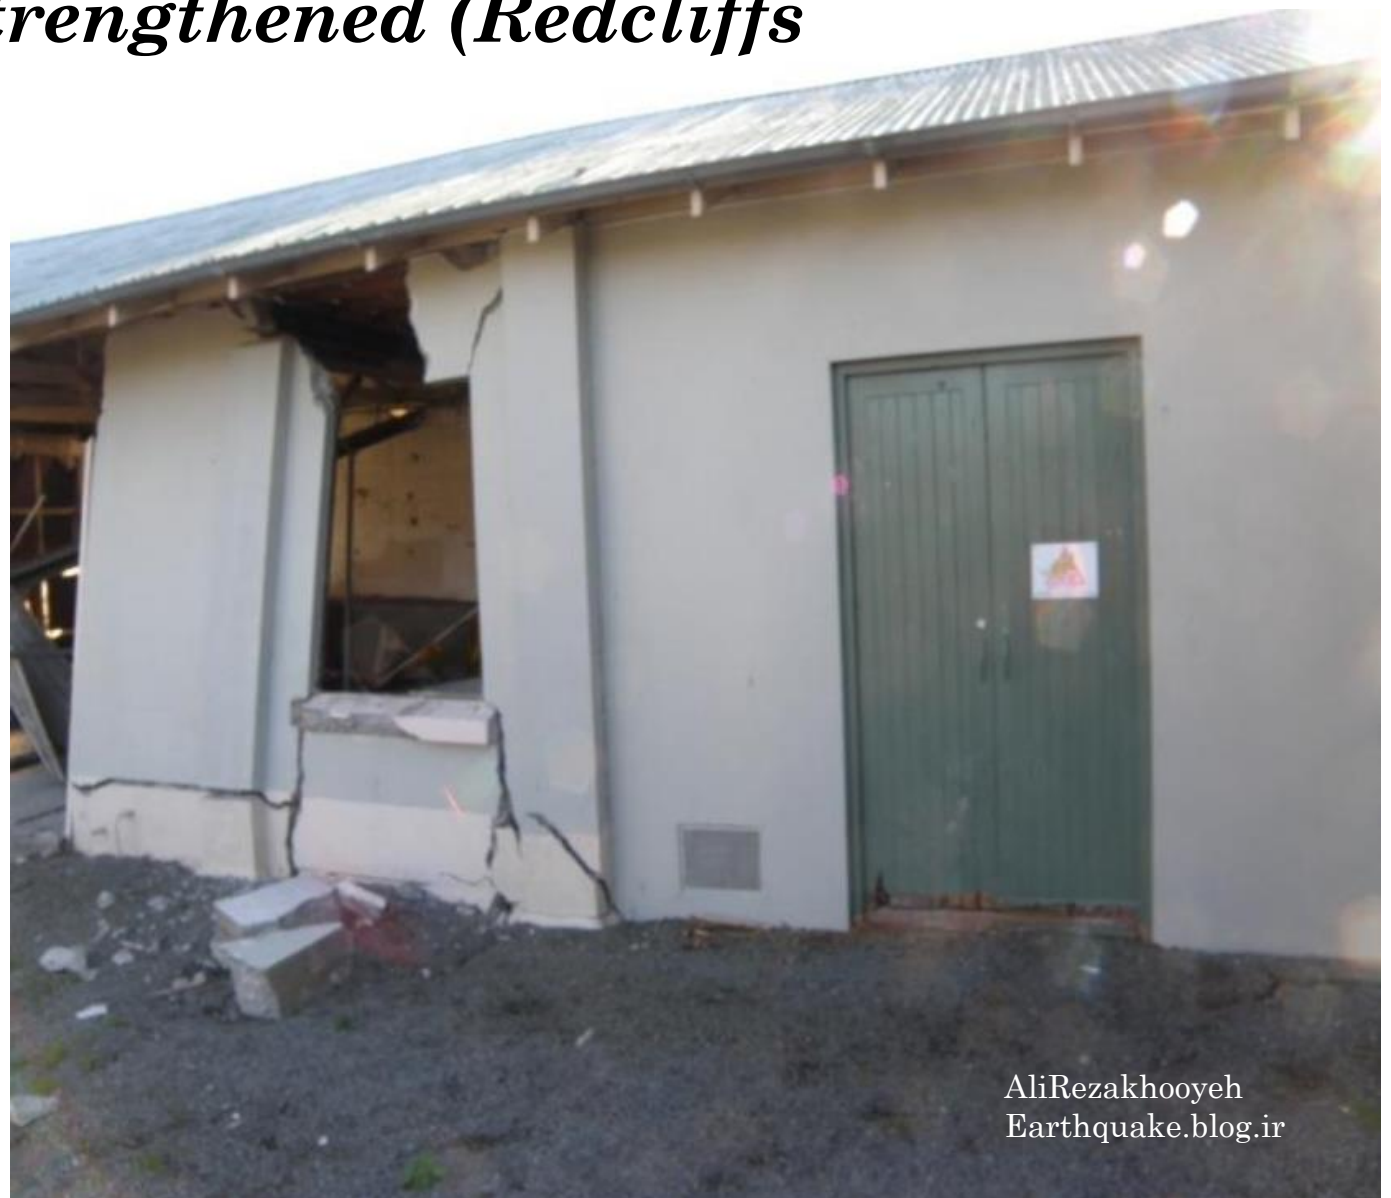
*A shared structure with the electrical substation
having been seismically strengthened (Redcliffs
waterworks substation)*

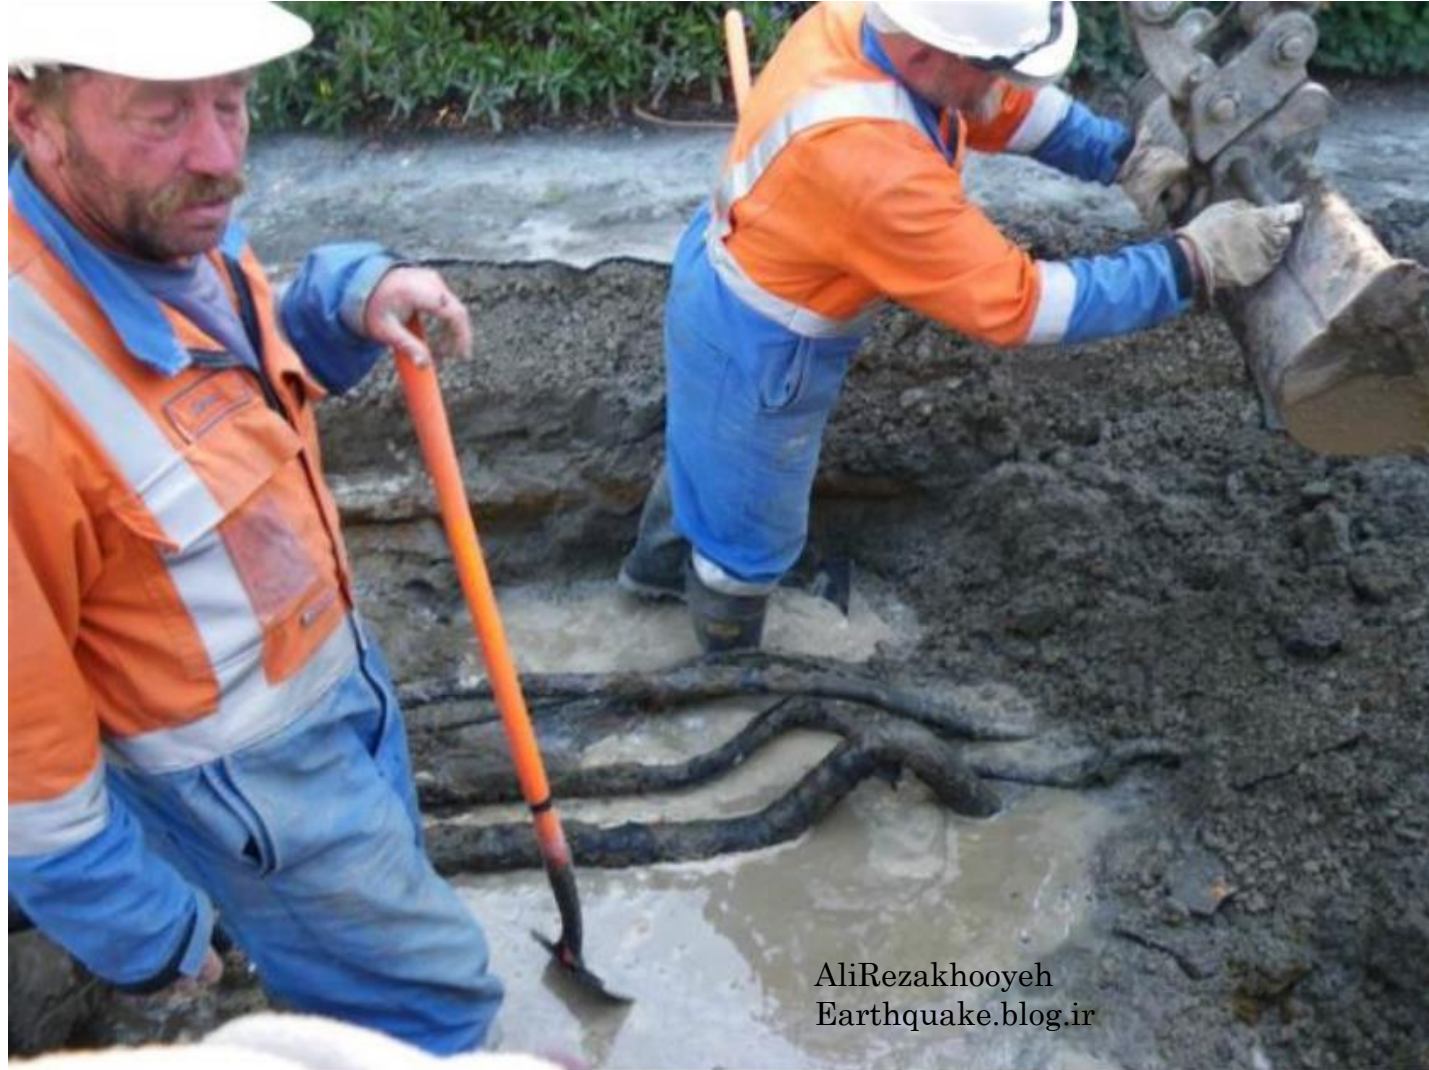
Digging up multiple faulty 11 kV cables

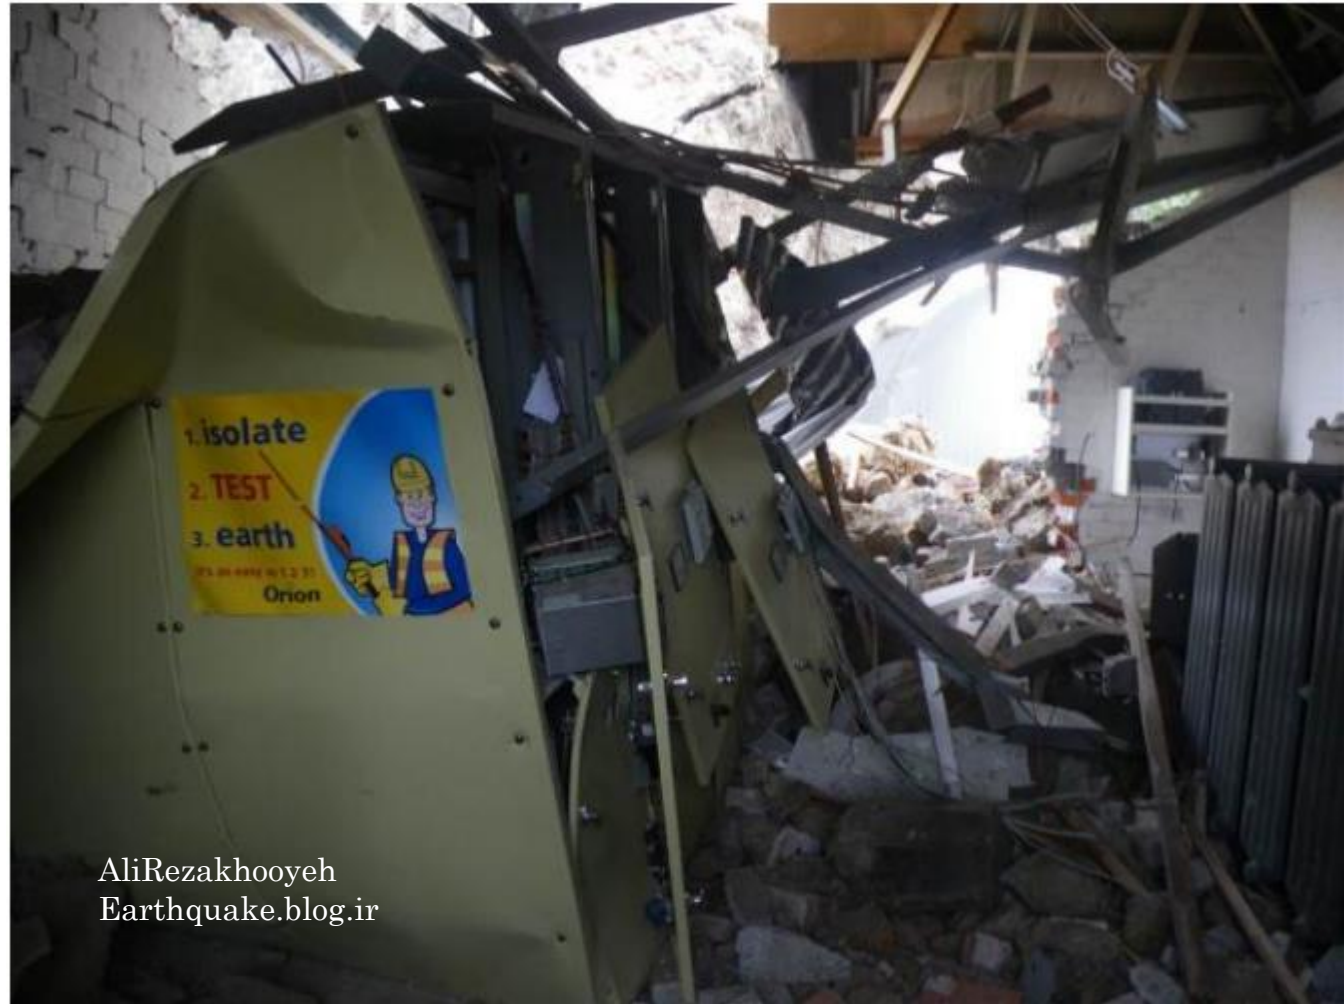
Sumner substation boulder damage

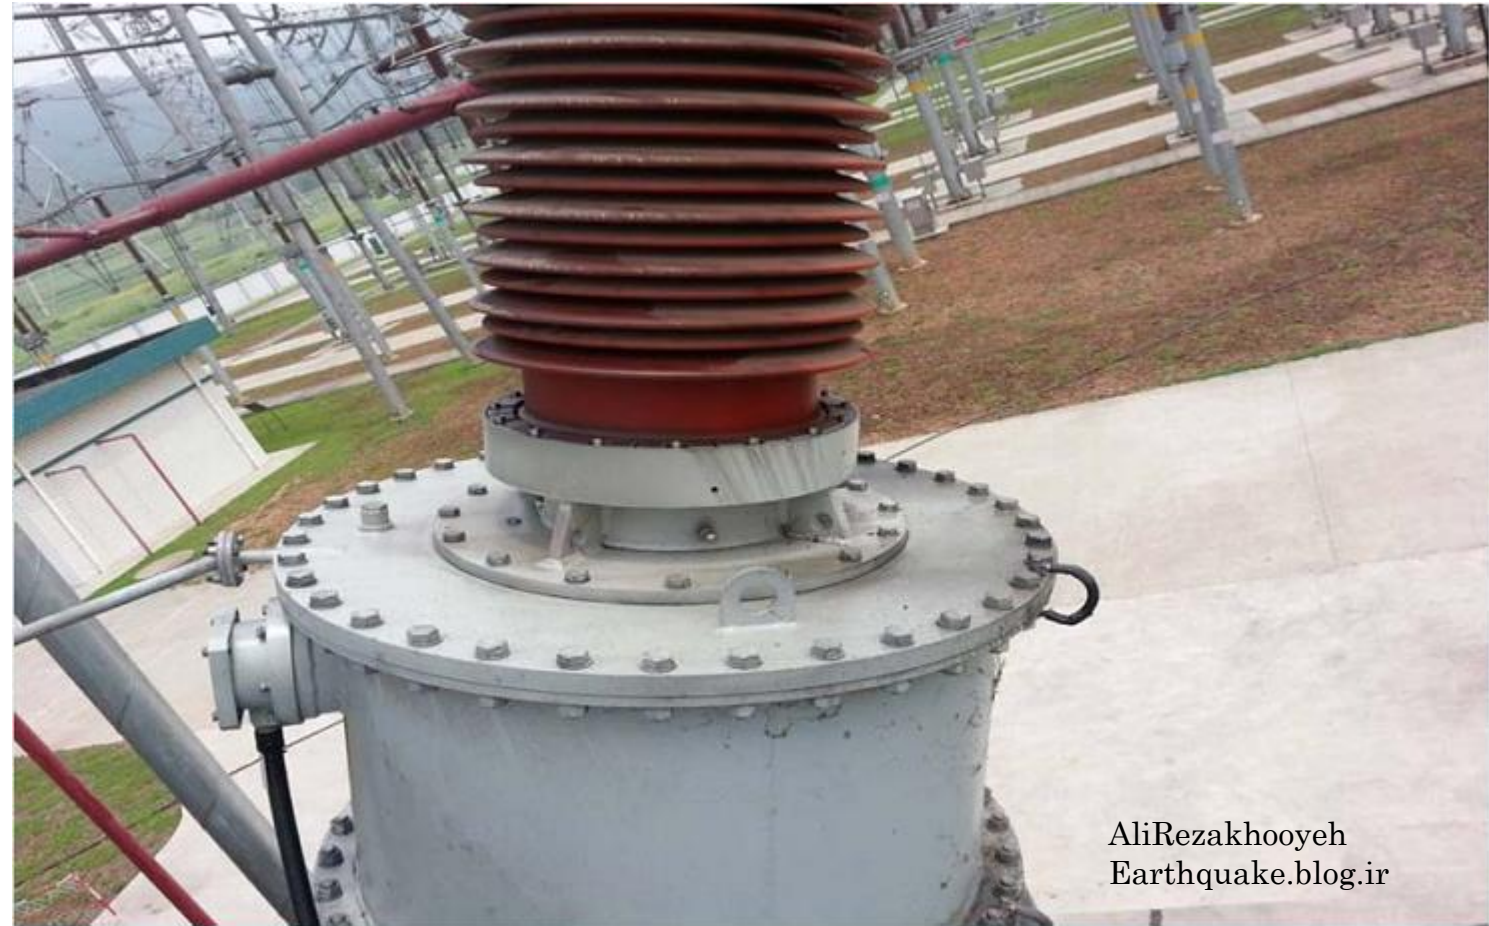
Oil Leakage Due to Ceramic envelope Breakage

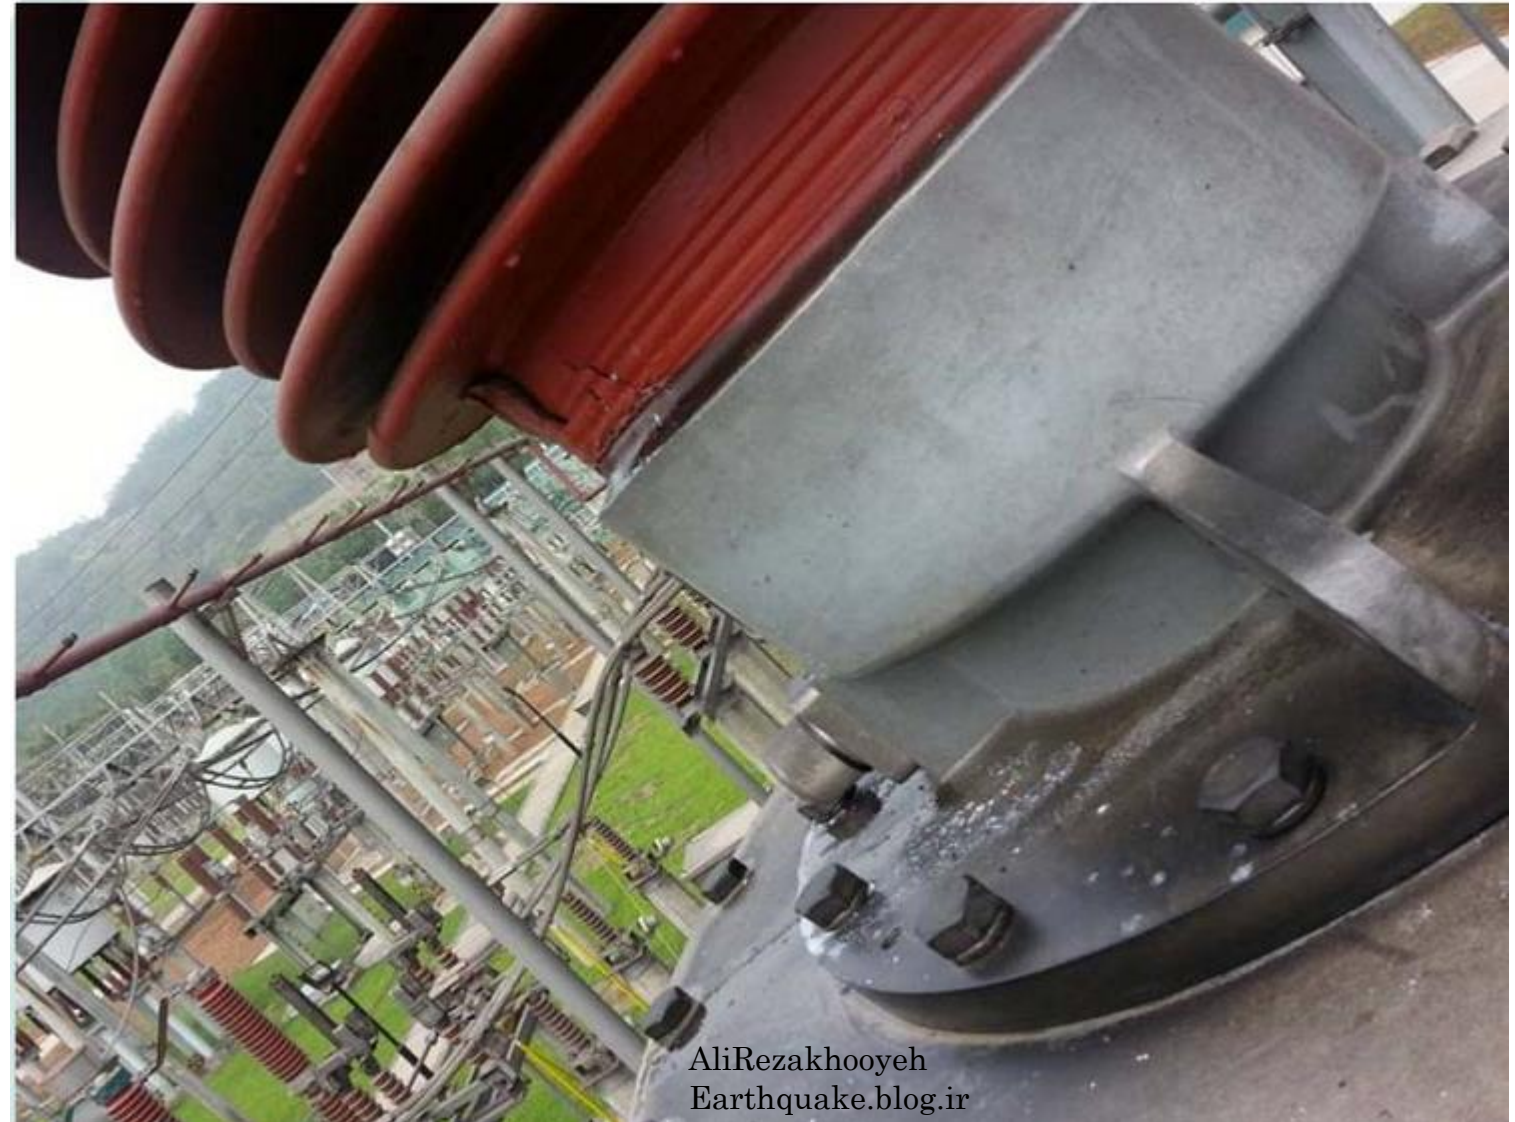
Oil Leakage Due to Ceramic envelope Breakage

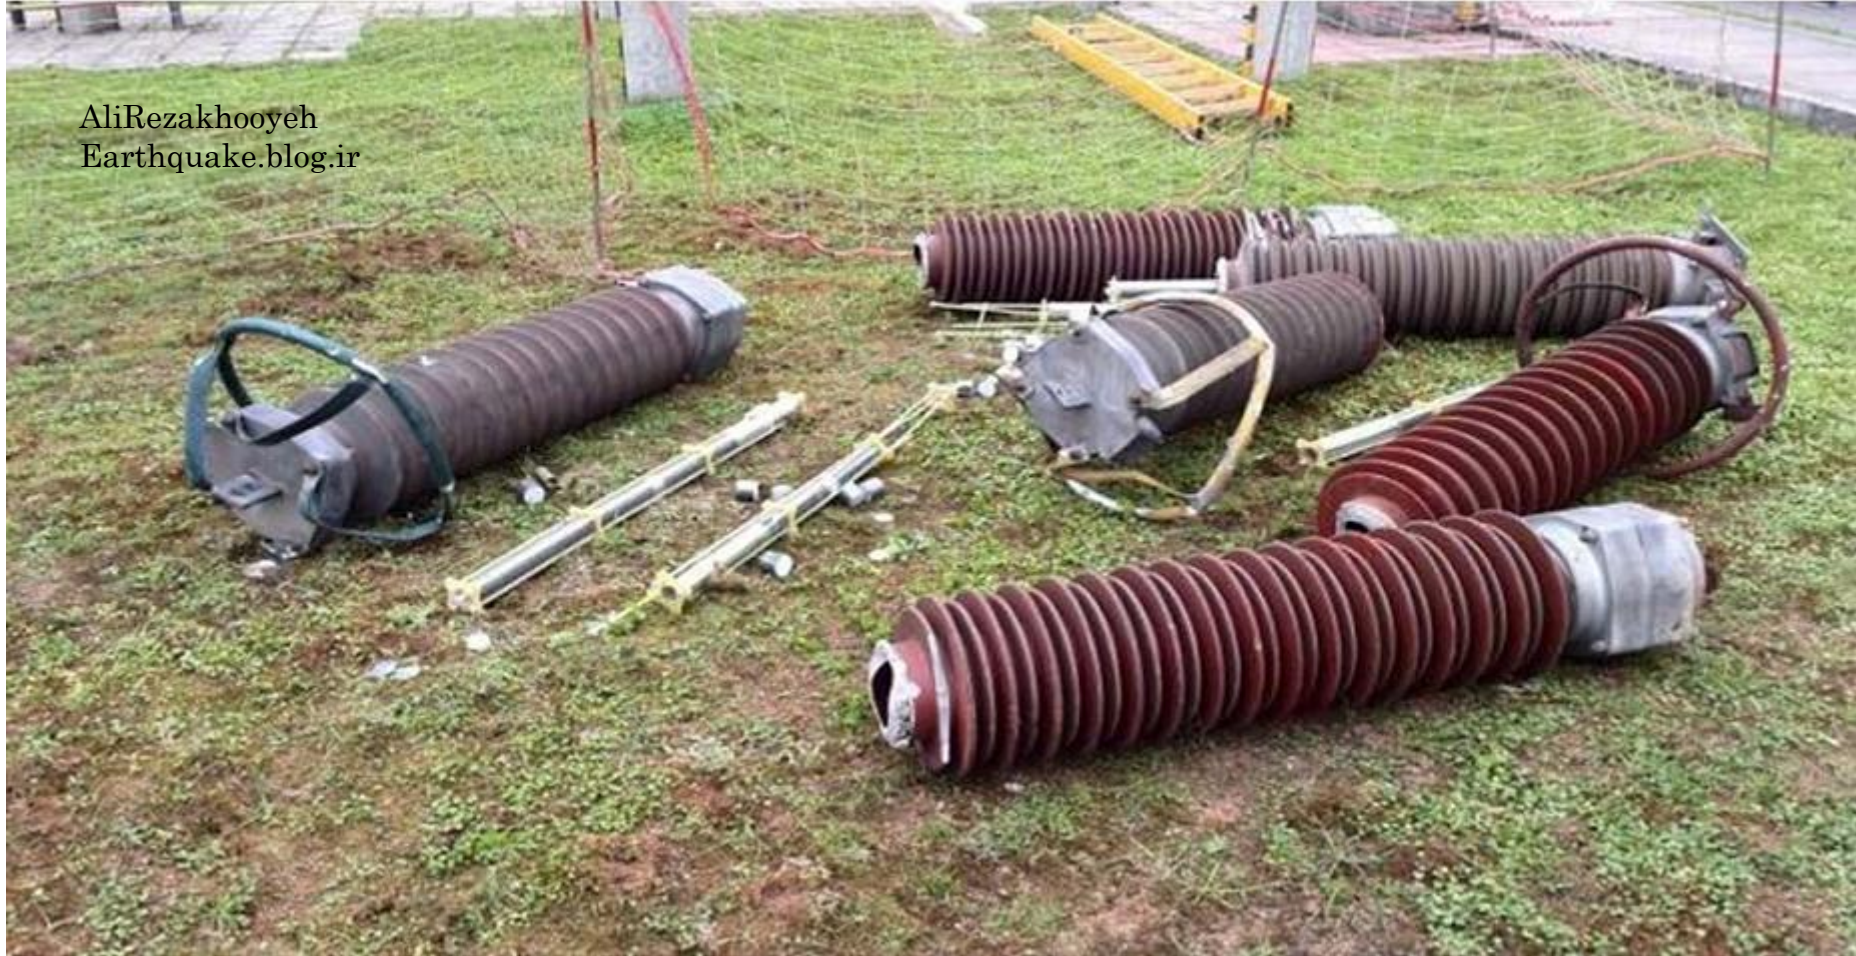
Collapse of 500kV MOA
