Earthquake Damage to the Electric-Power Infrastructure- Substation

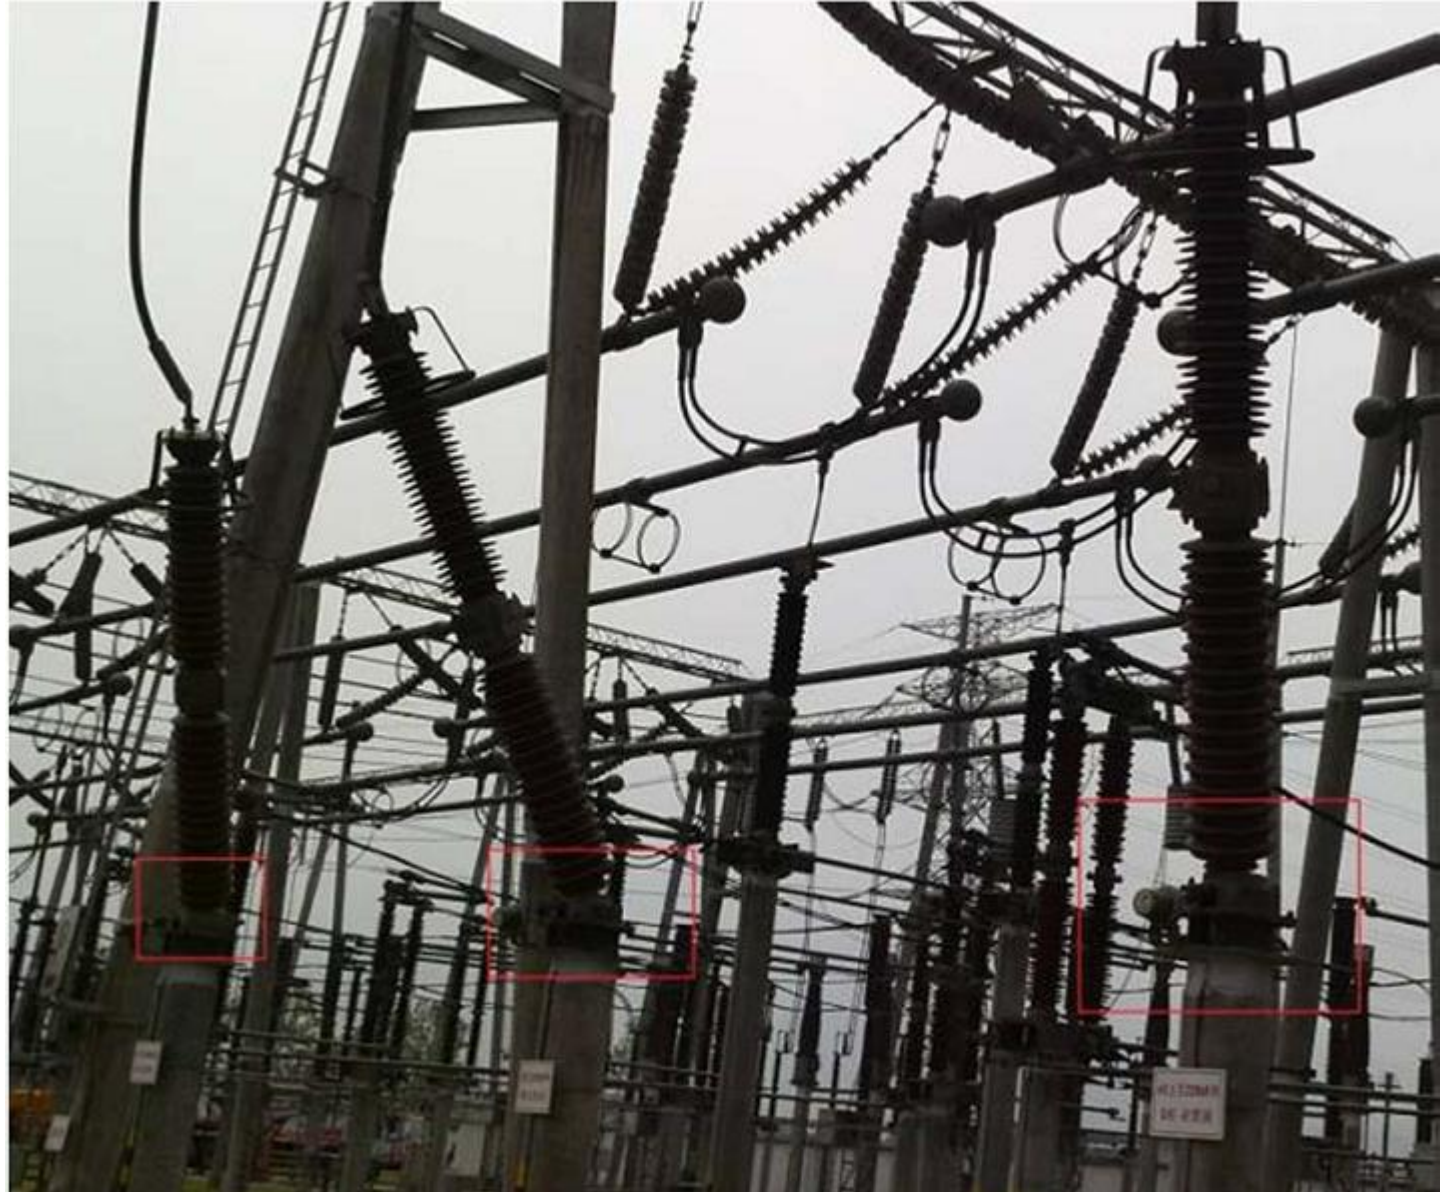
Collapse of 500kV MOA

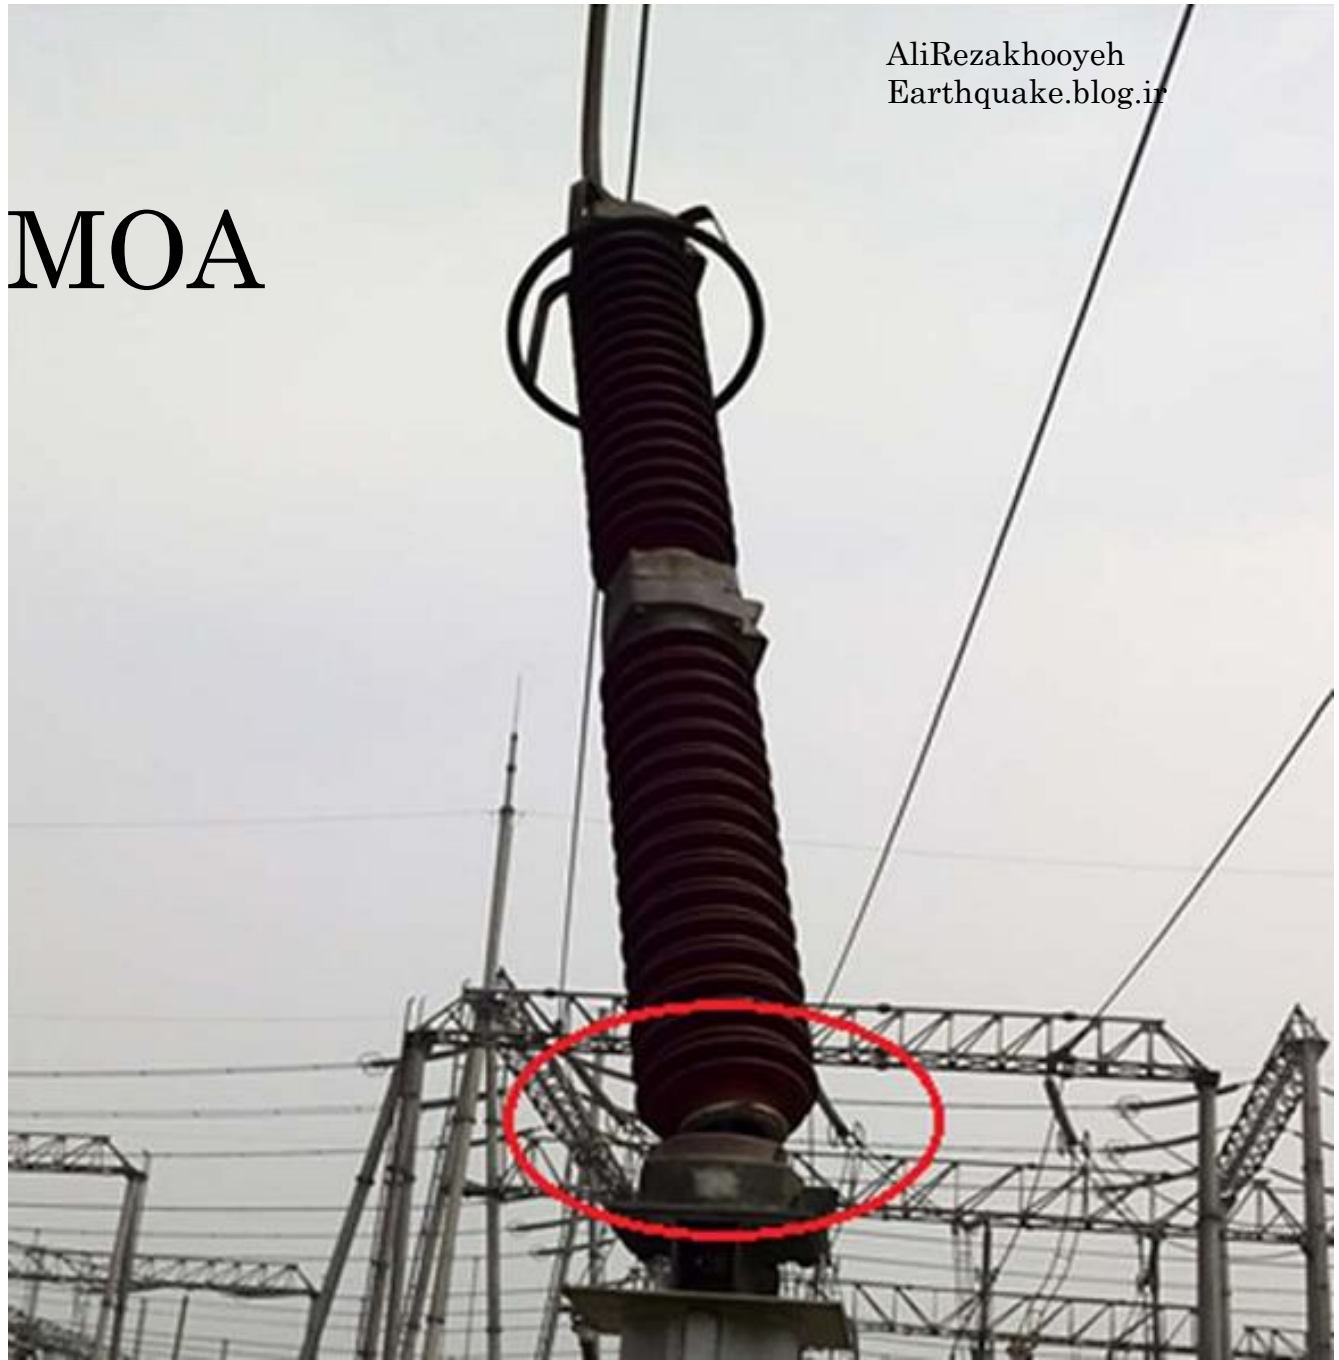
Oil Leakage

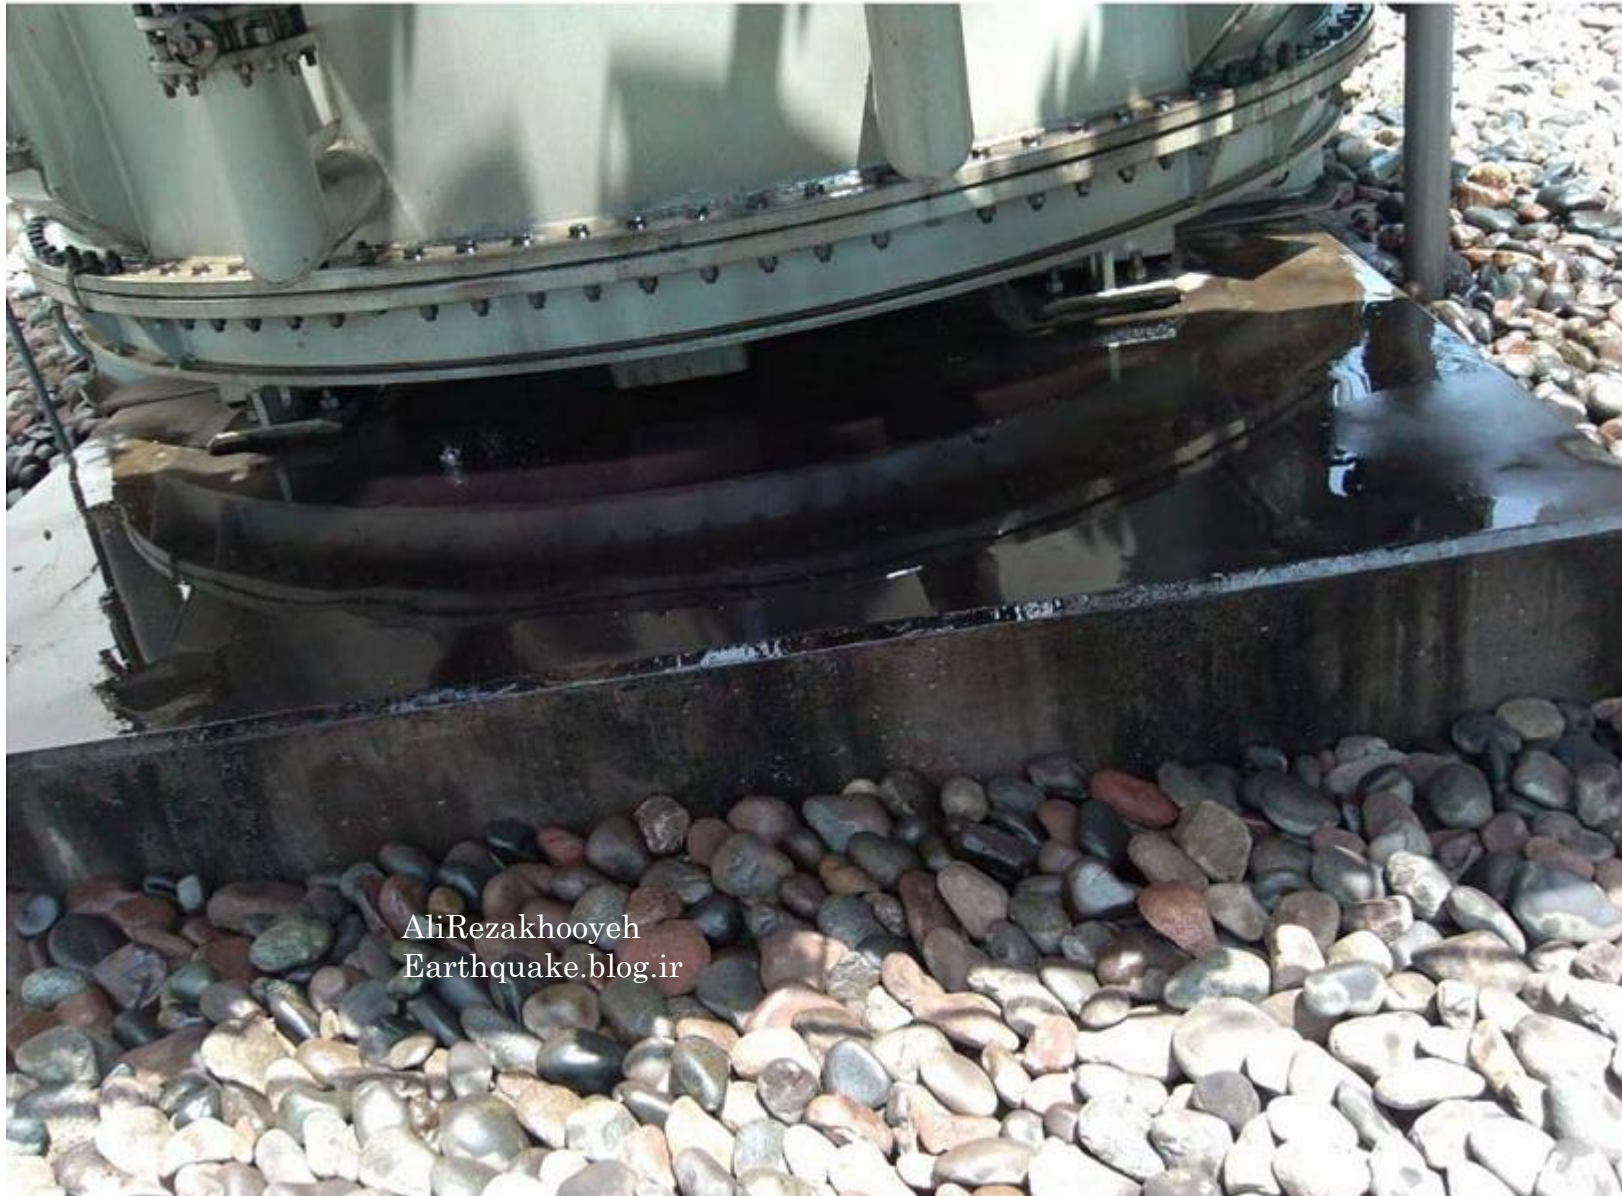
HV Bushing Oil Leakage

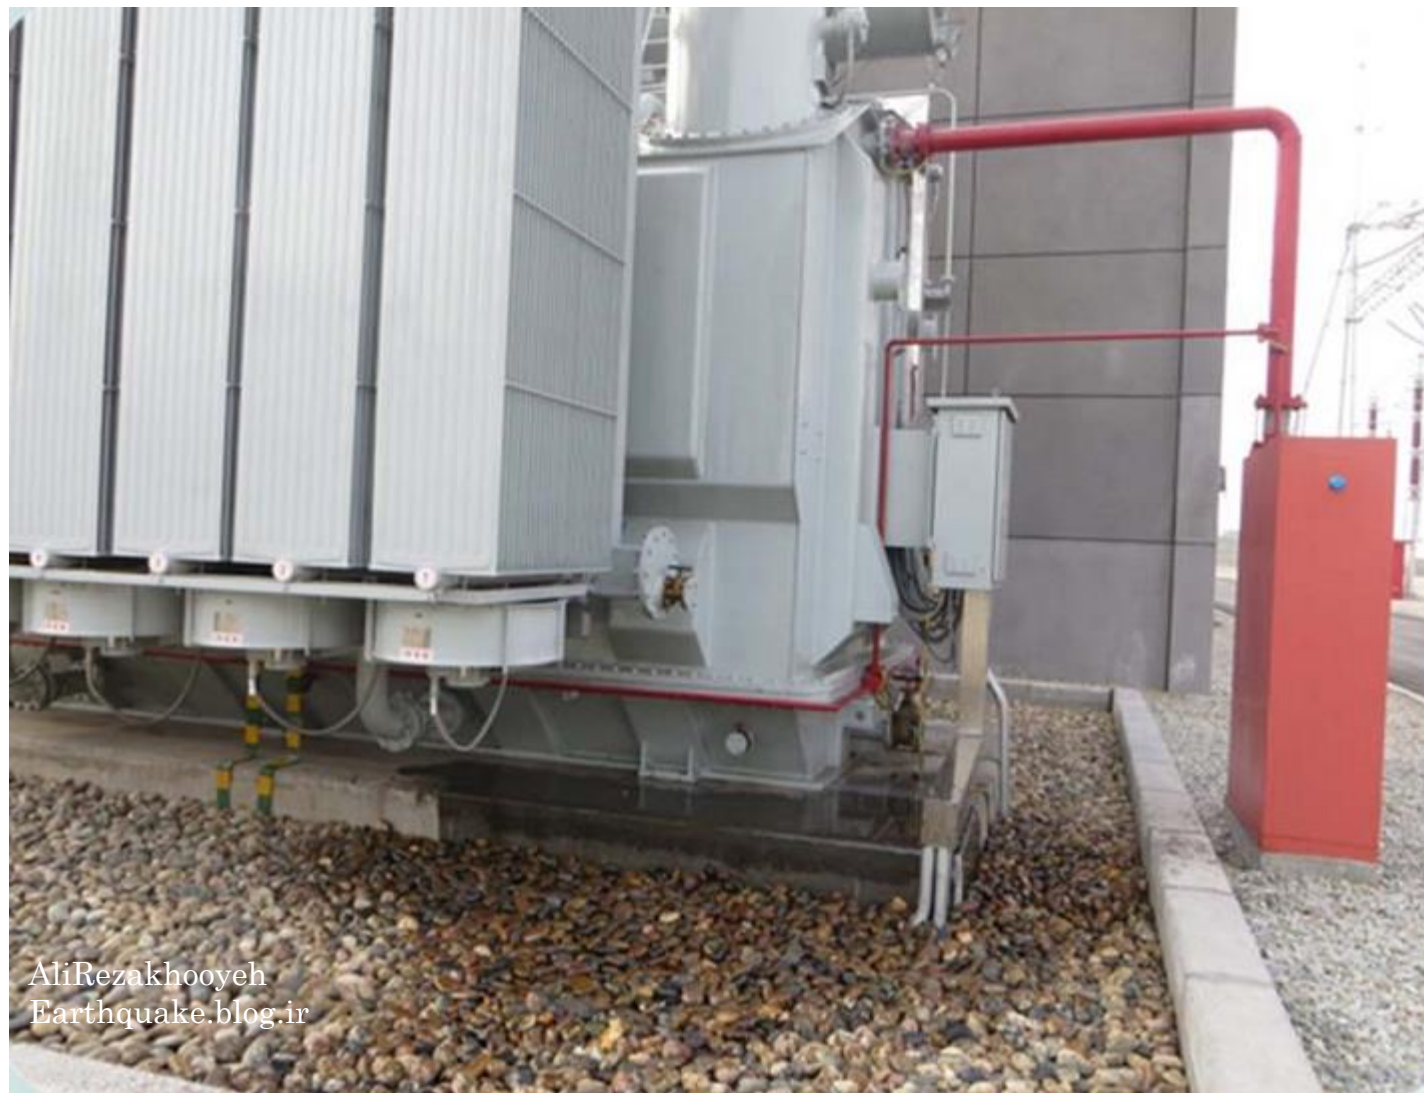
HV Bushing Oil Leakage

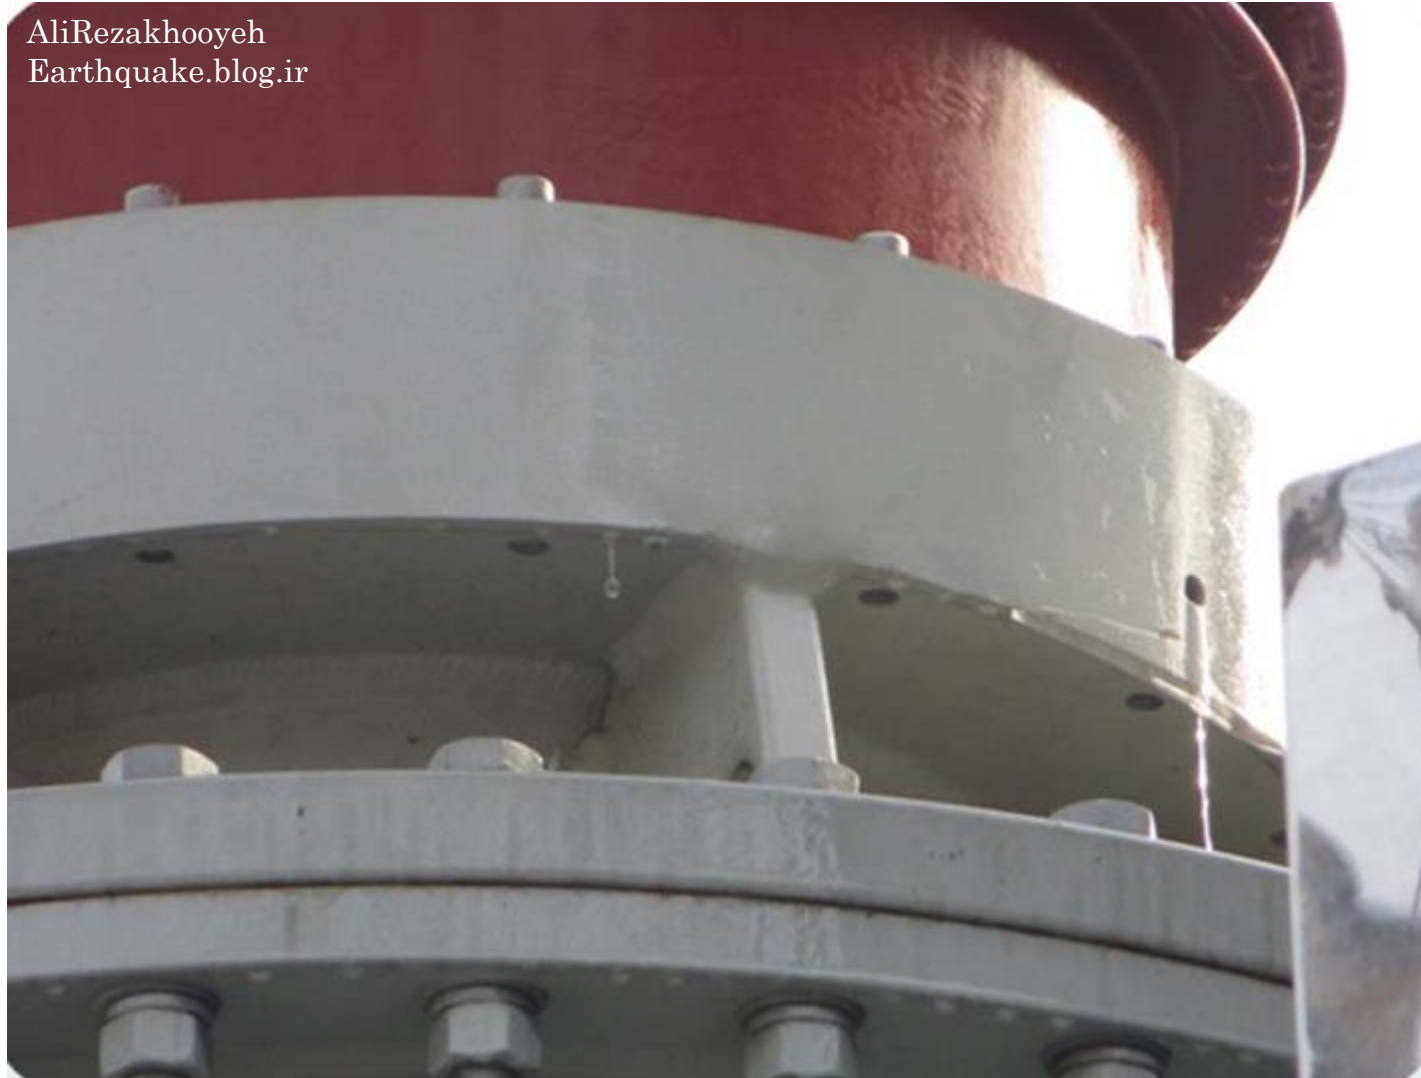
Transposition of Gaskets

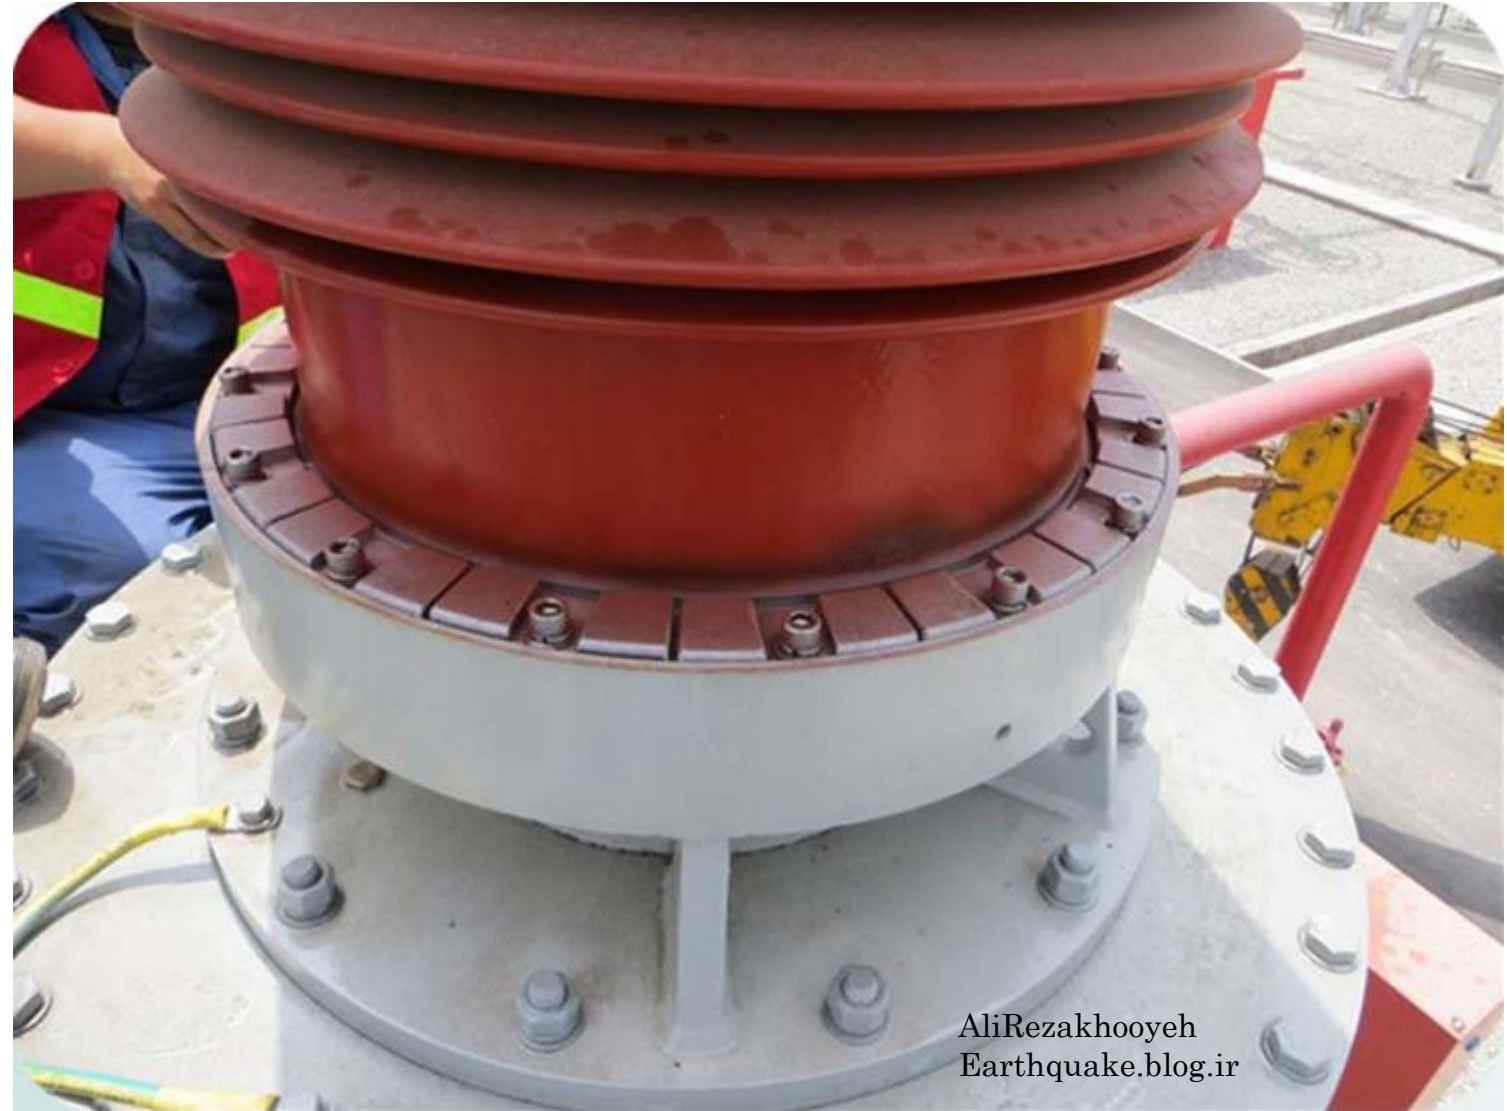
Loosening of 35kV Bushing Sealing

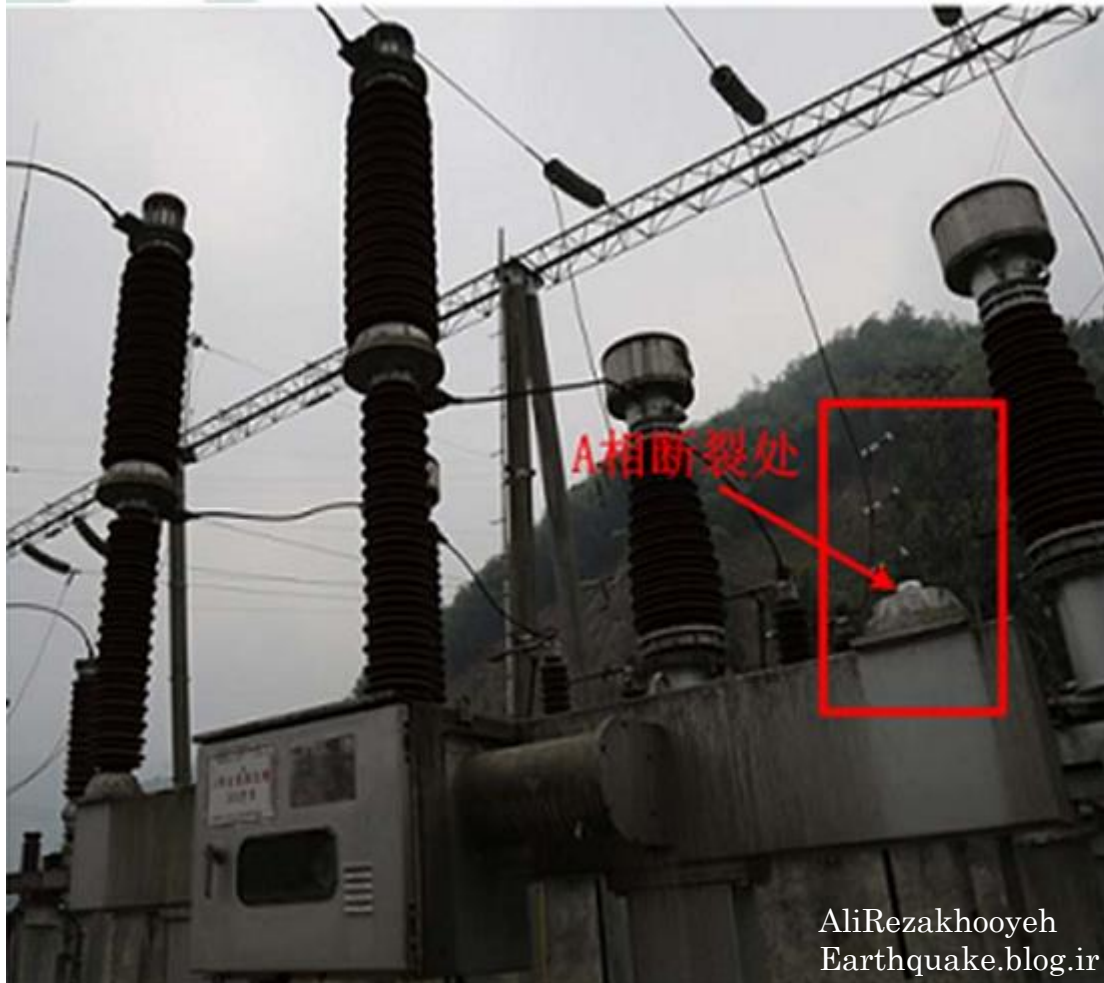
Damage of Circuit Breakers

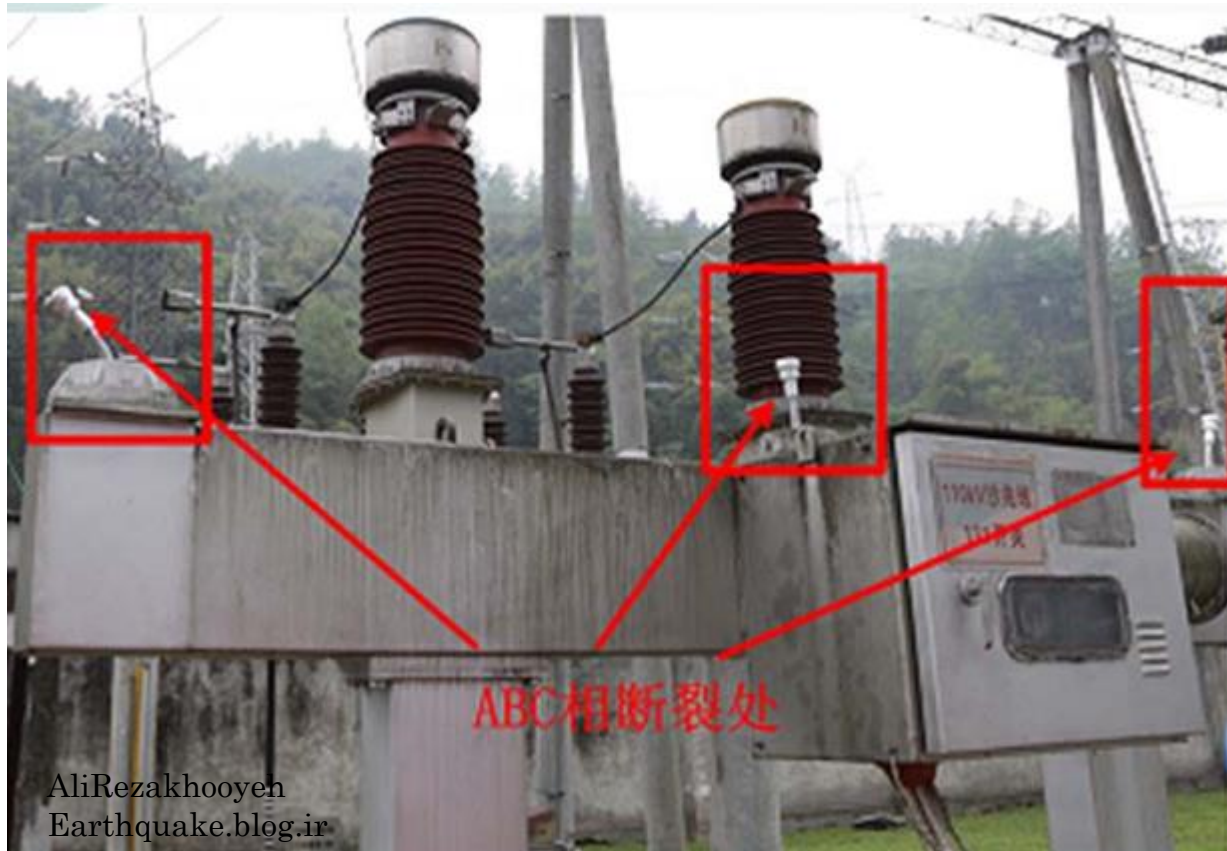
Damage of Circuit Breakers

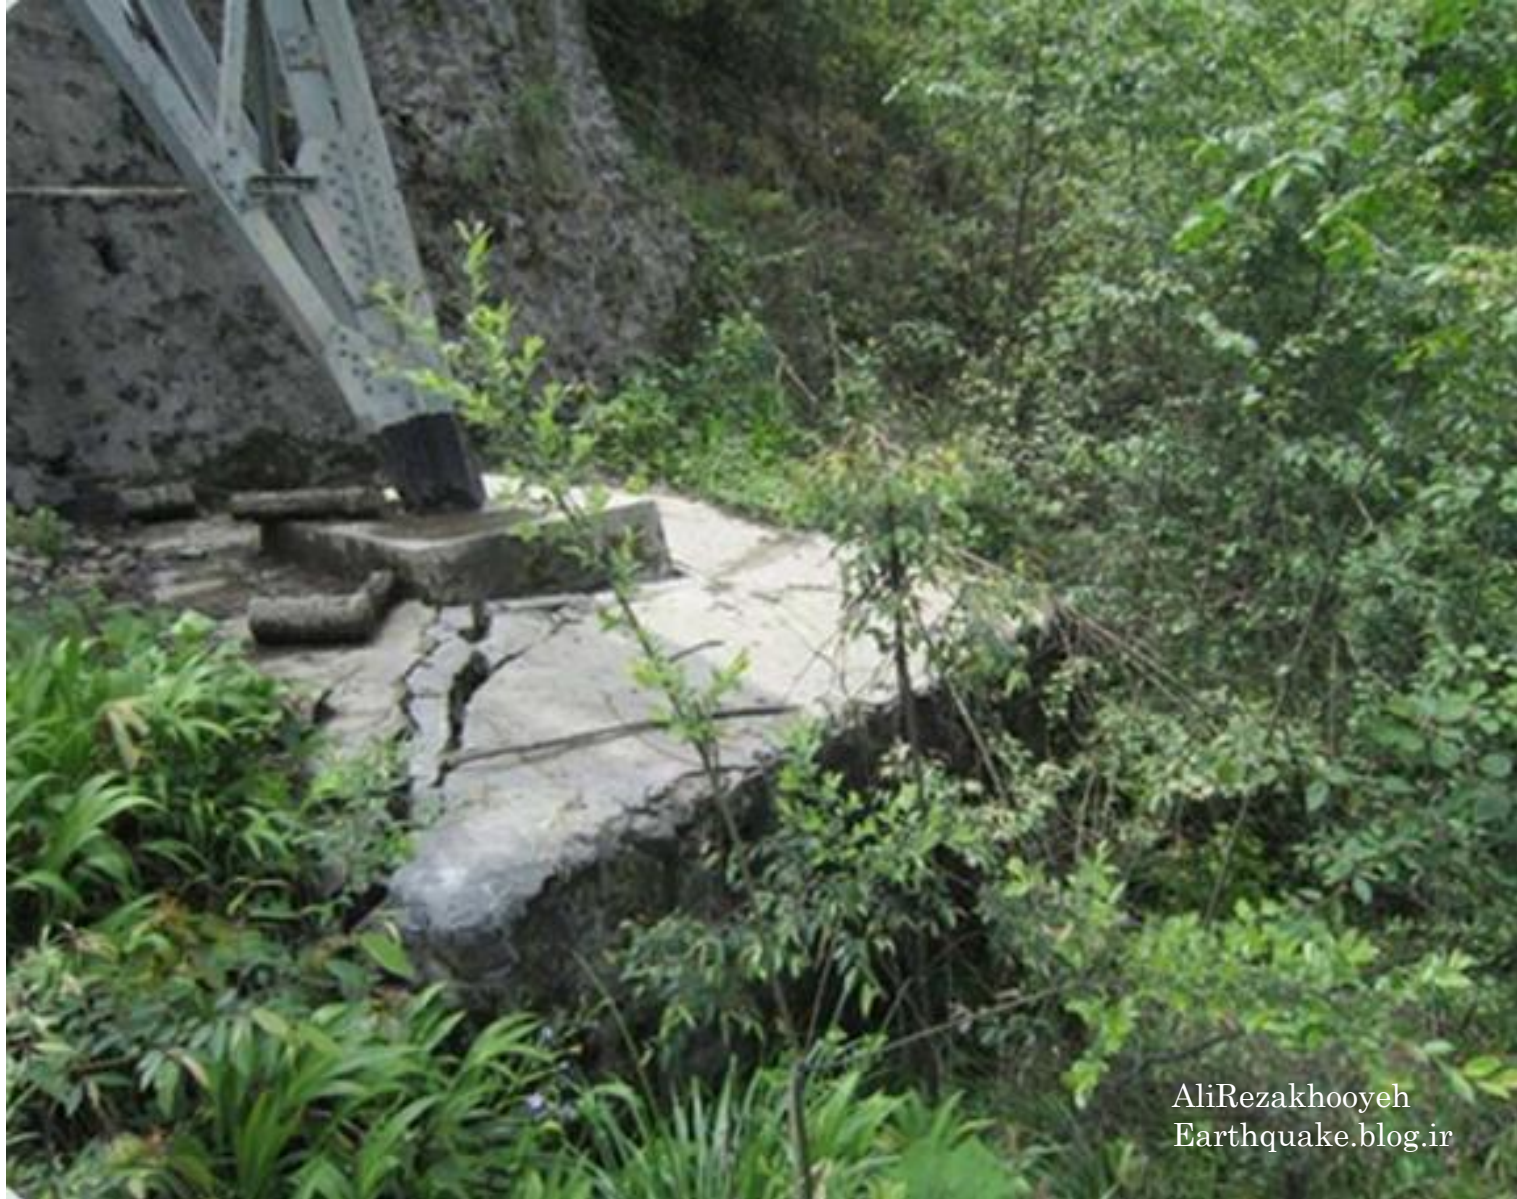
Crack of Tower Base and Slope Protection

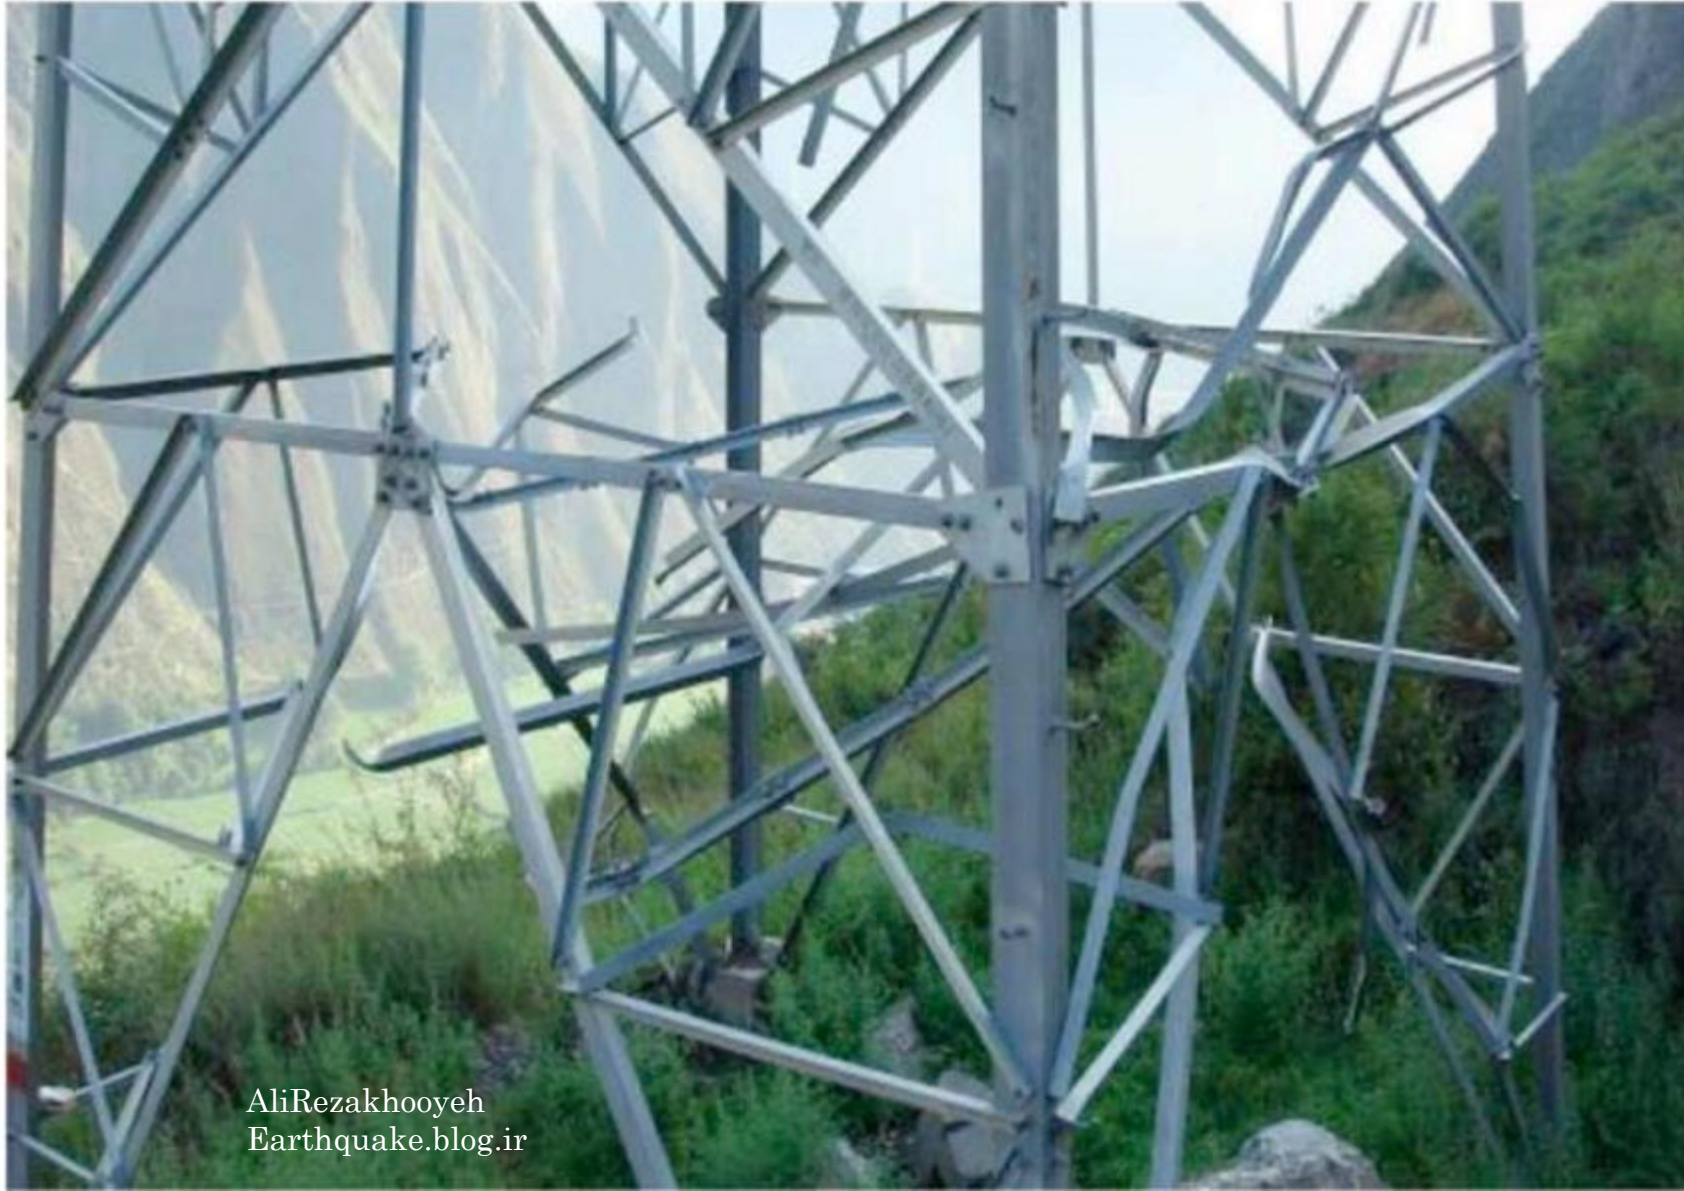
Rockfall-Impacted Tower, #123, Hongxue Line of Yingxiu Town

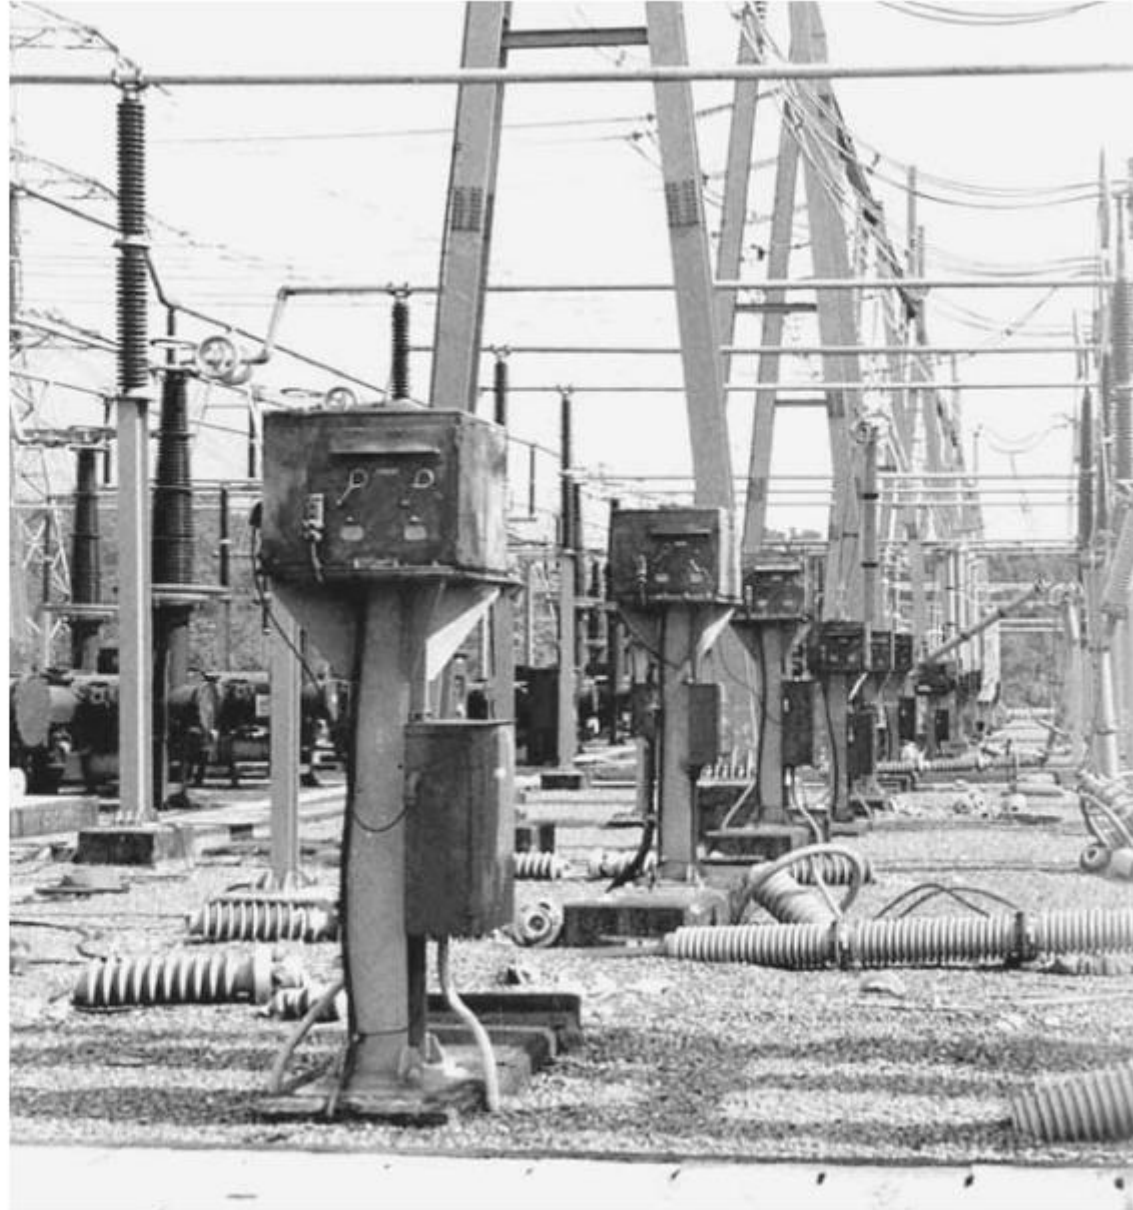
FIGURE 25.2 Damage to switchyard equipment.

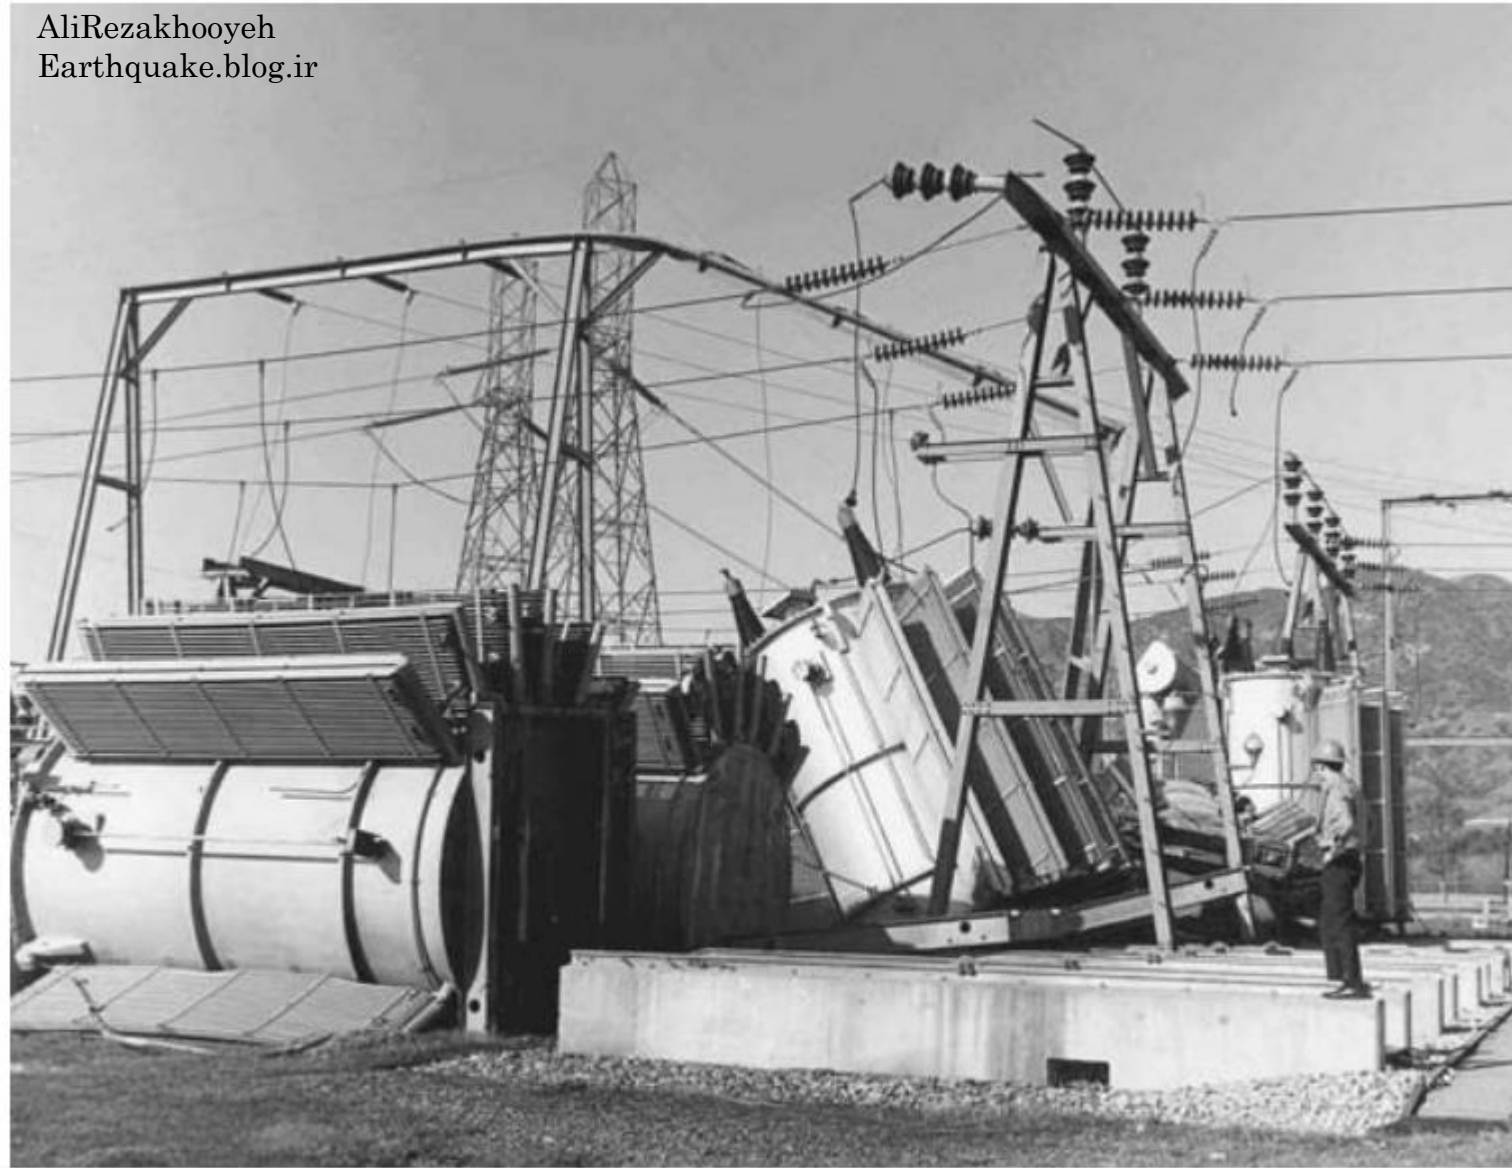
Damage to transformers due to inadequate anchorage.

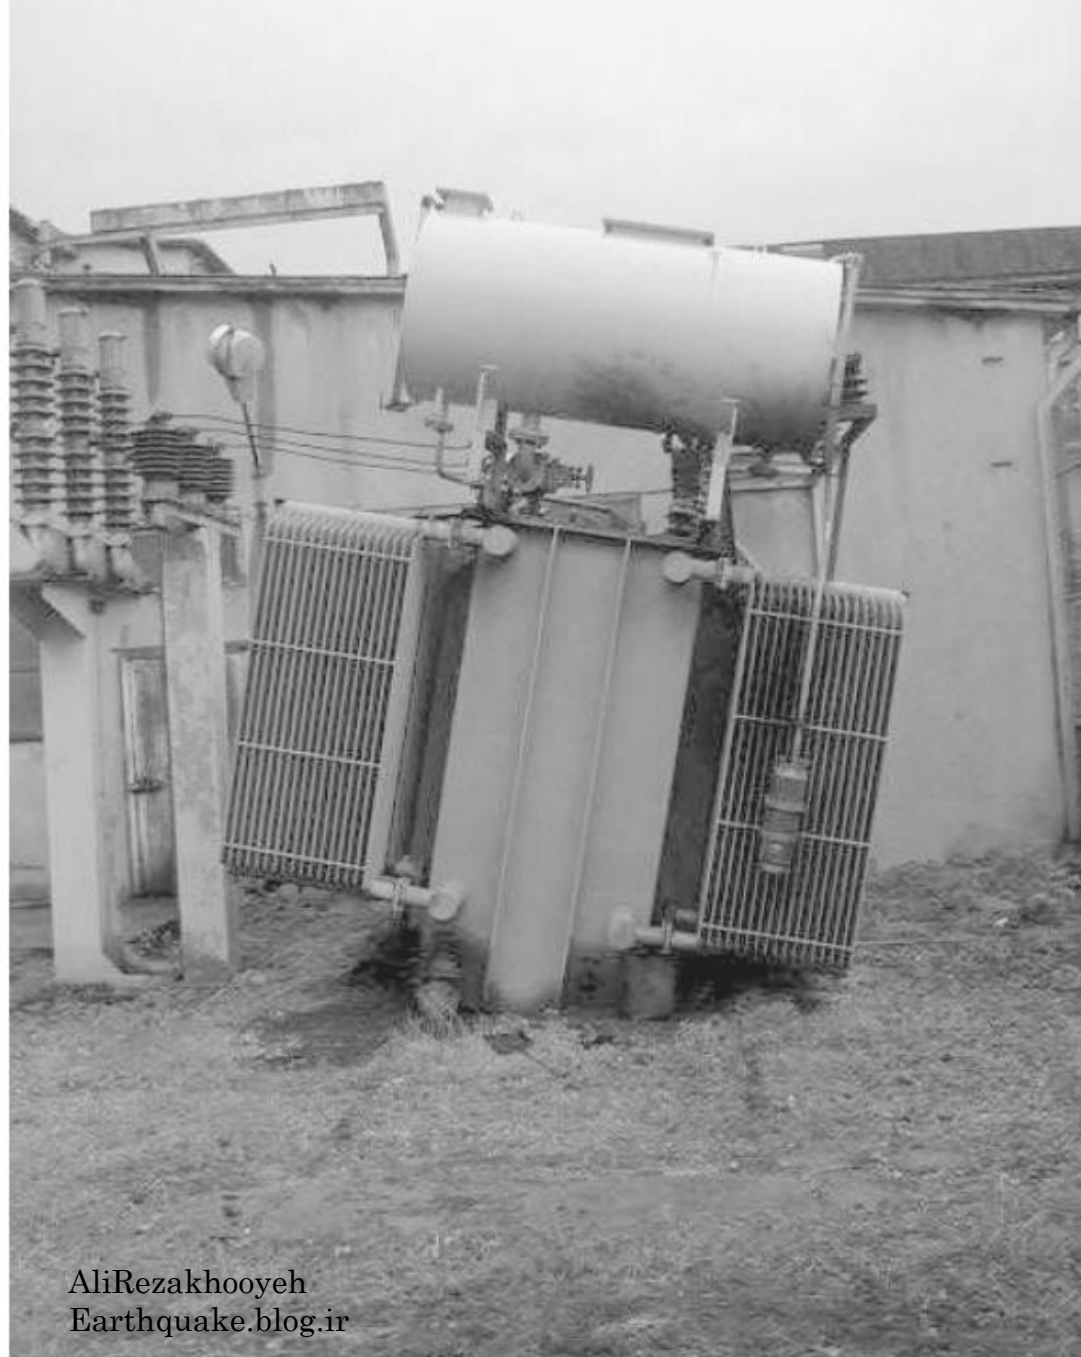
Damage to a transformer at the SEKA paper mill was expected to shut down this unit for several weeks.

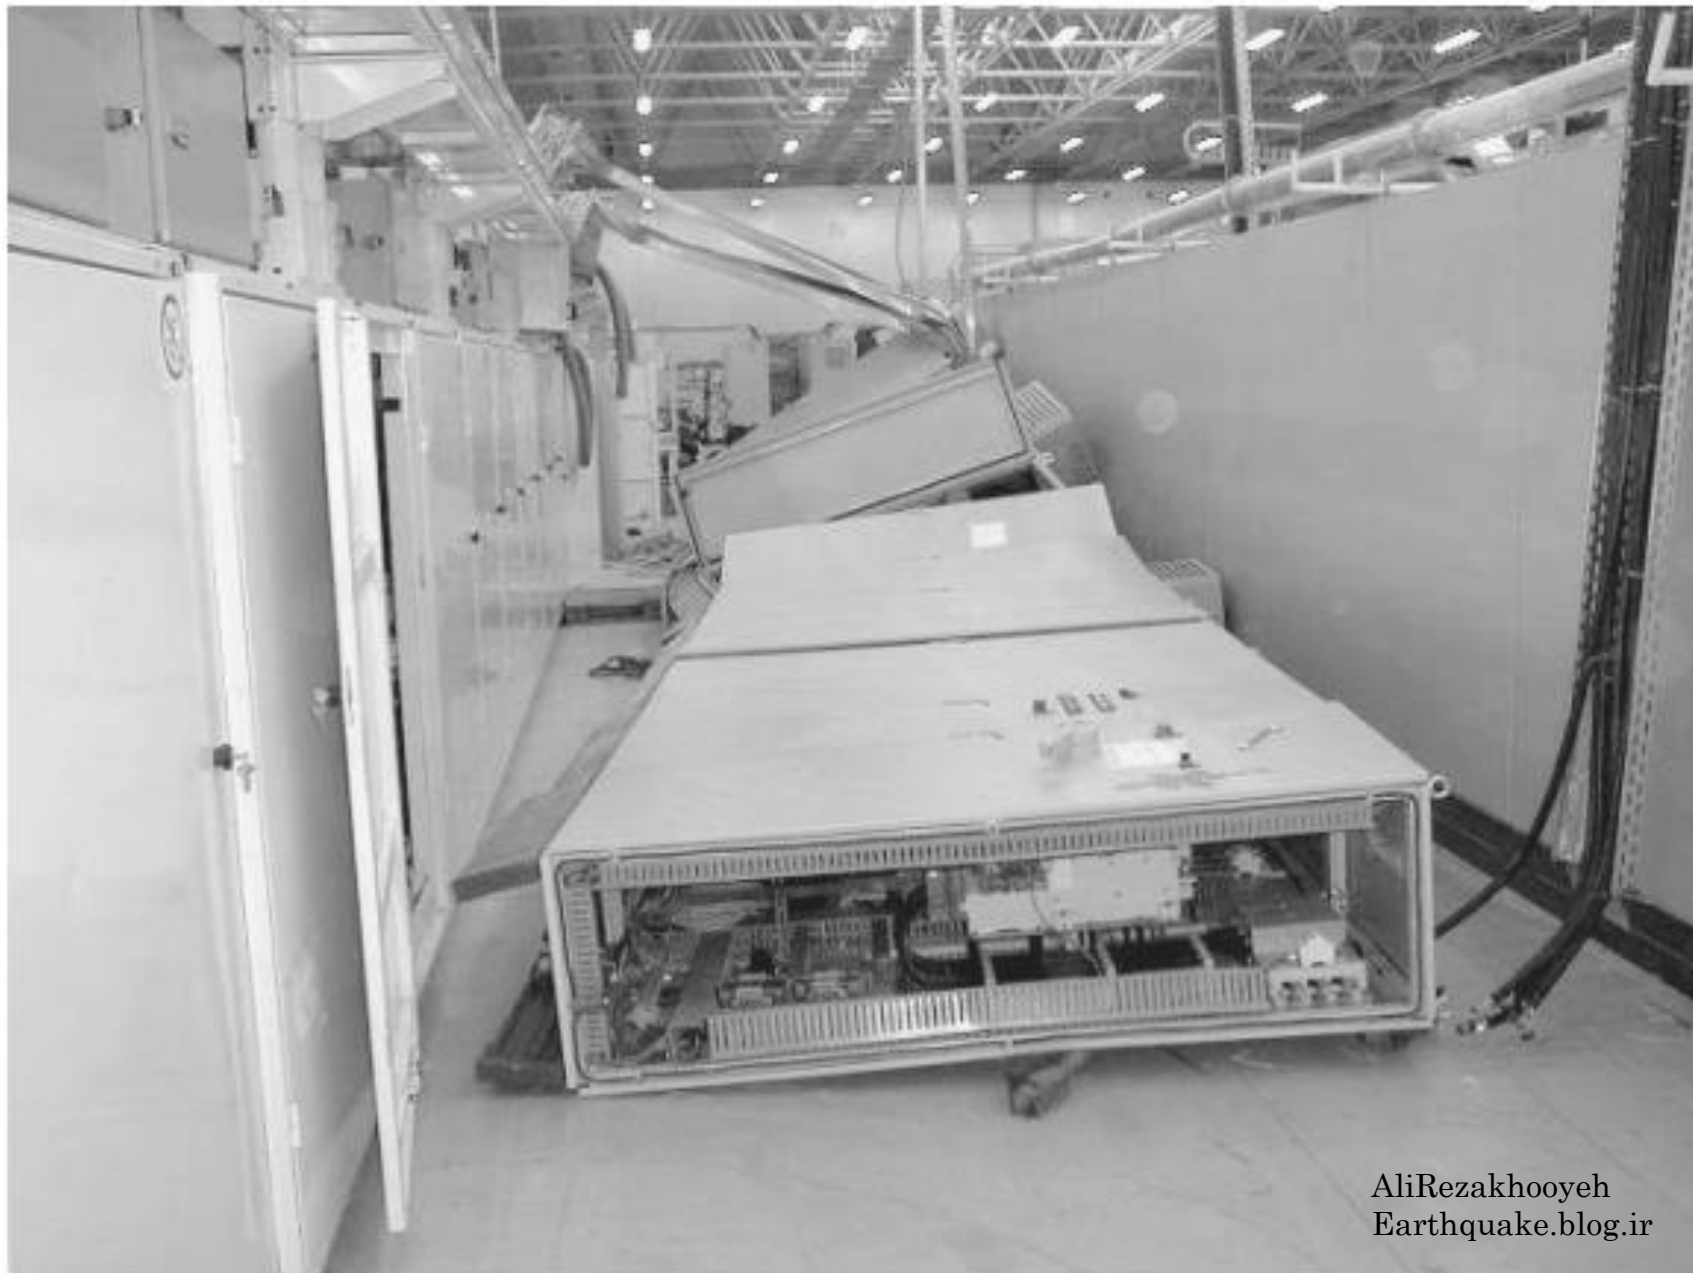
Collapse of unanchored cabinets at the Toprak Saglik facility.
