REPORT ON 1999 KOCAELI AND DÜZCE (TURKEY) EARTHQUAKES

MUSTAFA ERDIK

*Bogazici University, Dept. of Earthquake Engineering, 81220 Cengelkoy, Istanbul, Turkey
E-mail: erdik@boun.edu.tr*

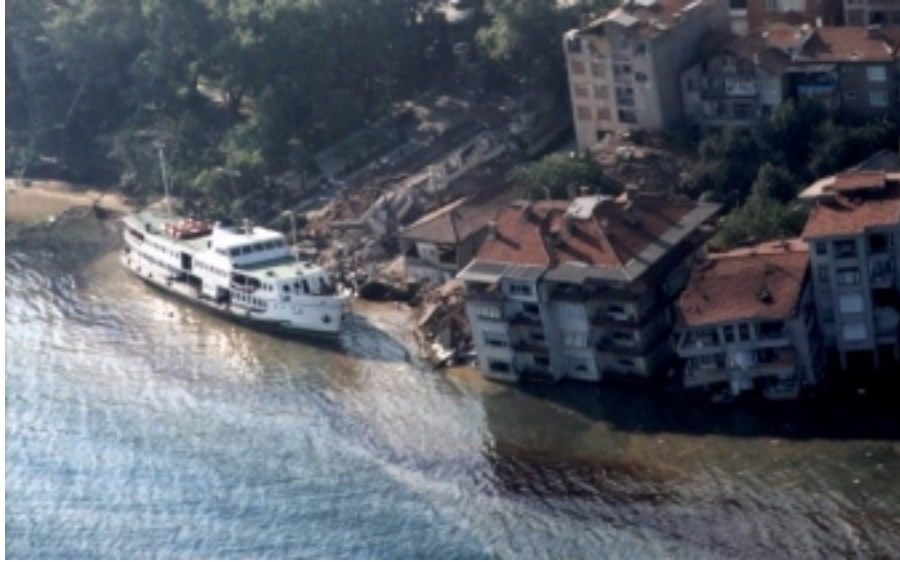
In Kocaeli earthquake large sea waves were reported in Izmit Bay. Run-up heights ranged up to 2.5m along the shores of the middle basin of the Gulf of Izmit between Hereke and Degirmendere after a general depression. The cause of this phenomenon is argued to be near shore tectonic subsidence and submarine sediment slumping. Figure 7 pictures a ferryboat carried onshore by a strong seismic wave.

Figure 7. Ferry Boat in Izmit Gulf thrown to shore due to strong wave action

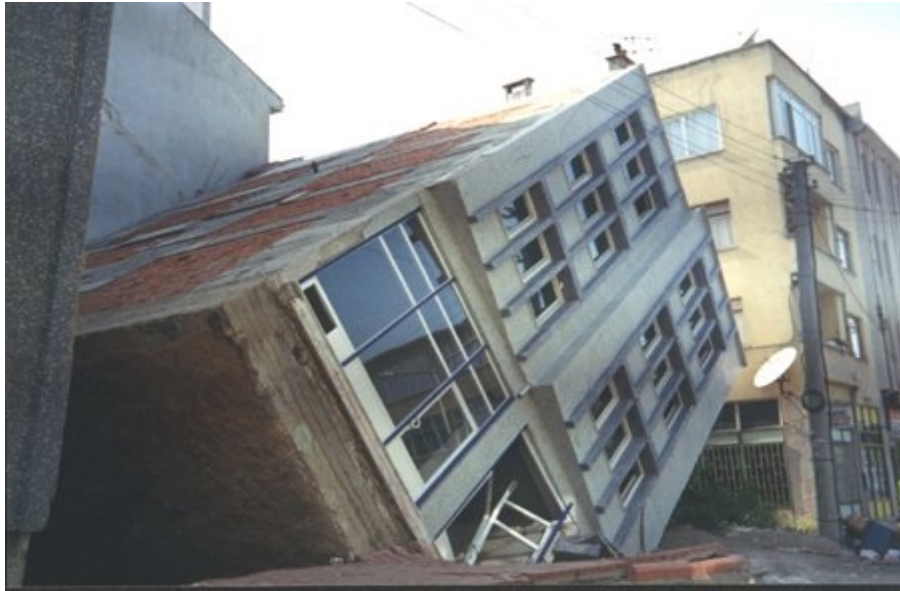
In Adapazari, located over young riverbed sediments with soft and liquefiable silts and sands, hundreds of buildings sank, as much as 1.5m, or tilted due to shear failure of the foundation media and liquefaction (Figure 12). Surface manifestations of liquefaction in Adapazari and Sapanca included sand boils and lateral spreading. Buildings punched down into the soil softened by the shaking and high numbers of oscillation cycles, which lifted up the sidewalks due to the injection of soil material (Figure 13). However the softened and/or liquefied soil media also acted as an isolator dissipating the energy at the foundation level and avoiding shaking damage to the buildings.

Figure 12. Overtumed buiding in Adapazari due to weakened/liquefied foundation

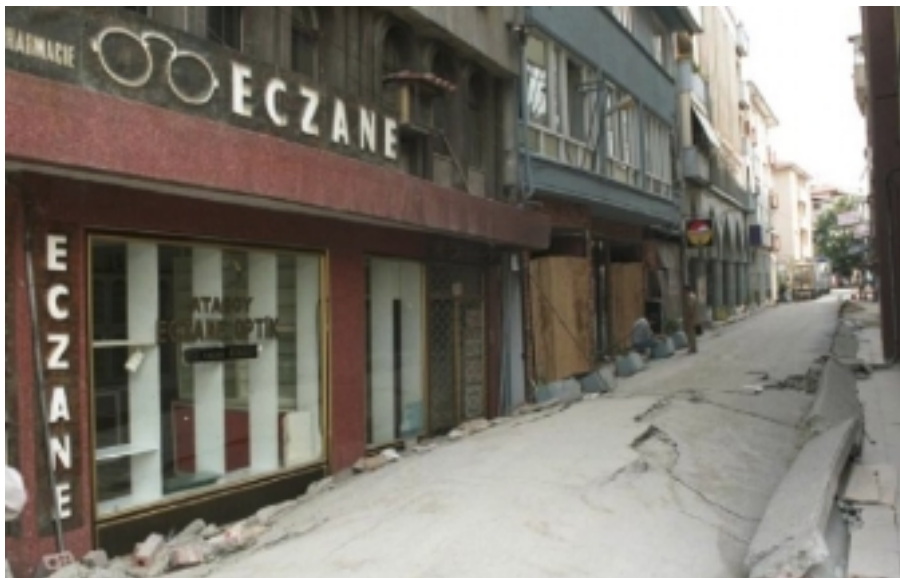
Figure 13. Building in Adapazari that sank into the ground and the displaced soil heaved

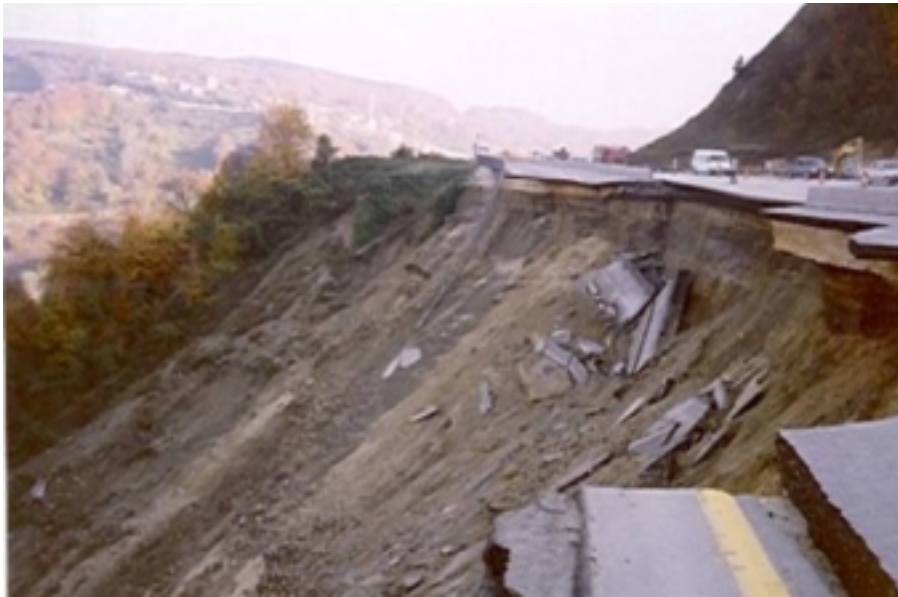
Only limited slope failure, mostly in the form of road embankment failures was observed in both events. The only major landslide took place on west bound lane of E-5 highway at Bakacak in Duzce earthquake which disrupted the traffic for several days until a bypass road was constructed (Figure 14). The landslide occurred on the natural slope and in the highly weathered parts of the rock.

Figure 14. Landslide on E5 Highway in Duzce Earthquake

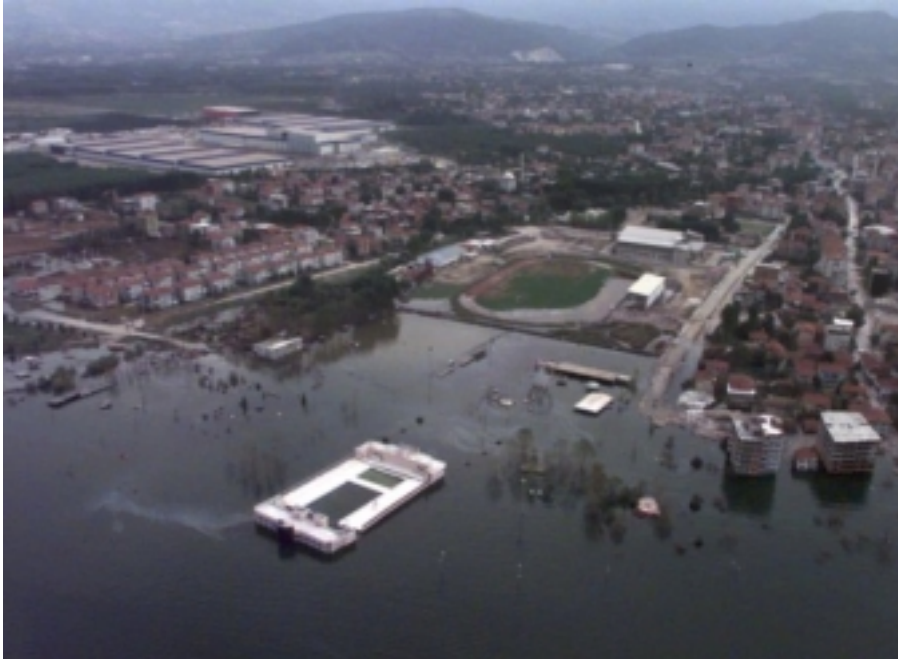
In the eastern part of Gölcük, a broad regional subsidence occurred affecting the Ford Factory under construction and several urban settlements (Figure 15). The subsidence is believed to be the result of a graben-like action associated with a local pull-apart tectonic structure. The subsidence caused a 4-km-long section of the coast near Gölcük to submerge about 3 m.

Figure 15. Subsidence at Golcuk along the southern shore of the Izmit Bay

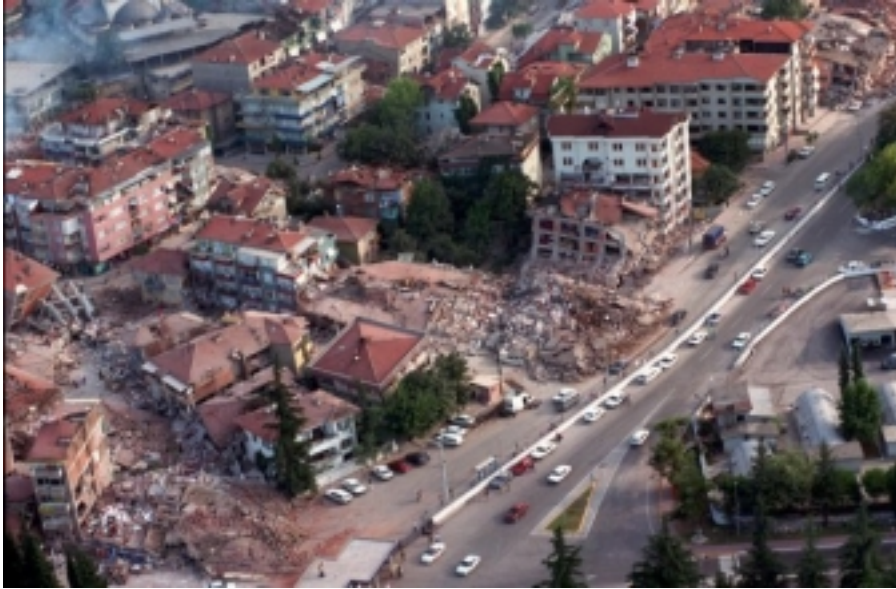
Figure 16. A general view of building damage in Golcuk

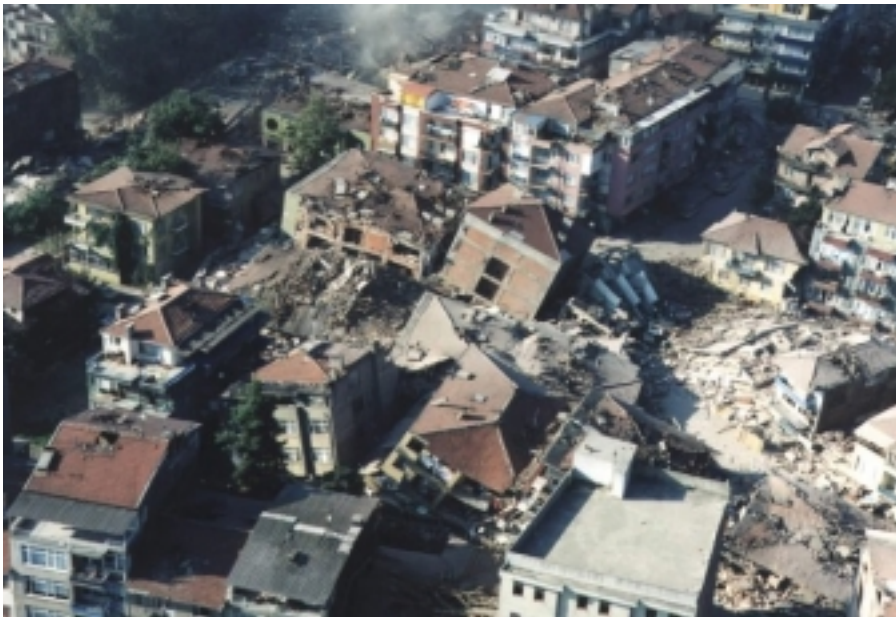
Figure 17. A general view of building damage in Duzce

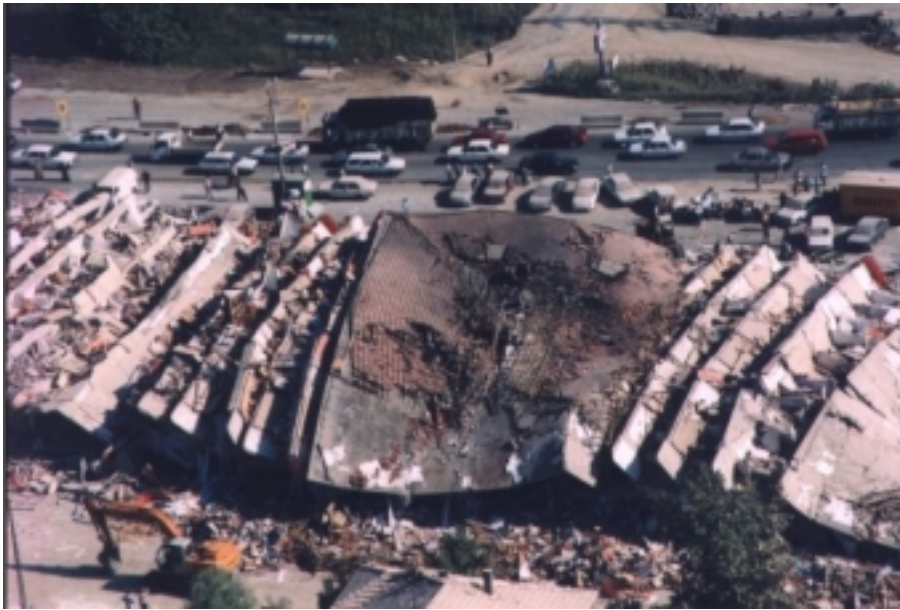
Figure 18. A “pancake” type collapse in Kocaeli Earthquake

The predominant structural system used for buildings in Turkey consists of reinforced concrete frames with a symmetric floor plan and with unreinforced masonry infill walls. Typically hollow clay tiles are used with inadequate mortar at the joints. Although not intended, these walls form the first line of resistance against the earthquake forces and, in many cases, control the lateral drift. Once the infill walls fail, the lateral resistance is to be provided by the reinforced concrete frames alone, with usually have low concrete quality, inadequate reinforcement and poor detailing. Extensive inelastic action at the critical regions has caused varying degrees of building damage that, in extreme cases, lead to formation of hinge mechanisms and pancake-type collapses.

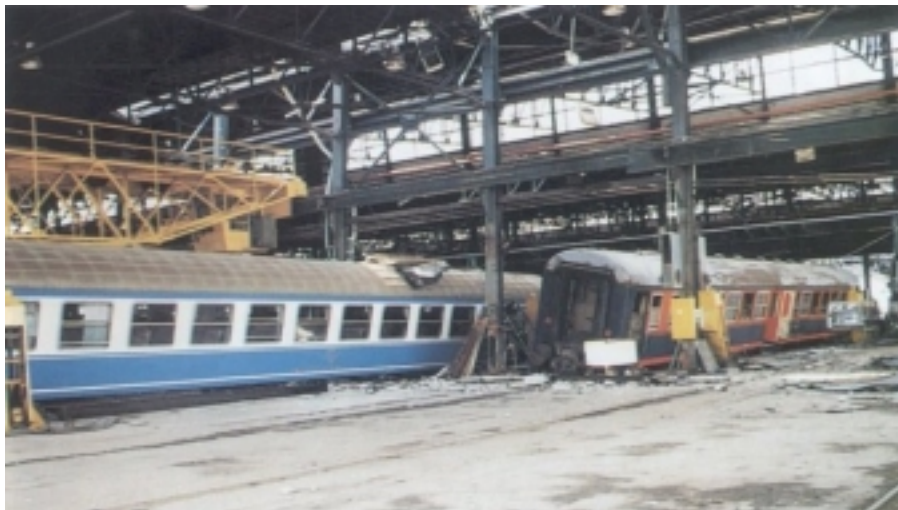
Figure 21. Damage at TUVESAS rail car factory (steel building) in Adapazari

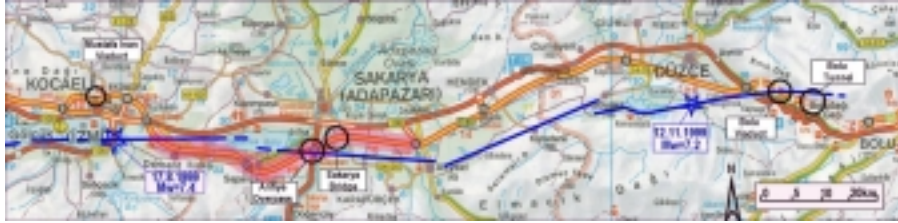
Figure 22. General view of highway and viaduct damages in Kocaeli and Duzce Earthquakes

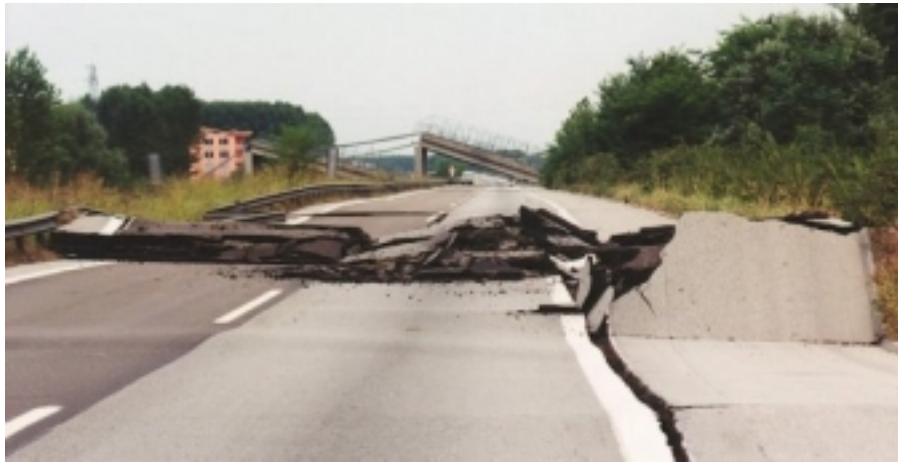
parallel to the fault rupture at a less than 3km distance. The damage was in the form of surface ruptures (both tension and compression cracking) and settlement of roadway fills. Settlements ranging between 10 to 50cm were observed (Figure 23).

Figure 23. Damage to road surface on TEM Highway in Kocaeli Earthquake

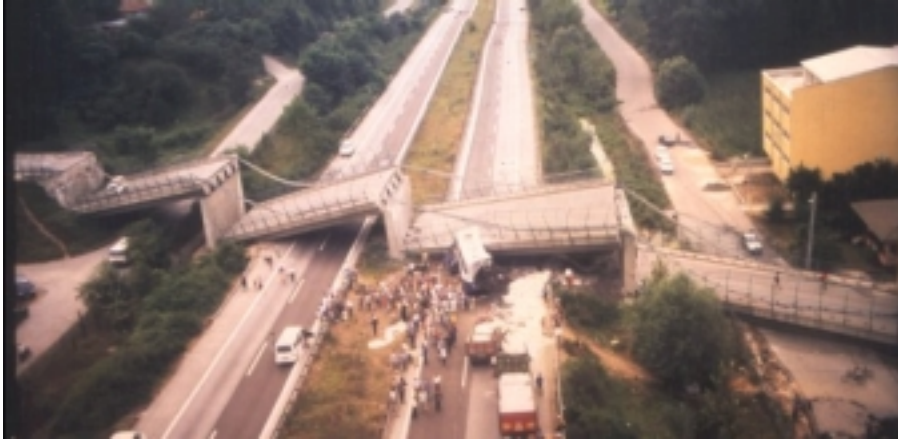
The most common types of damage to bridges and overpasses were displacements of girders at seating, shear key failures, and cover concrete spalling of deck around abutments. Several overpasses and viaducts on TEM sustained damage varying from limited shifting of girders from their seats (Mustafa Inan Viaduct), failure of shear keys and damage of elastomeric bearings (Sakarya River Bridge and D310 Overpass) to total collapse (Arifiye Overpass – D650). Location of these viaducts and bridges are shown in Figure 22. Sakarya River Bridge is located about 2km to the north of the fault. Most girders in the north lane are shifted off their seats as much as 0.5m as a result of the failure of shear keys. Most of the elastomeric bearing pads were dislocated and become dysfunctional. The fault rupture passes under the Arifiye Overpass with a right-lateral offset of 1.5m (Figure 24). The fault rupture passed between the northern abutment and the adjacent pier at

an angle of about 65 degrees with the bridge axis. As a result of this tectonic movement in excess of the seat width the girders were unseated in a consecutive manner and fell from their supports.

Figure 24. Collapse of the Arifiye overpass on TEM Highway in Kocaeli Earthquake.

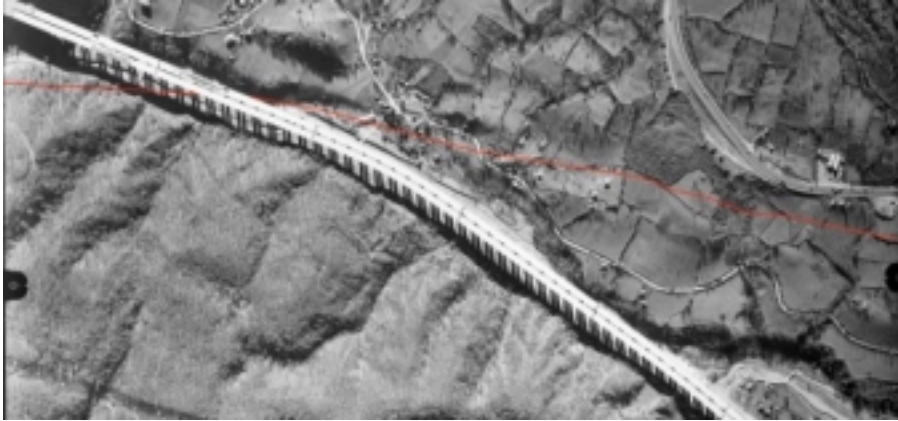
A section of the Trans-European Motorway (TEM) between Bolu and Düzce is under construction. The motorway follows the northern side of the Düzce basin from Gümüşova to the Asarsuyu portal of the Bolu Tunnels. Bolu Viaducts #1 and #2 (under construction), Bolu Bridge and Bolu Tunnel (under construction), located in the last segment of the TEM to be completed, were strongly affected by the earthquake. Bolu viaducts 1 and 2 carry a 6 km long section of the motorway with a maximum height of 49 m, span of 39m and a width of 17.5m. The piers are supported by 12 1.8m diameter piles. Bolu Viaduct #1, 2.3km long with dual 59 spans, was located directly on the fault rupture. The fault crossed the viaduct at Pier#46 at an angle of 20-30 degrees with the viaduct axis, with a right lateral offset of 2.5m, causing substantial shifts between the superstructure and the piers (Figure 25). Some piers rotated (about the vertical axis) by 13 degrees (Figure 26). Almost all the sliding elements at girder seats and the energy dissipating devices between spans became damaged or useless.

Figure 25. Aerial view of the Bolu 1 Viaduct. The fault rupture is indicated by the red line.

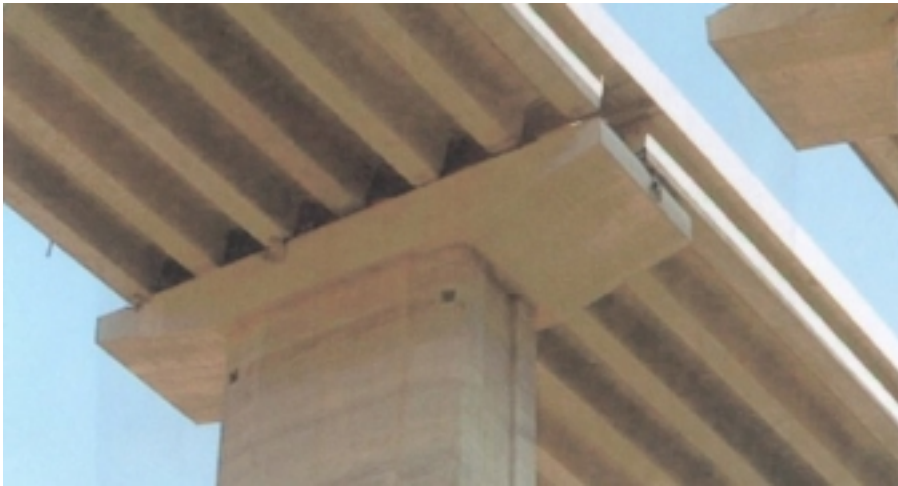
Figure 26. Movement between the piers and the girders of Bolu 1 Viaduct

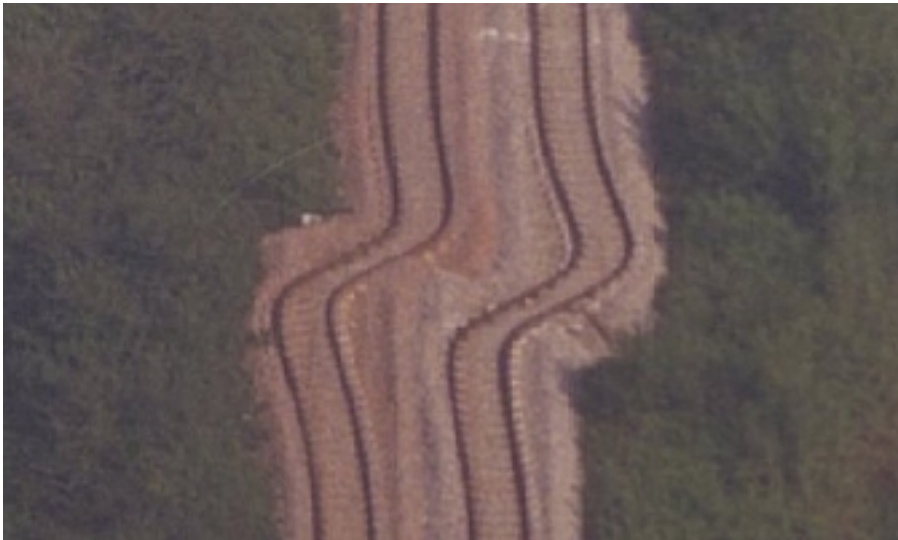
At the fault crossing near Arifiye, the tracks of the main railroad between Ankara and Istanbul were damaged. The tracks were distorted to an “S” shape by the fault offset at the Tepetarla station damaging about 200m section of the railroad. At

Figure 27. Bucking of the railroad track near Sapance in Kocaeli Earthquake

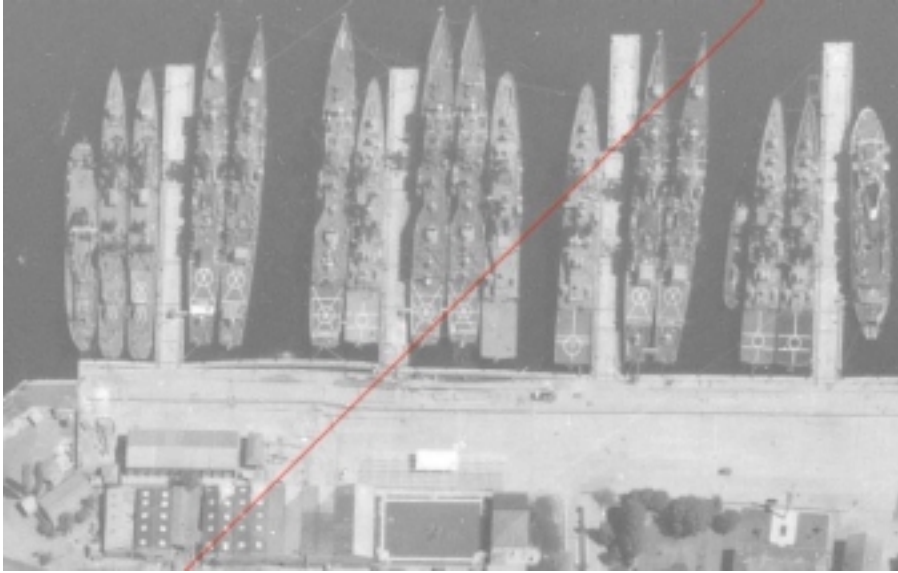
Figure 29. Aerial view of the Navy Base in Golcuk. The fault rupture is indicated by red line.

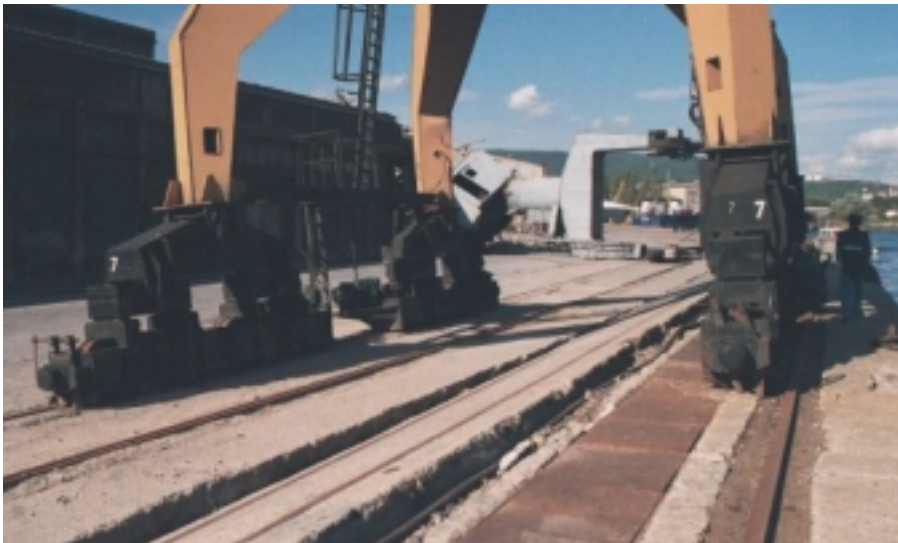
Figure 30. Damage at Derince Port in Kocaeli Earthquake

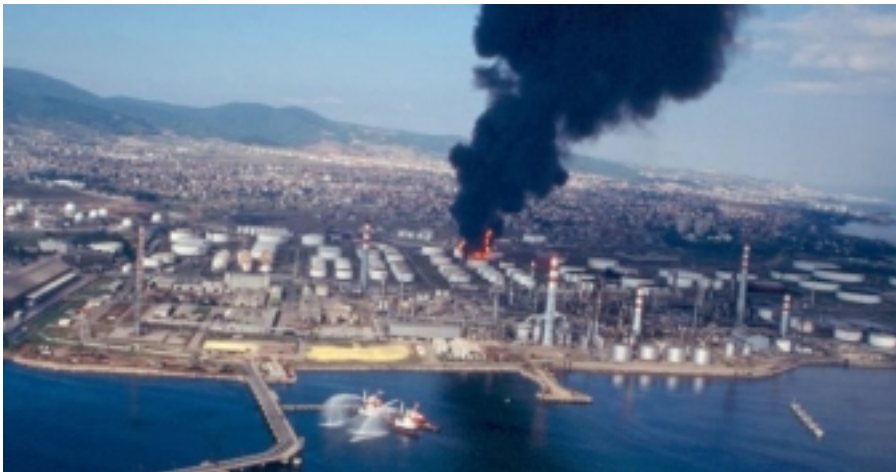
An extensive concentration of state-owned petrochemical complexes is located within 5km of the fault, including Tupras, Petkim and Igsas. The heaviest damage occurred at the Tupras facility, the largest refinery in the region producing about twelve million tons per year. The refinery was working at about 90 percent of its design capacity and can be considered a modern and efficient plant. The earthquake caused significant structural damages to the refinery itself and associated tank farm with crude oil and product jetties. The consequent fire in the refinery and tank farm caused extensive additional damage (Figure 31). Fire started in one of the Naphtha tanks continued for three days endangering the safety of the whole region. Six tanks of varying sizes in the tank farm of 112 tanks were damaged due to ground shaking and fire (Figure 32). There were damage to cooling towers and the port area. Collapse of a 150m high heater stack on the boiler and crude oil processing unit caused significant damage and started a second fire. The total damage is estimated to be around US\$350 million.

Figure31 A helicopter view of the fire in Tupras petrochemical complex.

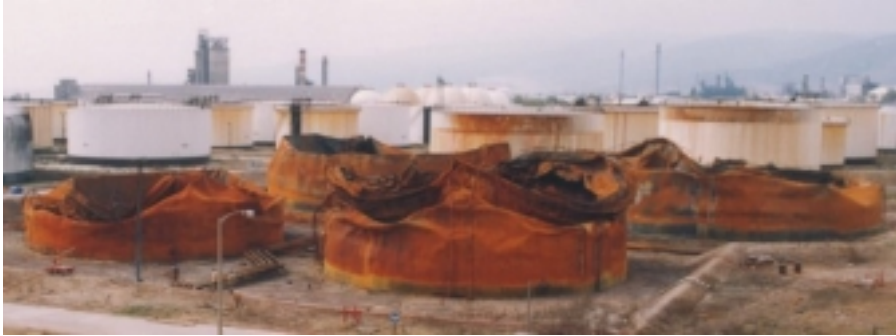
Figure 32. Post-earthquake fire damaged tanks in Tupras petrochemical complex
