# REDESIGN OF A HIGH SPEED COMPRESSOR DRIVE STEAM TURBINE TO OVERCOME CAPACITY, EFFICIENCY, AND RELIABILITY ISSUES

## ABSTRACT

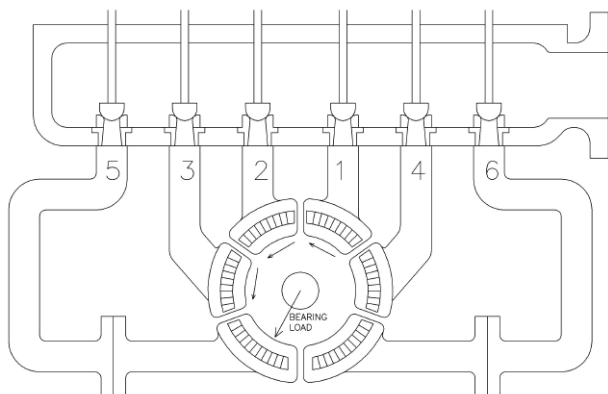
Figure 8. Original Valve Opening Sequence.

The redesigned turbine was installed and run at part load for an extended period of time. The high pressure journal bearing temperature was very high and continued to climb as steam flow to the turbine was increased. The elevated bearing temperature was determined to be the result of steam forces from the partial arc of nozzles on the first stage pushing the HP end of the rotor into the side of the bearing resulting in elevated reaction and undesirable loading angle on the HP journal bearing. Figure 8 shows the configuration of the first stage nozzle arcs and valve opening

sequence. With the first three valves open, the steam force exerted on the stage one wheel pushes the turbine rotor down and to the left. This steam force coupled with the rotor gravity load results in a very high load on the HP journal bearing, which caused the elevated bearing temperature. A new V1 camshaft assembly was installed with revised opening sequence as shown in Figure 9. With this opening sequence, the maximum bearing load was reduced and the unit was able to increase load without exceeding bearing temperature limits.

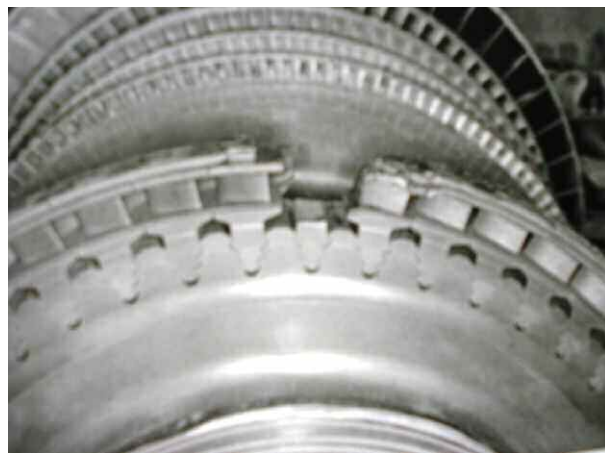
Figure 10. Failed Stage One Blade.

A piece of the failed blade was sent to a metallurgical lab for failure analysis. Although the fracture surface was somewhat compromised due to the broken blade getting bounced around within the steam path, the mode of failure was determined to be fatigue. Figure 10 shows the failed stage one blade and damage to adjacent blades.

The results of the failure analysis did not point to any one cause that would be expected to cause the blade to fail in such a short period of operation. However, the existing turbine configuration and operating conditions made this a very

challenging blade design. The single stage HP section results in very high stage one blade loading. A modern turbine would typically be designed with a two or three stage HP section for these operating conditions, which would dramatically reduce the load on each row of blades. The existing nozzle plate configuration could create a harmonic stimulus on the blades that could potentially result in elevated vibratory stress levels. If these issues could be addressed reliability of the stage one blades could be significantly improved.

A second redesign effort was undertaken to address the performance shortfall and blade reliability issues. This required changes to the turbine to correct the inherent problems with the original configuration. In order to reduce the high pressure ratio across first stage to improve efficiency and reduce blade loading, the HP section was converted to a two stage design. This required significant modification to the turbine rotor. The rotor was built up with weld in the area downstream of the existing first stage wheel. Two new wheels were machined with axial entry dovetails at reduced diameters. New blades were installed on the two new HP section rotor wheels.

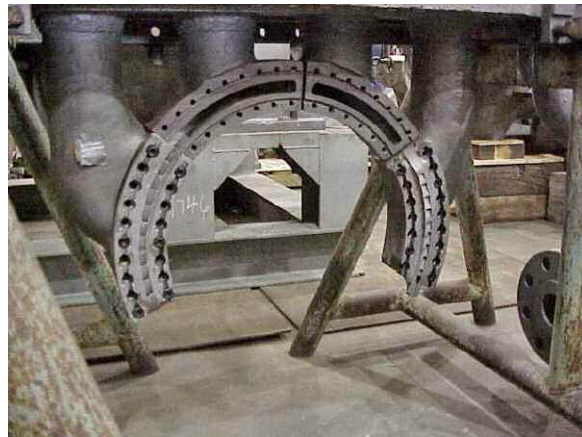
Figure 11. Original Stage One Nozzle Configuration.

Finite element analysis of the stage one blade and wheel was completed in an attempt to uncover the cause of the blade failure. All steady stresses were evaluated and determined to be within acceptable limits. Potential vibratory stresses due to resonance with nozzle passing stimulus were evaluated, and again were determined to be within acceptable limits. Another potential source of harmonic stimulus on the blades is the partial arc of steam being fed by the nozzle plate. On most industrial steam turbines, the nozzle plate is designed so that as the valves are sequentially opened, there is always only one continuous arc of nozzles feeding steam to the stage one blades. The stimulus from the partial arc of nozzles and resulting vibratory stress was calculated assuming a single nozzle arc and found to be within acceptable limits. However, the stage one nozzle plate configuration on this unit created multiple separate arcs of nozzles as shown in Figure 11.

The nozzle plate is made up of six segments, each fed by a control valve through a separate duct. The four inboard valves feed four upper half nozzle segments, and two outboard valves feed lower half nozzle segments via jumper pipes external to the turbine. This arrangement creates gaps between the nozzle segments creating a stimulus on the blades as they pass in and out of the active nozzle arcs. This unusual arrangement could potentially result in a harmonic stimulus resonant with natural frequencies of the stage one blade and wheel system that may have contributed to the blade failure.

A new stage one nozzle box was designed to eliminate the issues with the original nozzle duct arrangement, and also allowing a reduction in the stage one wheel diameter. This design eliminated the gaps between the individual nozzle arcs and also eliminated the restrictions in the passages between the control valves and nozzles. Figure 17 is a photograph of the new nozzle box.

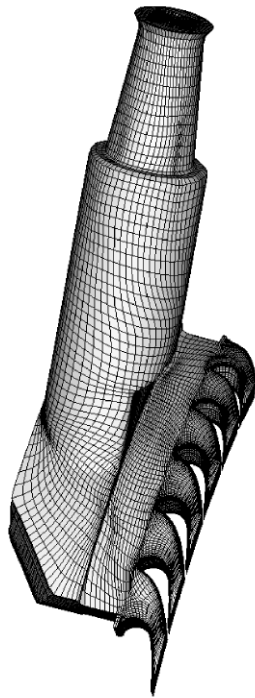
Figure 12. Model of Nozzle Duct.

The nozzle inlet duct arrangement shown in Figure 12 creates numerous restrictions for the steam passing from the control valve to the nozzles. Figure 13 shows the geometry of the inside of the duct. This configuration requires the steam to make a sharp turn at the bottom of the port to feed out circumferentially and axially to feed the nozzle arc. There is also an obstruction in the pipe that the steam must bypass before reaching the nozzle port.

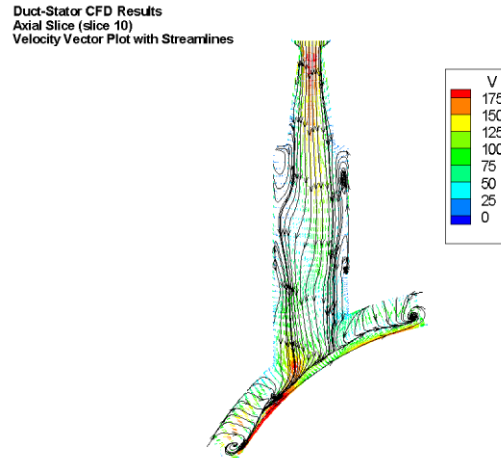
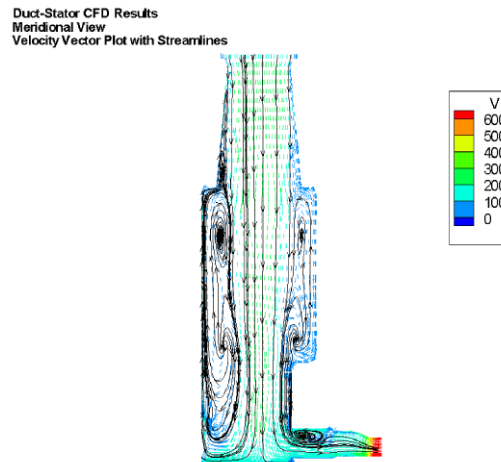
Computational fluid dynamics (CFD) modeling was completed on the inlet duct to determine if the restrictions resulted in excessive pressure losses that could negatively impact turbine efficiency. Figures 13 and 14 are CFD results showing the steam trajectories through the duct.

Figures 13 and 14 show that the duct geometry does not allow for smooth, unrestricted flow between the control valve and the nozzle vanes. Numerous sharp turns in the steam trajectory results in excessive pressure loss as shown in Figures 15 and 16.

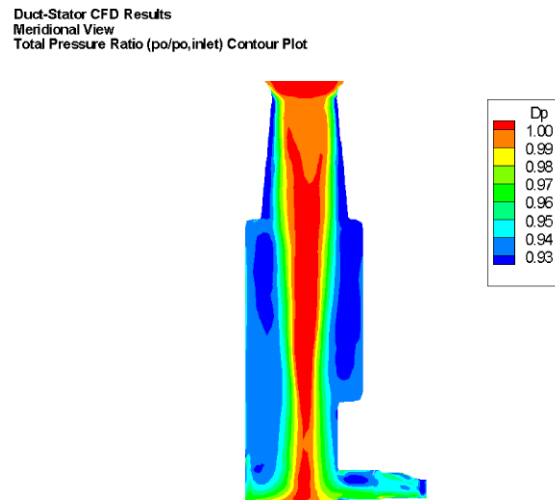
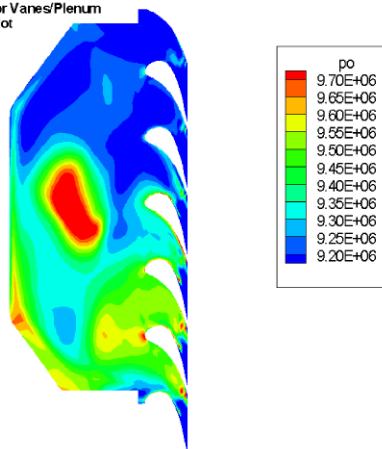
A significant pressure loss occurs before the steam reaches the inlet to the nozzle vanes. This pressure loss results in reduced available energy across the first stage and a reduction in HP section efficiency. Additionally, Figure 16 shows that there is a variation in pressure upstream of the arc of nozzle vanes. This variation results in a force variation across the arc that could increase the potential harmonic stimulus on the stage one blades mentioned earlier.
