# CORROSION ATLAS

Case History 01.01.01.001

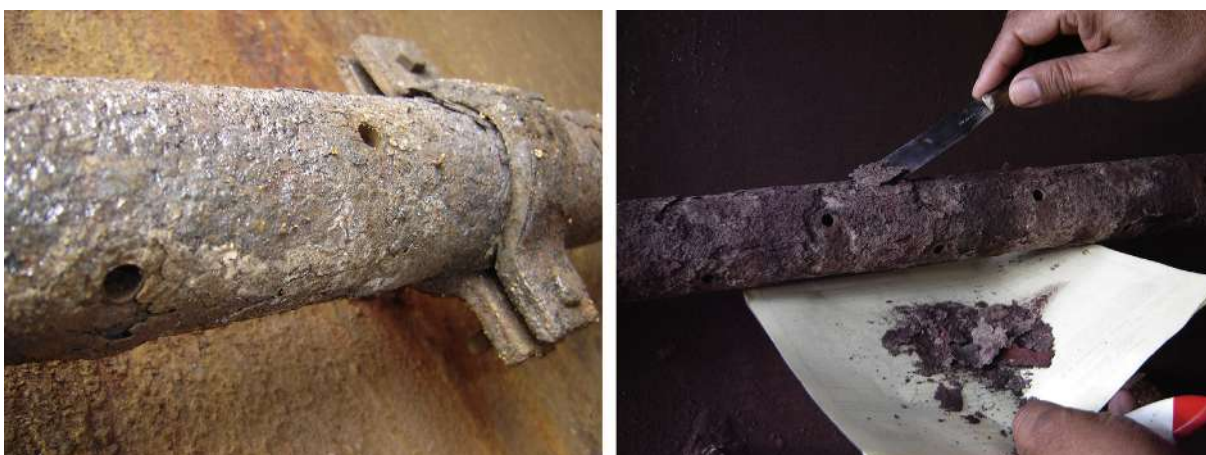
<b>Material</b>	Carbon steel (AISI-SAE 1025)
<b>System</b>	Saturated steam line in autoclave for tires retreading
<b>Part</b>	Saturated steam pipe
<b>Phenomenon</b>	High-temperature corrosion

<b>Appearance</b>	Uniform attack (external side), thick layer of corrosion products
<b>Time in Service</b>	1 year
<b>Environment</b>	Autoclave operation conditions: 90 psi (max. working pressure), 154°C (309.2°F), saturated steam
<b>Cause</b>	Unsuitable material for the operation conditions, leading to uniform corrosion with formation of a thick, nonadherent layer of corrosion products. The recommended material for the pipe was carbon steel according to ASTM A106, but the used material does not correspond to those specifications. The inner walls of the autoclave also showed signs of uniform corrosion, but the damage was more serious on the pipe after just 1 year of service.
<b>Remedy</b>	Replacement of the pipe with a new one, for example, made of carbon steel ASTM A106 (Standard Specification for Seamless Carbon Steel Pipe for High Temperature Service), or similar.

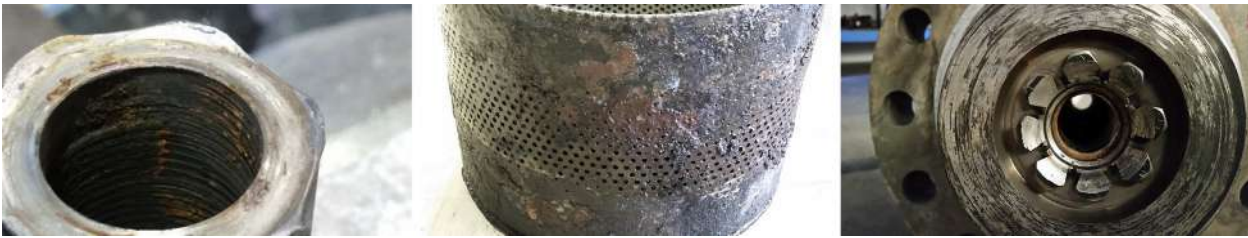
Case History 01.01.01.002

**Appearance** Corrosion product around the strainer of the valve with black and brown product in layers

**Time in Service** 6 months

**Environment** Pressure: 10 bar(g)  
Temperature: 186°C  
Impurities

**Cause** High carryover in boiler, high levels of oxygen

**Remedy** Improve the separator of the steam and condensate the boiler by adding cyclone separators and injection of sulfite in parts per million to inhibit the corrosion

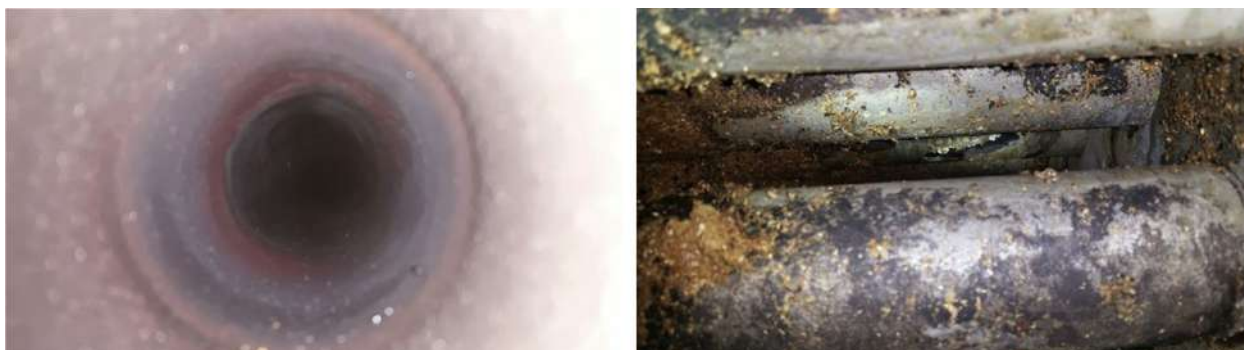
Case History 01.01.12.001

<b>Material</b>	Carbon steel
<b>System</b>	Shell and tube heat exchanger
<b>Part</b>	Tube
<b>Phenomenon</b>	Localized corrosion

<b>Appearance</b>	Rupture of the tubes close to the welded points. Small accumulation of iron oxide inside the tube. Product accumulation on the outside of the tubes Cracks around the supports of the tube and shell heat exchanger
-------------------	---

<b>Time in Service</b>	5 years
------------------------	---------

<b>Environment</b>	pH < 5 outside the tube pH (5, 7) inside the tube Pressure: approx. 5 bar(g) Temperature: 120–200°C Moisture content: approx. 5% Steam and condensate fluid
--------------------	---

<b>Cause</b>	Mechanical failure and caustic
--------------	--------------------------------

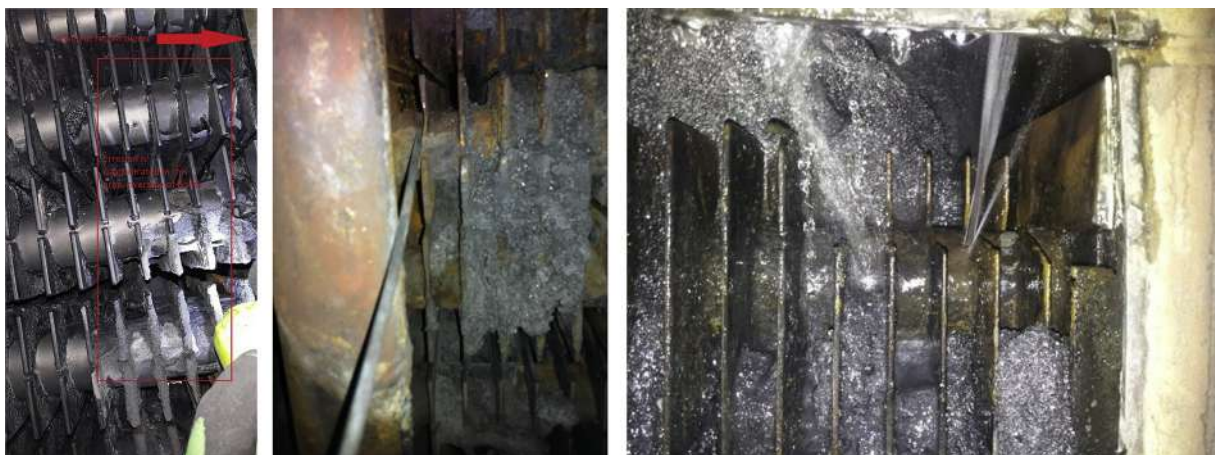
**Phenomenon** Under deposit corrosion and erosion

The SS shield has worn dramatically at the 2 o'clock and 10 o'clock positions where the surface appears irregular. Some plates have been completely eroded. Ash is observed in some areas between the fins along with iron oxide. Pinholes were showing at the same positions with a great accumulation of ash  
Ash has built up in between the fins

**Cause** Ash/coal particle average velocity: 11 m/s, max. up to 25 m/s

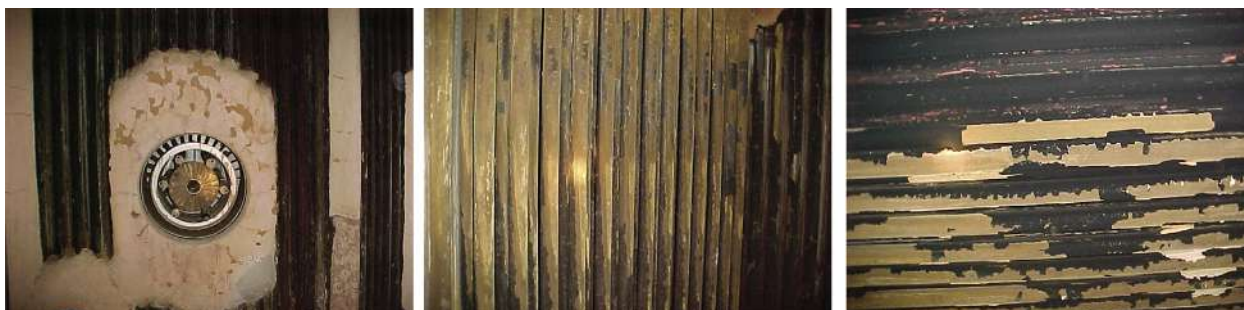
<b>Material</b>	Carbon steel
<b>System</b>	Boiler furnace
<b>Part</b>	Tubes—furnace side
<b>Phenomenon</b>	Iron oxide caused by uniform corrosion in the tubes

<b>Appearance</b>	Black sludge 3 to 5-mm-thick covering sections of the tube bank in the furnace side of the boiler CS section are exposed without any sludge
<b>Time in Service</b>	15 years
<b>Environment</b>	Fly ash Air Moisture Organic oil High temperature High pressure
<b>Cause</b>	Lack of sootblowers and problems with full combustions
<b>Remedy</b>	Cleaning the tubes and adding sootblowers

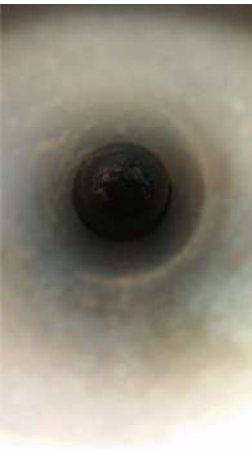
<b>Material</b>	CS
<b>System</b>	Boiler steam generation
<b>Part</b>	Tubes from the generating banks
<b>Phenomenon</b>	Under deposit/scale corrosion

<b>Appearance</b>	Iron oxide with a corrosion deposit layering up inside the boiler tubes
<b>Time in Service</b>	12 months
<b>Environment</b>	Carryover and impurities. High levels of silica promoting deposition on the tube where the temperature drops
<b>Cause</b>	Inappropriate water treatment
<b>Remedy</b>	Improve the softener's performance to maintain the hardness within the recommended range
<b>Additional References Pertaining to Case Study</b>	ASME guidelines

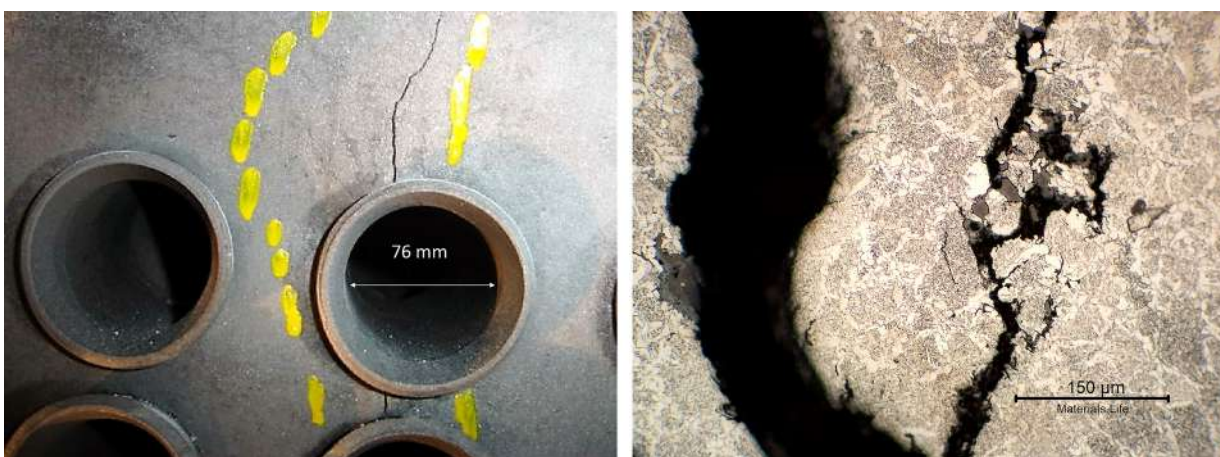
<b>Material</b>	Low carbon steel UNS K03101 Ferritic weld metal
<b>System</b>	Boiler steam drum
<b>Part</b>	Shell plate previously repaired in a position between tube holes Thickness of the cracked vessel 37.3 mm Tube diameter of 76.2 mm
<b>Phenomenon</b>	Caustic stress corrosion cracking

<b>Appearance</b>	Transgranular stress corrosion cracks in the weld repaired shell, close to tube holes
<b>Time in Service</b>	Months after repair
<b>Environment</b>	Steam
<b>Cause</b>	Concentration of caustic products from water treatment associated to high temperature, and a nonheat-treated condition of the weld repair, evident by the high hardness (280 HV10)
<b>Remedy</b>	Better control of water treatment Any weld repair requires heat treatment
<b>Additional References Pertaining to Case Study</b>	Materials Life Database

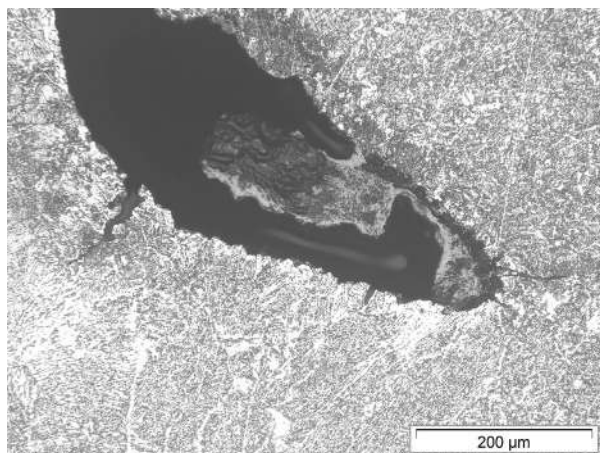
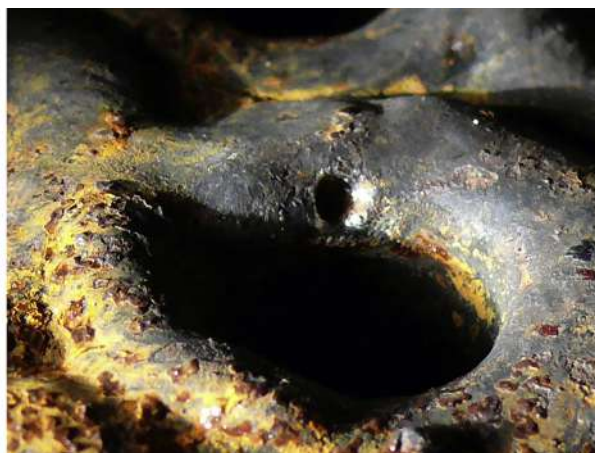
<b>Material</b>	Carbon steel
<b>System</b>	Hot water system (hot water (120°C) through shell and tube heat exchangers, with steam inside the pipes and hot water on the outside)
<b>Part</b>	Heat exchanger
<b>Phenomenon</b>	Stress corrosion

<b>Appearance</b>	Leakage at the weld from the pipe at the baffle plate
<b>Time in Service</b>	4 years
<b>Environment</b>	Demin water by reverse osmosis with sodium hydroxide dosage. pH 10.6, conductivity 117 $\mu\text{S}/\text{cm}$ , $\text{Cl}^- < 0.5 \text{ mg}/\text{l}$ , p-alkalinity 0.4 meq/l, m-alkalinity 0.6 meq/l
<b>Cause</b>	The cracks indicate leaching corrosion. The corrosion could have taken place because the pipes were not rolled and sodium hydroxide was dosed in demin water. When a pipe is rolled the crevices between the pipe and the baffle plate are removed and accumulation of caustic in these crevices will not be possible
<b>Remedy</b>	The pipes in the new heat exchangers are all rolled in and the dosing of the sodium hydroxide solution and the pH control are improved (maintain pH around 9.5)

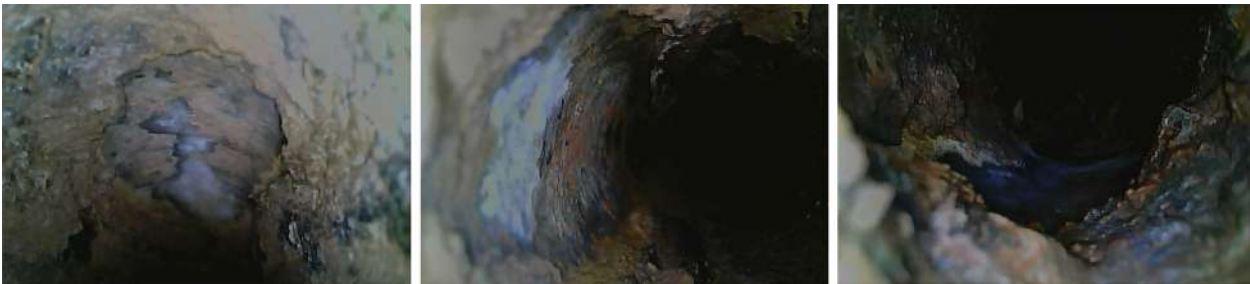
<b>Material</b>	Carbon steel
<b>System</b>	Steam generation
<b>Part</b>	Boiler's tubes
<b>Phenomenon</b>	Silicate scales and iron oxide

<b>Appearance</b>	Brown and reddish layers corrosion building up inside the tubes Substrate cover in the majority of the surface
<b>Time in Service</b>	3 years
<b>Environment</b>	pH: $>8 < 10$ Temperature: approx. $150^{\circ}\text{C}$ Pressure: 18 bar(g) Fluid inside the tubes: softened water
<b>Cause</b>	Inappropriate water treatment
<b>Remedy</b>	Adding of hydrochloric acid (HCl) and ammonium bifluoride (ABF) chemical cleaning to clean up the tubes Monitor the system to understand the chemistry of the water and make the improvement required

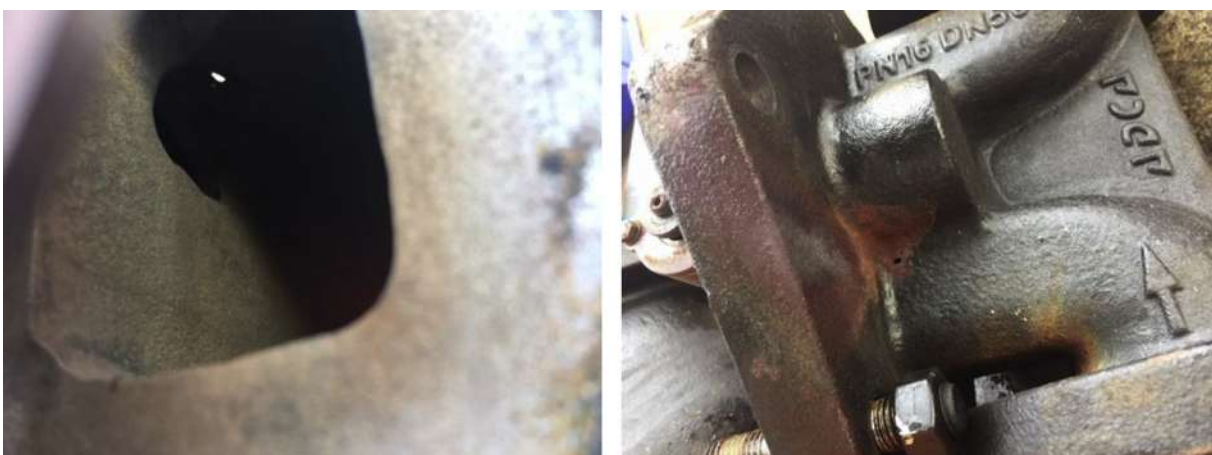
<b>Material</b>	Carbon steel
<b>System</b>	Steam trap
<b>Part</b>	Shell
<b>Phenomenon</b>	Pitting corrosion activated by oxygen and impurities

<b>Appearance</b>	Pinhole on the condensate side of the steam trap, around the pinhole there was erosion and color changed around the area affected
<b>Time in Service</b>	2 years
<b>Environment</b>	Saturated steam line pH: >8<10 Pressure: 10 bar(g)
<b>Cause</b>	Carbonated in the water turning into CO <sub>2</sub> during condensation gas stream
<b>Remedy</b>	Improve the steam quality and water quality

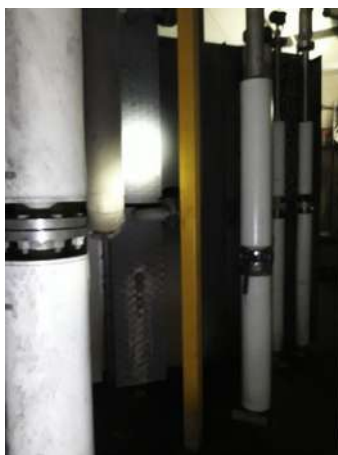
<b>Material</b>	Carbon steel
<b>System</b>	Counter-flow heat exchanger
<b>Part</b>	Condensate outlet of the shell of the heat exchanger
<b>Phenomenon</b>	Pitting corrosion caused by oxygen and carbonic acid

<b>Appearance</b>	Pinholes in the header and wall thickness lost, iron oxide on the surface of the shell Product running of the steam box leaving residual marks
<b>Time in Service</b>	5 years
<b>Environment</b>	pH: <10>8 Pressure: 10 bar(g) Impurities Two fluid flow
<b>Cause</b>	Oxygen, carbonic acid in the steam
<b>Remedy</b>	Improving the process design to guarantee the flow direction of the condensate. Change the CS steam header boxes for SS316

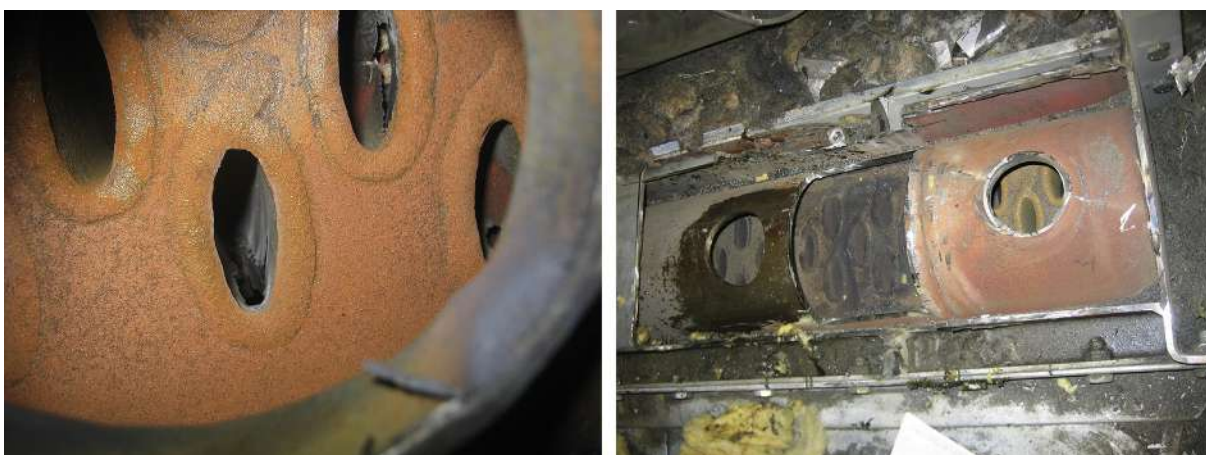
<b>Material</b>	Carbon steel
<b>System</b>	Air heater with condensate
<b>Part</b>	Heat exchanger for heating the process air with condensate after a flash tank
<b>Phenomenon</b>	Erosion corrosion

<b>Appearance</b>	Gaps have been found at the water inlet of different tubes of the heat exchanger. The wall thickness of the tubes is locally decreased and a gap is formed in the pipe
<b>Time in Service</b>	After 1 year
<b>Environment</b>	Steam and water
<b>Cause</b>	This type of damage indicates that the flow velocity was too high. The damage was fatal in such a short time because the velocity was more than 10 times (almost 20 times) the maximum allowed velocity of 2 m/s Because of the high flow velocity, the steel was locally worn away. The water quality has none or a secondary influence on this process
<b>Remedy</b>	Minimizing the amount of flash steam through pressure stabilization and maintaining the velocity of the heat exchanger at 2 m/s through putting an appropriate controllable valve, 6.5 bar.
<b>Additional References</b>

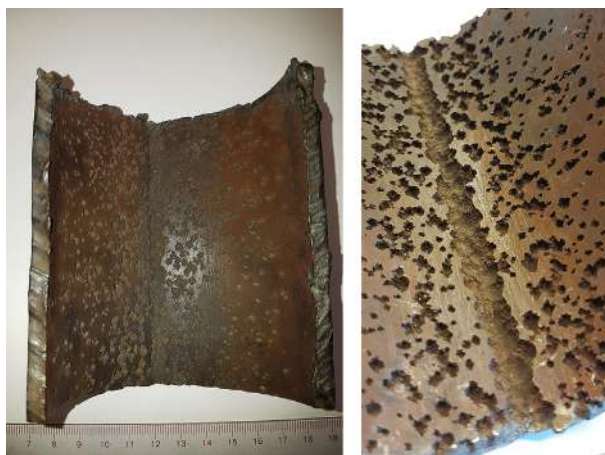
**Phenomenon** Cavitation erosion

**Appearance** Attack with sharp edges, concentrated at the upper side of the pipe, and preferential attack of the weld

**Cause** A condensate/steam mixture from a leaking steam trap was fed in upstream at the upper side of the line. The entrained steam imploded in the relatively colder condensate present in the line, thereby causing cavitation with preferential attack to the weld

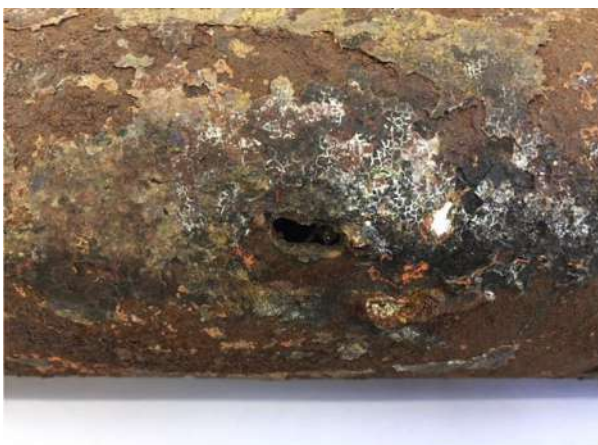
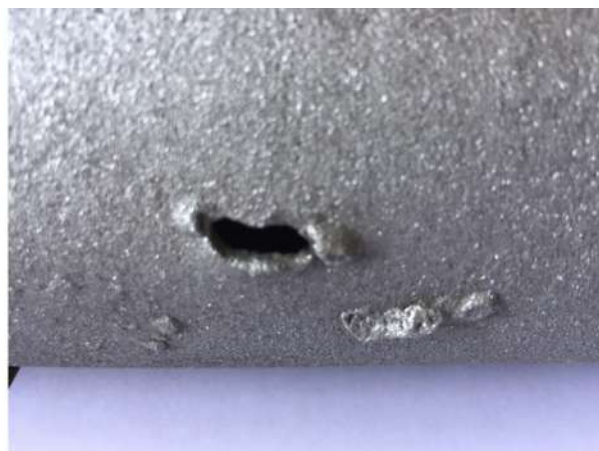
<b>Material</b>	Seamless API 5L X52 Gr.B pipe of homogenous ferrite–pearlite microstructure containing MnS inclusions
<b>System</b>	Piping at a hydrocarbons exploitation field
<b>Part</b>	Thermally insulated hot water pipeline
<b>Phenomenon</b>	Corrosion under insulation, corrosion at arc strike welding defect

<b>Appearance</b>	Uniform corrosion under insulation, perforation at the location of the weld arc strike outside of the weld HAZ area
<b>Time in Service</b>	30 years
<b>Environment</b>	Degraded, minimum pigmented alkyd paint covered by thermal insulation containing 1040 ppm Cl <sup>-</sup>
<b>Cause</b>	Arc strikes serving as a corrosion nucleation site due to heat-affected zone in base metal and crevice like imperfections in that area
<b>Remedy</b>	Replacement of perforated pipe segments. Avoiding and/or removing (grinding, repairing) of arc strikes on new construction
<b>Additional References Pertaining to Case Study</b>	B. Boling, Understanding arc strikes, Inspection Trends, 16, 3 (2013) 22–25.

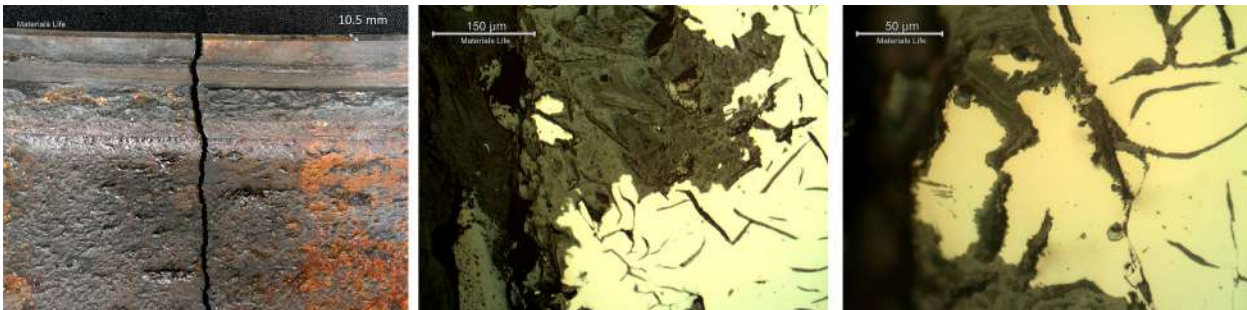
**Phenomenon** General corrosion from the water side, associated to graphite to matrix interface corrosion that created a notch morphology

**Appearance** Brittle fracture by graphite decohesion and cleavage of the corroded case

**Cause** Overloading of the case due to the thickness loss associated to notch effect of the corrosion

**Remedy** Protection of the case from the general corrosion

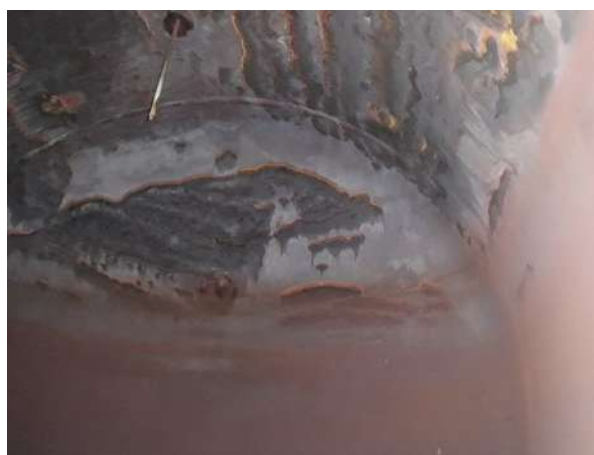
<b>Material</b>	Carbon steel
<b>System</b>	Spray-type deaerator
<b>Part</b>	Shell
<b>Phenomenon</b>	Oxygen water treatment

<b>Appearance</b>	Hematite and magnetite deposited under the coating, presenting dark lines. Orange lines resemble iron oxide and potentially a waterline in the drum
<b>Time in Service</b>	15 years
<b>Environment</b>	pH: <8>10 Pressure: approx. 5 bar(g) Temperature: 120–200°C
<b>Cause</b>	Localized corrosion investigated by oxygen and under corrosion deposit
<b>Remedy</b>	Coating and improving internals

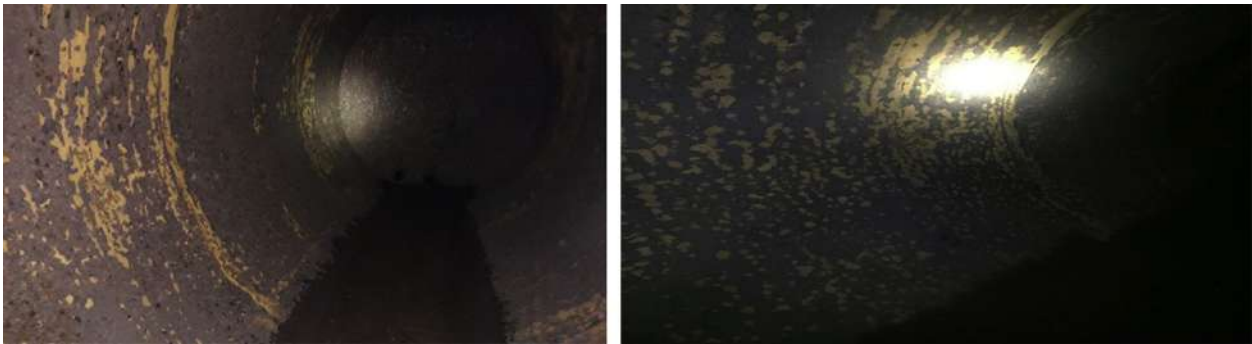
<b>Material</b>	Carbon steel
<b>System</b>	Feedwater tank for a boiler
<b>Part</b>	Shell
<b>Phenomenon</b>	Uniform corrosion accelerated by iron content in the feedwater walls

<b>Appearance</b>	Iron oxide build up on all the walls of the tank. Large amounts of corrosion deposits on the bottom. Some of the area exposed the substrate
<b>Time in Service</b>	2 years
<b>Environment</b>	Temperature measured °C: <60 Pick temperature estimated °C: <80
<b>Cause</b>	The original coating was not appropriate and high iron content in the feed of the tank
<b>Remedy</b>	Selection of the ceramic epoxy coating instead of the original Dulux Aperiore N1

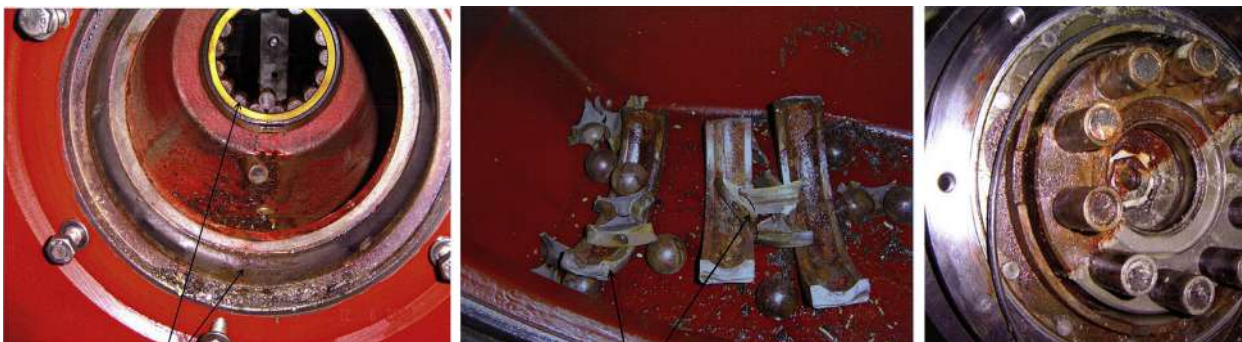
<b>Material</b>	CS
<b>System</b>	Decaners effluent treatment
<b>Part</b>	Bearings
<b>Phenomenon</b>	General and localized corrosion

<b>Appearance</b>	Corrosion build up product like iron oxide around the bearings and shaft of the pumps
<b>Time in Service</b>	5 months
<b>Environment</b>	Effluent water Operation pressure: 270 kpa Temperature: 50°C
<b>Cause</b>	Feeding the decanter The lubrications system was found with a lot of effluent water due to high flows during a standstill setting
<b>Remedy</b>	Replacing bearing, primary and secondary cycle gear

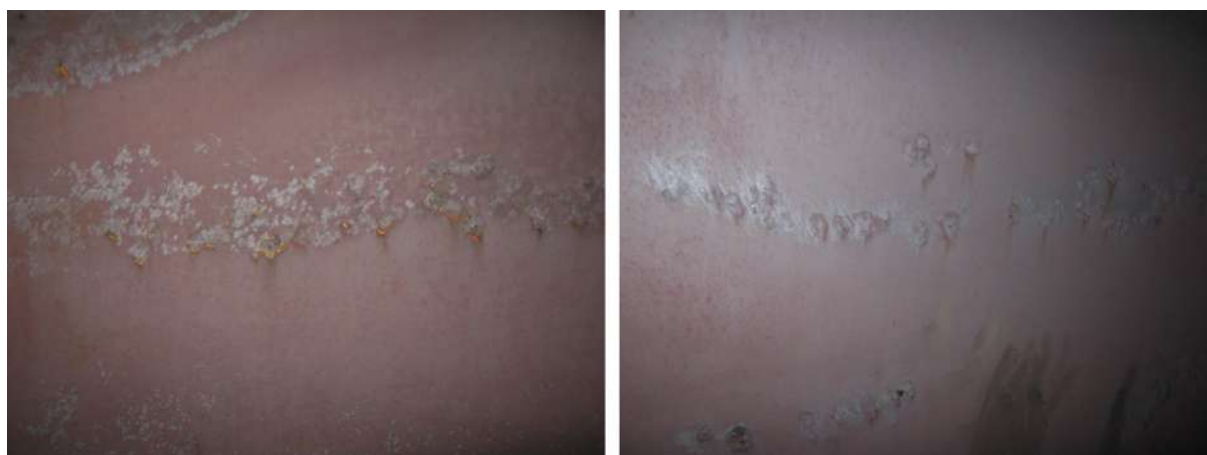
<b>Material</b>	CS
<b>System</b>	Deaerator
<b>Part</b>	Walls
<b>Phenomenon</b>	Oxygen corrosion, pitting, and uniform corrosion

<b>Appearance</b>	Blister in the protective coating with iron oxide around some of the pitting. Went deep in the surface
<b>Time in Service</b>	8 years
<b>Environment</b>	Condensable gases, soften water design pressure 350 Kpa, design working temperature 200°C
<b>Cause</b>	Insufficient separation, high concentration of oxygen in feedwater
<b>Remedy</b>	Addition of sulfite in parts per million to control the amount of oxygen below 7 ppb, improve the deaerator's performance

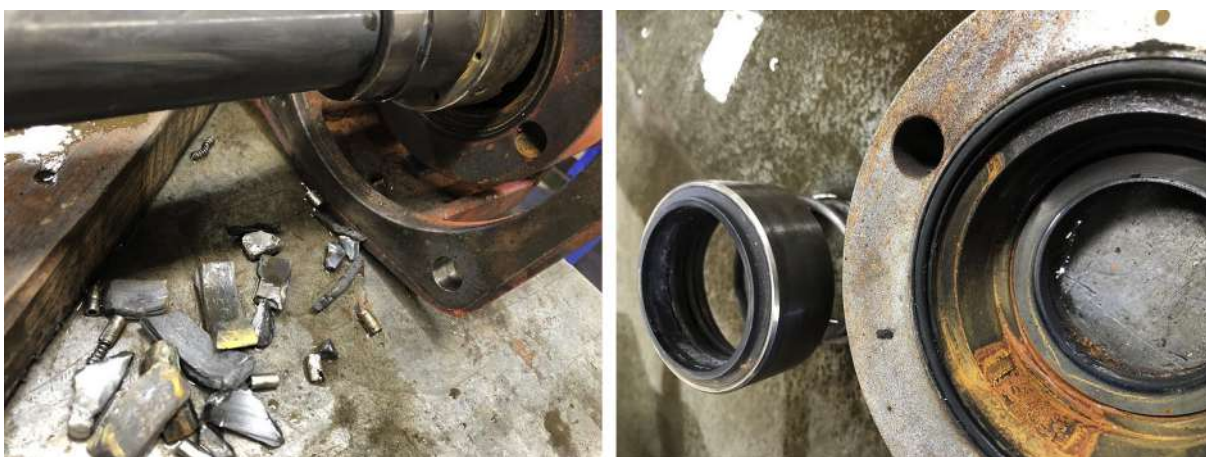
<b>Appearance</b>	Iron oxide product bottom of the mechanical seal
<b>Time in Service</b>	2 years
<b>Environment</b>	Water pH: 7-9 Carbonates 500 Kpa
<b>Cause</b>	Low pH in the feedwater repetitive times
<b>Remedy</b>	Replacement of the impeller and mechanical seal controlling pH

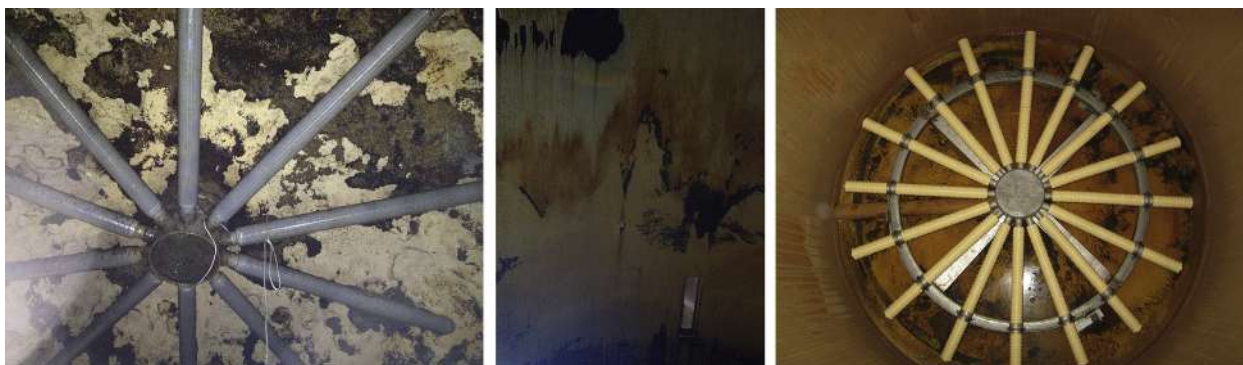
**Material** Carbon steel**System** Ion exchanger**Part** Shell**Phenomenon** Uniform corrosion

**Appearance****Time in Service****Environment** Acidic**Cause** Uniform corrosion**Remedy** Refurbishment**Additional References Pertaining to Case Study**

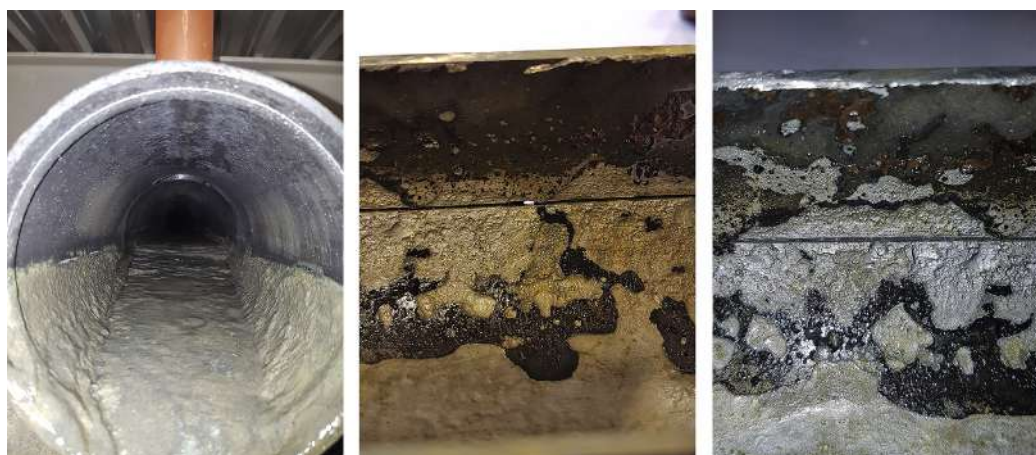
<b>Appearance</b>	Brown corrosion tubercles and a lot of mud
<b>Time in Service</b>	8 years
<b>Environment</b>	The sprinkler system is filled with surface water
<b>Cause</b>	The carbon steel is affected below the waterline near the air containment in the roof net. Surface water contains a lot of microbiology and nutrients, as a result of which MIC was formed in the stagnant water. The growth of microbiology in stagnant waters is very unpredictable, that is why corrosion was only detected when the first leaks occurred
<b>Remedy</b>	Use drinking water instead of surface water in combination with a corrosion inhibitor

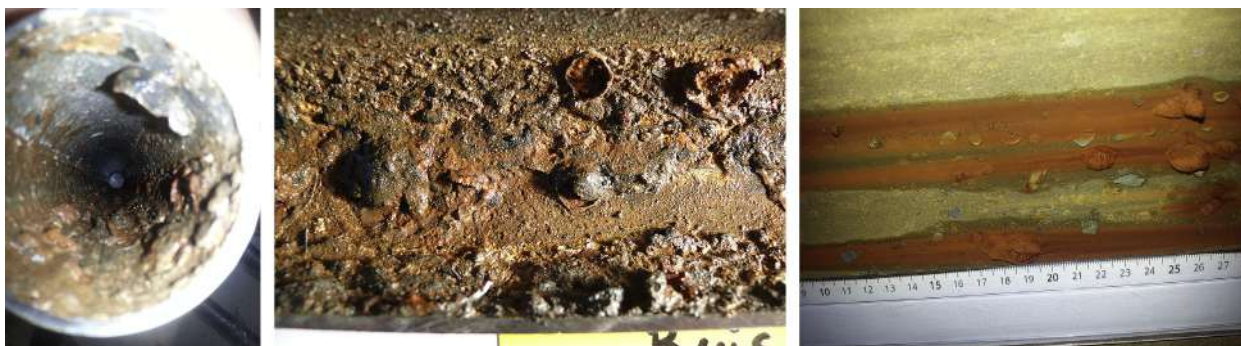
**Phenomenon** MIC

**Appearance** A lot of brown corrosion tubercles and mud

**Cause** The carbon steel is affected below the waterline near the air containment in the roof net. The drinking water contains an enough microbiology and nutrients, as a result of which MIC may have formed in the standing water

**Remedy** Using steel with an inhibitor or nitrogen. Another option is to use stainless steel also with an inhibitor against MIC

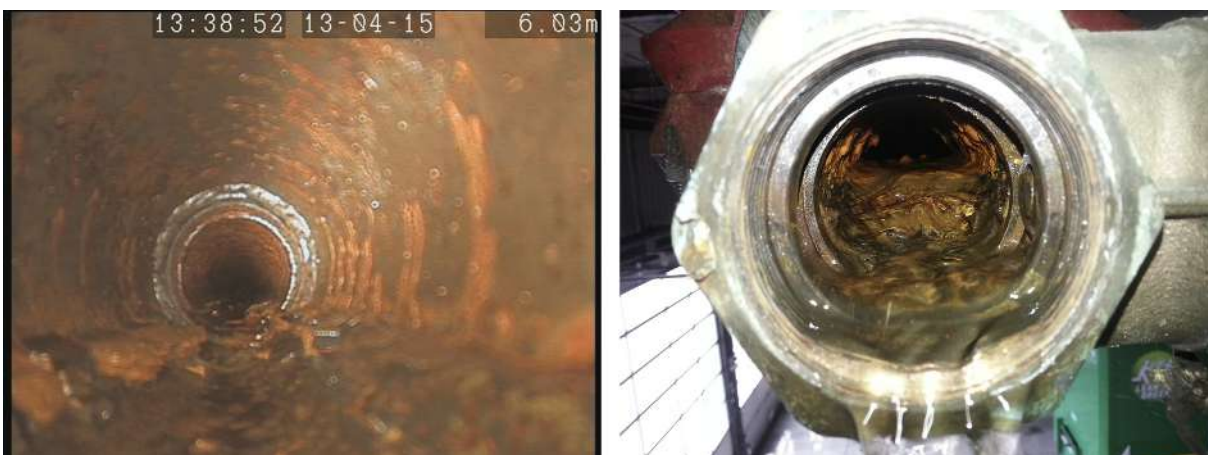
<b>Appearance</b>	Brown corrosion tubercles, a lot of mud and tubes
<b>Time in Service</b>	24 years
<b>Environment</b>	The wet sprinkler system is filled with surface water
<b>Cause</b>	The carbon steel is affected below the waterline near the air containment in the roof net. The surface water contains a lot of microbiology and nutrients, as a result of which MIC may have formed in the standing water. The microben formed tubs
<b>Remedy</b>	Use drinking water instead of surface water and use a corrosion inhibitor

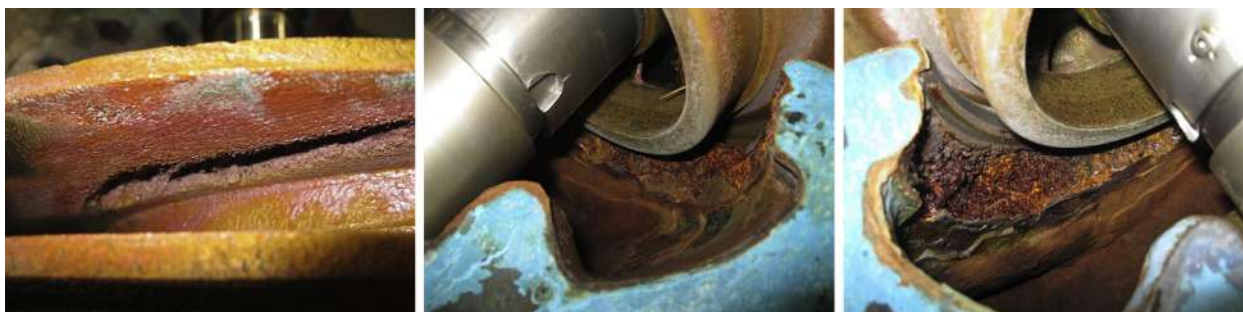
<b>Material</b>	Carbon steel
<b>System</b>	Saltwater pump
<b>Part</b>	Shaft and mechanical seal
<b>Phenomenon</b>	Pitting, erosion, localized corrosion

<b>Appearance</b>	Iron oxide, breakdown of the seal in different layers, coating peeling off and corrosion product around the seal
<b>Time in Service</b>	3 years
<b>Environment</b>	Saltwater, pressure: 7 bar Temperature: 45°C Flow Q: 250 lps TDH: 48 m/h Static lift: not provided
<b>Cause</b>	Oxygen and chloride ions
<b>Remedy</b>	Replace the shell for the CS with Belzona coating to surfaces, Impeller in SS, Anodes fitted, Duplex volute bolts Supply of a spare bronze impeller for the saltwater pumps

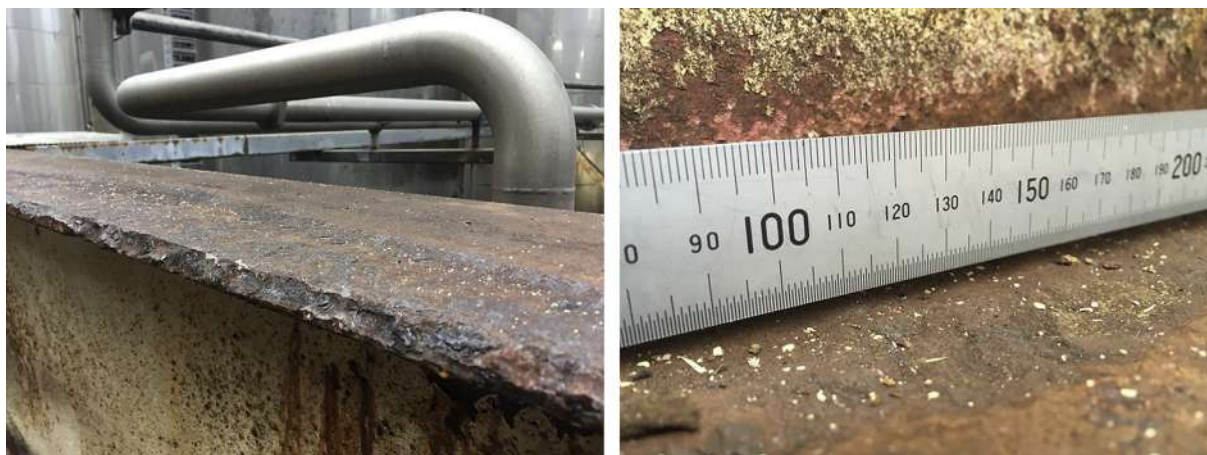
**Phenomenon** Uniform and acid corrosion

**Appearance** Iron oxide, coating protection worn out, strength and structure lost in the steel

**Environment** pH: <3  
Temperature and pressure: ambient  
Moisture: 45%

**Cause** Acid corrosion

**Remedy** Replacement of the structural and protection coating

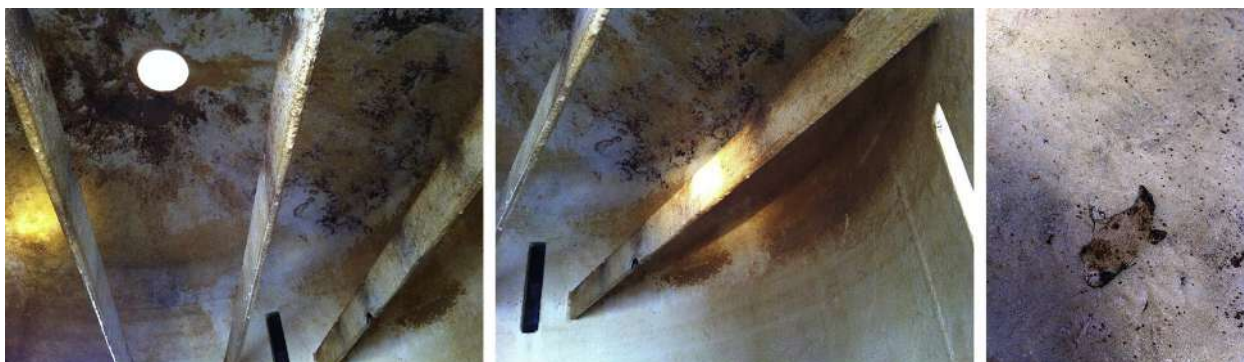
<b>Material</b>	Carbon steel
<b>System</b>	Mixed-bed vessel
<b>Part</b>	Shell
<b>Phenomenon</b>	Under-deposit corrosion

<b>Appearance</b>	Pitting on the walls of the tank and iron oxide deposit
<b>Time in Service</b>	8 years
<b>Environment</b>	High levels of chlorides above 2000 ppm pH: <5 Temperature: approx. 50°C
<b>Cause</b>	Acid corrosion
<b>Remedy</b>	Solid epoxy tank coating replacement for a 304L SS vessel and coating

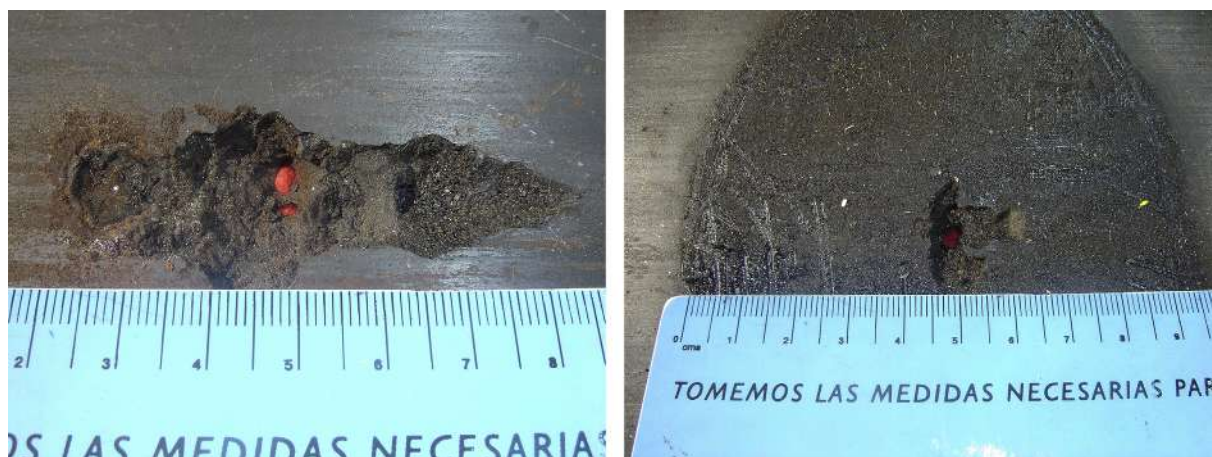
<b>Material</b>	Low carbon steel (API 5L Grade ×42)
<b>System</b>	Crude oil conveying line
<b>Part</b>	Pipe sections
<b>Phenomenon</b>	Microbiologically influenced corrosion (MIC)

<b>Appearance</b>	Large cavities, perforations in many zones of the pipeline
<b>Time in Service</b>	21 months
<b>Environment</b>	Crude oil, water, and gases (exact chemical composition of the fluid is unknown). External side: humid atmosphere
<b>Cause</b>	The first perforation of the pipe was detected after 21 months of service. In the next 3 months 17 perforations were detected in several tubes along the 15 km pipeline. The failure analysis of some failed pipe sections showed typical morphologies of microbiologically influenced corrosion. All cavities and perforations appeared at 6 o'clock position; some rests of sediments were also found. No crude oil, water, or sediment samples were provided for further analysis
<b>Remedy</b>	Use of new tubes with protection of the inner surface (e.g., high-density polyethylene jacket), or selection of a more suitable material

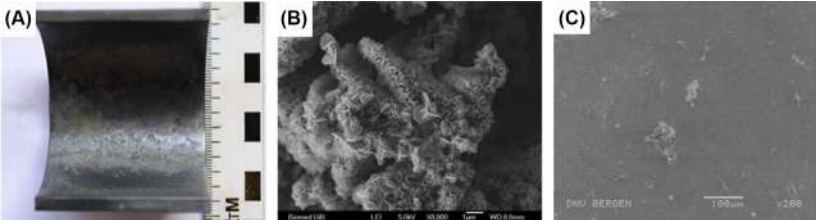
<b>Material</b>	S235JR carbon steel
<b>System</b>	Oilfield seawater injection system. Risk of microbial corrosion indicated in laboratory studies indicating a need for biocide treatment
<b>Location</b>	Pipe sections downstream chemical injection pump and seawater booster pump and upstream of injection zone. Laboratory study conducted on 60-mm ID pipe steel sections and using carbon steel electrochemical probes
<b>Phenomenon</b>	Microbially influenced corrosion (MIC)

<p>(A) Macro photograph of a pipe section showing corrosion products. A ruler is visible for scale. (B) Scanning electron micrograph (SEM) showing a porous, crystalline corrosion product. (C) Optical micrograph showing a surface with corrosion products. Scale bars are present in (B) and (C).</p>
<b>Appearance</b>	Materials exposed to abiotic environment were featured by green rust deposits under which uniform corrosion was revealed. Materials exposed to biotic environment were featured by black slimy deposits consisting of FeS and biological material, under which uniform corrosion was revealed

<b>Time in Service</b>	100 days
<b>Environment</b>	Deoxygenated and sulfate-rich North Sea coastal seawater at 15–25°C environments with contrasting presence or absence of microbial flora and associated metabolic activity
<b>Cause</b>	Conducted work has shown that under representative sulfate-rich seawater injection conditions, metabolic activity of sessile sulfide and carbon dioxide-producing bacterial populations dominated by <i>Caminiella</i> generated both an abundant sulfide film on the steel surface layer as well as carbonaceous mineral precipitates on the carbon steel samples. However, the overall impact of the bacterial consortium on the corrosion rate of S235JR carbon steel specimens was minimal. The presence of a microbial flora and associated metabolic activity causing deposits at metal surfaces resulted in similar corrosion rates to that observed in the control (sterile) microbe-free environment over 100 days of exposure. Clearly, the release of biogenic sulfide does not necessarily lead to extensive localized pitting attack. It is apparent that metabolic activities of cells are likely to influence the chemistry of bioinorganic corrosion products and should be considered when evaluating MIC risk

<b>Remedy</b>	Investigation concluded that biocide treatment is not necessary in short run. However, as the microbiological activity is postulated to accelerate with service time and biofilm abundance to increase, it is recommended to use glutaraldehyde-based biocide treatment one time per week at 500 ppm concentration and for duration for 2 h
<b>Additional References Pertaining to Case Study</b>	<a href="https://www.sciencedirect.com/science/article/abs/pii/S1567539413000984">https://www.sciencedirect.com/science/article/abs/pii/S1567539413000984</a> Stipanicev et al., Corrosion of carbon steel by bacteria from North Sea offshore seawater injection systems: Laboratory investigation, Biocorrosion (2011).

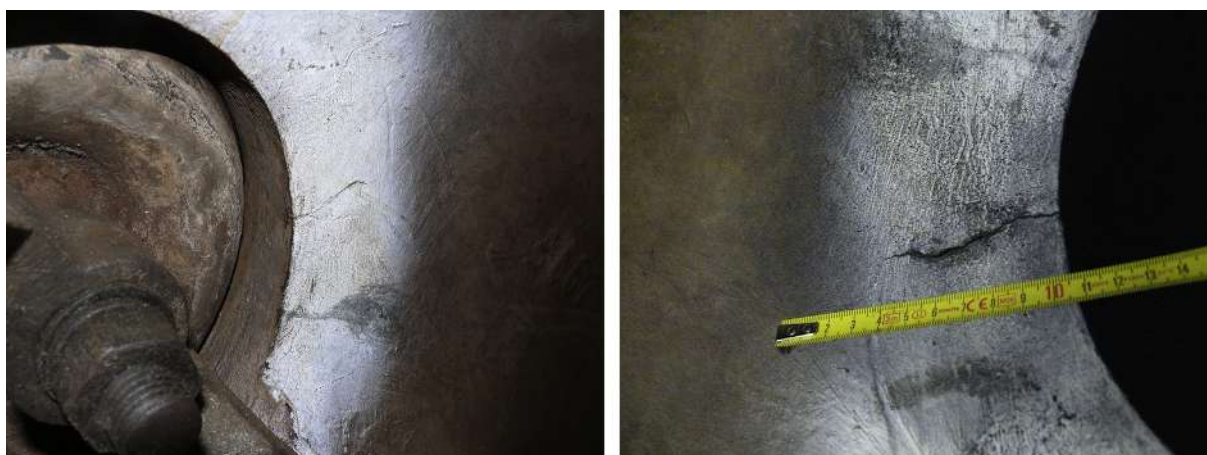
**Phenomenon** Mechanical stress cracks

**Appearance** Crack indications in the support for the manhole clamps

**Environment** Crack indications are on the outside where ambient air is present

**Cause** The construction of the manhole in the front plate of the cylinders where a crack indication is found is unfavorable for distributing the mechanical stresses

**Remedy** Because cracks in cast iron cannot be easily repaired, it is advisable to replace the front plates. For the purchase of the new front plates, a different closure and construction of the manhole and the manhole cover must be chosen in consultation with the supplier. It must be investigated in which way the mechanical stresses can best be distributed over the front plate

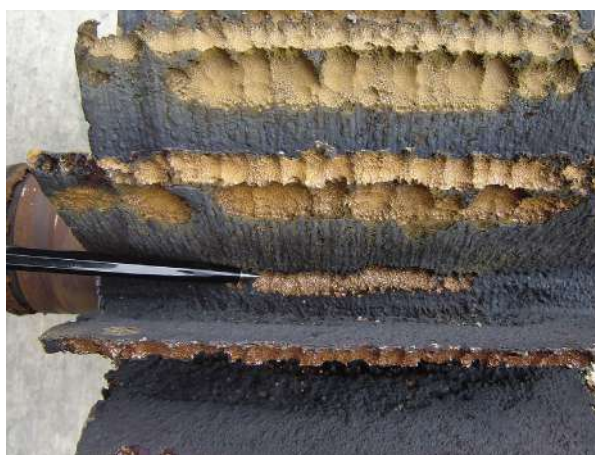
<b>Material</b>	Ductile cast iron
<b>System</b>	Liquid-ring vacuum pump
<b>Part</b>	Impeller rotor
<b>Phenomenon</b>	Erosion corrosion

<b>Appearance</b>	Wide pits at impeller rotor blade ends, related to the flow direction. Brownish-red corrosion products in the cavities. Blackish corrosion products layer on the blades
<b>Time in Service</b>	6 months
<b>Environment</b>	Water vapor and process water (average chemical composition: pH = 8, chloride = 45 mg/L, sulfates = 185 mg/L, total suspended solids = 4 mg/L)
<b>Cause</b>	Loss of vacuum led to the failure analysis. A pump generating higher vacuum than the expected for the system design was installed 6 months prior to the failure, leading to erosion corrosion problems at the rotor impeller blades, due to too high fluid velocities. The system was used 12 h a day for dehumidifying soap paste; the rest of the time remained humid (process water), which caused the formation of brownish-red corrosion products
<b>Remedy</b>	Replacement of the pump (using a pump suitable for the system design). Consider the use of a different material for the rotor impeller (e.g., stainless steel)

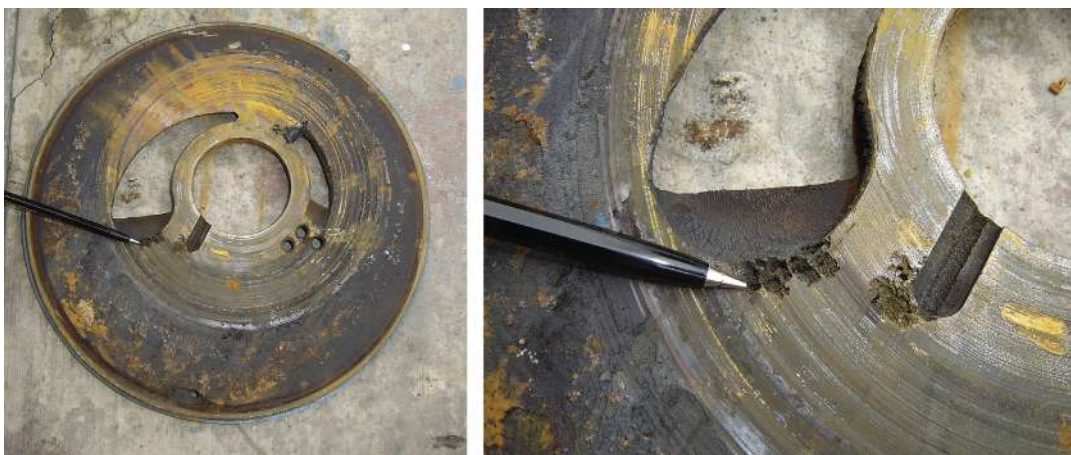
**Appearance** Small pits and cavities

**Cause** Loss of vacuum led to the failure analysis. The original pump of the system was replaced by a pump generating higher vacuum, which caused further increase of the temperature of the water forming the ring, diminishing the boiling point of the water, and increasing the risk of cavitation (see also Case 01.13.32.001)

**Remedy** Replacement of the pump (using a pump suitable for the system design)

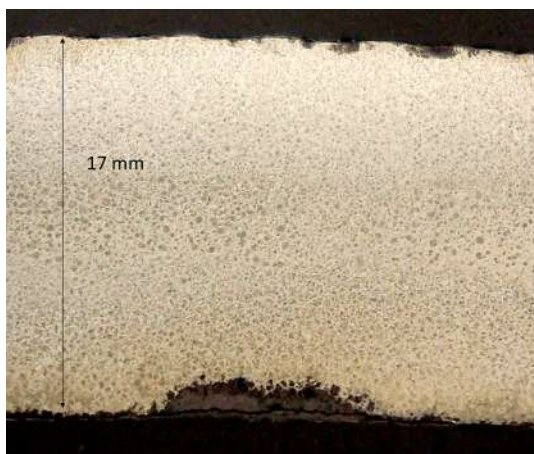
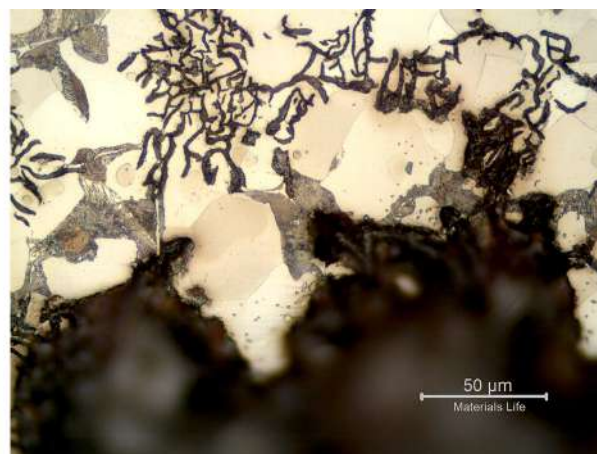
<b>Material</b>	Gray cast iron UNS F11701 Graphite in flakes in a ferritic–pearlitic matrix
<b>System</b>	Buried aqueduct
<b>Part</b>	Several meters long Centrifugally cast pipe Nominal diameter: 1524 mm Actual thickness: 17 mm
<b>Phenomenon</b>	General corrosion from the water side

<b>Appearance</b>	2 mm thinning from the original 19.05 mm
<b>Time in Service</b>	45 years
<b>Environment</b>	External soil and internal water
<b>Cause</b>	End of life
<b>Remedy</b>	Not required

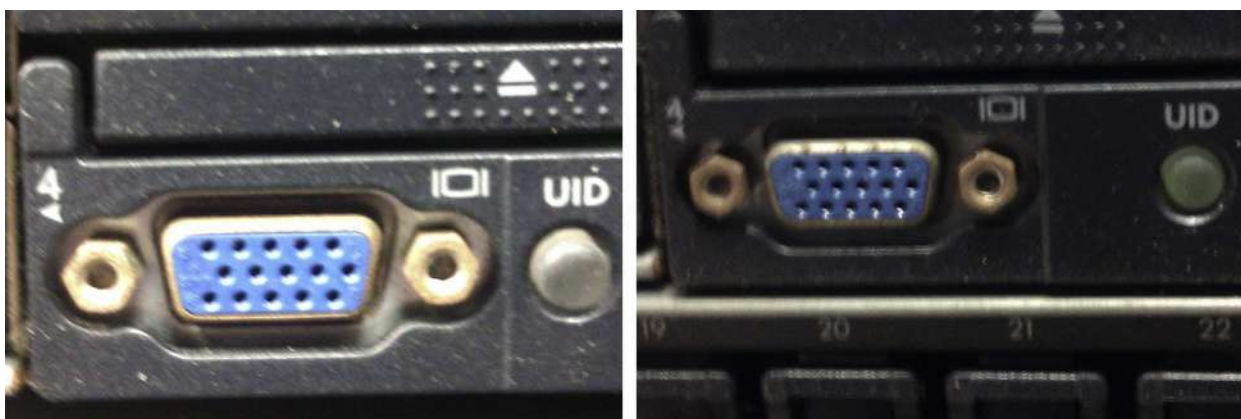
**Phenomenon** Oxygen corrosion through microcondensation

**Appearance** Corroding various metal parts of the servers and computer parts

**Cause** The observed corrosion on some metal parts of some computers is most likely due to microcondensation. The combination of large air temperature fluctuations and a high relative humidity of the supply air causes this microcondensation, causing corrosion of the metal parts that are sensitive to this. The traces of chloride and sulfur in the air, and the possible presence of dust/dirt, may have further affected the process

**Remedy** By placing meters, insight is gained into the air temperature and the relative humidity per room. This provides insight when microcondensation can take place. Working with a narrower bandwidth in terms of temperature. A far-reaching measure is further conditioning of the supply air. That means not only regulating the temperature, but also the relative humidity. Our advice is to control the temperature at  $23 \pm 1^\circ\text{C}$  and the relative humidity between 30% and 60%

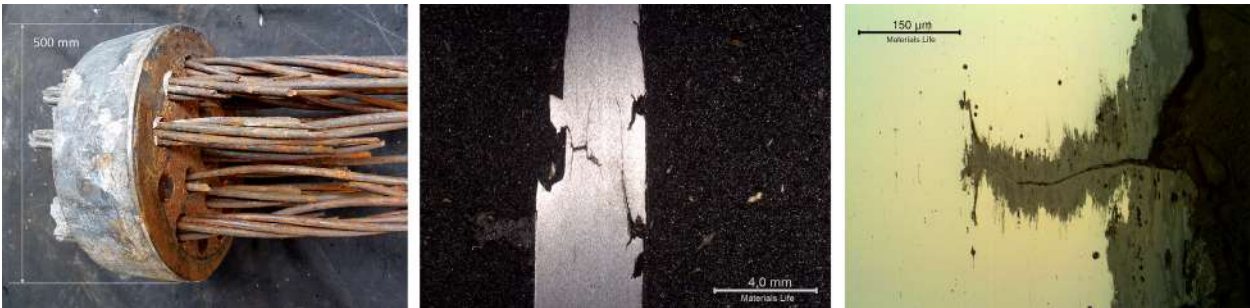
<b>Material</b>	High carbon steel UNS G10700 Strain-hardened (predominantly) pearlitic microstructure
<b>System</b>	Prestressed concrete strand
<b>Part</b>	Wire rope 5 mm diameter Hardness 500HV1
<b>Phenomenon</b>	Fatigue corrosion

<b>Appearance</b>	Multiple fractures in the ropes in the region out of the concrete The analysis indicated that the rope broke by corrosion fatigue in 50% of the wires, 27% fatigue, and 23% overloading
<b>Time in Service</b>	Several years in service
<b>Environment</b>	Urban atmosphere, wet
<b>Cause</b>	Synergic effects associated to loads and environment
<b>Remedy</b>	Corrosion control
<b>Additional References Pertaining to Case Study</b>	Materials Life Database
