# CORROSION ATLAS

Case History 01.01.01.001

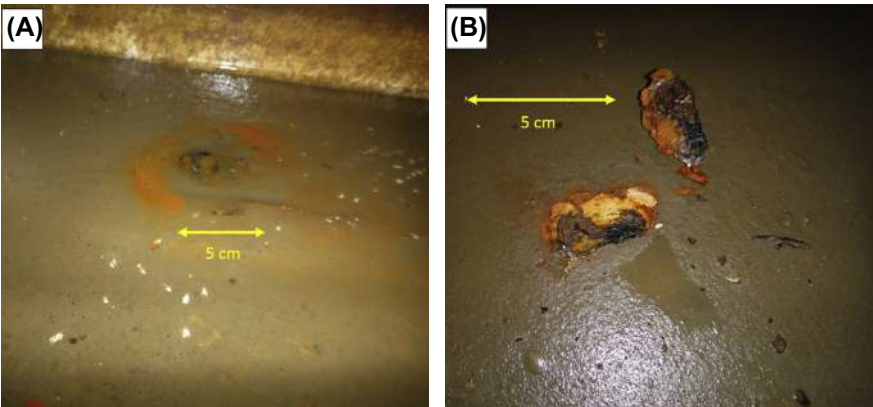
<b>Material</b>	Steel
<b>System</b>	Very large crude carrier (VLCC) ballast tank and ballast piping
<b>Part</b>	Tank floor and ballast piping. Epoxy coated carbon steel.
<b>Phenomenon</b>	Microbiologically influenced corrosion (MIC)

<b>Appearance</b>	Coating appeared to be in good condition both where exposed and examined under sediments. However, hemi-spherical orange “tubercles” observed on the ballast tank floor (Figure A). Evidence of a rusty, orange corrosion deposit emanating from the tubercles. Removal of tubercles revealed that they covered black deposit and, in numerous cases, pits with a 2–3 mm depth (Figure B).
<b>Time in Service</b>	Less than 5 years
<b>Environment</b>	Seawater ballast tank
<b>Cause</b>	The appearance of the corrosion deposits and pits were typical of MIC caused by Sulfate Reducing Bacteria (SRB). Corrosion deposits associated with the pits were analyzed on-site by acidification and checking for release of hydrogen sulfide using lead II acetate indicator papers; this confirmed a high iron sulfide content, a strong indicator of SRB activity. On-site analysis of deposit samples using Sig Sulfide Tests (ECHA Microbiology Ltd.) detected high numbers of sulfide generating bacteria (including SRB). No Sulfur Oxidising Bacteria (SOB) were detected in subsequent laboratory culture tests. It was concluded that the pitting was caused by the activity of SRB. It is believed that poor surface preparation and/or inadequate application of protective coating was a factor in the incidence of corrosion.

<b>Remedy</b>	Corrosion sites were ground out to remove corrosion deposits and repaired by welding and grinding to a smooth finish. In some cases, ballast piping had to be physically removed from the vessel to accommodate this. Affected areas were re-coated following a final finishing grit blast.
<b>Additional References Pertaining to Case Study</b>	<ul style="list-style-type: none"> <li>• B.J. Little and J.S. Lee (2007). Microbiologically Influenced Corrosion. Wiley-Interscience (ISBN 978-0471-77276-7).</li> <li>• G.C. Hill (2003). Microbial Problems in Bilge &amp; Ballast, in Microbes in the Marine Industry, Ed. E.C.Hill, Inst. Marine Engineering Science &amp; Technology (ISBN 1-902536-46-0).</li> <li>• P. Bos and J.G. Kuenen (1983). Microbiology of Sulphur Oxidising Bacteria, in Proceedings of Microbial Corrosion, National Physics Laboratory, Teddington and the Metals Society, London.</li> <li>• NACE Standard TM0-194-2014. Field Monitoring of Bacterial Growth in Oil and Gas Systems.</li> </ul>

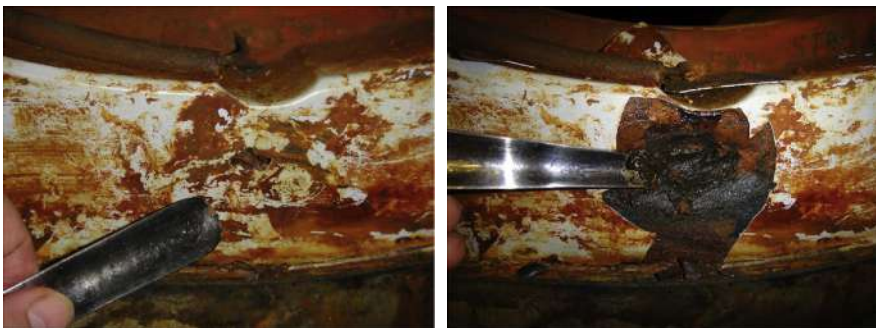
<b>Material</b>	Steel
<b>System</b>	Very large crude carrier (VLCC) seawater-lubricated stern tube system
<b>Part</b>	Stern tube and forward and aft flanges. Epoxy-coated carbon steel.
<b>Phenomenon</b>	Microbiologically influenced corrosion (MIC)

<b>Appearance</b>	Coating covered in orange deposits. Fractures and holes were observed in flange's epoxy coating (Figure A). Chipping away the coating (Figure B) revealed orange deposit covering black deposits. Removing black deposit revealed severe wastage of steel which had a dull grey pitted surface. A viscous brown acidic (pH 2) liquid, believed to be sulfuric acid, exuded from some corrosion sites.
<b>Time in Service</b>	Less than 5 years.
<b>Environment</b>	Filtered seawater flow through system for stern tube lubrication. There were extensive periods of lay up during commissioning of the vessel, during which stagnant conditions are likely to have developed. It is believed anoxic regions would readily develop underneath coating fractures which is where worst corrosion was observed.

<b>Cause</b>	The appearance of the corrosion was typical of that caused by Sulfate Reducing Bacteria (SRB) but the amount of highly acidic orange deposits (pH 2–5) suggested simultaneous activity of Sulfur Oxidising Bacteria (SOB). Black corrosion deposits associated with the pits were analyzed on-site by acidification and checking for release of hydrogen sulfide using lead II acetate indicator papers; this confirmed high iron sulfide content, a strong indicator of SRB activity. On-site analysis of deposit samples using Sig Sulfide Tests (ECHA Microbiology Ltd.) detected high numbers of sulfide generating bacteria (including SRB). Subsequent laboratory analysis for culturable SOB detected moderately high numbers of aciduric <i>Thiobacillus</i> spp.
<b>Remedy</b>	Stern tube was grit blasted, corrosion sites ground out to remove corrosion deposits and repaired by welding and grinding. In some cases polymeric composite filler was used to restore substantial metal loss. The system was re-coated after a final grit blast. Seawater lubrication was replaced with a closed loop fresh water system using ship's distilled water in order to reduce levels of nutrients and sulfate to minimize the opportunity for microbial activity and sulfate reduction. A routine microbiological condition monitoring program was implemented.

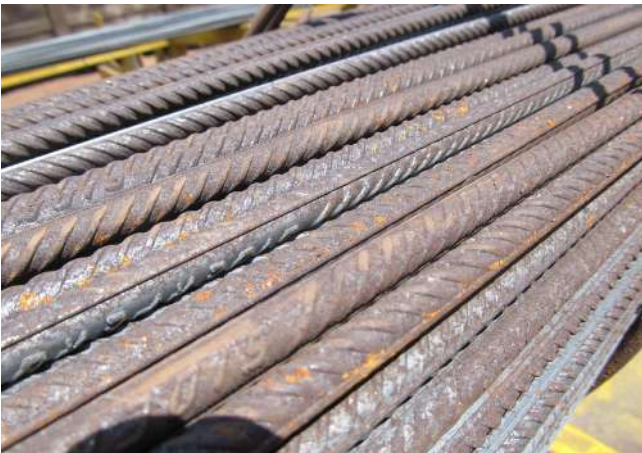
<b>Material</b>	Carbon steel
<b>System</b>	Stored steel bars
<b>Part</b>	3/8" corrugated bars
<b>Phenomenon</b>	Atmospheric corrosion in marine environment (uniform corrosion)

<b>Appearance</b>	Red-brownish layer of corrosion products, with small zones of yellow-brownish corrosion products
<b>Time in Service</b>	1 year
<b>Environment</b>	Marine atmosphere (approximately 1 km away from the seashore)
<b>Cause</b>	Several batches of steel-corrugated bars were stored outdoors. The most affected bars were located on the top of the piles of bars. A distance of 1 km from the seashore is close enough for corrosive attack due to marine aerosol
<b>Remedy</b>	Corroded bars treatment: pickling, rinsing, neutralizing, phosphating, drying. Store under roof, and dry conditions
<b>Additional References Pertaining to Case Study</b>

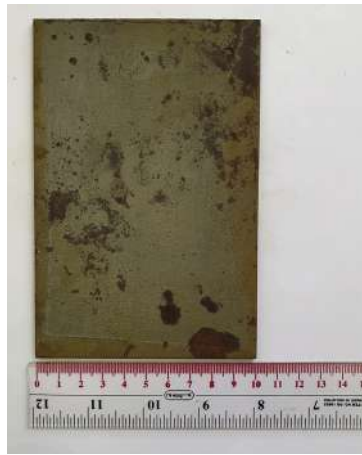
**Appearance** Uniform corrosion with brown nodules

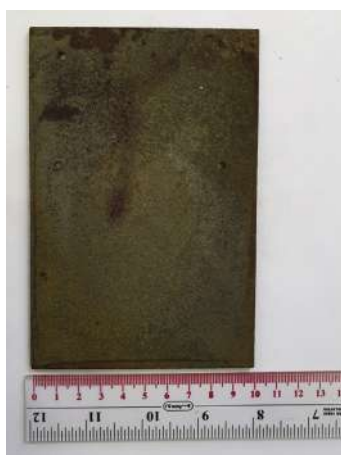
<b>Appearance</b>	Pitting, rough surface, dark brown spots
<b>Time in Service</b>	One year
<b>Environment</b>	Marine industrial site (CO <sub>2</sub> , H <sub>2</sub> CO <sub>4</sub> , SO <sub>X</sub> , NO <sub>x</sub> )
<b>Cause</b>	Exposed to corrosive environment, i.e., CO <sub>2</sub> , H <sub>2</sub> CO <sub>4</sub> , SO <sub>X</sub> , NO <sub>x</sub>
<b>Remedy</b>	Coating or use cathodic protection (CP) system

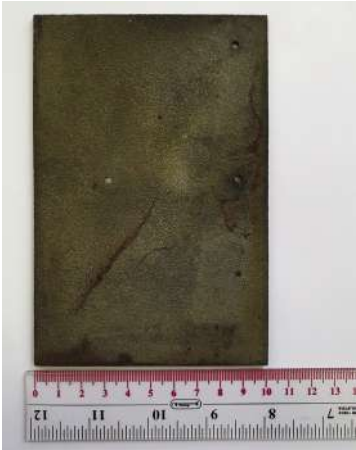
<b>Appearance</b>	Pitting, rough surface, dark brown spots
<b>Time in Service</b>	One year
<b>Environment</b>	Marine industrial site (CO <sub>2</sub> , H <sub>2</sub> CO <sub>4</sub> , SO <sub>X</sub> , NO <sub>x</sub> )
<b>Cause</b>	Exposed to a corrosive environment, i.e., acid rain
<b>Remedy</b>	Coating or use cathodic protection (CP)

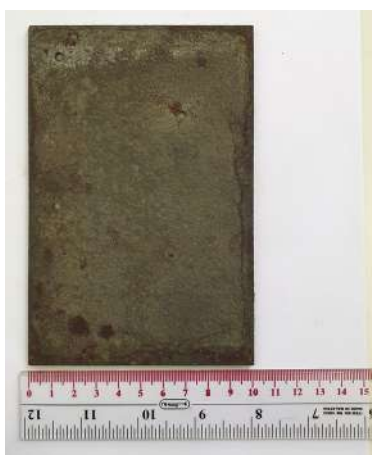
**Appearance** Pitting corrosion, very rough surface, dark brown

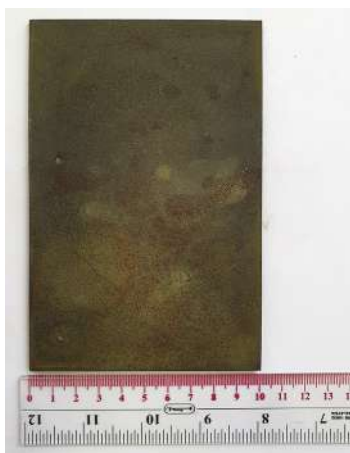
**Appearance** Light uniform corrosion, some dark brown spots

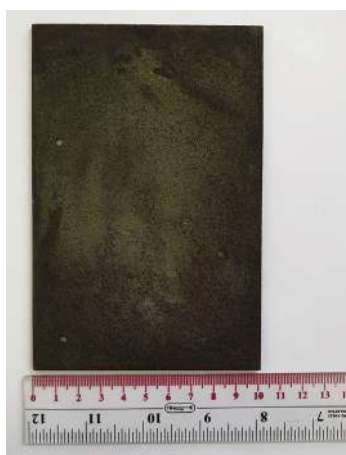
<b>Appearance</b>	Uniform corrosion, dark brown
<b>Time in Service</b>	One year
<b>Environment</b>	Samples exposed to atmospheric wet and dry cycle during the year
<b>Cause</b>	Oxygen with presence of 40%–70% of humidity. Temperature varies from 7 to 30°C
<b>Remedy</b>	Coating

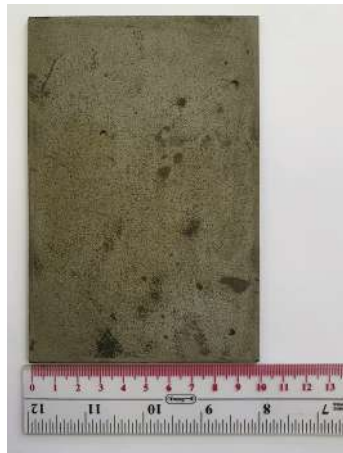
<b>Appearance</b>	Pitting corrosion, rough white and golden surface
<b>Time in Service</b>	One year
<b>Environment</b>	Marine site
<b>Cause</b>	Sample exposed to oxygen and chloride in the site. The average of humidity and temperature is 60% and 35°C
<b>Remedy</b>	Coating or cathodic protection (CP)

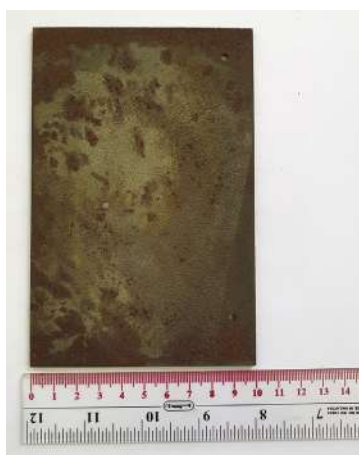
**Appearance** Uniform corrosion, dark brown spots

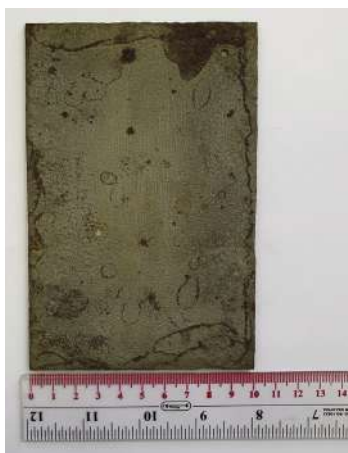
**Appearance** Uniform and localized corrosion, large corrosion layer due to high corrosion rate

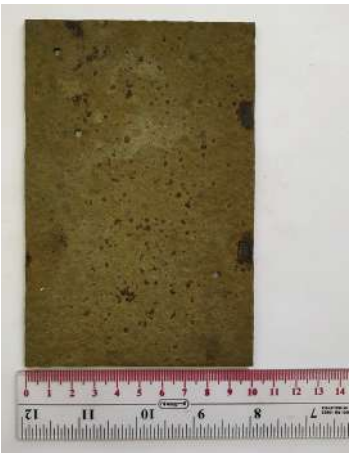
<b>Appearance</b>	Uniform and localized corrosion, golden and dark brown corrosion product
<b>Time in Service</b>	One year
<b>Environment</b>	High humidity and pollutant level (such as SO <sub>2</sub> and chloride ion)
<b>Cause</b>	Oxygen and chloride ion attack in the presence of acid rain
<b>Remedy</b>	Coating or cathodic protection (CP)
<b>Additional References Pertaining to Case Study</b>

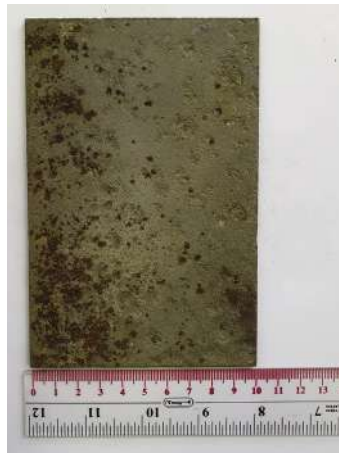
**Appearance** Uniform and localized corrosion

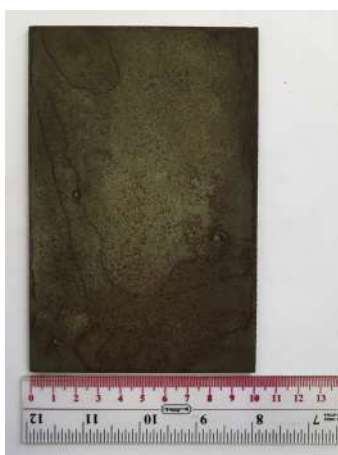
**Appearance** Light and uniform dark brown

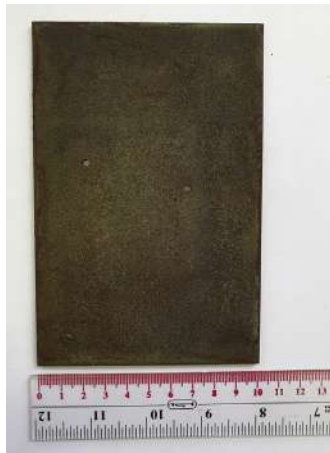
**Appearance** Light uniform corrosion as dark brown spots

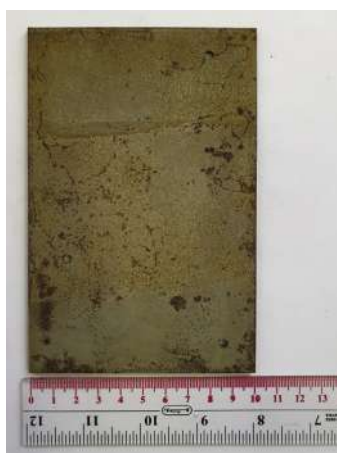
<b>Appearance</b>	Uniform corrosion, golden brown spots
<b>Time in Service</b>	One year
<b>Environment</b>	High temperature in the summer around 46°C
<b>Cause</b>	Uniform corrosion due to oxygen attack instigated by large variation in temperature during the year
<b>Remedy</b>	Coating

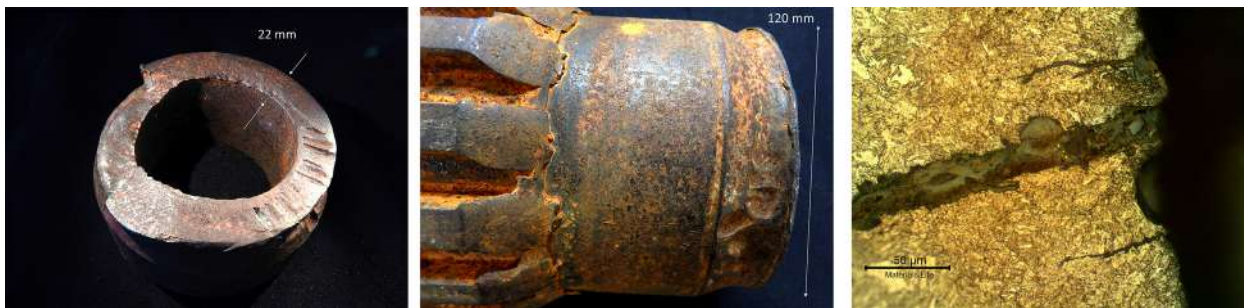
<b>Appearance</b>	Fracture with washout
<b>Time in Service</b>	More than 10 years in service
<b>Environment</b>	Drilling environment
<b>Cause</b>	Synergic effects associated to loads and environment
<b>Remedy</b>	The drilling tool was close to the end of its life
