A VERY HIGH HEAD PUMP

J.T. McGuire

Flowsolve Corporation

ABSTRACT

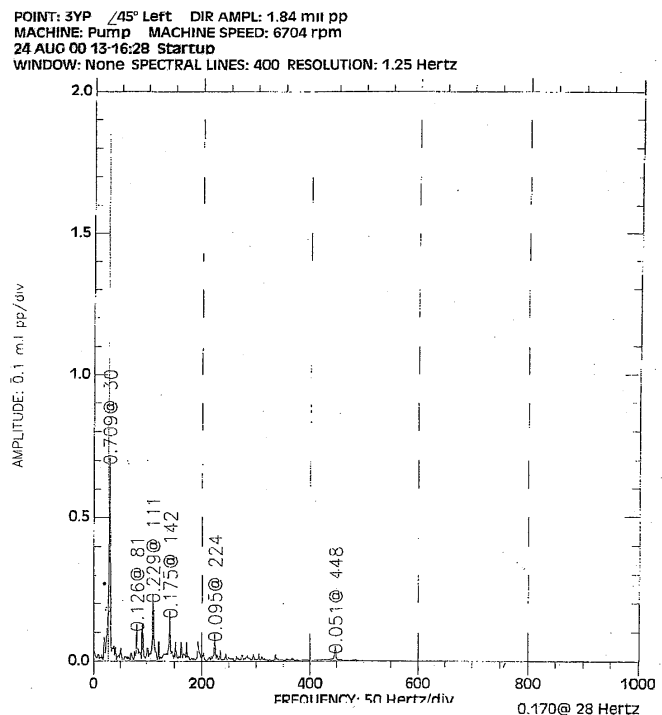
Figure 12. Vibration Spectrum, Pump B, August 24, 2000, 13:16:28, 3YP, 6704 RPM.

The available data do not include spectra of the outboard end vibration that caused the trip. Table 9 shows the spectra from the inboard end.

As with the July 17 “as-found” dimensions, rub marks in the bottom of the stator pointed to a rotor set low in its clearances. That was carefully checked when the element was reinstalled, so was not likely to be the cause of the repeated damage. Adams (2000), who examined the element, suggested the following alternative explanation:

- Eccentricity between the discharge end of the element and the balancing drum; supported by two observations:
 - Installed rotor lift of only 0.013 inch (0.330 mm), low for 0.014 to 0.016 inch (0.356 to 0.406 mm) diametral clearance in the balancing drum, and
 - Rub marks after 83 seconds of operation in the bottom of the stationary wearing rings and bushings from the third stage on.
- As a result of the eccentricity, the rotor “was being severely pinched between the centering forces of the balancing drum and the lifting forces at the bottom of the rings leading to an unstable situation and rubs.”

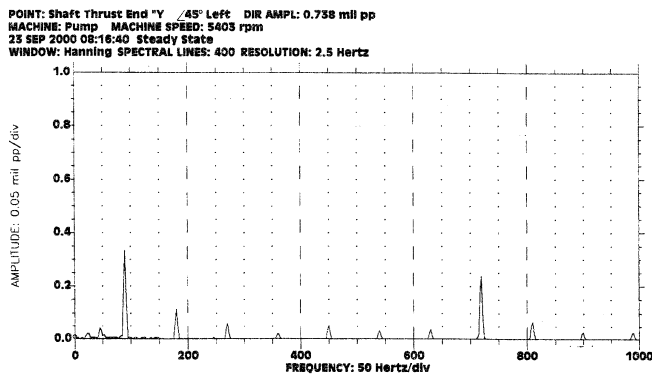
Figure 13. Vibration Spectrum, Pump B, September 23, 2000, 6XP, 08:16:40, Shop Test, 5403 RPM.

Shop testing on water September 23, 2000, showed:

- Rotor lift about 2 mil (51 μm) on startup.
- Running at 5400 rpm (nominal), rotor vibration did not exceed 0.82 mil (21 μm), was predominantly at 1 \times with minor components at 0.25 \times , 0.52 \times , and 2 \times (Figure 13).

In the shop test on water, the pump had a higher pressure rise than in operation (about 5680 psi [392 bar] at BEP, 62 percent higher than rated) and higher damping. Evidently one or both of these acted to effectively restrain the rotor’s motion.

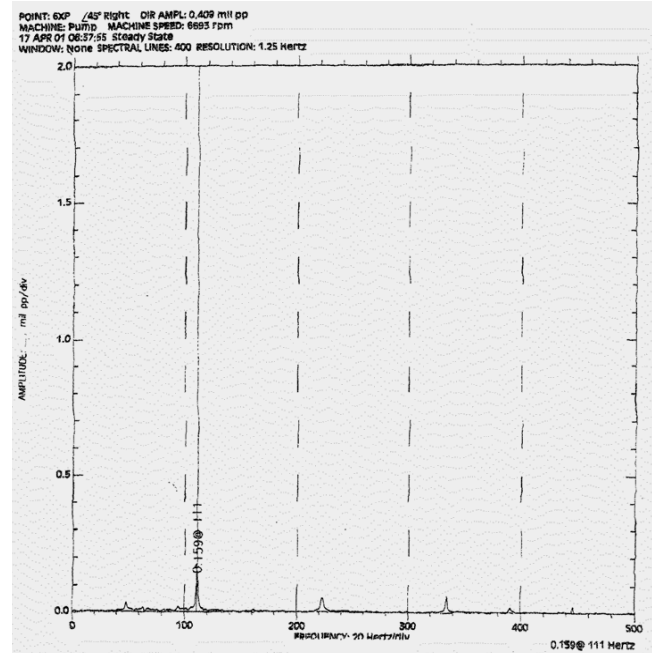
Figure 14. Vibration Spectrum, Pump B, April 17, 2001, 6XP, 08:37:55, Steady-State, 6693 RPM.

Spectra of rotor vibration during operation in the field April 17, 2001, showed the rotor was now very well behaved indeed (Figure 14 and Table 10).
