# TURBINE OVERSPEED TRIP PROTECTION

**Charles R. Rutan**

Lyondell/Equistar Chemicals, LP

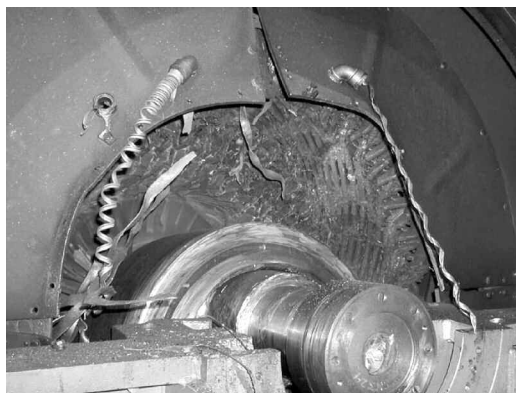
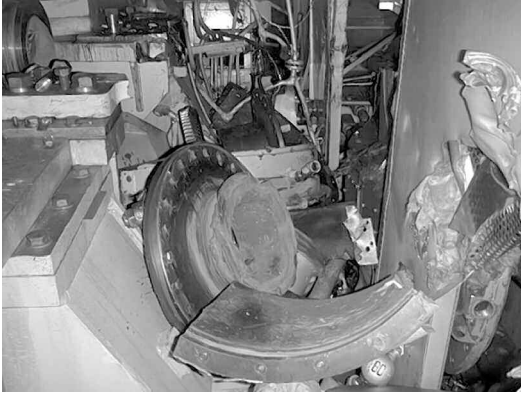
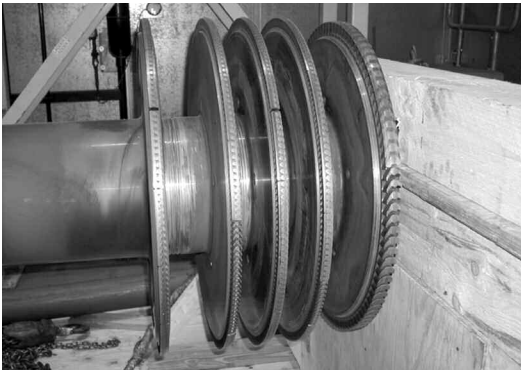
A 22 Megawatt, 3600 rpm unit oversped to at least 5400 rpm as a result of the disk and bolt, from an upstream extraction nonreturn valve, became loose and moved into a position that resulted in the nonreturn valve sticking open (Figures 14, 15, and 16).

Figure 14. Generator.

Figure 15. LP Turbine End to Generator.

Figure 16. Turbine Rotor (Incident 1).

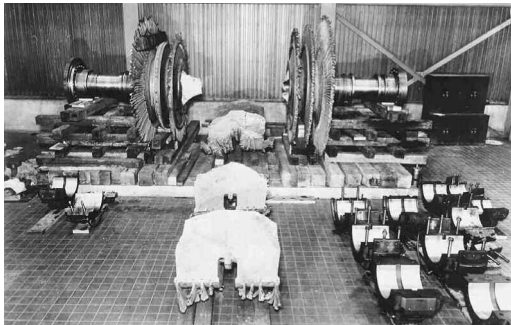
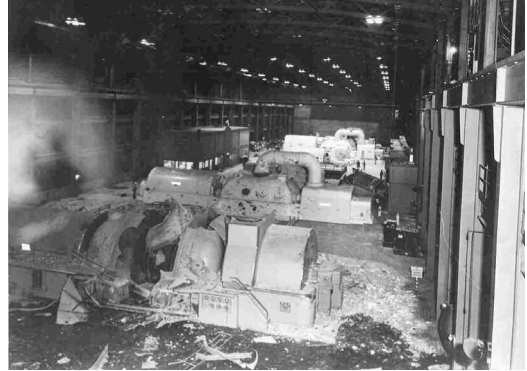
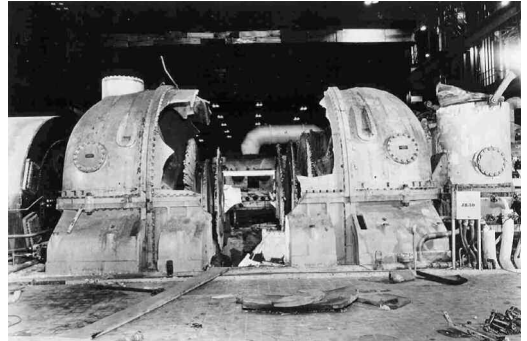
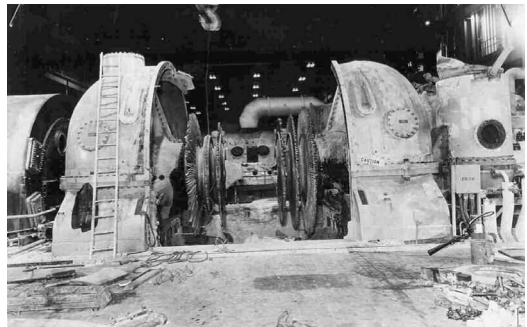
An incident showing a turbine driving a generator with an instantaneous loss of load is shown in Figures 17, 18, 19, and 20.

Figure 17. Turbine Rotor (Incident 2).

Figure 18. Turbine Generator Bay (A, Incident 2).

Figure 19. Turbine Generator Bay (B, Incident 2).

Figure 20. Turbine Generator Bay (C, Incident 2).
