# Case History

Experience with API Plan  
53B

Pressurized Dual Seal  
Systems

Roger Jones, Ken Savoie & Zhou DaLi

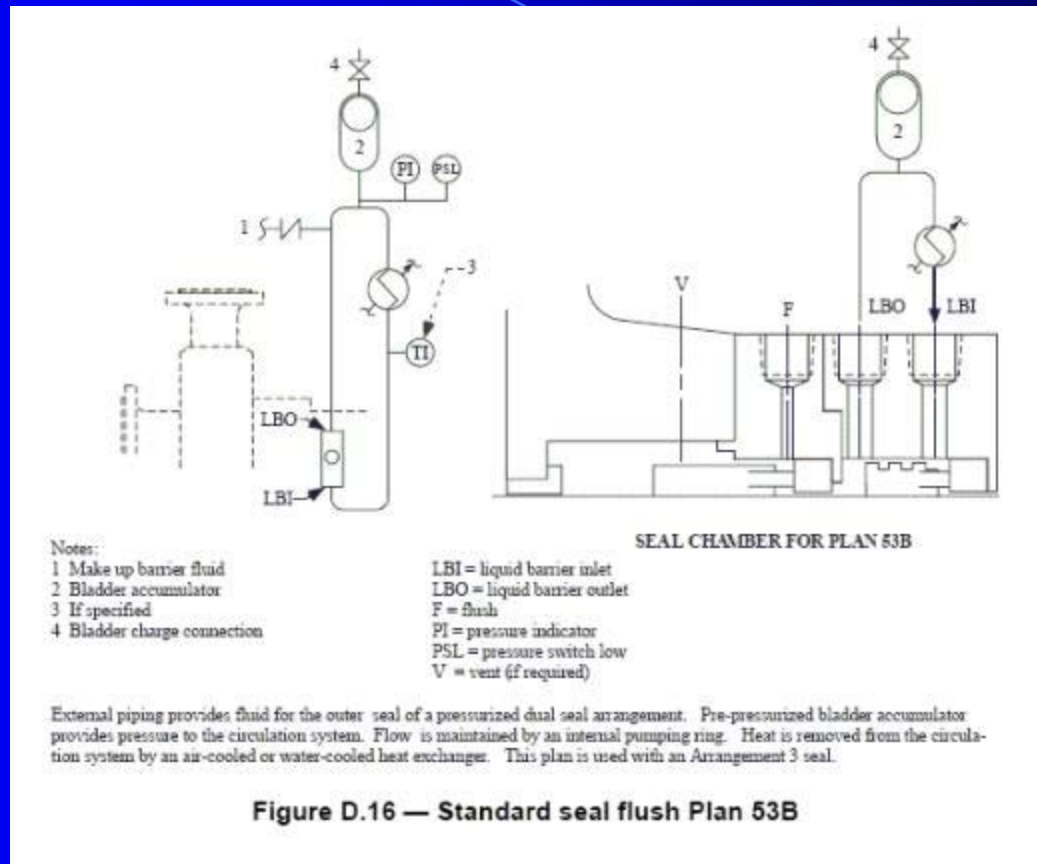
Figure D.16 — Standard seal flush Plan 53B

**This API 682 Second Edition schematic is incomplete and it won't keep you out of trouble.**

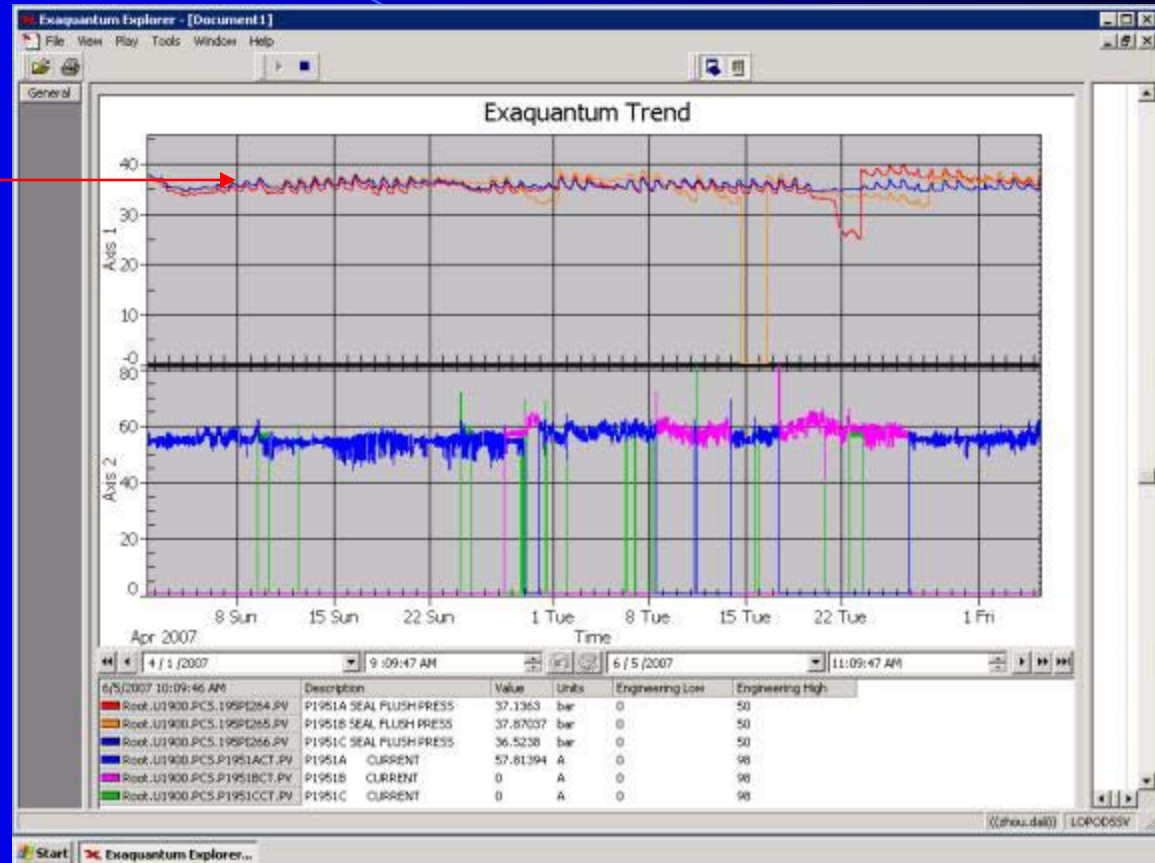
Daily fluctuations in pressure due to ambient temperature.

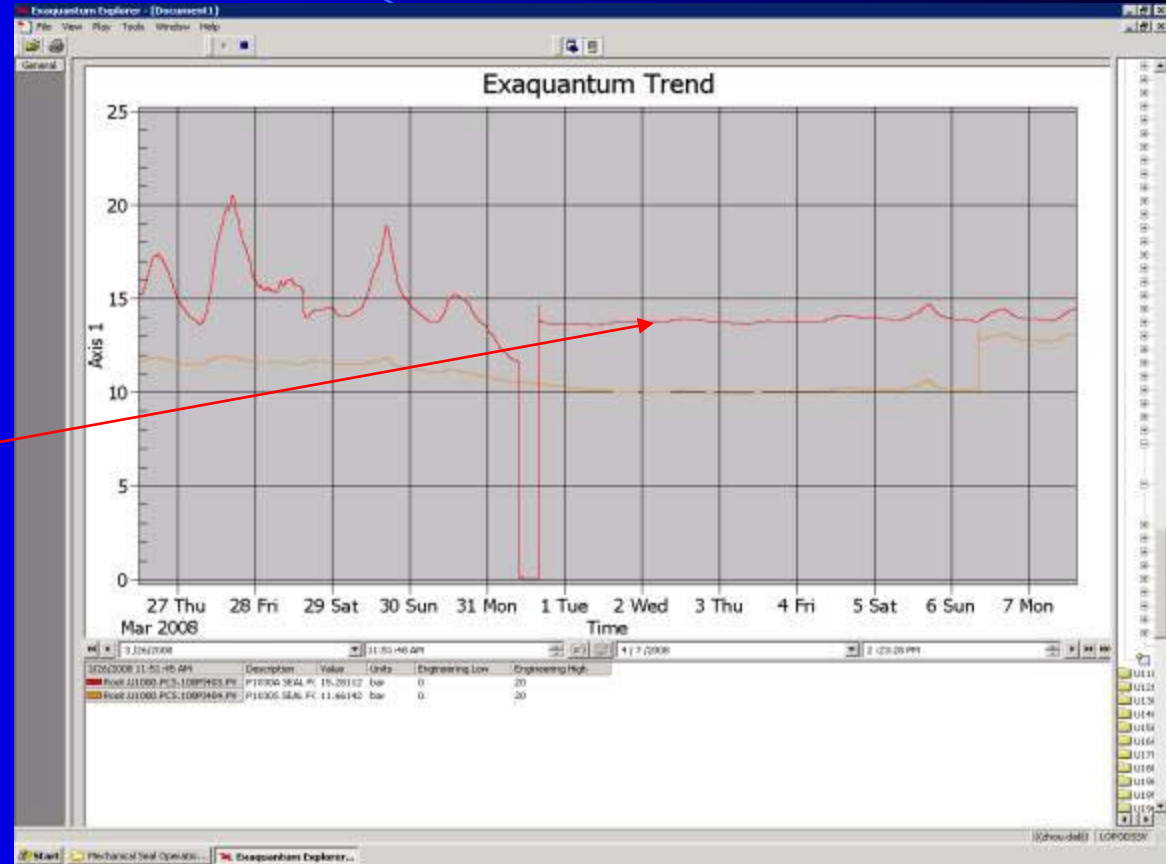
Low bladder pressure makes for wider daily pressure fluctuations.

Pressure fluctuations reduced after recharging bladder.

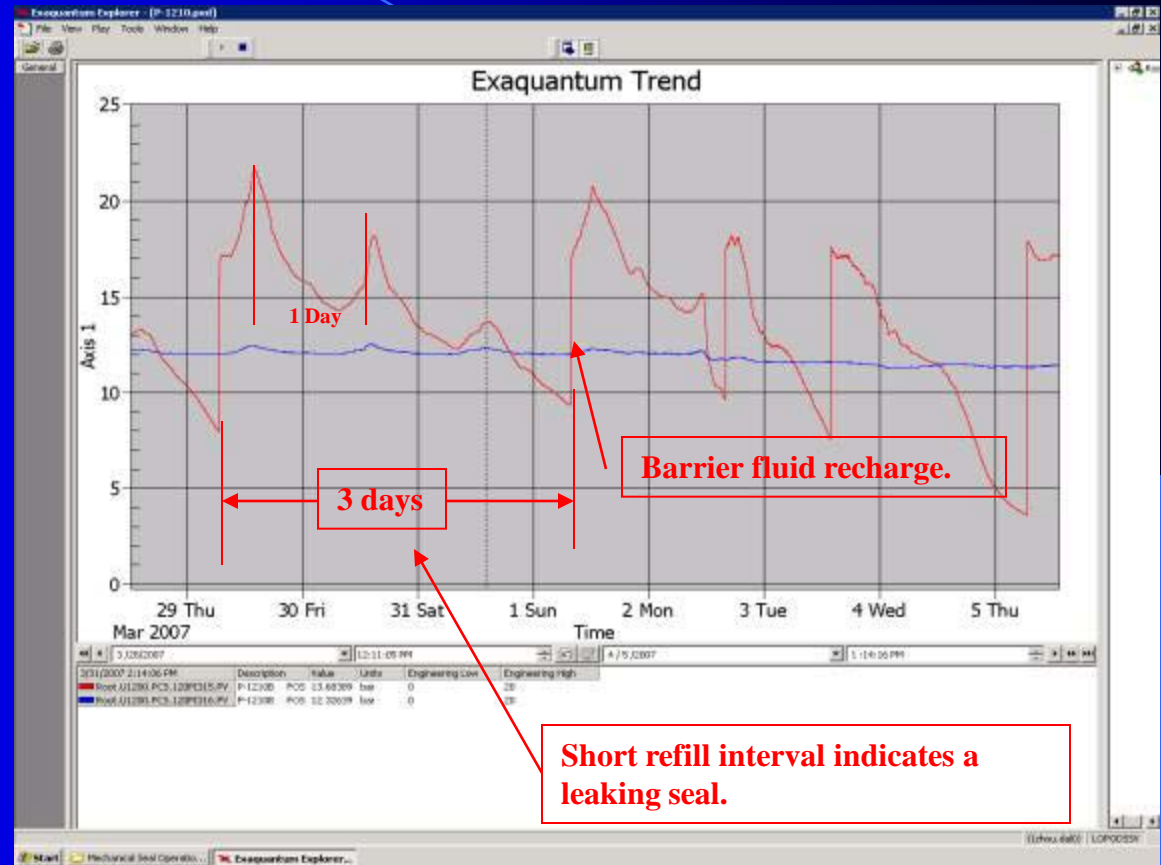
Between Bearings Pump with 2 seals

The barrier liquid system pressures fluctuate on the same daily period but one seal (red) fluctuates much more than the other (blue). This is clearly abnormal. Bladder (red line) was confirmed to have failed.

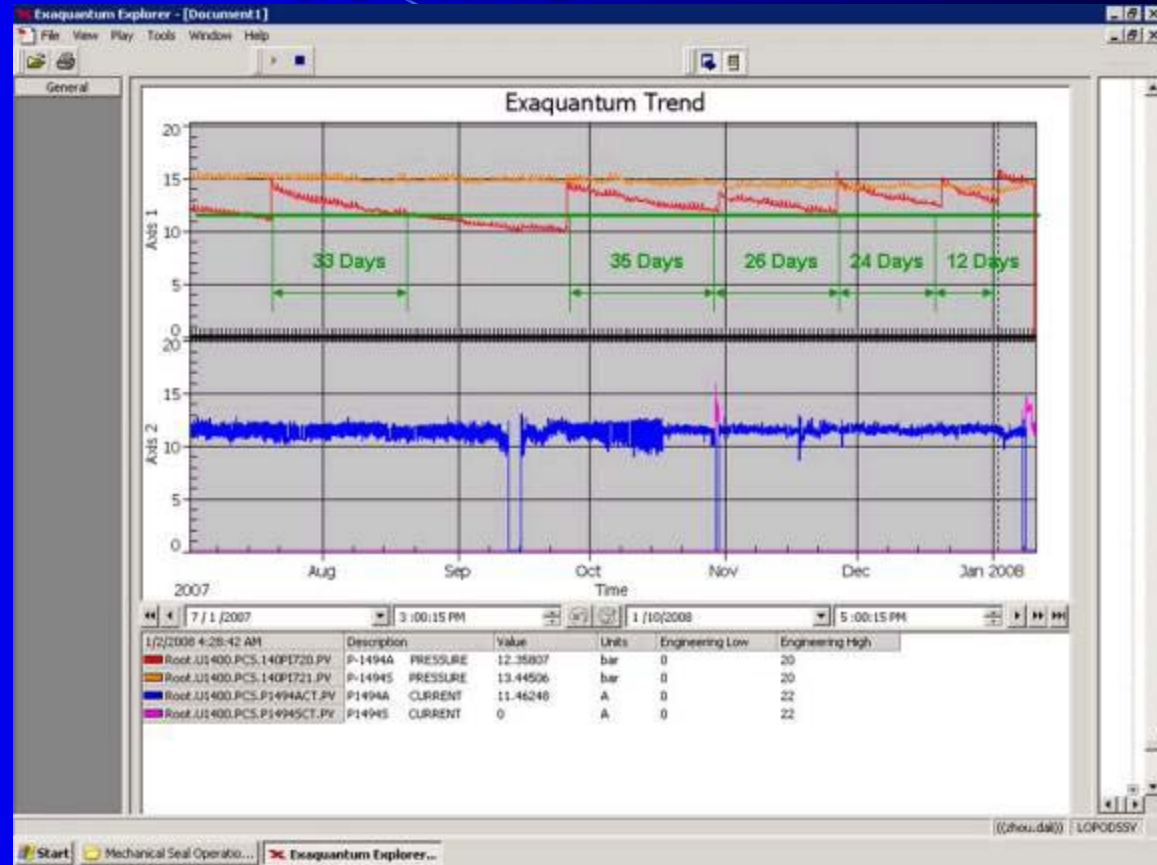
When the system pressure reaches a preset limit the system must be refilled.

Declining refill interval is a sign of a deteriorating seal or other leak.

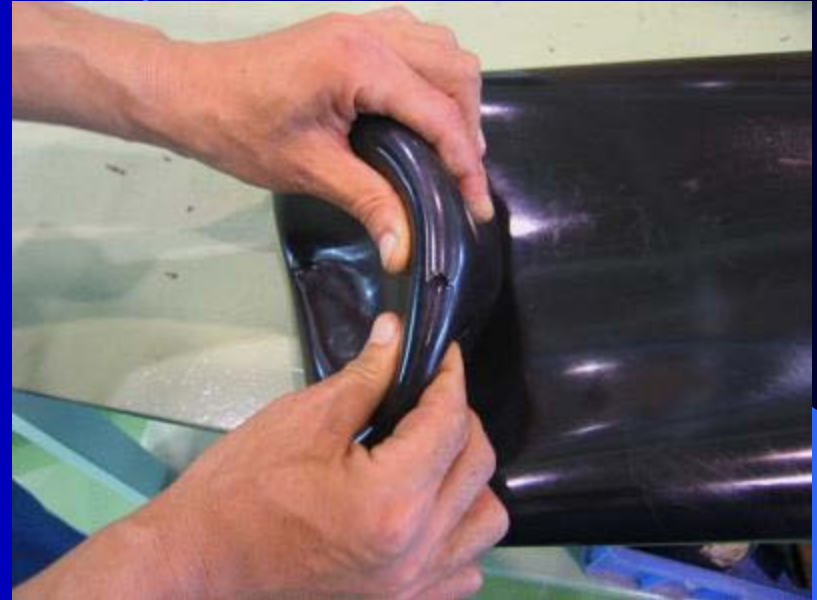
- Bladder damage can occur if the precharge pressure falls below 35% of the working pressure
- With low pressure the bladder flexes excessively as system pressure fluctuates
- This crack at the bladder rim suggests this cause of failure.
- One must shut the pump down and depressure the system to detect bladder failure
- If “apparent bladder pressure” goes to zero bladder has failed
