RELIABILITY IMPROVEMENTS TO A HIGH PRESSURE, HIGH TEMPERATURE, THIRTEEN STAGE CHARGE PUMP

Dave A. Johns

Shell Oil Company

Norco, Louisiana

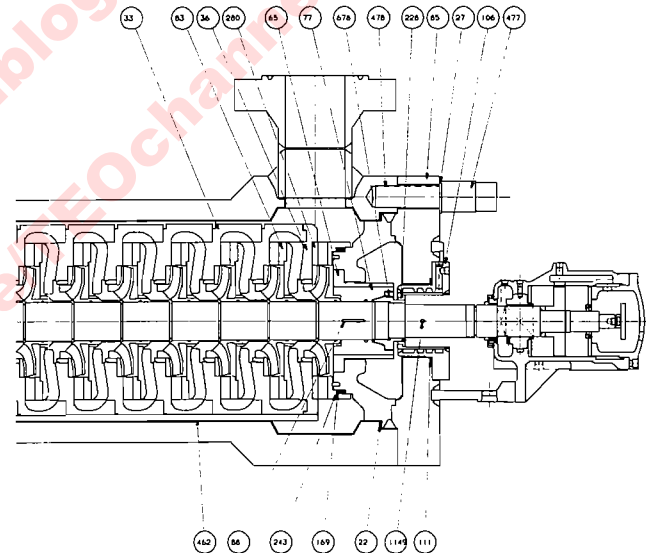
Figure 2. Discharge Head Assembly.

The head to case joint has been a leakage area in the past.

The original pump assembly specifications called for clearance between the pump head and casing. Designers of the pump, in an effort to maintain rotor to case alignment, also wanted the head parallel to the case within 0.002 in. Asking a machinist to tighten 24, 2.0 in studs holding a 500 lb chunk of steel and keep the surfaces parallel within 2.0 mils is like winding a Rolex with an impact wrench. This is a challenging task under ideal laboratory conditions, and nearly impossible under field conditions. The metal to metal case fit has several advantages:

The modification required machining the discharge head, the mating surface of the casing, and the inner discharge head. All other machined faces and bores were welded and remachined so that the entire case was brought back to factory specifications.

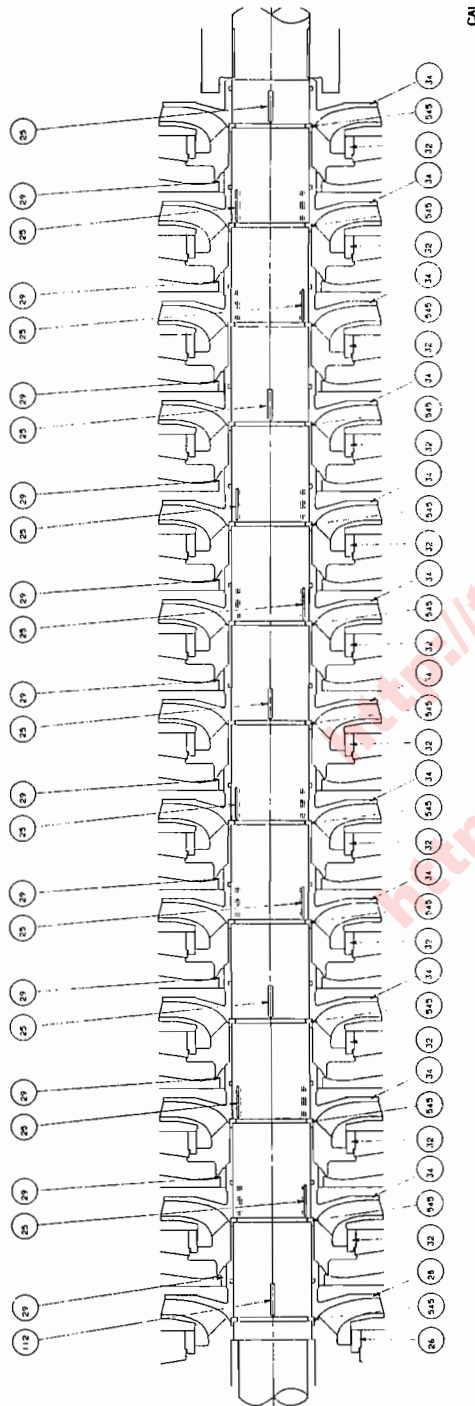
Figure 3. Rotor Assembly.

The original shaft was the same diameter from the first to the last impeller, with each impeller driven by a single key. Proper axial impeller position was established by a shaft shoulder on one end with impellers and sleeves stacked from this shoulder.

- Galling probability during rotor assembly increases with the length of same diameter shaft that impellers and sleeves have to pass over.
- Axial stack-up errors are likely, because everything is referenced from one point, the shaft shoulder.
- Difficulty maintaining rotor straightness, which depends upon the squareness of the impeller hub and spacer sleeve faces when the components butt together.

The new design shaft has several features to ease assembly and increase stack-up accuracy. Starting from the first stage, the shaft diameter under each impeller is progressively smaller. Therefore, the impeller has clearance on all fits except the mounting fit. Each shrunk fit impeller is individually located by split rings which fit into machined grooves on the shaft. The impeller is machined to retain the rings. The sleeves are fabricated as part of the impeller instead of each being a separate item.

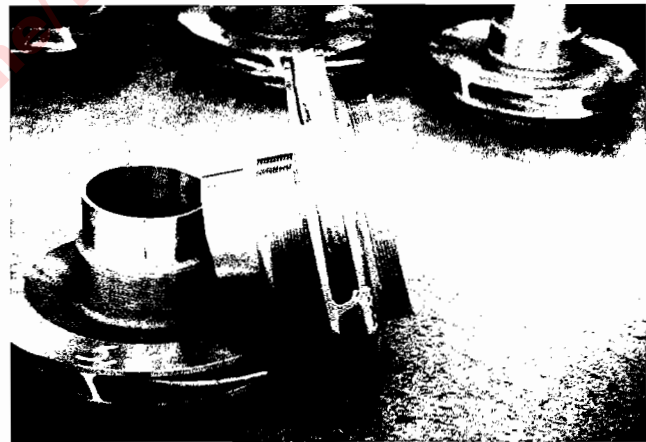
Figure 4. Impeller with Counter Rotating Spiral Grooves.

Standard wear rings attached to the impeller by tack welds or set screws were originally supplied. These separate impeller wear rings tend to crack and come off of the impeller if suddenly heated, such as during mechanical contact or the pump running dry. These loose metal parts then go on to cause further damage in the pump. The following modifications were made to minimize the potential damage to the pump due to wear ring touch off or failure.

- The rings and mating bushings were made with spiral grooves on the surface instead of the typical smooth surface (Figure 4). The grooves in the rotating part are in the opposite direction of the grooves in the stationary part. The counter spiral grooves have two benefits:

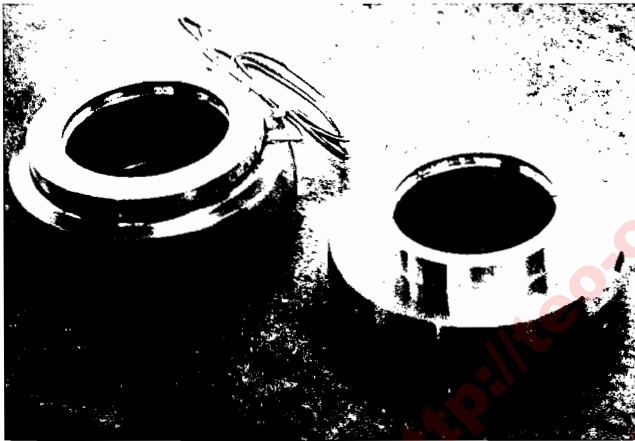
Figure 6. Spherically Seated Babbitt Lined Journal Bearings.

The pump's radial bearings are spherically seated babbitt lined sleeve bearings (Figure 6). Original design required the bearing crush to be adjusted by varying the gasket thickness on the bearing housing horizontal split line. This is a time consuming task and end results were of questionable accuracy. Present day precision bearing manufacturing techniques eliminate the need for an "adjustable" bearing housing split line. Elimination of the split line gasket required machining of the horizontal split line and reboring of the spherical seat. After machining, the housings were centered and doweled into position on the pump case.

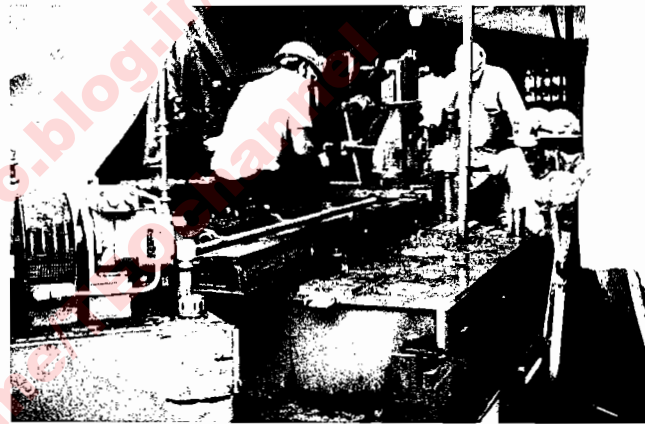
Figure 16. Section of Discharge Piping.

The moments acting on the discharge nozzle were the highest loads and source of greatest concern. The normal methods of lowering forces and moments by adding, moving, or subtracting guides and restraints produced no workable solutions. Since the moments could not be reduced without cutting pipe, the designer elected to induce equal, but opposite, moments and forces as close to the pump as possible. This was the one solution that met all of the criteria. Since this in effect applied the high loads to the piping instead of the pump nozzles and casing, additional flange calculations were done to ensure that the pipe flanges were within allowable stress limits.

Inducing equal and opposite moments and forces was accomplished by mounting three spring supports in the horizontal plane (Figure 16). Bolt on clamps were fabricated to attach the spring supports to the pipe and structural steel was added to provide anchor points. The location and spring ratings of the horizontal supports are shown in Figure 17.
