ROOT CAUSE ANALYSIS OF FIVE COSTLY CENTRIFUGAL PUMP FAILURES

Heinz P. Bloch

Process Machinery Consulting

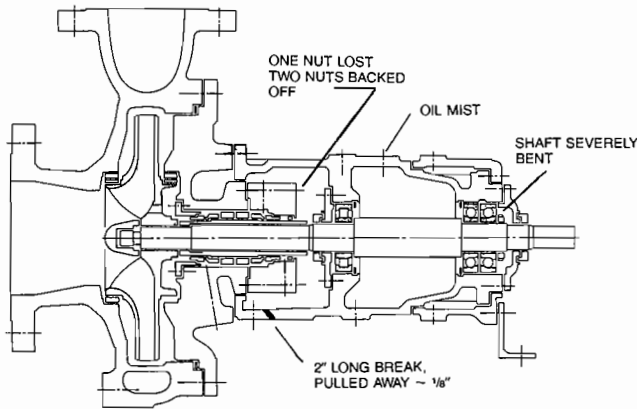
When the pump was dismantled, the seal area was found in clean and undamaged condition. Some solids were found in the impeller. Impeller wear rings and inboard bearing appeared satisfactory. The duplex thrust (outboard) bearings were totally destroyed. Severe metal loss was noted on virtually every bearing ball. Many balls were deeply embedded in the inner race; the ball separators had disintegrated. The shaft was severely bent in the region adjacent to the duplex bearing lock nut (Figure 6). Two of the four seal gland nuts had loosened, a third one had fallen off completely. A pedestal support bracket at point A had not been connected to the pump casing. The ductile iron bearing bracket was fractured at point B.

fire. Excessive friction resulting from severe and near-instantaneous bearing failure could have caused the shaft to bend. Extreme vibration was certain to be generated and could have caused the less-than-optimally installed seal to release pumpage. By this time, the outboard bearing area was thought to have been red hot, causing spilled pumpage to ignite.

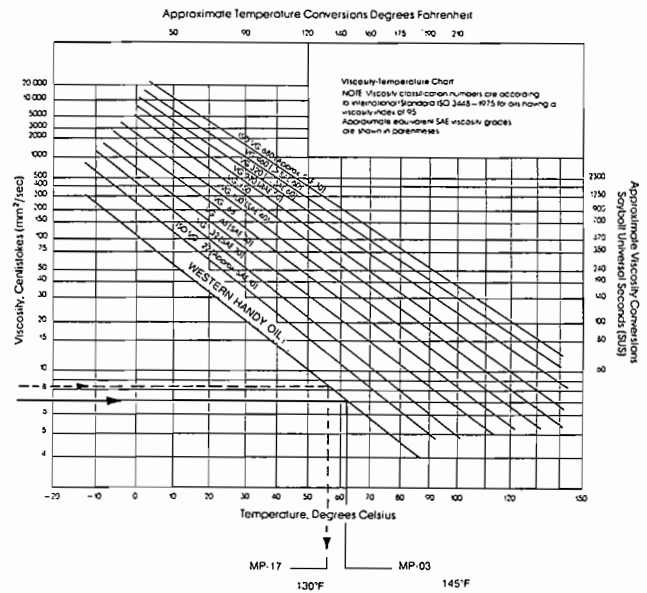
The chart in Figure 7 was used to determine the viscosity required to adequately lubricate the MP-17 bearings. At a mean diameter of 87.5 mm and a speed of 3570 rpm, a minimum lubricant viscosity of 8.3 cSt is required. As shown in Figure 8, maintaining this minimum viscosity is possible only if operating temperatures do not exceed 130°F. Newly installed duplex and double row thrust bearings will, however, experience temperatures well in excess of 130°F. Although a superior grade oil mist lubricant was supplied to these particular pump bearings, the mist lube could not overcome the diluting effect of the inferior low viscosity oil which was present in a "trough" formed by the bearing outer race at the six o'clock position. The existence of this "trough," or minisump explains why oil mist lubricated bearings in horizontally arranged pumps and drivers generally survive for periods of eight or more hours after the oil mist supply has been turned off. Unfortunately, if the minisump is filled with a dilutant, the beneficial effects of applying highly viscous lubricants cannot come into play until the damage is done.

In conclusion, prelubrication with an inadequate lubricant was proven to be the root cause of this and other serious pump failures which had preceded this particular event. Had the reviewer allowed himself to be distracted by additional but, in the final analysis, minor deviations such as the out-of-perpendicularity of seal faces, defective sleeve gasket, and a missing support brack-

Figure 7. Temperature-Viscosity Chart Illustrates that Excessively Low Viscosity Lubricants Will Not Support Oil Film at Temperatures Typically Encountered by Process Pumps.

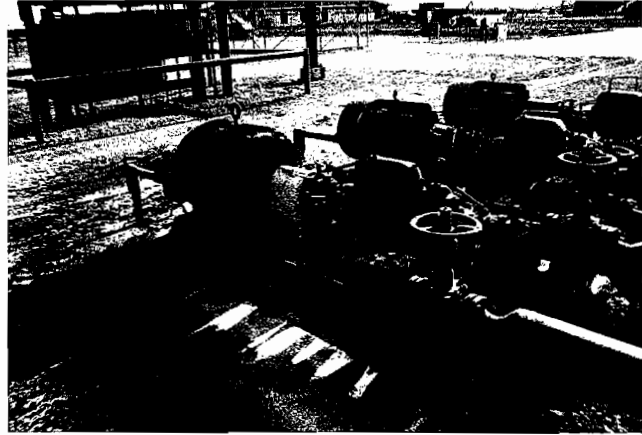
Figure 11. Propane Pumps Involved in a Disastrous Flash Fire.

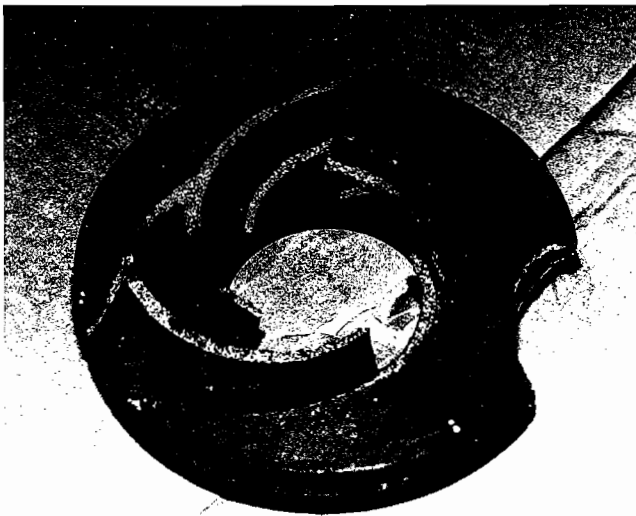
Figure 17. Impeller Destroyed at Disassembly.

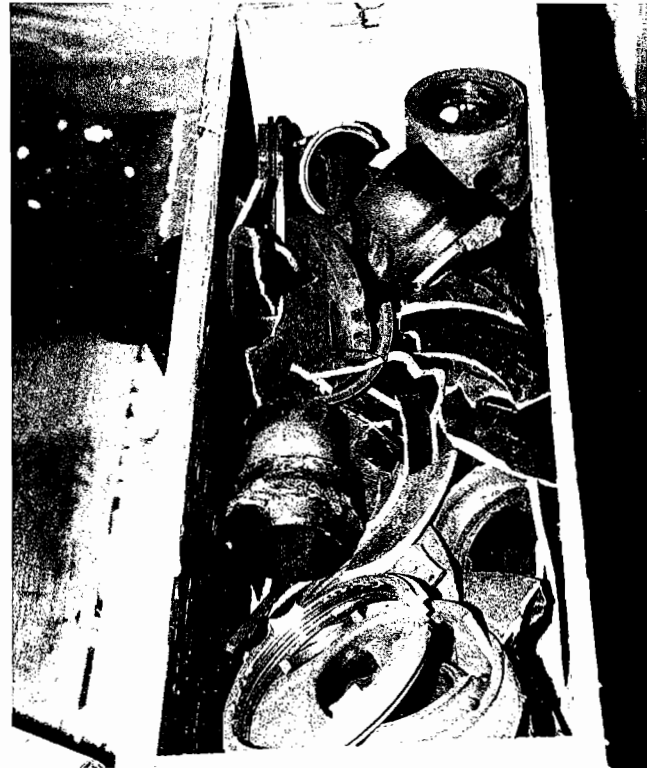
Figure 18. More Components Destroyed at Disassembly.

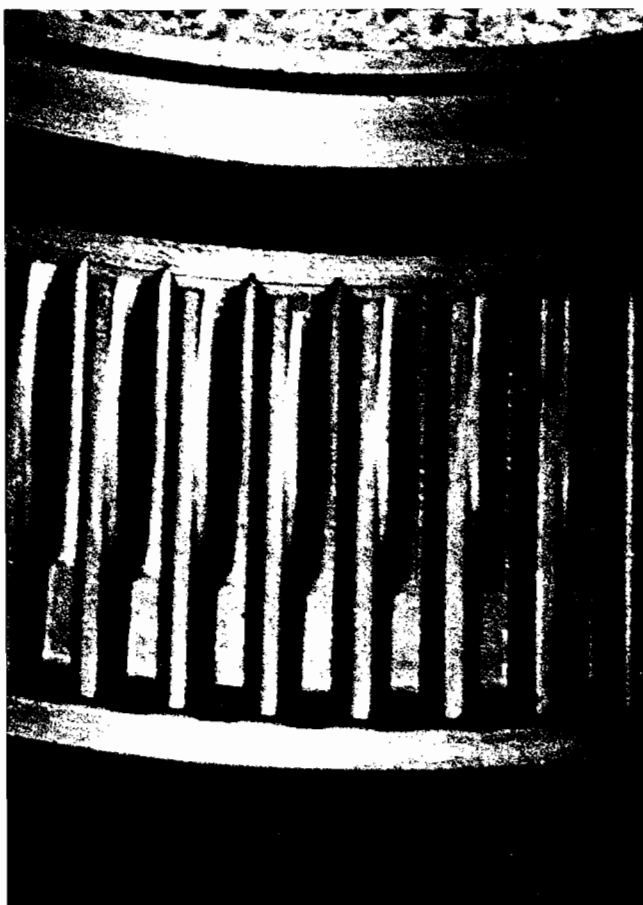
Figure 20. Closeup of Worn Gear Coupling.
