# MATERIALS PROBLEMS AND SOLUTIONS—A METALLURGICAL PERSPECTIVE

**Colin McCaul**

**Senior Consultant Materials Technology  
Ingersoll-Dresser Pump Company  
Phillipsburg, New-Jersey**

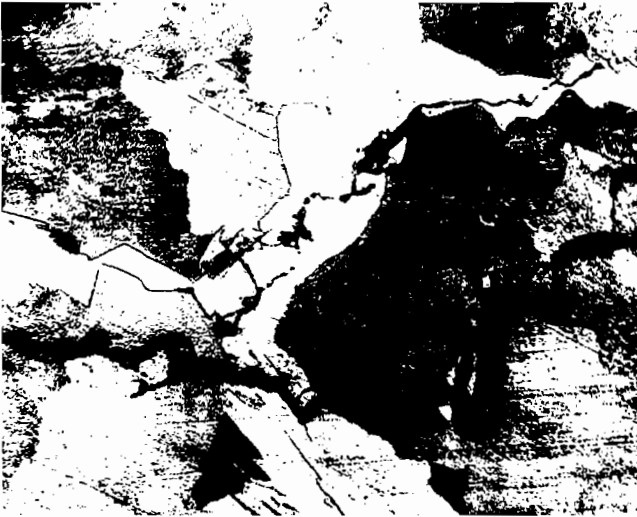
Figure 3. Etched Microstructure, Showing Cracks Are Transgranular, Traversing Ferrite and Pearlite Phases.

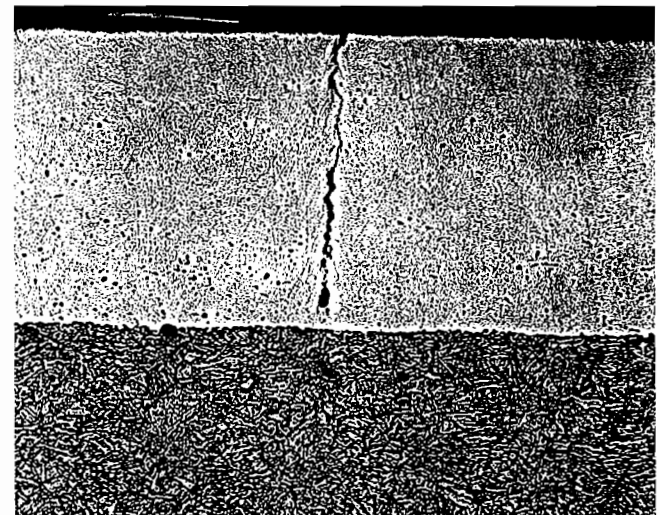
Figure 6. Radial Cracks Through Thickness of Chrome Plate Adjacent to Fracture Surface.

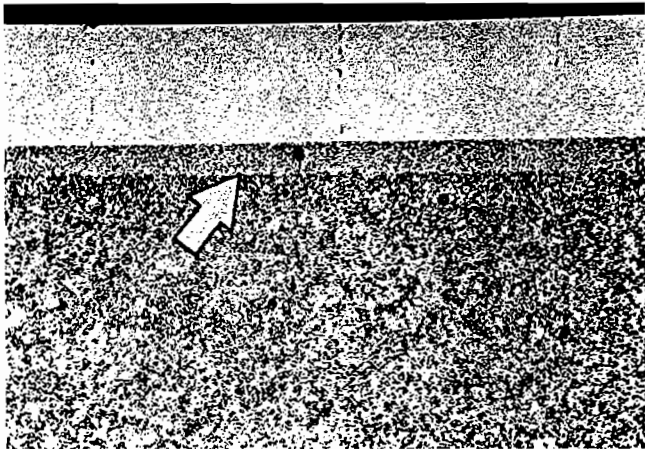
In another instance, a steel shaft experienced fatigue cracking in an area that had been chrome plated. This area had been ground at overhaul to remove a scored surface. Following grinding, the chrome plate had been applied. It appeared initially that the fatigue strength reducing effect of the chrome plate was responsible for the failure. Metallographic analysis, Figure 7, showed a rehardened

Figure 7. *Rehardened Zone under Chrome Plate in Failed Shaft.*

zone containing many small cracks under the plate. Chrome plate evident in some of the cracks (Figure 8) proved that these were present prior to plating. Grinding cracks and burns, such as these, can be readily detected by magnetic particle inspection and etching after grinding and prior to plating.

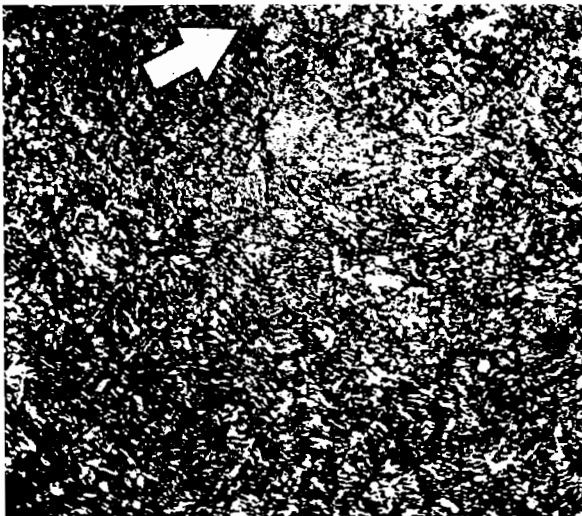
Figure 8. *Chrome Plate in Pre-existing Crack.*

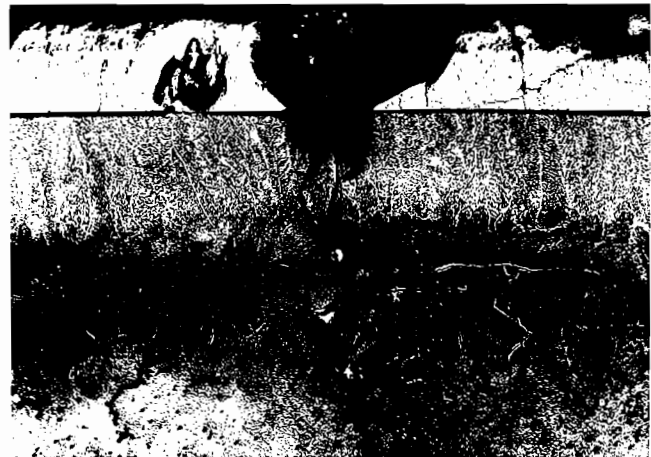
There were numerous intergranular cracks in the hardened area (Figure 10), that were caused by hydrogen embrittlement. Several of these progressed into fatigue cracks during operation. Hardened or high strength steels are susceptible to hydrogen embrittlement during electroplating. Hydrogen is absorbed into the surface, and must be removed by a subsequent thermal treatment. Steels that are fully hard, or hardened and not tempered, are especially susceptible to embrittlement. The hardened area of the failed shaft had a hardness of Rc 46, which is the maximum hardness obtainable in this grade of steel.

Figure 10. *Intergranular Cracks in Localized Hardened Area.*

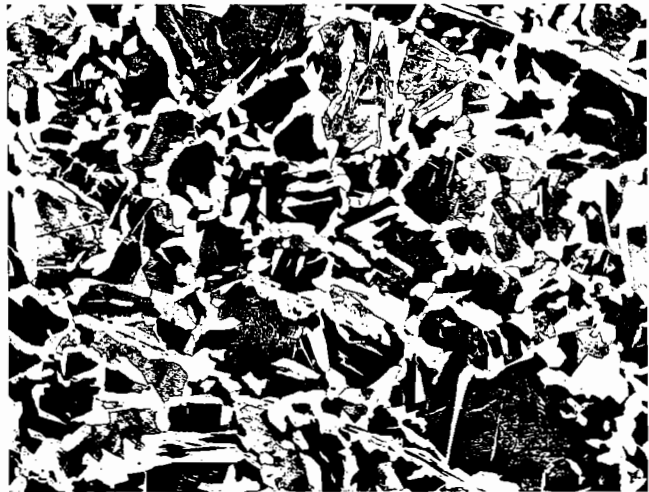
Figure 14. Coarse Grain Structure Has Poor Fatigue Resistance.

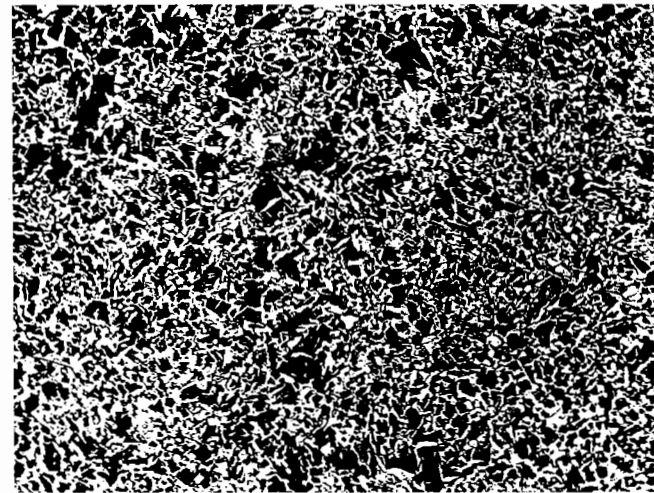
Another metallurgical condition that influences fatigue cracking is grain size. Steels with fine grain size, produced by proper heat treatment, have superior fatigue strength to those with coarse grain size. A shaft failed in fatigue at a change in section adjacent to the keyway. Failure had initiated in this sharp corner, which had been machined with an insufficient radius and acted as a stress raiser. Metallurgical examination also showed that, contrary to specification requirements, this medium carbon steel had a coarse grain structure (Figure 14). Heat treatment of a portion of the fractured shaft demonstrated that the desired fine grain structure could be obtained (Figure 15).

Figure 15. Heat Treatment Produces Fine Grain Structure with Much Improved Fatigue Resistance.

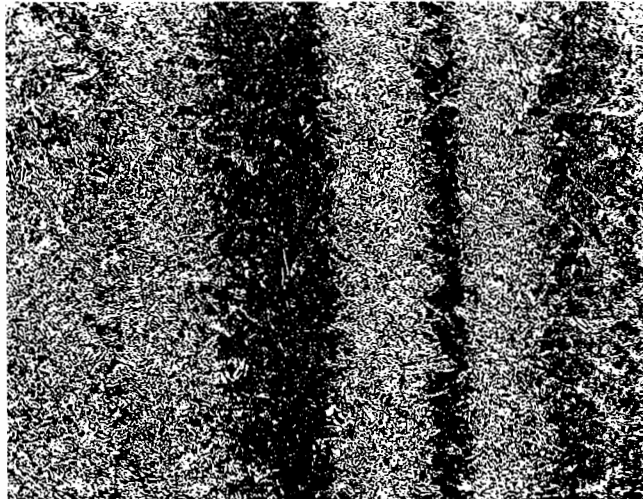
Banding can also occur in martensitic 13 percent chrome steels. A heavily banded structure in a 400 stainless shaft that failed in bending fatigue at a sharp keyway is shown in Figure 17. The reduction in fatigue strength associated with banding is not well defined.

Figure 17. Banded Structure in Martensitic Stainless Shaft That Failed in Fatigue.

Nevertheless, this condition is clearly undesirable in bar stock intended for pump shafting, and should be cause for rejection.

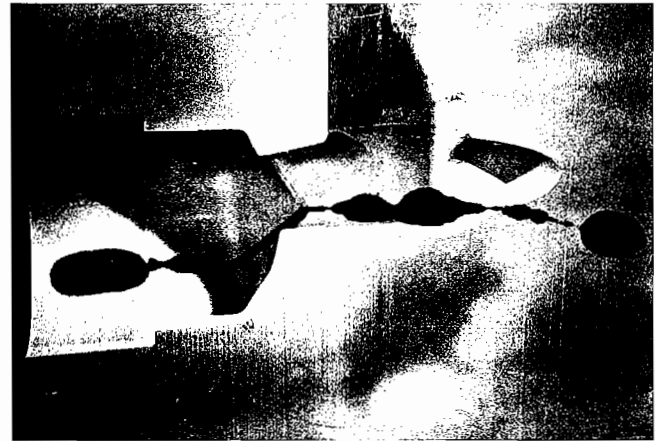
The large crack shown in Figure 18 was found in an austenitic stainless forging that served as the liquid cylinder in a reciprocating pump handling demineralized water. Cracking initiated at a small gouge left by the tooling used to drill the large vertical bore

Figure 18. Liquid Penetrant Developer Delineates Large Fatigue Crack in Reciprocating Pump Forging.

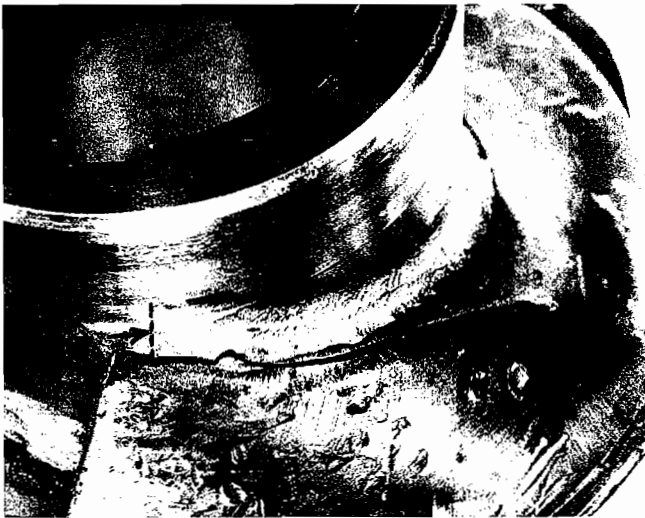
Fatigue failures in pump components are often associated with welds. The inducer shown in Figure 20 consists of a central hub with three spiral shaped blades welded to it. The welding process employs a GTAW root pass for the fillet weld on both sides of each blade, followed by a SMAW top pass. After manufacture, the inducer is dynamically balanced. The reverse side of this blade, after removal of the cracked portion by saw cutting, is shown in Figure 21. A poor quality repair weld, with considerable porosity, was made on the lower fillet. This weld was made in a direction opposite to that of the original fillet weld. Lack of access appears to have contributed to the poor quality of this weld.

Figure 20. Inducer, with Large Crack Initiating at Blade to Hub Weld.

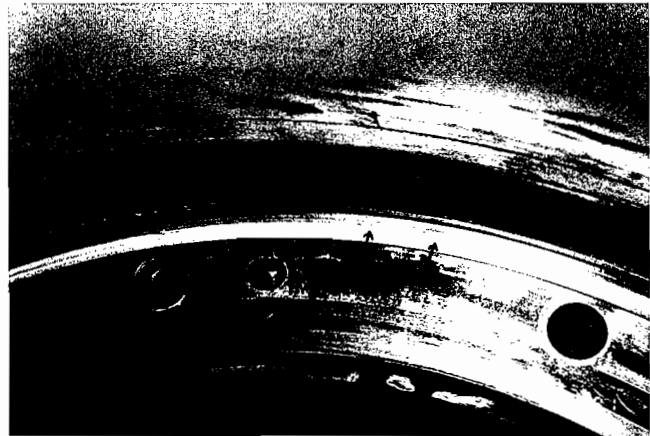
Intermittent cracks were found (Figure 22) around the circumference of a large forged carbon steel barrel at the edge of a stainless steel weld overlay. The pump handles boiler feedwater and had been in service for some 25 years. Metallurgical evaluation revealed the cracks were fatigue, propagating transgranularly along the carbon steel-heat affected zone interface. They were caused by service induced cyclic thermal stress generated by the

difference in coefficient of thermal expansion between the carbon steel barrel and the austenitic stainless steel pressure face weld overlay.

Figure 22. Circumferential Cracking at Weld-base Metal Interface in Forged Barrel.

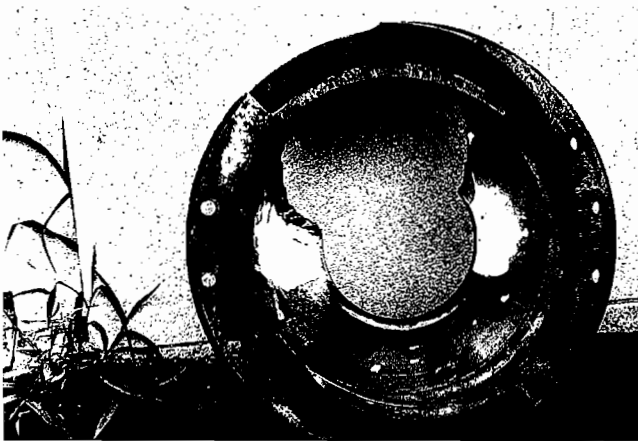
A diffuser from a large barrel pump is shown in Figure 23 with a section broken out of the casting. The diffuser fractured after some twenty-five years of service. After cleaning, a large austenitic repair weld was found at the site of crack initiation. This was one of several austenitic welds, evidently made at some previous time to repair cracks. Cracking propagated, by a fatigue mechanism, along the fusion line between austenitic weld and martensitic base metal (Figure 24), eventually causing fracture. These welds produce hard brittle heat affected zones, which act as notches and can induce fatigue cracks in components that are cyclically stressed. This approach to repair should be discouraged in most instances, in favor of repair with a matching filler metal followed by postweld heat treatment. Although this may involve additional welding and remachining to accommodate dimensional changes, it is the preferred method for making a sound and durable repair.

Figure 23. Diffuser, Fractured Due to Fatigue Cracking after Long Service.

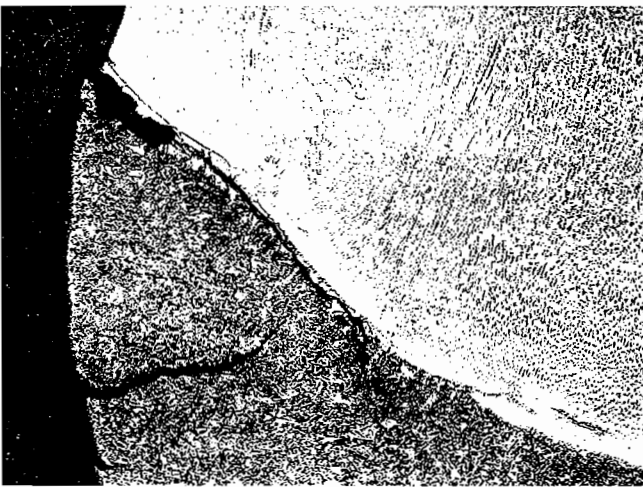
Figure 24. Crack Propagation along Fusion Line in 13 Percent Chrome Diffuser Weld Repaired with Austenitic Filler Metal.
