# FAILURES IN CONCRETE STRUCTURES

Case Studies in Reinforced  
*and* Prestressed Concrete

Robin Whittle

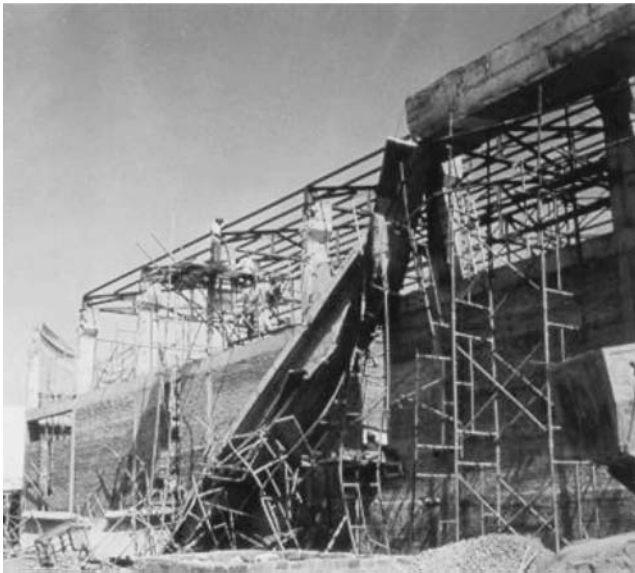
*Figure 1.1* Collapse of concrete gutter.

The contractor had been using the gutter to pile bricks and sand. This load exceeded the design load and failure occurred.

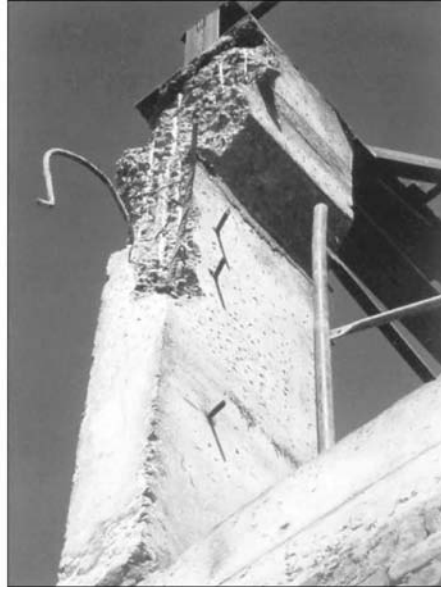
*Figure 1.3* Column where edge beam has broken off.

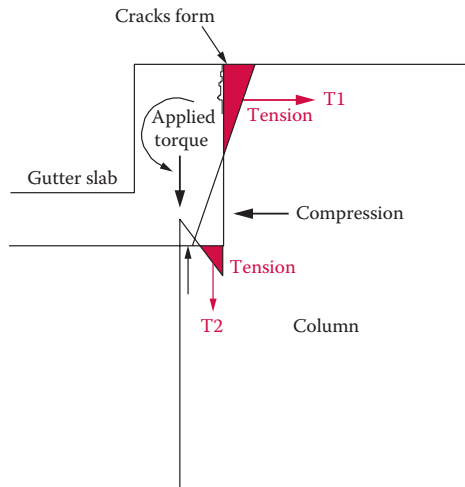
**Analysis** — Figure 1.4 shows a failure model based on the tension strength of the concrete. Even if the links that had been detailed to pass through the joint had been constructed this way, they would have been inadequate to support the loading.

*Figure 1.4* Failure model relying on tension strength of concrete.

**Comment** — Although the edge beam had been designed and detailed to resist the full load from the gutter (moment, shear, and torsion), this had not been carried through to the joint. The joint relied on the tension strength of the concrete which was not sufficient. This was a serious design error, but it is unlikely that the failure would have occurred if the gutter had been subject to just the load from rain. If the detailing and construction had been carried out thoroughly and correctly it is unlikely that the collapse would have occurred.

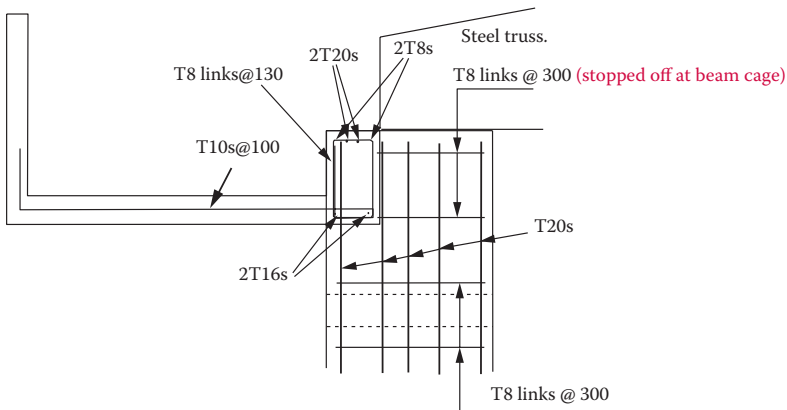
**Detailing** — The reinforcement for the edge beam–column joint was built as shown in Figure 1.5. The top two links were detailed to enclose

**Figure 1.5** Reinforcement detailing for edge beam and column joint.

all the column main bars. Even if the links that had been detailed to pass through the joint had been constructed this way, they would have been inadequate to support the loading. If the detail had been drawn to a large scale it would have become apparent that the column links would have been difficult to fit through the beam cage, and this should have triggered concern about the connection.

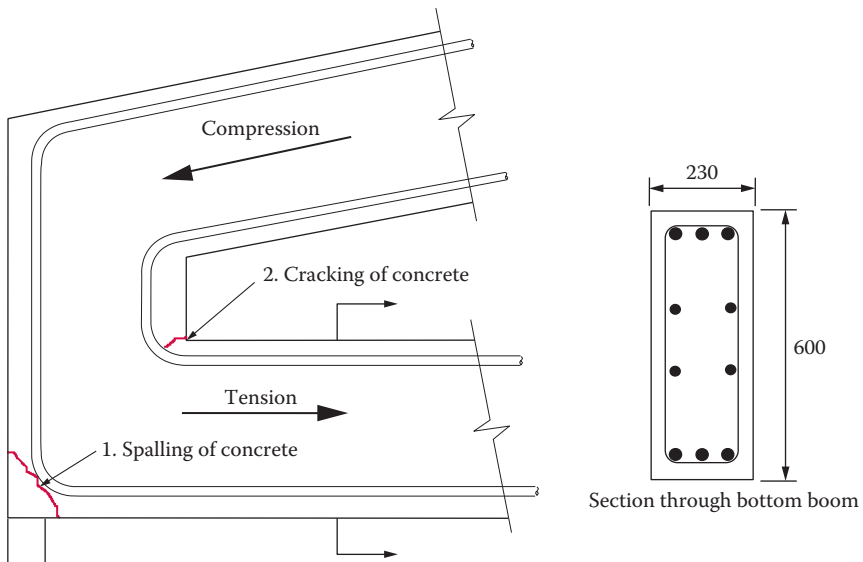
It was also apparent that the detailing required some changes. Figure 1.6 shows the main T32 bars, drawn as if they could be bent with sharp corners when in fact the minimum inner radius of bend required ( $3.5 \times$  diameter of bar) is 112 mm. When drawn to scale, it became clear that the concrete would fail in two places as shown in Figure 1.8.

**Failure of concrete at support (1 in Figure 1.8)** — The support width was only 150 mm and the drawing did not show any reinforcement in the connection to the truss. If reinforcement was intended in the joint, then it would be difficult to fit this between the reinforcement of the truss. If not, the effect of the cover and the radius of bend of the T32 bars at the corner of the truss would lead to spalling of the concrete and the support would fail.

**Failure of concrete at inner corner (2 in Figure 1.8)** — Since the bottom boom was a tension member, the top reinforcement in it would be in tension. The way that it was detailed meant that a crack in the concrete would develop on the inside of the bend where it joined the vertical post at the end of the truss.

Figure 1.8 Concrete failure points.

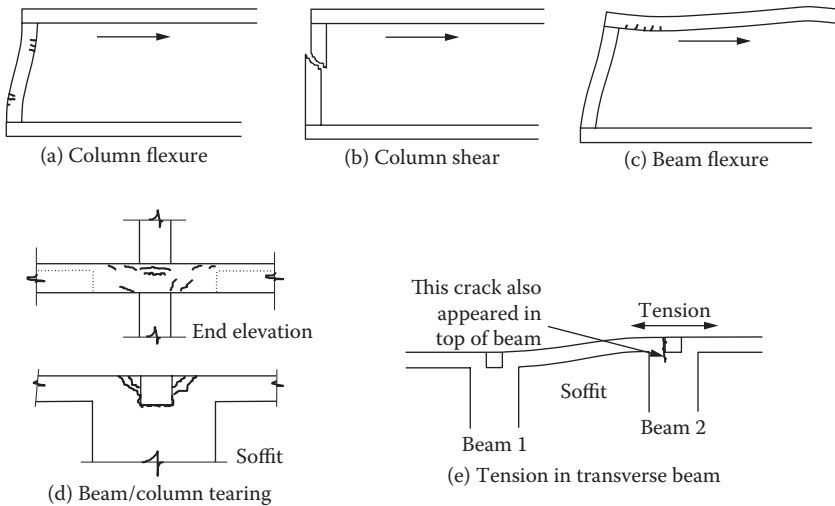
Figure 1.14 Different types of cracking.

widespread in both the columns and beams and exceeded 0.7 mm in places. Figure 1.14 shows the different types of cracking that occurred.

It took a long time to understand what caused the cracking. Whilst the problem was debated, in order to proceed with construction with minimum delay, the prestressing was altered to a two-stage process—only 50% applied at transfer and the remaining prestress applied after 2 weeks. After much discussion, it was concluded that when early thermal effects were included with the other shortening effects, the total shortening was sufficient to cause the cracking. At that time (early 1990s) it was not common to include early thermal effects in the designs of concrete frames (for reinforced or prestressed concrete). The calculated value of early thermal movement at the outer ends of a six-span beam was over 8 mm which, when added to the elastic shortening from prestress of 7 mm, provided sufficient movement to cause the cracking that occurred.

From a layman's view, as the concrete started to set, the temperature rose. During this period, the concrete remained somewhat plastic. The stiff columns prevented any expansion of the beams (they just bulged a bit). When the temperature started to fall, the concrete had hardened and the beam shortened, causing the cracks.

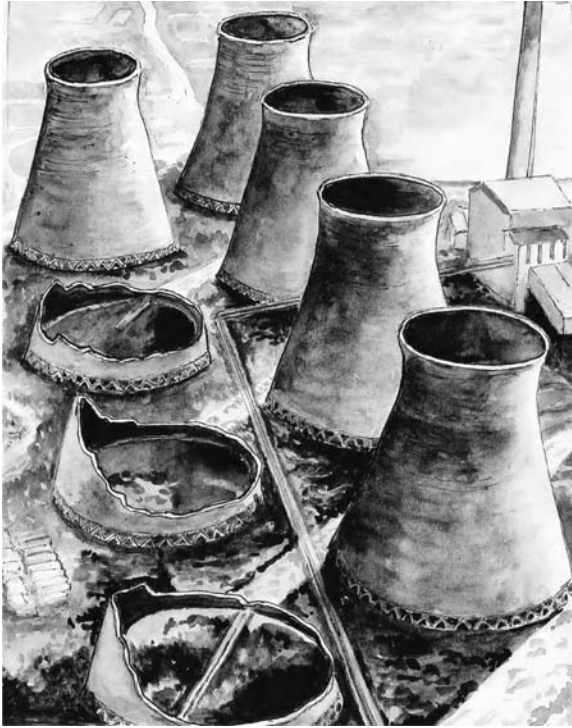
- British Standard wind speeds had not been used in the design; as a result, design wind pressures at the tops of the towers were 19% lower than they should have been.
- Basic wind speed was interpreted and used as the average over a 1-minute period, whereas, in reality the structures were susceptible to much shorter gusts.
- The wind loading was based on experiments using a single isolated tower. The grouping of the towers created turbulence on the leeward towers—the ones that did actually collapse.
- Safety margins did not cover uncertainties in the wind loadings.

**Figure 3.1** View of collapsed cooling towers. (Courtesy of Gillian Whittle.)

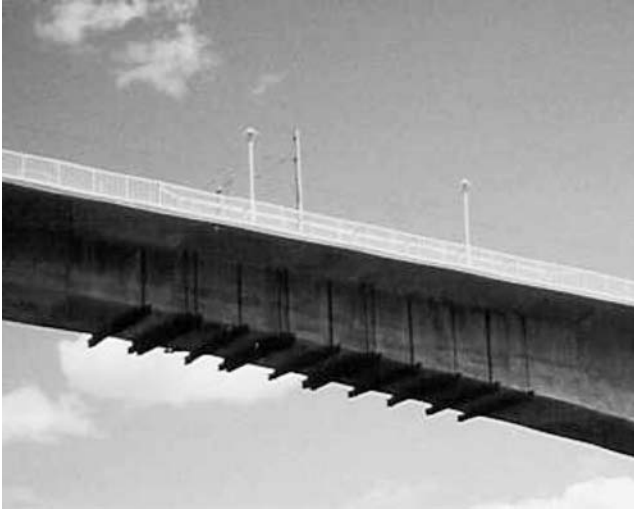
The design of a prestressed bridge section followed a code of practice that some considered to overestimate the shear capacities of prestressed beams. Soon after construction, cracks appeared. There was a long debate about the cause of cracking and, until remedial work was carried out, temporary additional external shear reinforcement was put in place (see Figure 3.5).

Figure 3.5 Temporary repair work on bridge.

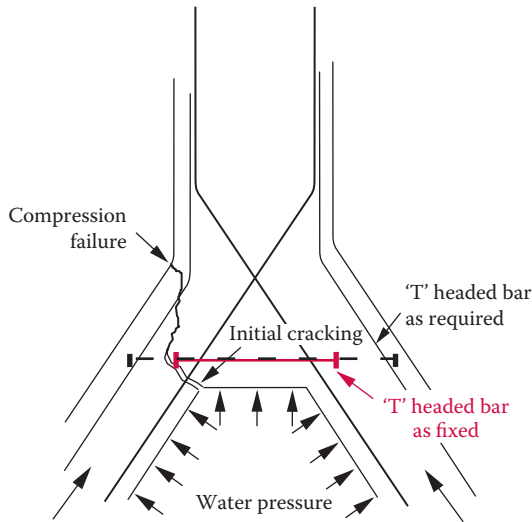
Figure 6.4 Section through tri-cell where failure occurred.

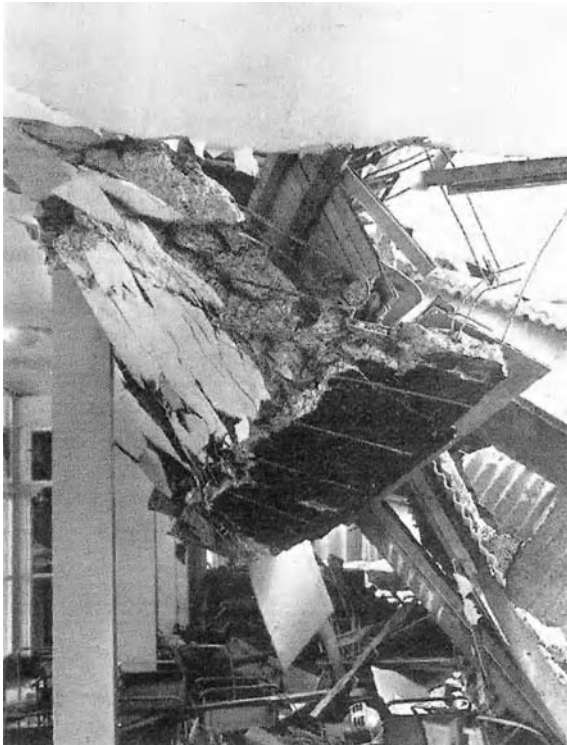
**Comment** — This was an example of inadequate design and poor detailing of the end bearing nibs built into the supporting beam for the precast beams. The reduction in strength caused by HAC left no margin for temperature effects. The combination was likely to have triggered the collapse.

**Figure 6.6** Part of roof that collapsed on chairs below. (From Scott, G.A., *Building Disasters and Failures*, Construction Press Ltd., Lancaster, 1976. With permission.)

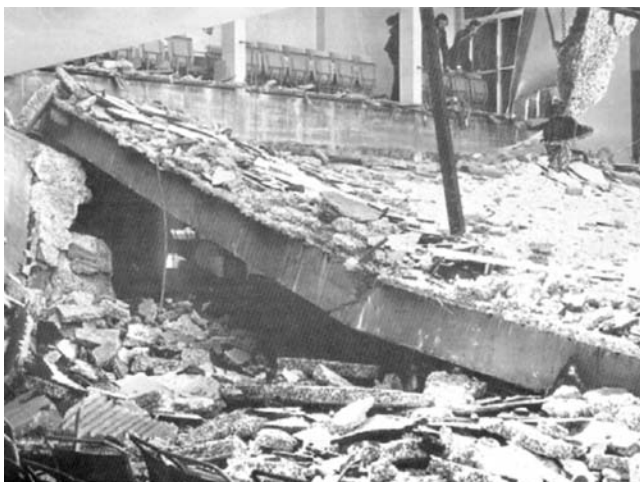
**Figure 6.7** Collapsed roof lying on floor below. (From Scott, G.A., *Building Disasters and Failures*, Construction Press Ltd., Lancaster, 1976. With permission.)

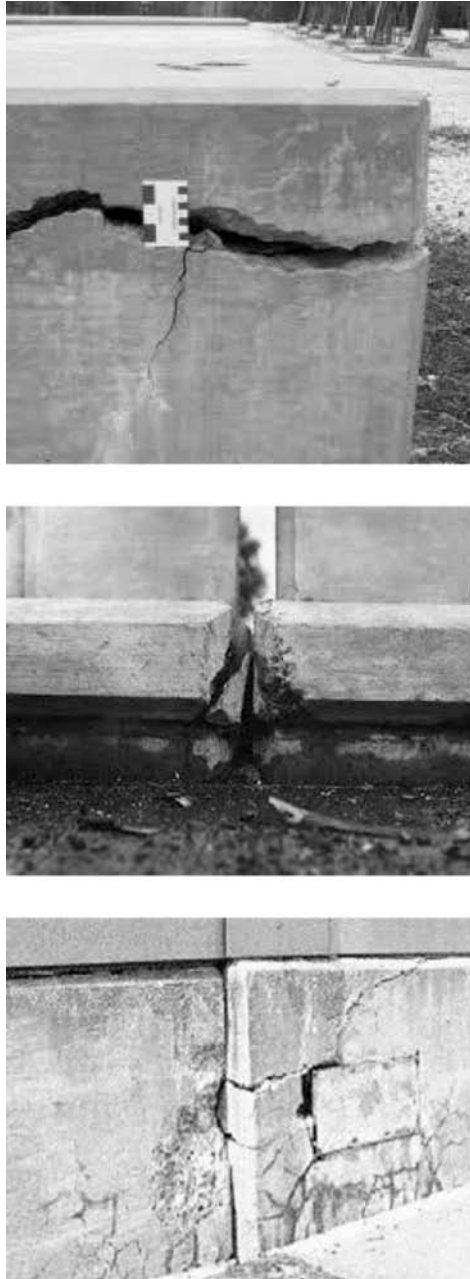
In mainly unidirectional reinforced members, the cracks become linear and parallel to the reinforcement. The degree of cracking depends on the amount of confining reinforcement, i.e., links, etc. One major concern was that ASR caused cracking that led bits of concrete to fall off structural elements and hit people below. This led to demolition of the structures in some cases. Examples of ASR effects are given in Figure 7.6.

*Figure 7.6* Examples of alkali-silica reaction. (Top: From the US Department of Transportation Highway Administration; middle: From Dr. Ideker, <http://web.engr.oregonstate.edu/~idekerj/>; bottom: From the US Department of Transportation Highway Administration.)

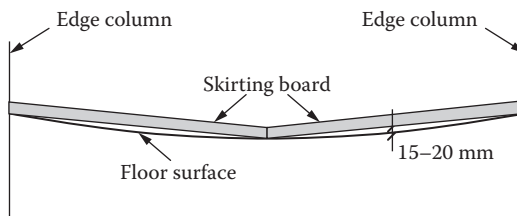
The conclusion was that much of the deflection occurred during construction, some of which was due to the sagging of the formwork and some due to early removal of the formwork.

Figure 8.2 Skirting board deflection.

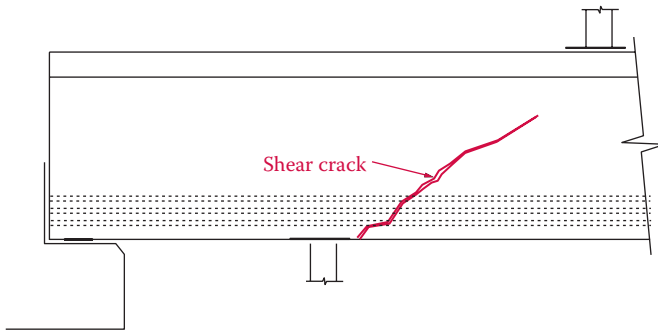
Figure 8.3 Cracked T unit.

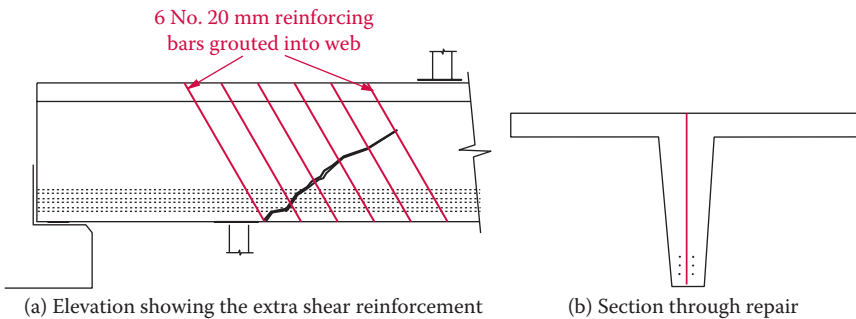
Figure 8.4 Repair of T unit.

The subcontractor proposed to repair the damaged T unit by drilling angled holes down the centre of the web and grouting in straight deformed reinforcing bars. He was sufficiently confident to agree to then test load

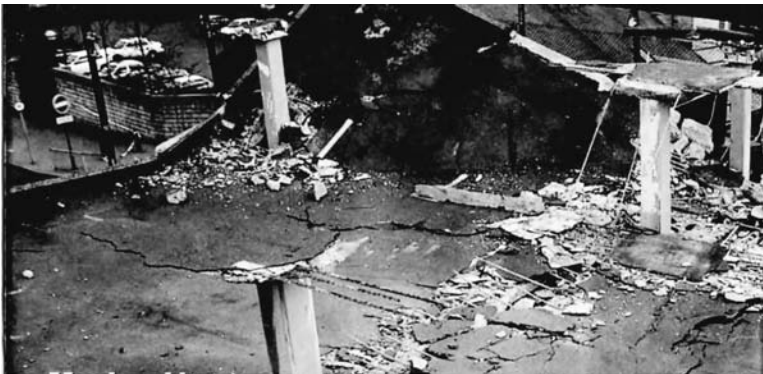
**Figure 8.8** Collapse of roof of car park. (From Jonathan Wood, <http://www.hse.gov.uk/research/misc/pipersrowptl.pdf>.)

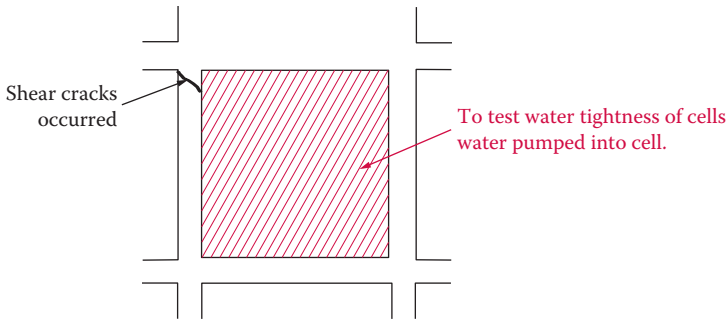
Figure 8.13 Shear crack in wall.

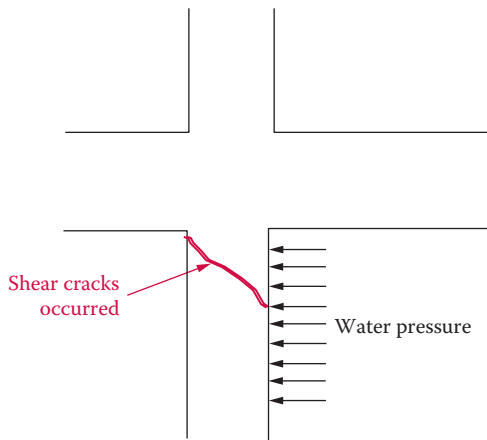
Figure 8.14 Enlarged view of shear crack.

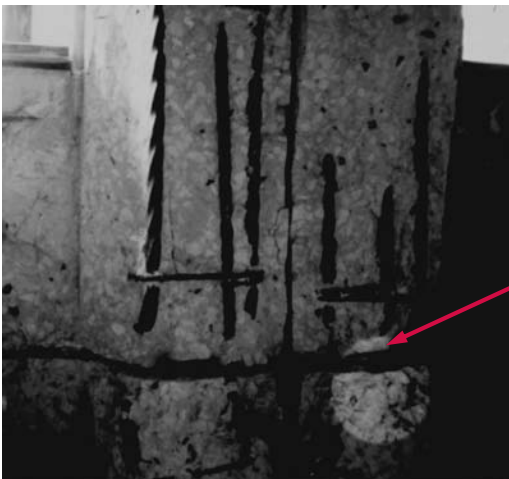
*Figure 8.17* Spalling of mullions. (Courtesy of Poul Beckmann.)

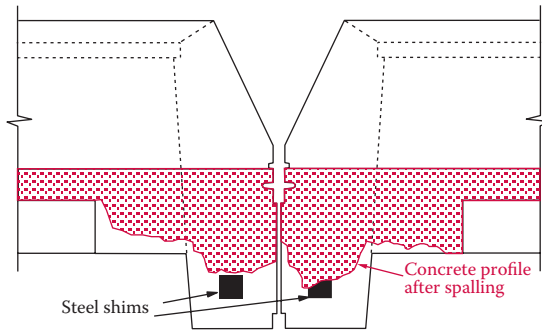
Figure 8.18 Plan section through mullion after spalling.

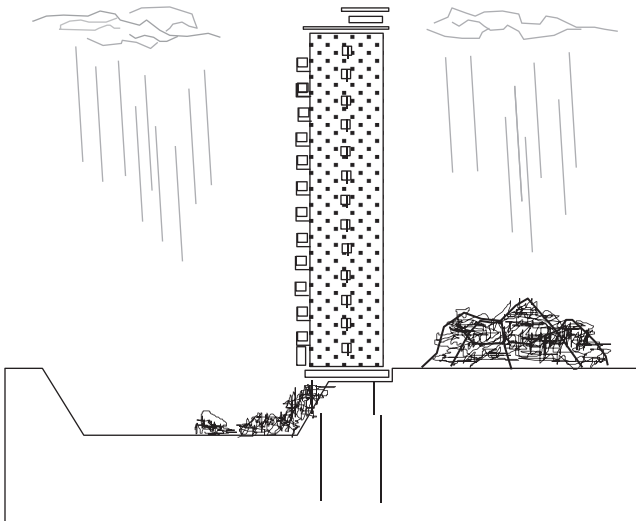
Figure 10.5 Diagrammatic view of pile shear failure.

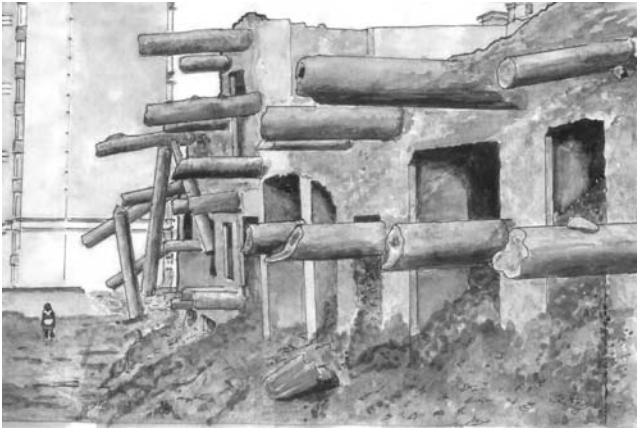
*Figure 10.8* View of piles that failed in shear. (Courtesy of Gillian Whittle; redrawn from Reuters, <http://www.telegraph.co.uk/news/worldnews/asia/china/5685963/Nine-held-over-Shanghai-building-collapse.html>.)

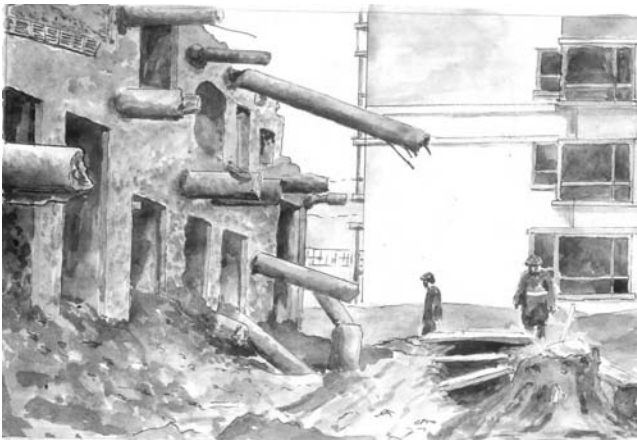
*Figure 10.9* Unreinforced piles with short reinforced length at tops. (Courtesy of Gillian Whittle; redrawn from Reuters, <http://www.telegraph.co.uk/news/worldnews/asia/china/5685963/Nine-held-over-Shanghai-building-collapse.html>.)

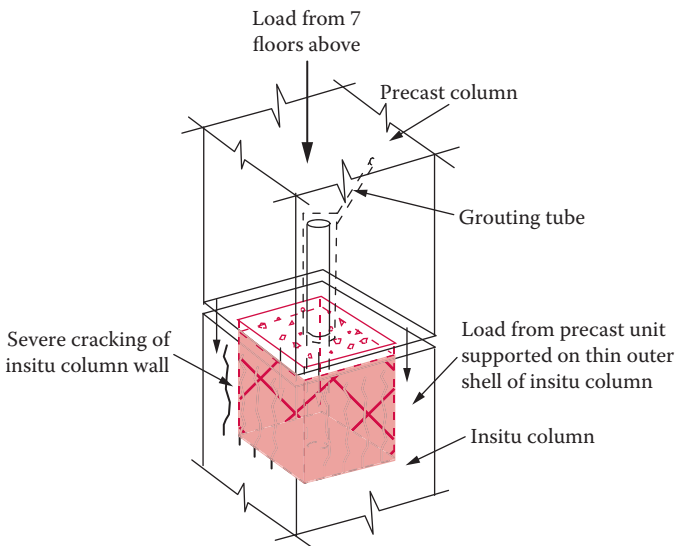
Figure 11.5 Cracking of outer rim of in situ column.
