CO₂ CORROSION ON NATURAL GAS COMPRESSORS: CRITERIA AND GUIDELINES

Liquid water and CO₂ can easily lead to carbon steel corrosion, especially at high pressures. Corrosion can happen either during normal running or during pressurized standstill conditions. The present paper describes three real cases of gas lift compressors operating in offshore platforms that suffered internal damage due to the formation of carbonic acid and unfavorable process conditions. The damages found were slightly different on each machine due to specific design characteristics (such as the presence or not of inlet guiding vanes), different manufacturers and process conditions. Full description of the failure mode and relevant root cause analysis as well as the modifications implemented to solve the issue are provided. Additionally, a review of the monitoring tools used to diagnose internal corrosion will be presented, including typical responses that can be expected in compressors subjected to CO₂ corrosion. Finally, detailed criteria to define CO₂ corrosion potential are proposed as well as comprehensive guidelines on material selection to avoid similar problems.

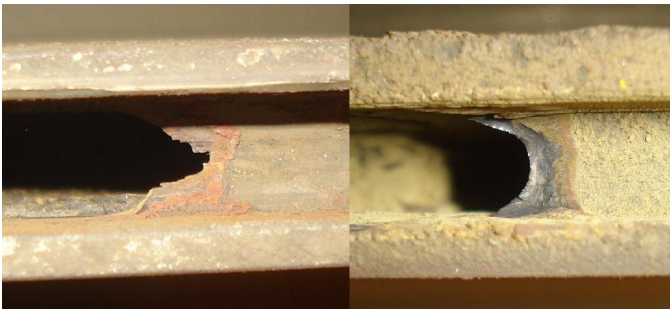
As can be observed in Figure 5, the failed impeller (as all others in these rotors) was cut back. During shop acceptance tests, it was necessary to machine the impellers vanes outer diameter to reduce compressor head and required power, in order to match API requirements and avoid future operational problems, as motor overloading.

Figure 5. Erosion on the blades trailing edge of first impeller of third section.

It should be noted that only the impellers vanes were machined, the impeller disc and cover remained with its original diameters.
