# Understanding Bridge Collapses

Björn Åkesson Consulting Engineer, Fagersta, Sweden

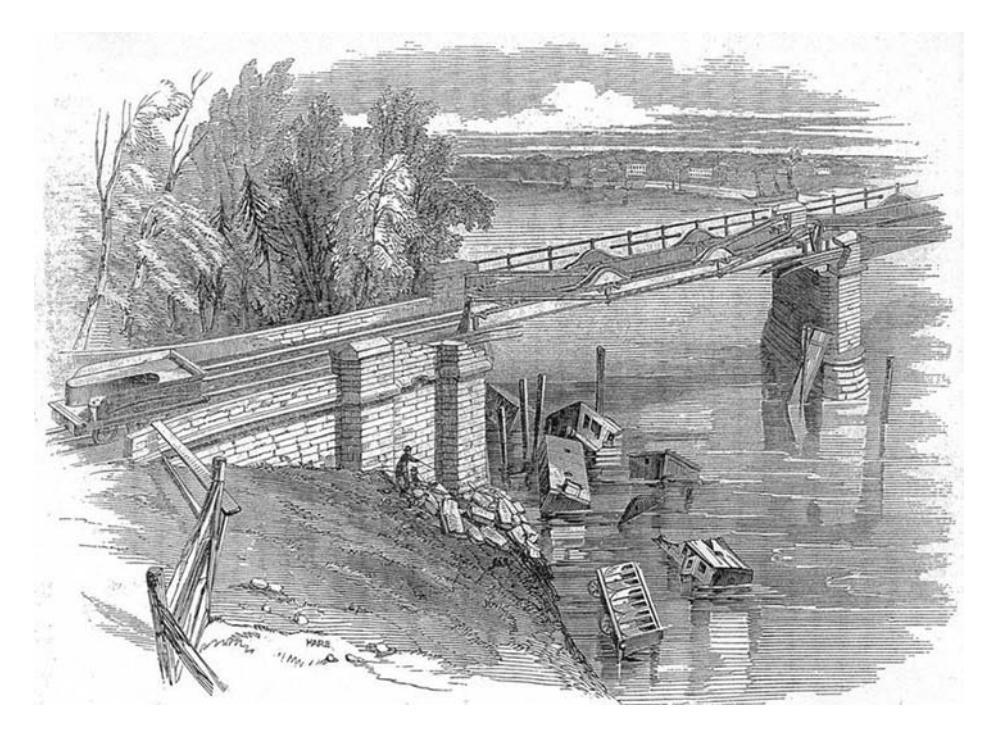
Fig. 1.12 As the train passed the last span over the river Dee, one of the girders failed, and all of the carriages followed the girder into the river below. (http://en.wikipedia.org/wiki/Dee\_bridge\_disaster)

as a crack had been found in the lower flange of one of the girders. At the repair it was found that the tension bars had not been properly installed, thus making the girder becoming overloaded when trains were passing. However, it was at the same time an apparent proof of the reinforcing effect coming from the tension bars, which saved the bridge from a complete collapse by coming into action after the lower flange of the girder had broke. After repair of this damaged girder, and inspection of the remaining others, the bridge could once again be taken into service. The bridge was thereafter performing without any problems; however, only some six months after the bridge had been taken into service, the bridge collapsed during the passage of a train. The train had left the station in Chester at 6.15 P.M., 24 May 1847 – on its way to Ruabon, approximately 25 kilometres southwest of Chester – and arrived at the Dee Bridge site after just some few minutes. The locomotive and the carriages did pass the two first girder spans without any indication of anything being wrong. However, as the train set was passing the last span, the driver felt the carriages sink beneath him. He pulled full throttle for maximum steam pressure and the locomotive and the tender (the carriage behind the locomotive which carries fuel and water) succeeded to reach the shore behind the abutment, but all the remaining carriages fell into the river. It was the outermost girder – of the two in this last span – that had failed (Fig. 1.12).

Eyewitnesses distinctly talked about a crack that opened up from the lower part of the girder as the bridge span was loaded by the train, and that the last carriage in the train set fell into the river first, followed by the other carriages.

The same morning a 12.5 centimetre thick layer of ballast had been added to the bridge (supported by a wooden deck on top of the sleepers) in purpose of protecting the bridge against any fire hazard (a recent bridge fire – due to hot ashes/sparks – had attracted the attention to this potential risk). This additional loading of about 18 tons on each bridge span was apparently judged as something that the girders could carry, however, it also meant that the mean stress level was increased by some 8–9 MPa, which is a markedly stress raise to an already heavily strained girder. As the fatal train to Ruabon was to pass the bridge later the same day, the total stress loading became too much for the girder to carry, and the tension strength of the same was exceeded.

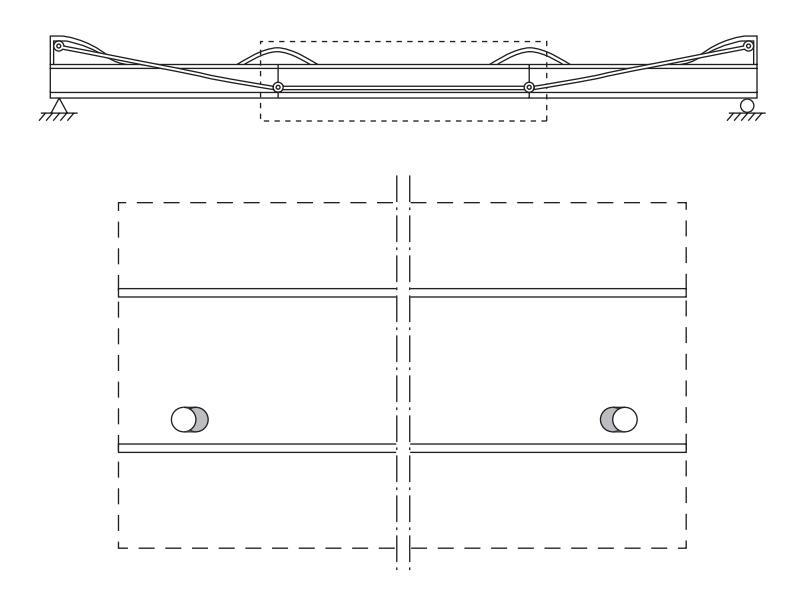
Because of the relative hardness of the tension bars and the pin bolt (in comparison to the softer cast-iron material in the girder, see Fig. 1.9) it will in time develop a localized deformation in the contact pressure area between the pin bolt and the web plate of the girder (the contact pressure here is also the largest). This will lead to an ovalization of the hole (read: remaining plastic deformation) – the hole has quite simply been elongated through wear and excessive local contact pressure (Fig. 1.19).

Fig. 1.20 Elongated holes in the cast-iron girder web plate.

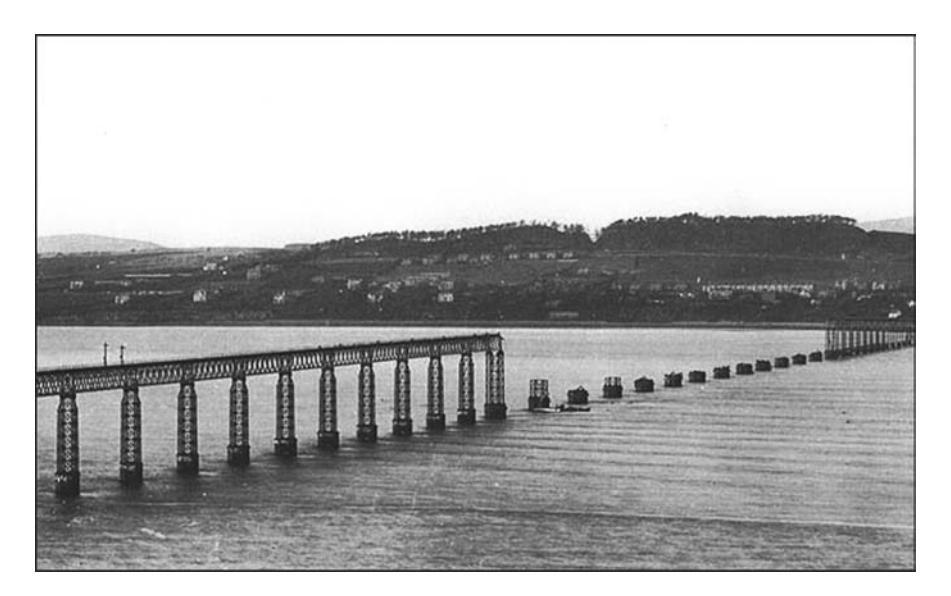
Fig. 3.7 All thirteen high girders of the Tay Bridge had collapsed into the river. (Wolcott: The breaks of progress. Mechanical Engineering)

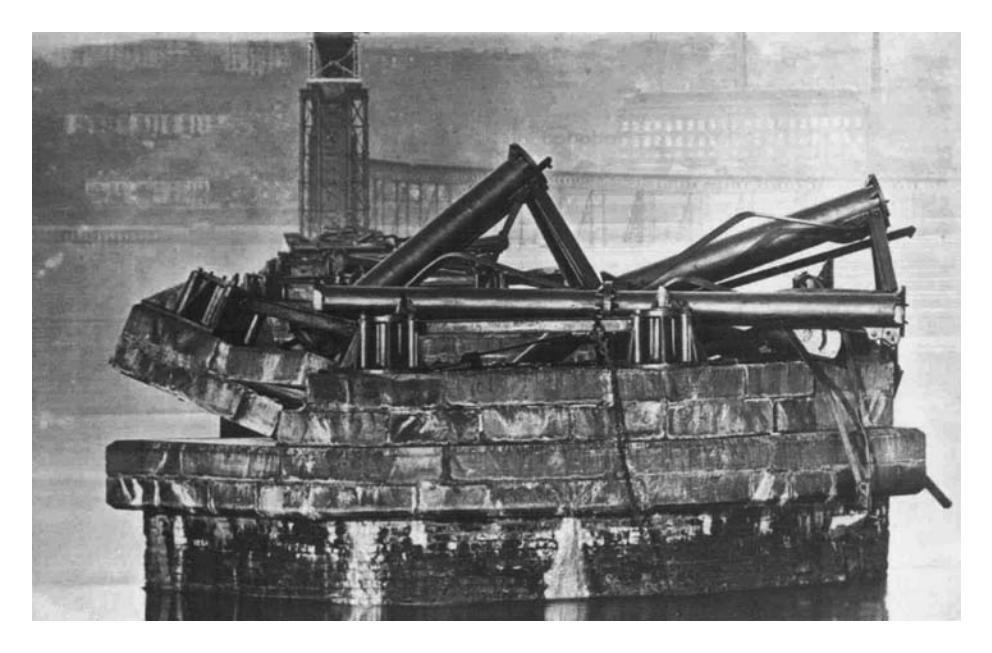
Fig. 3.18 One of the broken piers of the collapsed high-girder bridge section (looking north). (http://taybridgedisaster.co.uk/)

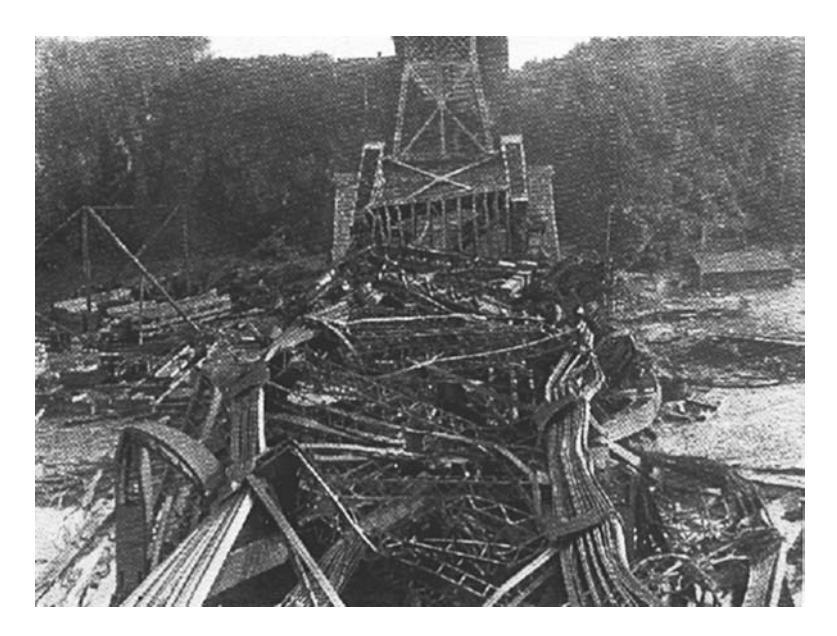
*Fig. 4.13* The collapsed 152.5 m long south anchor arm of the Quebec Bridge. The photo is taken from the main pier and facing south towards the river bank. The cantilever arm and the part of the suspended span that was completed lay under water on the river bed. (www.civeng.carleton.ca/ECL/reports/ECL270/Introduction.html)

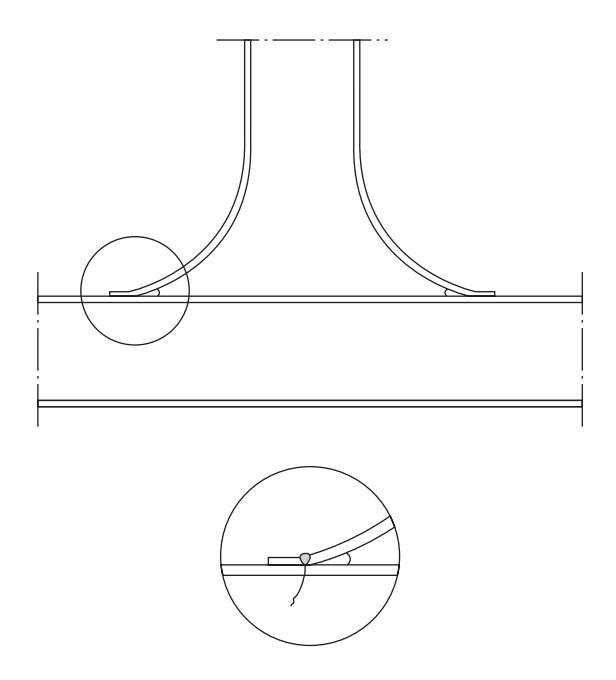
Fig. 5.3 The initiating point where the crack started that ruptured the lower tension chord.

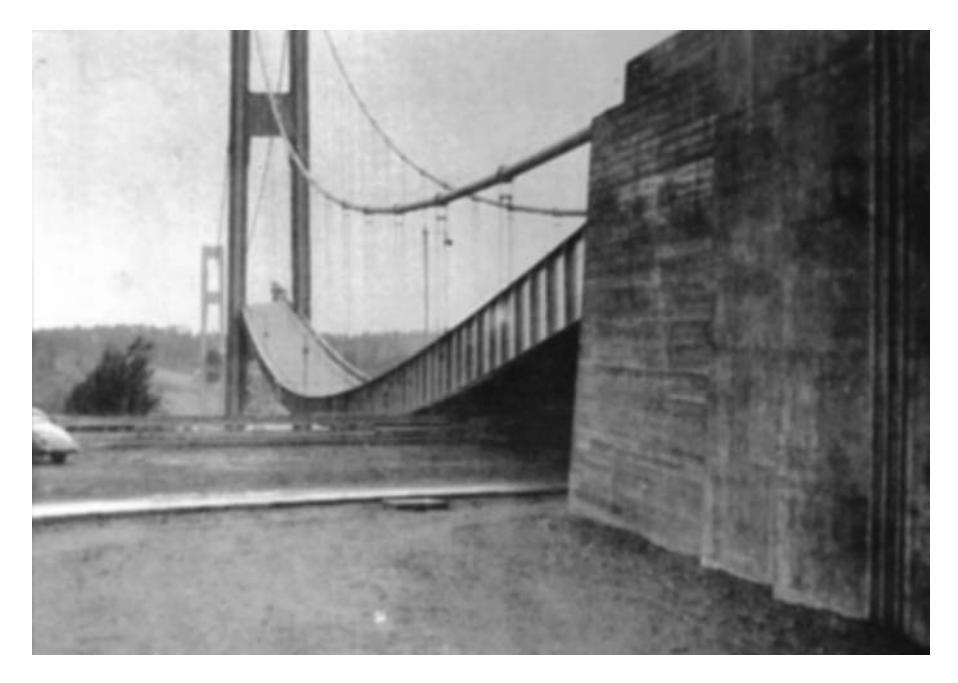
Fig. 7.7 The deflected side span on the east side, at the time of the collapse of the main span. (University of Washington Libraries, Special Collections, UW 27459z)

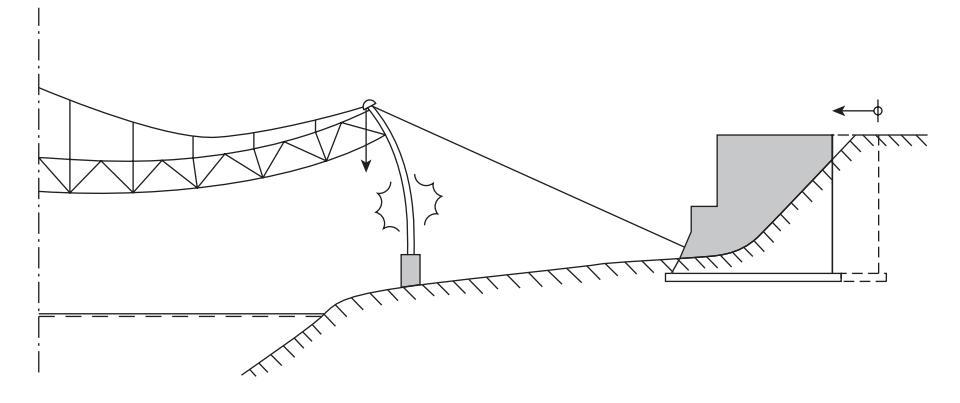
Fig. 8.12 The deformation of the cable bent as the abutment slid.

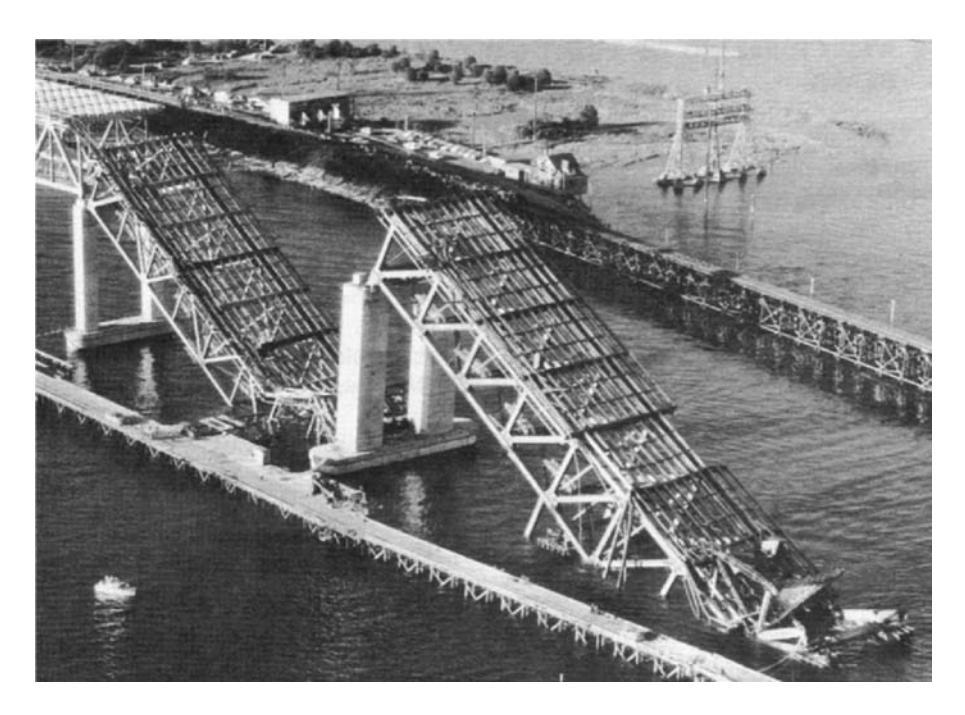
*Fig. 9.4* The collapse of the Second Narrows Bridge. (McGuire: Steel Structures. With kind permission of Pearson Education Publications).

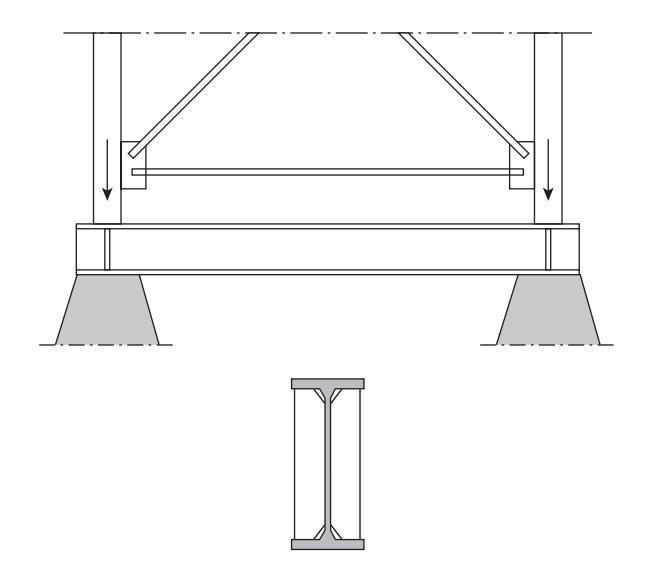
Fig. 9.9 Vertical web stiffeners at the load application points would have saved the bridge, but were unfortunately missing.

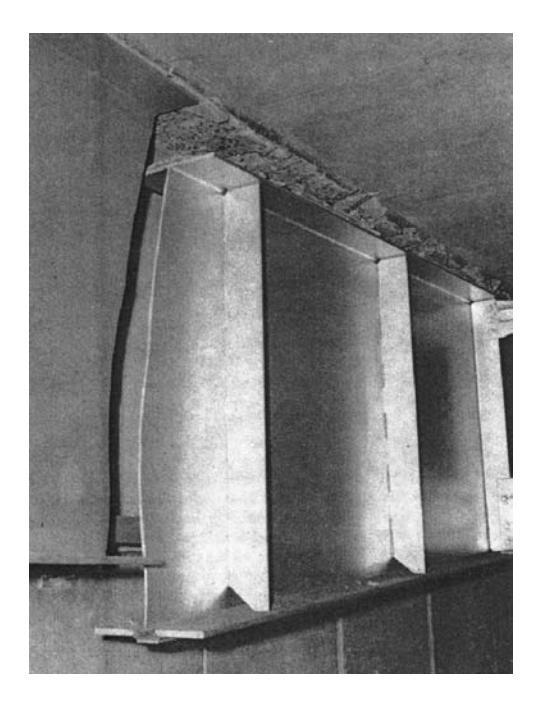
*Fig. 10.7* Complete fracture of I-girder No. 1 on the western carriageway. The photo is taken inside the bridge looking north, in between girder No. 1 and 2. (Hopkins: A span of bridges – an illustrated history).

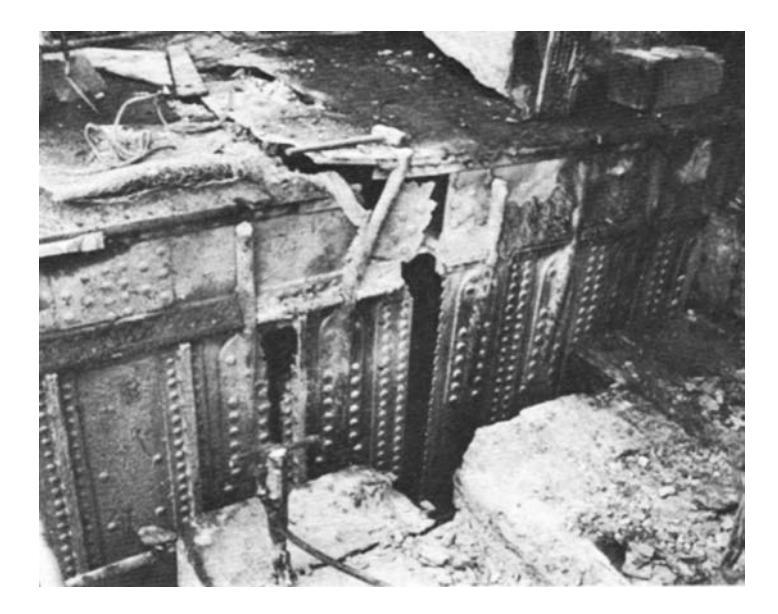
Fig. 13.14 The tubes split open over each intermediate support (i.e. at the towers).

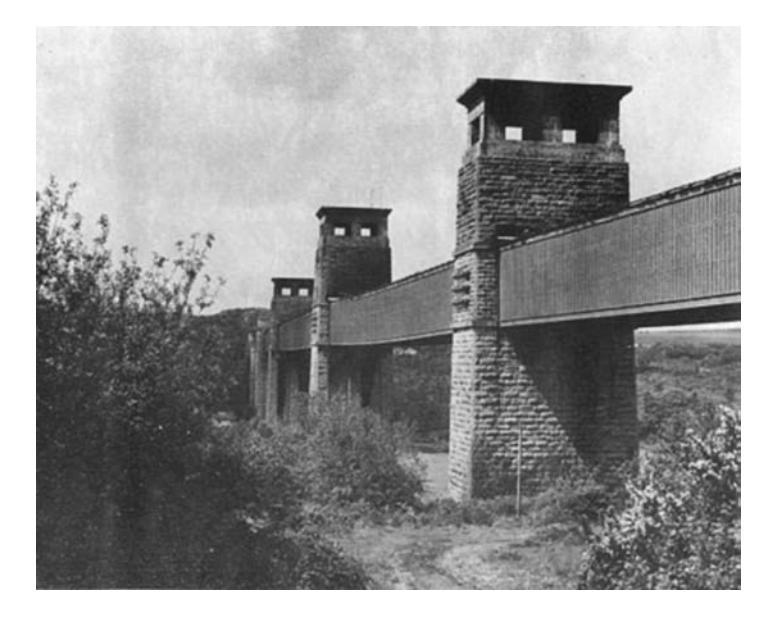
Fig. 13.15 The sagging of the bridge spans because of the vertical split over the intermediate supports. (http://vivovoco.rsl.ru/V/E\_LESSON/BRIDGES/ BRIT/BRIT.HTM)

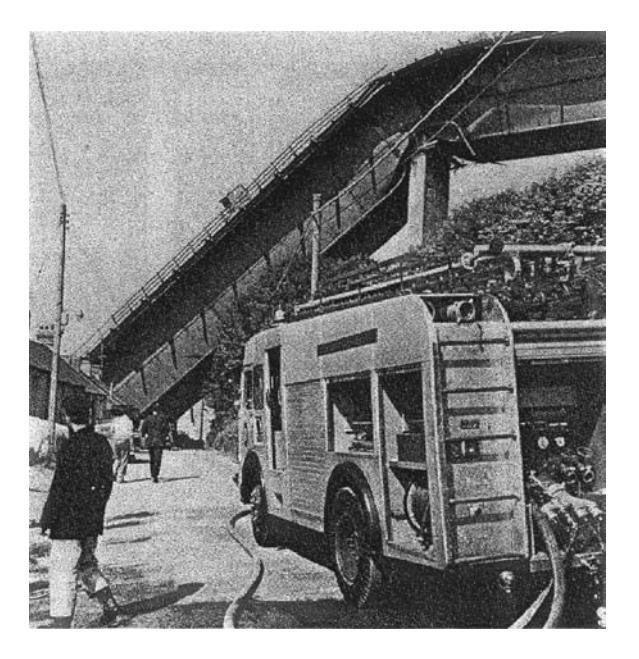
Fig. 14.5 The cantilever arm of the second span on the south end of the bridge buckled over the inner support and fell to the ground. (Aurell/Englöv: Olyckor vid montering av stora lådbroar. Väg- och Vattenbyggaren)

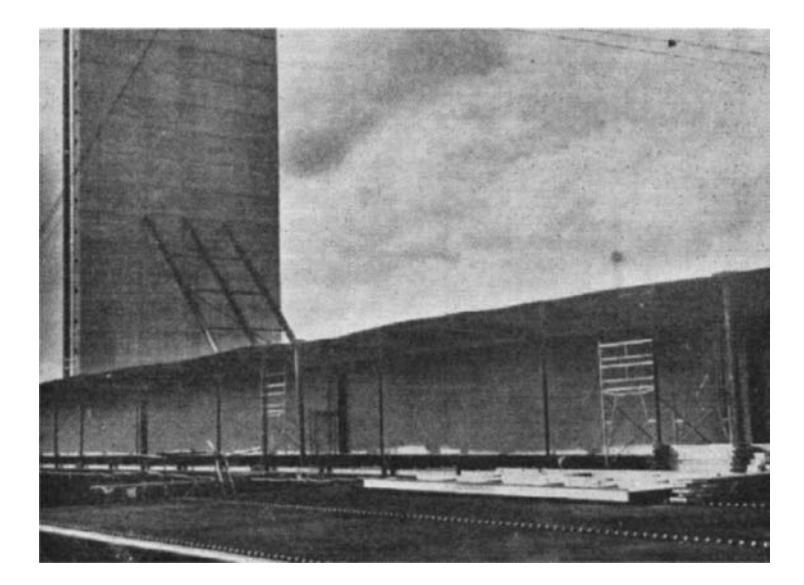
*Fig. 15.6* The upper (and outstanding free) flange buckled already when the bridge half lay on the ground, supported at the ends (before being lifted). (Report of Royal Commission into the Failure of West Gate Bridge. Copyright State Government of Victoria, Australia)

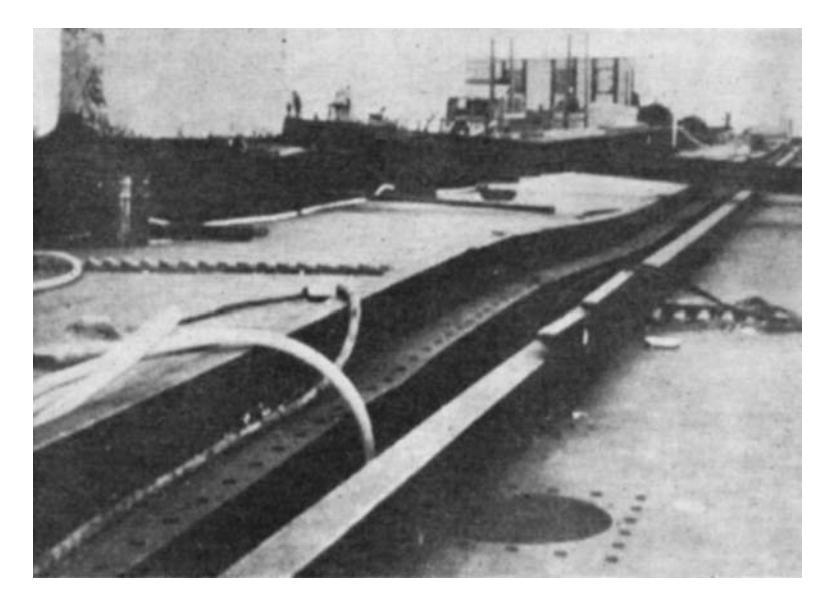
Fig. 15.15 The difference in deflection was evened out by the extra weight of the concrete blocks (to be seen on the left), but the free edge (of the extra loaded half) buckled, still being stiffened by the extra longitudinal stiffener at the free upper flange end. (Report of Royal Commission into the Failure of West Gate Bridge. Copyright State Government of Victoria, Australia)

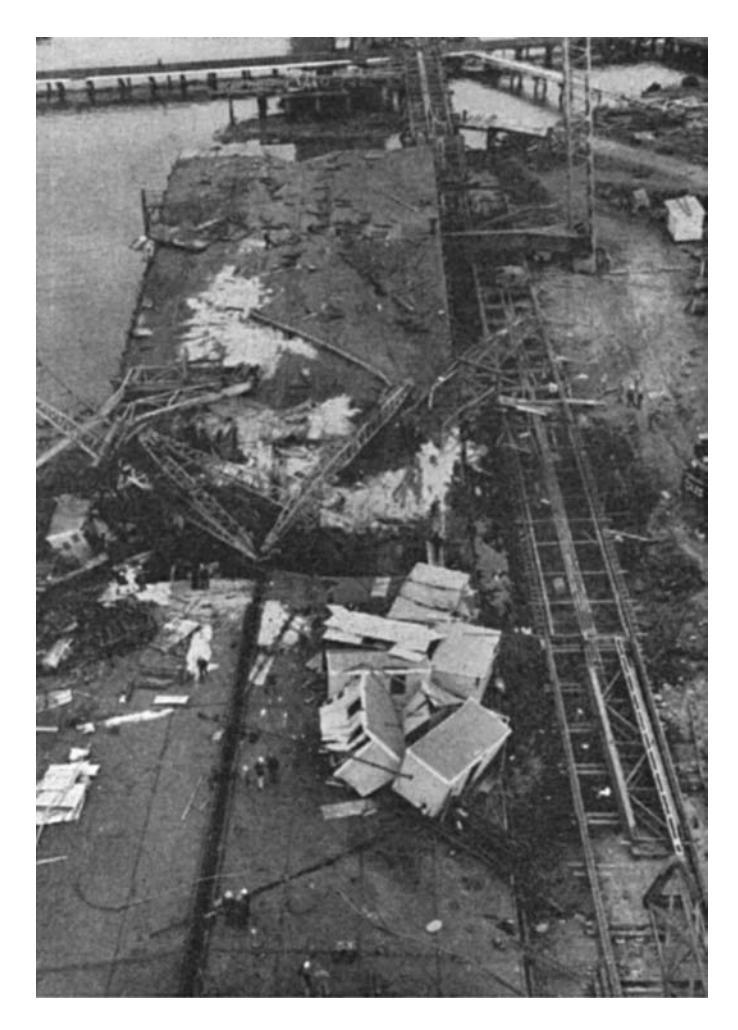
*Fig. 15.18* The collapsed girder span on the ground. (Report of Royal Commission into the Failure of West Gate Bridge. Copyright State Government of Victoria, Australia)

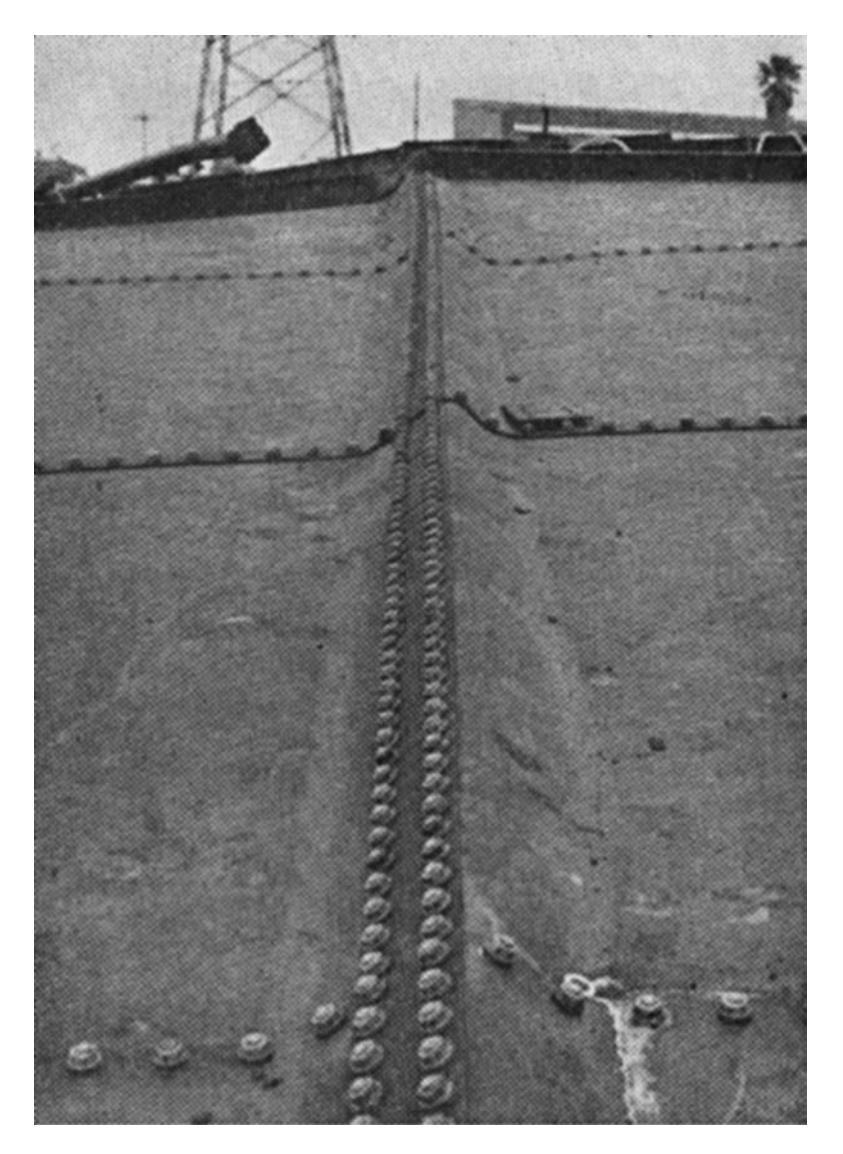
Fig. 15.19 The local collapse of the deck plate due to the weak splicing of the longitudinal stiffeners (see also Fig. 15.11). (Report of Royal Commission into the Failure of West Gate Bridge. Copyright State Government of Victoria, Australia)

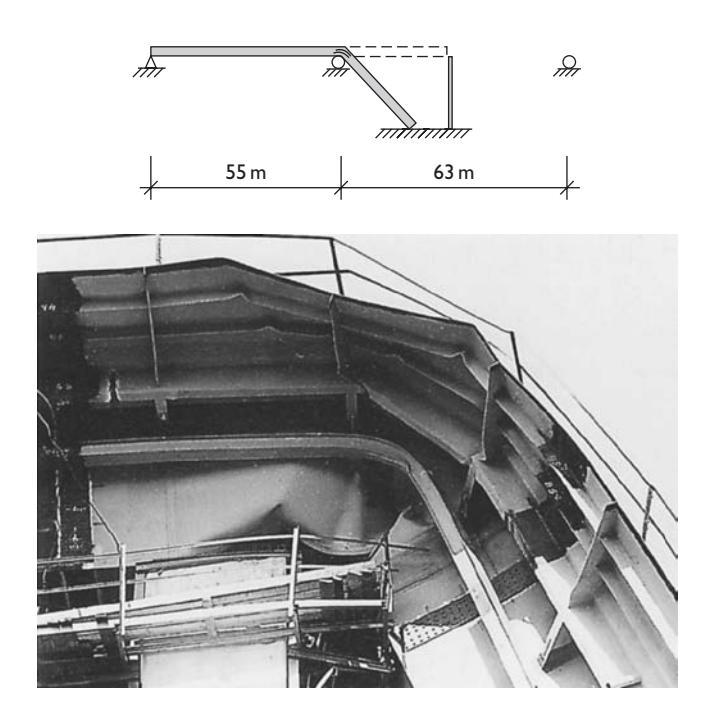
Fig. 17.4 Collapse mechanism and a close-up of the buckled corner (i.e. the hinge). (The photo: Ekardt: Die Stauseebrücke Zeulenroda. Ein Schadensfall und seine Lehren für die Idee der Ingenieurverantwortung. Stahlbau. With kind permission of Karl-Eugen Kurrer)

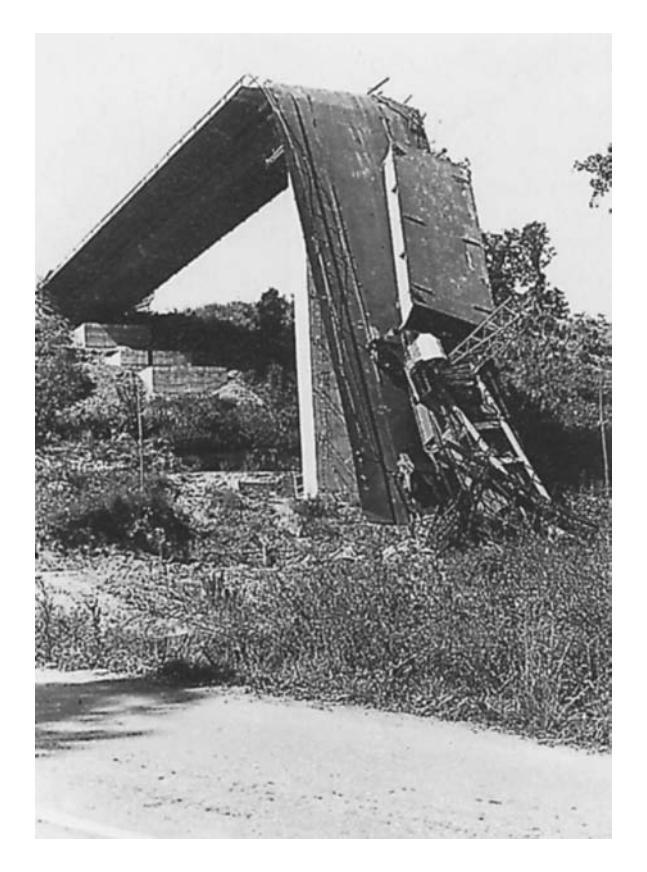
*Fig. 17.5* The unexpected and sudden collapse of the Zeulenroda Bridge. (Ekardt: Die Stauseebrücke Zeulenroda. Ein Schadensfall und seine Lehren für die Idee der Ingenieurverantwortung. Stahlbau. With kind permission of Karl-Eugen Kurrer)

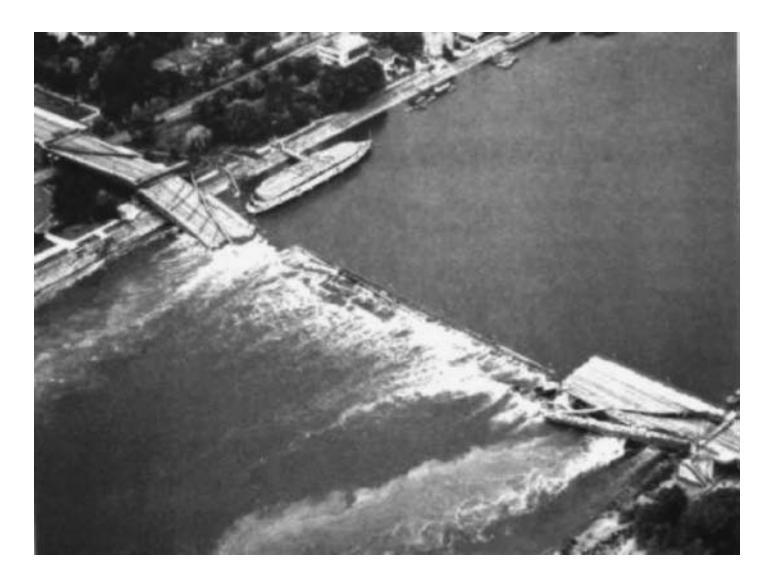
Fig. 18.5 The collapsed Reichsbrücke. (www.reichsbruecke.net/geschichte\_e.php)

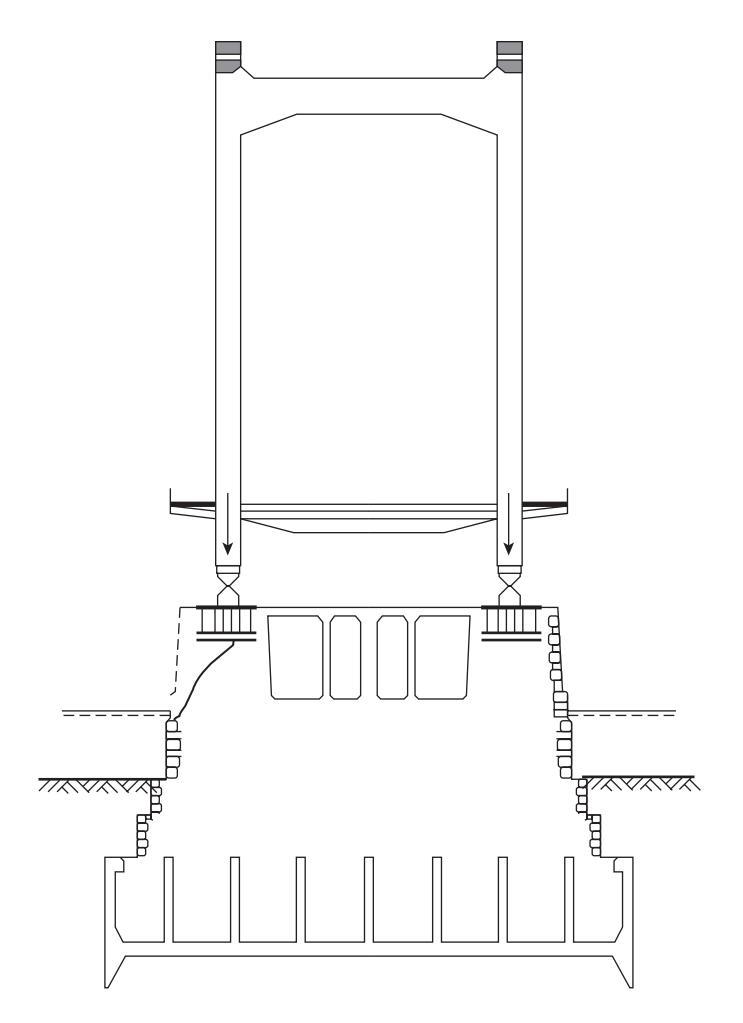
Fig. 18.12 When the tower leg lost its footing the bridge collapsed, tilting to the left. (first published by IABSE in Reiffenstuhl, H.: Collapse of the Viennese Reichsbrücke: Causes and Lessons. IABSE Symposium, Washington 1982)

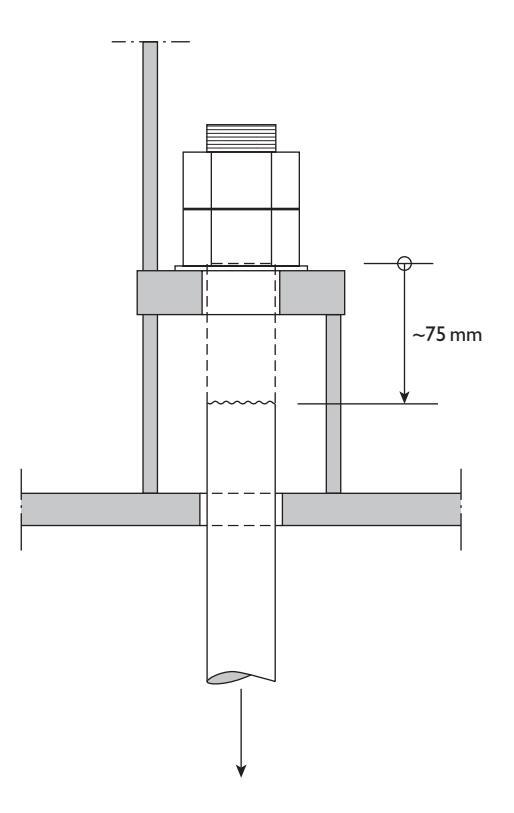
Fig. 20.13 Fracture of Hanger I (the one closest to the abutment on the northwest corner of the bridge). See also figure 20.7 as a comparison.

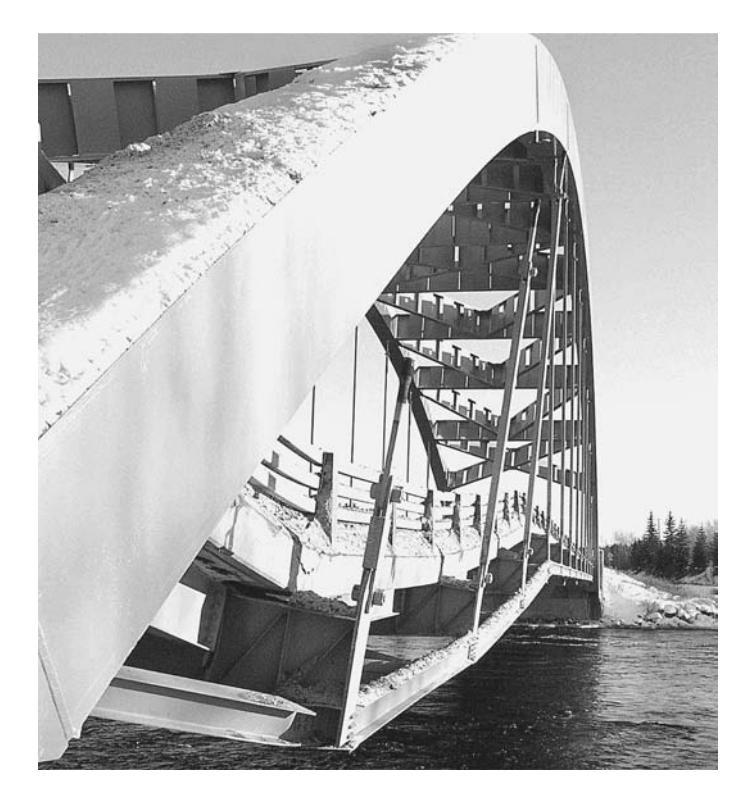
Fig. 20.15 The (partial) collapse of the Sgt. Aubrey Cosens VC Memorial Bridge. (http:speaker. northernontario.ca/content/Feature%20Story/C%20Front%2011:01:06.pdf)
