SEVENTH EDITION

BUILDING SURVEYS

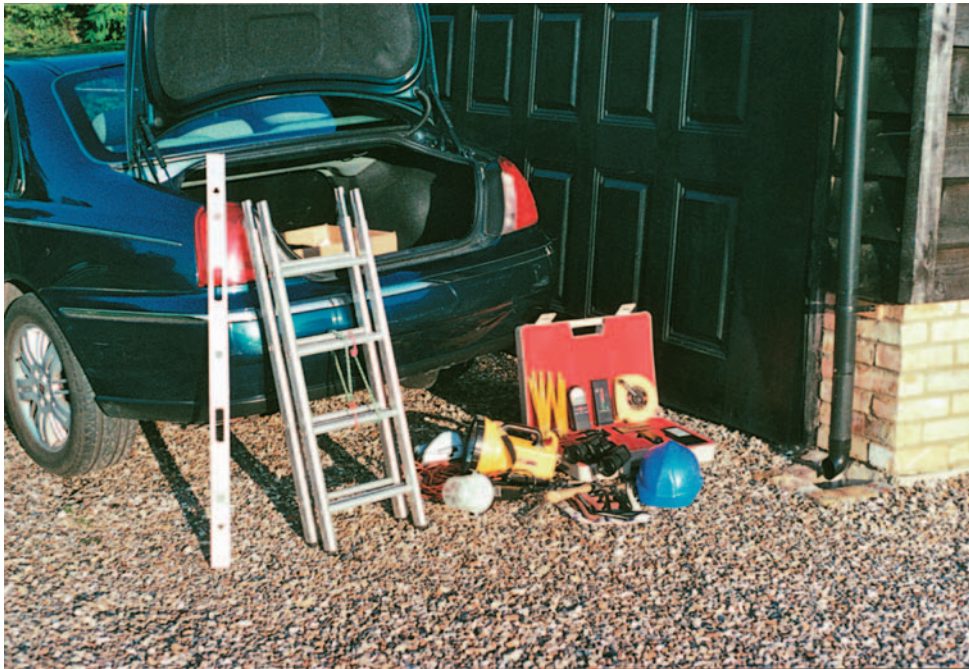
FIG 1.1 Equipment for a Building Survey of a simple low rise structure.

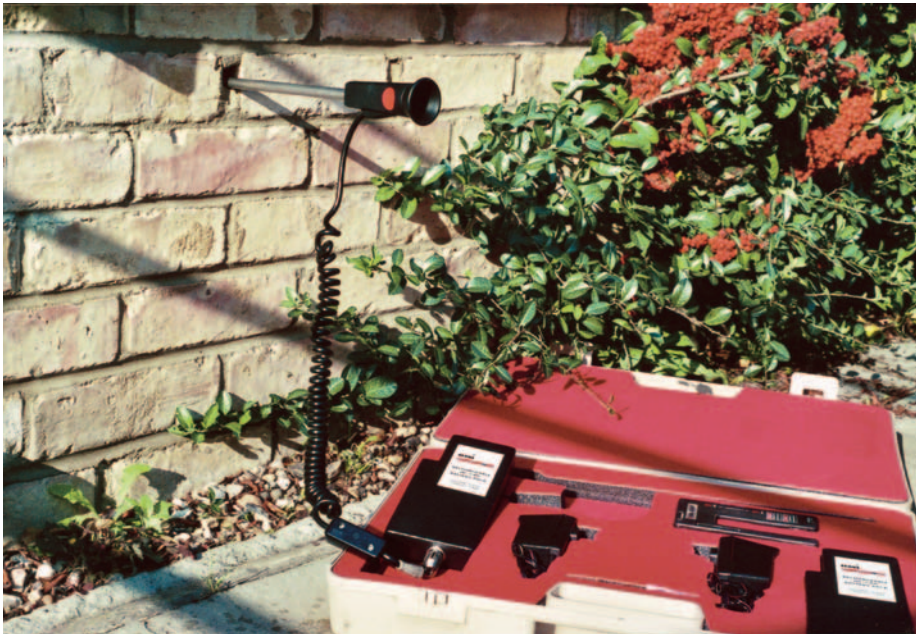
FIG 1.2 Borescope for inspecting inside wall cavities, sub-floor voids and other areas. The wide-angle lens provides good depth of field.

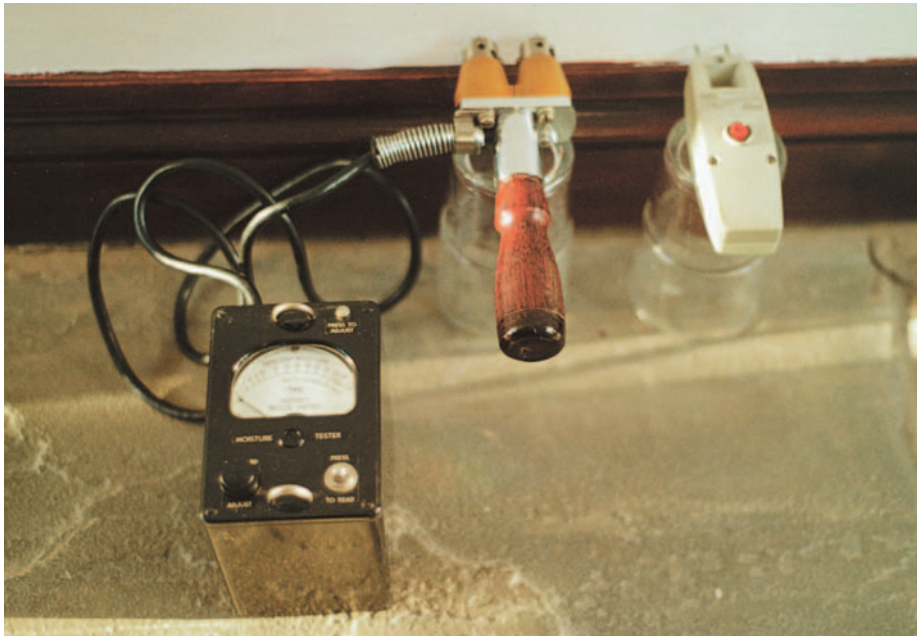
FIG 1.4 Moisture meters are not a new invention. On the left a Weston Moisture Meter manufactured by the Weston Electrical Instrument Corp in the USA in the 1930s. Principally designed to check moisture levels in timber but also having a scale to measure dampness in plaster. On the right an Aquatrace made in England in the 1960s – you press the red button and a flashing light indicates damp. The faster it flashes the damper the wall.

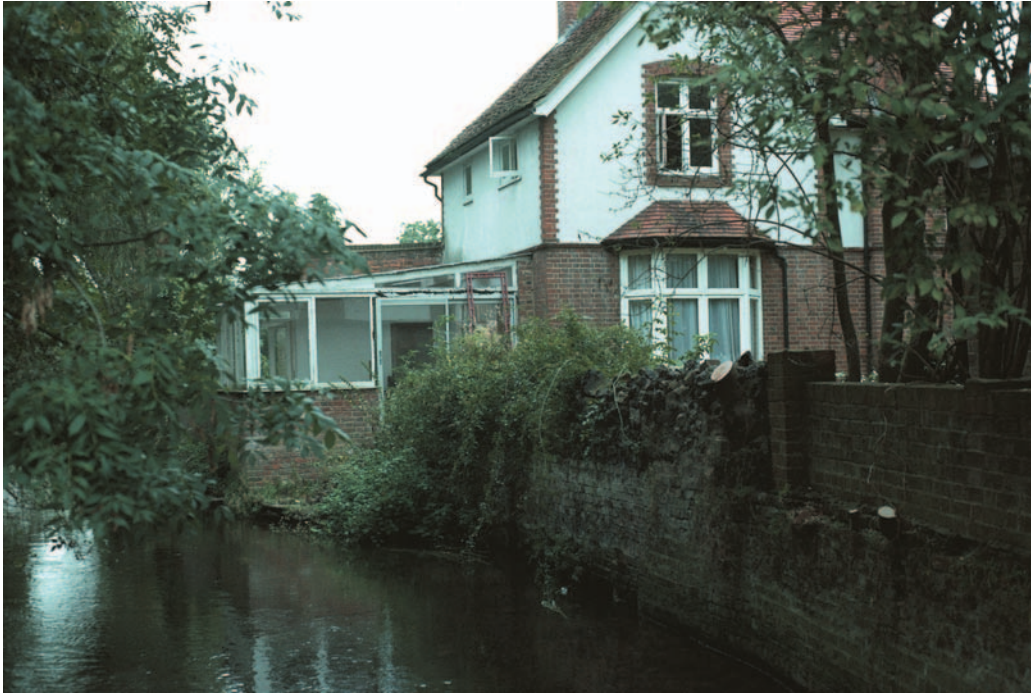
FIG 2.1 This house is built directly on the riverbank. Issues arising include foundations, potential riparian liabilities and flood risk.

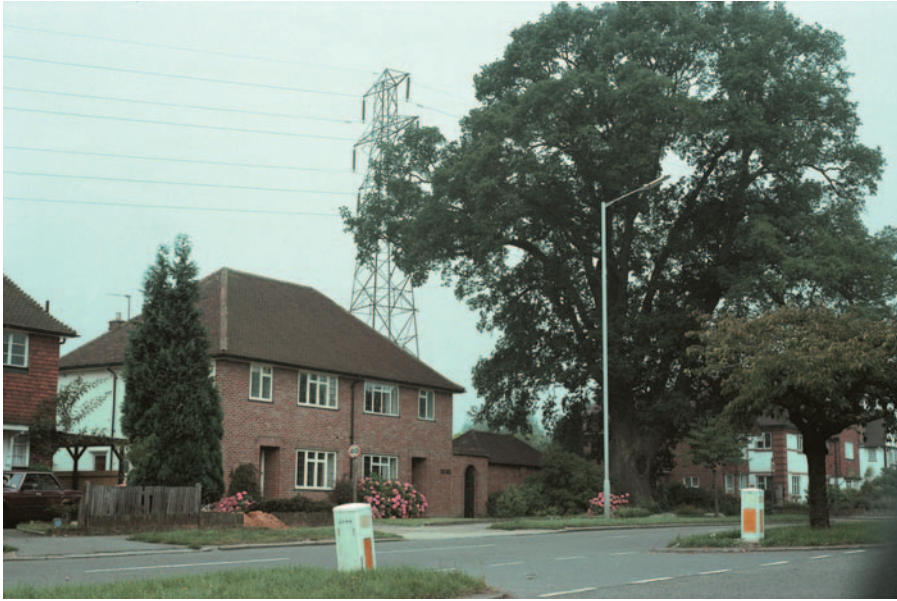
FIG 2.2 The huge oak tree almost touches the garage wing to this house and there are a pylon and overhead power lines close by, both matters to be reflected in the report.

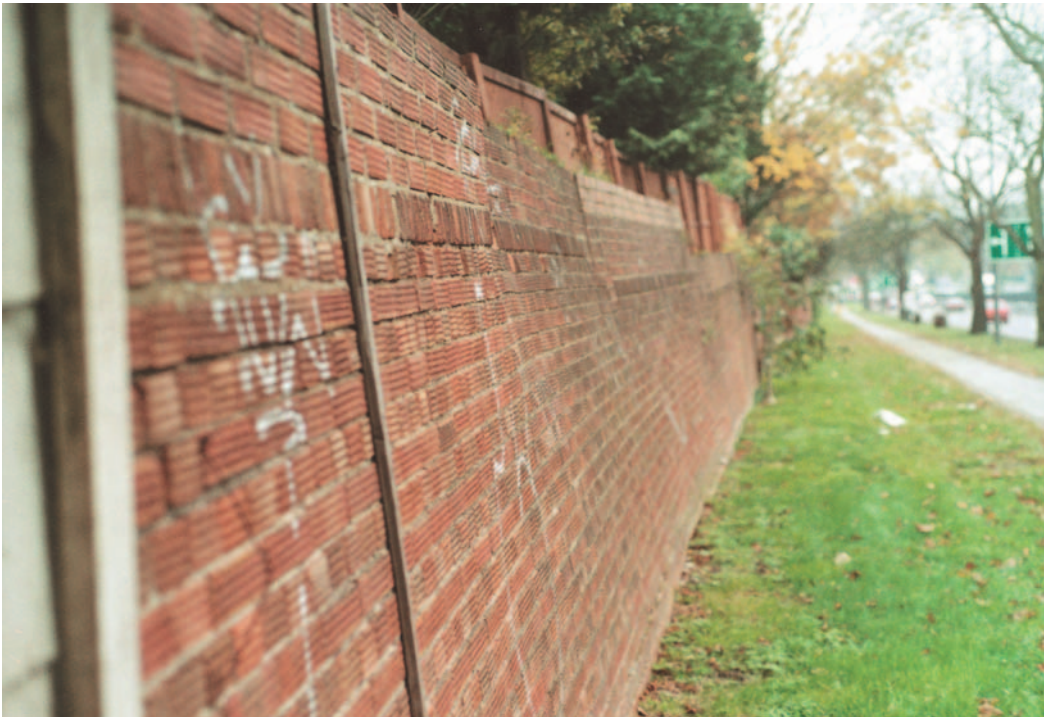
FIG 2.4 If leaning boundary walls have to be rebuilt this can be very expensive.

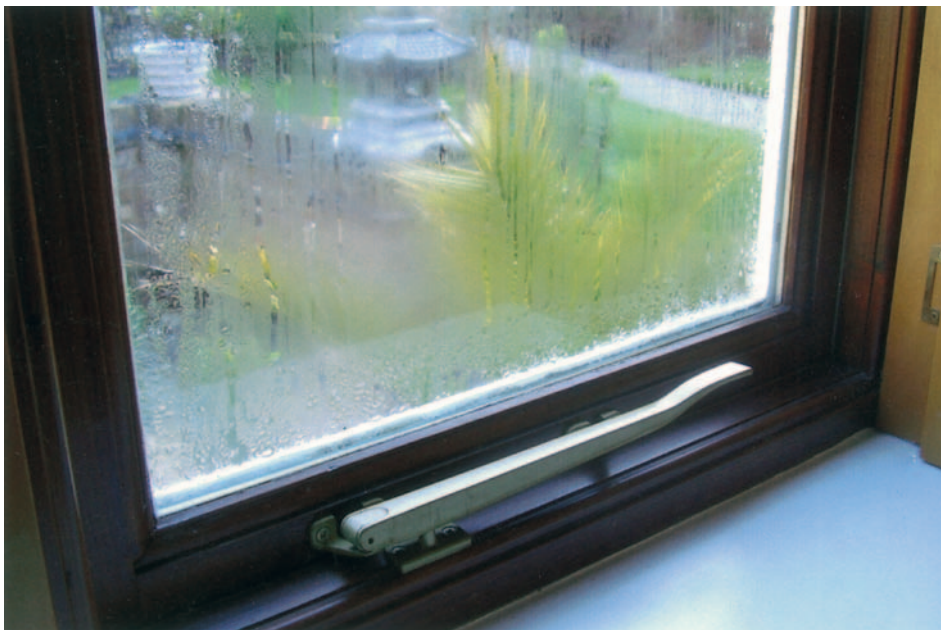
FIG 2.5 Condensation between the glass in double-glazed sealed units generally arises when the windows are between 10 and 20 years old, often (and conveniently for the manufacturers), just after the 10-year guarantee period has run out. The sealed units then have to be replaced. The cost/benefit and payback calculations for double glazing need to reflect the fact that these windows are not maintenance free. During a Building Survey, it is necessary to check any condensation on the glass to see if it is inside, outside or between the panes. If it is between the panes, there is likely to be a developing problem with the windows which could be expensive for the client.

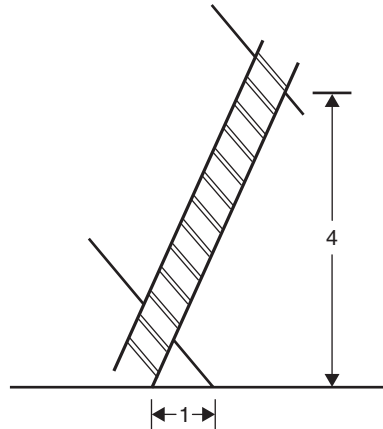
FIG 2.6 During the survey any ladders used must be properly angled and grounded. A 4 to 1 ratio of height to distance is best. Steeper and the user may topple backwards; shallower and the ladder may slide from beneath.

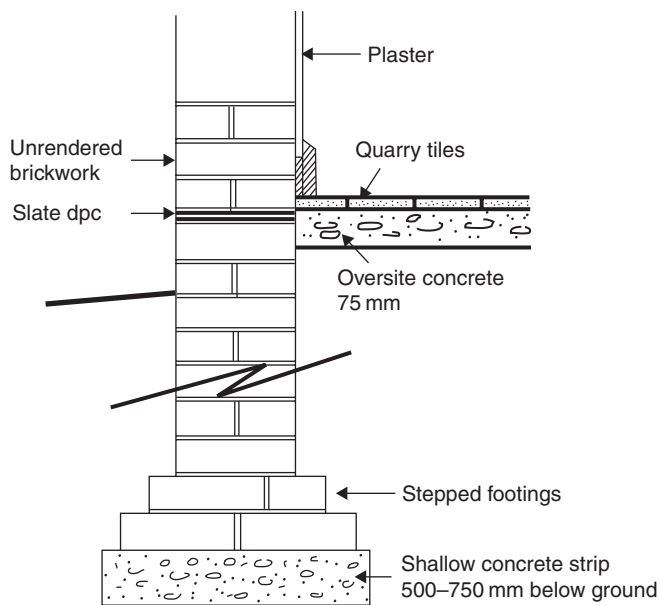
FIG 3.1 Late Victorian foundation, circa 1900.

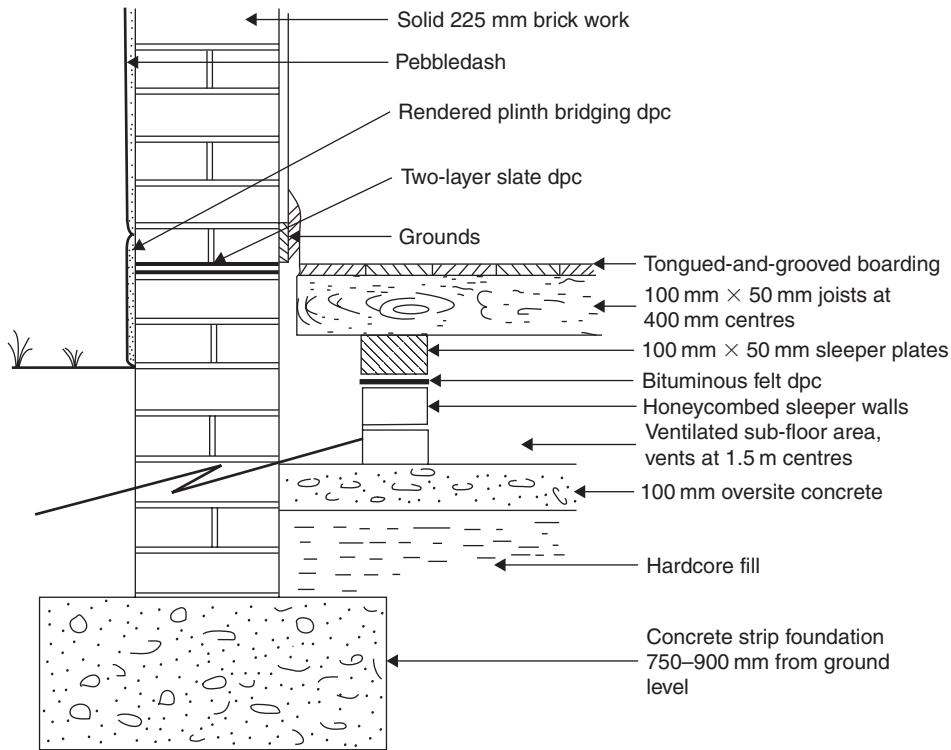
FIG 3.2 Typical 1930 domestic foundation.

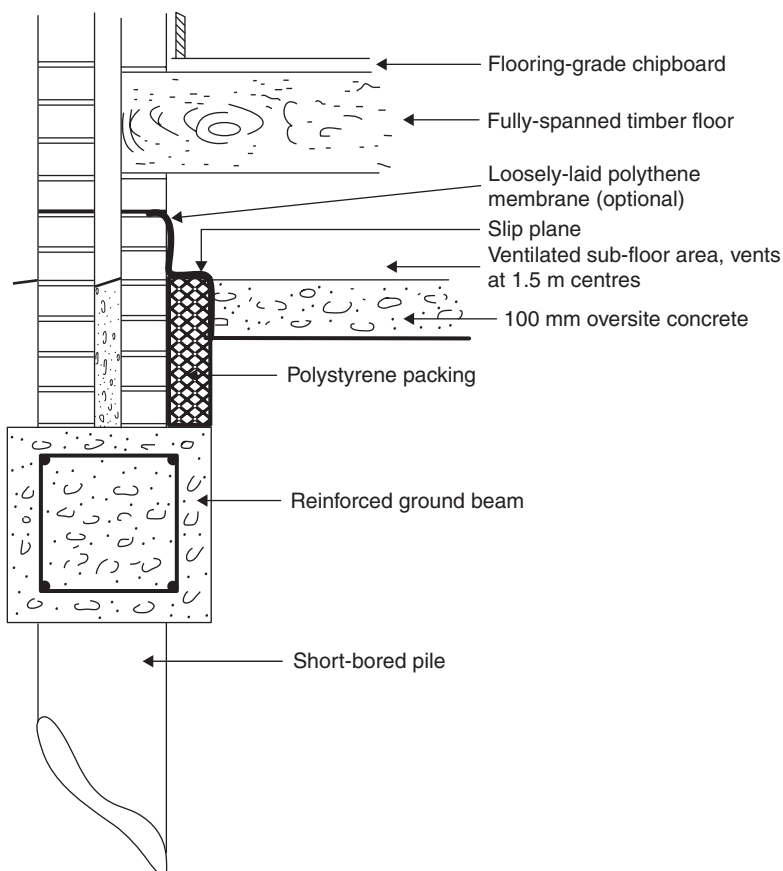
FIG 3.3 Modern short-bored pile foundation for domestic and other buildings. Common 1990 foundation.

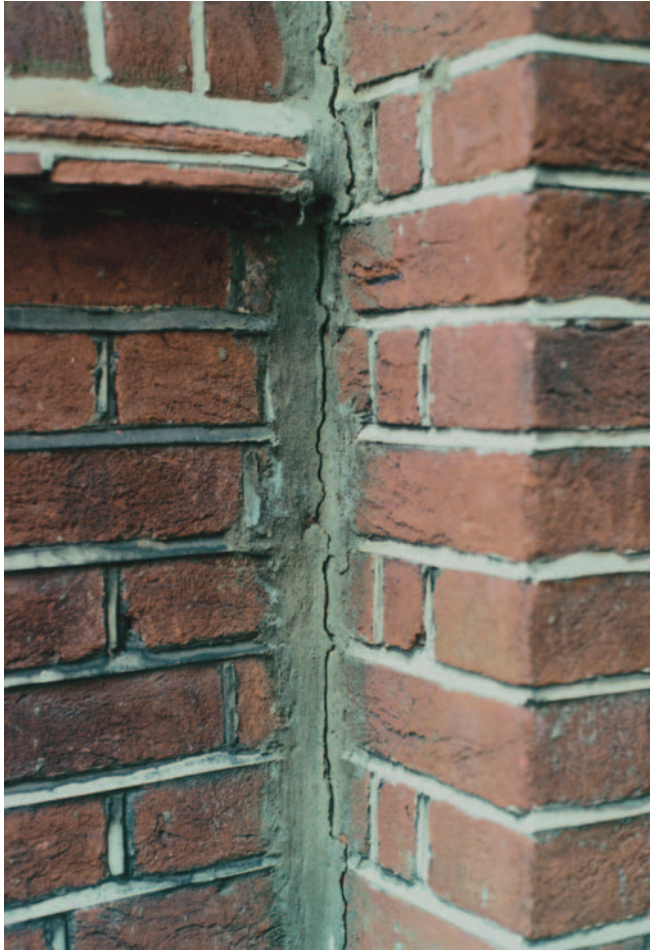
FIG 3.4 This settlement fracture has been poorly repaired and opened up again indicating continuing movement.

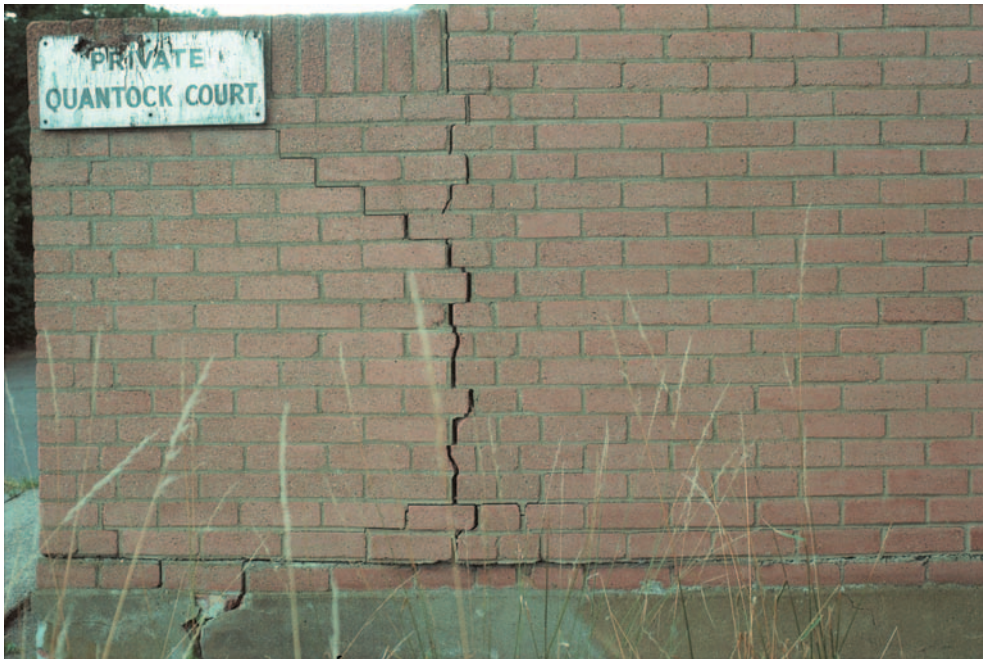
FIG 3.5 A bulge fracture due to compression not related to foundations.

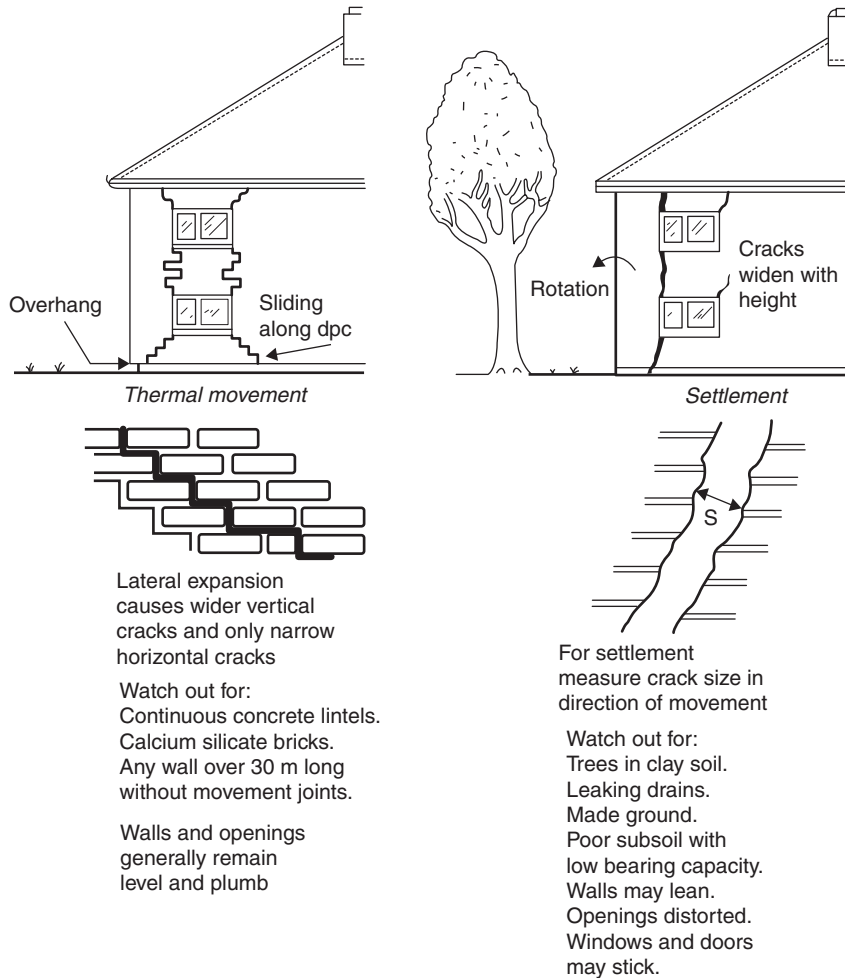
FIG 3.6 Assessing crack damage – 1.

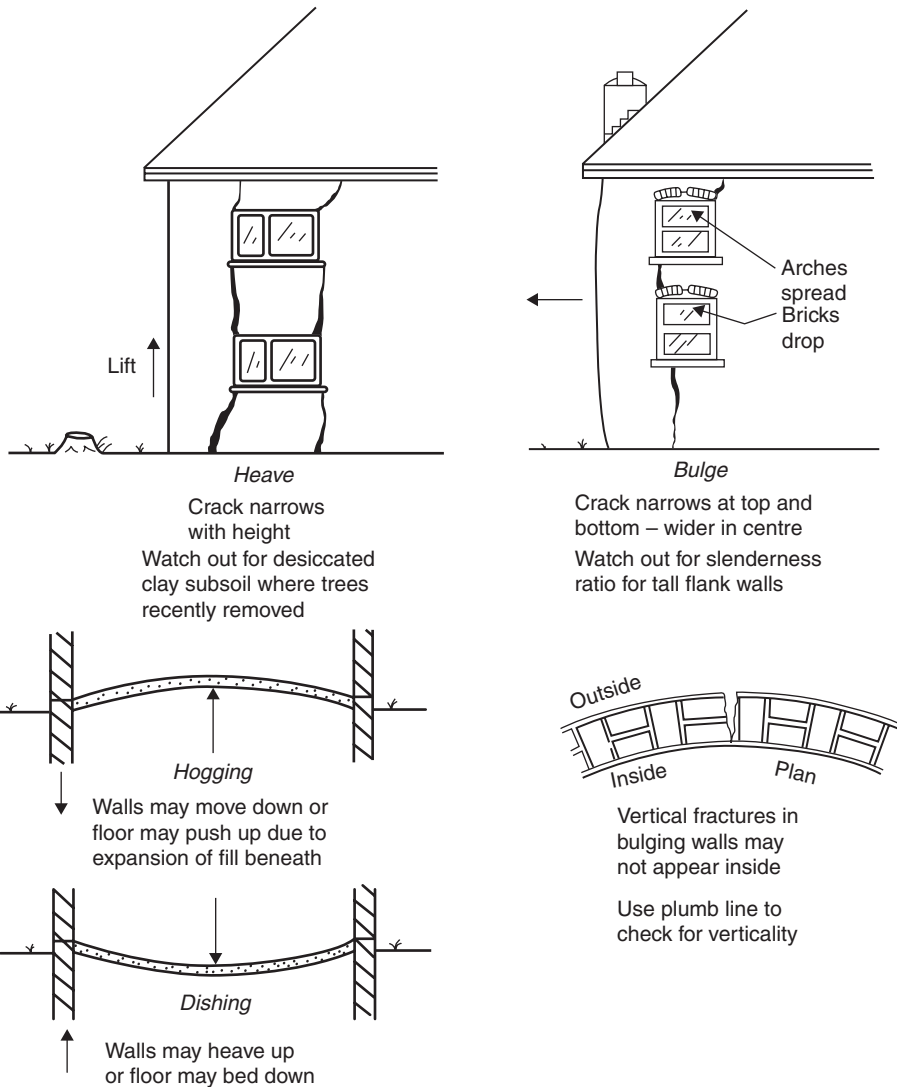
FIG 3.7 Assessing crack damage – 2.

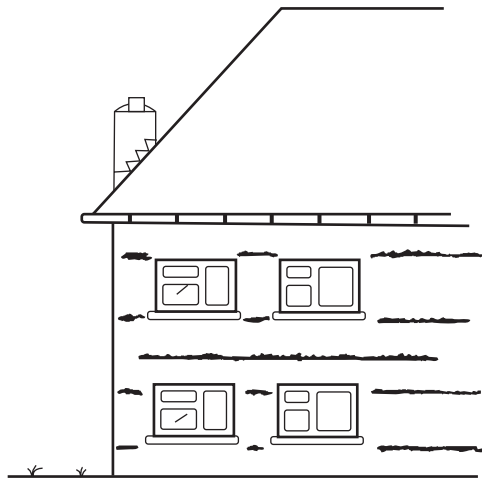
The question of which category in which to place a specific observed area of damage is very much a matter of judgement. A large number of narrow cracks may, in some cases, be more significant than a few larger ones. The recommendations for categorising damage can be no more than a guide, and each property and area of damage has to be

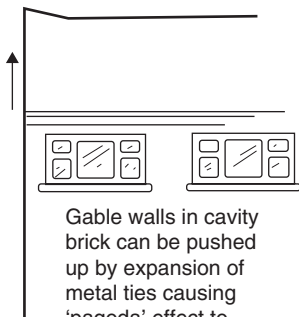
Gable walls in cavity brick can be pushed up by expansion of metal ties causing 'pagoda' effect to verge tiles.

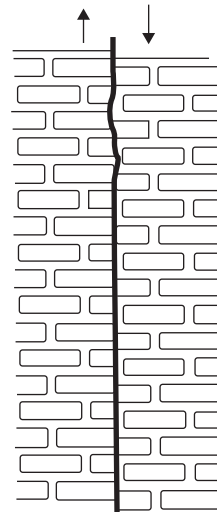
Watch out for:
Slender brick piers, especially at corners and bays taking high loads.
Weak stonework.

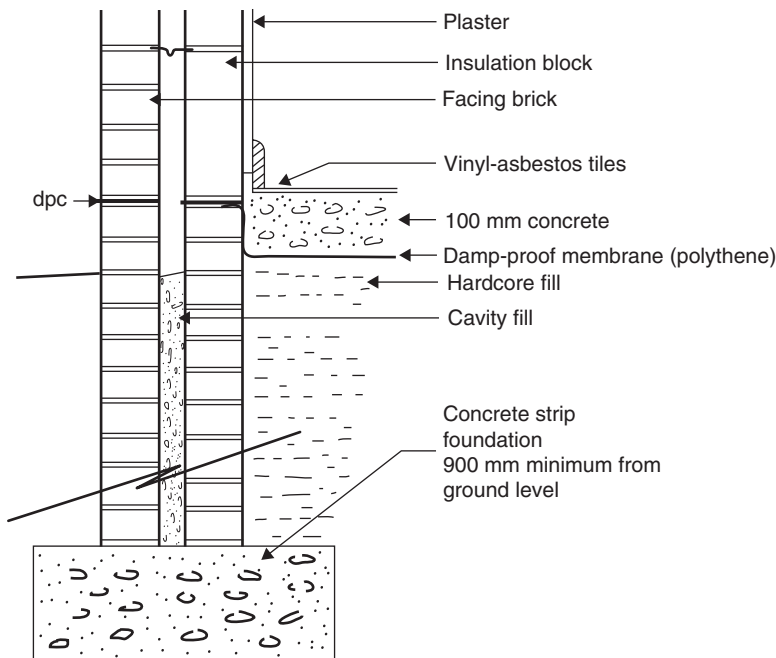
FIG 3.9 Typical 1970 domestic foundation.

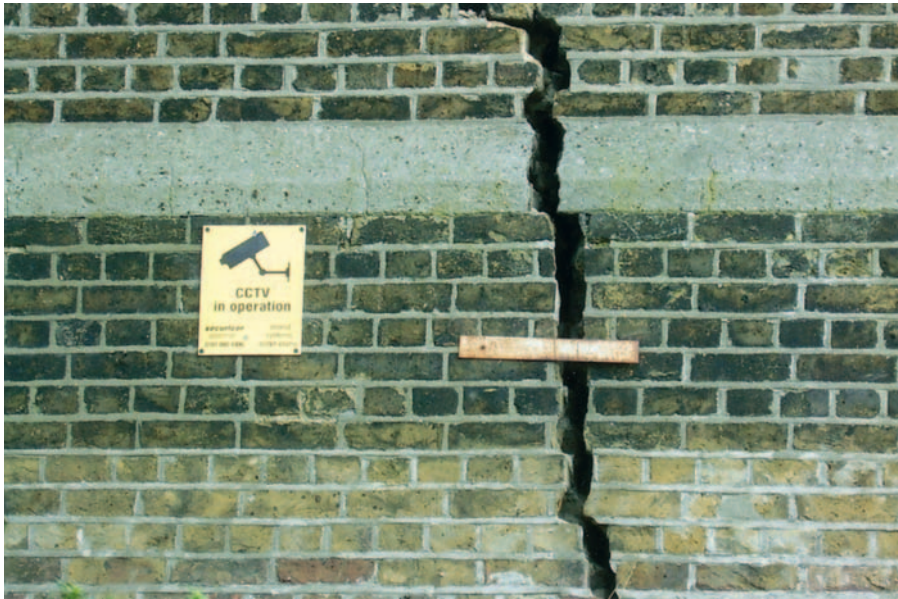
FIG 3.10 London stock brickwork laid in lime mortar to English bond c.1900 and a significant structural fracture which widens to about 75 mm. A crude linear telltale has been fixed over the crack to measure movement. This telltale will indicate the extent of movement over time but it will not tell us which part of the wall is moving relative to the other part, or indeed whether both sections of the wall are moving. A rather more sophisticated method of measurement is needed to confirm precisely what is going on.

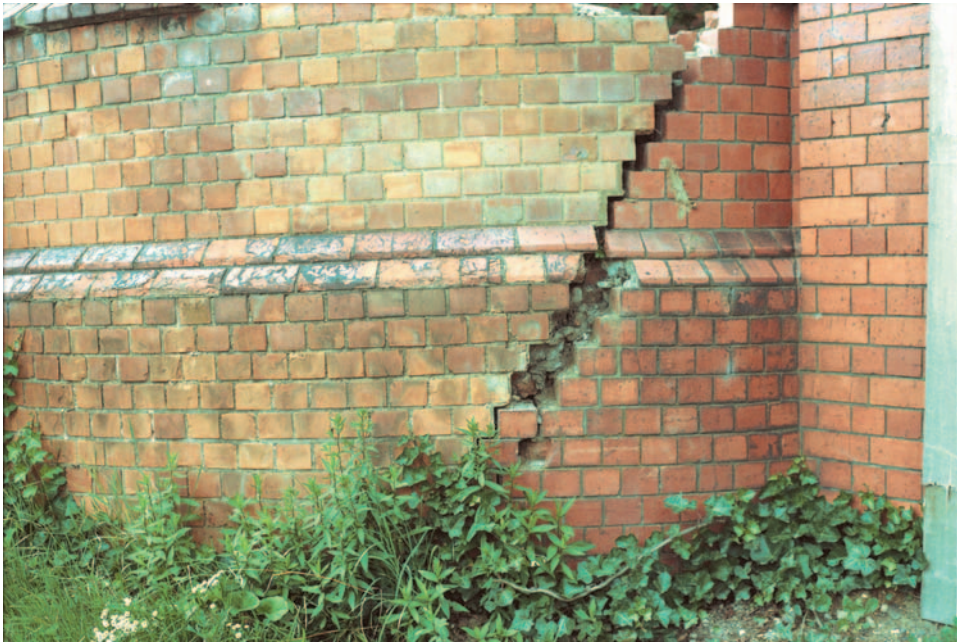
FIG 3.11 Settlement or subsidence. The crack widens with height.

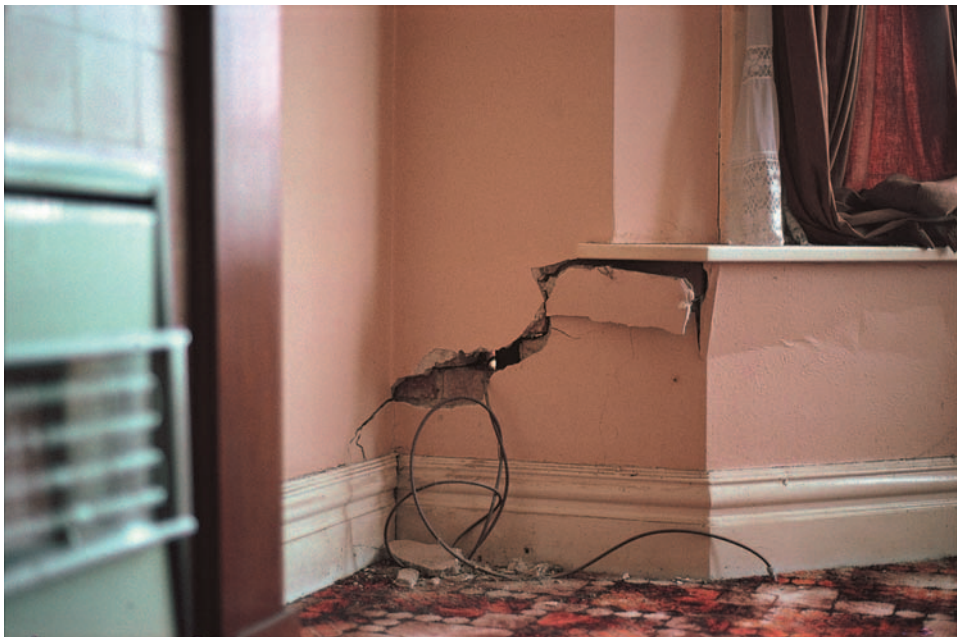
FIG 3.12 Subsidence damage inside house.

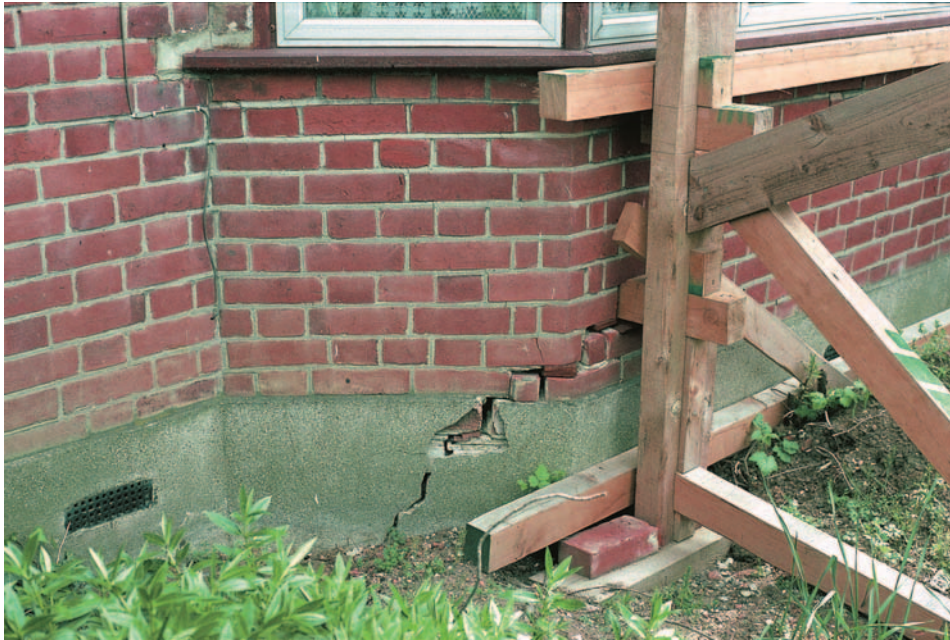
FIG 3.13 Subsidence damage outside house.

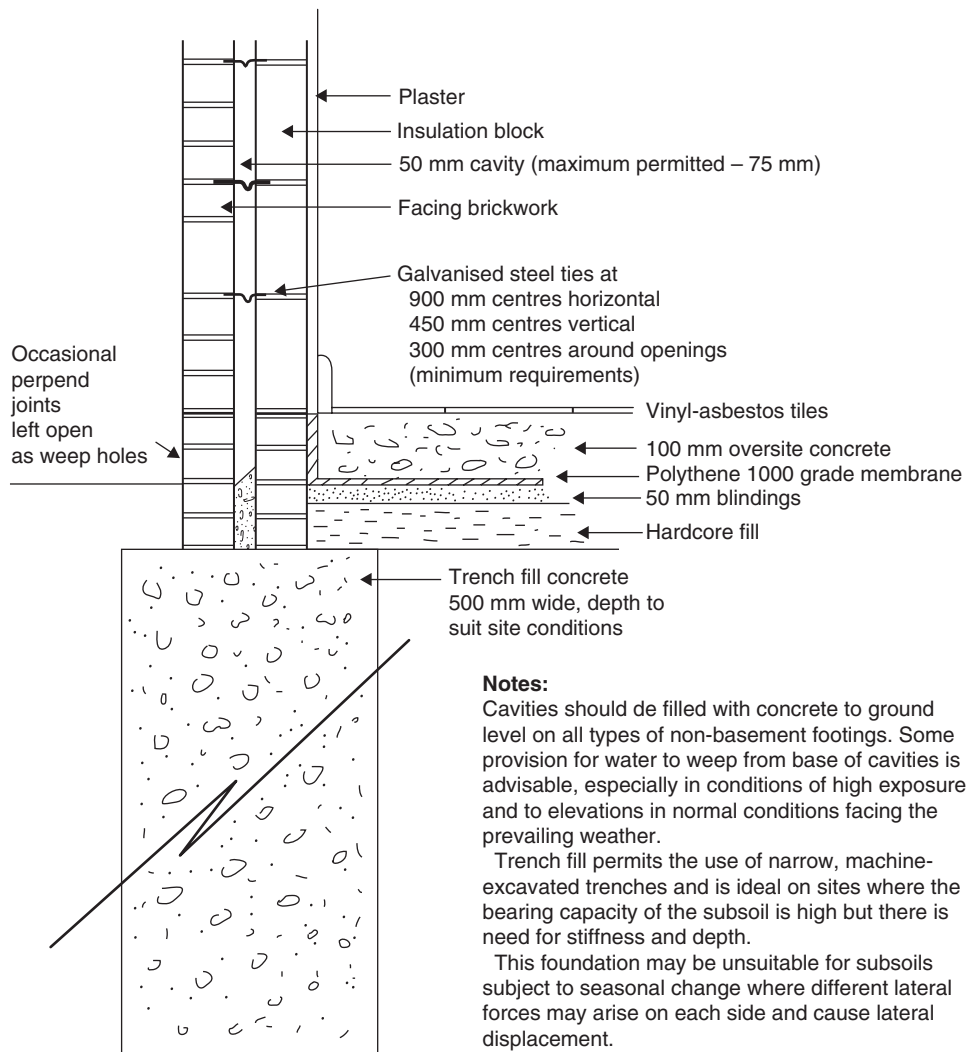
FIG 3.14 Modern deep strip or trench-fill foundation.

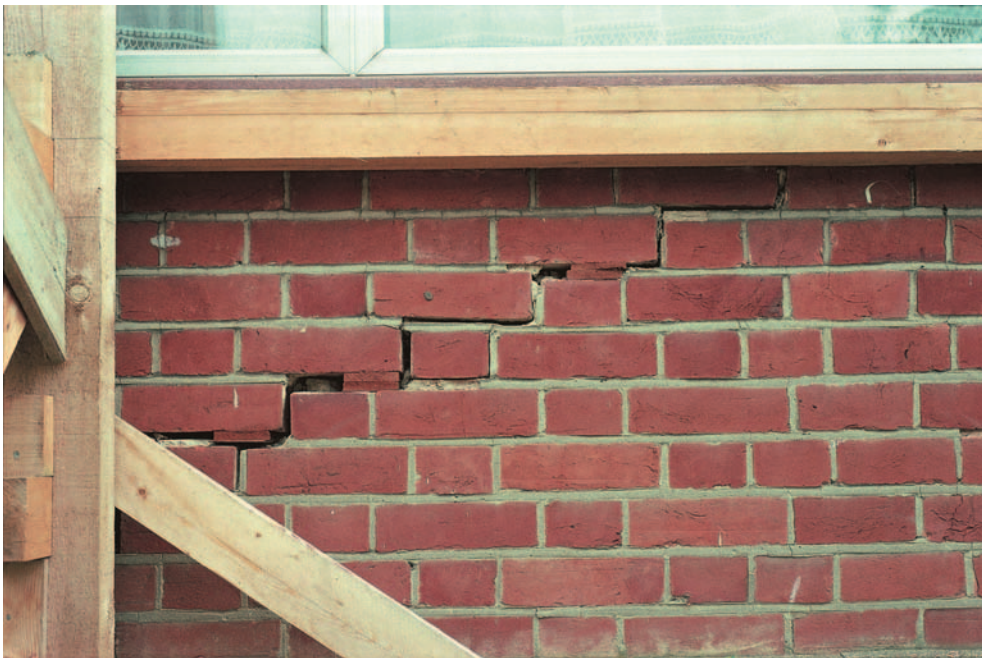
FIG 3.15 Subsidence has affected the lower part of this wall. As a temporary measure raking shores have been placed against the wall and hardwood wedges driven into the open bed joints to prevent further movement of the construction above.

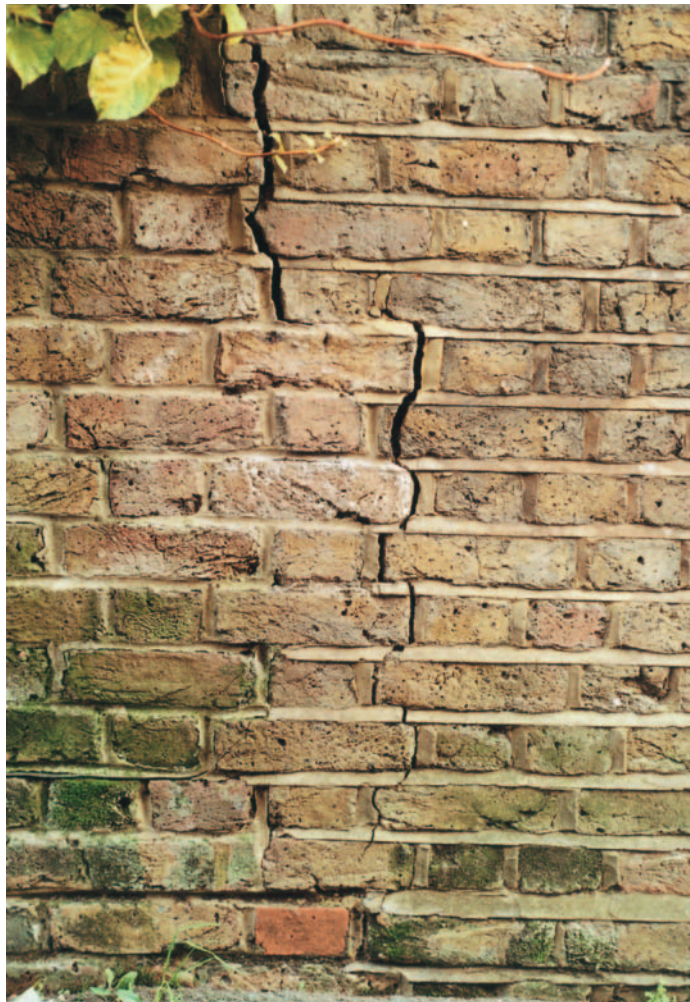
FIG 3.16 Settlement or subsidence again with the crack widening with height.

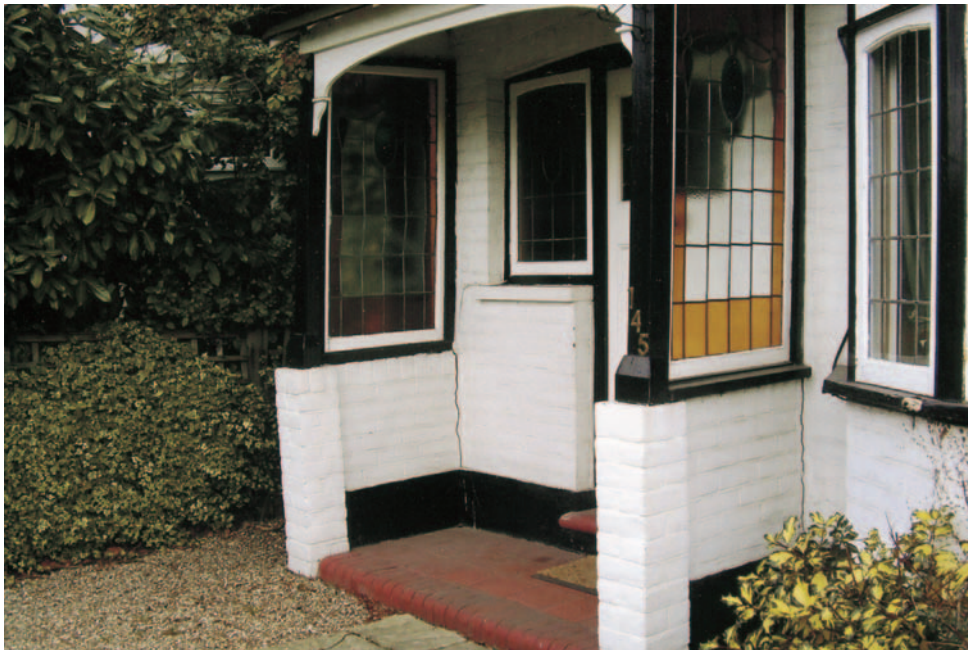
FIG 3.17 Builders will often use a very shallow foundation for a porch thinking that because the weight is low they do not need to excavate as deeply as for the main house; this is not so and the porch in this case will need to be rebuilt on deeper footings.

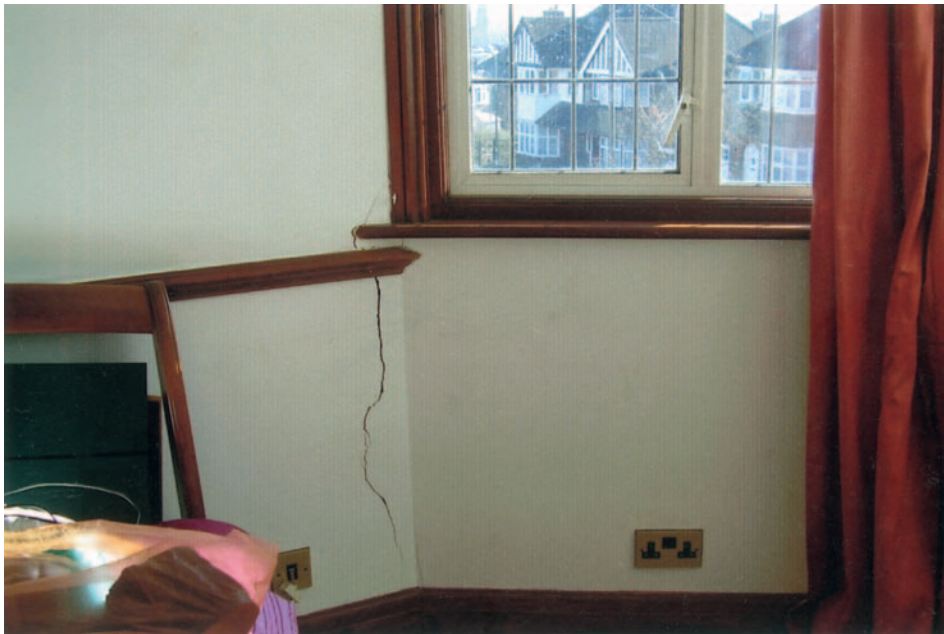
FIG 4.1 A number of problems may be found when sealed unit double glazing is installed in existing buildings. Condensation between the glass in sealed units is very common necessitating replacement of the glass. When double glazing is installed in bay windows, it is important to check whether the construction above is fully cantilevered or whether the ground floor window frames support the window, wall and gable above. In this case the bedroom bay is cracking and pulling out because the support provided by the original, more substantial, window frame below has been removed.

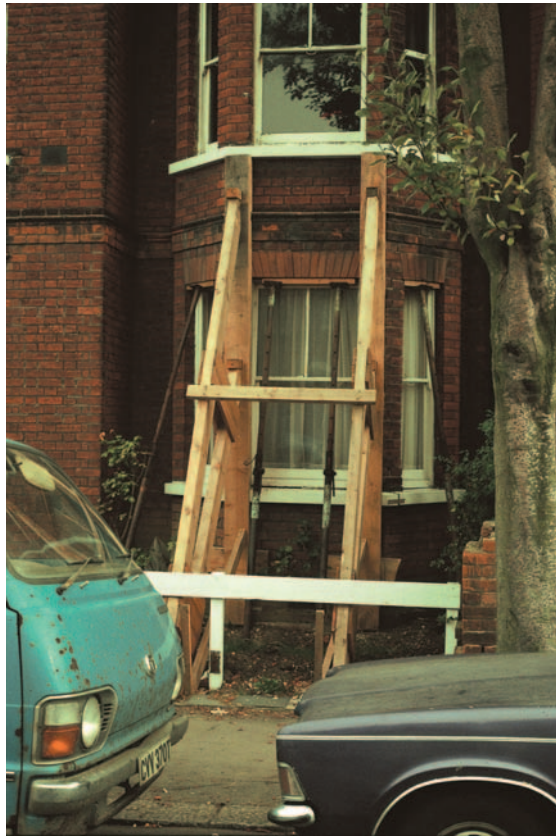
FIG 4.2 Raking shores used to support bay suffering from subsidence pending repair. Note the tree.

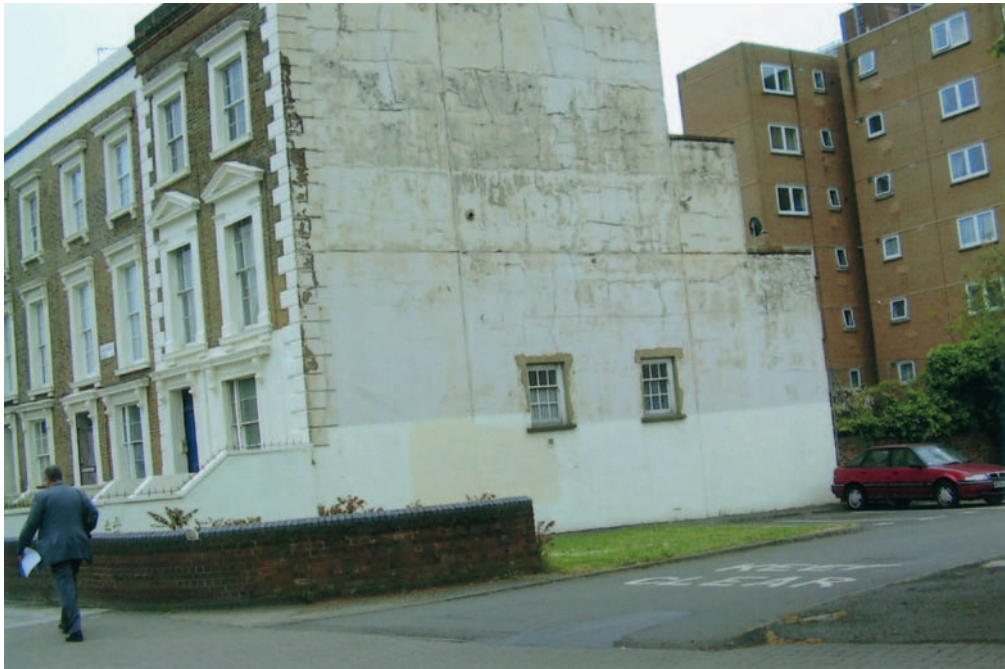
FIG 4.3 Stucco render has been applied to the flank wall of this London terrace. Poor preparation of the wall behind with inadequate keying, trapped moisture and the wrong mix, badly applied, combine to produce this unfortunate result. The builders need to hack it all off back to the brickwork and then start again. Many of these flank walls in London have resulted from Second World War bomb damage, so that part of a terrace has been demolished and something has to be done to weather-proof the exposed wall.

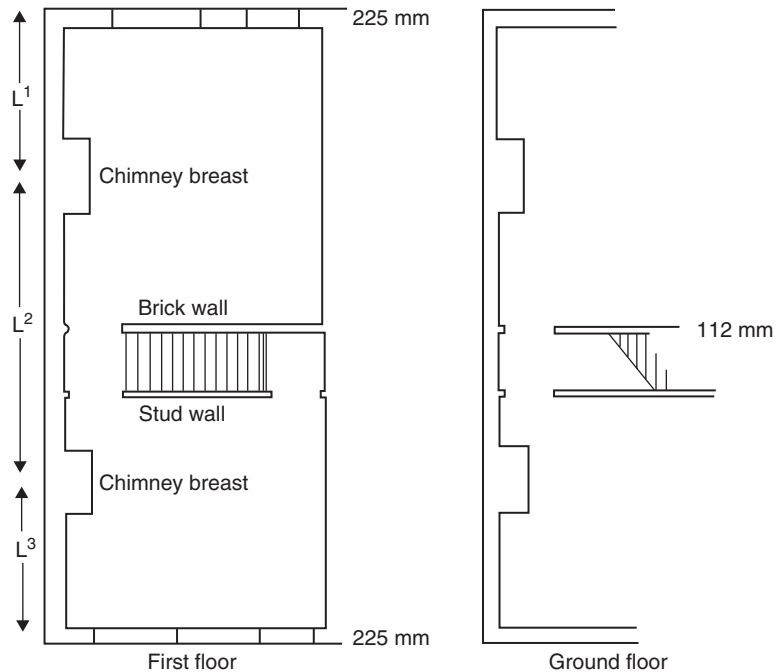
FIG 4.4 Ground and first floor plans of end-of-terrace Victorian cottage.

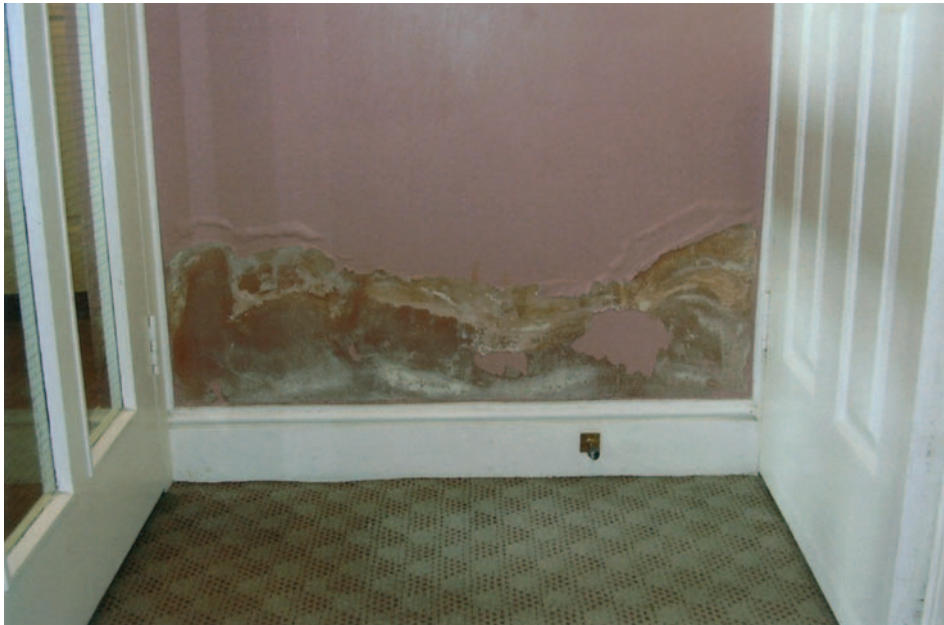
FIG 4.5 Rising damp due to failure of the damp-proof courses will result not only in high readings from a moisture meter but also invisible deterioration to the plaster and decorations. If you cannot see it then it is probably not rising damp. Obviously, there is a problem here which will require investigation, treatment and replastering using a special plaster mix. The condition of any adjacent areas will also need to be checked, especially any timber floors.

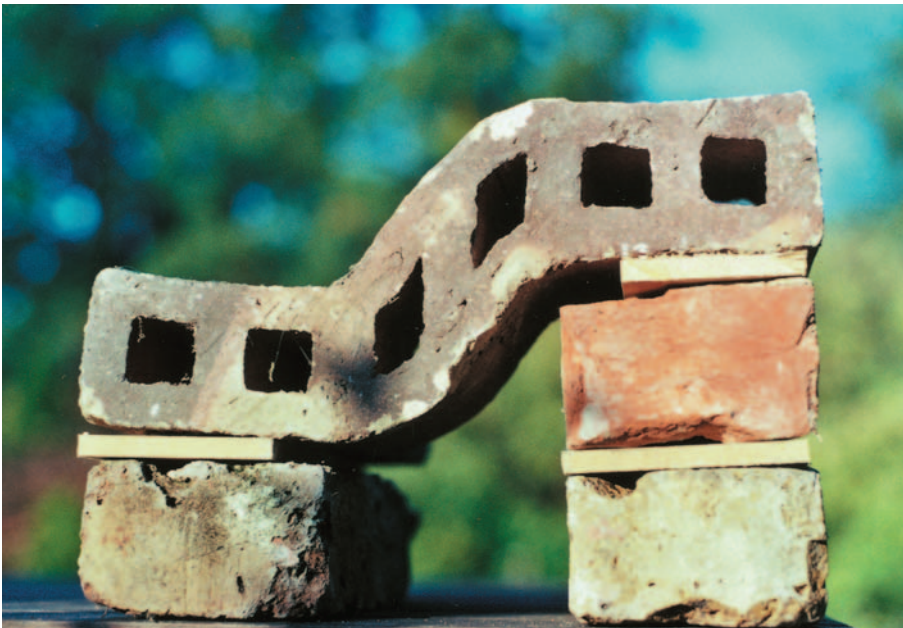
FIG 4.6 The Victorians used special-shaped bricks as wall ties in their cavity walls.

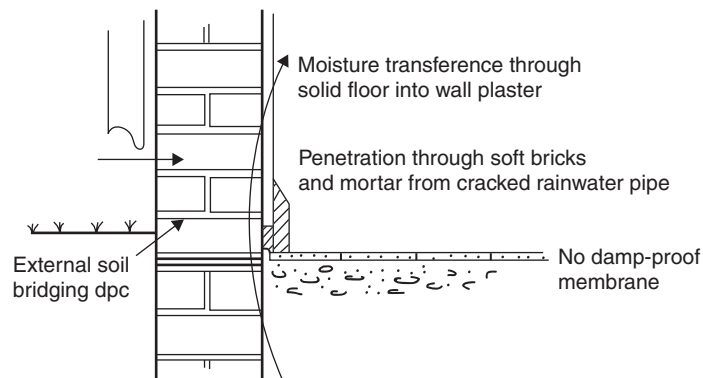
FIG 4.7 Bridging of slate damp-proof course in unrendered, solid brick wall.

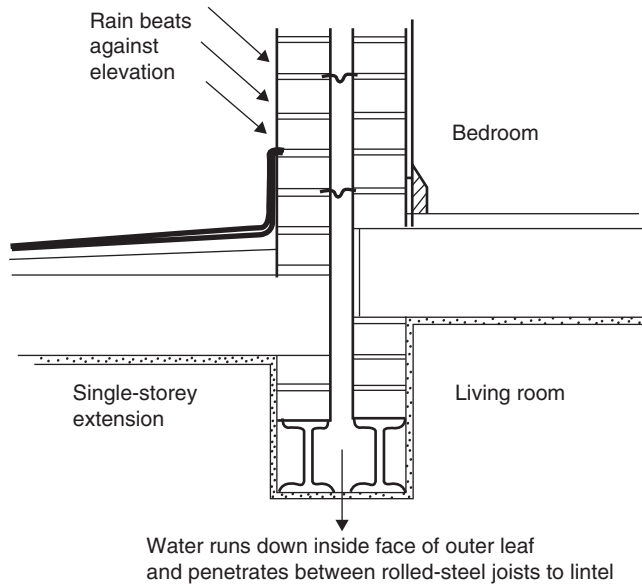
FIG 4.8 Lack of damp-proof cavity tray to cavity wall over opening for living-room extension.

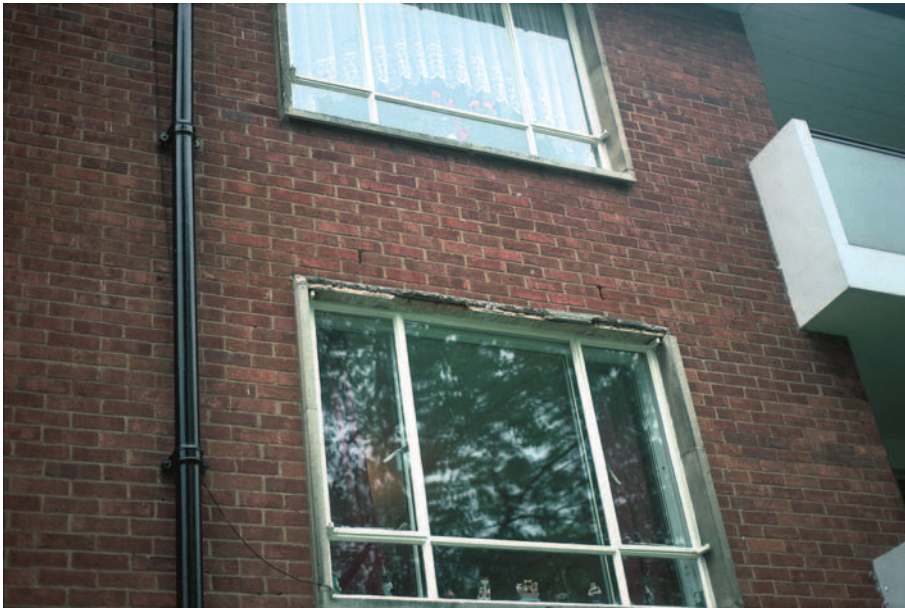
FIG 4.9 Inadequate cover for steel reinforcement in concrete lintel. Rust can take up to seven times the space of the steel it replaces causing bursting to the concrete surface.

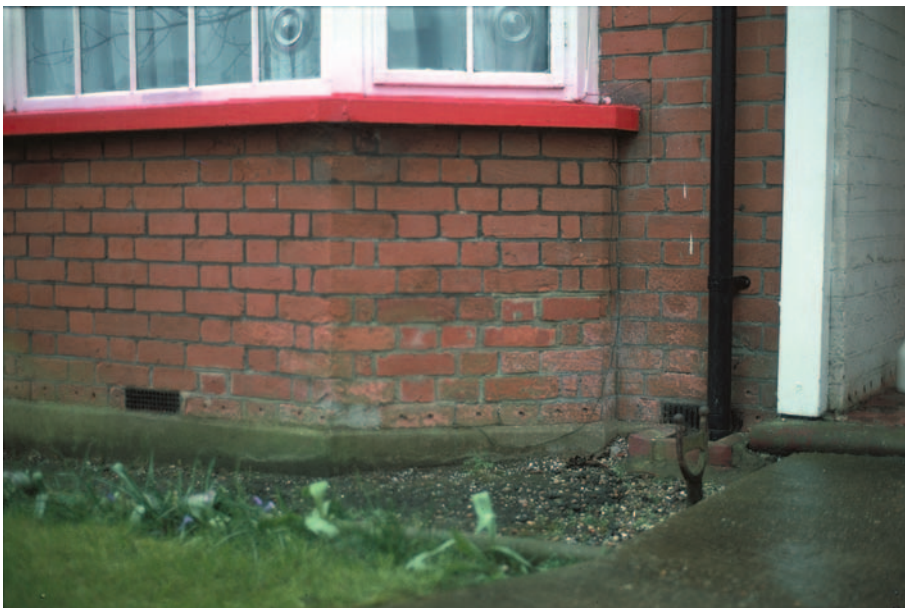
FIG 4.10 Drill holes at the base of the wall indicate that a chemical injection damp-proof course has been added.
