SEVENTH EDITION

BUILDING SURVEYS

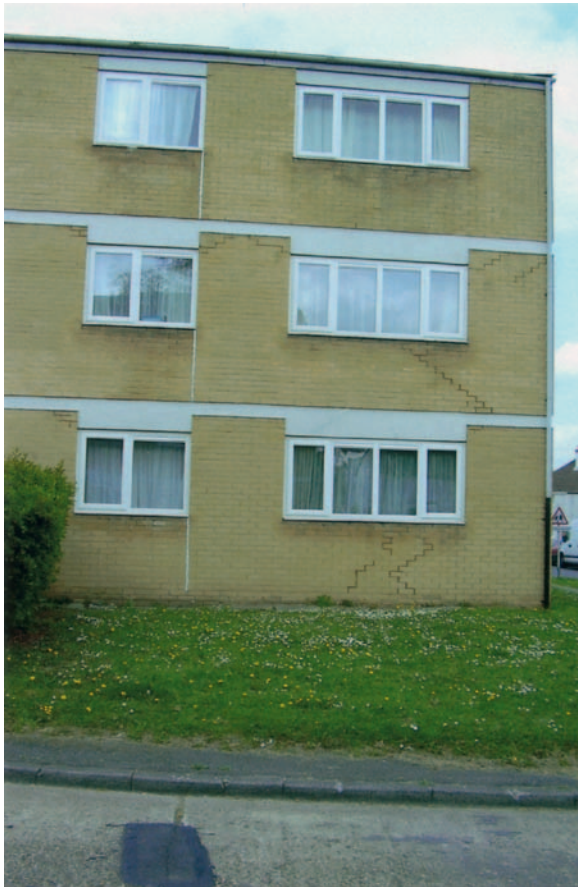
FIG 4.11 These cracks are not related to foundation movements. They are due to differing rates of thermal expansion and contraction between the concrete beamwork and the outer skin to this cavity wall. The cracks have been pointed in a poorly matched mortar, and a vertical sealed movement joint has been added, finished in a white mastic, to accommodate future movement. Potential purchasers may be alarmed by these cracks but in structural terms they are nothing to worry about – they just give the wall a poor appearance. Similar cracking to the plastered blockwork inner skin may present a decorative problem however.

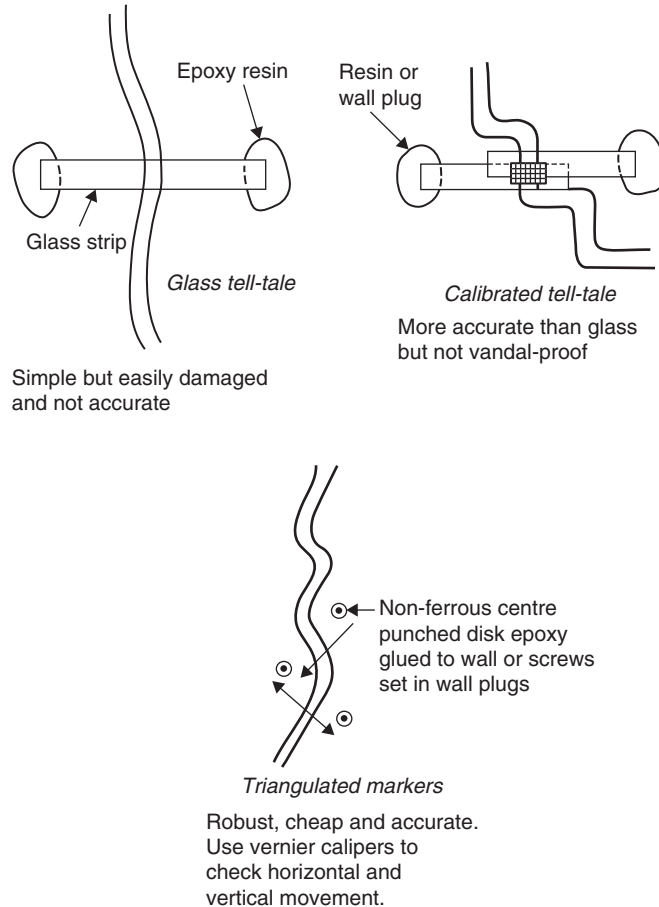
One feature of crack damage occasionally encountered in Victorian and Edwardian construction of a cheaper type is that some solid walls were built without crossbonding and snapped headers used to the outer face, such walls having the appearance of 225-mm solid brickwork but, in fact, comprising two skins of 112-mm brick with a continuous lime mortar joint rising vertically in the centre. Curious crack patterns, and leaning and bulging of such walls may be found showing different patterns to inner and outer faces. This construction was used to minimise cost by saving all facing bricks for outside and in practice may be found to develop instability with age, especially where tall gable-ends are concerned.

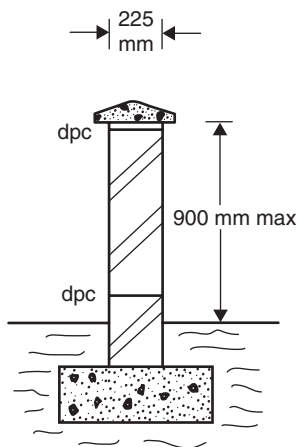
FIG 4.14 Freestanding wall construction. Throated weathering projecting at least 45 mm, plus damp-proof courses at top and bottom, allow ordinary-quality brickwork to be used for normal exposure conditions, but special-quality bricks are necessary for footings below damp-proof course, (dpc).

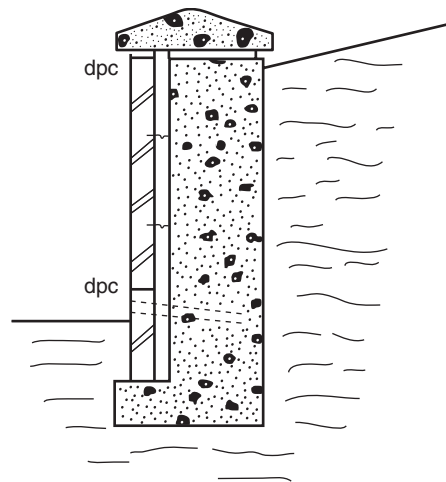
FIG 4.15 Mass concrete retaining wall with brick face.

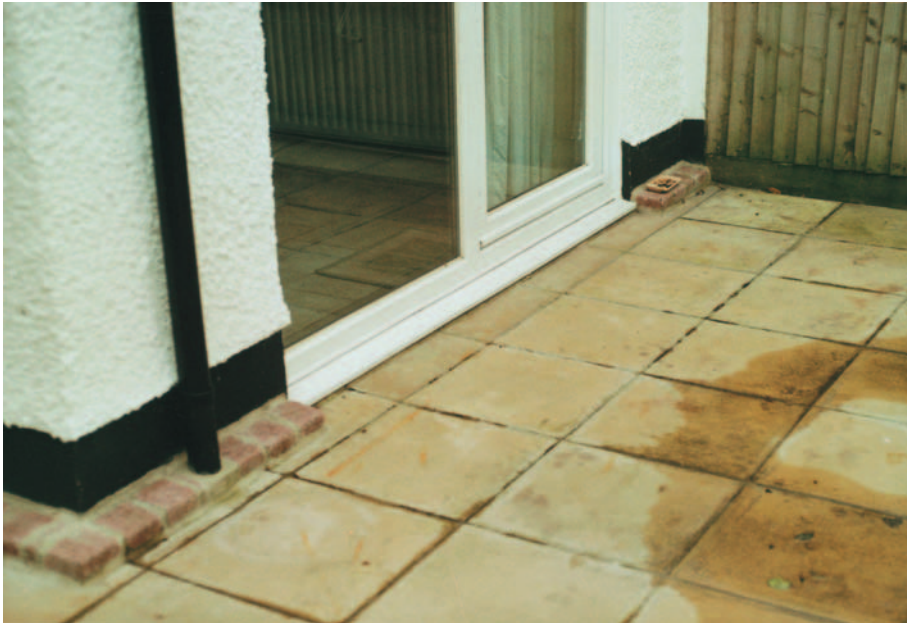
FIG 4.17 The paving is too high. It should be lowered to at least 150 mm (2 brick courses) below the damp-proof course or internal floor level whichever is the lower, with a slope away from the wall.

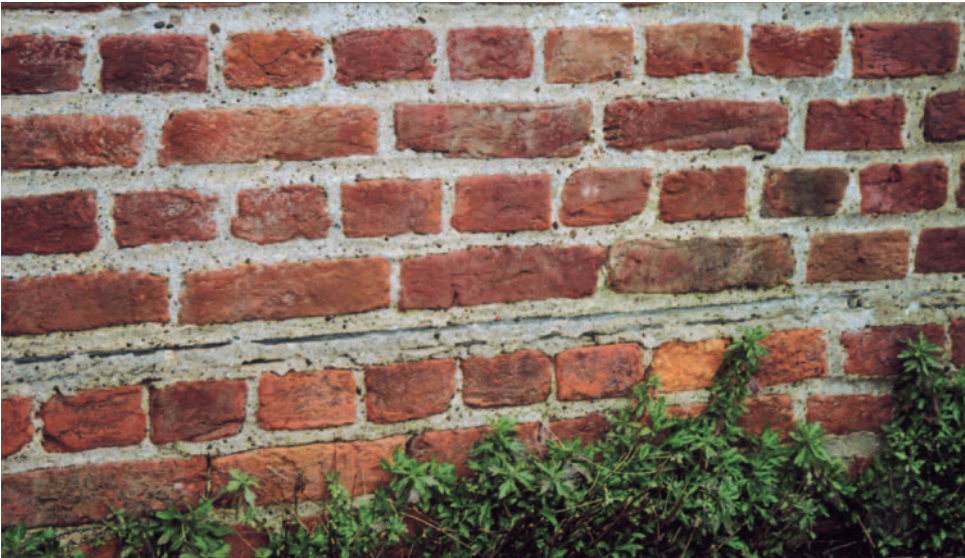
FIG 4.18 Hand-made red facing bricks set in lime mortar to English Bond with a two-course slate damp-proof course. Good ground clearance below the damp-proof course.

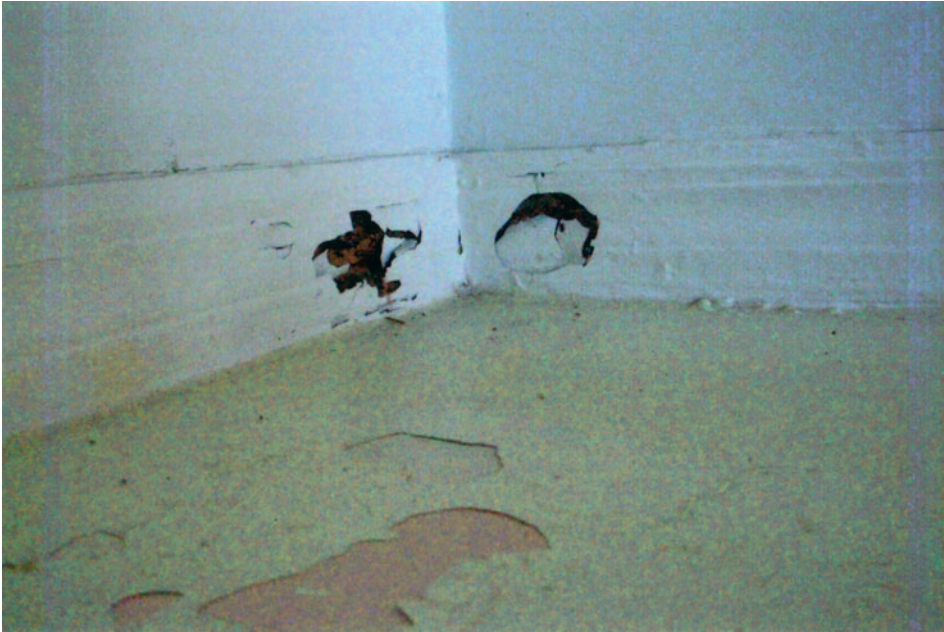
FIG 5.1 A solid concrete floor and masonry walls. The damp-proof membrane in the floor is not contiguous with the damp-proof course in the walls, allowing dampness to rise up behind the skirting boards resulting in rot. Look out for rusting nail heads showing through skirting board paintwork – a sure sign of dampness behind. Fortunately, in this case there is no adjacent timberwork, so the remedy is to deal with the damp and replace the skirtings. If this were a timber floor then more extensive investigation would be needed to establish how far the rot had travelled beneath and whether the true dry rot fungus – *Serpula lacrymans* – may be active.

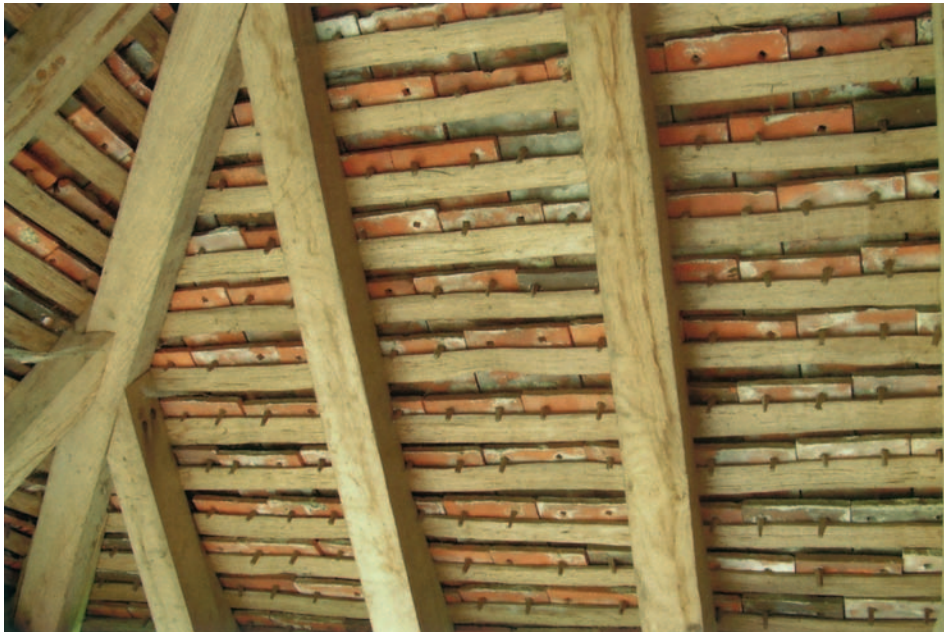
FIG 6.1 Double lap plain clay tiles held in place using traditional wooden pegs on battens with no underfelt. Pegs may rot or shrink causing them to fall out – as has happened to some here – then tiles slip. Tiles can be replaced and, if there is no underfelt, new pegs inserted from beneath, although then the pegs will taper the wrong way and need to be pinned to the battens. This type of tile was gradually superseded in the 19th century by plain tiles with nibs to hold the tiles on the battens. These plain tiles with nibs remain very popular today in both traditional clay and modern concrete form and incorporate nail holes just below the nibs so that they can also be nailed to the battens for an even more secure fixing.

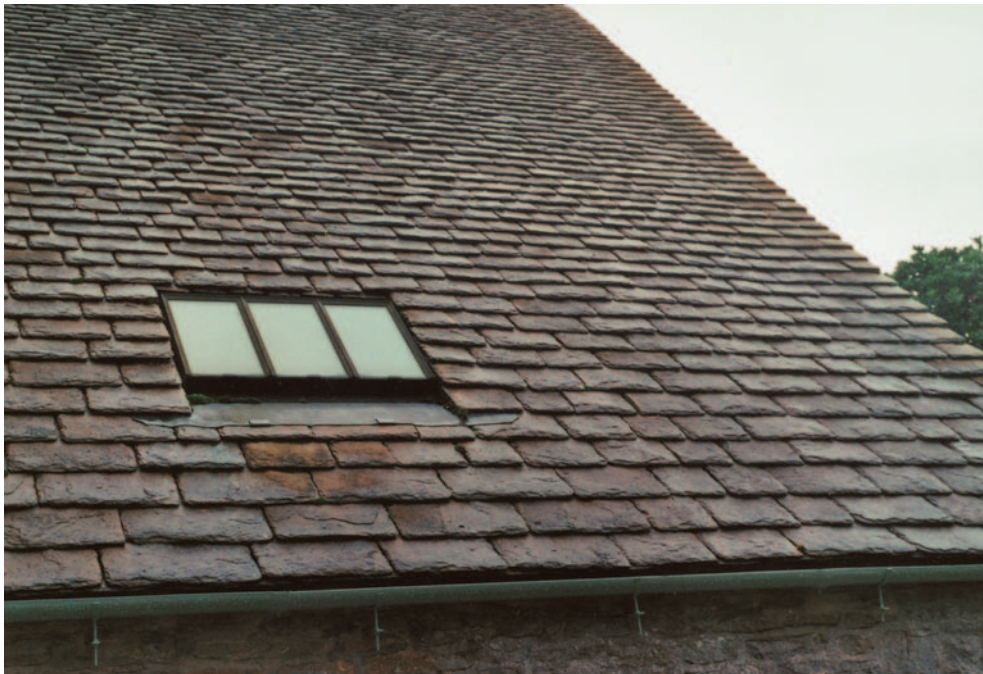
FIG 6.2 Cotswold stone roof with skylight and lead apron. Careful attention to detail is needed if leakage around skylights is to be avoided.

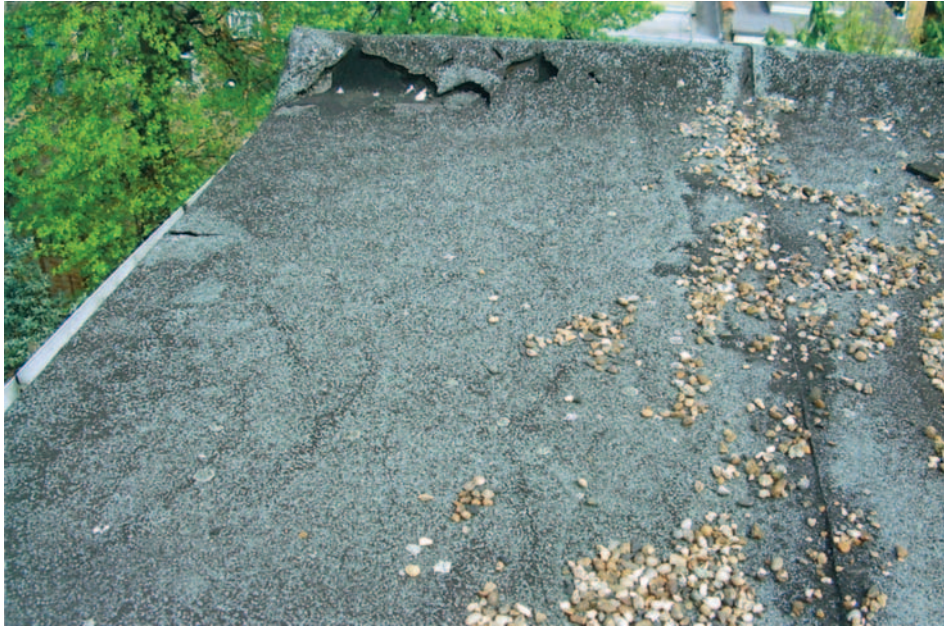
FIG 6.3 A flat roof surfaced in three layers of built-up mineral felt to British Standard 747. Typical life expectancy is less than 10 years. A number of important matters cannot be confirmed without exposure including the condition of timbers, insulation, ventilation under the decking and the presence or otherwise of a vapour barrier. Take care when walking on one of these roofs – the decking may be rotten, and collapse is possible. Watch out for holes cut in the ceiling beneath for downlights, or similar; these can provide a mechanism for warm damp air from the interior to pass into the roof void condensing on timbers and causing premature flat roof failure.

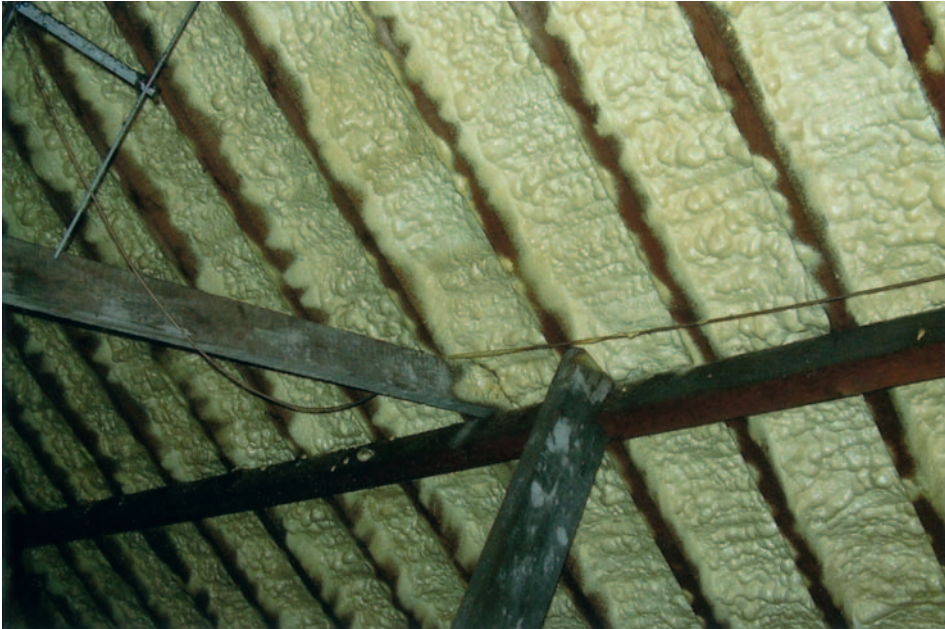
FIG 6.4 Homeowners will sometimes be encouraged by a salesman to have sprayed foam insulation applied from within the roofspace under the tiles and battens between the rafters. I do not recommend this as the timbers cannot breathe, and if they become damp, rotten battens and rafters may result. A roof needing this type of treatment is probably due for recovering with tiles, battens and sarking felt, incorporating ventilation. The best place for insulation is directly over the ceilings between the joists.

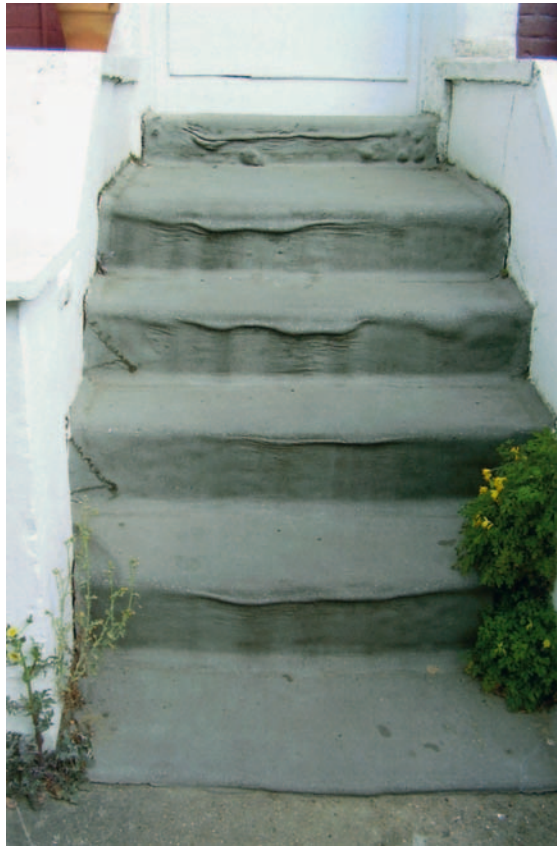
FIG 6.5 Asphalt is used for flat roof covering, basement tanking and as a waterproof surface coating to steps if there are vaults or other accommodation beneath. Vapour blowing and creep can be a problem. Creep to the asphalt on these south-facing steps results from poor preparation and application of the asphalt exacerbated by trapped moisture and exposure to the full heat of the sun.

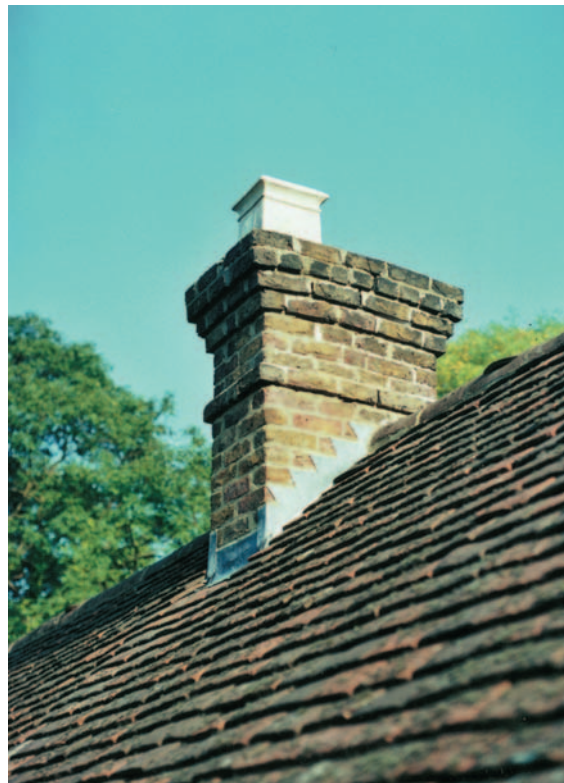
FIG 6.6 Traditional lead flashings are fixed by plumbers, not roofing contractors, this being part of the plumber's trade.

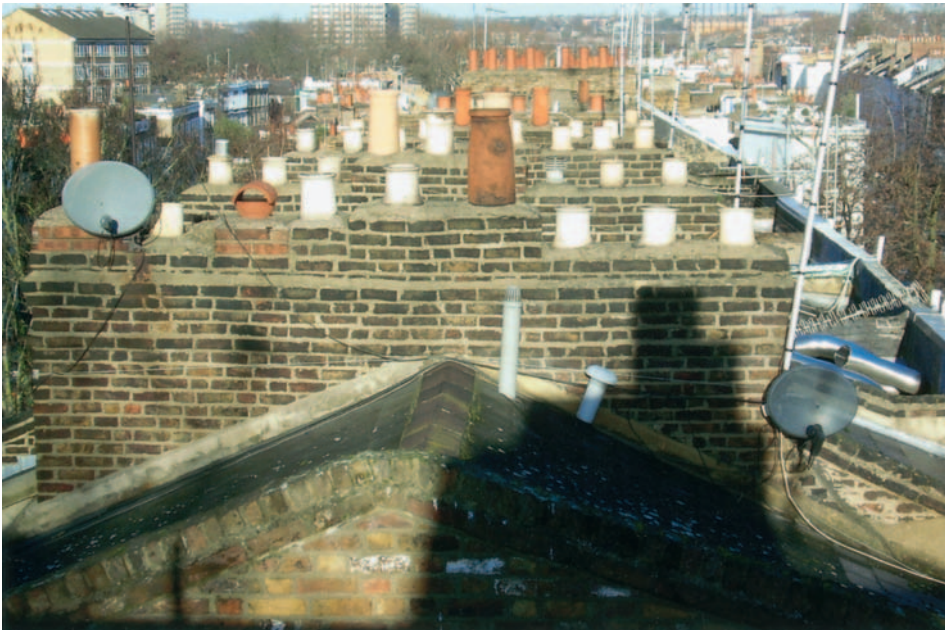
FIG 6.7 In Victorian London almost every room had a fireplace with the flues gathered together in shared chimney stacks over the party walls. Lots of scope here for downward damp penetration. Redundant flues should be vented at the base with hooded pots on top to keep them dry. Often only a limited view will be available from ground level even with the use of binoculars but many of these roofs have external trapdoors from the roofspace, especially the centre-valley or “butterfly” London roofs, so the surveyor can climb out onto the roof to view the construction at close quarters.

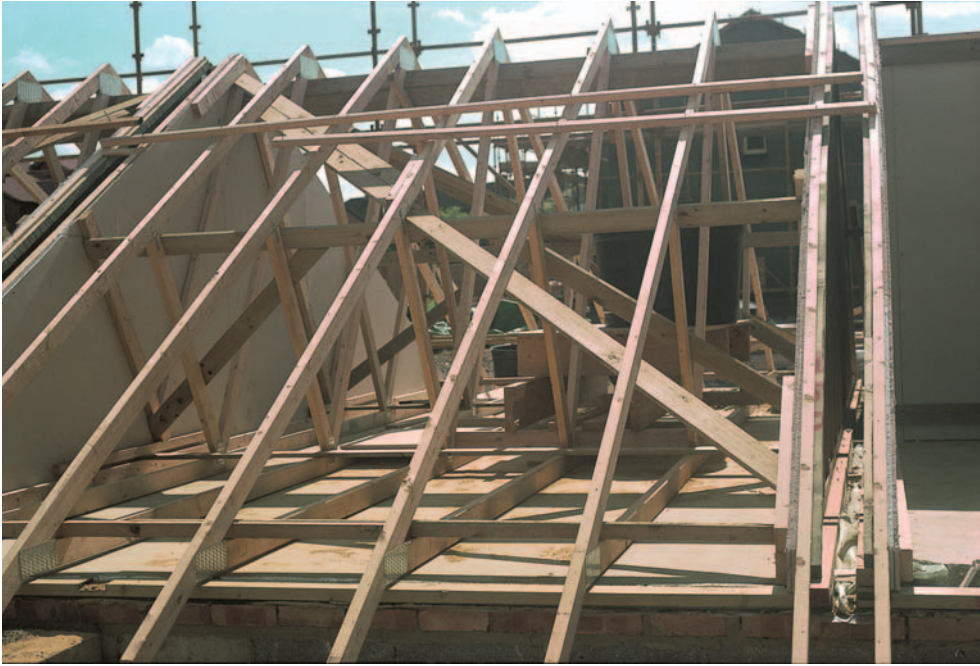
FIG 6.8 Modern gang-nailed trussed rafter roofs require diagonal bracing and gable-end strapping to prevent racking.

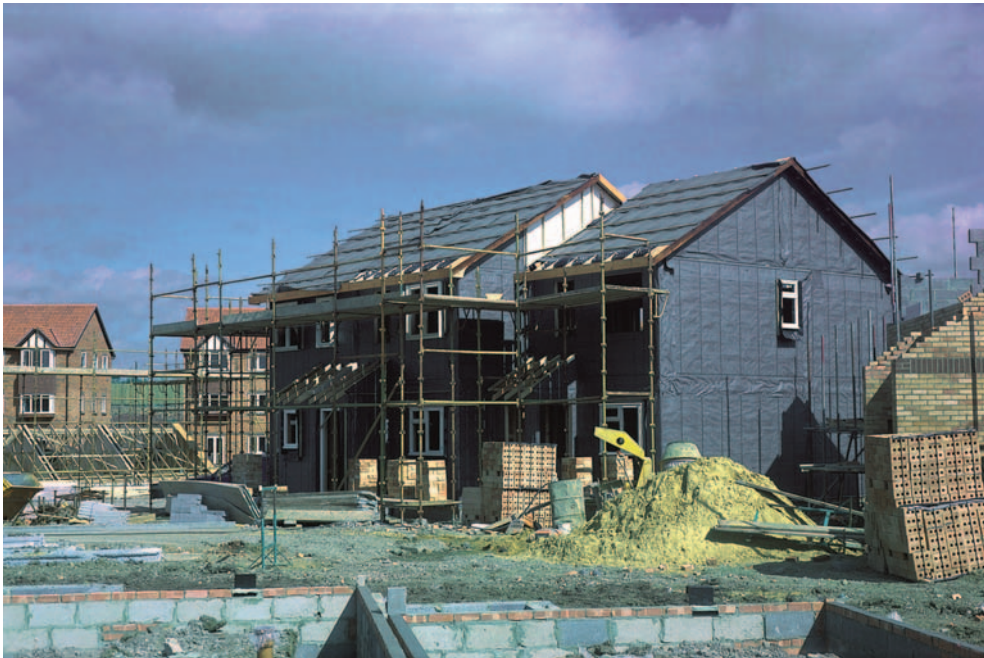
FIG 7.1 Timber frame house under construction in an estate. Note the breather membrane over the timber frame inner skin to the prefabricated timber frame construction.

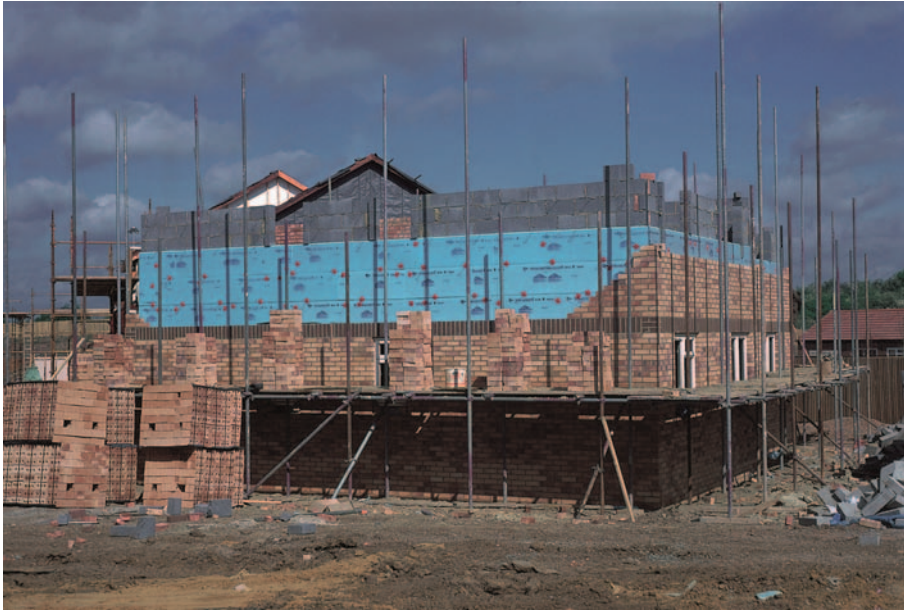
FIG 7.2 A traditional brick and block house under construction in the same estate as the house in Fig. 7.1.

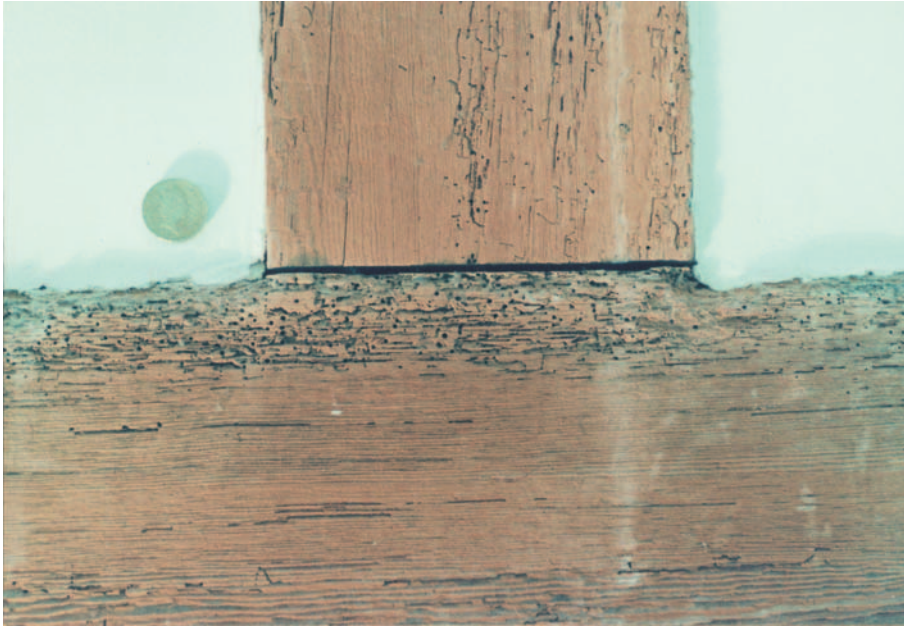
FIG 7.3 Flight holes of the common furniture beetle (*Anobium punctatum*) in relation to a £1 coin.

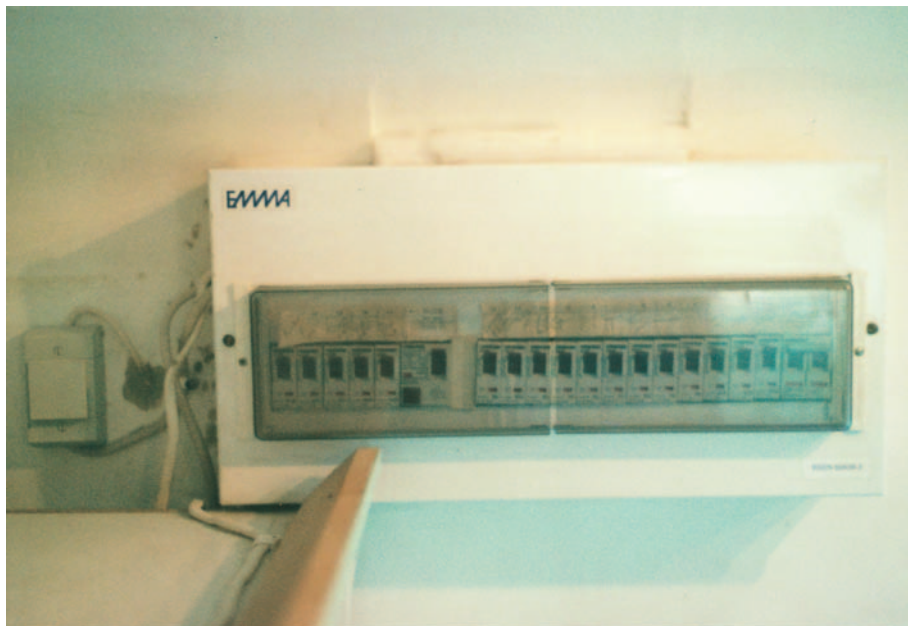
FIG 9.1 RCCB unit with circuit breakers and adjacent bell transformer for simple domestic system.

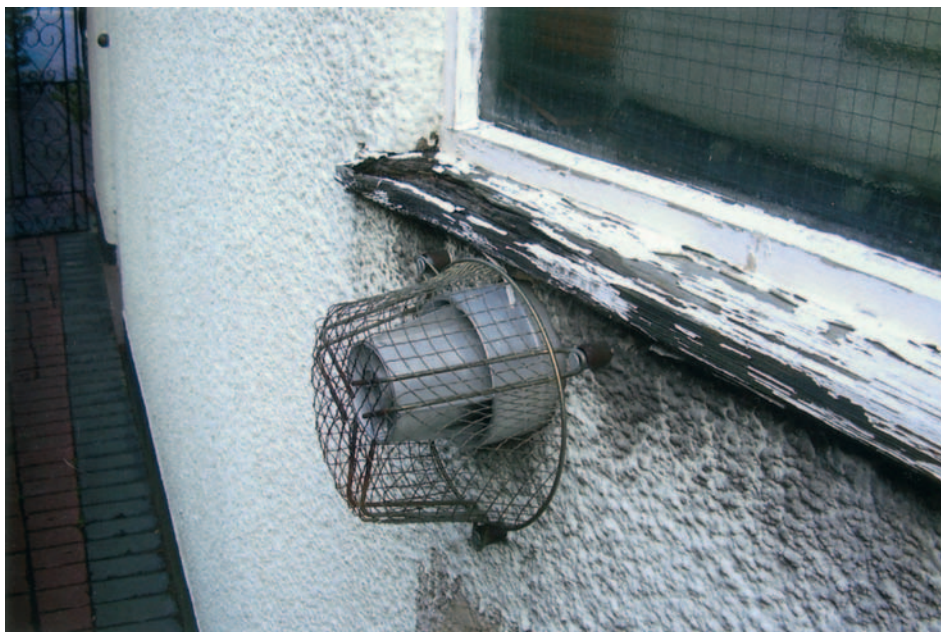
FIG 9.2 The location of this balanced flue directly under the window sill would not comply with current regulations. The discharge of flue gases – mostly water vapour – has had a predictable consequence in the form of wet rot to the window woodwork.

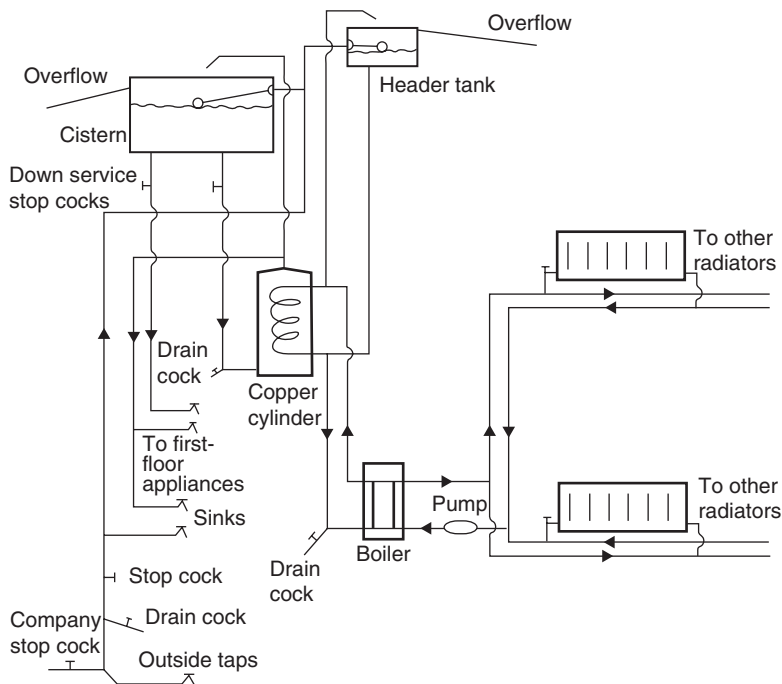
FIG 9.3 Diagrammatic layout of a simple domestic water and heating system using copper piping in 15-, 22- and 28-mm diameters. Indirect gravity primary circulation is provided to the cylinder. A pumped heating system is provided in small-bore, two-pipe layout to pressed-steel panel radiators.

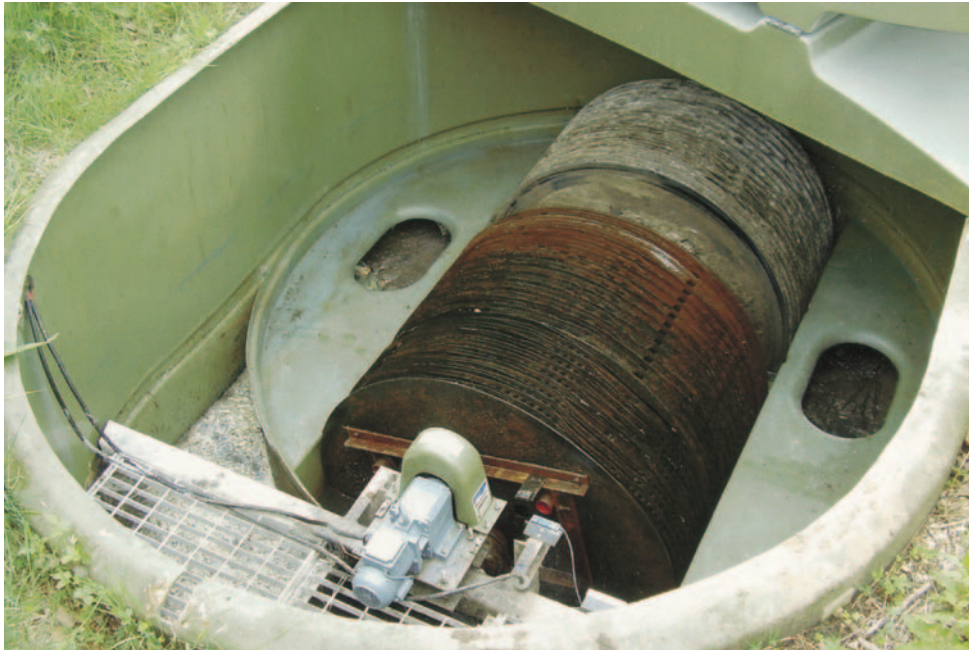
FIG 9.4 When mains drainage is not available a modern alternative is the Klargester Biodisk septic tank drainage system. Effluent enters the system and is rapidly broken down by bacteria with the process hastened by the electric motor and rotating disks which increase the exposure to oxygen in the air. The treated effluent emerging from the system is clear water suitable for draining into soakaways or an adjoining water course. Consent to discharge effluent is required from the Environment Agency. Periodic de-sludging is necessary.

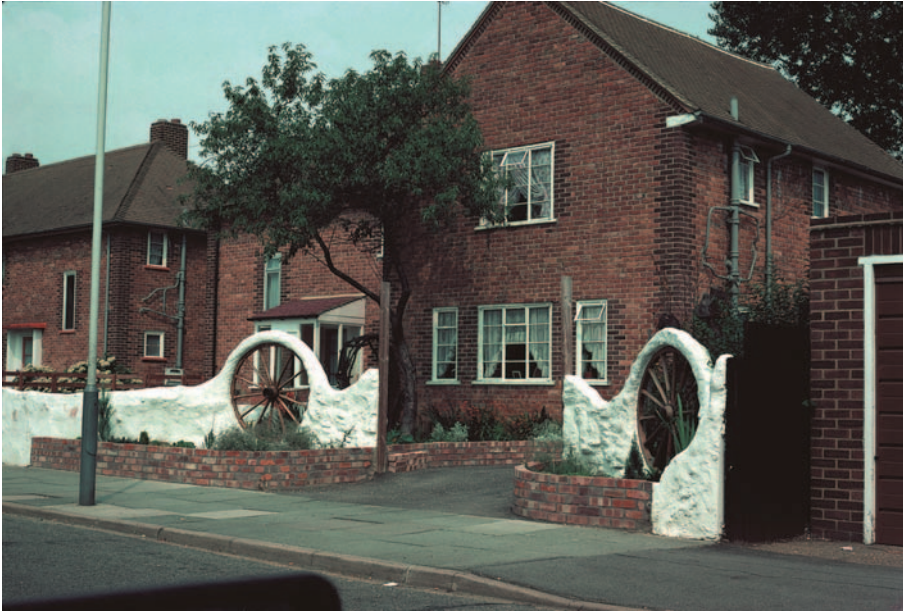
FIG 11.1 The Home Inspector should not comment in the HCR on questions of taste.

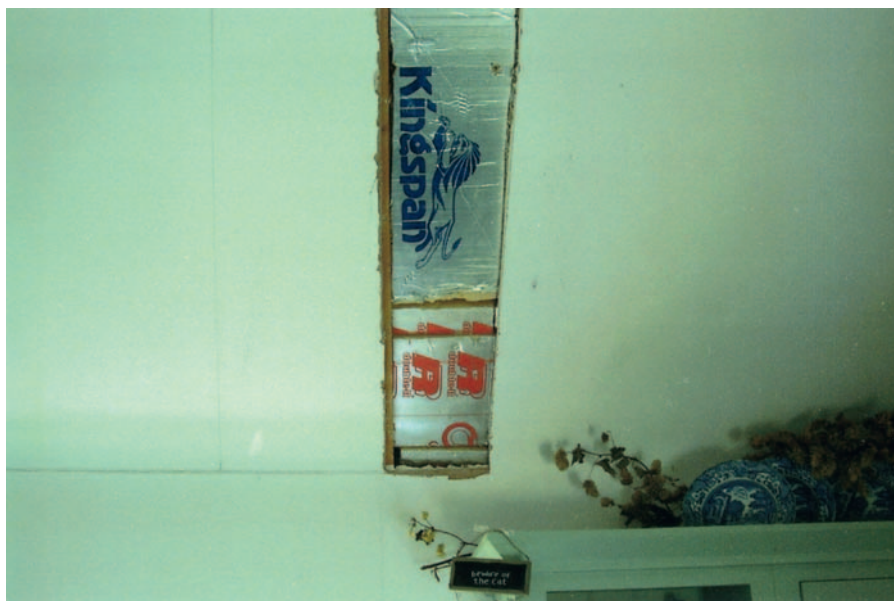
FIG 11.2 A section of plasterboard to a sloping ceiling is removed revealing Kingspan foam insulation panels. Normally, the actual level of insulation above a ceiling cannot be confirmed in these circumstances because there is no access behind. So, the computer program used to provide an energy rating makes certain assumptions based upon the age of the property and the Building Regulations applicable at the time it was built. This presupposes, of course, that the property is correctly dated and that the builders complied with the Regulations.

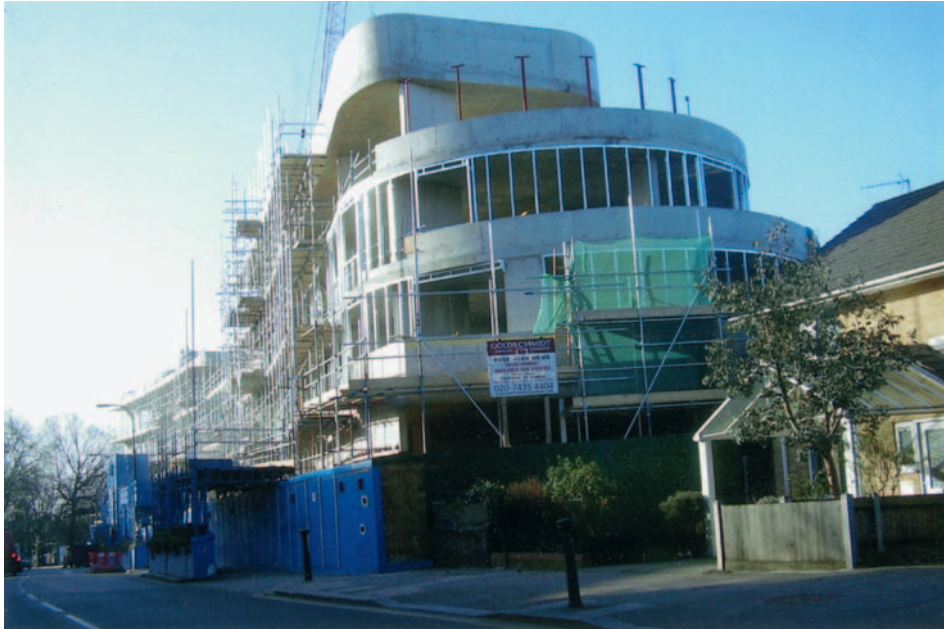
FIG 12.1 Concrete is artificial stone and ferrous reinforced cast-in-situ concrete construction makes use of some fortuitous chemistry. Steel reinforcement encased in Portland cement concrete does not normally rust, being protected by the alkali cement so provided that the depth of concrete covering the steel bars is satisfactory and so long as deleterious chemicals such as chlorides, sulphates or high alumina cement are not present, this type of construction is very durable. It also presents architects with the facility to incorporate slender columns and curved cantilerved elevations as in this building under construction in north London.

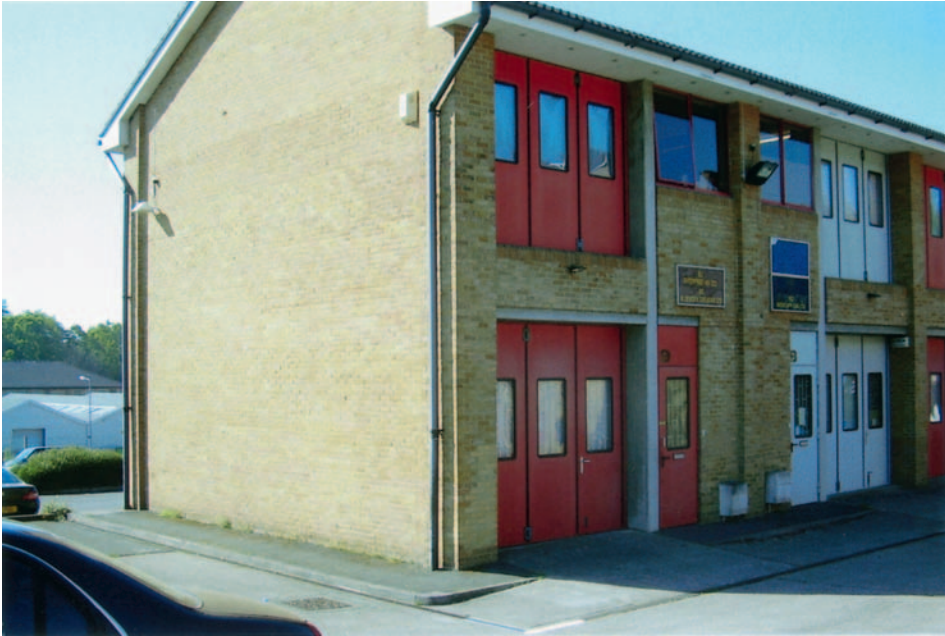
FIG 12.2 A simple low-rise industrial building. A Building Survey here follows the same principles as for a residential property. Buildings of this type are often built on brownfield sites or disturbed ground, so look out for signs of movement. Also will the floors take the weight? access and loading heights? services including three-phase electricity? adequate heating, lavatory and washing facilities?

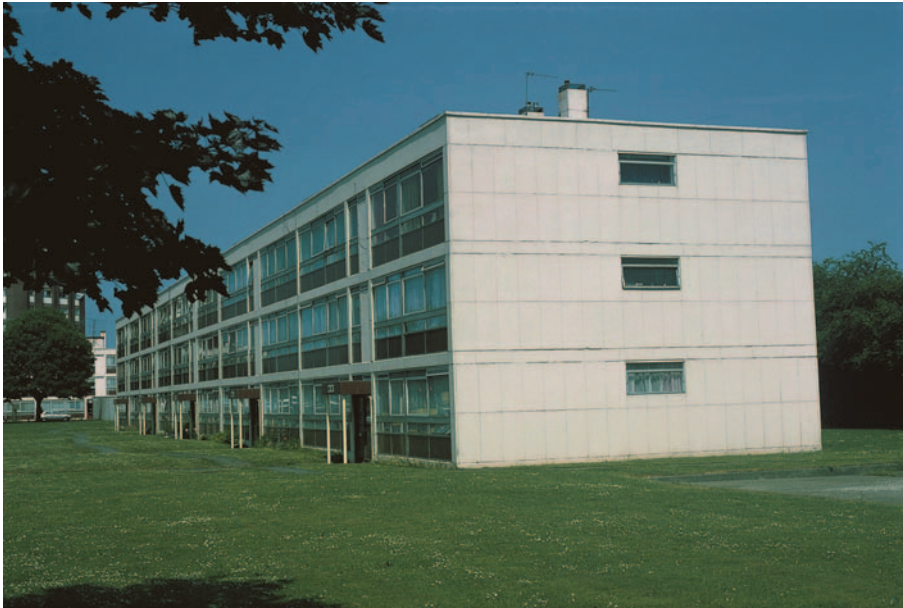
FIG 13.1 Flats system built in the 1960s using pre-cast concrete panel construction. This construction may be unacceptable as mortgage security for most mainstream mortgage lenders.

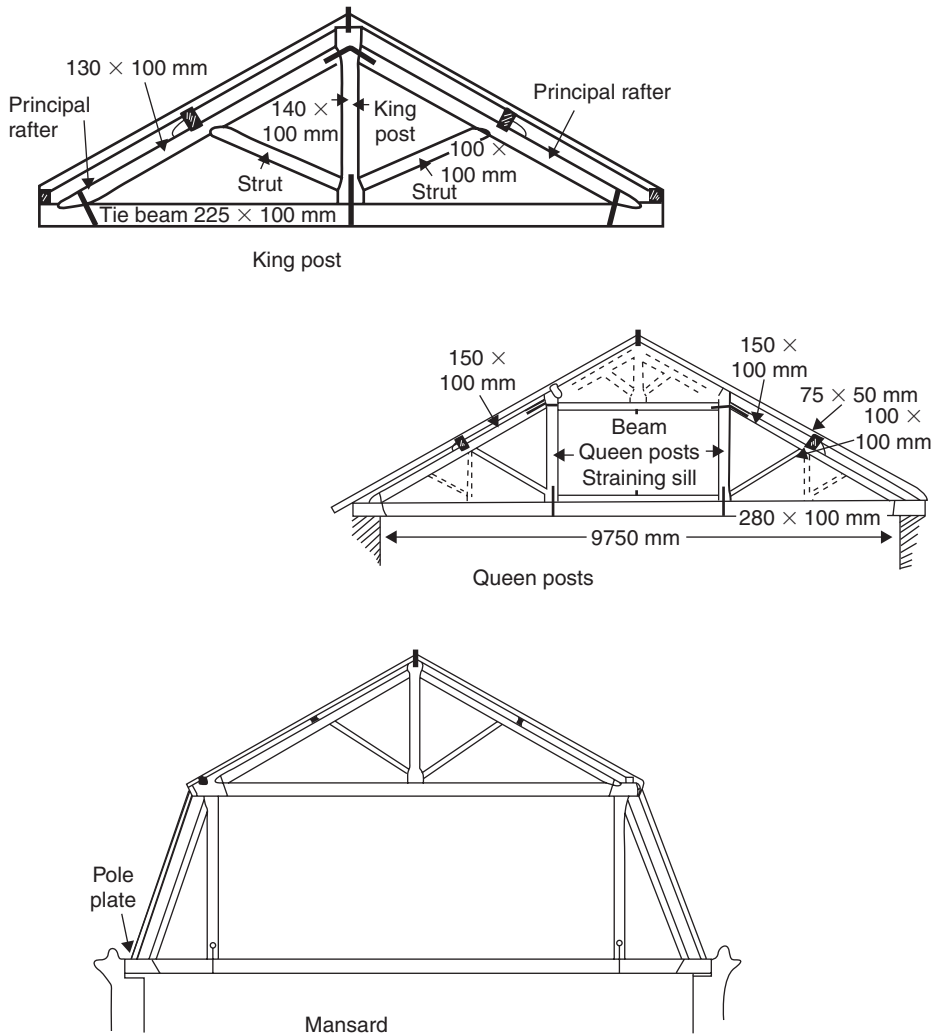
FIG 15.3 Early timber trusses, variations of which will be commonly encountered in older buildings.

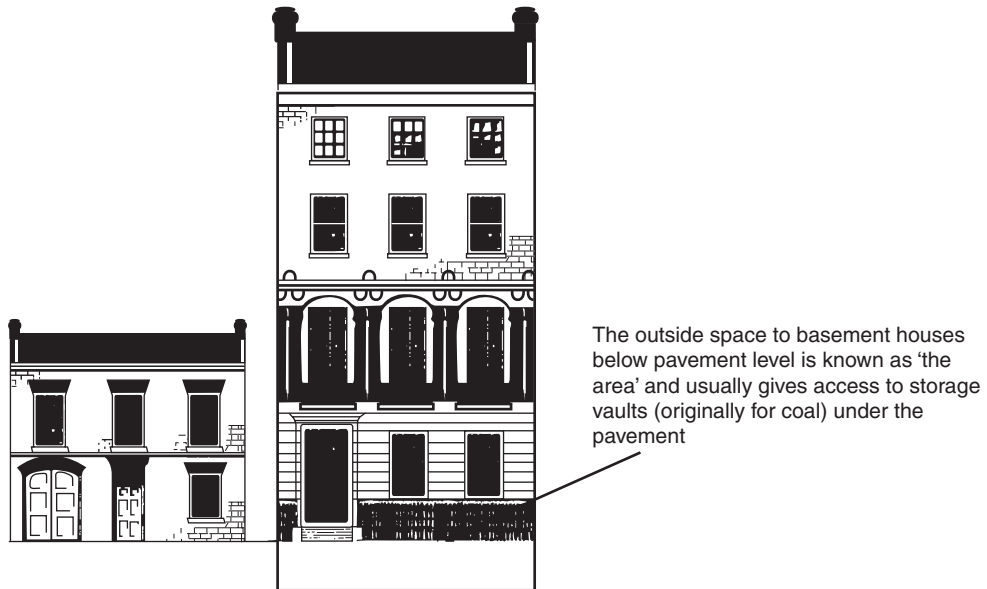
FIG 15.4 First Rate house and its mews.

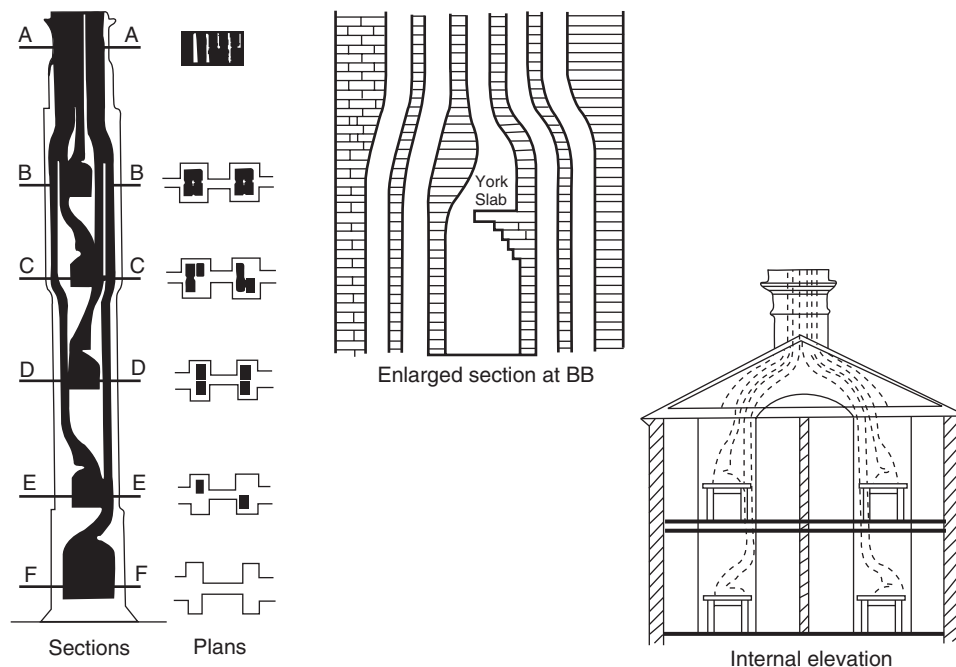
FIG 15.6 Nineteenth century flue construction. During inspection it is wise to count the chimney pots and trace the flues within the building. The bringing together of flues to the chimney is called 'gathering'.

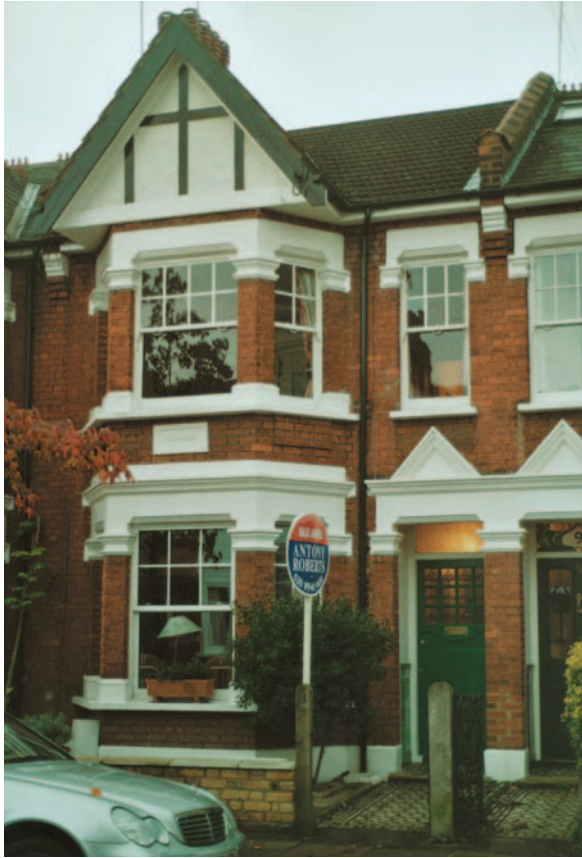
FIG 18.1 Suburban Road.

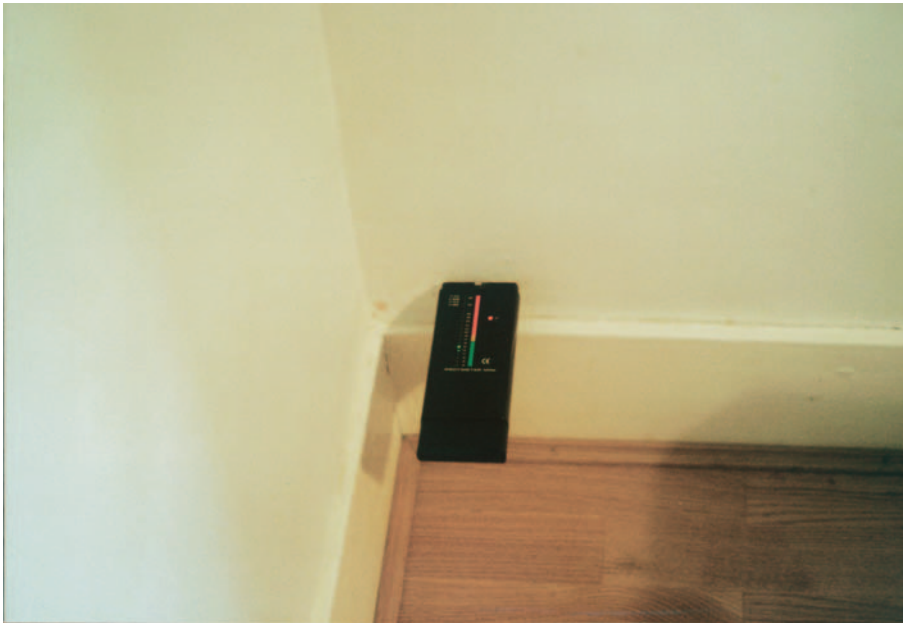
FIG 18.2 Testing No. 1 Suburban Road for damp. The green light on the left indicates that the wall is dry. If the light moves up into the red sector it would indicate increasing levels of moisture in the wall plaster. This would not necessarily indicate rising damp due to failure of damp-proof courses however; there are many other reasons why wall plaster could be damp.

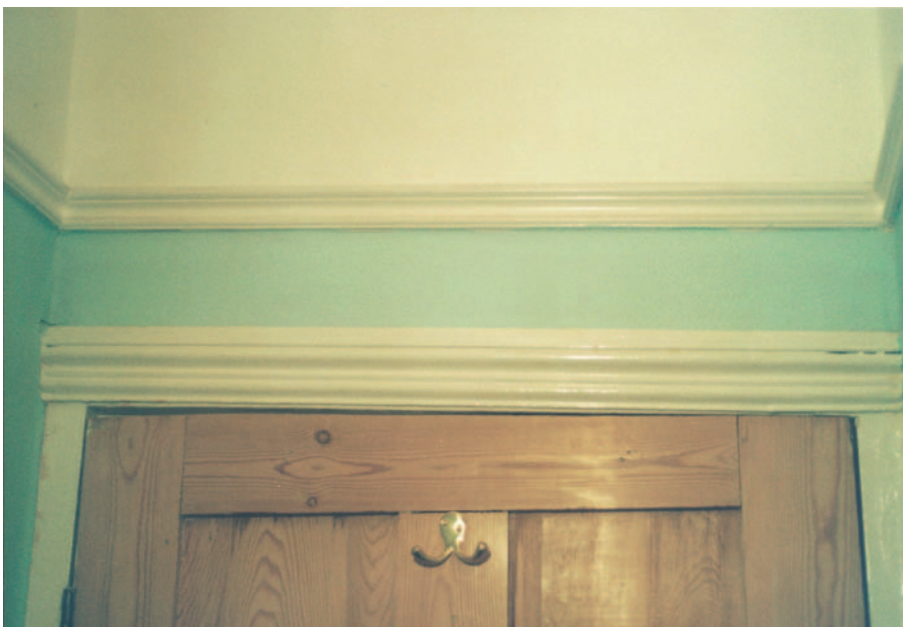
FIG 18.3 Sloping door head due to downward settlement of partition walls.

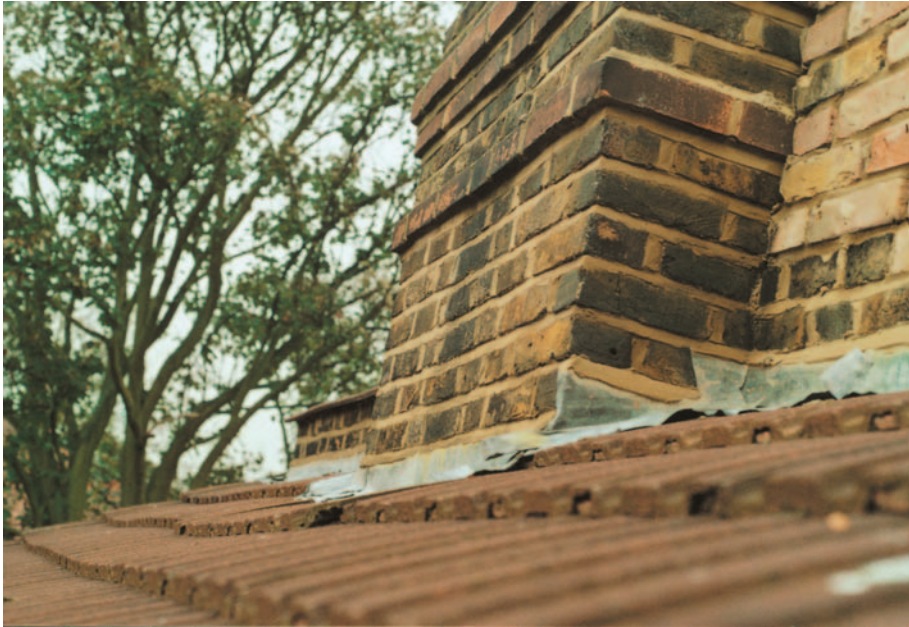
FIG 18.4 Loose and lifting lead flashings will allow driving rain to penetrate.

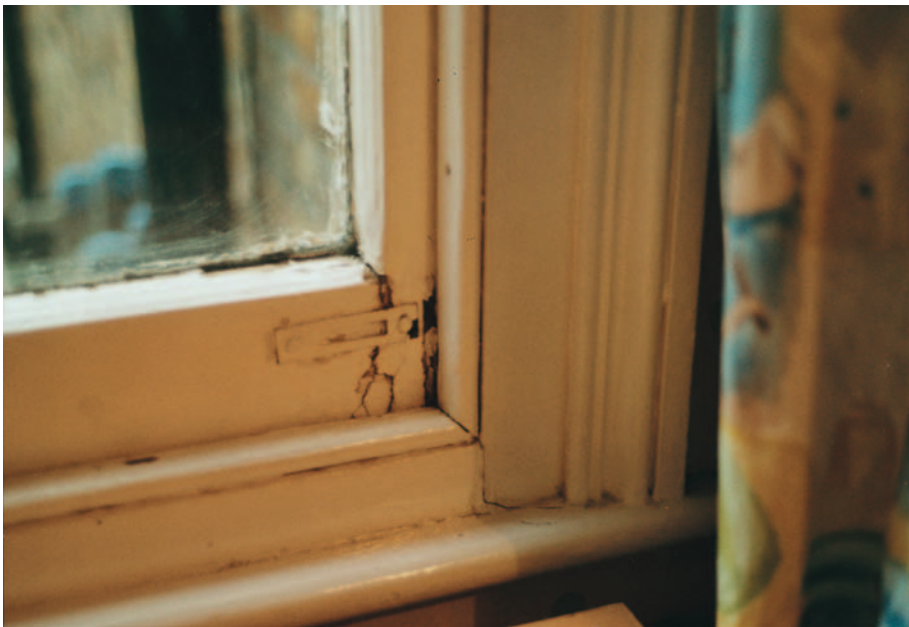
FIG 18.5 Significant expenditure on repairs or replacements of window frames will be needed prior to the next redecoration.
