SEVENTH EDITION

BUILDING SURVEYS

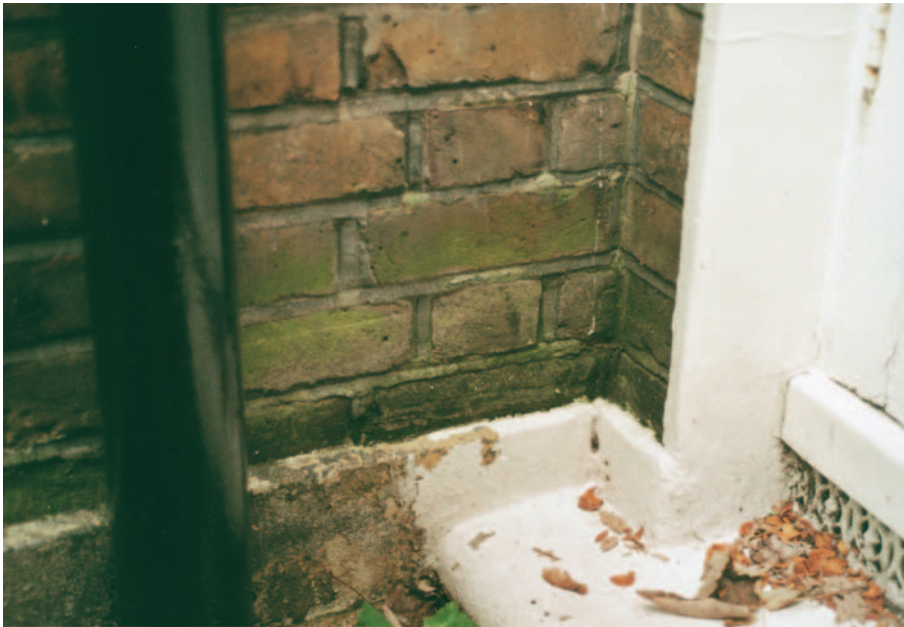
FIG 18.6 Green algae and moss growing at the base of a wall due to gutter splash.

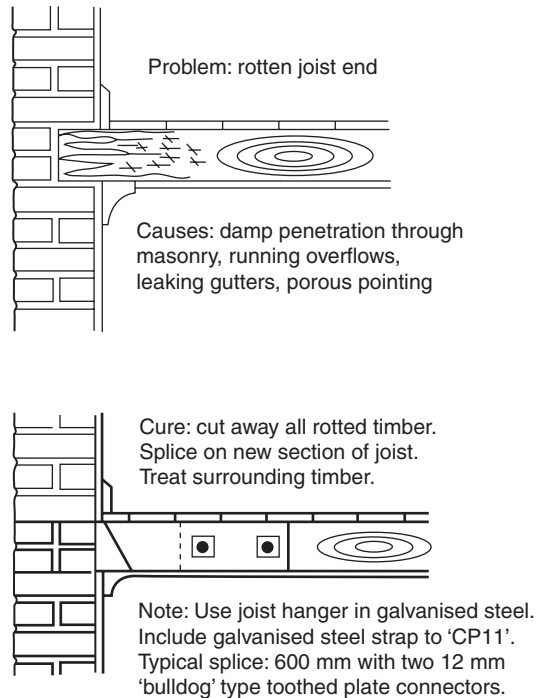
FIG 21.1 Conserving floors.

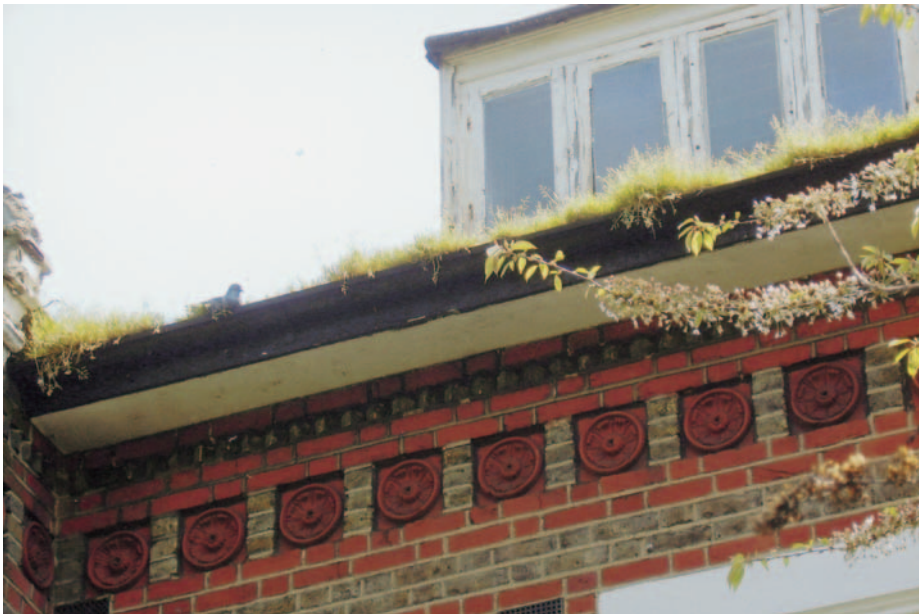
FIG 21.6 The grass growing in this gutter results from years of neglect. Sometimes conservation is just a matter of common sense.
