## TECHNICAL ASSISTANCE TO THE MANUFACTURE, CONSTRUCTION AND ASSEMBLY OIL PIPELINE FLOW PUMPS

This paper reports the experiences acquired through the modifications and improvements implemented in the manufacture, construction and assembly of the oil flow centrifugal pumps. A Brazilian oil pipeline pumping capacity expansion, on Rio Grande do Sul – South Region of Brazil, was conceived aiming at refinery processing increase project from 20,000 m<sup>3</sup>/day to 30,000 m<sup>3</sup>/day, besides changing the product profile from processed product to national high viscosity national oils. Due to this reason, a new pump park and a new intermediate pump station have been erected. Thus, the oil received by a tanker and stored at the first pump park should be sending through a 97 km long and 560 mm diameter oil pipeline. In order to get such oil flow done, 03 new main pumps have been installed at the first pump park, one of them being a stand-by one, and other 03 pumps at second pump park, one of them being also a stand-by.

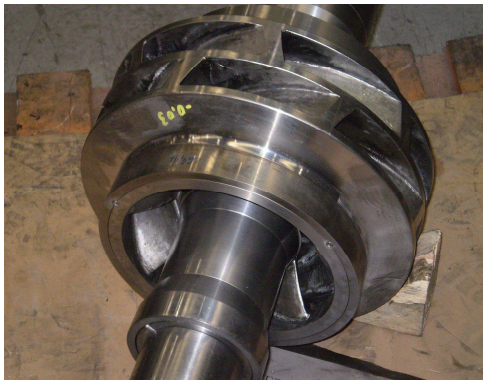
Figure 4: Impeller detail

The replacement of the impellers originally melted in sand mold for components melted in ceramic molds aimed at eliminating the maximum of dimensional deviations (of approximately 20%) in the impeller fluid exit areas. A greater dimensional uniformity in this region provides a better radial distribution of pressure and, consequently, a greater rotor hydraulic balance.

- Replacement of the impellers for parts melted in ceramic molds;
- Verification of the impeller and rotating assembly's dynamic balance;
- Superficial finish suitability (run out) in the vibration sensors' operating region;
- Replacement of the bearings that presented excessive clearance;
- Modification of the forced-lubrication pump coupling sleeve;
- Verification of the melted casings' manufacturing dimensional clearances and tolerances;
- In-plant mechanical operation and performance testing, in plant, as per in-field pipeline layout.
