TOWARD REDUCED PUMP OPERATING COSTS, PART 3— MINIMIZING THE EFFECTS OF WEAR AND OPTIMIZING PUMP EFFICIENCY

James P. Netzel

Eugene P. Sabini

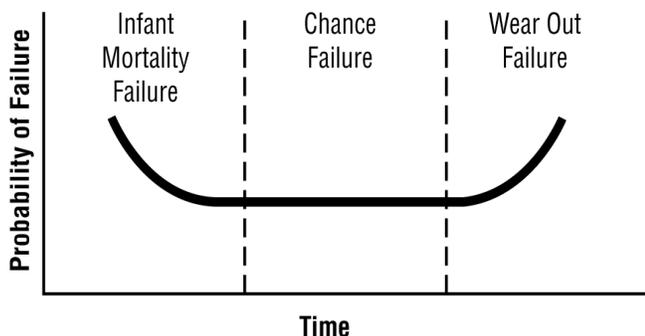
Figure 1. Concept of the Bathtub Curve.

In reliability engineering, the types of failures described can be illustrated on what is referred to as the bathtub curve (Figure 1). Infant mortality and premature failures must be eliminated. Then changes in design or operation must be made to reduce or eliminate wear-out failures (Figures 2 and 3).

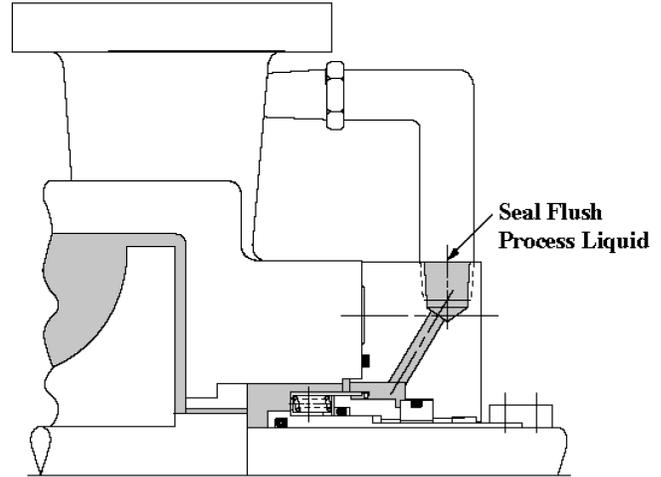
Figure 5. Typical Mechanical Seal Design.

For seals, the primary ring is usually made of carbon graphite and considered to be the wearing part in the seal assembly (Figure 5). The mating ring surface will also wear, but to a lesser extent. Face loads, by design, are sufficiently low enough that only mild adhesive wear occurs. This is necessary in the design to prevent the vaporization or carbonization of the fluid being sealed. If vaporization or carbonization occur, there is a substantial reduction in seal life.

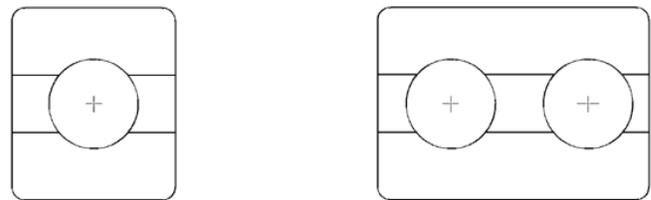
Figure 6. Common Types of Rolling Element Bearings Used in Pump Design.

For bearings, the rolling contact surfaces are made of alloy steel and have a hardness of R_C60 (Figure 6). These components are normally lubricated by oil, which generates the lubricating film at the bearing contact surfaces. Here the user has complete control in providing excellent environment to operate the bearing. Moisture must also be kept out of the bearing area to extend life and eliminate wear.

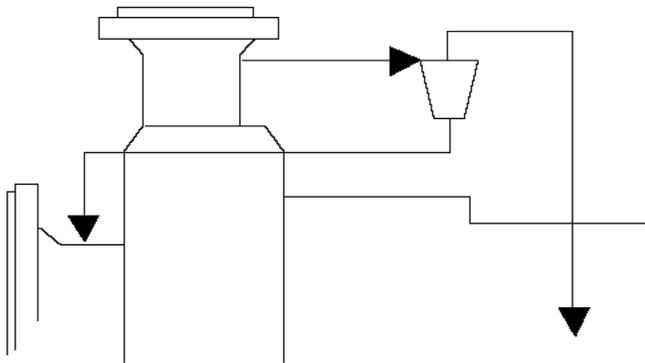
Figure 7. API Plan 31—Use of a Cyclone Separator.

thereby avoiding contamination of the pumpage with the injected fluid. These piping plans are shown in Figures 7, 8, and 9.

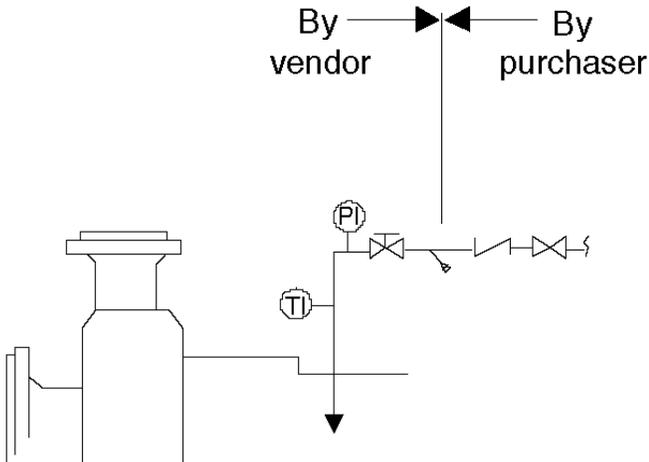
Figure 9. API Plan 32—Clean Fluid Injection from an External Source.

Another method of keeping an abrasive from the seal chamber is with API Plan 32. In this case, a separate fluid from the pumpage is injected from an external source. Care must be taken in selecting the external fluid for injection. The injection fluid must provide good lubrication to the seal and eliminate the potential for vaporization,

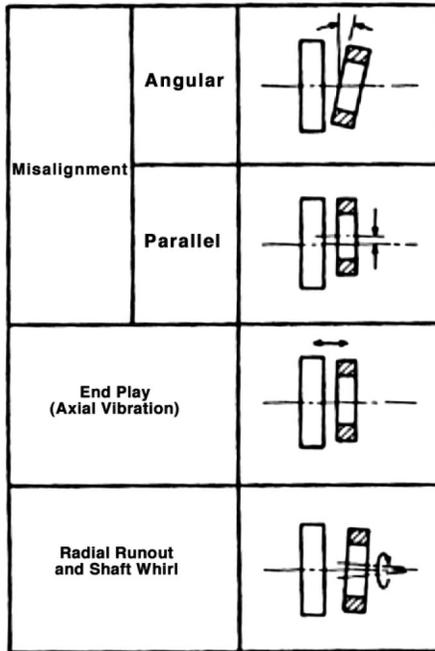
Figure 10. Common Types of Motion Transmitted to a Seal.

The major cause for pump repairs is due to a leaking seal. The problem of short life may be a symptom of another problem that is affecting the performance of the pump. Also, at least 20 percent of short life problems are the result of poor or incorrect seal installation. A successful seal installation not only depends on the correct installation of the pump, but also the correct installation of the seal to the pump. Motion transmitted to the seal must be kept to a minimum to achieve exceptional results. Motion can be transmitted to the seal faces from misalignment (angular or parallel), end play, or radial runout of the pump as shown in Figure 10.

Angular misalignment occurs when the mating ring in the seal assembly is not square with the shaft. As the shaft turns, the primary ring must follow the mating ring. If the surface of the seal is out by 0.005 inches total indicator reading (TIR) then at 3600 rpm, the seal face must move 0.005 inches 3600 times per minute. The resulting motion will overstress the seal materials as well as cause fretting wear on the shaft or seal hardware.

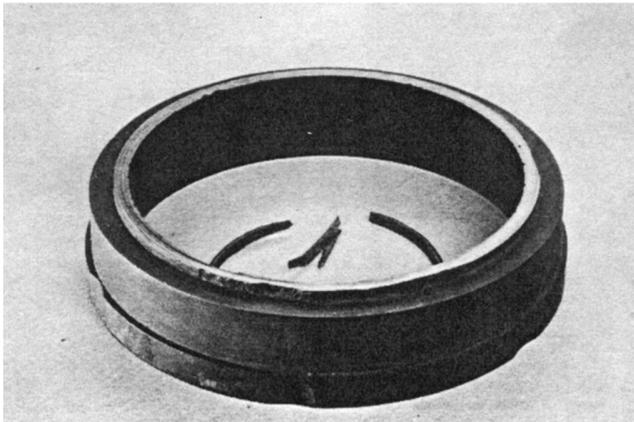
Figure 11. Damage to a Seal from Angular Misalignment.

An example of damage to a seal face from angular misalignment is shown in Figure 11. The seal face or primary ring is from a 5.375 inch diameter seal operating at a surface speed of 5000 fpm in water at 180°F. The seal chamber pressure was 150 psig. Misalignment resulted in edge chipping at the seal faces. This damage occurred opposite the drive notch in the carbon ring. The highest axial force due to friction at the drive mechanism will occur at this point on the seal ring. Chipping occurs due to the constant impact of the seal faces for each revolution. This failure

occurred after two months of operation. Surface waviness, a measure of flatness, was 2550 microinches of flatness through 360 degrees. A new seal face will measure 22 microinches of flatness. The surface profile, a measurement from face OD to ID, was irregular from convex to concave ranging from 200 to 350 microinches every 90 degrees. As noted in the figure, the O-ring seal is completely worn and broken. This damage is the result of motion transmitted to the seal from misalignment. This type of result in varying degrees is from angular misalignment. Correcting the cause has resulted in a significant improvement in life.

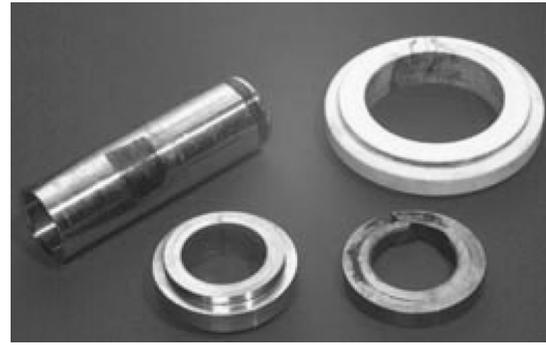
Figure 12. Damage to a Seal from Parallel Misalignment.

Parallel misalignment results when the seal chamber is not properly aligned with the rest of the pump. No seal problems will occur unless the shaft strikes the inside diameter of the mating ring. This type of damage is shown in Figure 12. If damage has occurred, there will also be damage to the bushing at the bottom of the seal chamber at the same location as the mating ring.

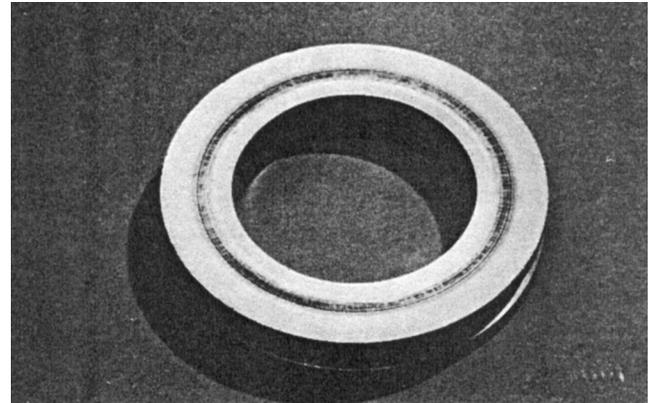
Figure 13. Heat Checking of a Seal Face.

Excessive axial end play can damage the seal faces and can cause fretting wear on the shaft or sleeve. If the seal is continually being loaded and unloaded, wear debris can penetrate the seal faces and cause premature wear of the seal faces. Damage can also be in the form of heat checking or cracking shown in Figure 13.

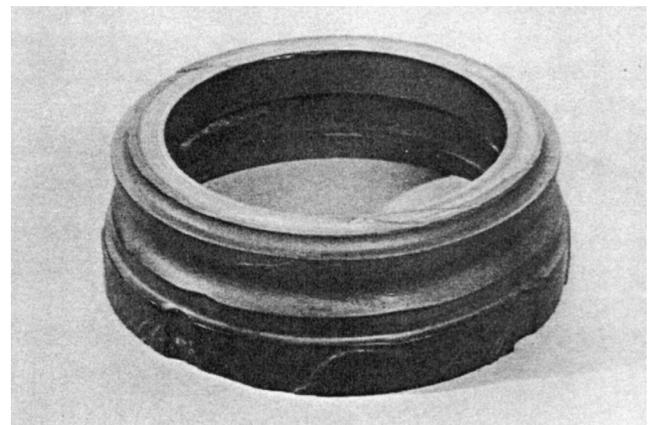
Figure 14. Damage to Outside Diameter of a Seal from Erosion.

Erosion of a seal face may take one of two forms. Shown in Figure 14 is erosion on the outside diameter of the carbon seal ring as well as on the seal face. On the outside diameter, the seal flush with abrasives present has worn away much of the carbon ring. This is easily solved by redirecting the flow to the seal and by removing the abrasive from the seal flush as previously discussed.

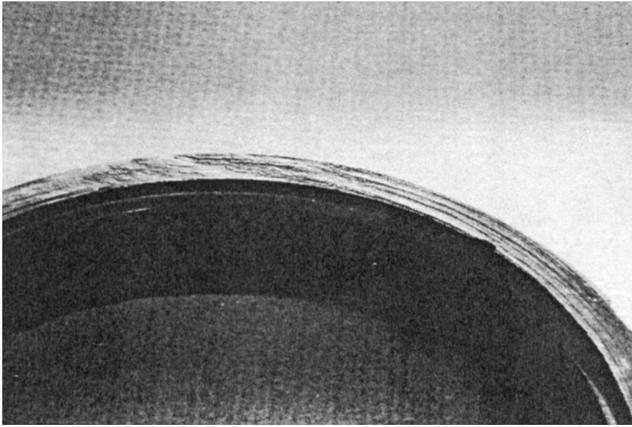
Figure 15. Erosion Damage of a Seal Face.

Another form of erosion to a seal face is shown in Figure 15. This condition of wear is referred to as wire brushing. This occurs when abrasives are present in the seal chamber and the seal is operated with a mechanically distorted mating ring. Again, the distortion must be eliminated to achieve long life.

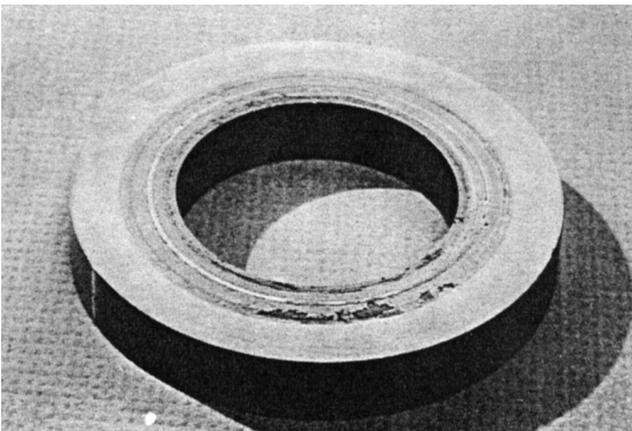
Figure 16. Damage to a Seal Face from Corrosive Wear.

Corrosive wear is shown in Figure 16. Here corrosion is accelerated due to the higher temperature at the seal faces. Once the corrosion and wear cover the entire seal faces, leakage will occur. Material selections should be made carefully to avoid this problem.

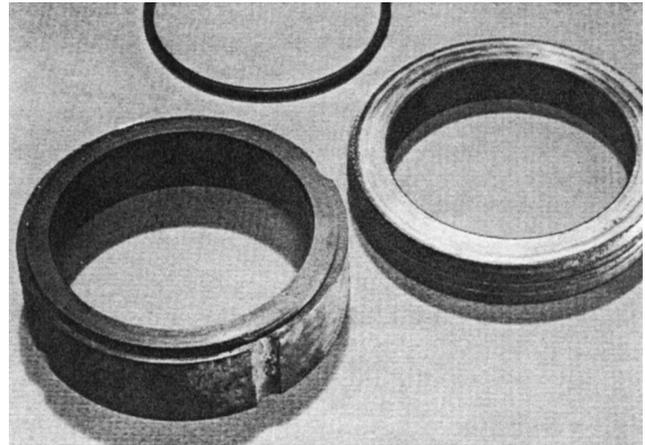
Figure 17. Seal Faces Operated Successfully for 25 Years.

Finally, when a seal has been properly selected, installed, and operated, the results will be years of trouble-free service. The seal shown in Figure 17 has been in service for over 25 years. This is over 200,000 hours of operation. This 3 inch seal was used to seal gasoline, fuel oil, and occasionally propane. Normal operating pressure and temperatures were 800 psig and 60°F. Shaft speed was 3560 rpm. The condition of the carbon ring exhibits virtually no adverse wear of the sealing face or at the drive notches, which represent the drive system on this seal. Wear at the carbon seal face is only 0.032 inches for this length of time in service. The mating ring is in good condition. This seal was not leaking even though some minor heat checking had occurred. It is believed this occurred as the O-ring aged in service increasing in hardness from 70 to 90 durometer. This increase in hardness would eventually lead to a loss of flexibility for the seal head.

This seal face was not subject to any excessive amount of angular and axial motion. Alignment of the equipment, both external and internal, was excellent. The amount of heat developed by the seal was easily removed by a seal flush. Also, all of the fluids handled, with the exception of propane, are good lubricants for the seal. During the service life of 25 years, no maintenance expenses on this pump were incurred by the plant operator. Paying attention to every detail in the design, installation, and operation of the equipment will result in exceptional life.

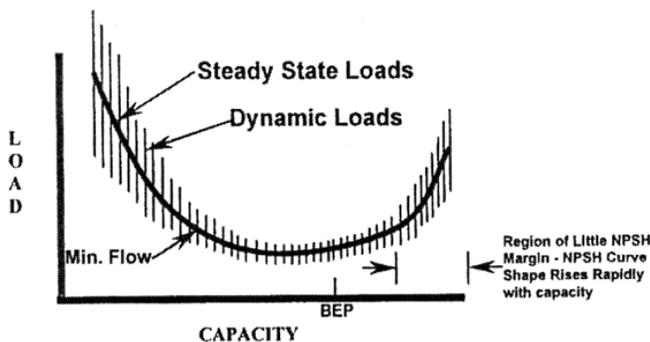
Figure 21. Pump Load-Capacity Curve.

Bearing failure often occurs during pump startup because of problems with baseplate installation, piping installation/design, alignment, and using pumps as pipe anchors, which tend to distort the casing transmitting higher than expected loads to the bearings. Other problems encountered are that pumps typically operate at much lower than normal flows also causing higher than expected steady-state and dynamic loads. The dynamic portion of the load, particularly on high-energy pumps, can approach, or even exceed, the steady-state loads in value. These dynamic loads, caused by internal recirculation, have a very random high frequency content. These dynamic loads produce pounding at the bearing fits, which causes bearing surfaces to overheat leading and premature failure. Table 1 summarizes problems typically encountered at flows other than normal. Steady-state and dynamic loading on a centrifugal pump is illustrated in Figure 21.

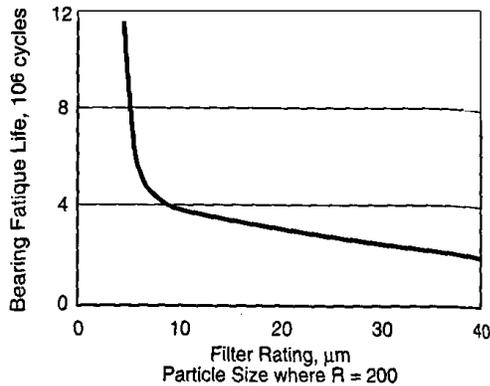
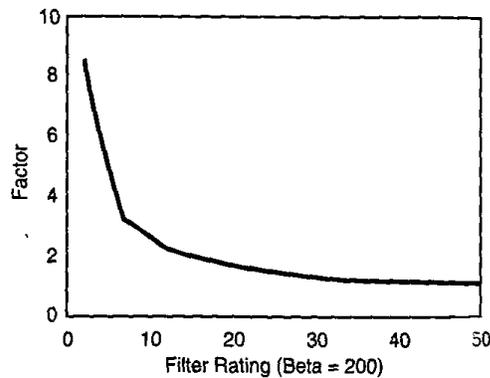
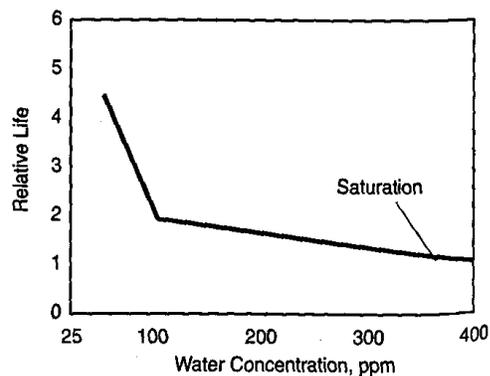
Adams, et al. (1996), proposed the following life charts (Figures 22, 23, and 24), which can be used to adjust rolling element bearing L_{10} life for both contaminant size and water concentration.

Figure 22. Bearing Life Versus Level of Friction.

Figure 23. Bearing Life Factor Versus Filter Rating.

Figure 24. Relative Bearing Life Versus Water Concentration.

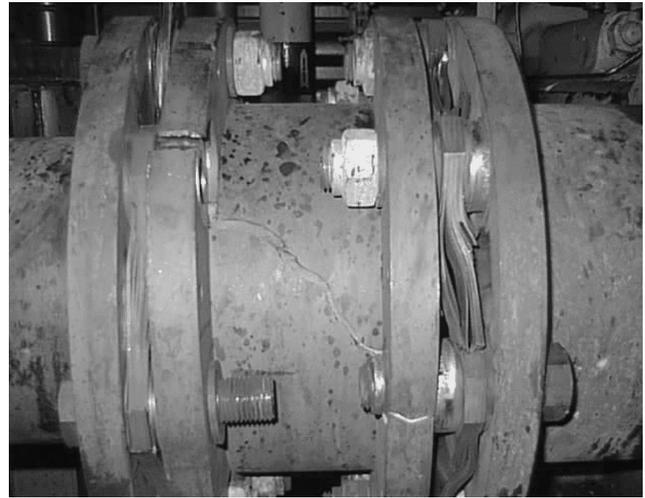
Figure 25. Stress Crack in a Coupling from Misalignment.

Failure to have good alignment will result in the coupling being overstressed. Figure 25 illustrates a stress crack found in a misaligned coupling. Had this not been discovered, a catastrophic failure would have occurred. This failure did not set off the vibration alarm and was found by visual inspection.

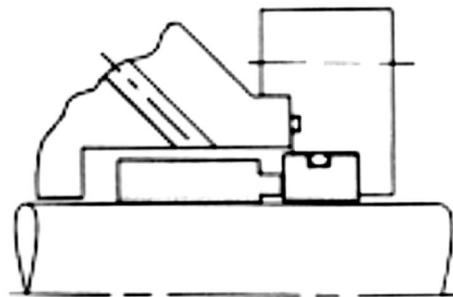
Figure 27. Small Cross-Section ANSI Seal Chamber.

Early ANSI pump designs had a seal chamber referred to as a small cross-section stuffing box bore. This stuffing box design allowed both packing and mechanical seals to be used interchangeably. However, as operating conditions increased, the small bore seal chamber became very restrictive. This resulted in the development of both the large bore and taper bore seal chambers. Figures 27, 28, and 29 illustrate the concept of these chambers.

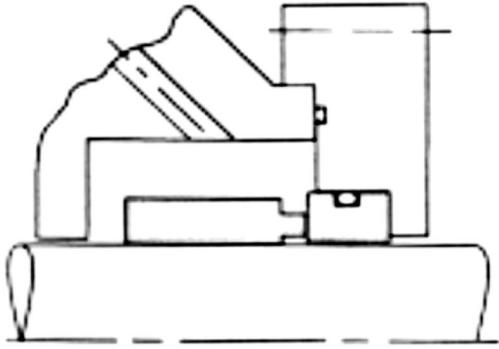
Figure 28. Large Bore ANSI Seal Chamber.

The large bore seal chamber is more than two times larger than the original small cross-section seal chamber. These dimensions allow for a standard ANSI seal to run for 25°F cooler than the original seal chamber. By opening up the back of the seal chamber and providing a slight taper to the bore, the seal chamber will run 40°F cooler than the original seal chamber design. The taper bore seal chamber allowed for easy removal of gas or vapor from building up in the seal area. Abrasives suspended in the fluid represented another problem. Any abrasives in the fluid being pumped would collect in the space at the outside diameter of the seal faces.

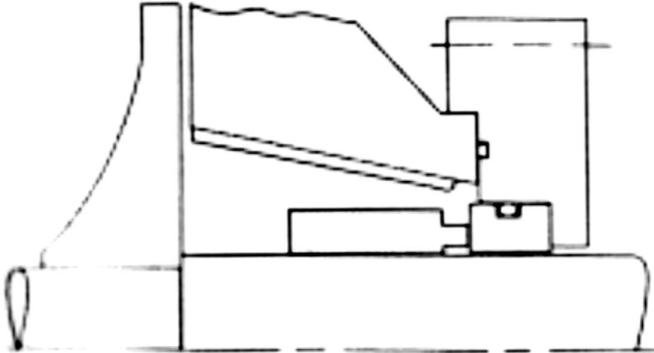
Figure 29. Taper Bore ANSI Seal Chamber.

Allowed to remain in the area, the coarseness and hardness of the abrasive particles began to wear away the bore of the seal chamber in this area. To eliminate this wear problem, axial ridges or vortex modifiers are added to the inside diameter of the seal chamber. This design feature effectively dispersed abrasive particles and eliminated wear to the seal housing.

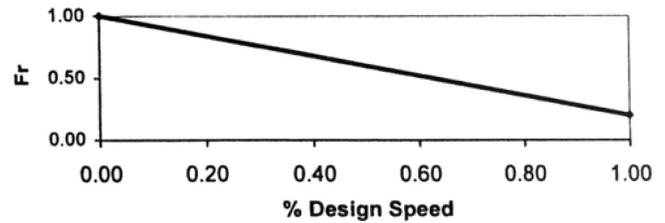
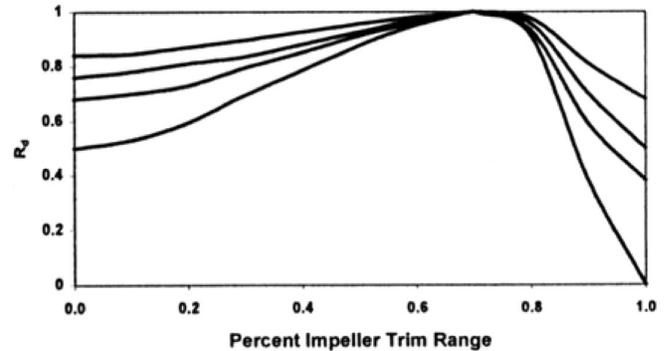
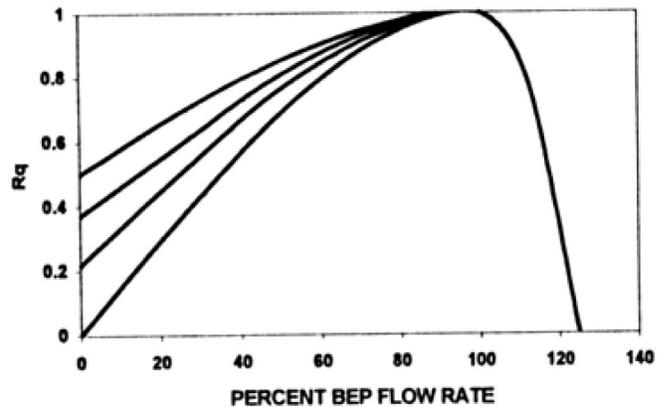
Bloch and Geitner (1994) quantified the above by defining a reliability index (RI), which is the product of the speed reliability factor (F_R), the impeller diameter reliability factor (F_p), and the flow rate capacity factor (F_Q). Figures 30, 31, and 32 are used to determine the individual reliability factors.

Figure 30. Speed Reliability Factor.

Figure 31. Impeller Diameter Factor.

Figure 32. Flow Rate Reliability Factor.

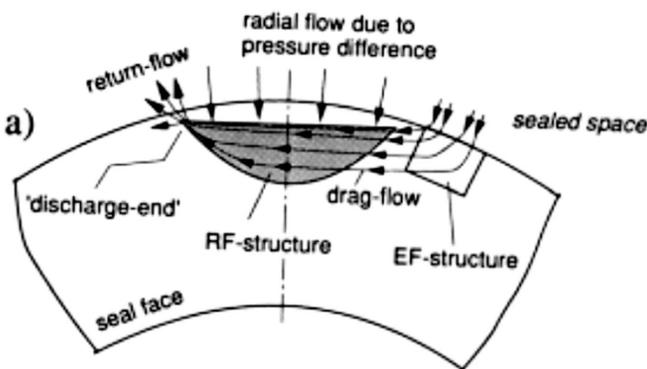
Figure 33. Laser Face Seal Geometry.

Seal face designs have been developed to promote seal lubrication to reduce wear. One such design is referred to as laser face. A typical laser face design is shown in Figure 33.

In this design, a series of rectangular slots and recesses allow for the fluid sealed to enter the seal face and flow across a portion of the seal face for cooling, and then is pumped back into the seal chamber. The surface features are only microinches deep. The friction at the seal faces can be reduced by as much as 50 percent. The benefits to the user are reduced wear, friction losses, and improved reliability.

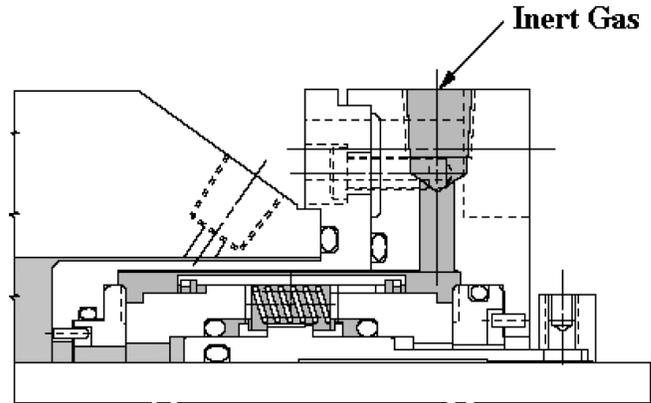
Figure 34. Noncontacting Gas Lubricated Seal Design.

For those applications where the fluid being pumped is not hazardous to the environment, a single noncontacting seal may be used. These involved liquid cryogenic gases like nitrogen, oxygen, and argon.

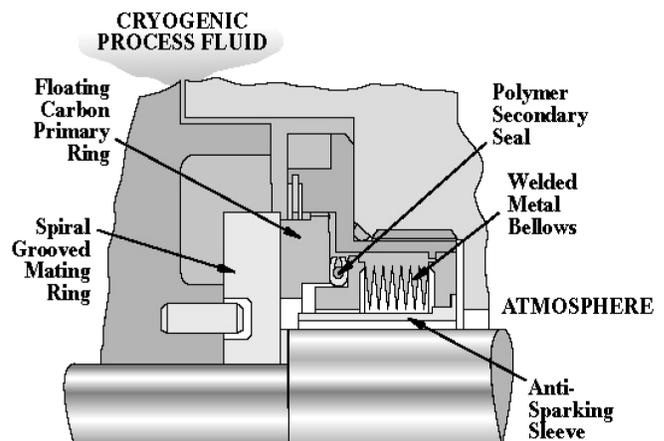
Figure 35. Noncontacting Gas Lubricated Seal for Nonfigure Hazardous Liquefied Gases.

Sealing of liquid oxygen, nitrogen, and argon on over-the-road tanks was identified as a serious problem. Seal life ranged from as short as six weeks to as long as 25 weeks. This involved a fleet of 25 tank trucks in which, during one period when 100 seal failures were removed from service, the face seals were heat checked and discolored. The solution was to provide a design that would eliminate frictional heat. This in turn would eliminate the flashing of the cryogenic gas. The design developed for this application is shown in Figure 35.

Seal life has now been extended to over six years of service. The resultant savings for the fleet is \$900,000. This exceptional service was achieved through the application of existing technology redesigned for low temperature service.
