THE PLASCO BUILDING COLLAPSE IN TEHRAN

A Preliminary Assessment
FEBRUARY 20, 2017

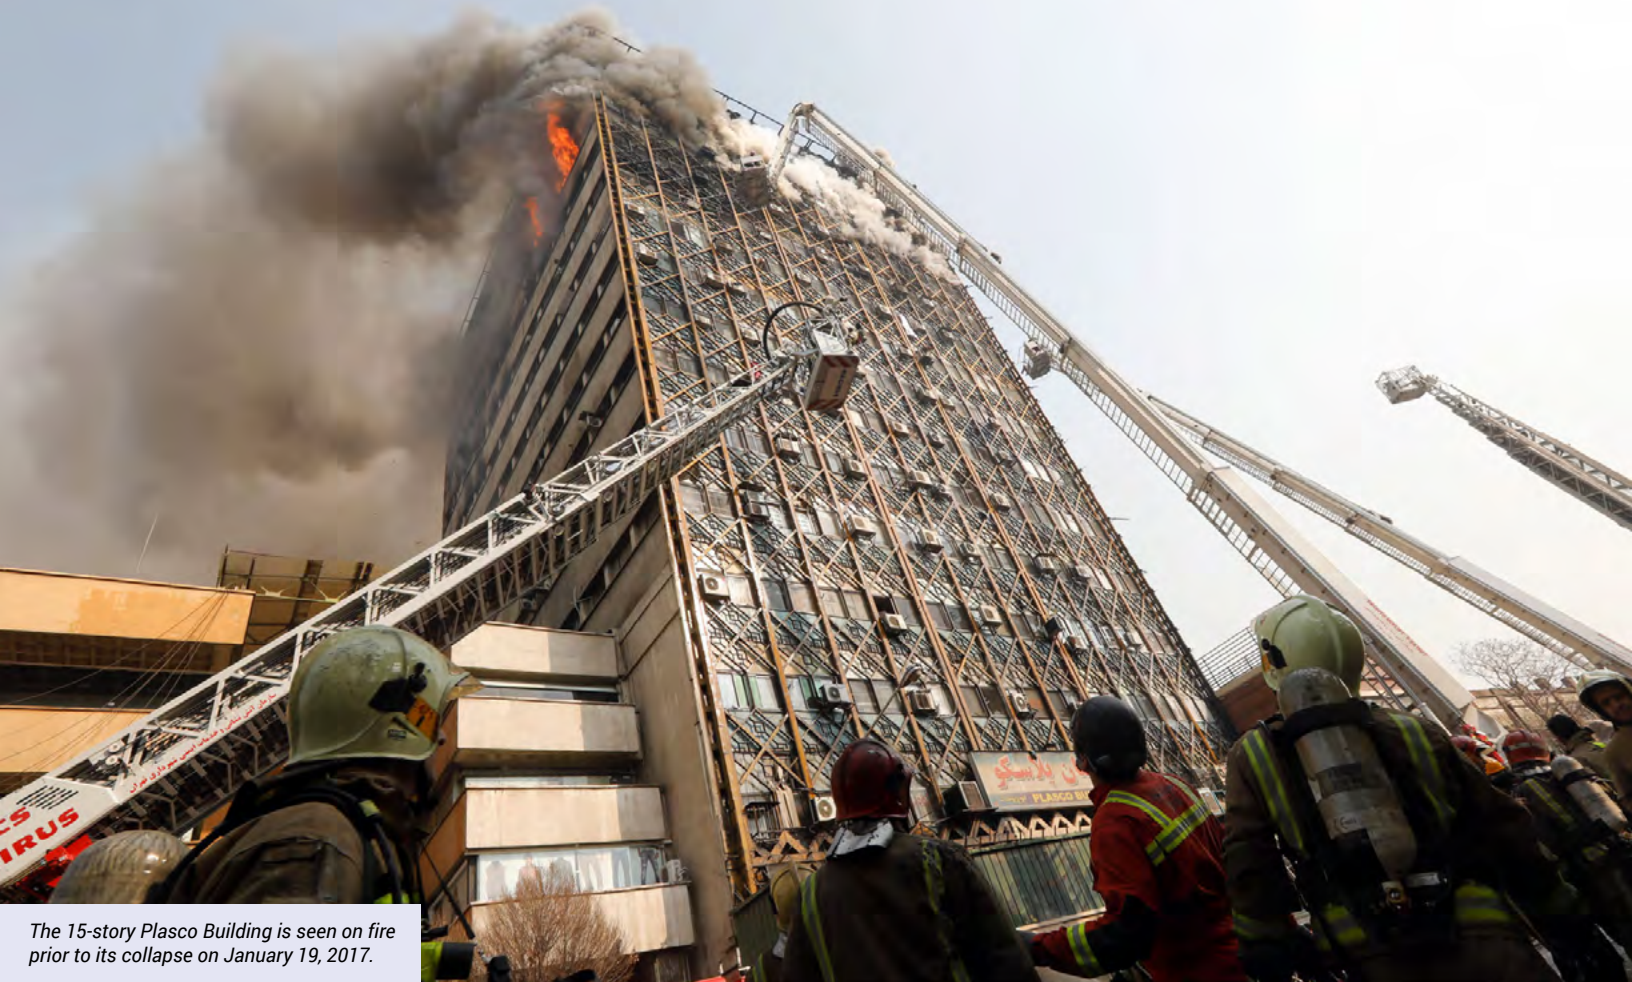
The 15-story Plasco Building is seen on fire prior to its collapse on January 19, 2017.

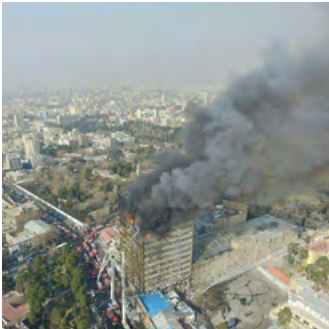
Figure 3: Aerial view of the building during the fire on January 19, 2017, showing the shopping mall at rear.

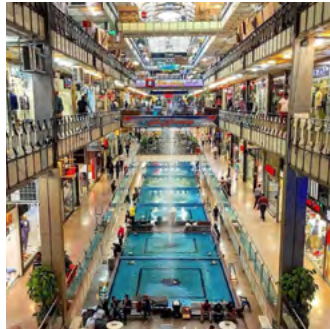
Figure 4: View of the four-story shopping mall from the entrance to it at the north side of the 15-story tower.

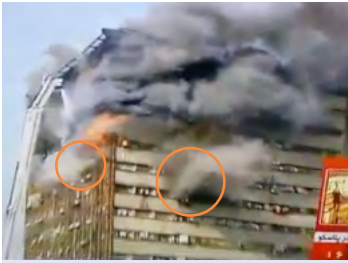
Figure 7: Video taken from the southeast.
https://youtu.be/XoyH_wYGpJ8

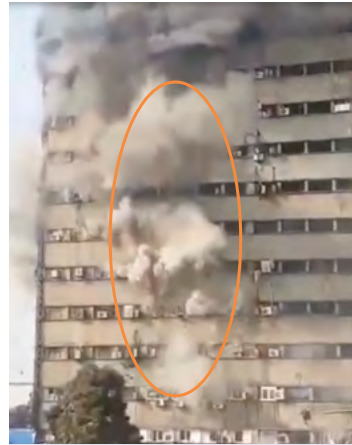
Figure 8: Video taken from the east.
https://youtu.be/_MgJTa7SDaY

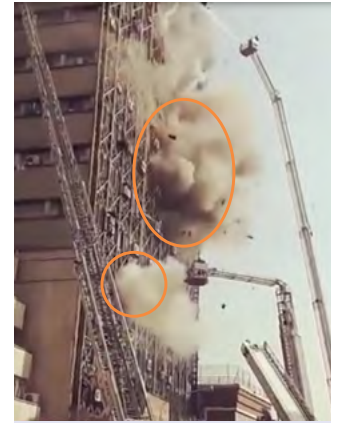
Figure 10: Video taken from the southwest closer to the building.
<https://youtu.be/jzB-QE8Emt0>

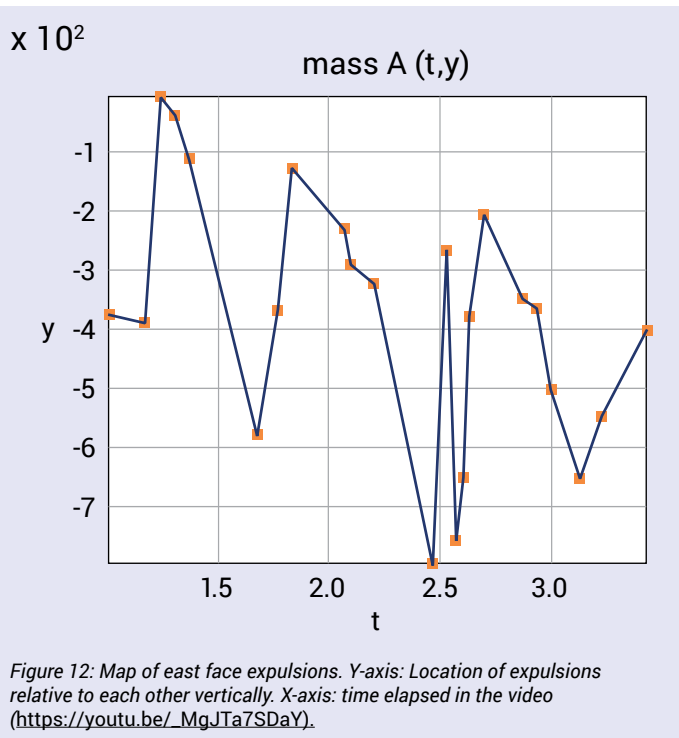
successively pancaking floors, we would expect expulsions to progress from one floor to the next downward. Also, we would not expect expulsions to occur on the same floor seconds apart, because the first expulsion on a given floor would relieve the air pressure on that floor, preventing later expulsions from that floor.

- A careful analysis of the series of expulsions that appear to travel down the east face of the building in a somewhat neat pattern reveals that, in fact, the expulsions occur in a disorderly sequence. As shown in Figure 12, which maps the time and vertical location of each expulsion on the east face, we see expulsions occurring high and low in the building, with no apparent order. We also see expulsions occurring seconds apart on the same floor. If the expulsions were caused by floor-wide air compression from

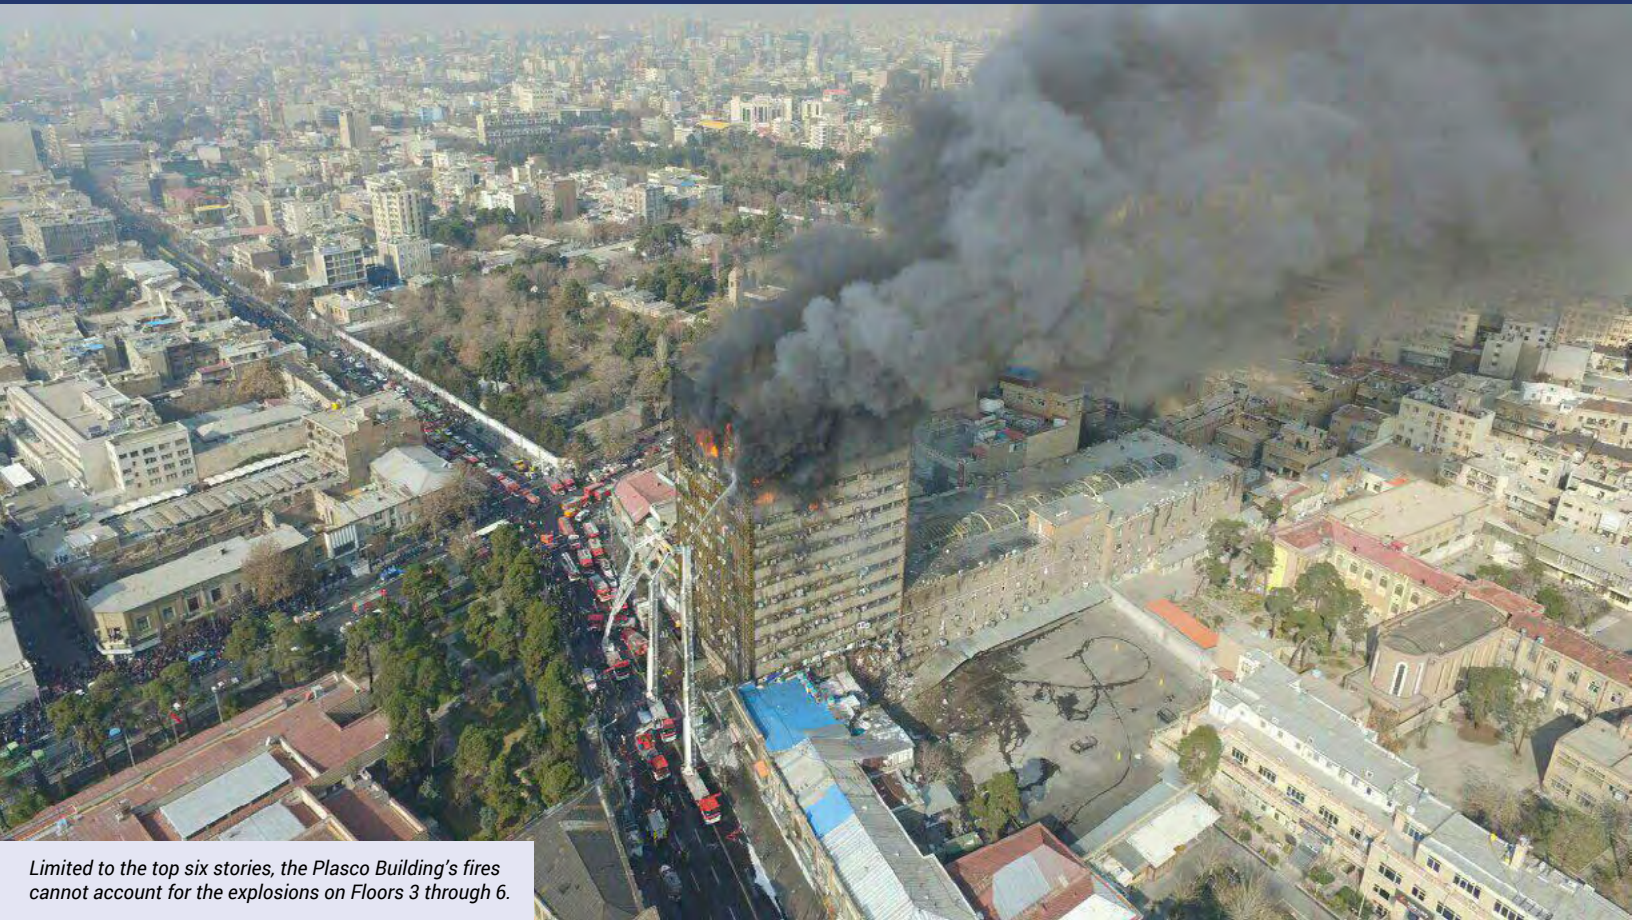
Limited to the top six stories, the Plasco Building's fires cannot account for the explosions on Floors 3 through 6.

Also, as we established in Section 2.1, fires could not have been the ignition source for the explosions that occurred before the collapse at the northeast corner on Floors 3 through 6, because the fires were limited to Floors 9 through 15. This fact alone appears to rule out the hypothesis that the explosions were caused by fire.
