METALLURGICAL FAILURE ANALYSIS—WHAT, WHY AND HOW

by
Edward L. Creamer

Engineering Advisor
Engineering Construction and Services
Shell Oil Company
Houston, Texas

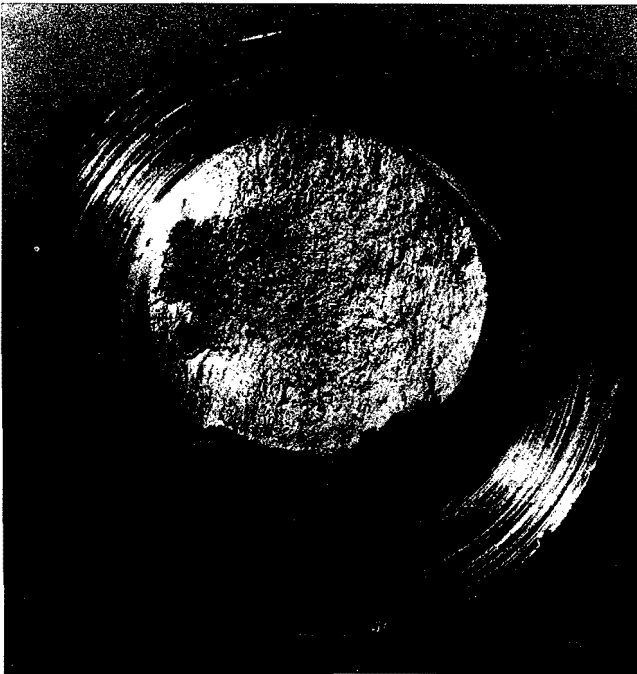
Figure 1. Ductile Fracture in Carbon Steel Resulting from Tension Overstress.

Tensile Overstress—Failures resulting from overloading in tension usually result in relatively simple fractures. In a ductile material, the failure is normally a shear fracture and is accompanied by plastic deformation in the failure zone (Figure 1). In a material with very limited ductility, the fracture is accompanied by little, if any, deformation (Figure 2). When examining a metallographic cross section from a ductile tensile overstress failure, the metallurgist normally detects severe localized distortion of the microstructure and a ragged fracture surface where ductility is lacking. Factors expected to be absent in a simple tensile overstress failure are multiple cracks, intergranular cracking, crack networks and/or evidence of environmentally assisted cracking.

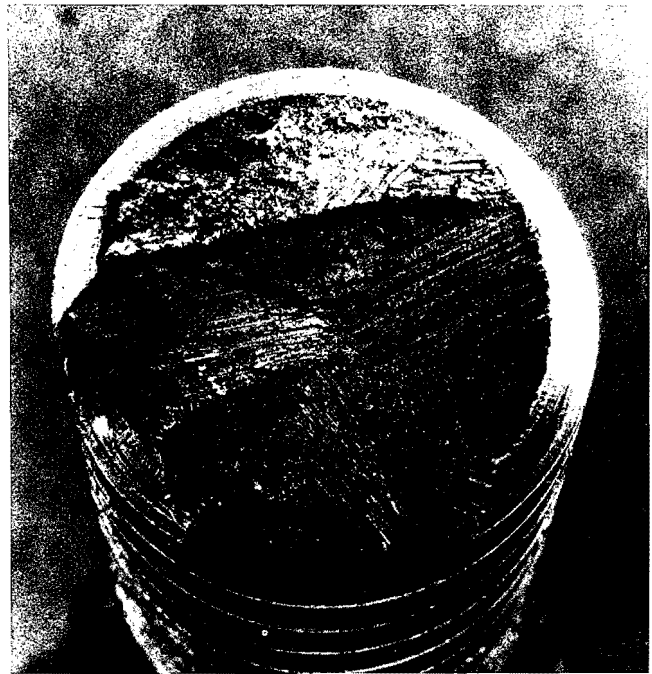
Figure 2. Low Ductility Fracture in Cast Hastelloy C Bolt Resulting from Tension Overstress.

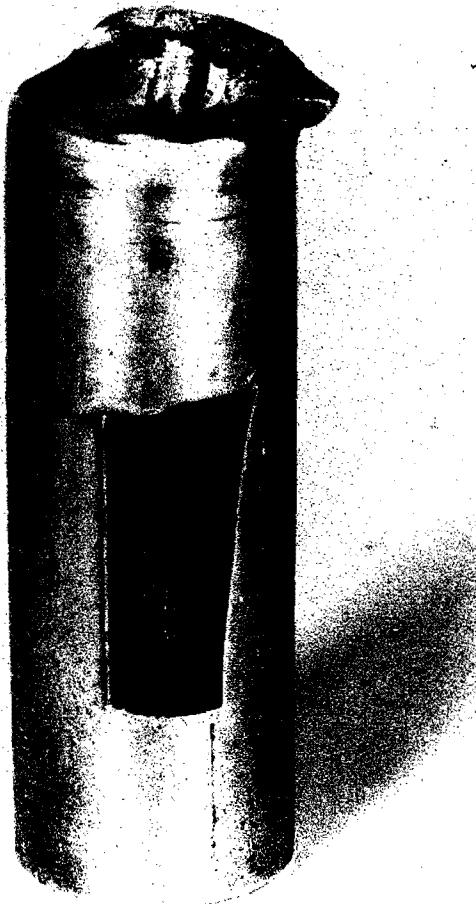
Figure 3. Torsional Overstress Failure in Carbon Steel Pump Shaft.

Torsional Overstress—When a component, such as a pump shaft, is overloaded in torsion, a torsional overstress failure occurs (Figure 3). The characteristic appearance of the

fracture is of vital importance in identifying the torsional overstress failure. In this example, further evidence of torsional overstress is found in the deformation of the rectangular section machined into the shaft surface.

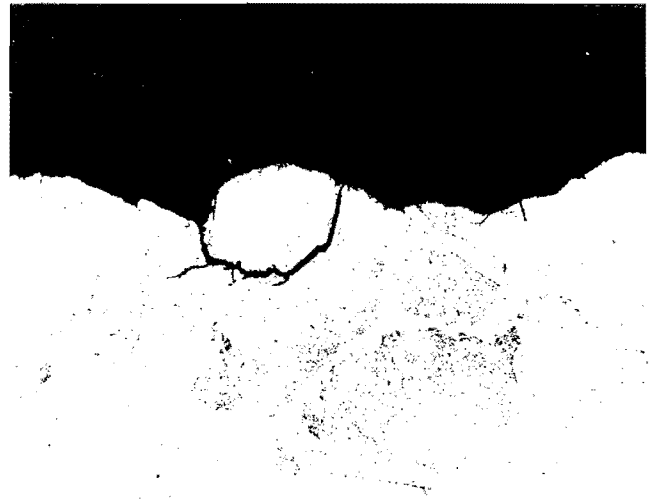
Figure 5. Section of Brittle Fracture Surface in a Medium Carbon Steel (Etchant: 2 percent Nital).

Brittle Fracture—When a brittle material experiences impact loading in the presence of a notch, a low energy brittle fracture can result (Figure 4). This type of failure can be especially serious because of the potential for releasing large quantities of the contained liquid or gaseous material. Microstructurally, brittle fractures are usually characterized by rough, transgranular fracture surfaces, sometimes exhibiting small secondary cracks (Figure 5). In diagnosing a brittle fracture, it is appropriate to examine not only the failed component for symptomatic evidence, but also to determine the brittle fracture susceptibility of the material by mechanical testing.

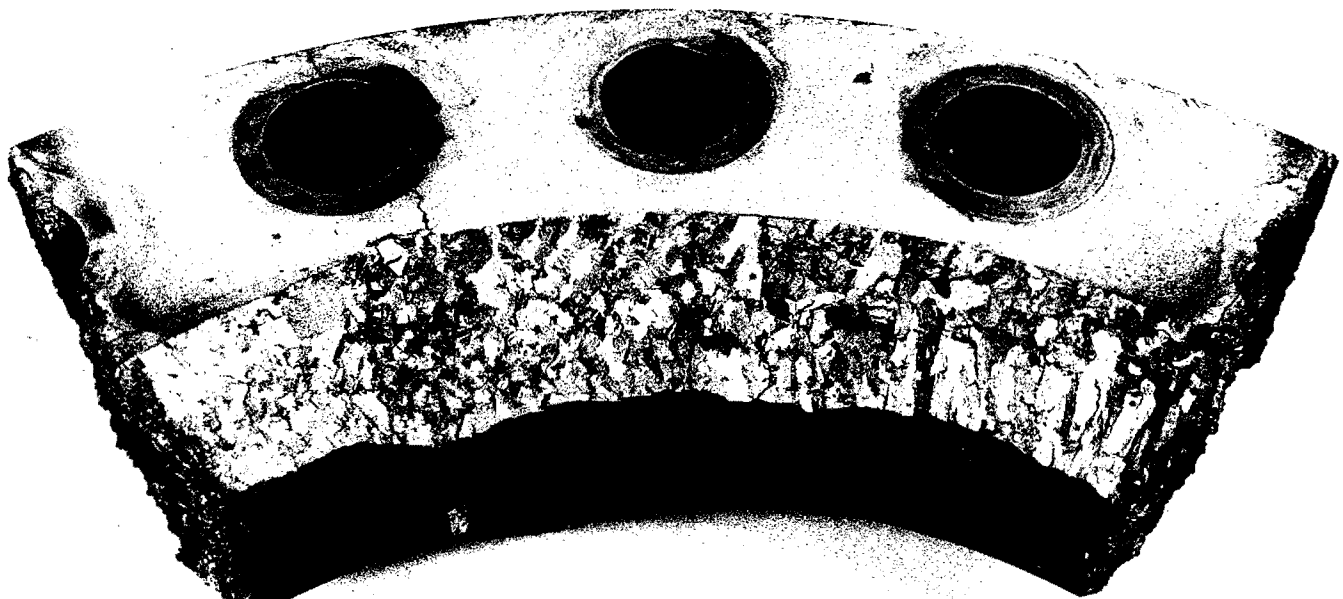
Figure 4. Brittle Fracture in 12 percent Cr Steel Casting.

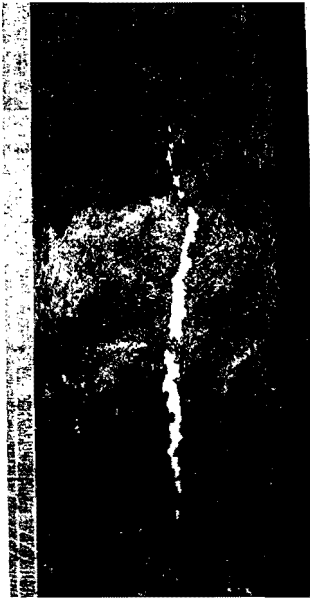
Figure 6. Creep Rupture Failure in Heater Tube.

Creep Rupture—When a material is exposed to stress and elevated temperatures for an extended period of time, deformation (creep) can be expected to occur. The rate at which creep occurs is dependent upon the strength of the material, the stress imposed, and the temperature. If the creep process continues unabated, rupture will occur eventually. Although, theoretically, this form of failure can occur in any stressed high temperature component, it is probably more frequently encountered in process heater and boiler tubes. Long-term creep rupture failures are usually accompanied by less overall deformation than is normally observed in a short-term high temperature tensile overstress failure (Figures 6 and 7).

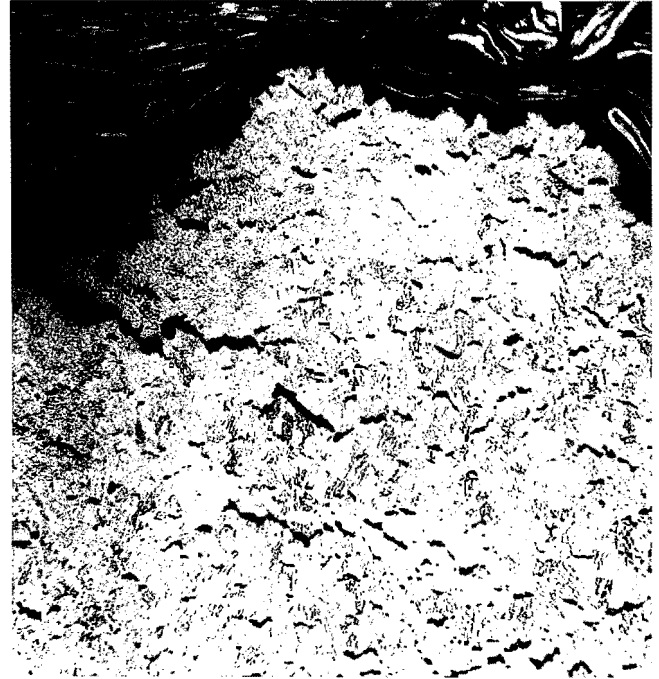
Figure 8. Microstructure of Heater Tube at Site of Creep Rupture Failure (Etchant: Vilella's Reagent).

In metallographic examination, metal that has failed in creep rupture exhibits little or no individual grain deformation in the microstructure. However, microvoids and microcracks are normally present and are in the greatest concentration nearest the rupture itself (Figure 8). By contrast, the microstructure in the rupture zone of a tube failure occurring at high temperature, with short-term tensile overstress, shows no microcracking but extensive grain deformation (Figure 9).

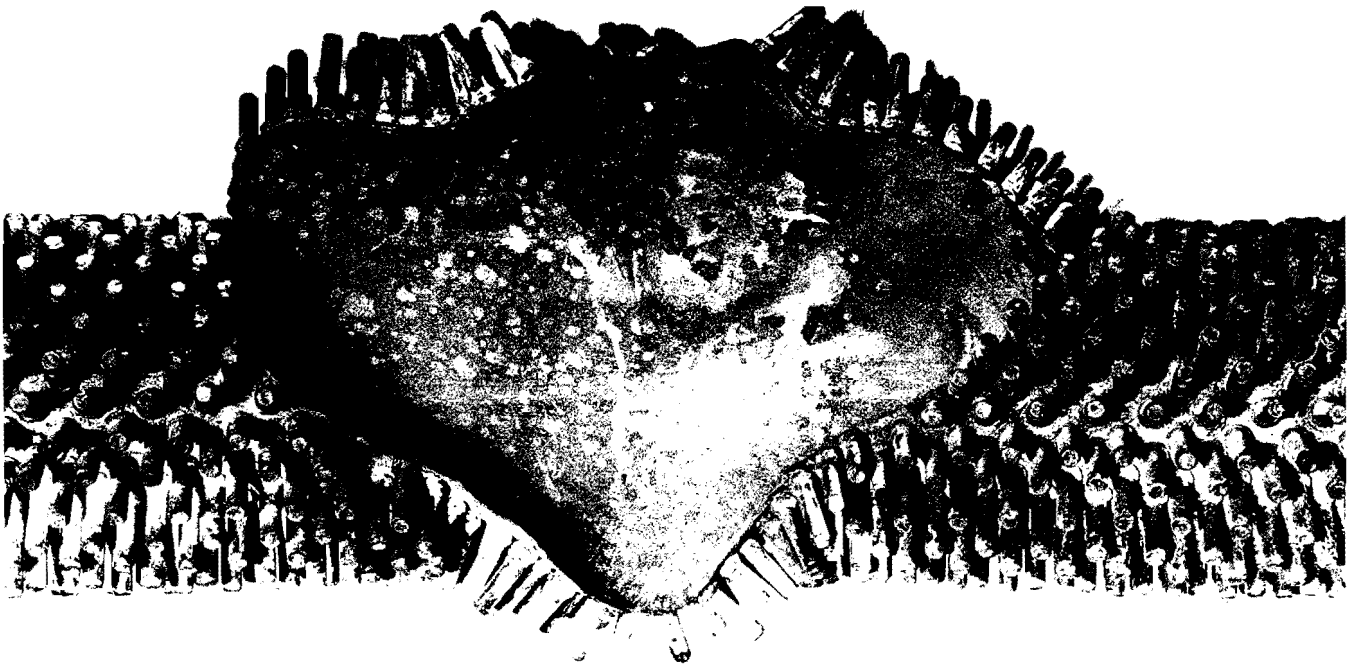
Figure 7. Short-Term High Temperature Tensile Overstress Failure in Boiler Tube.

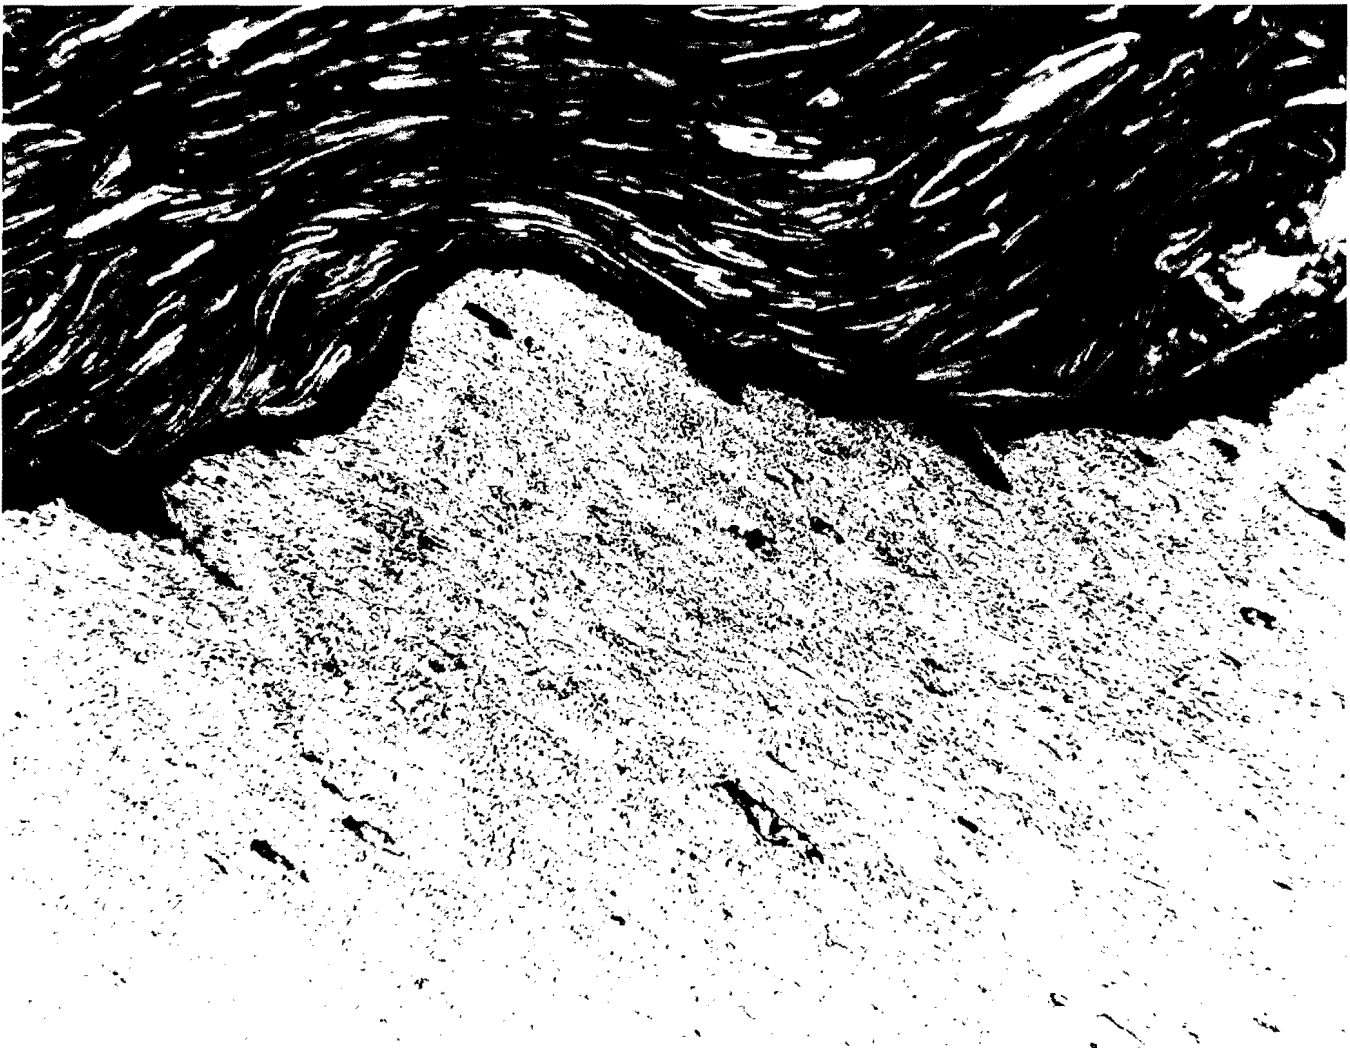
Figure 9. Microstructure of Heater Tube at Site of Short-Term High Temperature Tensile Overstress Failure (Etchant: Vilella's Reagent).

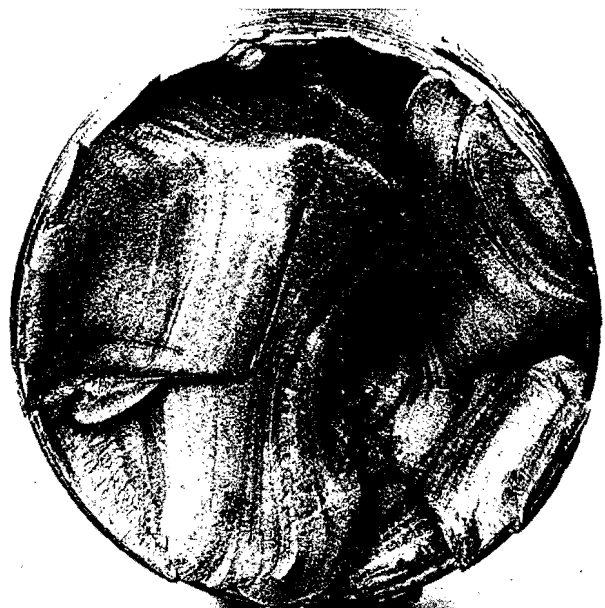
Figure 10. Fracture Surface of Pump Shaft Failed in Fatigue.

Fatigue failures usually exhibit both characteristic macroscopic and microscopic features. The appearance of a fracture surface in a shaft failed by fatigue (Figure 10) shows an extensive pattern of wave-like lines which reflect the cyclic nature of the loading that has occurred. After the fracture propagates by fatigue to a point at which the remaining intact section can no longer sustain the load, the fracture progresses to completion in either a ductile or brittle fashion, depending upon the properties and condition of the material. Metallographically, fatigue cracks are usually single rather than branched or filamentous and they often exhibit a step-wise appearance signifying several changes in direction (Figure 11). In scanning electron microscopic examinations of the fracture surfaces of fatigue failures, characteristic striations denoting cyclic stress are normally found (Figure 12). Fatigue cracks can occur in a wide variety of components, for example, a turbine blade (Figure 13), and a turbine hub, in this case drilled to arrest the cracks (Figure 14).

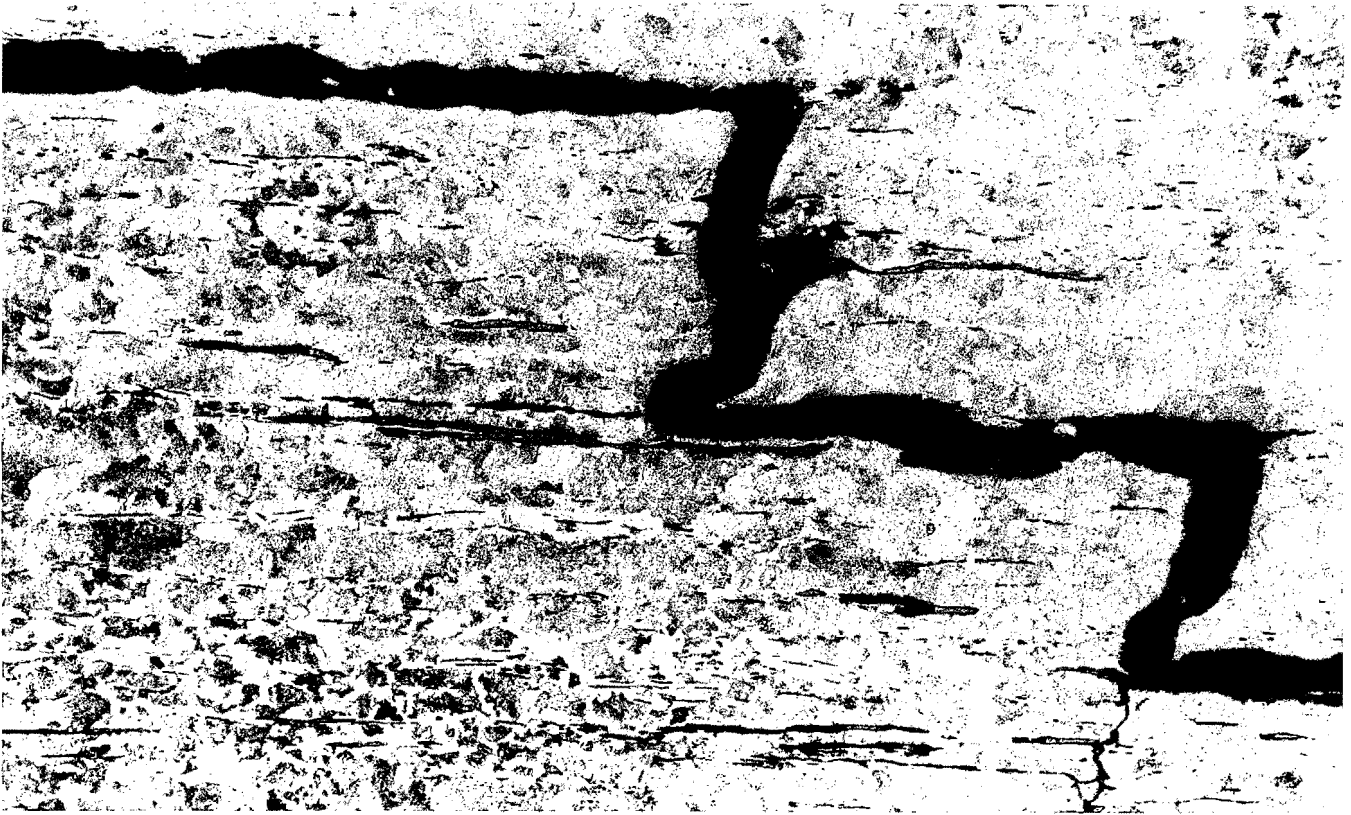
Figure 11. Characteristic Appearance of Cracks in Pump Shaft Failed in Fatigue (Etchant: 2 percent Nital).

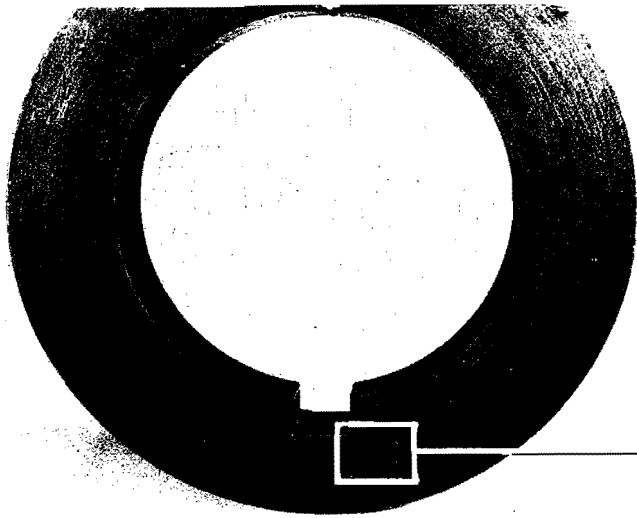
Figure 14. Section of Turbine Hub Cracked by Fatigue at Keyway Corners. The drilled holes are intended to prevent the propagation of the cracks.

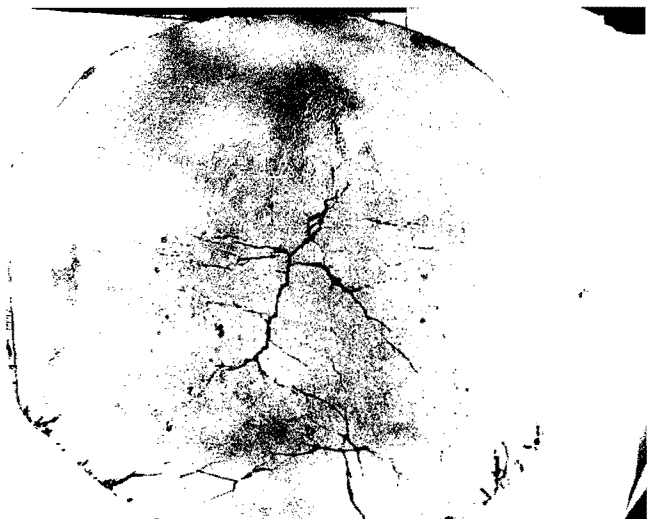
Figure 17. Chloride Stress Corrosion Cracking in Austenitic Stainless Steel Vessel Plate.

Stress Corrosion Cracking—When a susceptible material, such as an austenitic stainless steel, is subjected to residual or applied stress in the presence of a suitable corrosive medium, such as an aqueous chloride solution, failure by stress corrosion cracking can occur. Damage by this complex mechanism is usually severe. The cracking may be widespread, both macroscopically (Figure 17) and microscopically (Figure 18).

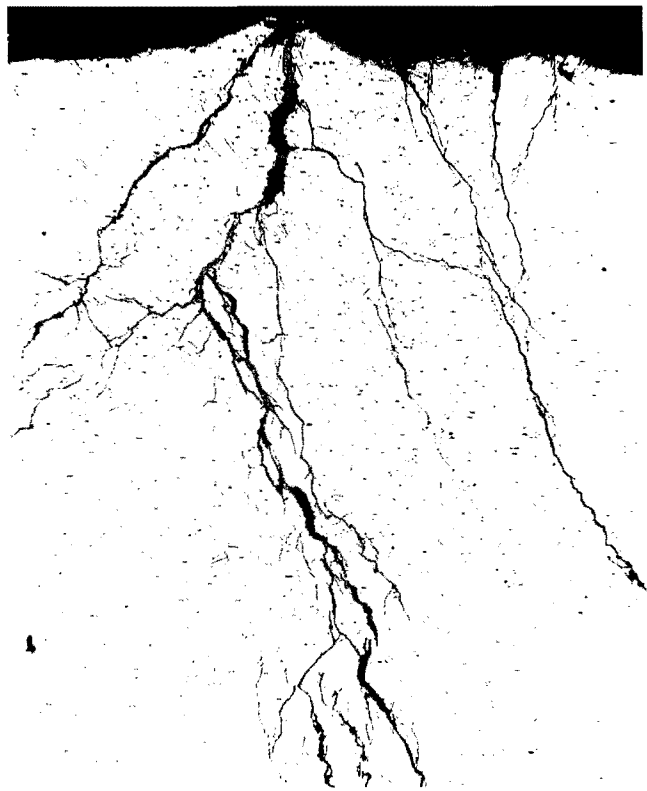
Figure 18. Section of Austenitic Stainless Steel Vessel Section Damaged by Severe Chloride Stress Corrosion Cracking (Etchant: Glyceregia).

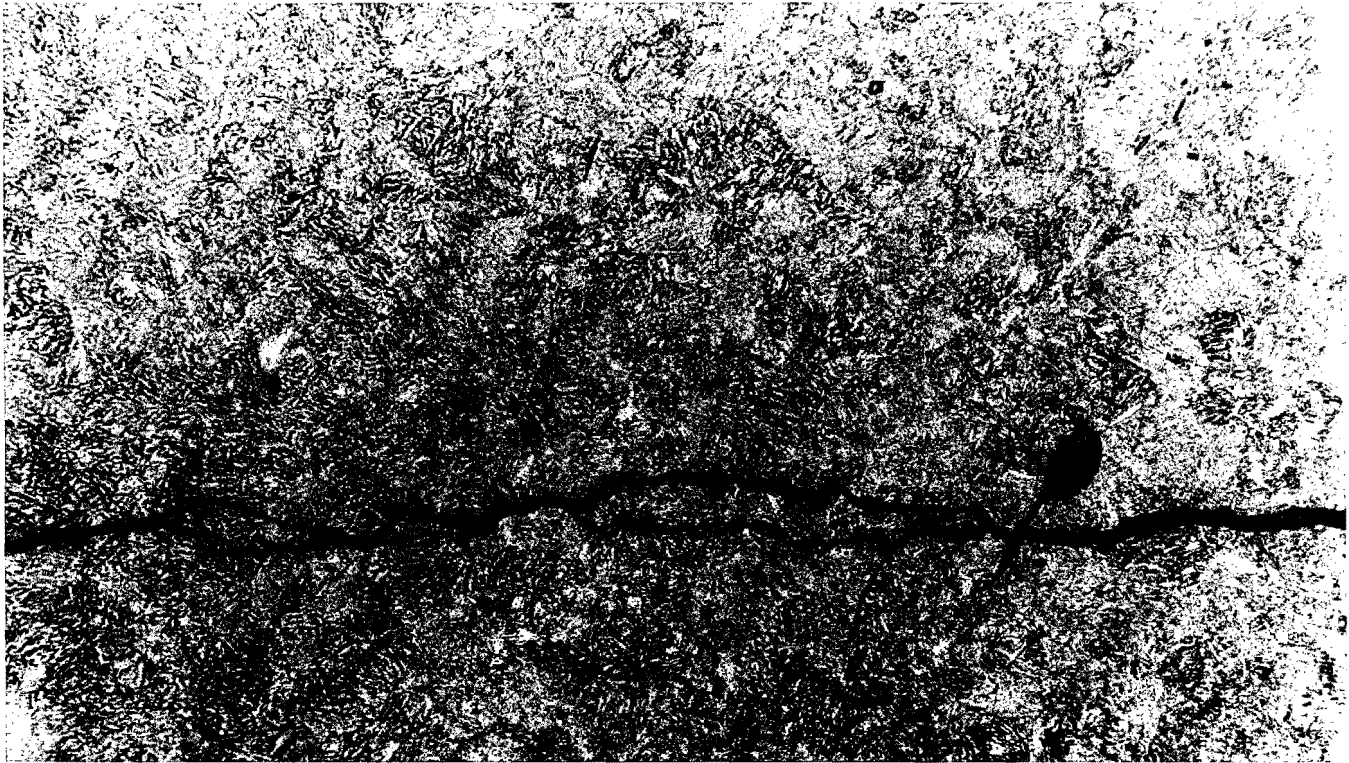
Figure 20. Section of Alloy Steel Bolt Failed by Sulfide Corrosion Cracking (Etchant: 2 percent Nital).

Sulfide Corrosion Cracking—When steels are contacted by aqueous hydrogen sulfide, the resulting corrosion reaction produces atomic hydrogen. Some of this hydrogen diffuses into the steel and can result in a failure, depending upon the strength of the steel and the stress level present. Although this failure mechanism is termed sulfide corrosion cracking and sometimes sulfide stress cracking or other similar terms, the mechanism actually depends upon the presence of atomic hydrogen in a metal having relatively high strength and correspondingly limited ductility. Failures produced by this mechanism macroscopically exhibit no deformation (Figure 19). Metallographically, the cracking is usually multiple, fine, and predominantly intergranular (Figure 20).
