INCREASED RELIABILITY AND REDUCTION IN LONG TERM COST OF OWNERSHIP THROUGH PROPER SPARE ROTOR STORAGE, INSPECTION, DOCUMENTATION, AND TRACKING

Rod Mitchell

The Dow Chemical Company

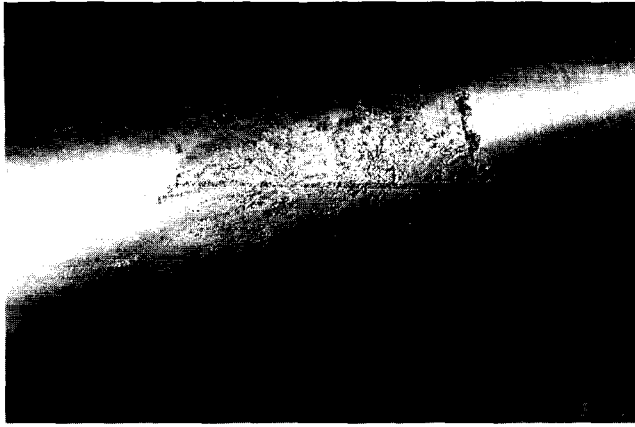
Figure 2. Severe Corrosion Damage of Bearing Journal as a Result of Long Term Storage.

The need for a rotor storage facility was originally identified in 1988. This was because the rotors in the division were stored in various warehouses throughout the division, utilizing a number of different storage methods that included rotor cans, dog houses, wooden boxes, pallets, etc. None of these storage methods proved to be very reliable. As a result of these ineffective storage methods, the corrosion problem was still causing significant damage to the rotors, which resulted in unnecessary costs (Figures 1, 2, and 3).

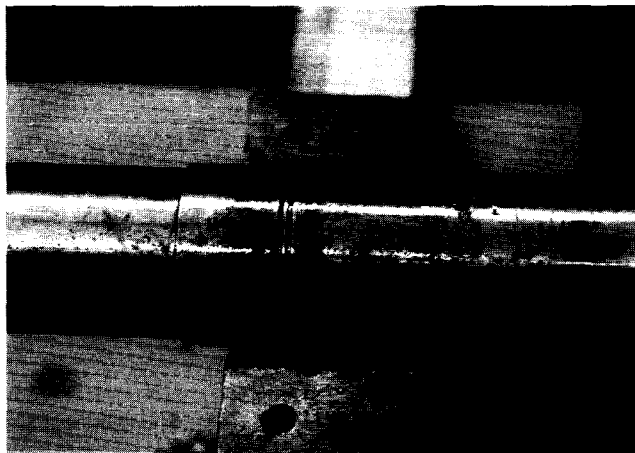
Figure 3. Severe Corrosion Damage of Bearing Journal as a Result of Long Term Storage.

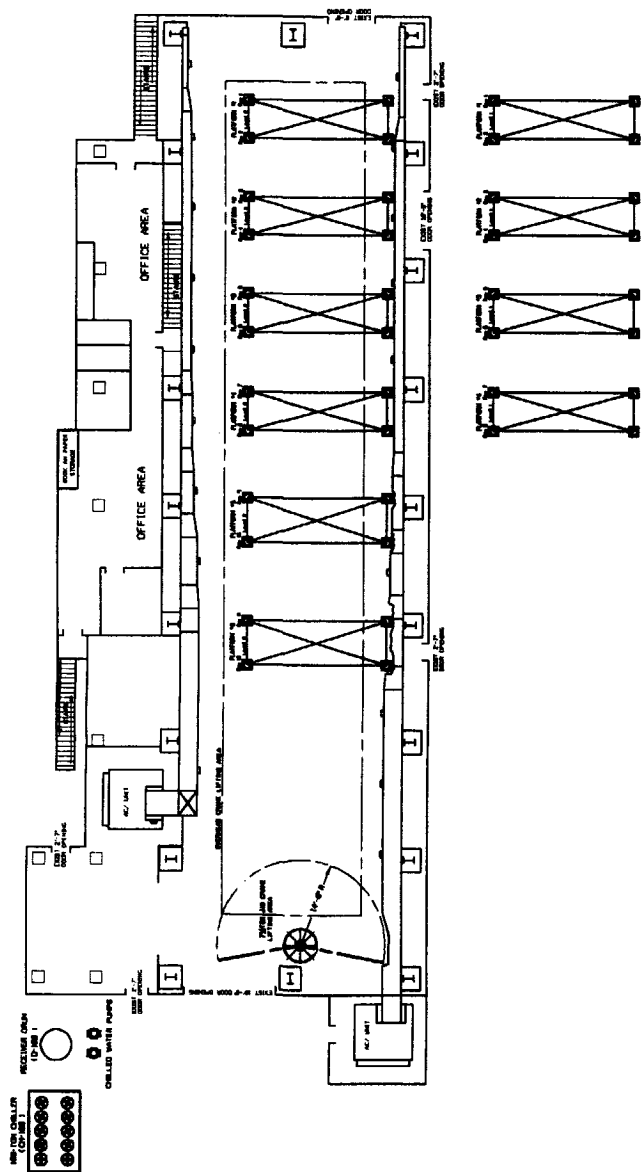
Figure 5. Floor Plan of Rotor Storage Facility Showing the General Layout of the Storage Racks and Staging Area.

To minimize lifting over other equipment and to maximize rotor access and mobility, the decision was made to establish six racks with two rows of rotors on each rack. Between each rack there was sufficient space to allow any rotor to be removed from the rack and moved down the alley between the racks to an alley that runs along the racks, which leads to the rotor staging area (Figure 5).

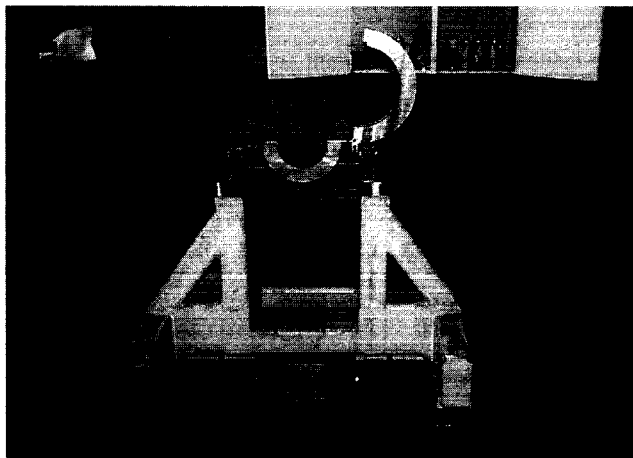
Figure 6. Rolling Support Stand with Pivot Block Assembly Used to Rotate the Rotors from the Horizontal to Vertical Position.

After the problems had been identified, a plan was developed to address each step. To address the first step, a rolling pivot block system was designed. The system consisted of two stands that supported the rotor when it was in the horizontal position. One of the stands was equipped with a pivot block assembly, which clamped onto the shaft utilizing a pivot stand bushing, and the other stand had an adjustable v-block (Figures 6 and 7).

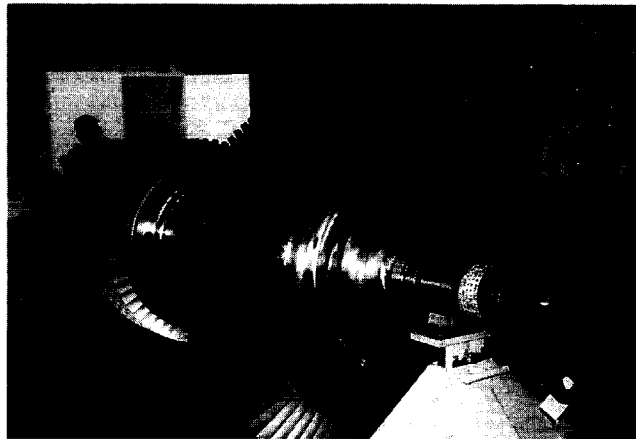
Figure 9. Gas Turbine Rotor Positioned in the Horizontal Position in the Rolling Pivot Block System, Ready to Be Lifted into the Vertical Position.

geometry to fit the specific shaft end. This allowed for multiple shaft ends to utilize the same pivot block assembly (Figure 8). The main purpose of the pivot bushing was to support the weight of the rotor and to react the axial load of the rotor against one of the shoulders on the shaft end, as it was lifted in the vertical position. This allowed the crane to be attached to the other end of the rotor and lift it straight up as the stand rolled forward, while the crane continued to lift the rotor. Once the rotor is in the vertical position, the rotor could then be lifted through the pivot block or, if it had an integral flange, the pivot block could be removed (Figures 9 and 10).

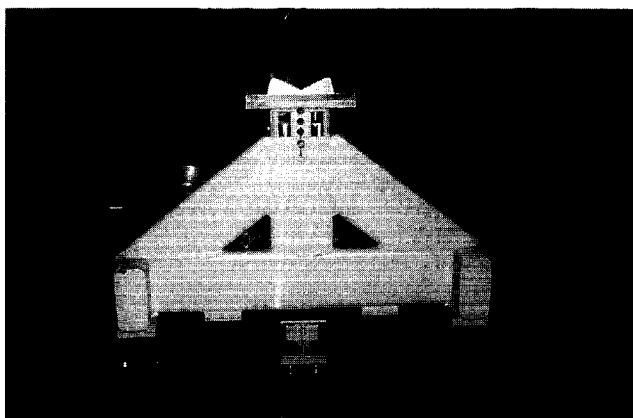
Figure 7. Rolling V-Block Stand Used to Support the Rotor in the Horizontal Position.

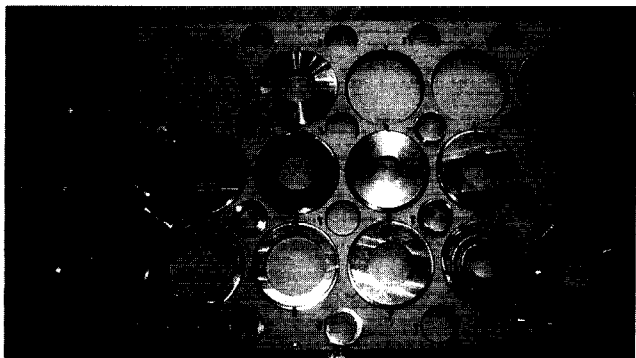
Figure 8. Assortment of Pivot Block Bushings Utilized to Adapt the Various Rotor to the Pivot Block Assembly.

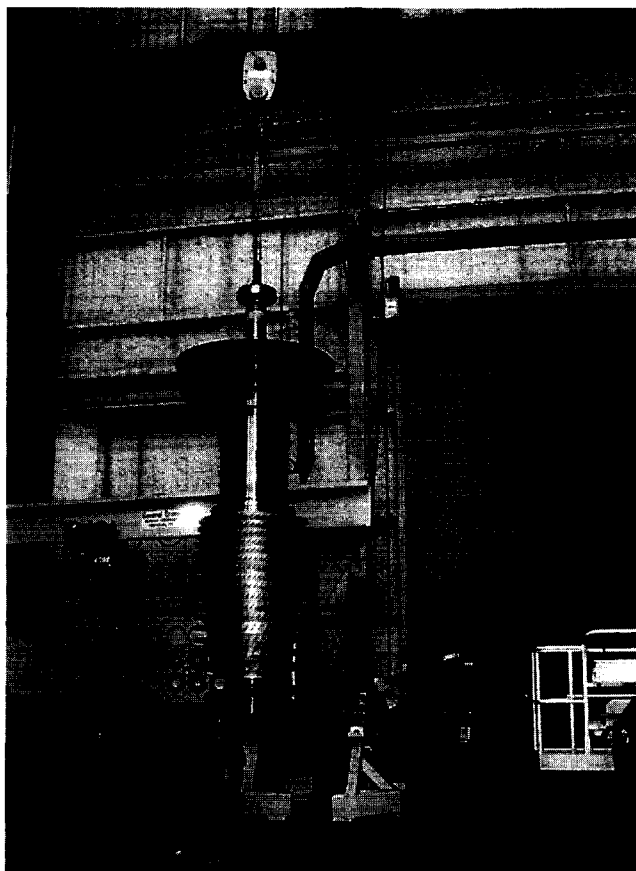
Figure 10. Gas Turbine Rotor Rotated to the Vertical Position and Ready to Be Removed from the Pivot Block Assembly.

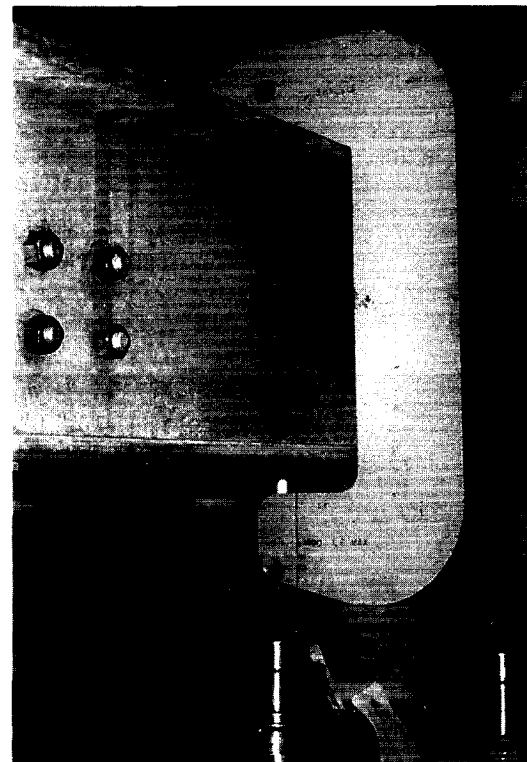
Figure 12. Standardized Fixturing Package for a Rotor That Utilizes the Coupling Nut Threads (which includes a rotor hanger, hoist ring, and an adapter plate threaded onto the coupling nut threads).

Three basic shaft end configurations were identified. They were the drilled and tapped shaft end, the integral coupling flange shaft end, and the tapered shaft end with the coupling nut (Figures 11 and 12). Standard design procedures with drawing details were developed for each. The preferred arrangement is the drilled and tapped shaft end, which does not utilize any type of adapter fixture and requires the drilled and tapped hole to be placed in the nondrive end of the rotor, if possible.

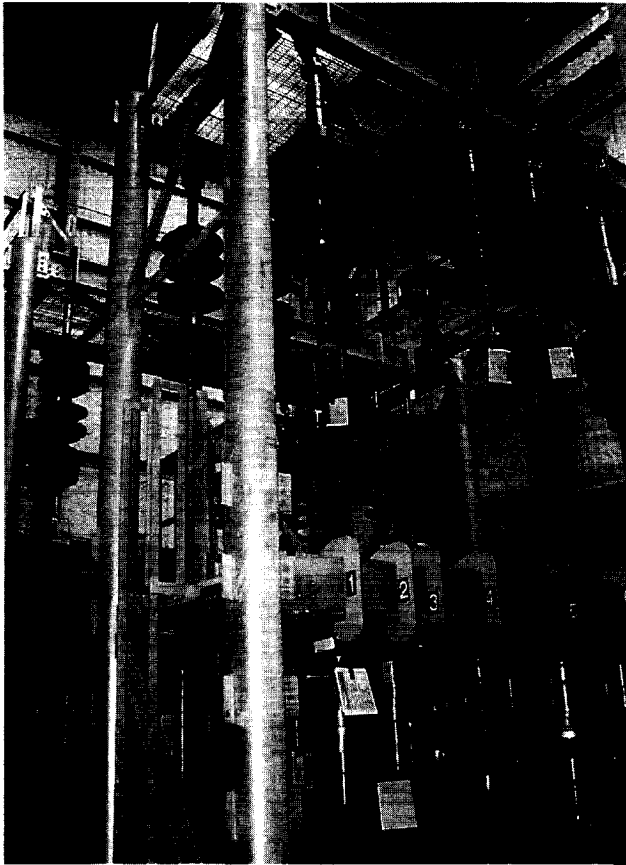
Figure 14. Two Level Storage Rack.

To maximize the rotor storage space, two standard types of storage racks were designed and constructed. The first storage rack design was a two level rack that had an adjustable bottom rack and a fixed top rack. This rack design could support multiple rotor weights up to a maximum total weight of 40,000 lb per I-beam, and lengths up to 13 ft on top and 7 ft on bottom (Figure 14). The other rack design was a single level rack that could support multiple rotor weights up to a maximum total weight of 60,000 lb per I-beam and a length of 21 ft (Figure 15). In addition to being able to support the weight of the rotor, they were also designed to withstand a wind load rating of 150 mph.

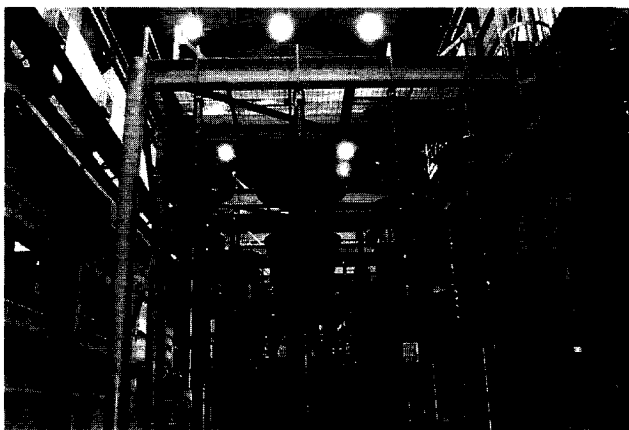
Figure 15. Single Level Storage Rack.

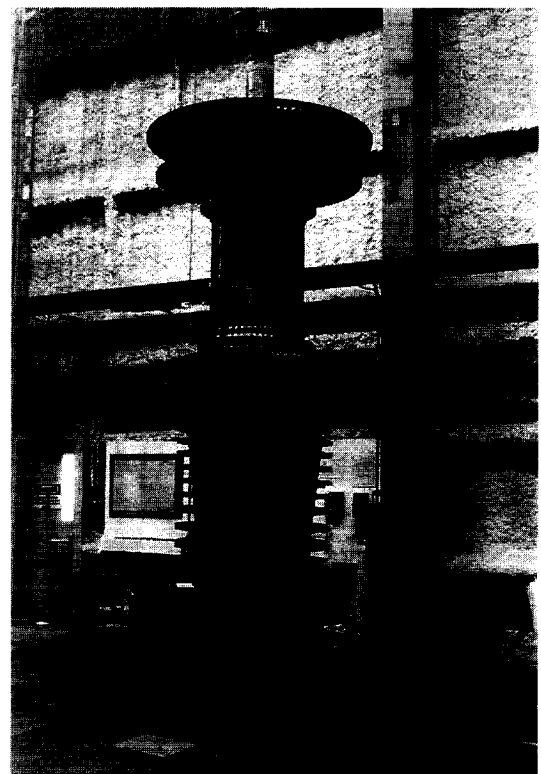
Figure 17. Gas Turbine on Support Stand.

The rotor storage racks were used to store all rotors except the gas turbines. The decision was made not to hang the gas turbine rotors due to the through bolting in the compressor section. Individual support stands were designed and fabricated on which those rotors would stand (Figure 17).

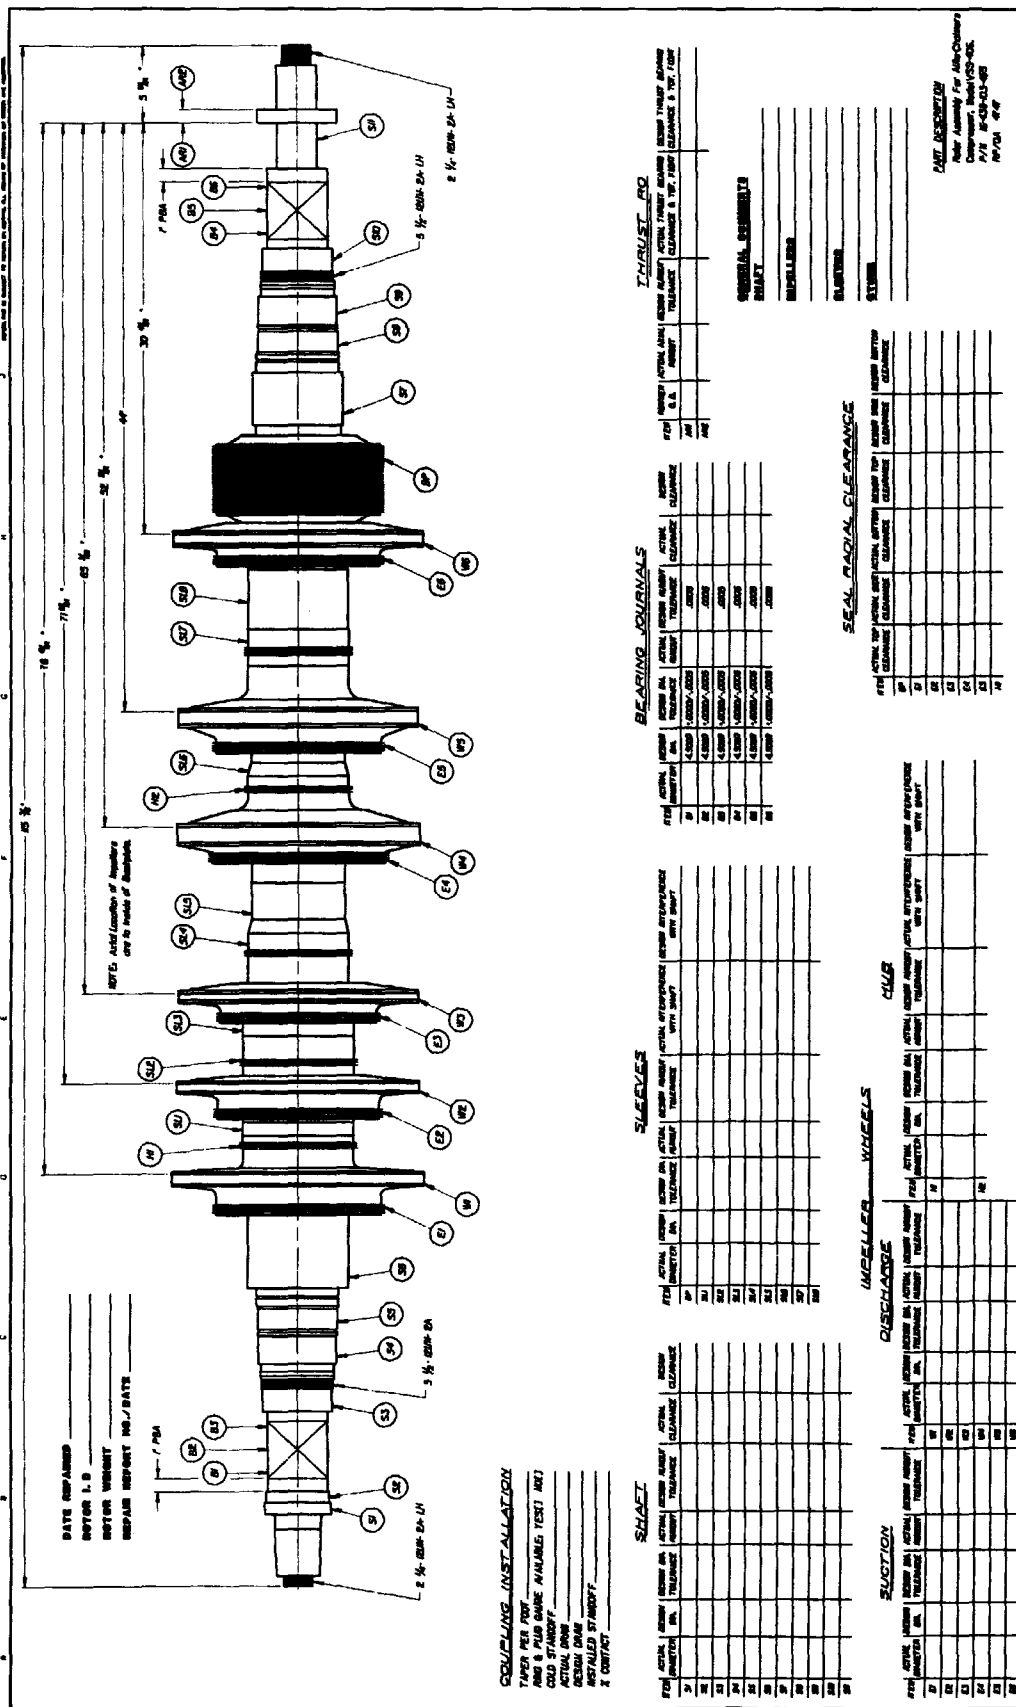
Figure B-1. Typical Critical Information Drawing for a Centrifugal Compressor Rotor.

CID provides an effective means for documenting and combining the vast amount of information that is critical to the repair and overhaul of the rotor into a standard documentation format (refer to APPENDIX B, Figure B-1).

The design dimensions and tolerances, along with the actual measured dimensions, are contained in the drawing. The majority of the design information is obtained from the manufacturer. When this information is not available, it is acquired by reverse engineering. When new equipment is purchased, the manufacturers are asked to complete a CID as part of the supplier required documentation. This helps reduce the amount of time and cost required to develop the CID, and ensures all the design information is received at the time of purchase.

Once the design information is obtained, it is made a permanent part of the drawing, which is then stored electronically. Each equipment type has a standard drawing format that is then adapted to each individual rotor. The actual dimensions for the rotor are recorded on the drawing as part of the inspection process and the operational clearances are recorded when the rotor is installed in the actual piece of equipment. The various information contained in a standard CID is detailed as follows:

- *General description*—The drawing consists of an outline of the specific rotor with labels identifying all the critical areas. Each of the major components is listed with the required information. Also, there is a section to provide general background information and describe visual observations.
