**HP Gas Compressor Package (M-12820C) - NDE Bearing**

**HP Gas Compressor Package (PK-12820C) - Gearbox**

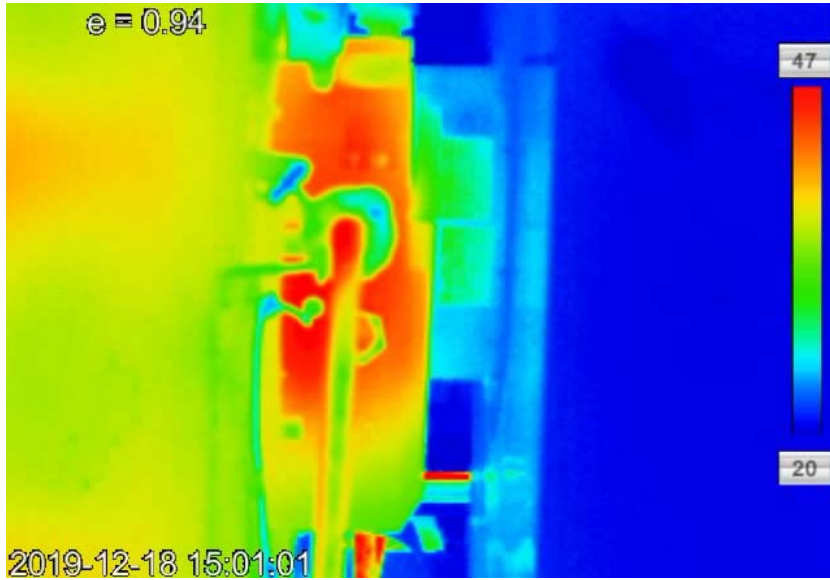
Previous Temp 12-Dec-2019	Current Temp 18-Dec-2019	$\Delta T$ (C)	Allowable Temp (Bearing Housing / Electro-motor)
<b>Electromotor</b>	56	52	-4	80 / 120
<b>Gearbox</b>	70	69	-1	-
<b>Compressor</b>	81	104	+23	130
<b>Comment</b>	Heat distribution status and temperature values are normal. Hot spots are found in some pipping and flange areas. This can be caused by decreasing thickness.
