Seismic Conceptual Design of Buildings – Basic principles for engineers, architects, building owners, and authorities

Hugo Bachmann

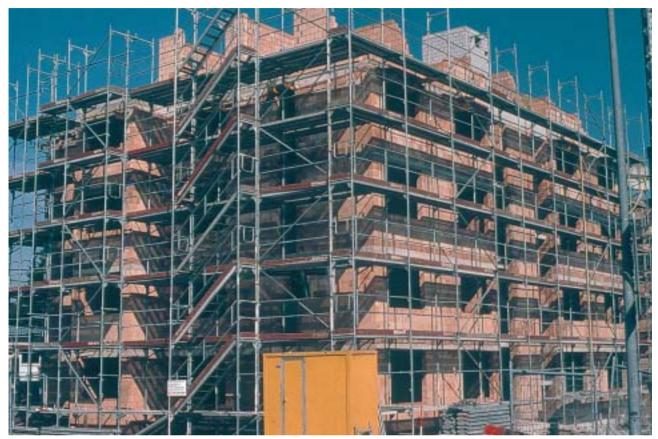
2/1 Buildings are still built for which no verification of adequate seismic resistance is conducted in accordance with the current building codes. In the case of this masonry building, it appears that no adequate measures (e.g. reinforced structural concrete walls) were taken. An insufficient earthquake resistance may cause a significant reduction in the value of the building, and may be the cause of a civil liability lawsuit (Switzerland, 2001).

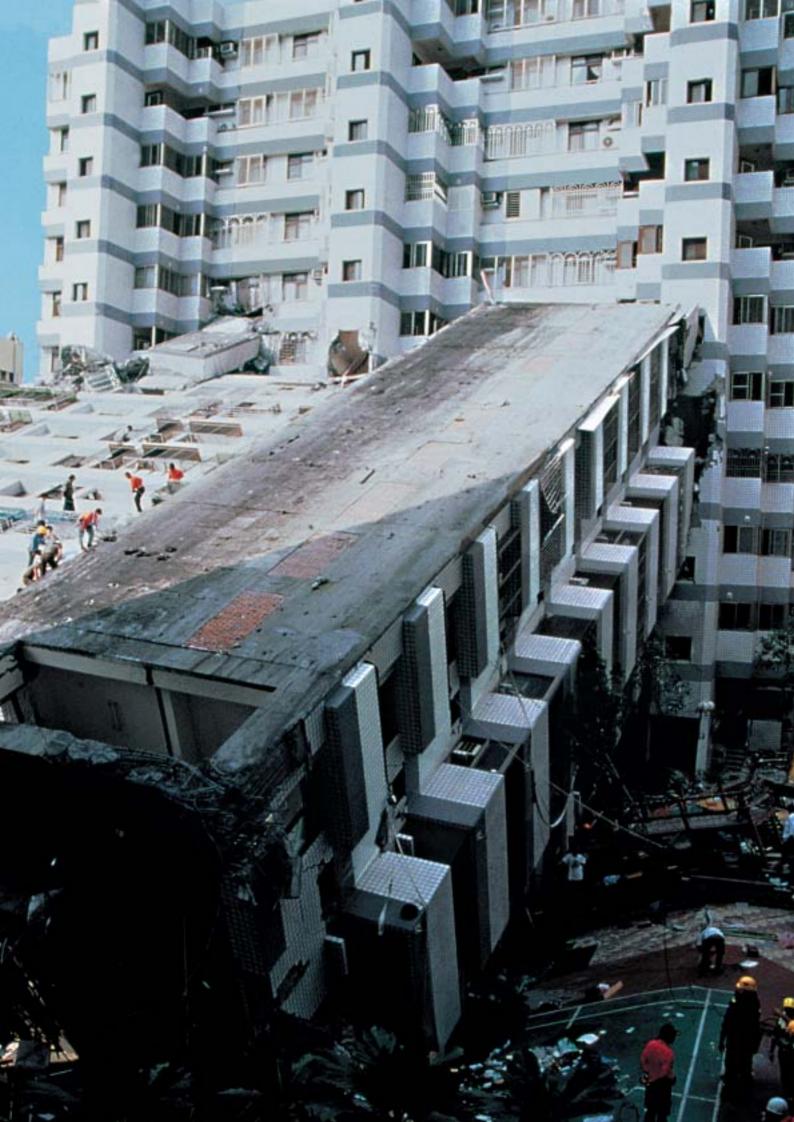
Page 16 4/4 This residential building is tilted as a result of column failure (Taiwan 1999).

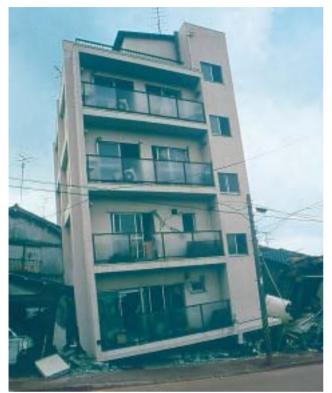
$4/5\,$ The well-braced upper part of the building collapsed onto the ground floor...

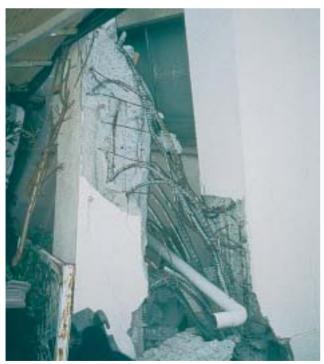
$4/6~\ldots$ and these are the remains of the left edge ground flour column (Kobe, Japan 1995).

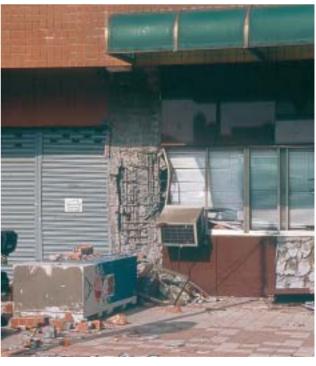
$4/8~\ldots$ thanks to resistant columns with well detailed stabilising and confining reinforcement (Taiwan 1999).

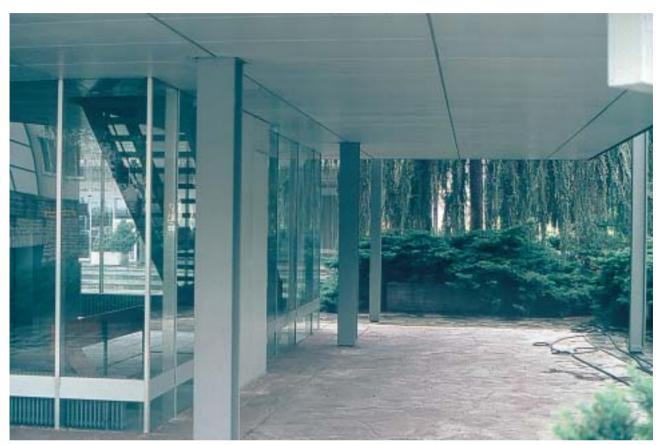
4/9 It is feared that existing buildings such as this one could collapse under even a relatively weak earthquake (Switzerland 2000).

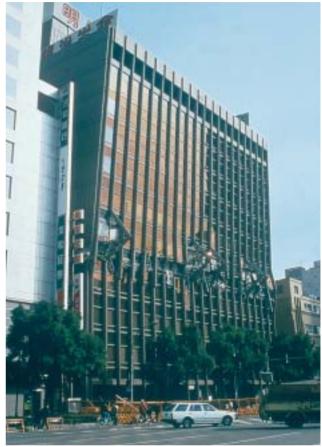
5/2 In this office building also, an upper storey failed. The top of the building has collapsed onto the floor below, the whole building rotated and leaned forwards.

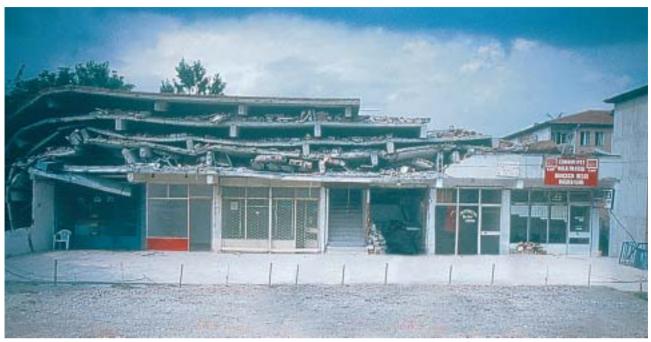
5/4 All the upper floors were too soft (Izmit, Turkey 1999).

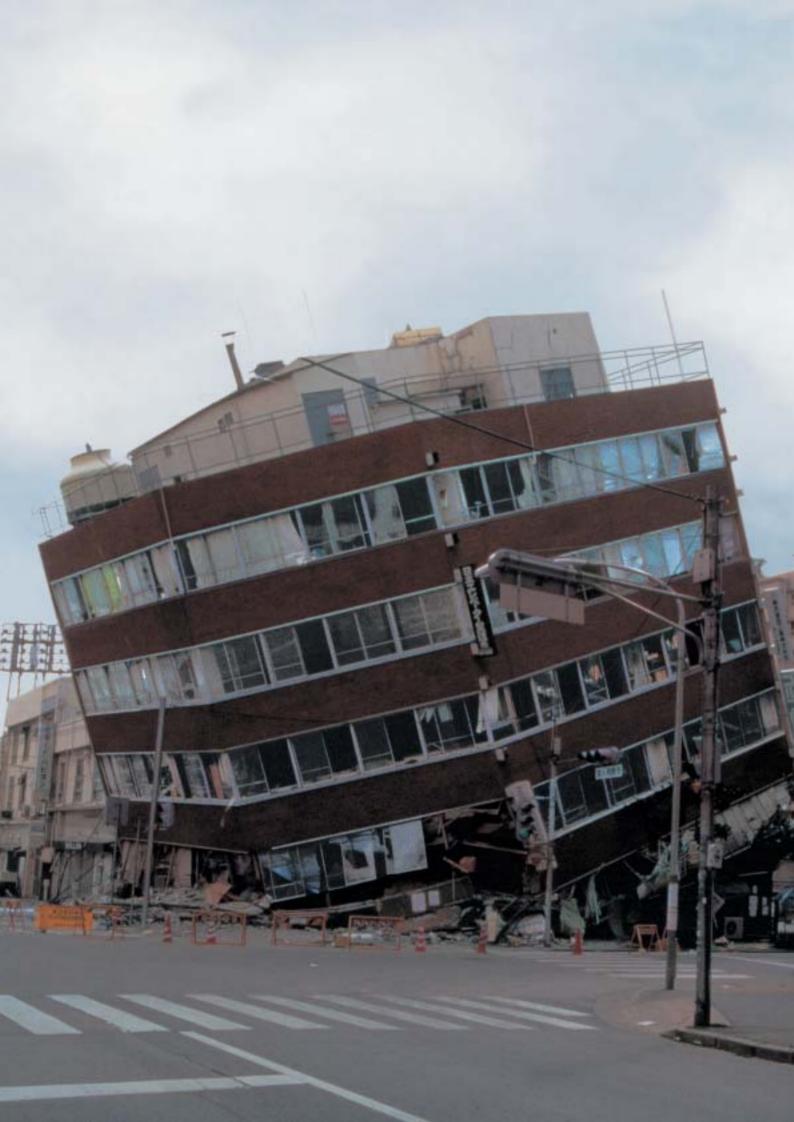
6/2 This office building had a continuous fire wall to the right rear as well as more eccentric bracing at the back. The building twisted significantly, and the front columns failed (Kobe, Japan 1995).

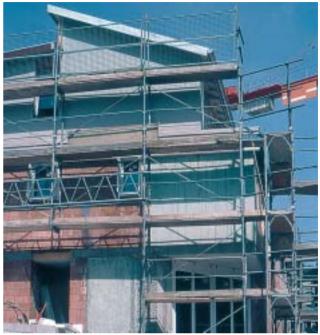
7/1 The horizontal offset of the reinforced concrete wall in the vertical plane causes large additional stresses and deformations in the structure during an earthquake. They include large local vertical forces (from the overturning moment), large additional shear forces in the slabs at offsets, redistribution of the foundation forces, etc. (Switzerland 2001).

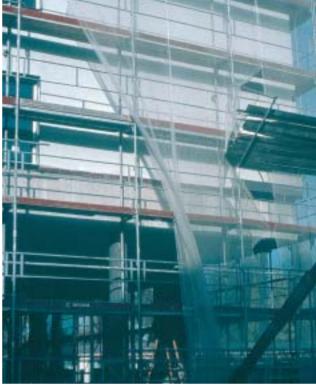
8/2 During an earthquake, the reinforced concrete cantilever wall (behind the curtain), will induce significant additional stresses in the already highly loaded column on the ground floor (Switzerland 2001).

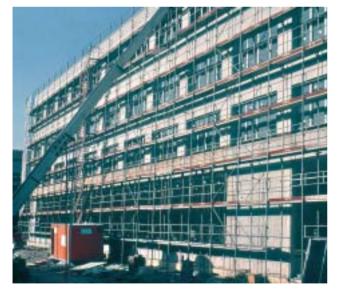
8/1 The transition from a reinforced concrete structural wall to a frame structure causes large discontinuities in stiffness and resistance (Switzerland 2001).

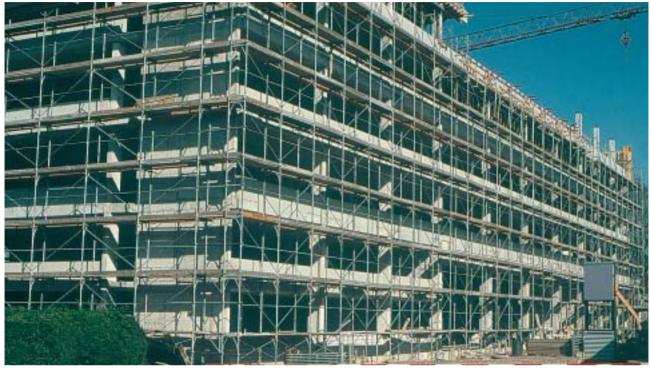
9/3 This skeleton structure has reinforced concrete structural walls in the transverse directions at two building corners.

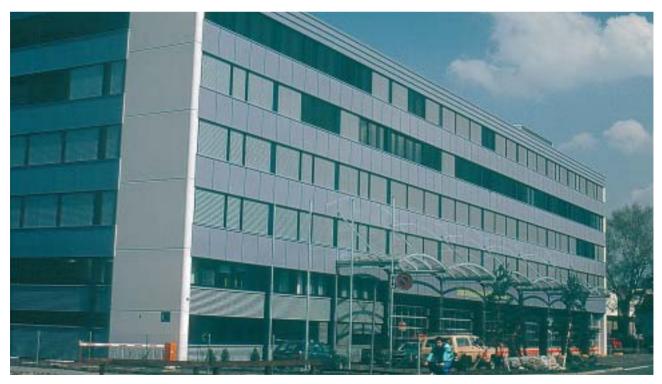
$9/4\;$ The structural walls were included as prominent elements in the architectural concept (Switzerland 1994).

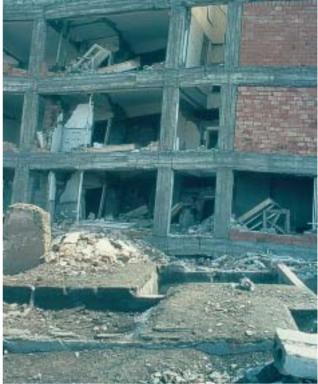
11/1 Here the columns were clearly stronger and the masonry fell out while the frame remained standing (Erzincan, Turkey 1992).

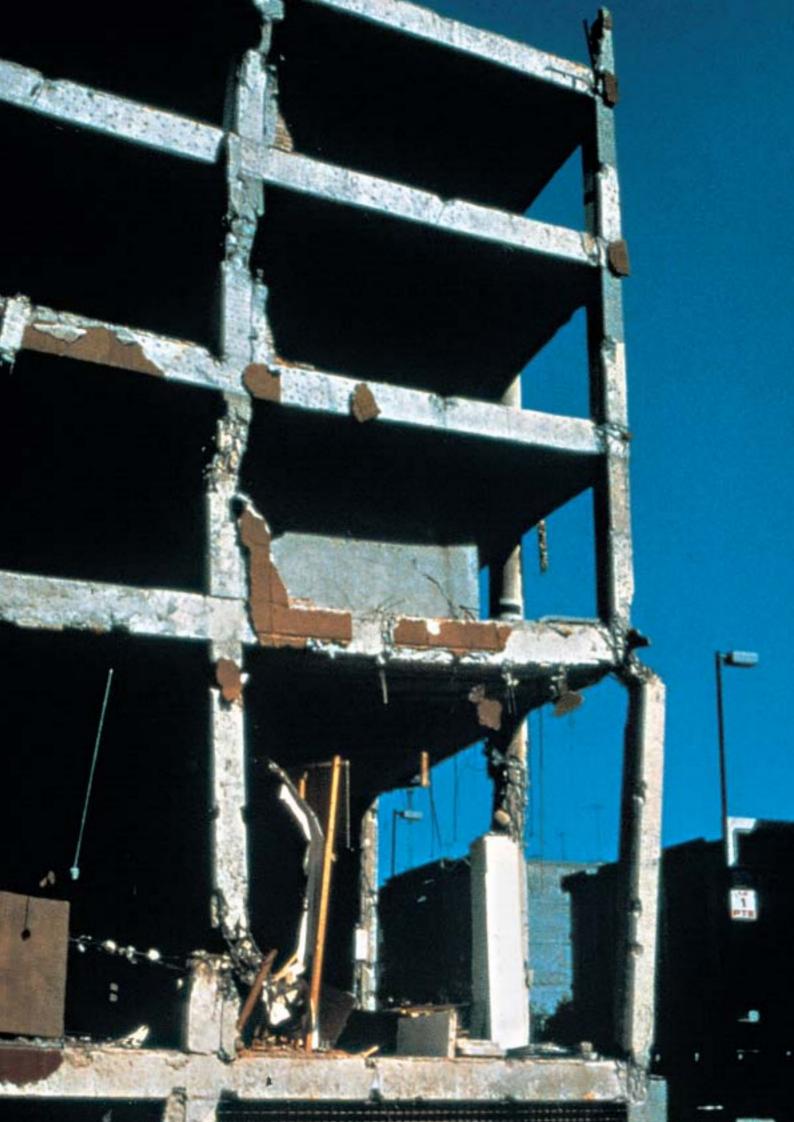
11/2 In this case the masonry was stronger: The columns experienced significant damage and were partly sheared; nevertheless, the frame is still just standing (Mexico 1985).

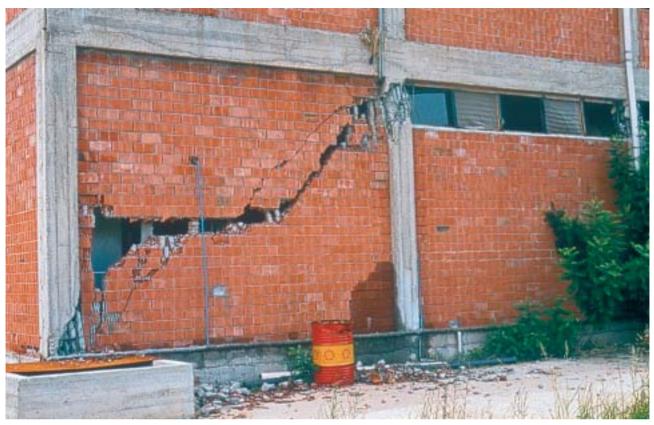
11/3 The masonry was also stronger in this case; it sheared the relatively large columns (Adana-Ceyhan, Turkey 1998).

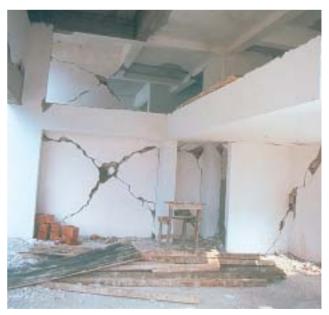
11/4 These diagonal cracks are typical of reinforced concrete frame masonry infills (Turkey, Izmit 1999).

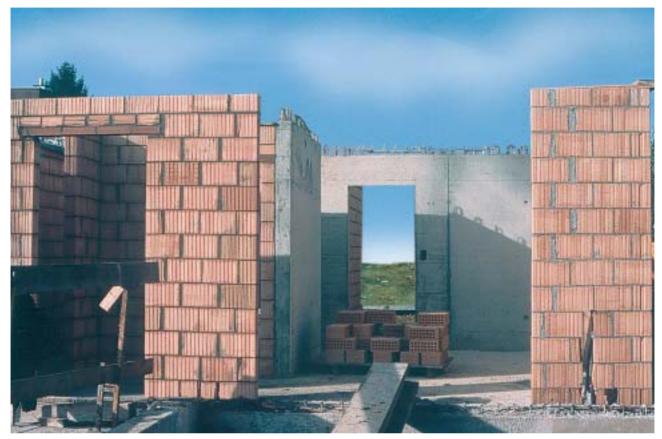
12/3 This new 4-storey masonry structure is braced by one reinforced concrete structural wall in each major direction. There is also a long masonry wall in both directions that has a horizontal layer joint reinforcement and is anchored to the concrete wall (Switzerland 2001).

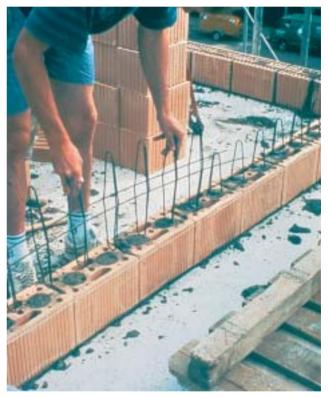
13/1 13/2 Reinforced masonry requires special bricks, particularly to incorporate and coat the vertical reinforcing bars. Worldwide developments in reinforcing systems and adequate bricks are under way. The two pictures show new developments in the clay masonry industry (Switzerland 1998).

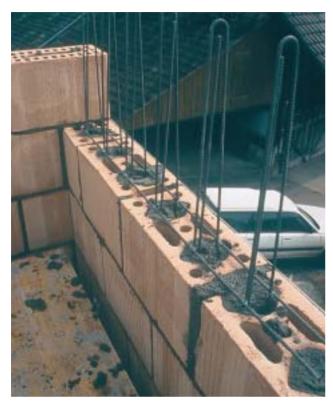
13/3 This type of vertical reinforcement is anchored at the top and bottom with U-shaped bars extending in 2 brick layers. The bars used to anchor the walls to the slabs or lower walls are very important (Switzerland 1998).

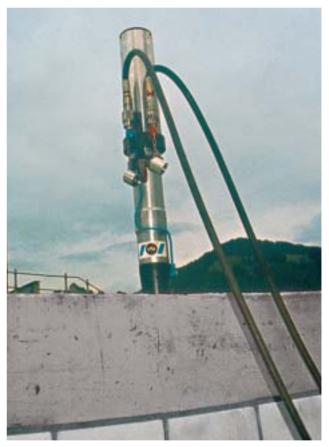
13/4 13/5 Vertical pre-stressing can also improve the earthquake behavior of masonry walls by substantially increasing the vertical force (Switzerland 1996).

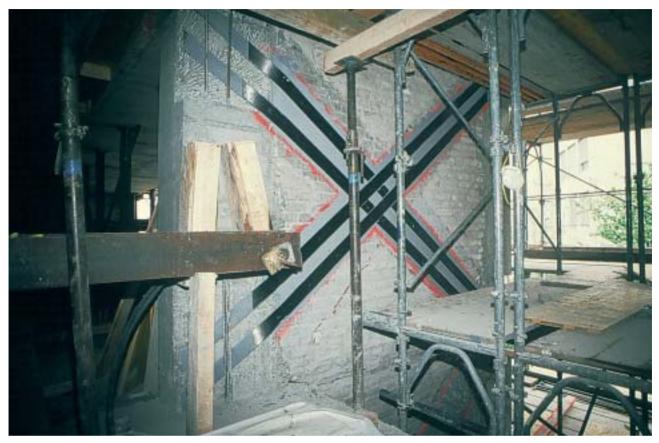
13/6 The strength and ductility of masonry walls in existing buildings can be improved with carbon fiber or steel plate reinforcements (Switzerland 1996).

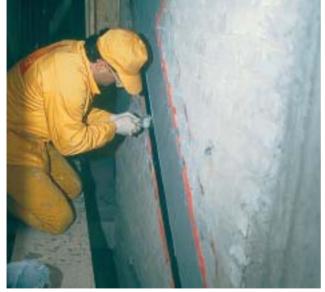
13/7 The plates must be glued on carefully and anchored in the slabs (Switzerland 1997).

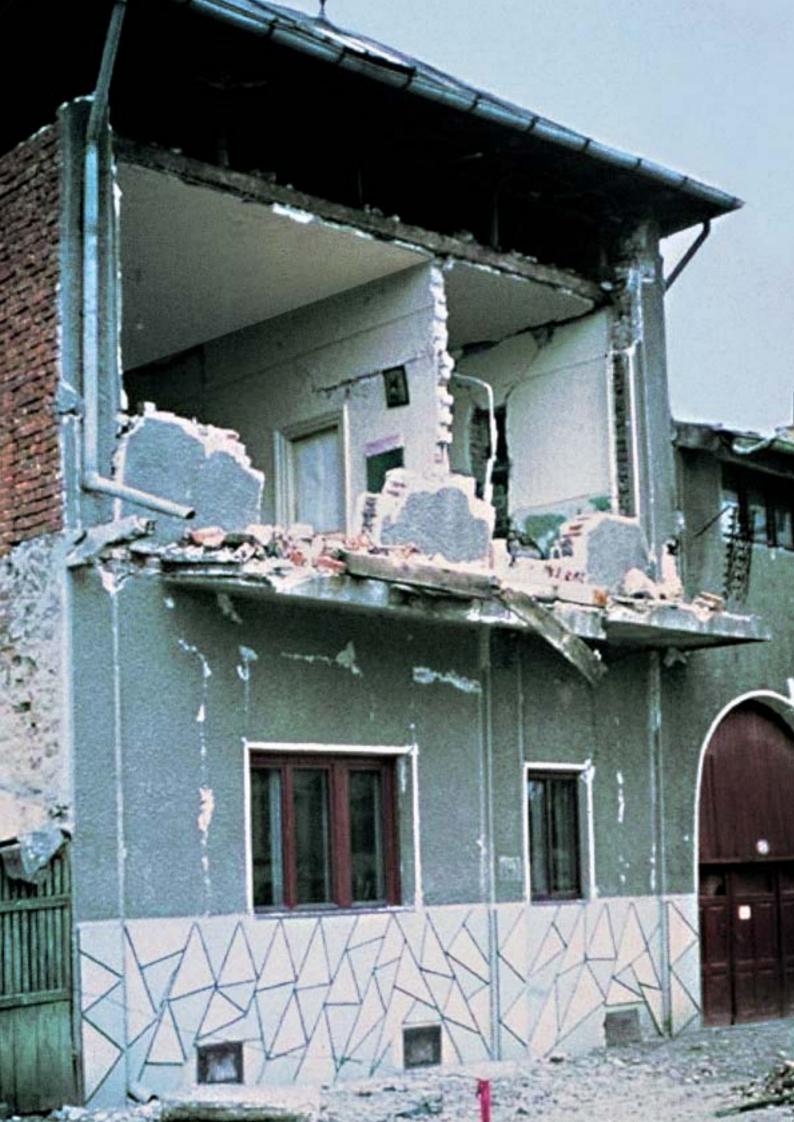
13/8 It is also necessary to consider the capacity requirement perpendicular to the wall («out-of-plane»). This applies in particular to gable walls (cantilever), to other masonry walls that are poorly restrained against horizontal forces and, for stronger earthquakes, also to walls supporting slabs. Here the walls in the upper floor, which carried only a small vertical load, failed «out-of-plane» (Loma Prieta 1989). Reinforcement, vertical pre-stressing, or glued on plates can also prevent such failure.

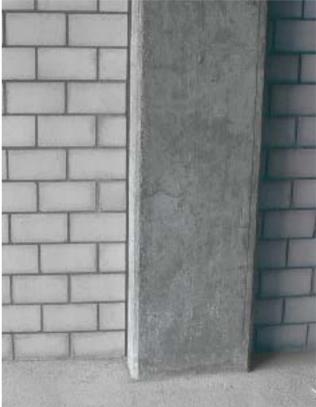
15/1 Here a vertical joint separates the masonry wall and the reinforced concrete column, but it is probably much too thin (Switzerland 1994).

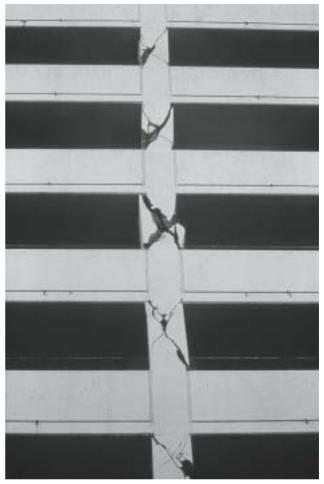
16/1 The diagonal cracks and shear failures in the short columns of a multi-storey car park almost caused collapse (Northridge, California 1994).

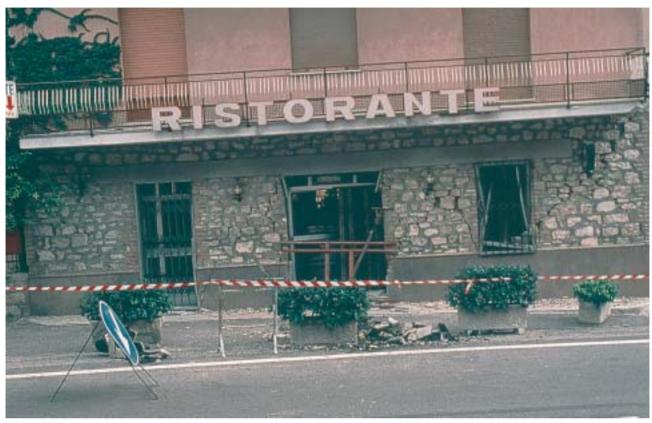
16/2 Here, the masonry columns in the ground floor of a restaurant behaved as short columns. They were highly damaged by diagonal cracks (Umbria, Italy 1997).

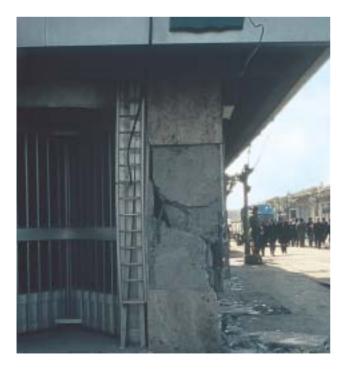
16/3 Shear failure in the corner short column on the ground floor led to near-failure of this commercial building (Erzican Turkey 1992).

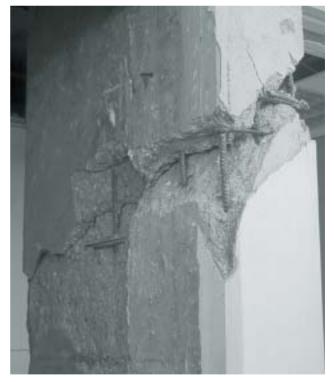
17/3 Better transverse reinforcement in the column (small spaced hoops and ties) would probably have prevented the shear failure. However, the source of the problem lies in the partial infilling of the frame that caused the short column phenomenon (Izmit, Turkey 1999).

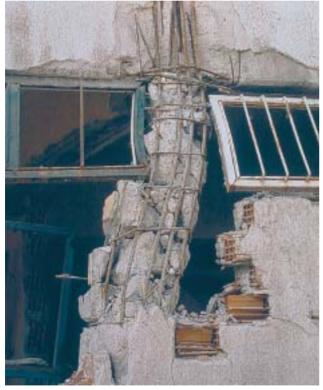
17/5 This column illustrates unsatisfactory detailing (hoops with 90° instead of 135° hooks, compare with BP 25). Without the unfavorable effect of the infill walls it would however have behaved much better (lzmit, Turkey 1999).

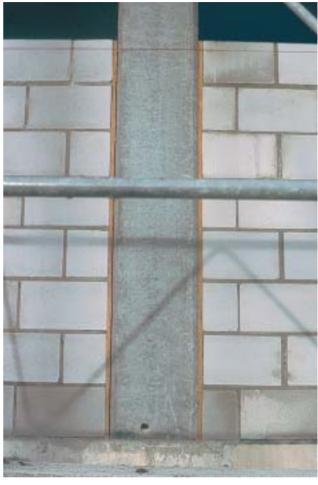
17/6 A possibility to avoid or strongly reduce the unfavourable effect of infill parapet walls into frames, is the addition of joints between the infill wall and columns. The joint was realized correctly, since it is filled by a soft and therefore strongly compactible rock wool sheet. However, the width only permits a 1% free lateral drift ratio of the column (Switzerland 2001).

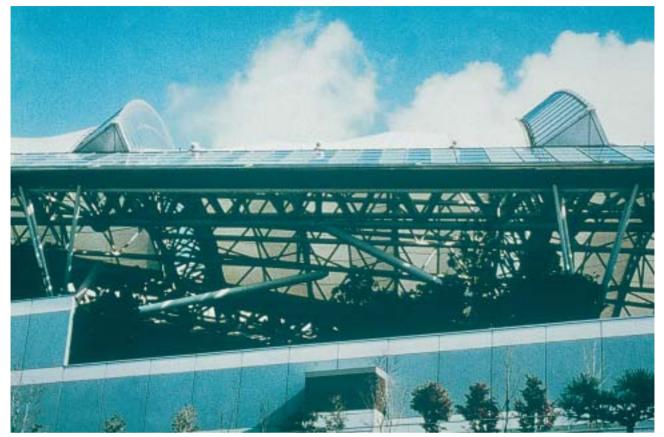
18/3 This truss structure also suffered buckling of truss elements and many local damages (Kobe, Japan, 1995).

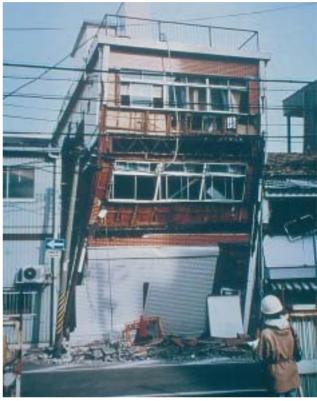
19/1 This steel frame suffered large permanent deformations. There was probably no lateral bracing and the connection detailing was inadequate for cyclic actions (Kobe, Japan 1995).

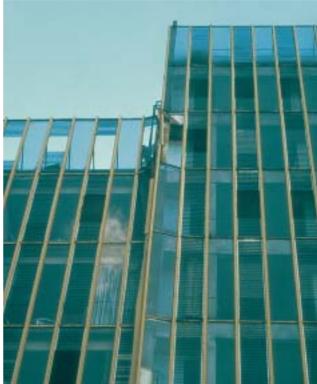
20/1 The pounding of two similar buildings with floors at the same levels caused damage to the façades as well as spalling etc. to the structure (Mexico 1985).

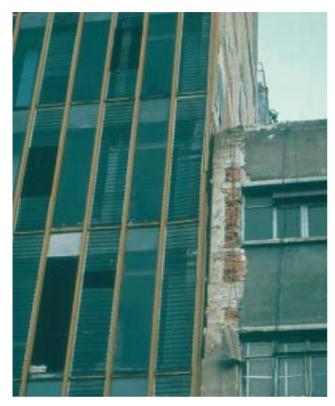
20/2 Substantial damage resulted from the pounding of these two, very different, buildings (Mexico 1985).

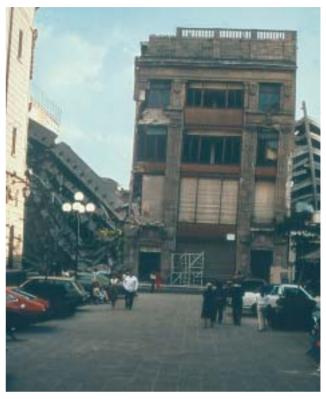
20/3 The modern reinforced concrete building to the left collapsed after pounding against the older very stiff building to the right (Mexico 1985).

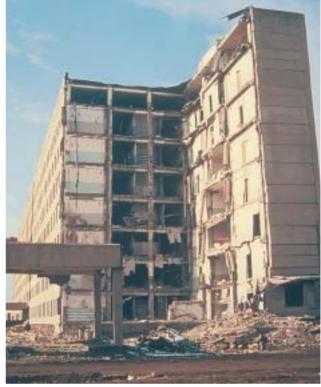
22/1 A corner area of this building collapsed. The slabs consisted only of precast elements without reinforced concrete cover and without reinforced connections to the vertical load bearing elements (Armenia 1988).

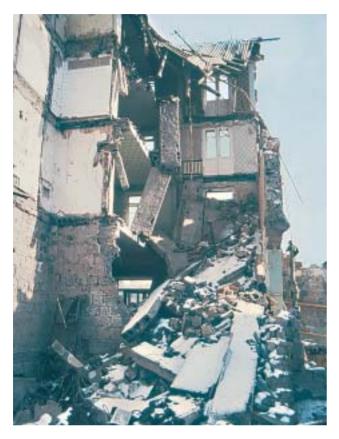
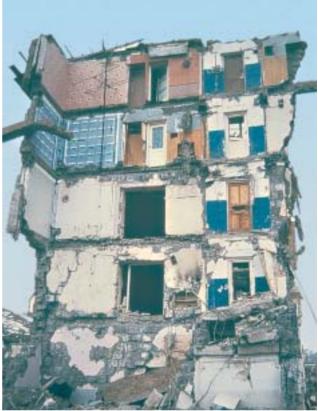
22/2 22/3 In these houses also, the slabs consisted only of precast elements, which were insufficiently connected between each other and with the walls (Armenia 1988).

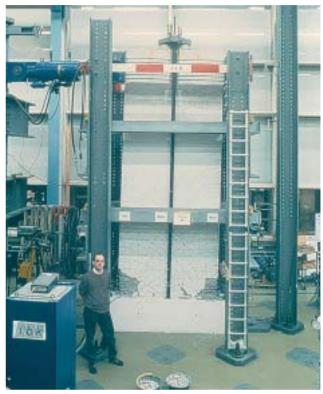
23/1 Static-cyclic tests on the lower part of 1:2 scale 6-storey reinforced concrete structural walls have clearly demonstrated the effectiveness of a ductile design [Da 99]. The capacity designed walls achieved, at little additional cost, a seismic capacity 3 to 4 times larger than that of walls conventionally designed according to the Swiss building code SIA 162.

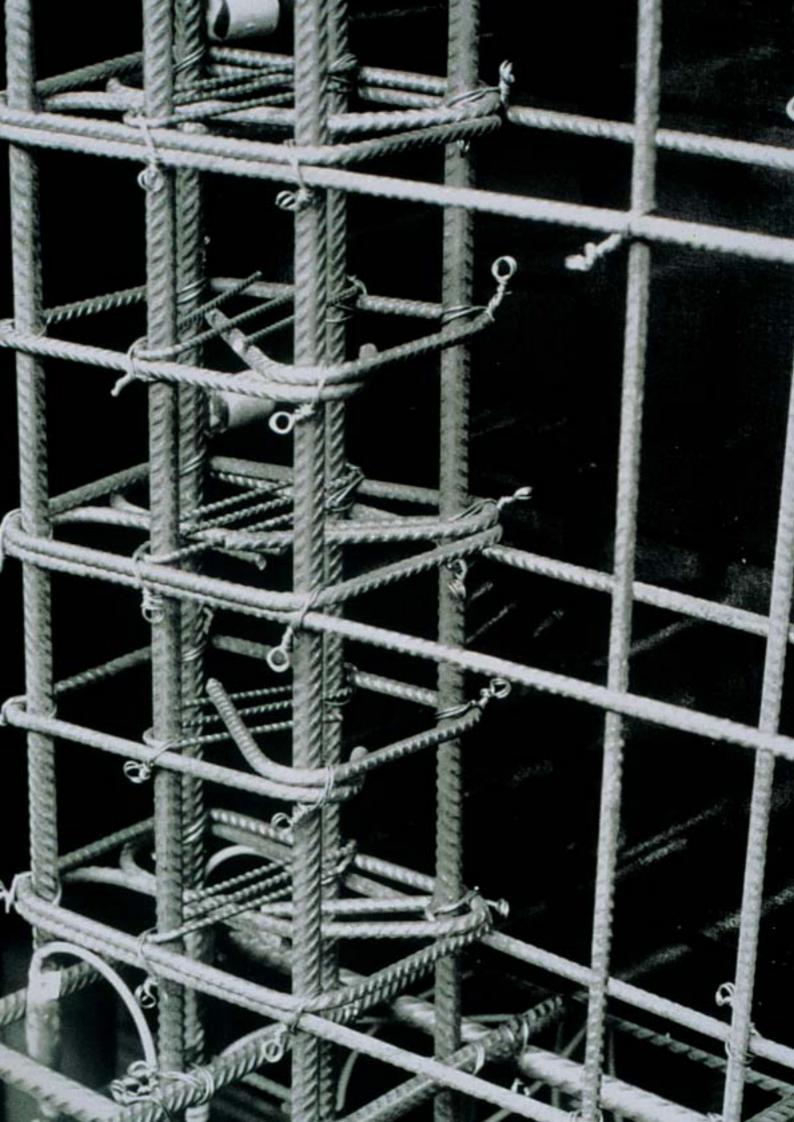
25/3 This transverse reinforcement – hoops and ties – at the edge of a reinforced concrete structural wall is exemplary concerning anchorage with 135° hooks. However, the vertical spacing of the transverse reinforcement is too large, i.e. s=7.5d instead of $s\leq 5d$ as required for steel with a relatively small strain hardening ratio (R_m/R_e = 1,15) [DW 99][TD 01].

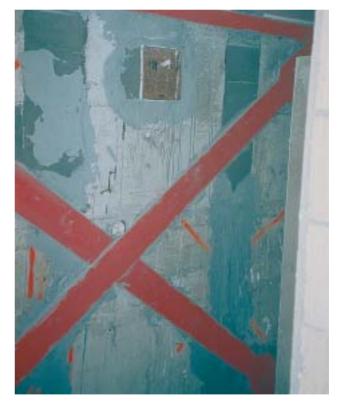
26/2 Expensive repair work, consisting of refilling the openings with expansive concrete and gluing steel plates restored the designed ultimate resistance of the wall. However, it is almost impossible to fully recover the ductile behaviour obtainable with the original reinforcement (Switzerland 2001).

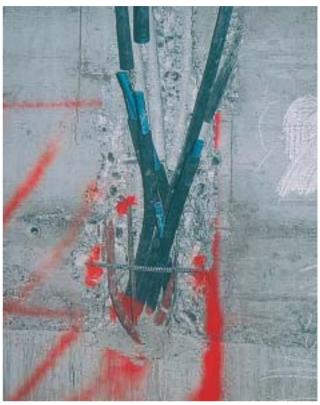
26/5 This type of unplanned insertion of pipes can also impair the seismic behaviour of a reinforced concrete structural wall (Switzerland 2001).

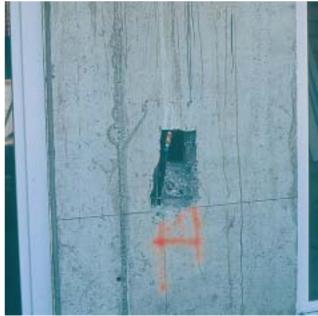
26/6 Under certain conditions, it is permissible to insert openings in elastic zones of «earthquake relevant» structural elements (here a slender reinforced concrete structural wall). Careful planning with the engineer is essential (Switzerland 2001).

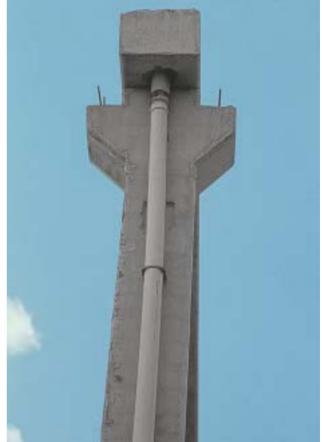
27/1 The dowels on the column corbels of this prefabricated factory building did not provide sufficient stability. The support area failed and the main beams overturned (in the direction of the longitudinal axis of the building)...

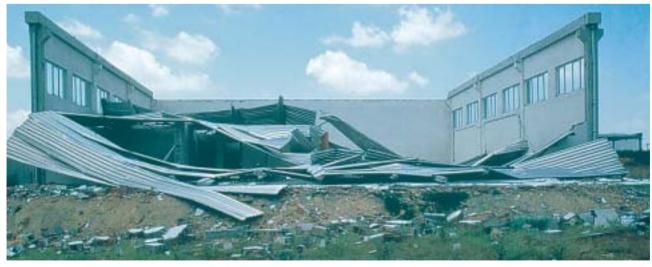
$27/2 \ \ldots$ and the entire roof structure collapsed (Adana-Ceyhan, Turkey 1998).

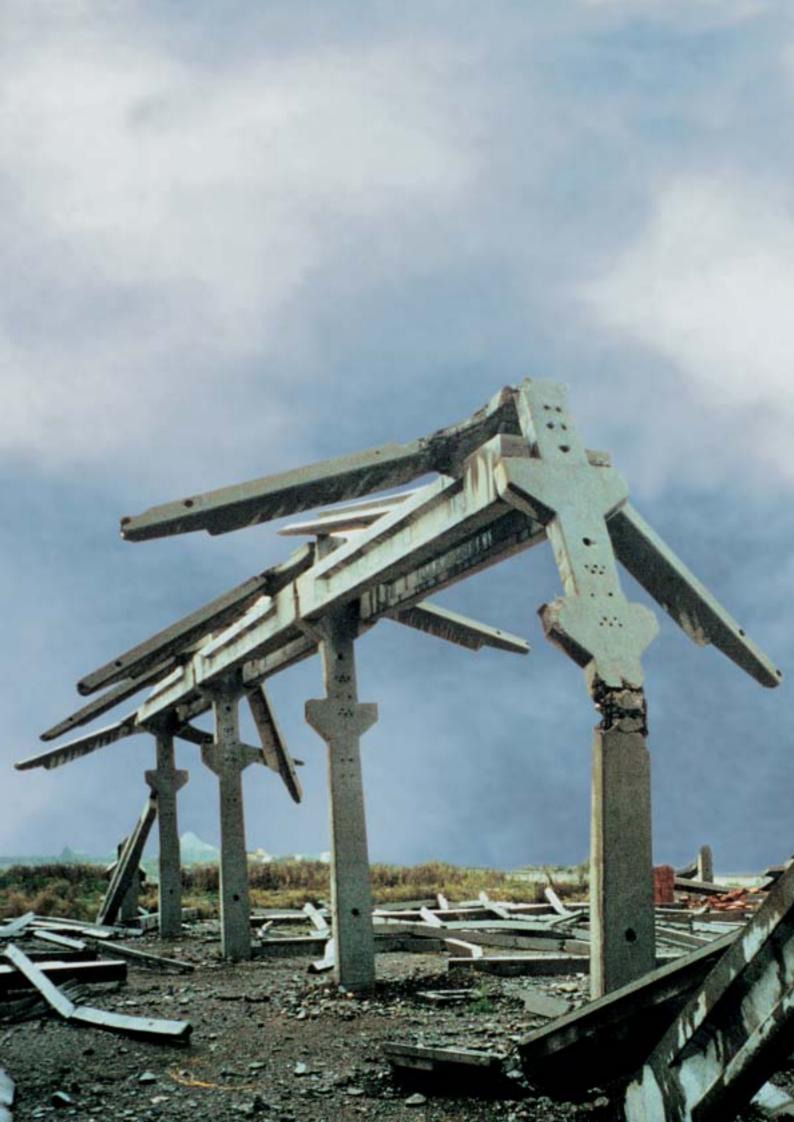
Page 63 27/3 The consequences of bad planning and insufficient design and detailing of a prefabricated industrial building (Adapazari, Turkey 1999).

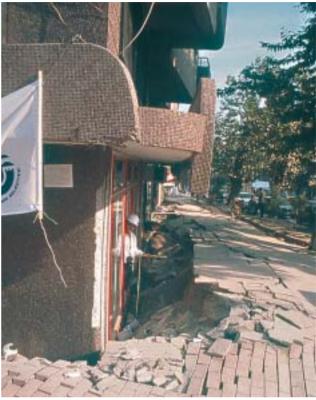
30/1 This building sank evenly about 1 m due to soil liquefaction. The displaced soil caused a bulge in the road (Izmit, Turkey 1999).

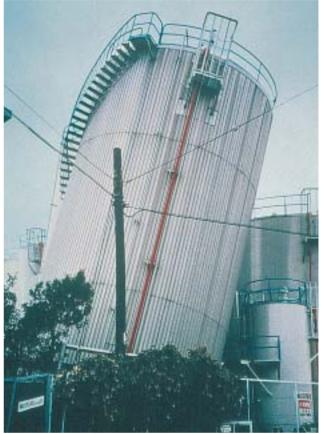
30/4 This tank also tilted due to the liquefaction of the sandy artificial landfill (Kobe, Japan 1995).

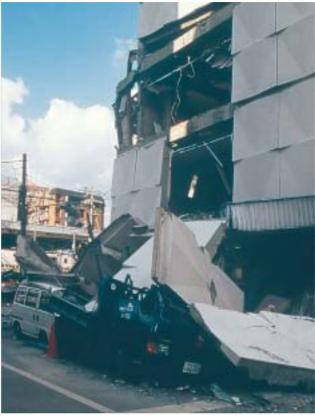
32/1 The structure of this building did not collapse, but heavy and insufficiently anchored facade panels fell to the ground (Kobe, Japan 1995).

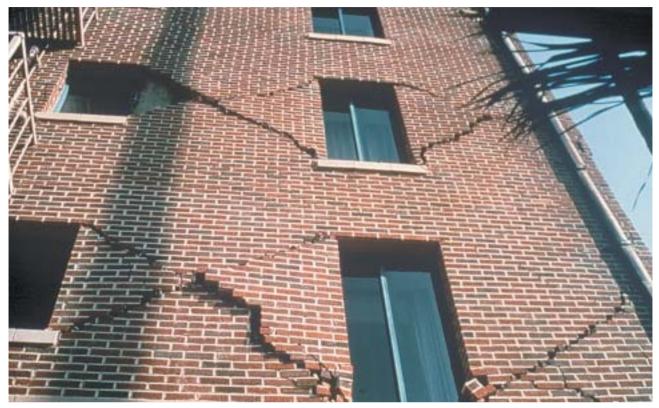
32/3 This facade cladding was insufficiently anchored and could not follow the deformations of the reinforced concrete frame structure (Northridge, California 1994).

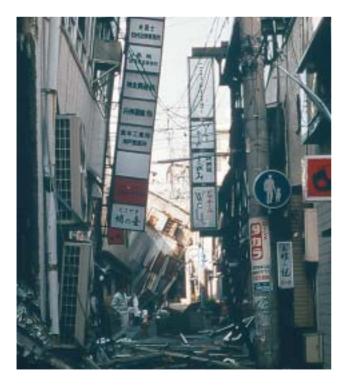
32/4 A glance into this side street reveals a vast amount of fallen facade materials. Rescue work, fire trucks access, etc. is seriously hampered (Kobe, Japan 1995).

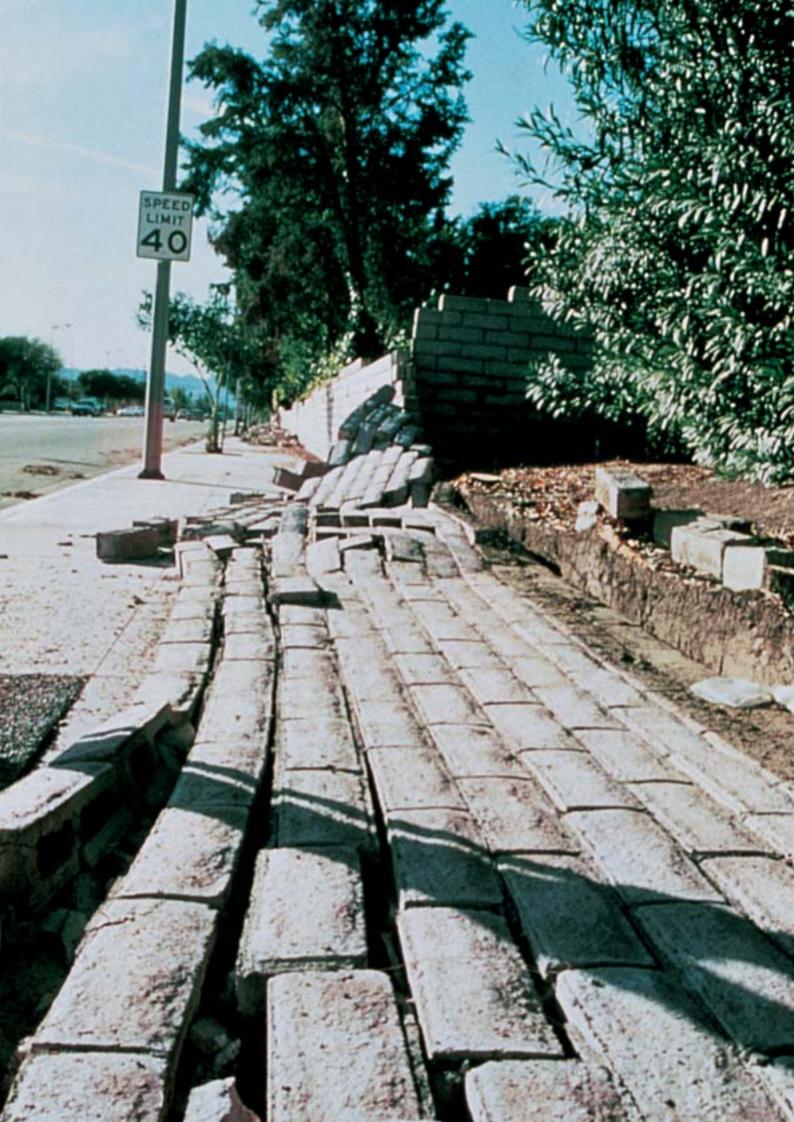
Page 73 33/4 These dry stone garden walls also turned over (Northridge, California, 1994).
