**The January 17, 1995 Kobe Earthquake
An EQE Summary Report**

April 1995

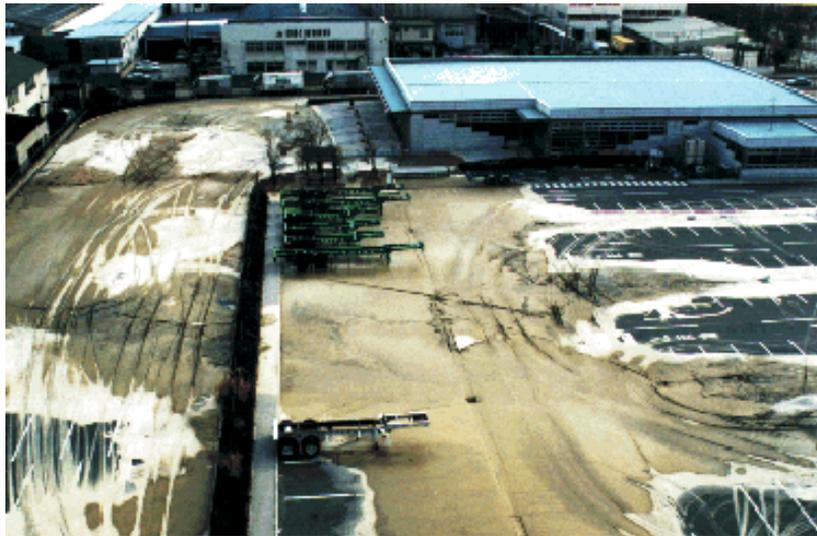
Parking lot on reclaimed land near Ashiya. Sand covering the lot is evidence of large-scale liquefaction and sand ejection.

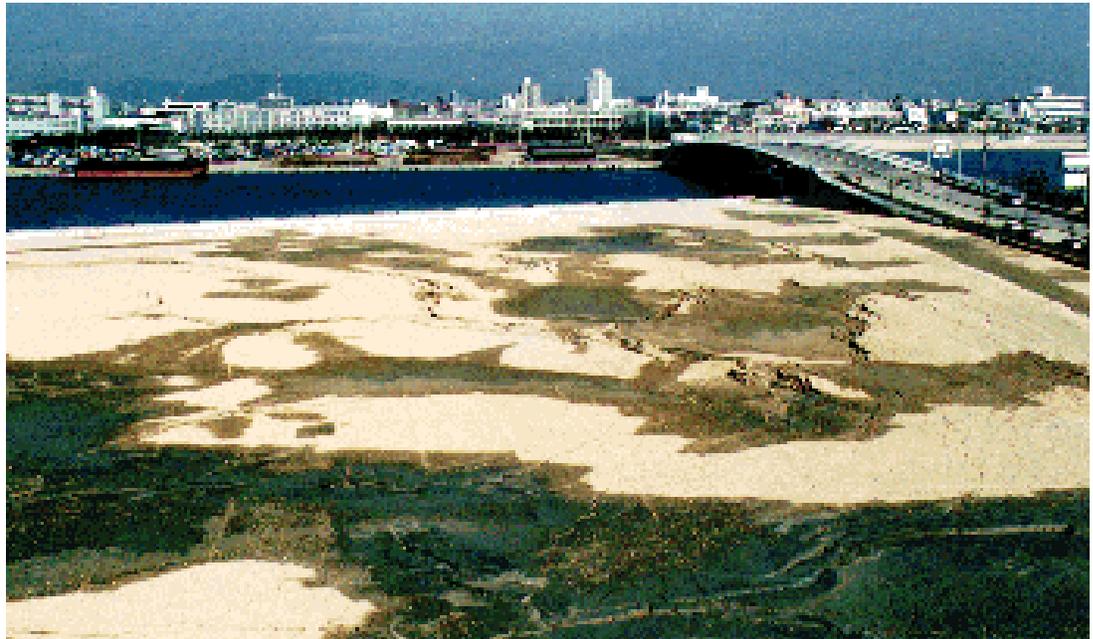
Human-made island in Nishinomiya showing evidence of large-scale liquefaction, settlement, and lateral spreading.

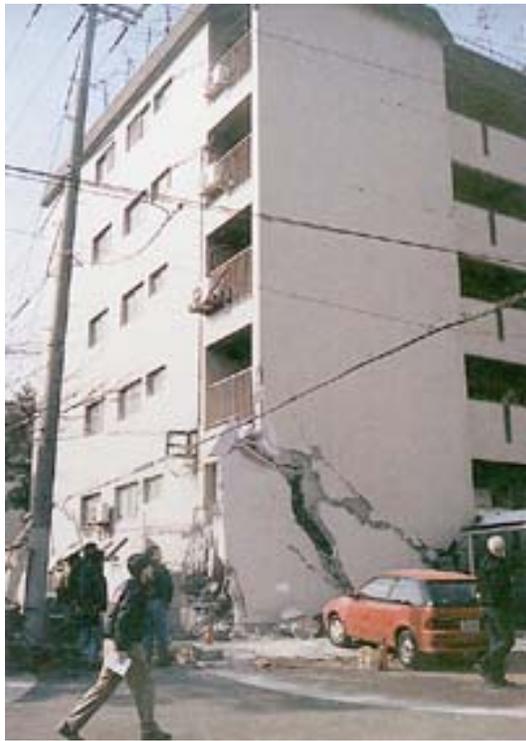
Top left: Badly damaged concrete shear wall building.

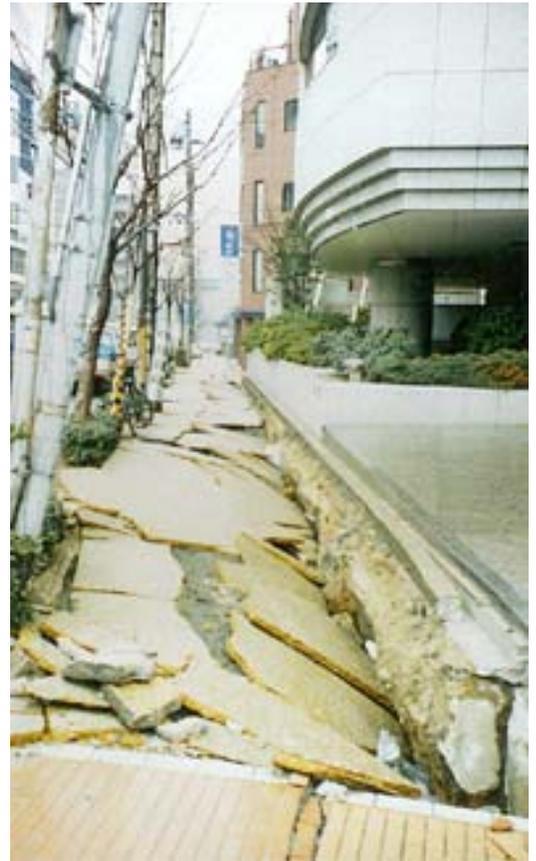
Top right: Ground settlement in central Kobe.

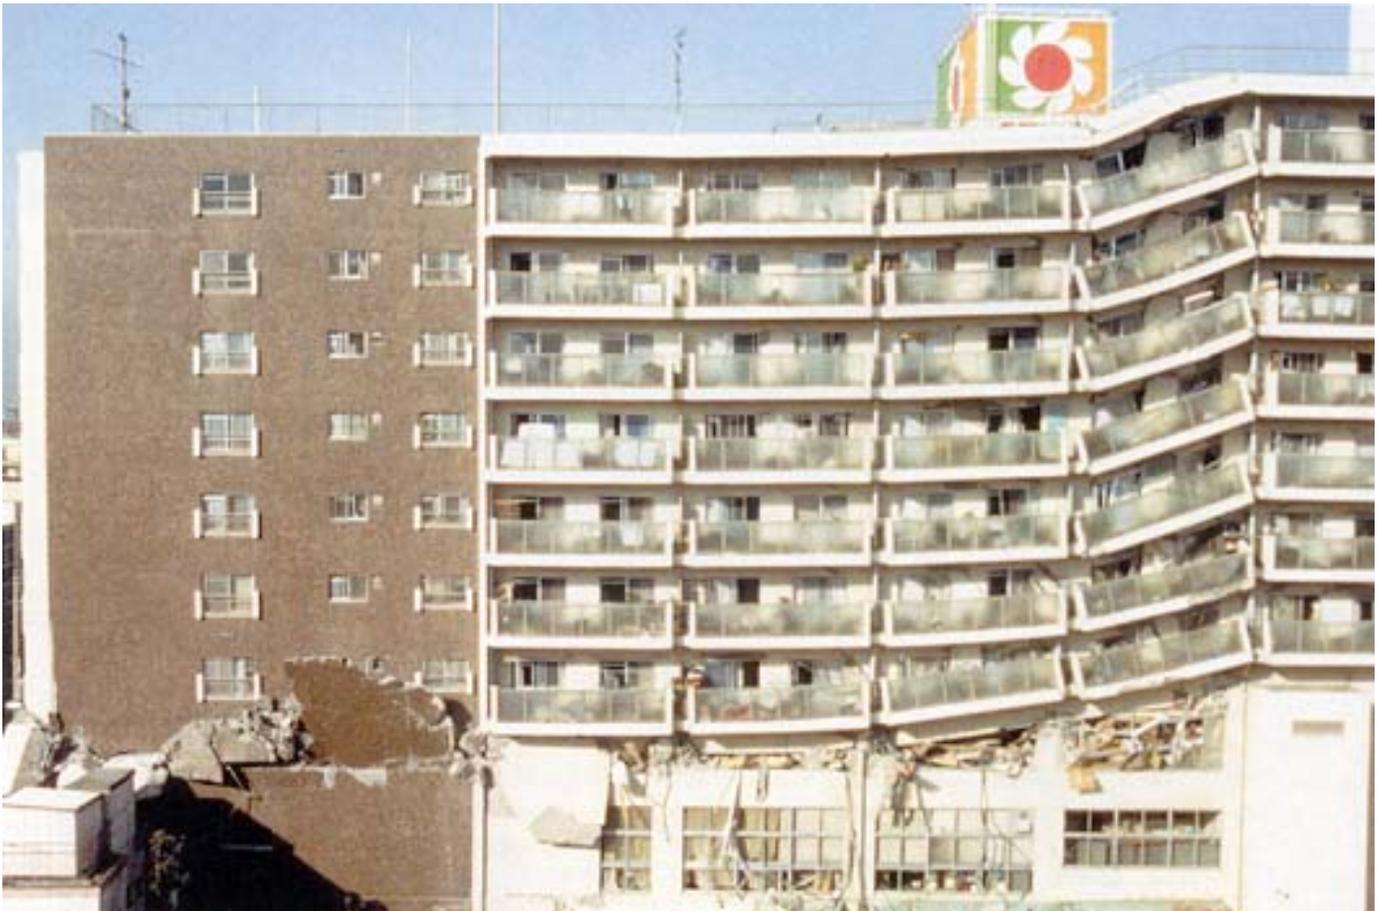
Bottom: Mid-height collapse of a mixed-use building (built circa 1977) in Nishinomiya. This type of collapse was very common in this earthquake.

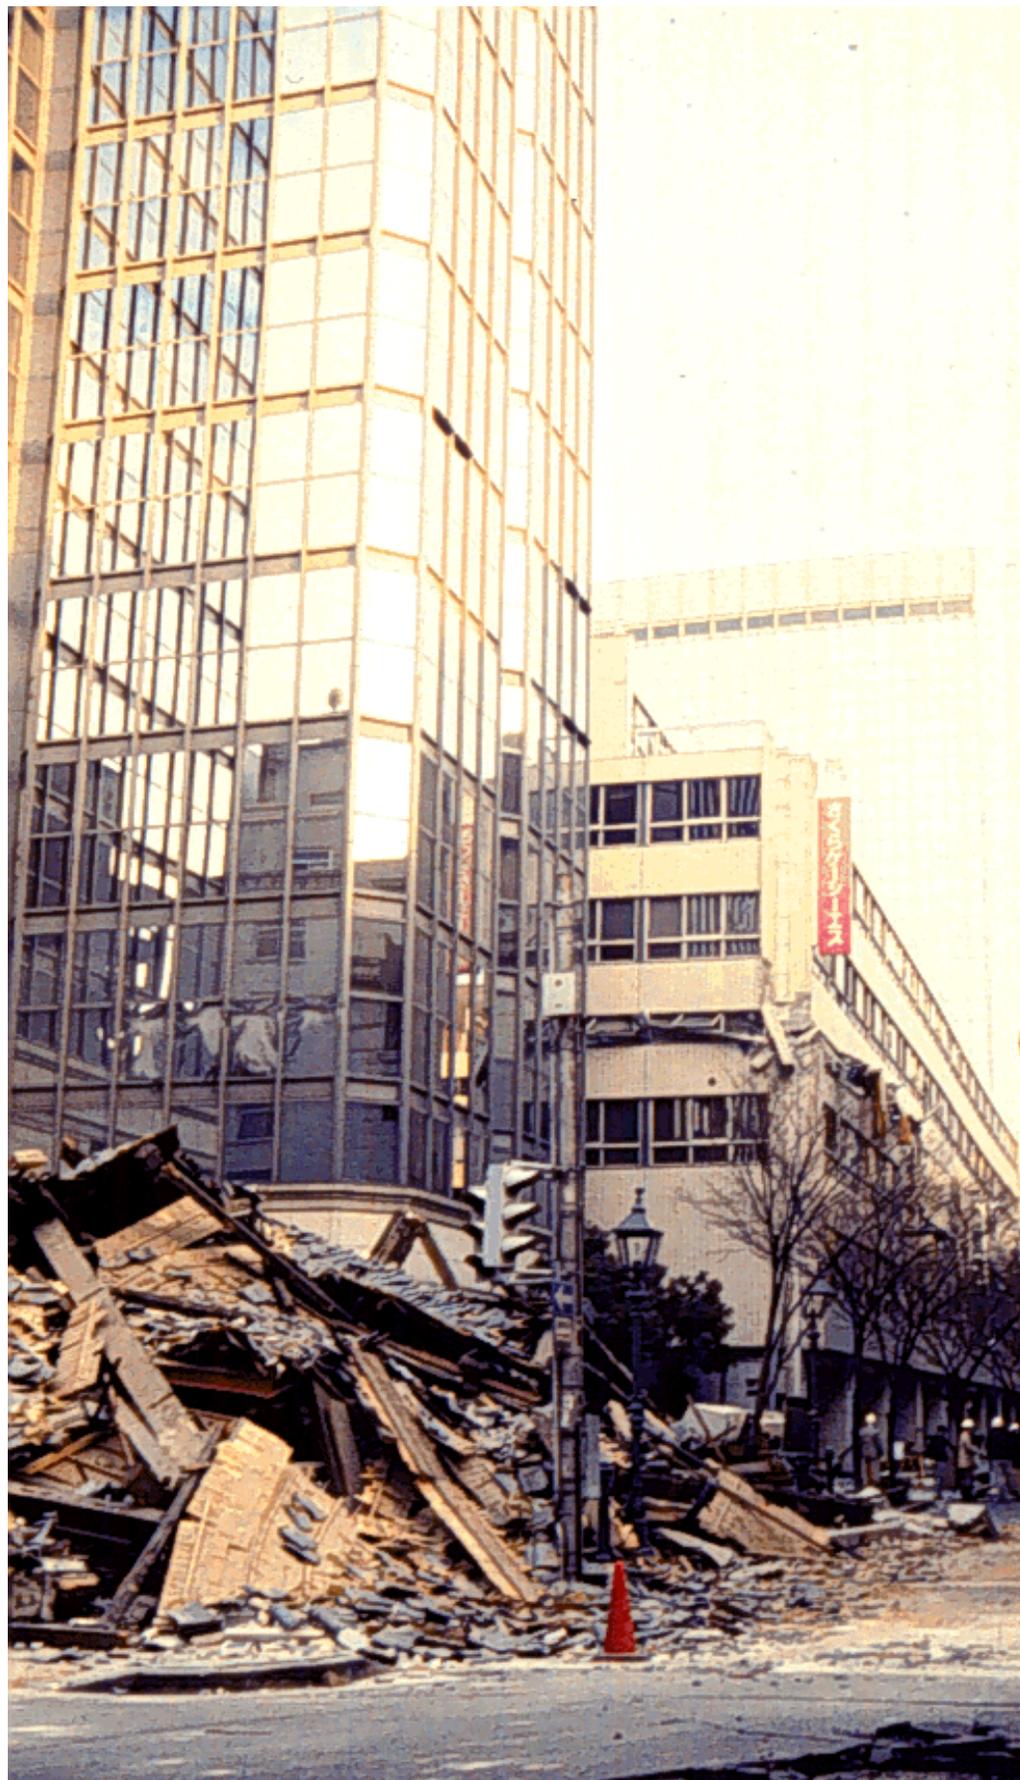
Buildings in central Kobe (Chuo Ward). In the foreground is the complete collapse of a two- or three-story traditional Japanese wood-frame building with a heavy tile roof. On the right is a six- or seven-story office building of 1960s' or 1970s' vintage. This reinforced concrete building is a typical example of a mid-height story collapse. The high rise to the left is a post-1981 office building that has no apparent damage. Ground settlement in the vicinity of these buildings was between 30 and 60 centimeters.

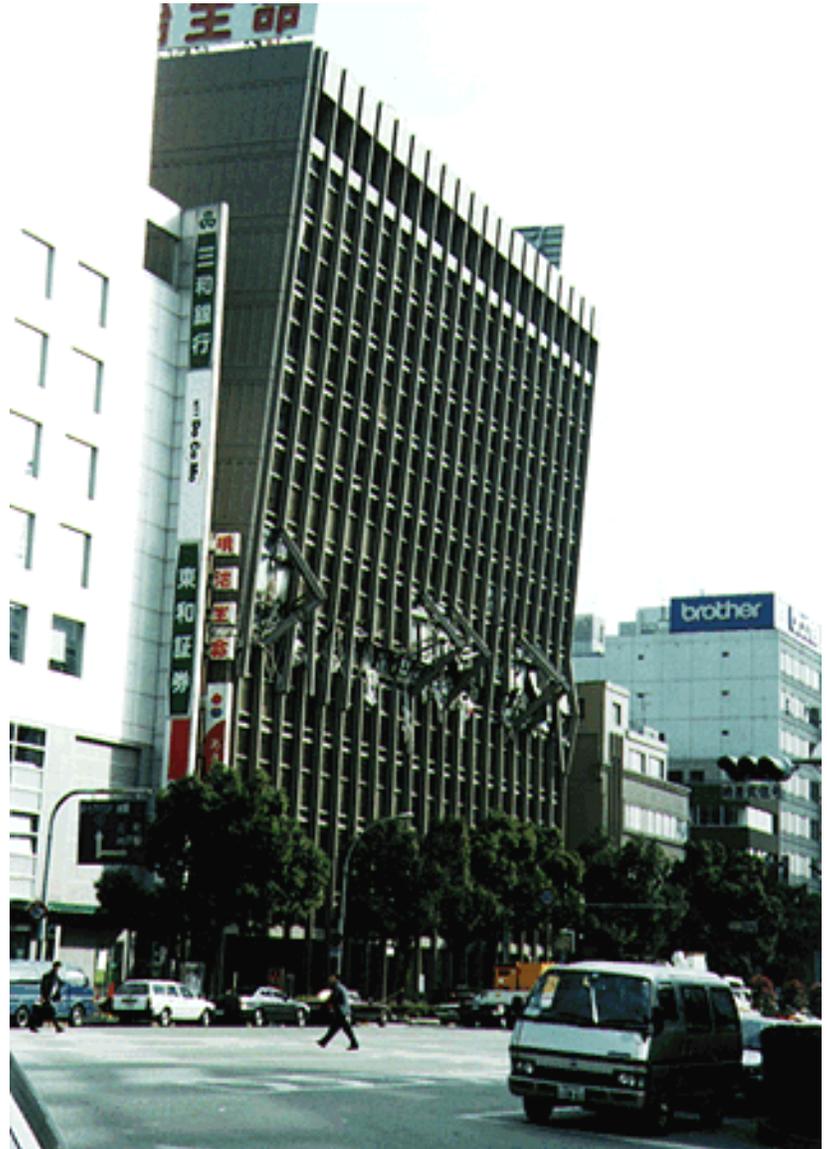
Concrete-frame structure with a mid-story collapse (Flower Road, Kobe).

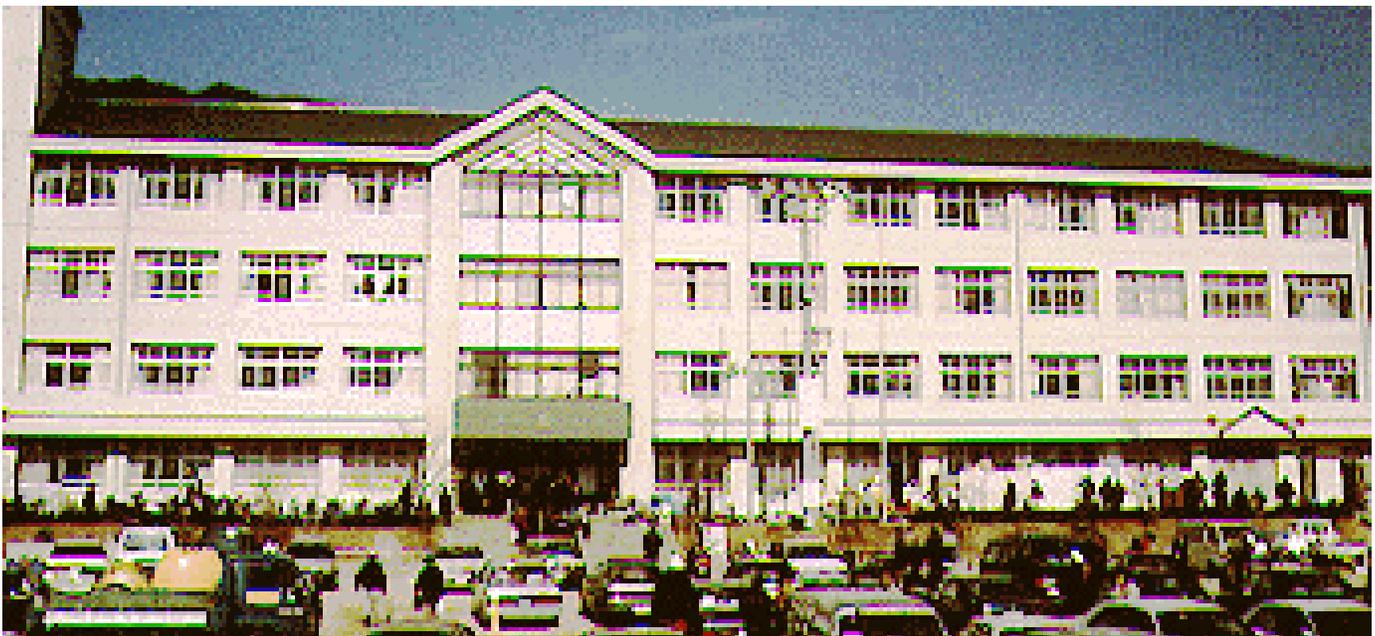
Undamaged reinforced concrete school in the Rokkomichi area. The building was used as a refuge center in the weeks following the earthquake.

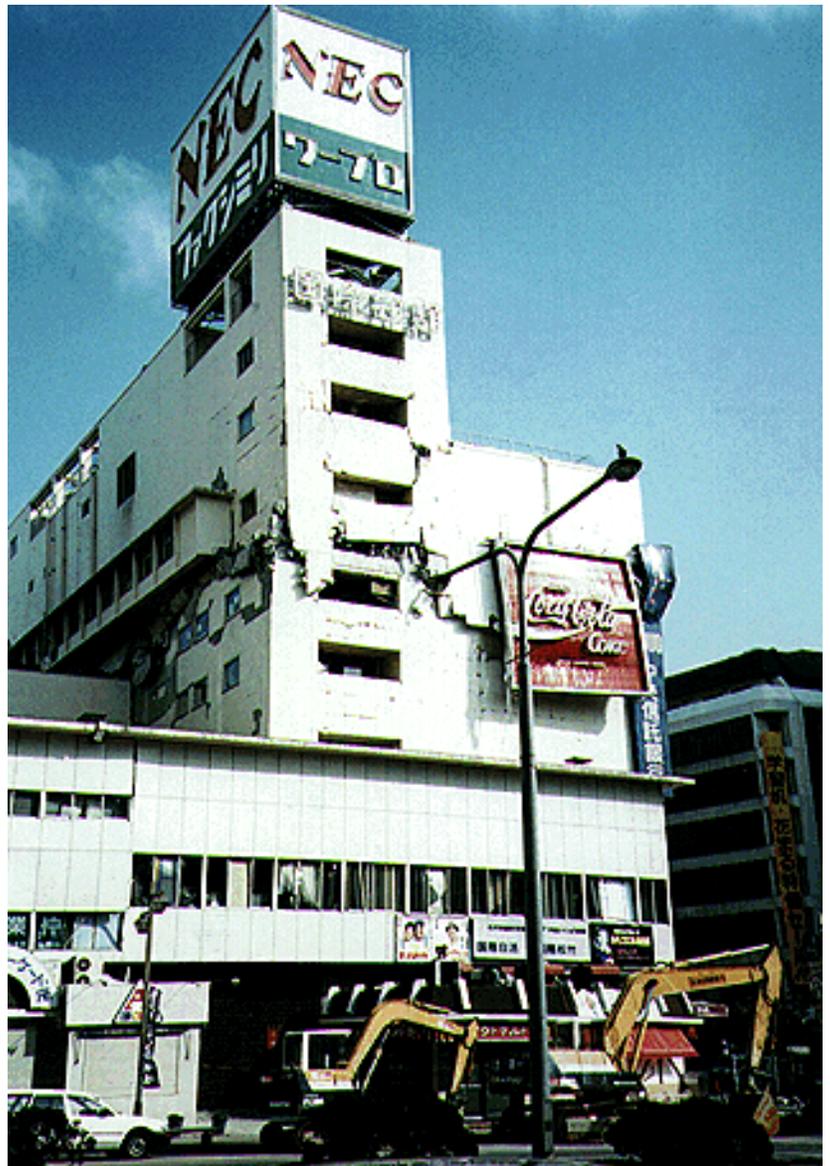
Badly damaged older reinforced concrete building in Sannomiya. Much of the damage is concentrated at structural discontinuities.

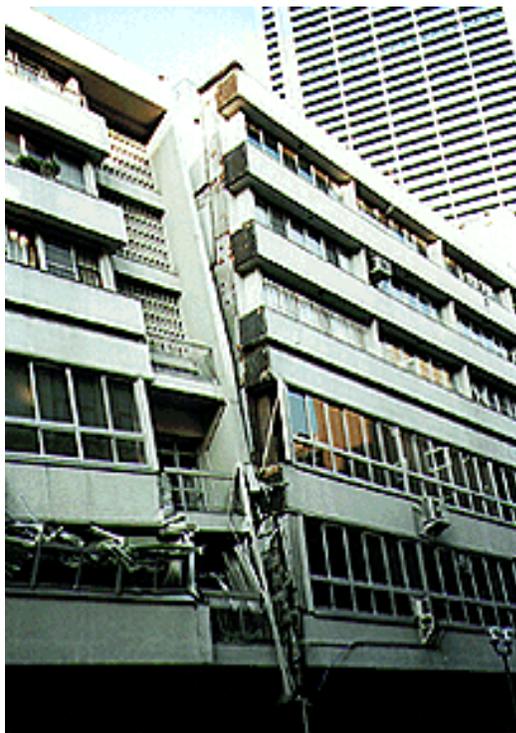
Bottom left: The two buildings in the foreground look similar, but their diverse performance indicates that they are probably structurally dissimilar. They may have been built at different times.

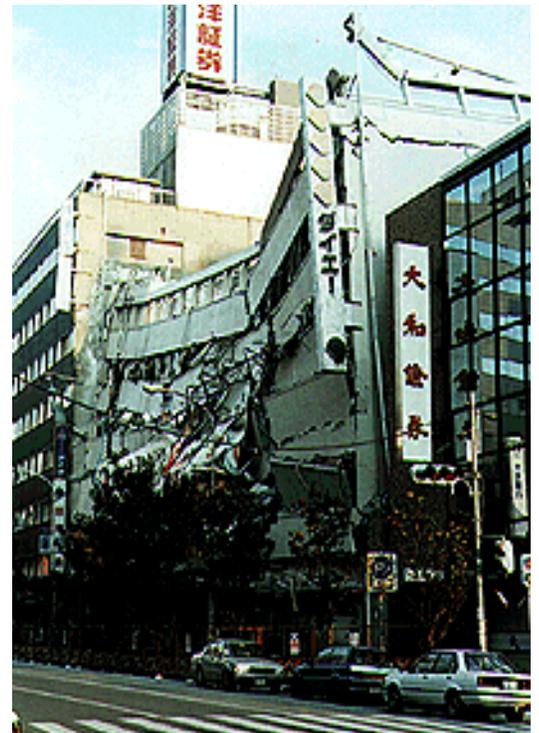
Bottom right: The collapse of this building was so complete that it was impossible to deduce an obvious failure mode.

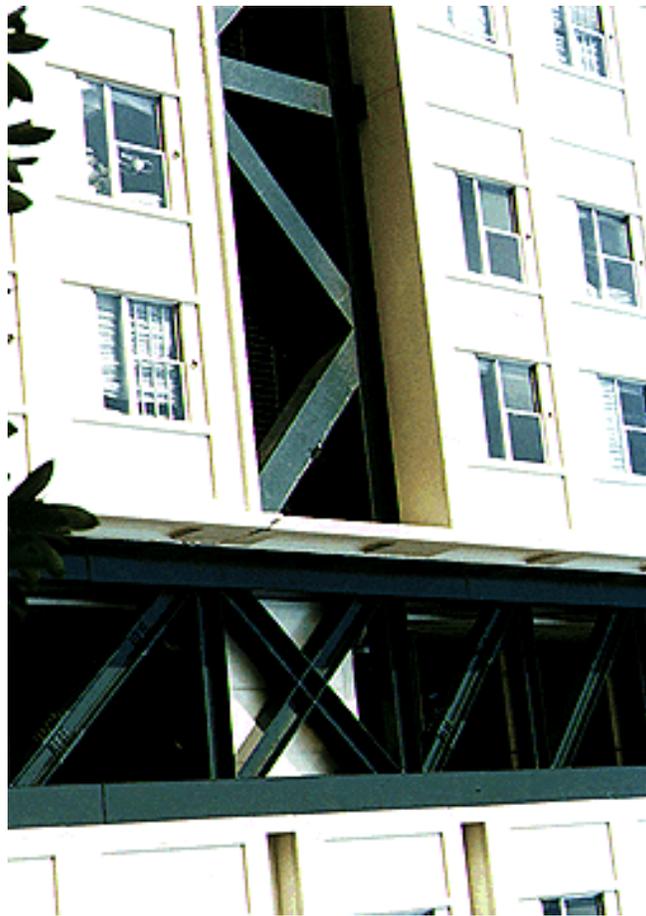
Top: Detail of the truss elements at the Ashiyama Seaside Town. Note the minimal damage to the concrete units. This photo shows the intersection of the vertical and horizontal frames.

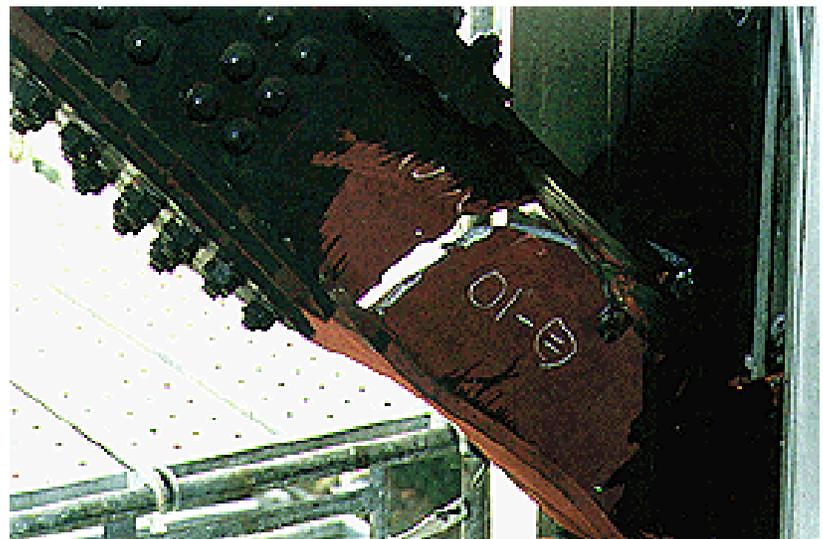
Bottom: Fractured web in a diagonal truss element, Ashiyama Seaside Town.

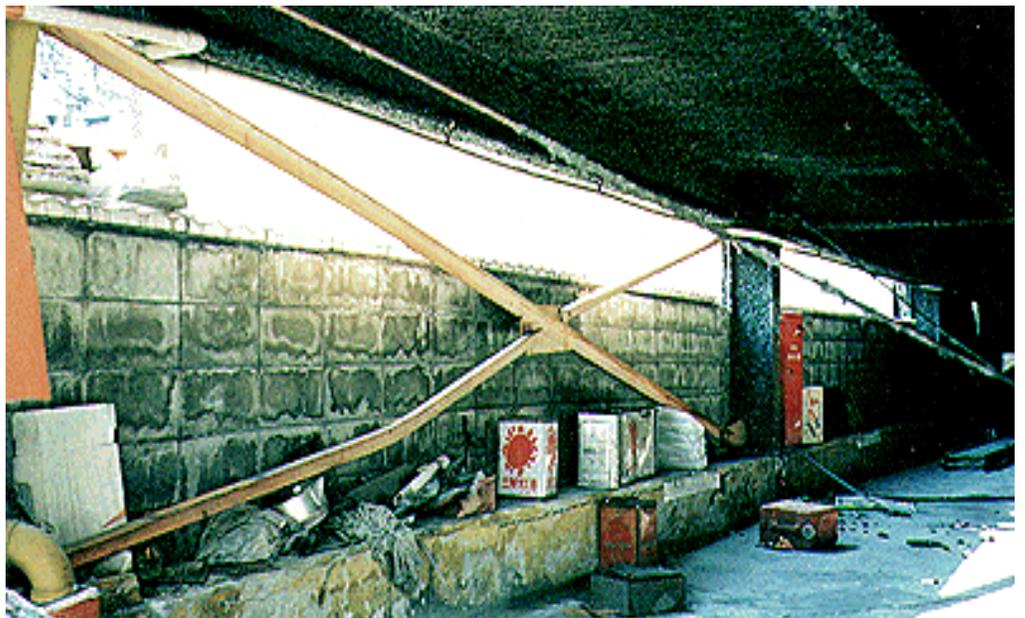
Bottom: Buckled diagonal brace in a parking garage.

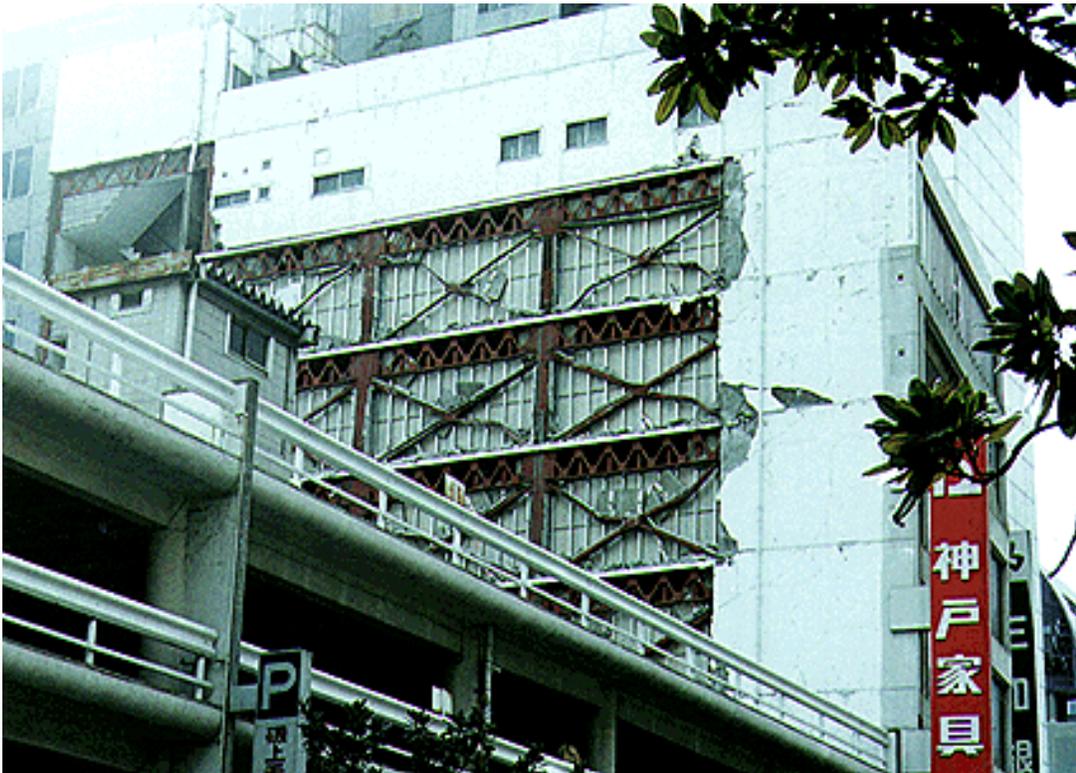
Top: Severely damaged steel-frame building in Sannomiya. This building illustrates the practice of bracing multiple bays.

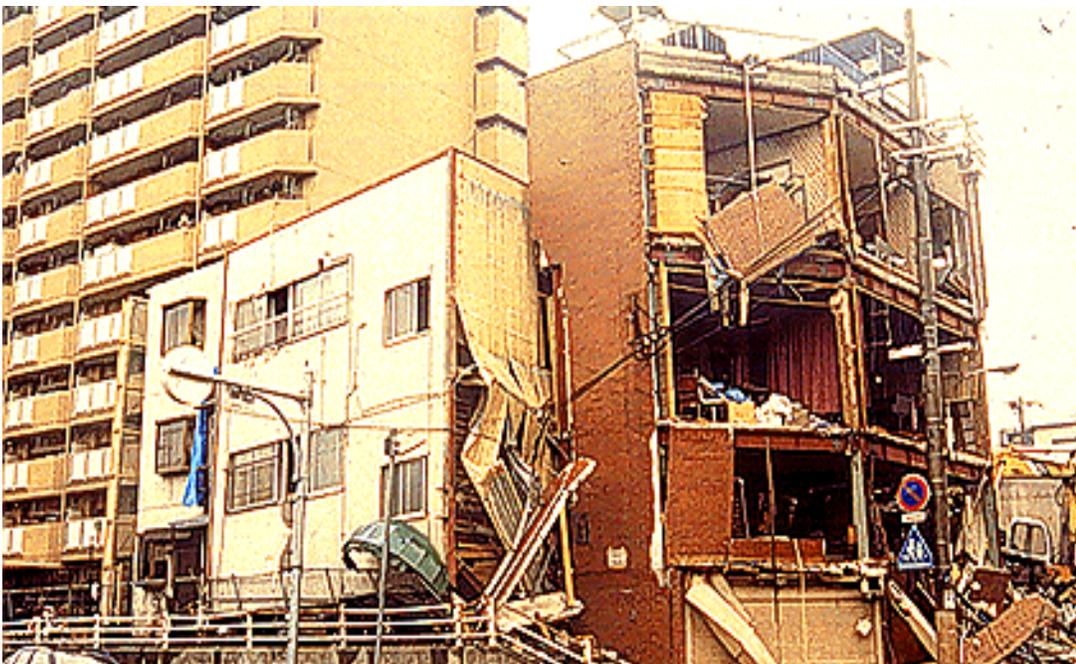
Bottom: Steel buildings in the Nagata Ward. While the frames appear to be in good shape, the cladding was shaken off the building, posing a severe life-safety hazard.

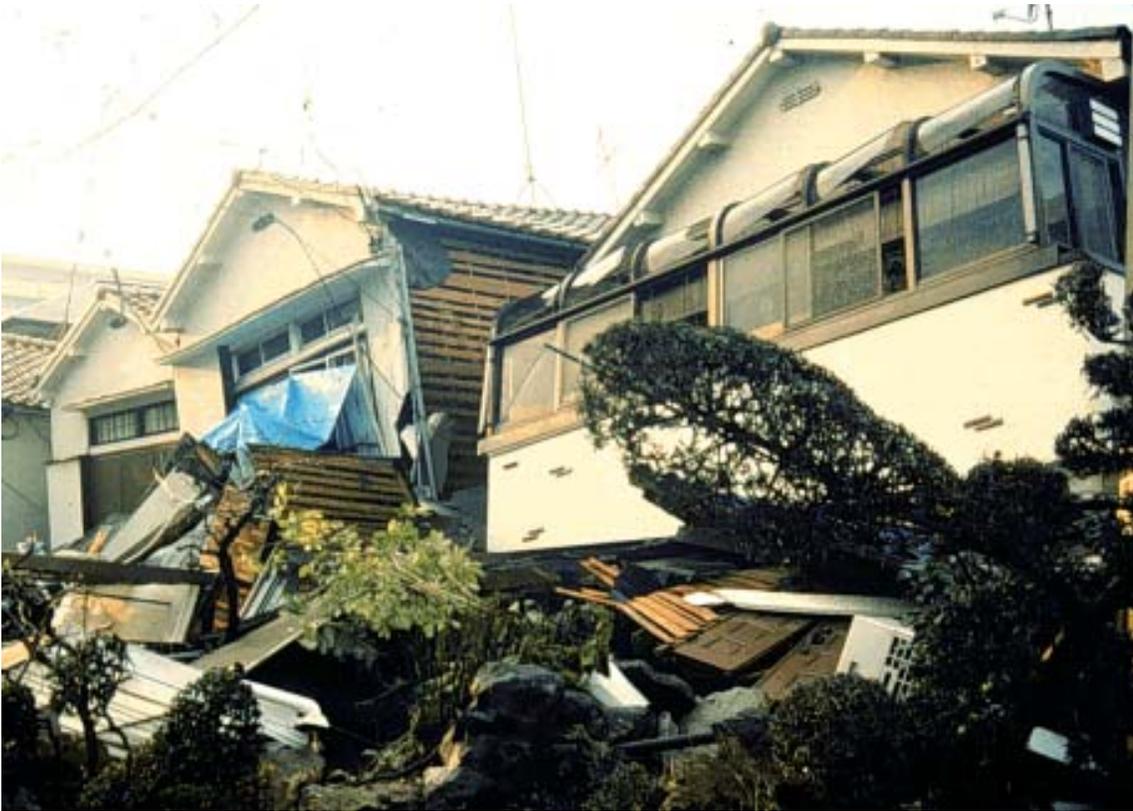
Bottom: Collapsed housing was responsible for most of the deaths in the earthquake.

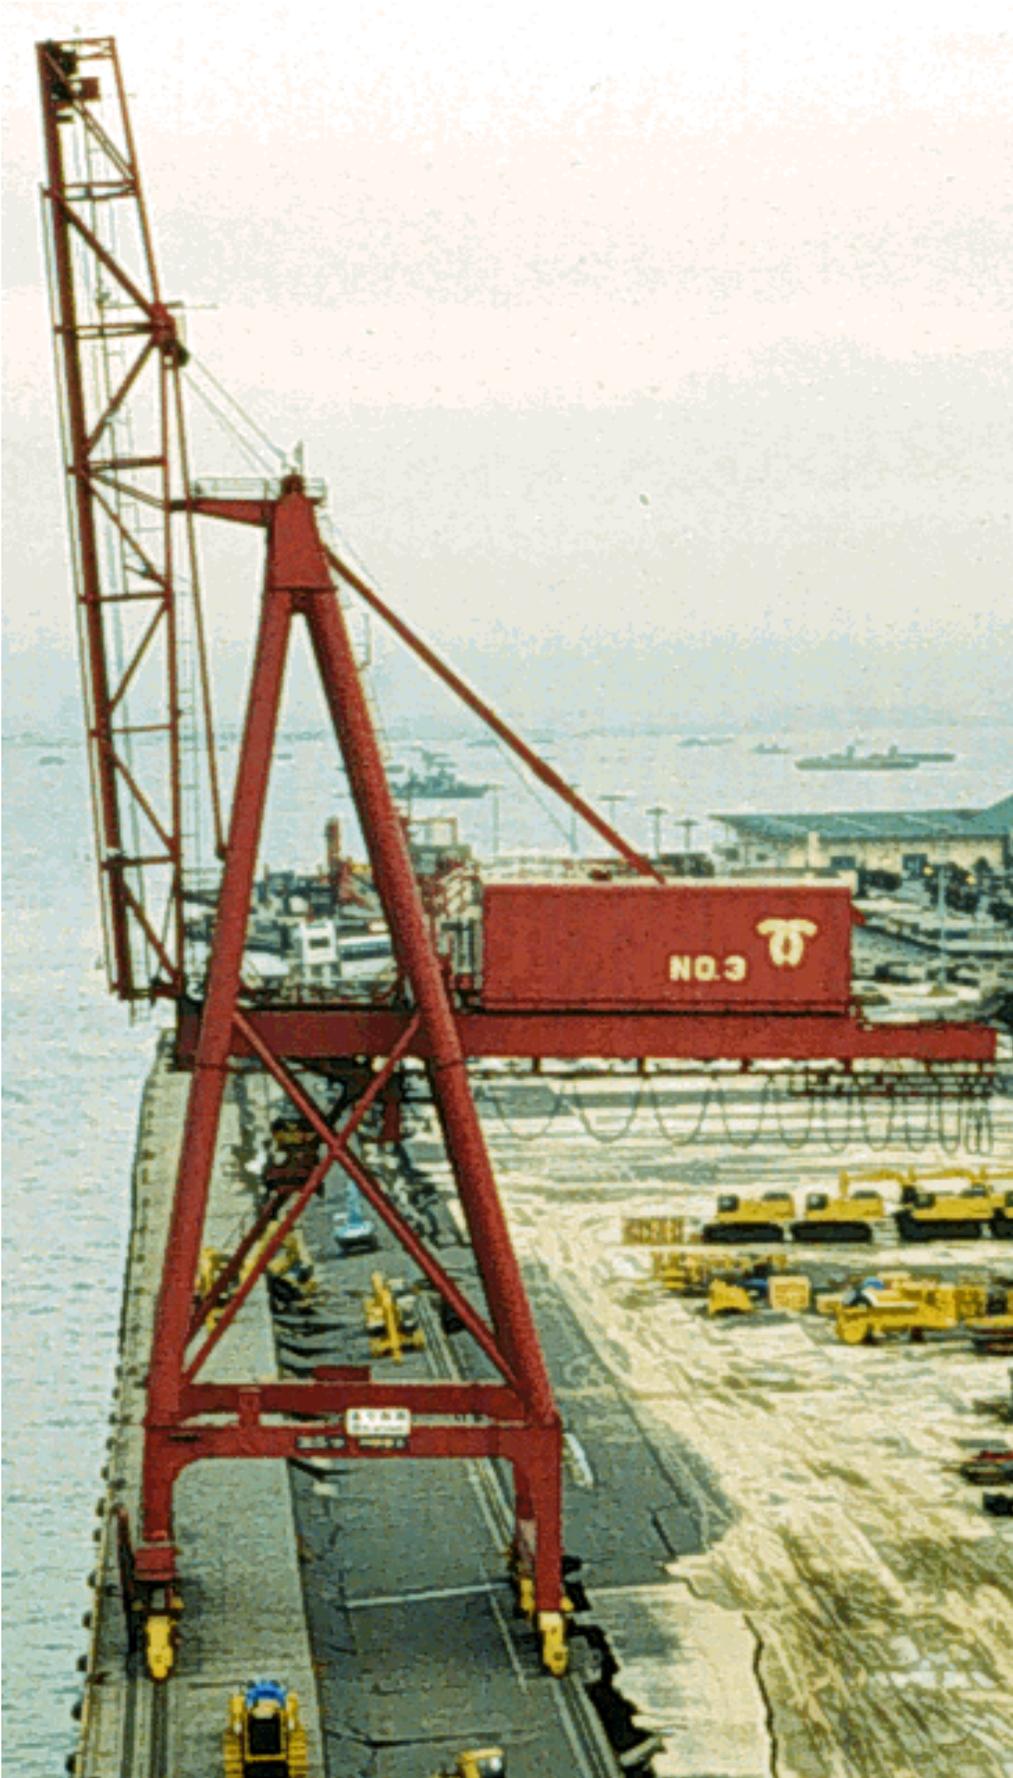
Left: A damaged port crane on Rokko Island. The damage occurred when the quay wall moved to the left from the overall lateral spreading and settlement of the island. There was differential lateral movement of the two crane rails, pulling the crane legs apart. This phenomenon continued to occur for days after the earthquake.

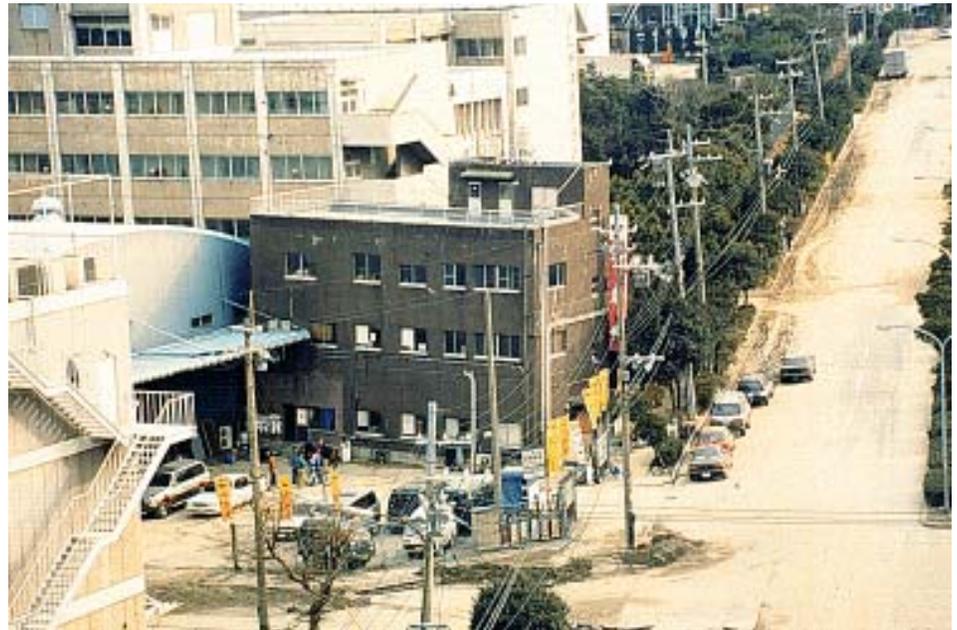
Top: An example of a heavy concrete structure supported on a slab-on-grade. When the underlying soils liquefied and settled, the building settled and rotated. Buildings on piles typically performed much better.

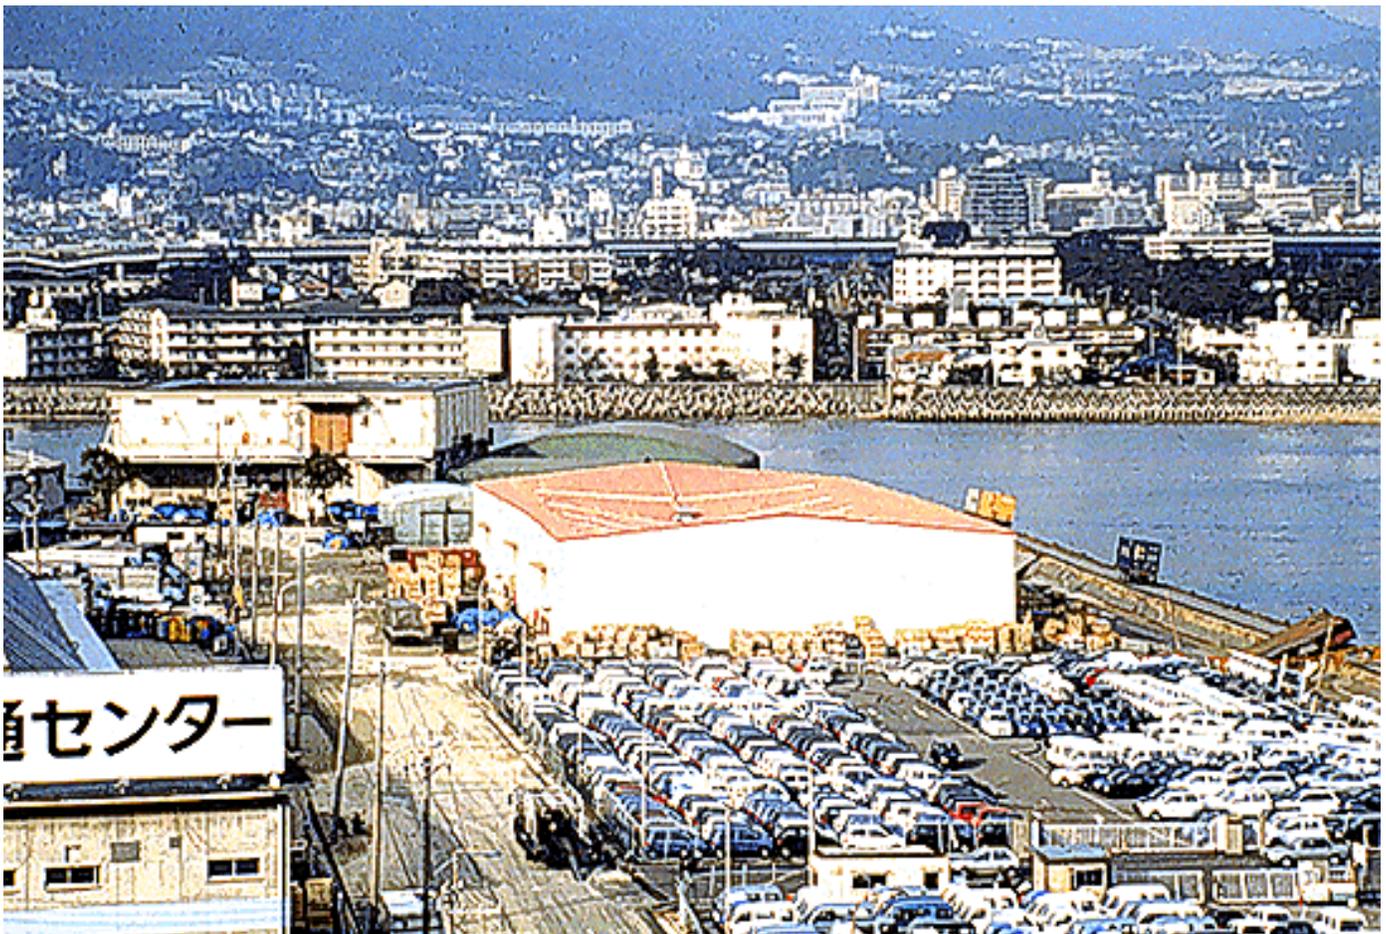
Opposite: Severe damage to piers and warehousing along damaged quay walls. The quay walls have rotated toward the water, pulling the structures with them. The partially collapsed Hanshin Expressway can be seen in the background.

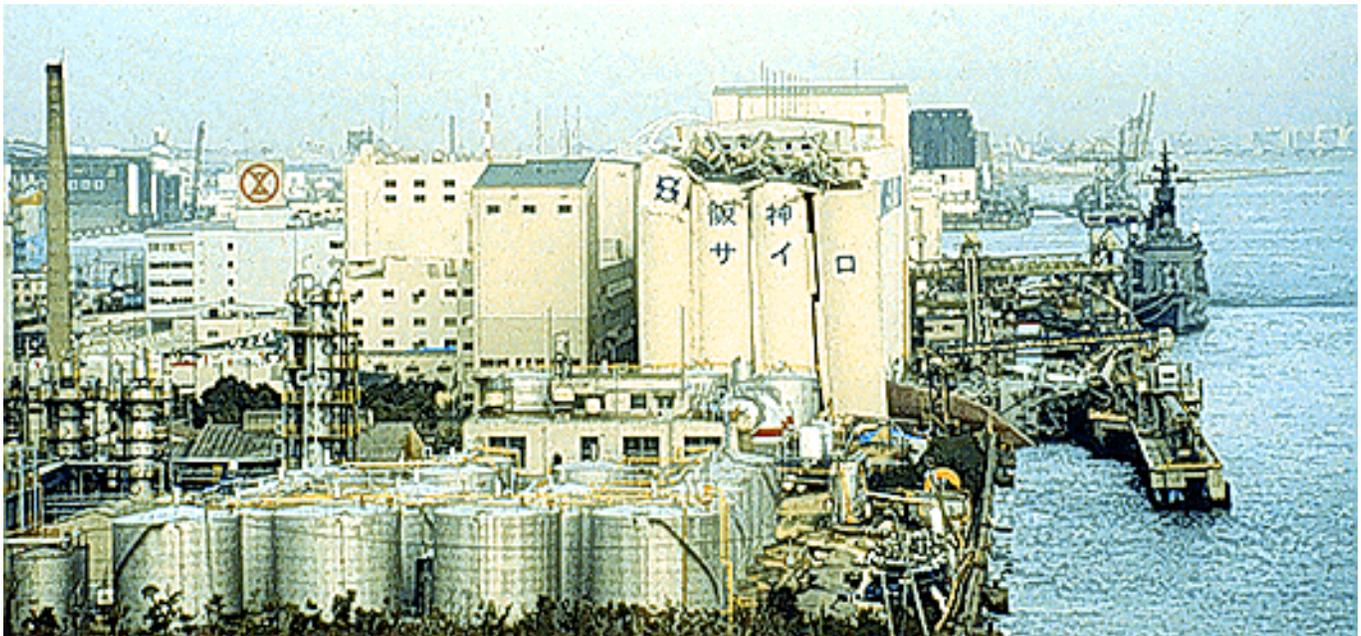
Top: Silos and port facilities on reclaimed land next to Rokko Island. Tanks in the foreground are leaning. The silos in the background are severely damaged.

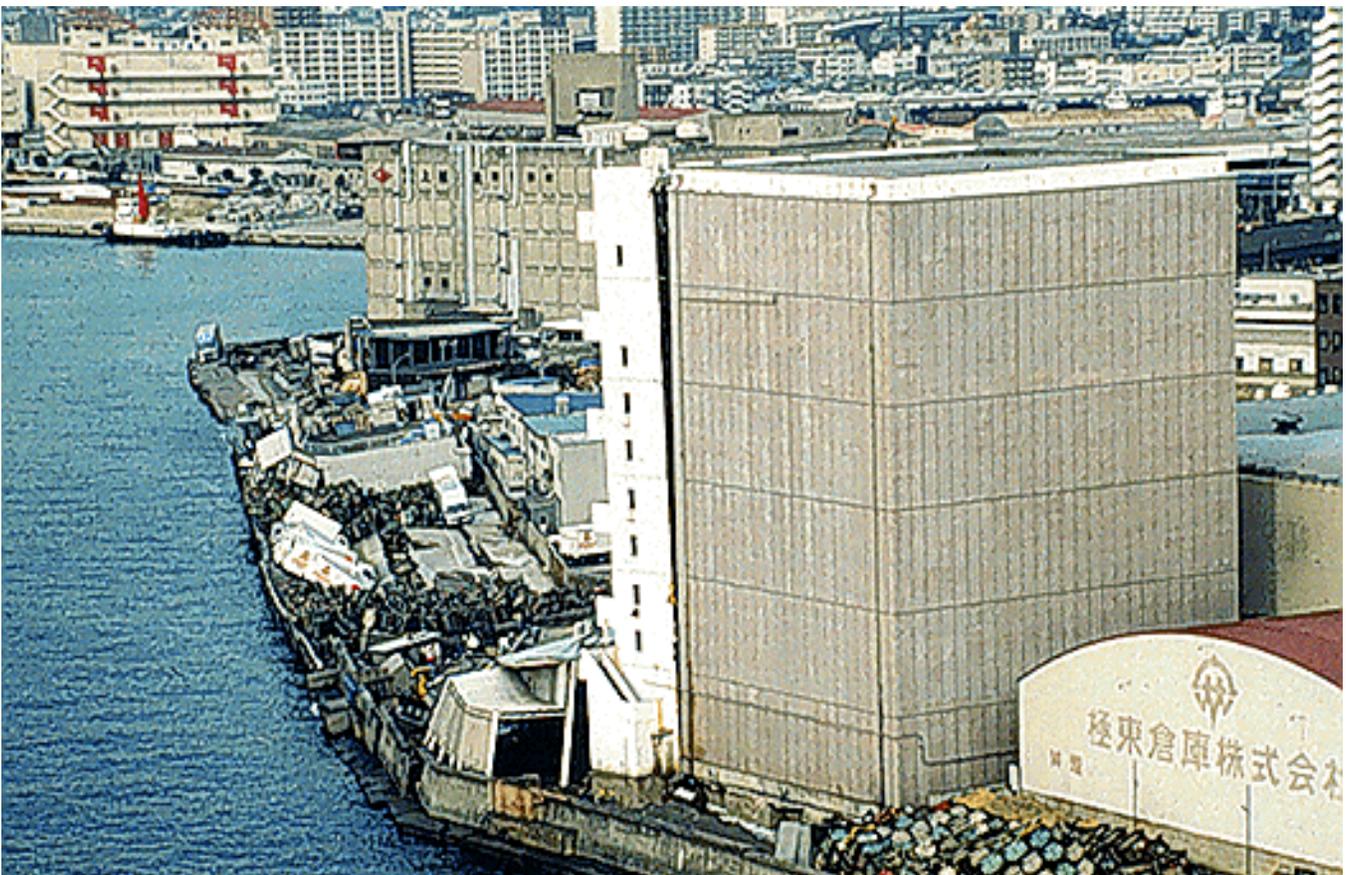
Bottom: Damage along the Port of Kobe shore. The severe rotation, lateral spreading, and settlement of the quay walls and fill material are typical of almost the entire developed border of the port. The building in the foreground has split into two parts.

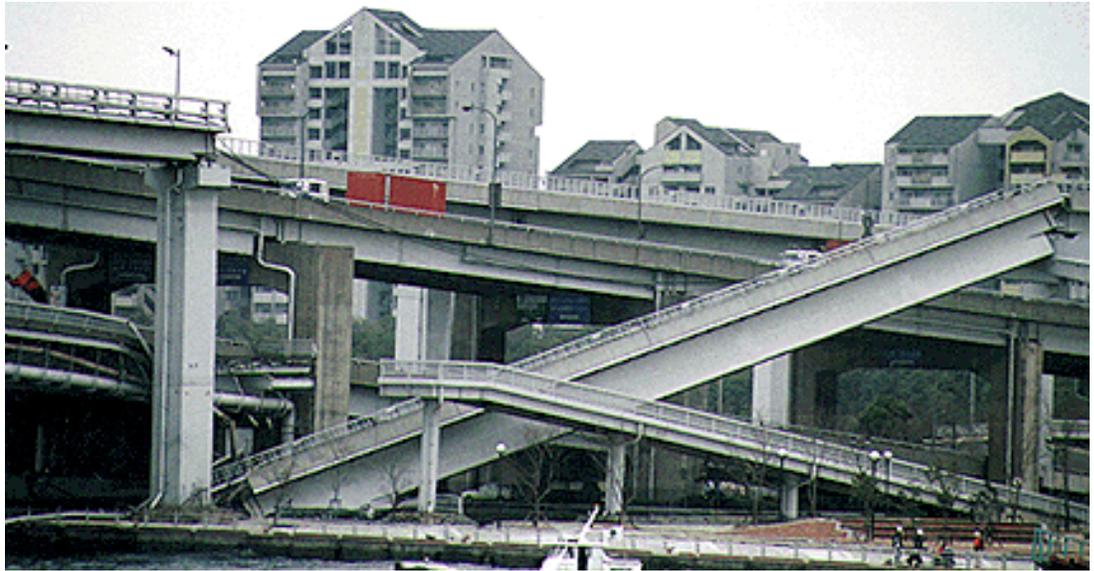
A failed portion of the Hanshin Expressway. The most heavily damaged portions of the expressway had concrete road deck (background); the less damaged portions typically had a steel superstructure (foreground). Where the two types joined, the heavier concrete deck portion pulled down the adjoining parts.

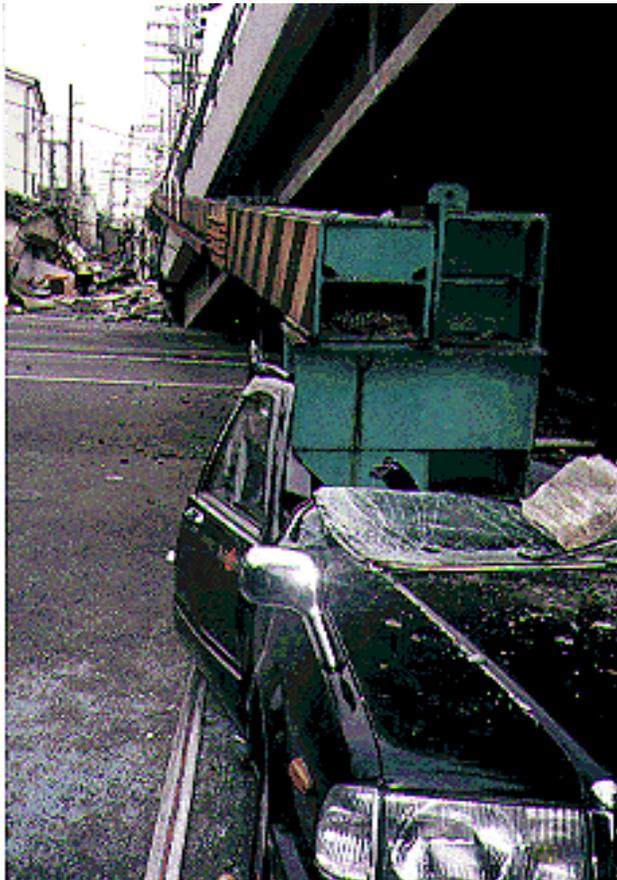
Collapsed sections of expressways.

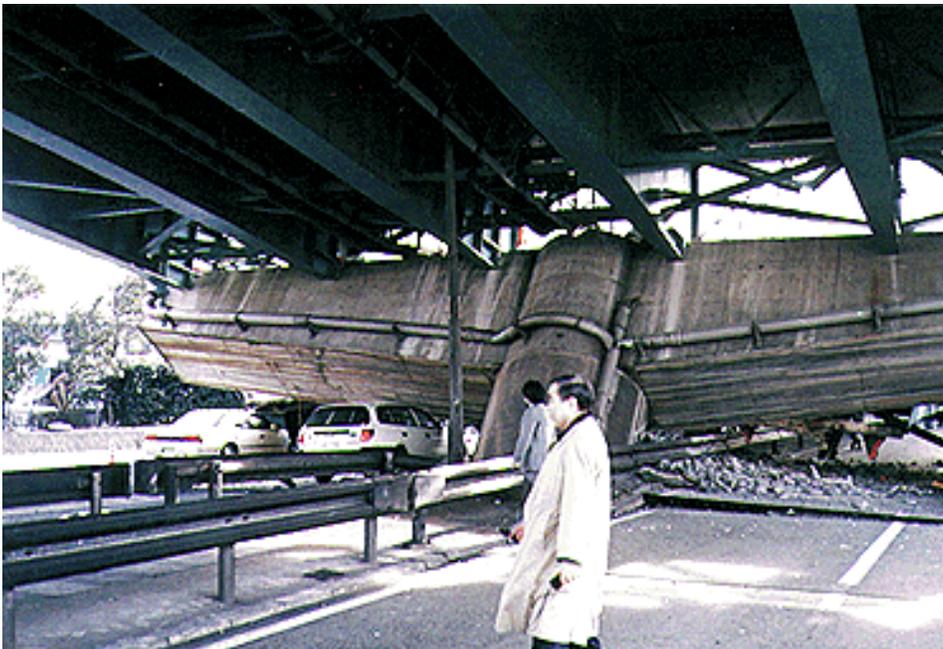
Bottom: A failed hammerhead support for the Hanshin Expressway.

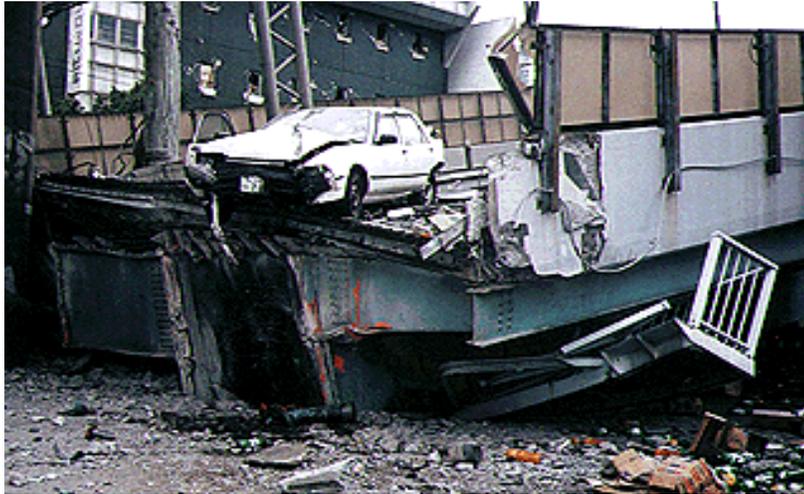
Top left: Damaged vehicle on the remains of the Hanshin Expressway.

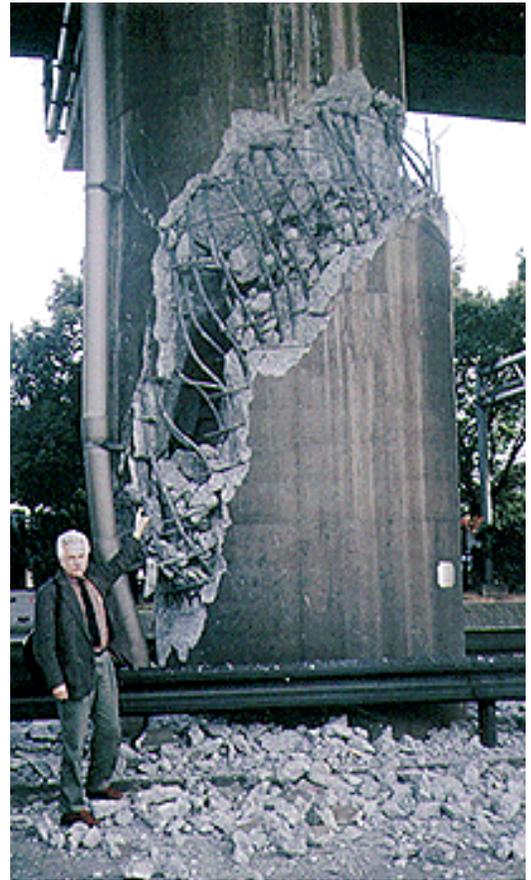
Top right: Typical damage to a massive reinforced concrete column supporting the Hanshin Expressway. This column had inadequate horizontal shear reinforcement.
