**The January 17, 1995 Kobe Earthquake
An EQE Summary Report**

April 1995

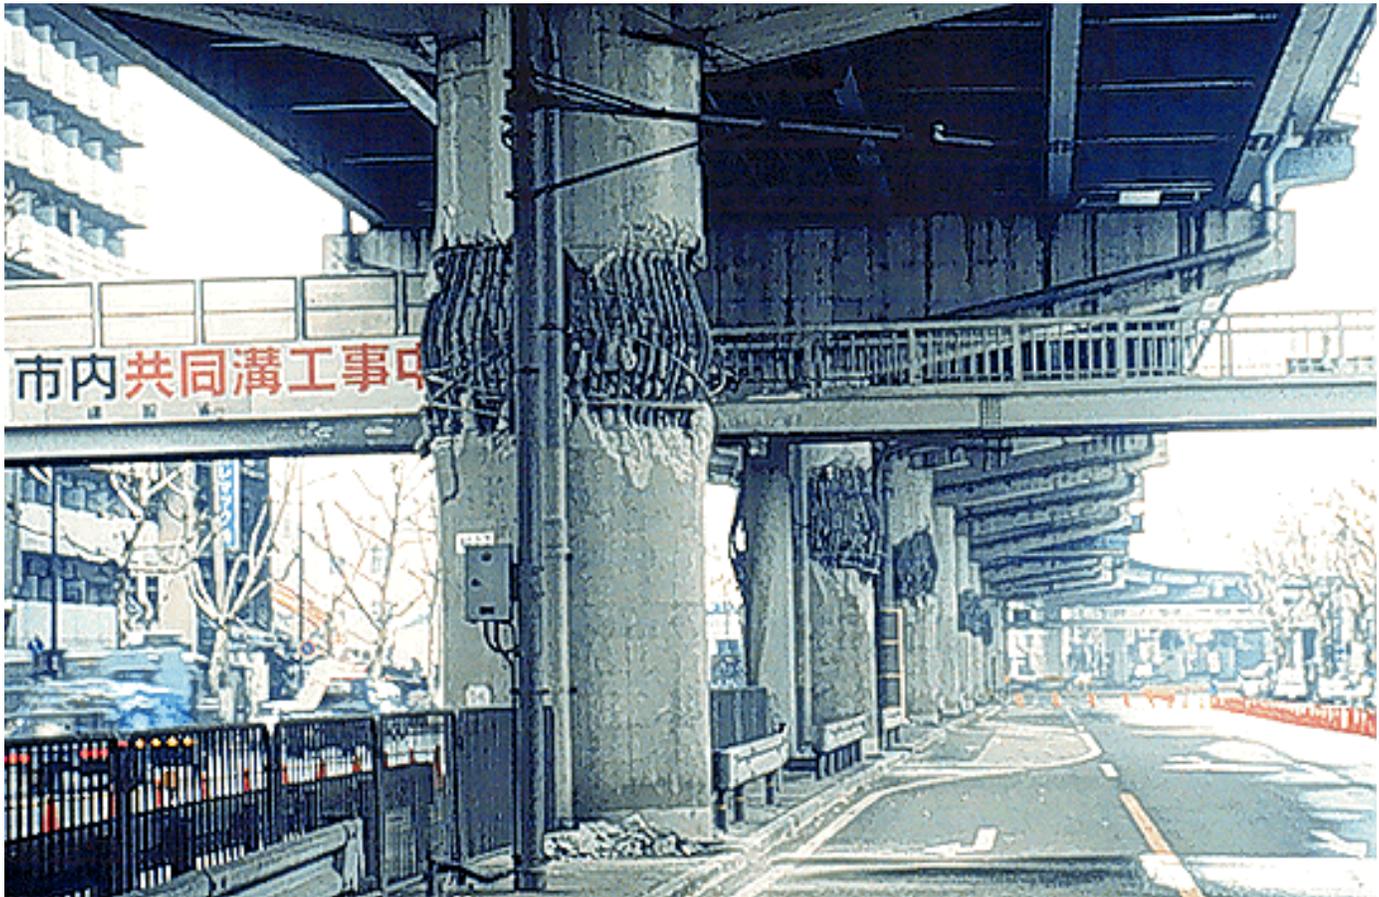
Bottom: Damage to columns supporting the Hanshin Expressway. The damage seen here was probably caused by both horizontal shear and high axial loading. This is a result of both the earthquake motion and the collapse of nearby portions of the freeway.

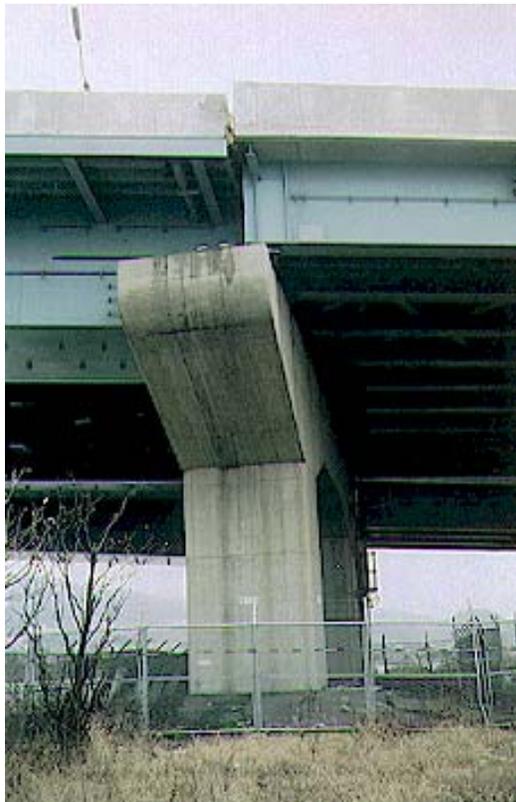
Bottom left: In the same abutment, the bent can be seen to have rotated, and there is evidence of longitudinal movement of the roadway and lateral spreading of the soil.

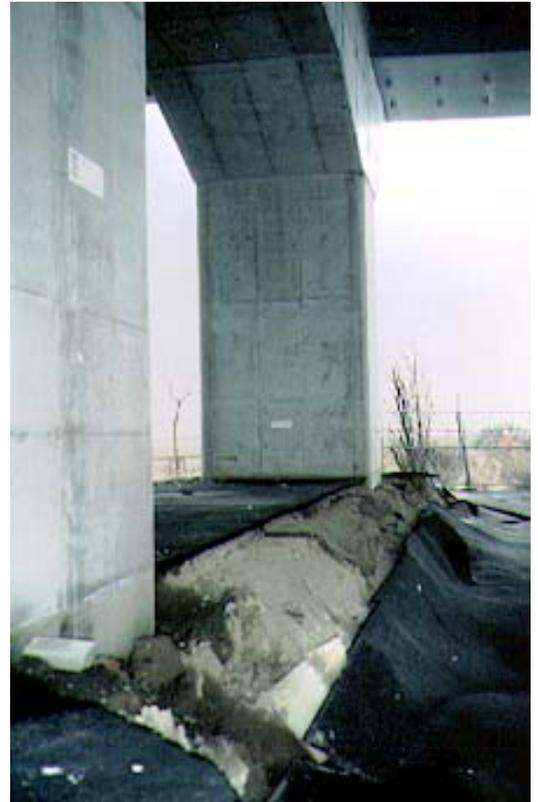
Bottom right: Ground failure at the base of an abutment of a bridge that crosses a shipping channel along the Wangan Expressway.

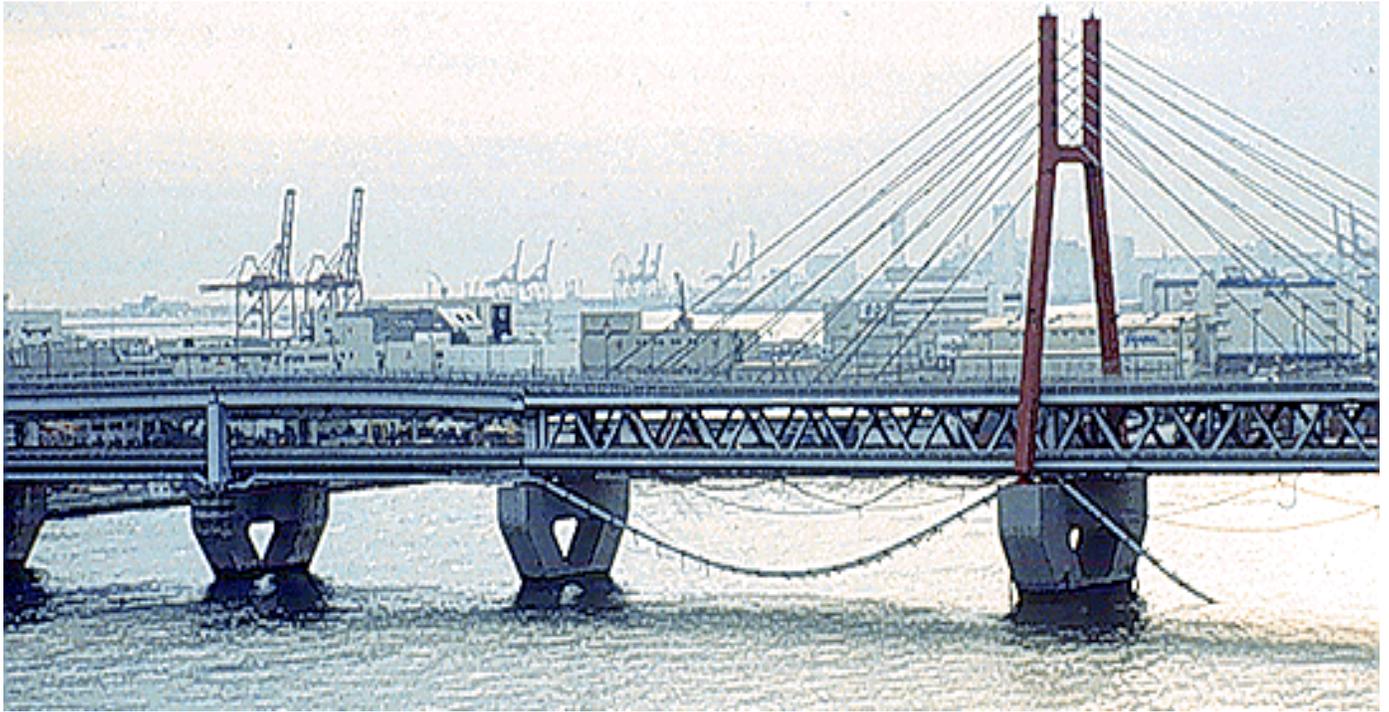
Top: The cable-stayed bridge linking Rokko Island to the mainland. Note the failed 46-centimeter water line dangling beneath the deck. All monorail lines to the island failed in the earthquake; the other bridge to the island is the steel-arch bridge shown on page 54.

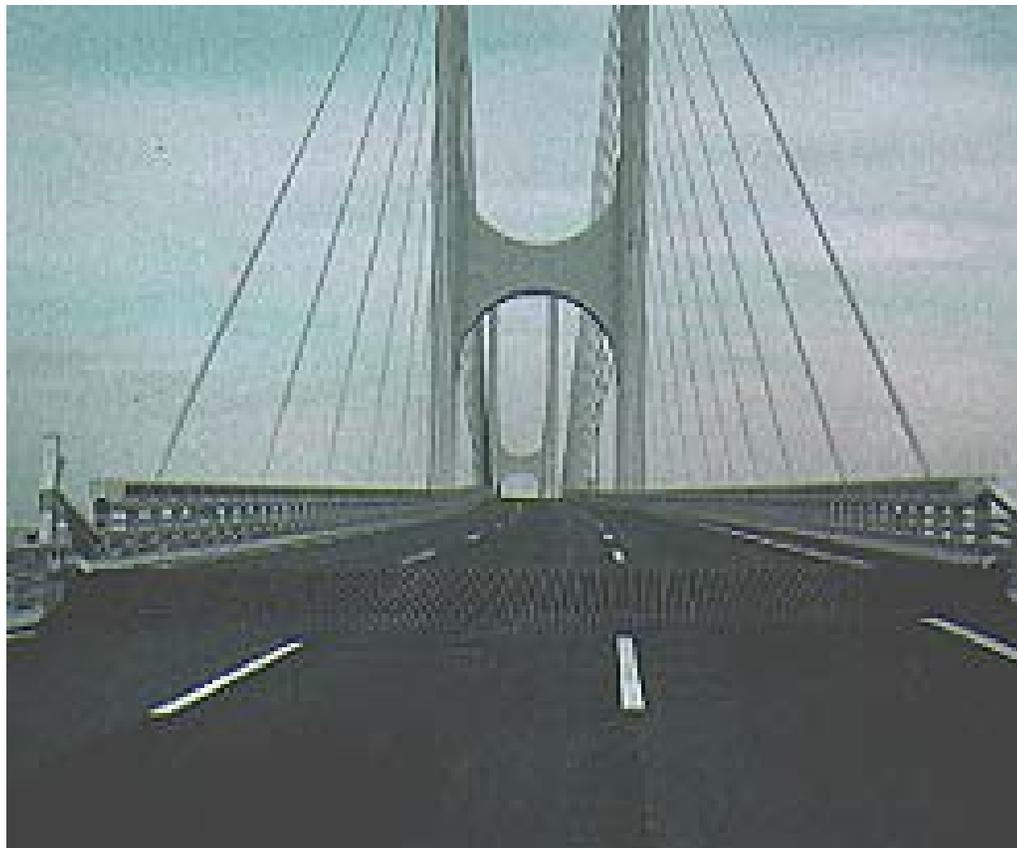
Bottom: Failed bearings were typical along the Wangan Expressway. This photograph shows a 50-centimeter vertical drop at the expansion joint from the bridge approach to the first span of a large cable-stayed bridge. The failures were typically more dramatic at both sides of major crossings along the Wangan Expressway.

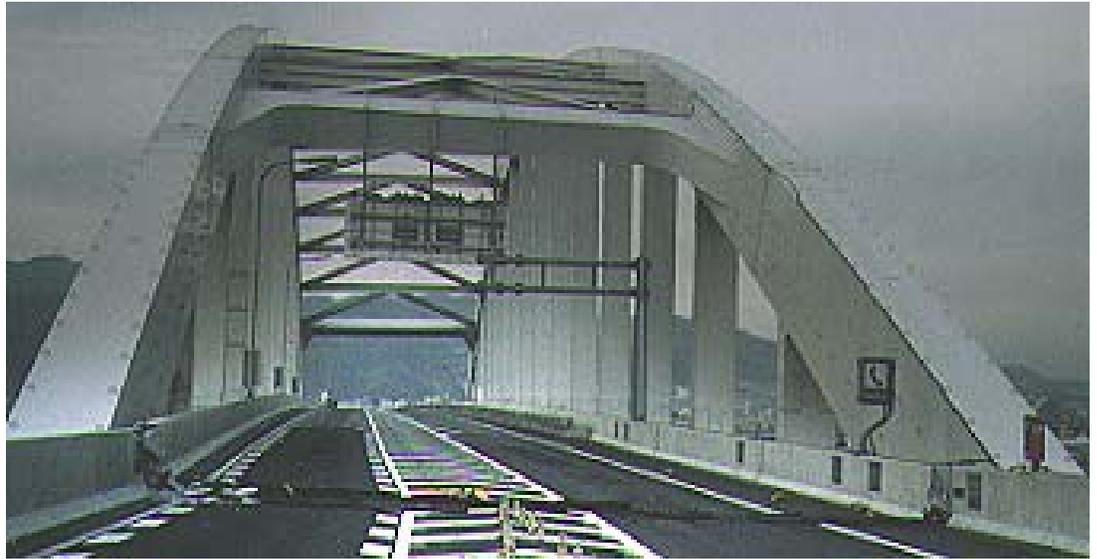
Top: The main span of a steel-arch bridge for the Wangan Expressway. Note the discontinuity in the road deck and the tilt of the bridge to the right.

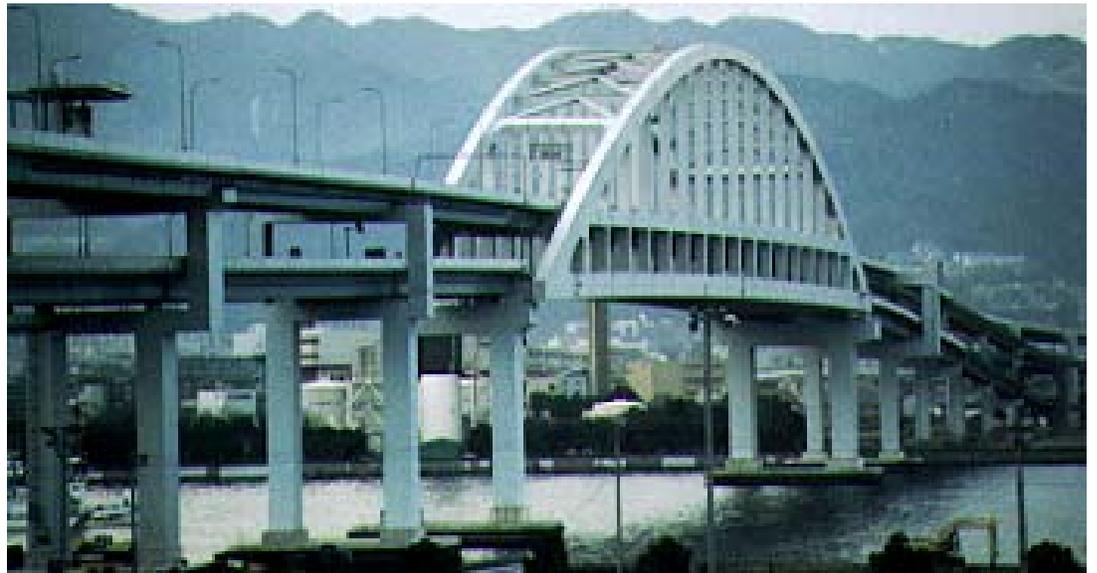
At the other end of the Wangan Expressway, where it crosses to Rokko Island, a smaller (about 200 meters long) braced-arch bridge failed, almost catastrophically. This bridge displaced laterally more than 30 centimeters and was in imminent danger of falling completely off its southern pier. The damage mode appears to be a bearing failure. Marks on the pavement made by sliding, unanchored concrete crash barriers on the upper bridge deck indicate that the bridge deck displaced laterally more than 1.2 meters.

Part of this displacement could have occurred because the bridge tilted when the southern bearing failed. Numerous approaches to the Wangan Expressway, including the elevated toll plaza for the cable-stayed bridge, failed because of ground settlement bearing failures, column rotations, and other inadequate support details.

Bottom: An overall view of the same bridge. The span is on the verge of falling off the pier at the south (closest) end of the bridge. The bearings supporting this end of the bridge failed.

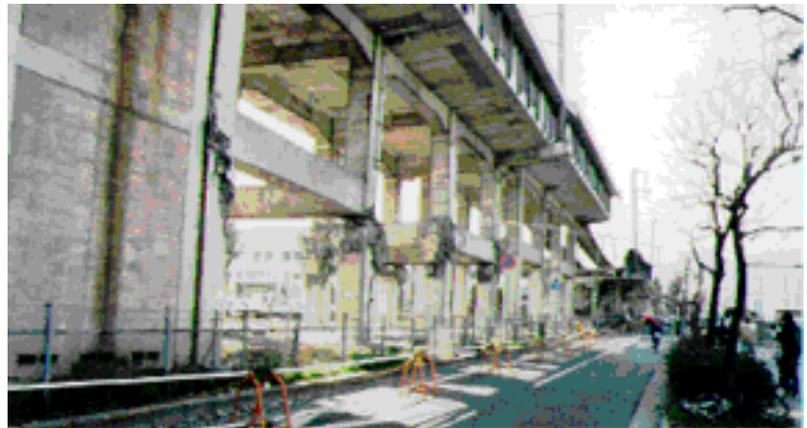
Top: Failure of the elevated train railway near Rokkomichi Station.

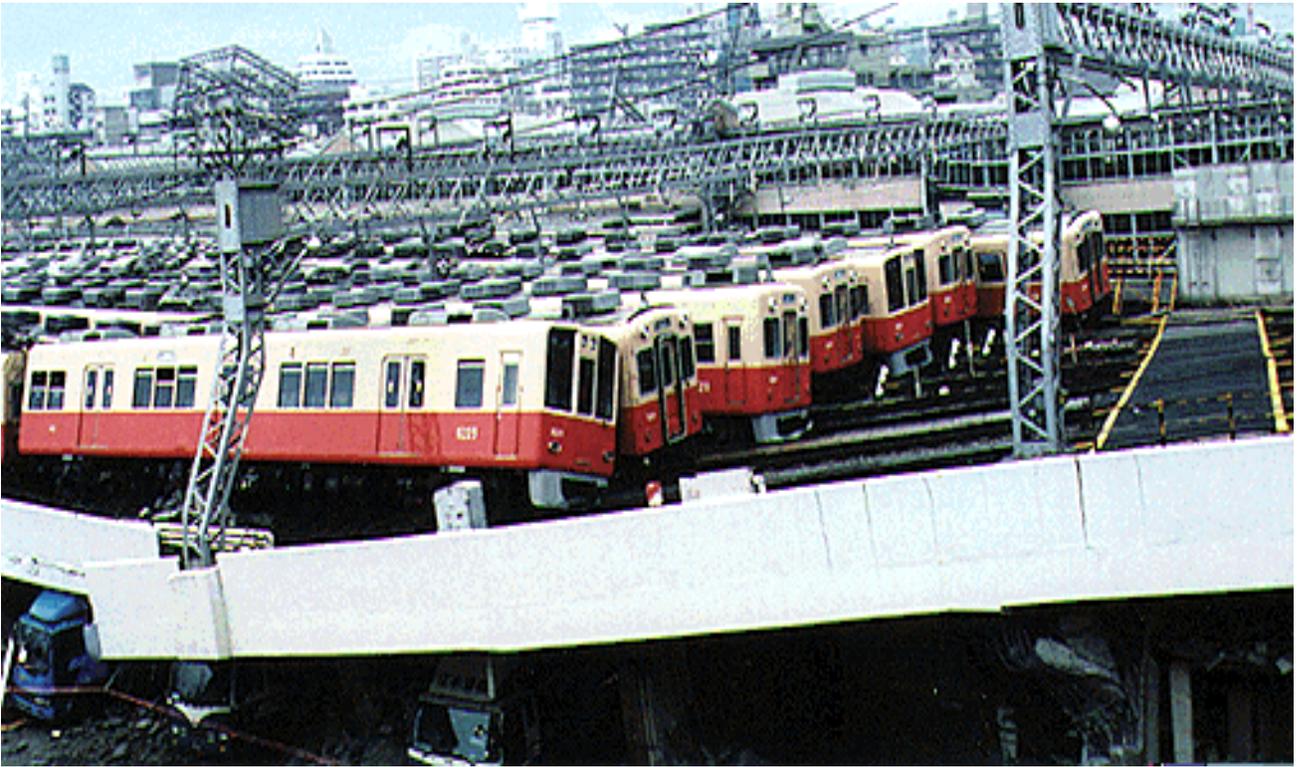
Bottom: Collapsed two-story Rokkomichi Train Station. The structure collapsed due to inadequate shear reinforcement in the supporting columns.

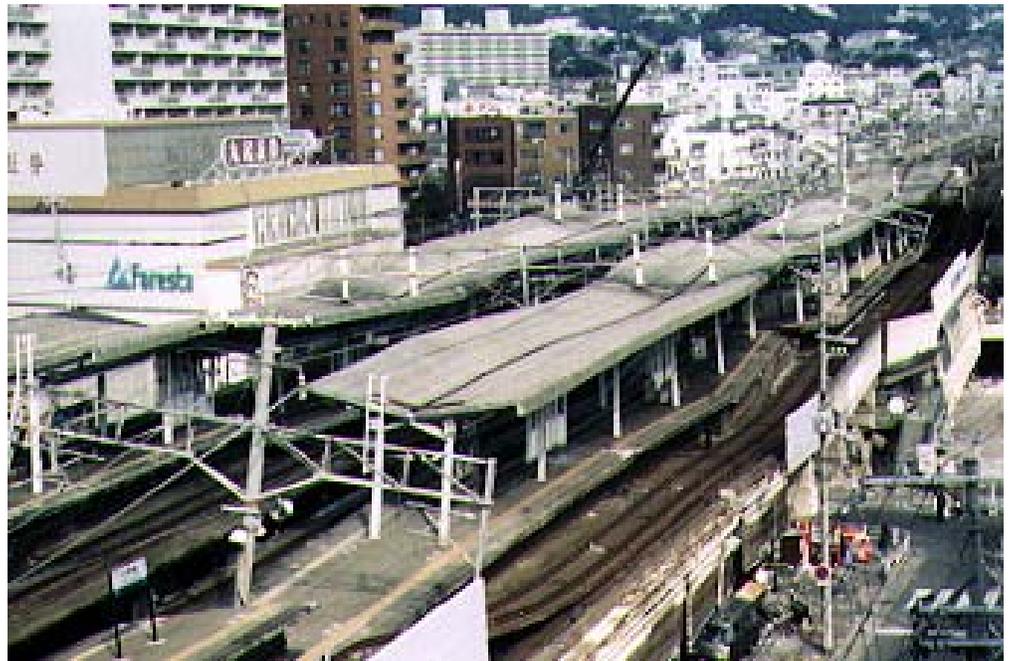
Opposite, top: Failed column supporting Rokkomichi Station, built in 1972. Note the minimal amount of shear reinforcement and nonductile detailing of the steel reinforcement.

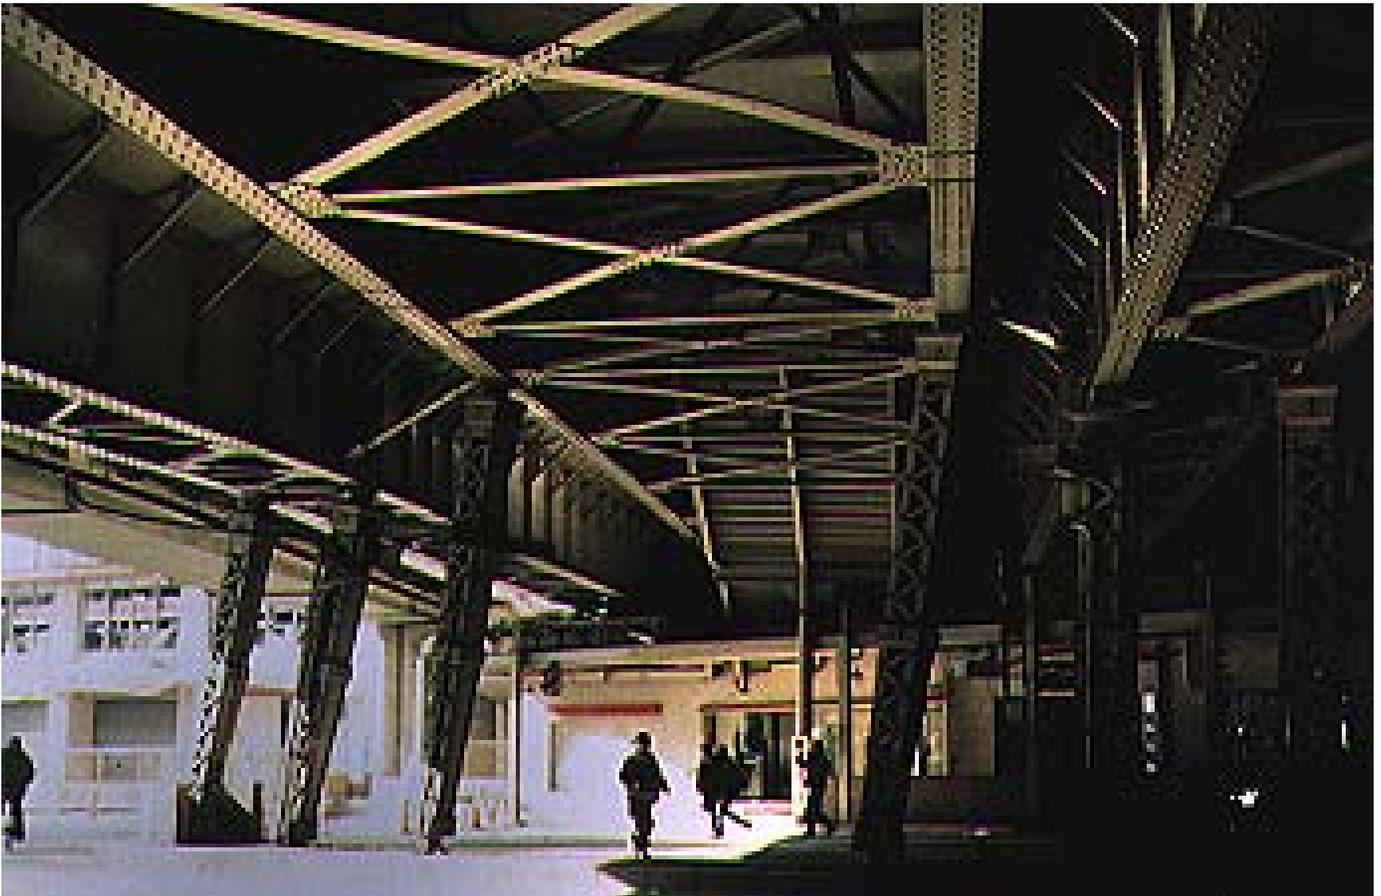
Bottom: Daikai Subway Station, Kobe. Columns supporting the roof at midspan have failed in shear, resulting in the roof's collapsing.

At the Nagata and Daikai stations, and in the tube section between, the between-track columns failed catastrophically in shear, dropping the roof slab almost onto the tracks over about a 90-meter length. More than 30 of the 35 piers supporting the platform and the ceiling at the Daikai Station were badly damaged, causing a 3-meter-deep cave-in on the street above, National Route 28. At the Sannomiya Station, 20 piers were damaged. Because the failed section is central to the entire Kobe system, most of the subway is out of service, with repairs scheduled to be completed in the fourth quarter of 1995.

Failure of the columns was caused by excessive deflection of the roof slab diaphragm combined with very light transverse (shear) reinforcement, relative to the main (bending) reinforcement. Excessive deflection of the roof slab would normally be resisted by (1) diaphragm action of the slab,

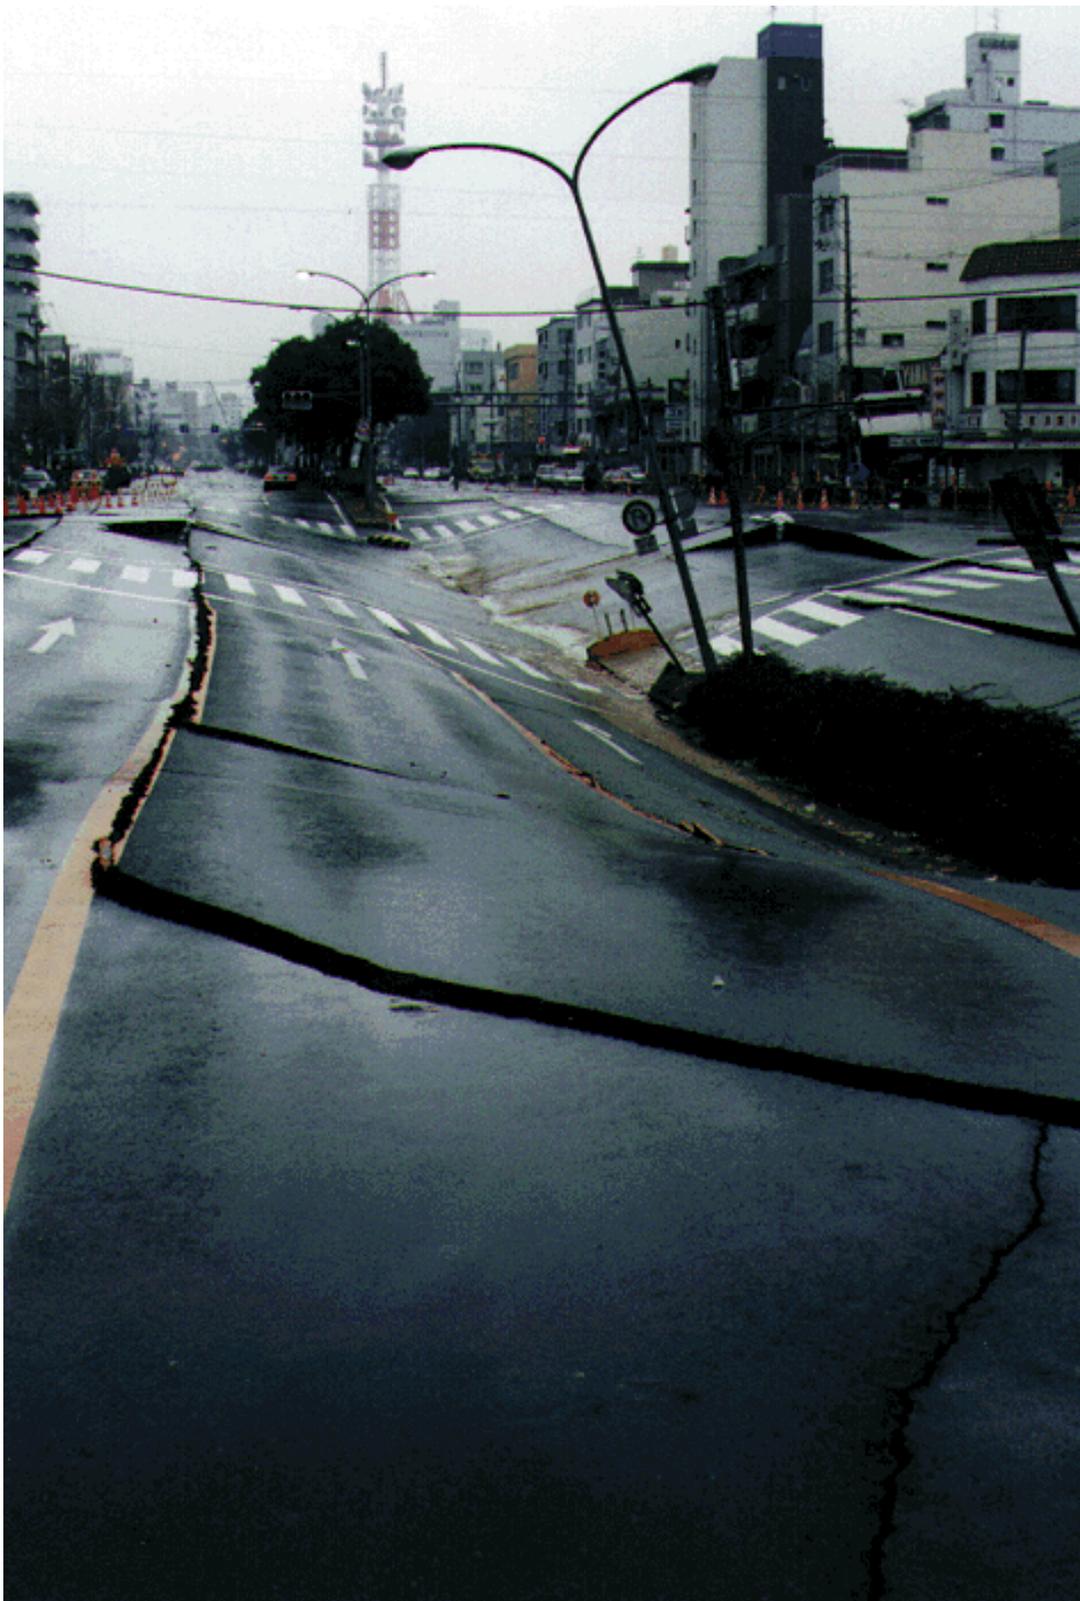
Massive depression in the roadway caused by partial collapse of the Daikai Subway Station below.

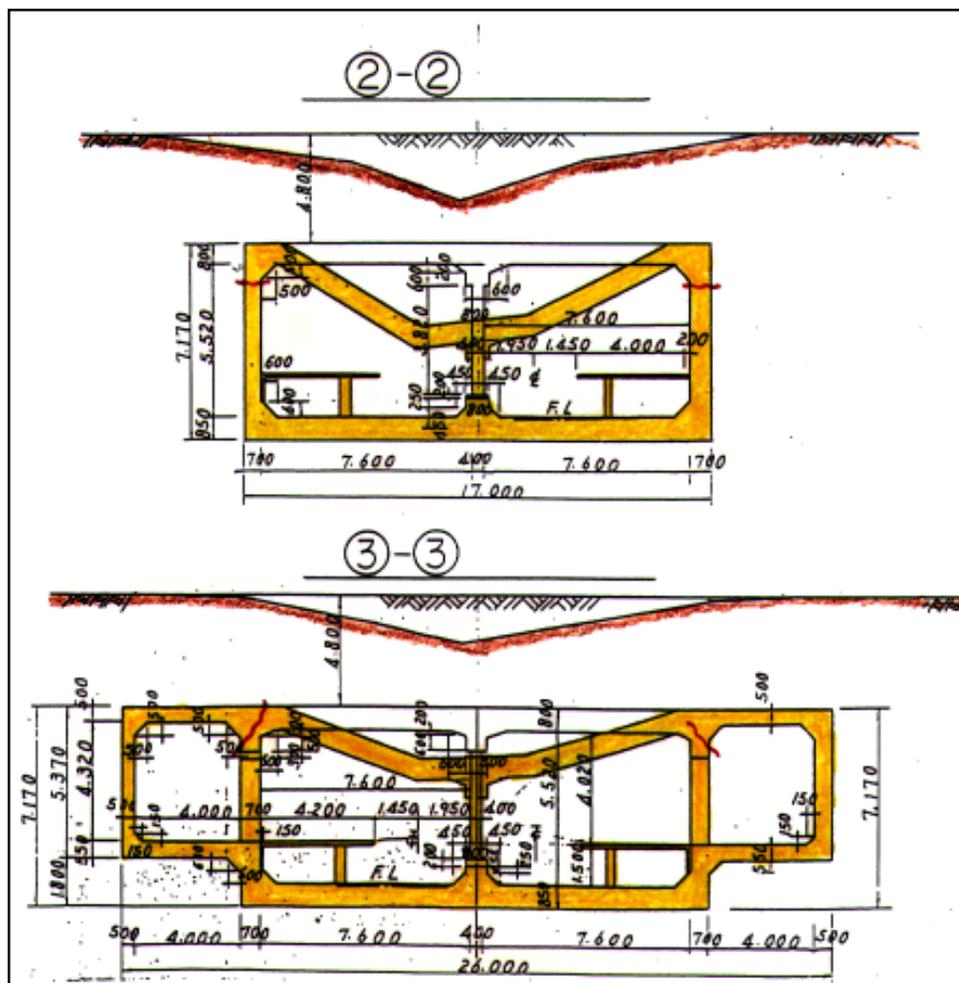
Cross sections of Daikai Subway Station after the earthquake, showing the roof collapse.

supported by the end walls of the station, and (2) passive earth pressure of the surrounding soils, mobilized as the tube racks. Diaphragm action was less than anticipated, however, due to the length of the station.

The lack of passive earth pressure is extremely interesting, because it highlights a common cause of failure—the difference between design assumptions and constructibility. That is, designers in this situation often assume that passive earth pressure of the surrounding soil will provide partial support for the tube under lateral loading. Because of the method of construction (cut-and-cover, involving sheathed excavation with narrow clearance between the sheathing and the tube wall), compaction of backfill would have been difficult to impossible, resulting in the tube's inability to mobi-

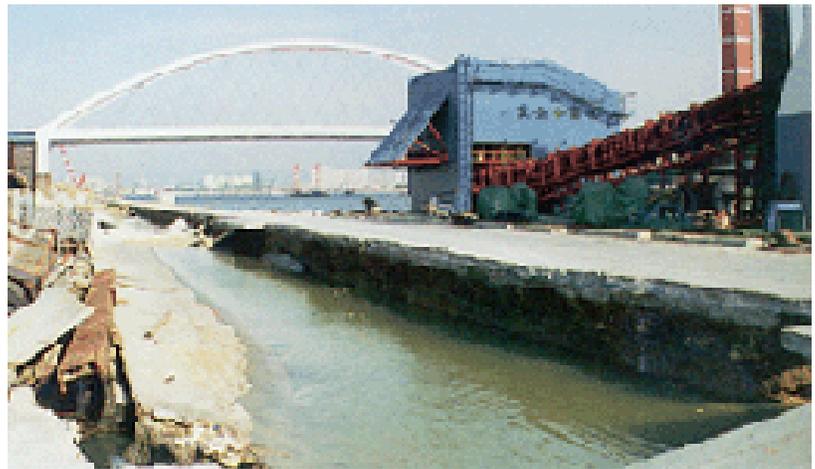
Top: Water behind a failed quay wall. Caissons have tipped and slid toward the water, allowing the supported deck to collapse behind them.

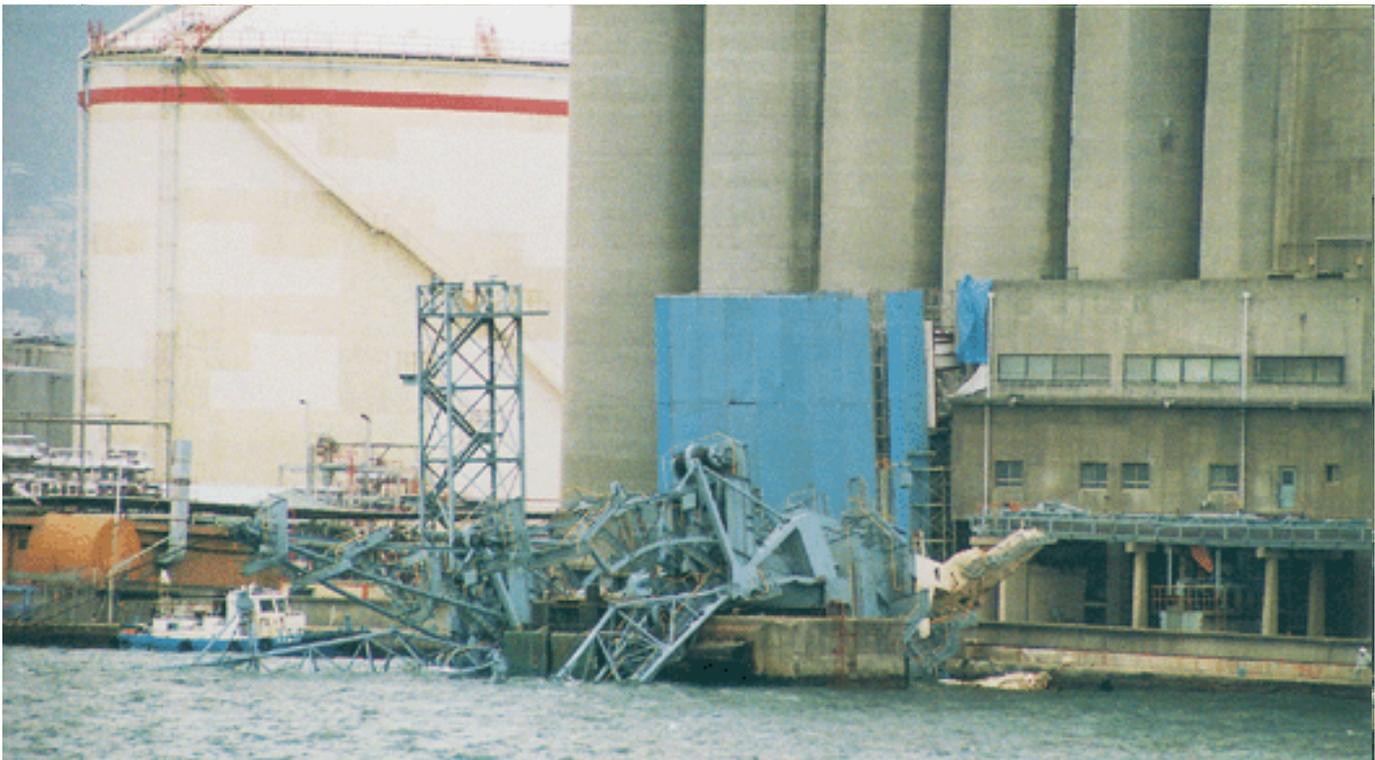
Bottom: Failed structures at the edge of the port across from Rokko Island.

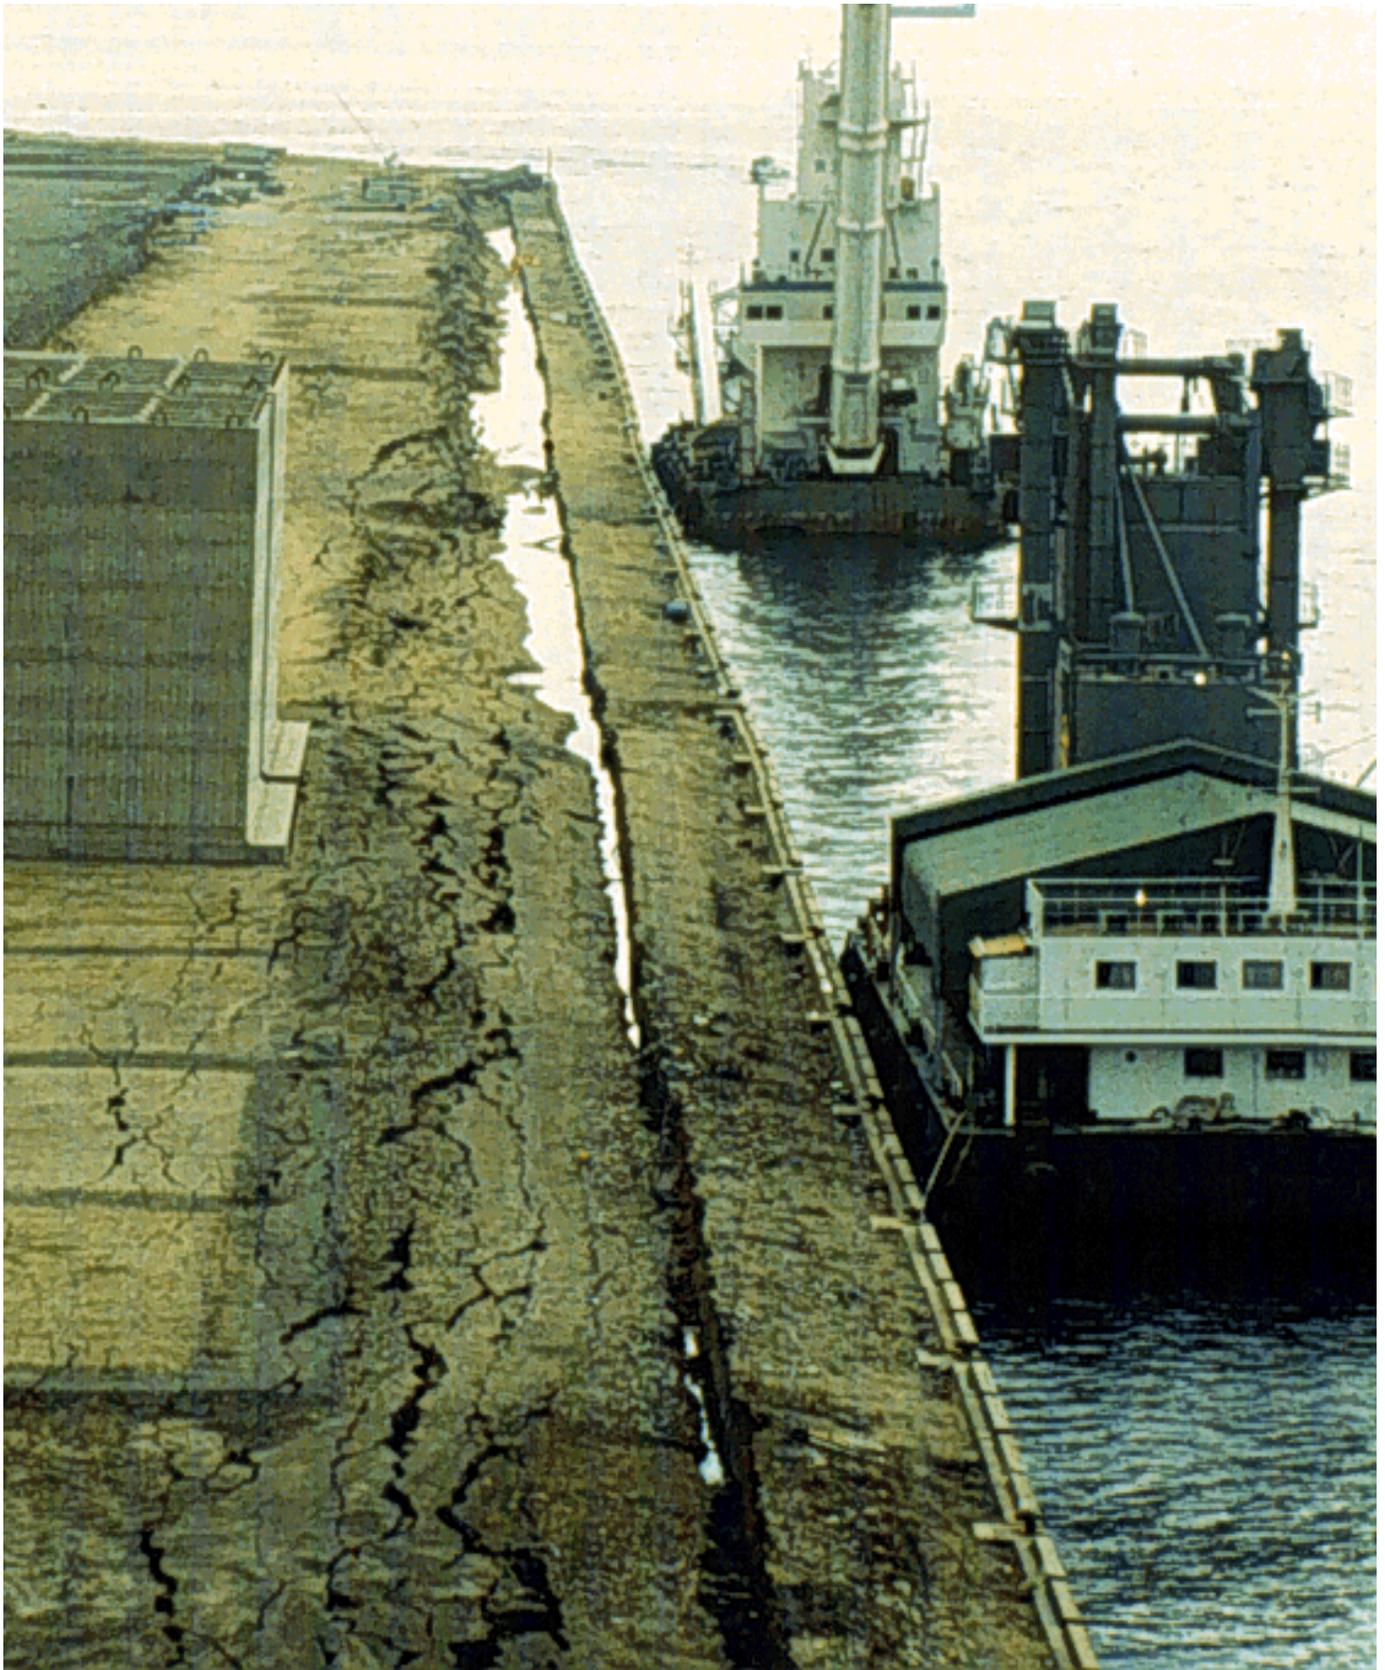
Cranes damaged by lateral spreading, Rokko Island.

Damage to the gantry cranes was in the form of leg and cross-beam buckling, as well as rupture at the wheels. The extent of buckling varied, depending primarily upon the relative horizontal displacement resulting from the movement of the caissons. Relatively few cranes jumped off the tracks, which can be attributed to most of the cranes being in the stowed position with their pins engaged at the time of the earthquake. Numerous other cranes throughout the port were damaged because of foundation damage. Several cranes collapsed; some collapsed because of structural damage caused by inertial forces generated by the earthquake.

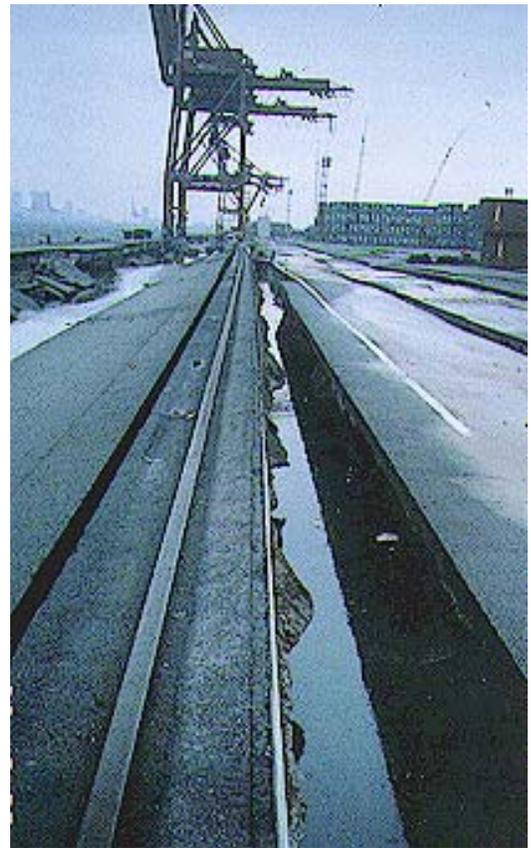
Opposite: Typical failure of a caisson wall; the wall has moved to the right (lateral spreading), allowing the fill behind to settle. This island is newly constructed. An unused caisson can be seen to the left.

Quay wall caisson displacements, which undoubtedly propagated the major damage in the port, may be attributed to several phenomena. Earthquake accelerations applied to the massive sand-filled caissons resulted in large horizontal forces, which may have exceeded the sliding resistance offered

by the base. This can be further aggravated by the rocking motion of the caissons, which may result in excessive bearing pressures at the toe of the base. The latter coupled with the possibility of liquefaction may explain the observed tilting of many caissons. Since the islands' fill placed below water was dumped

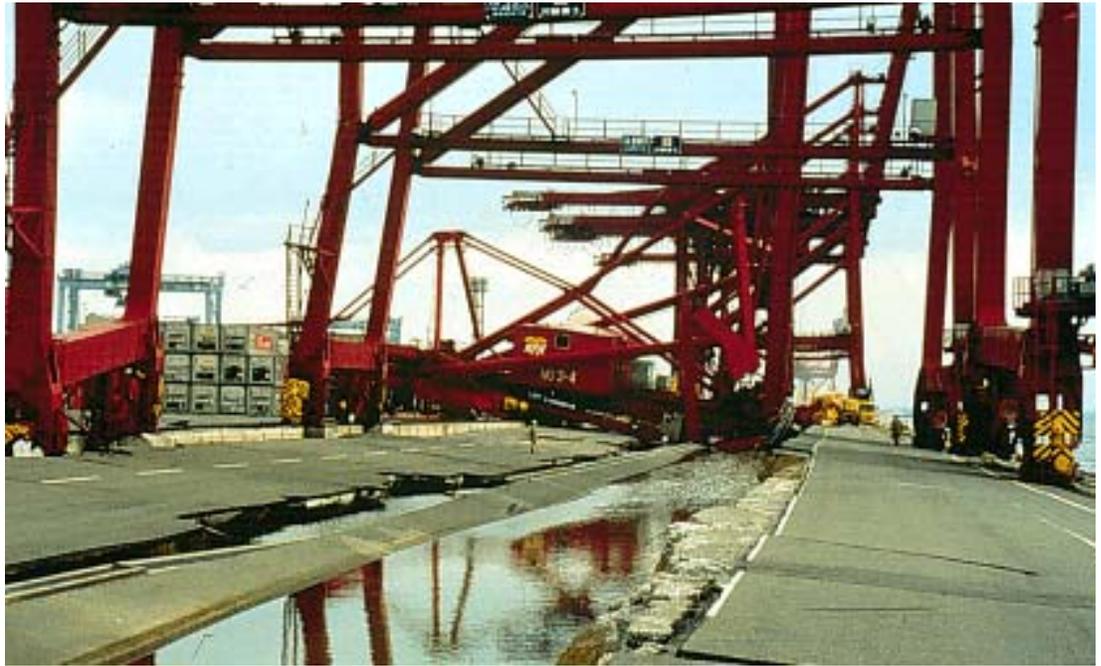
Container pier on Rokko Island. Severe damage to the pier and cranes was caused by lateral spreading. Note the damage to the legs of the cranes.

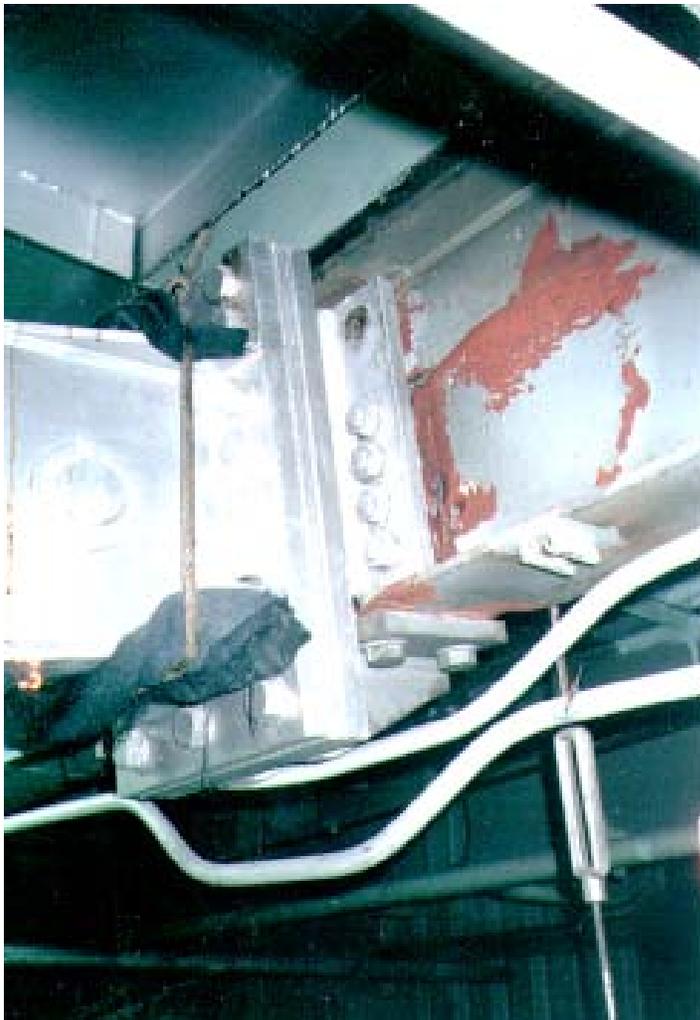
Failure of seismic ties for the boiler at the Amagasaki No. 3 plant.

significant ground settlement observed. The most significant damage was the failure of seismic ties between the boiler and its support structure. Preliminary observations indicate that the ties were not loaded linearly, resulting in dramatic failure of the ties near the top of the structure. U.S. fossil plants with suspended boilers have undergone similar ground motion but have seismic stops rather than ties. The stops absorb energy by deforming during an earthquake, while ties are stronger but less ductile. Both the seismic ties observed at Amagasaki No. 3 and the stops found at U.S. stations have had substantial damage from moderate ground motion, although stops do appear to prevent damage to the boiler.

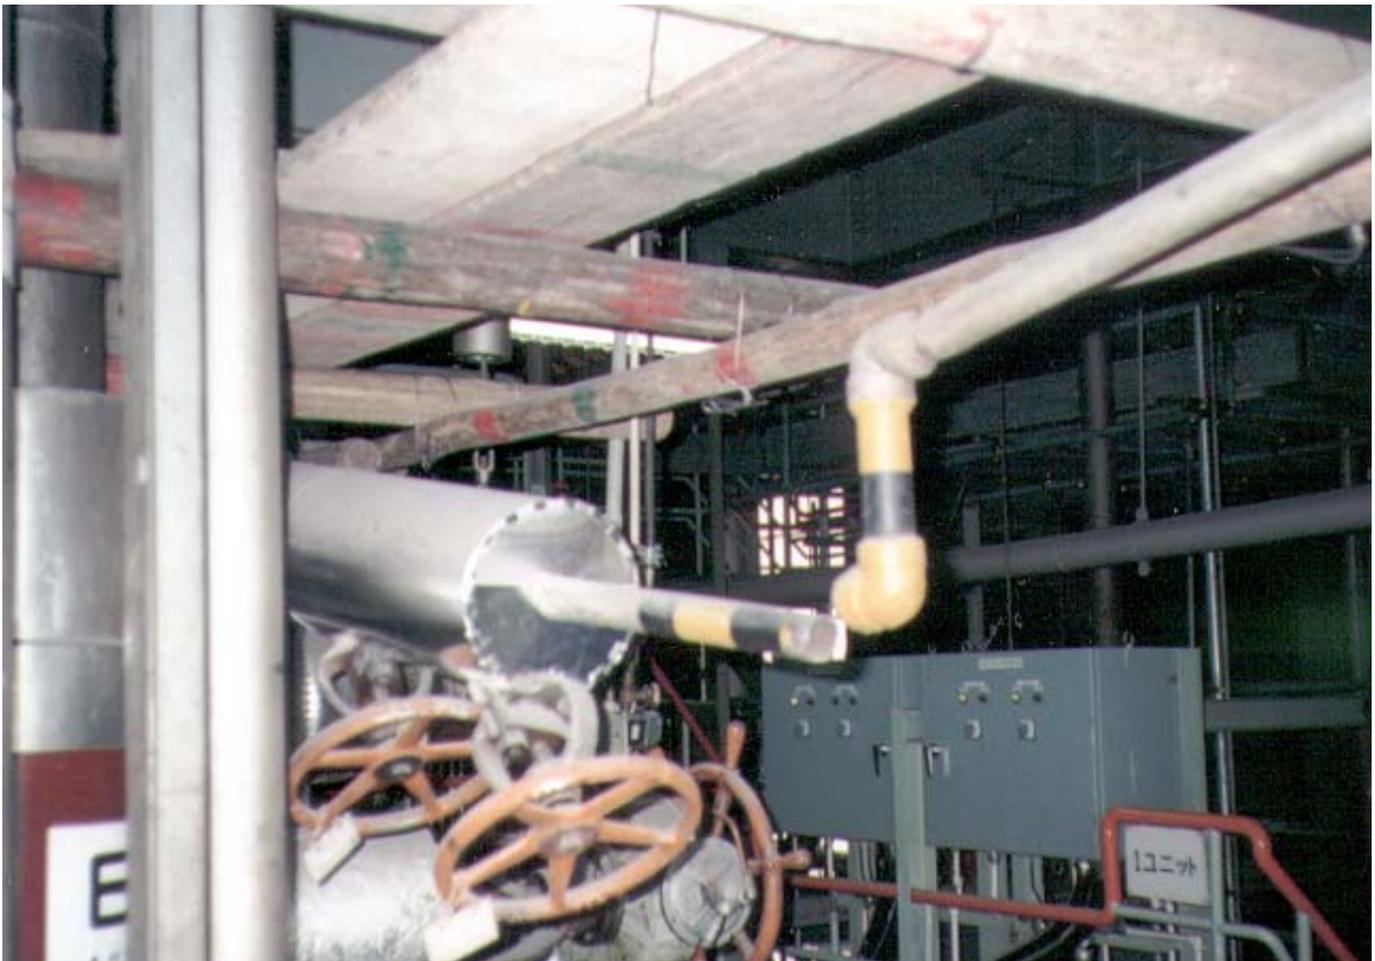
Amagasaki No. 3 also had a small pipe failure caused by steam drum displacement relative to the structure and miscellaneous

Pipe failure caused by steam drum displacement at the Amagasaki No. 3 plant.

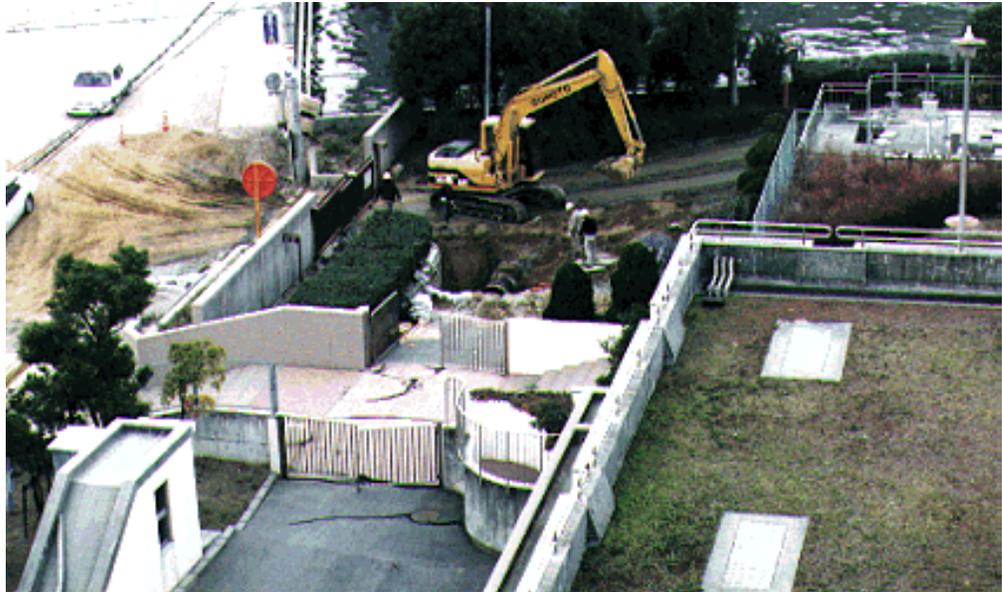
Workers repairing damage to a water treatment plant across from Rokko Island.

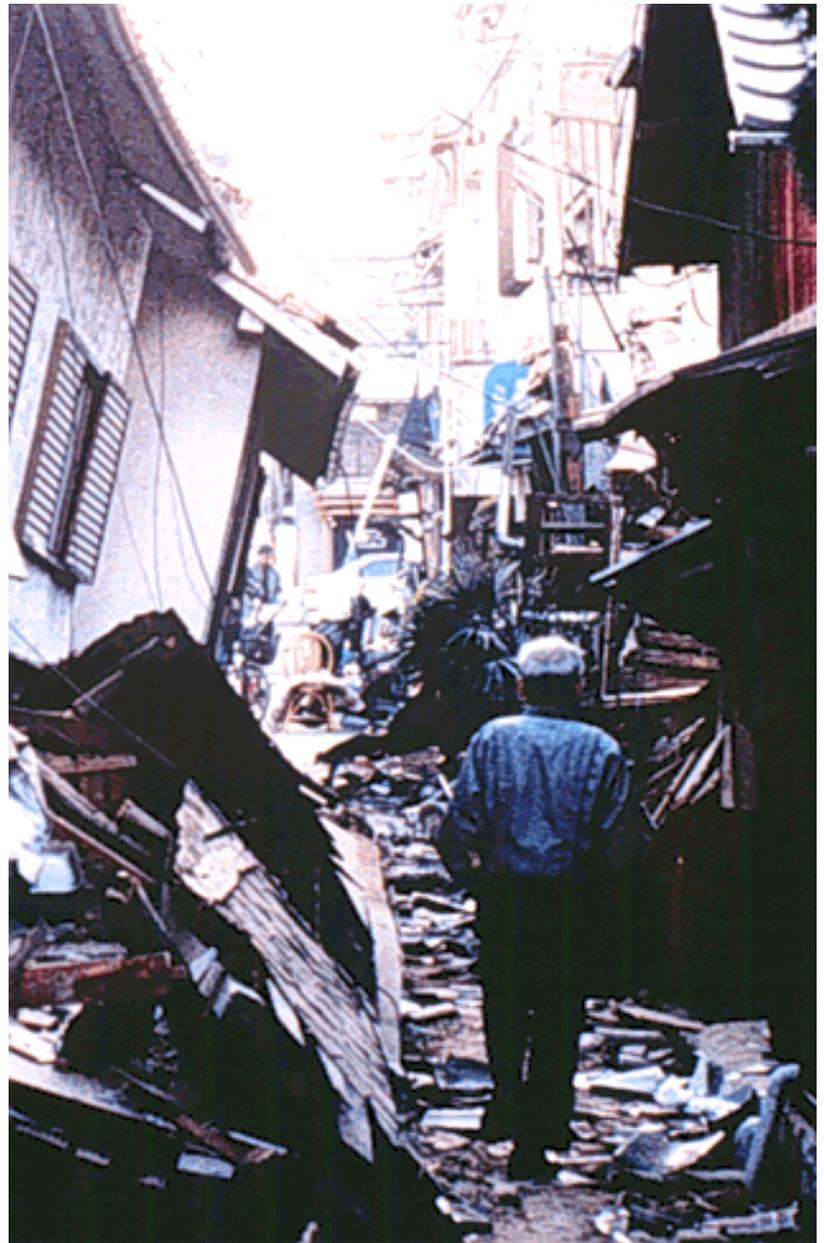
A typical street scene in a residential and light commercial area of Kobe. A house has collapsed, blocking the very narrow street and preventing access to the area by the fire department. Thousands of narrow streets were blocked like this. In other areas, many of the collapses were traditional buildings with ground-floor stores or shops and second-floor residential units.

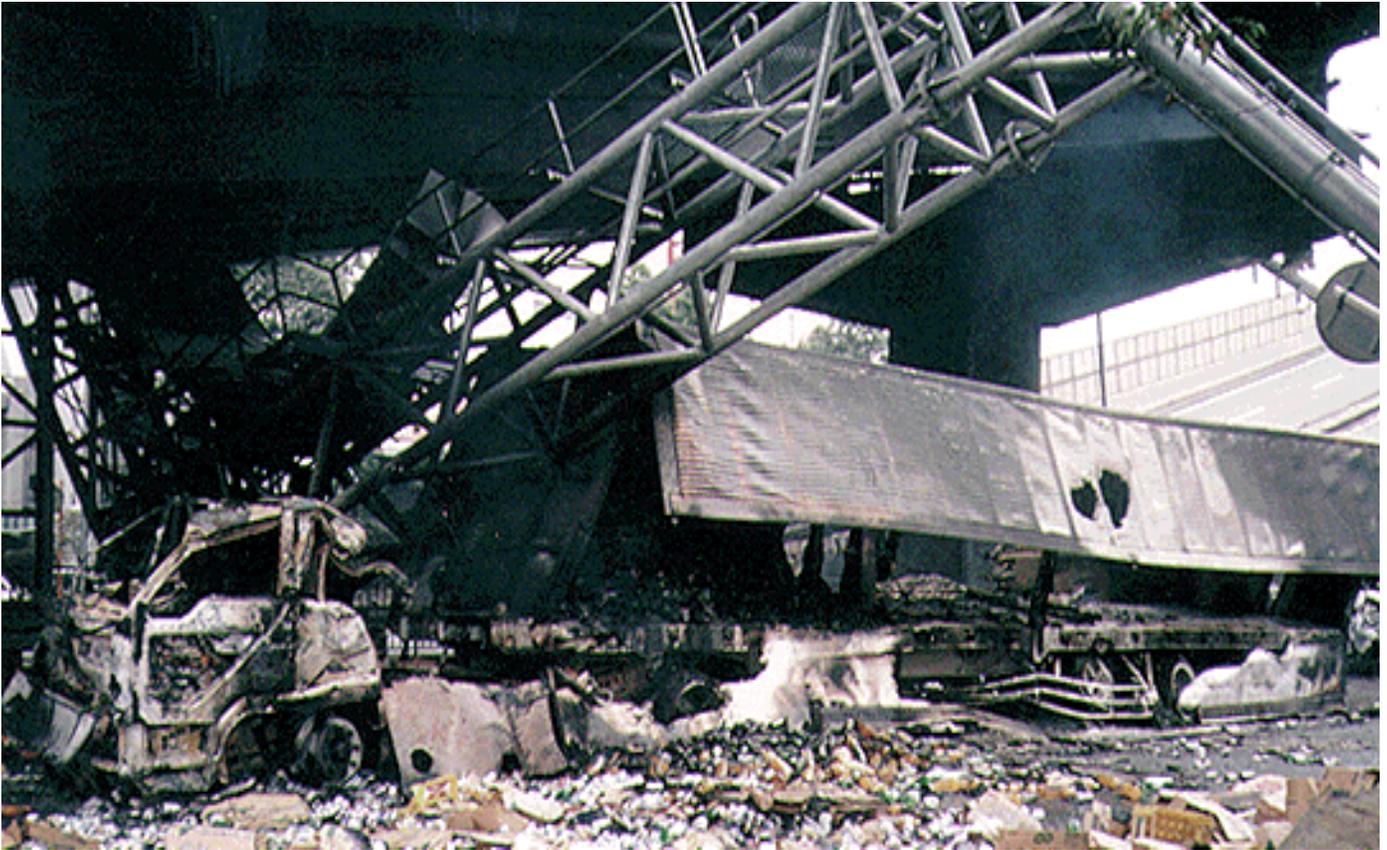
This truck carrying kerosene caught fire when the overhead roadway collapsed onto it.
