**The January 17, 1995 Kobe Earthquake
An EQE Summary Report**

April 1995

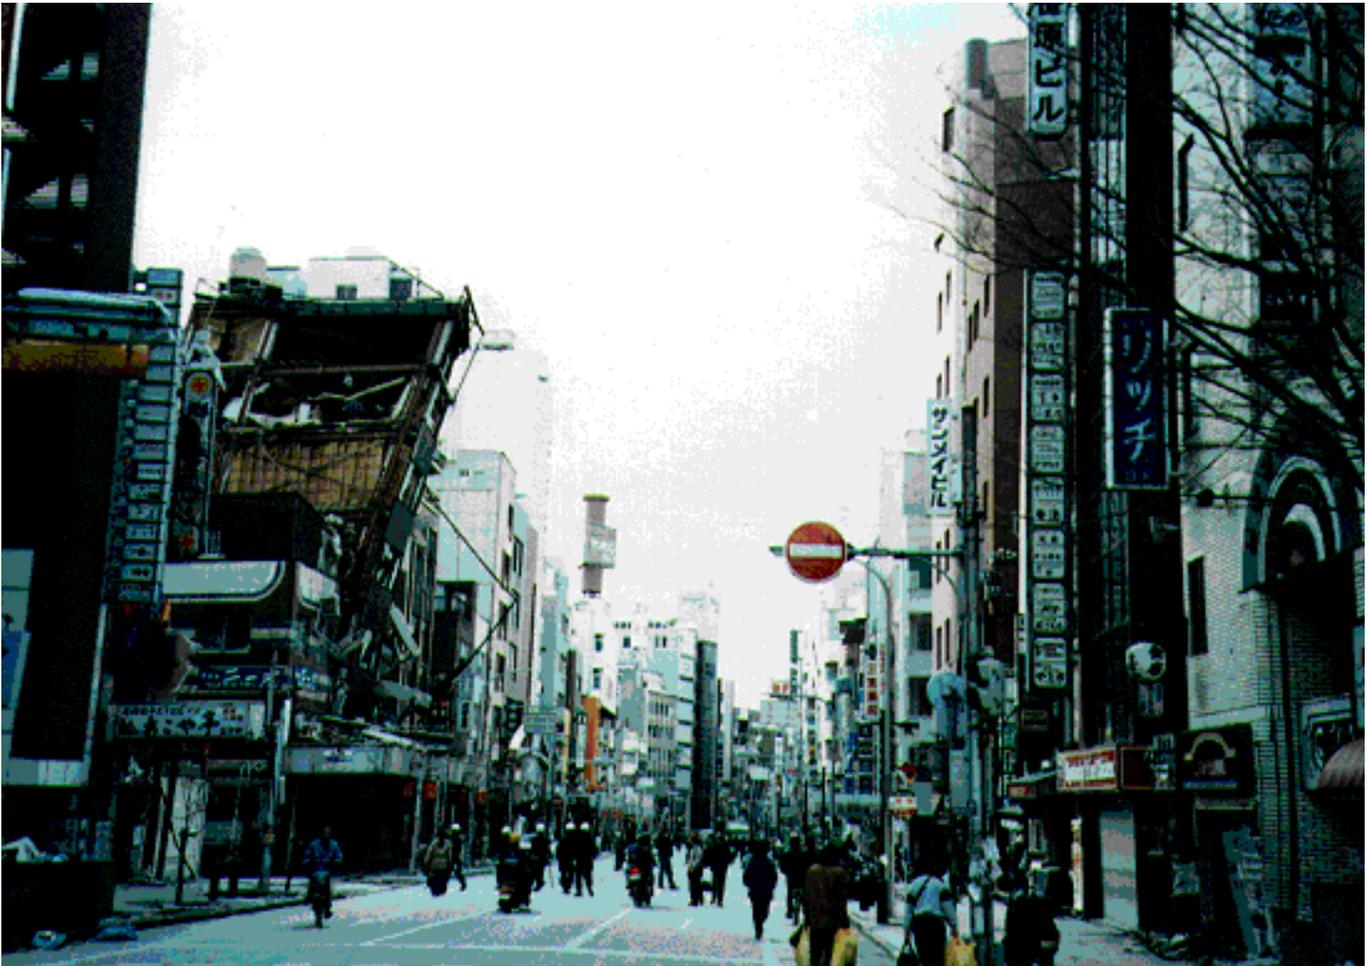
Residents walked the streets of Kobe after the earthquake examining the damage.

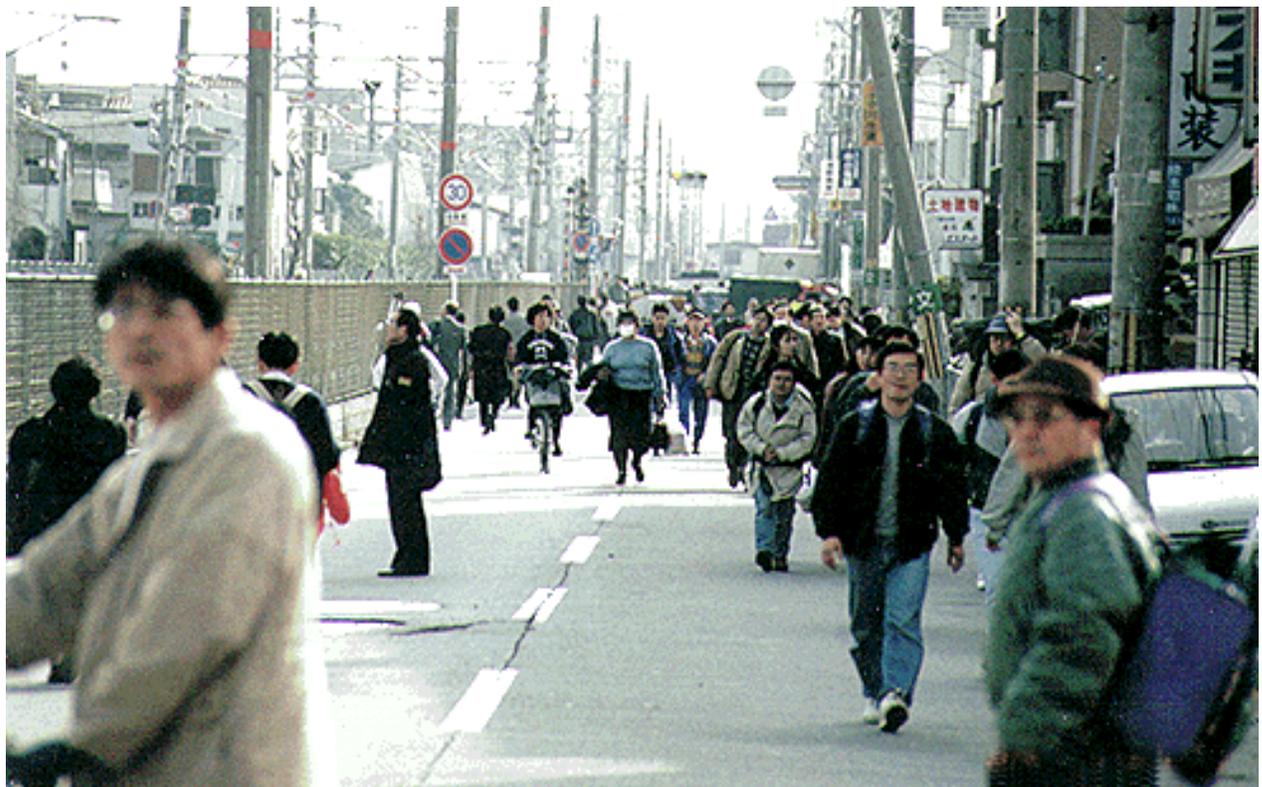
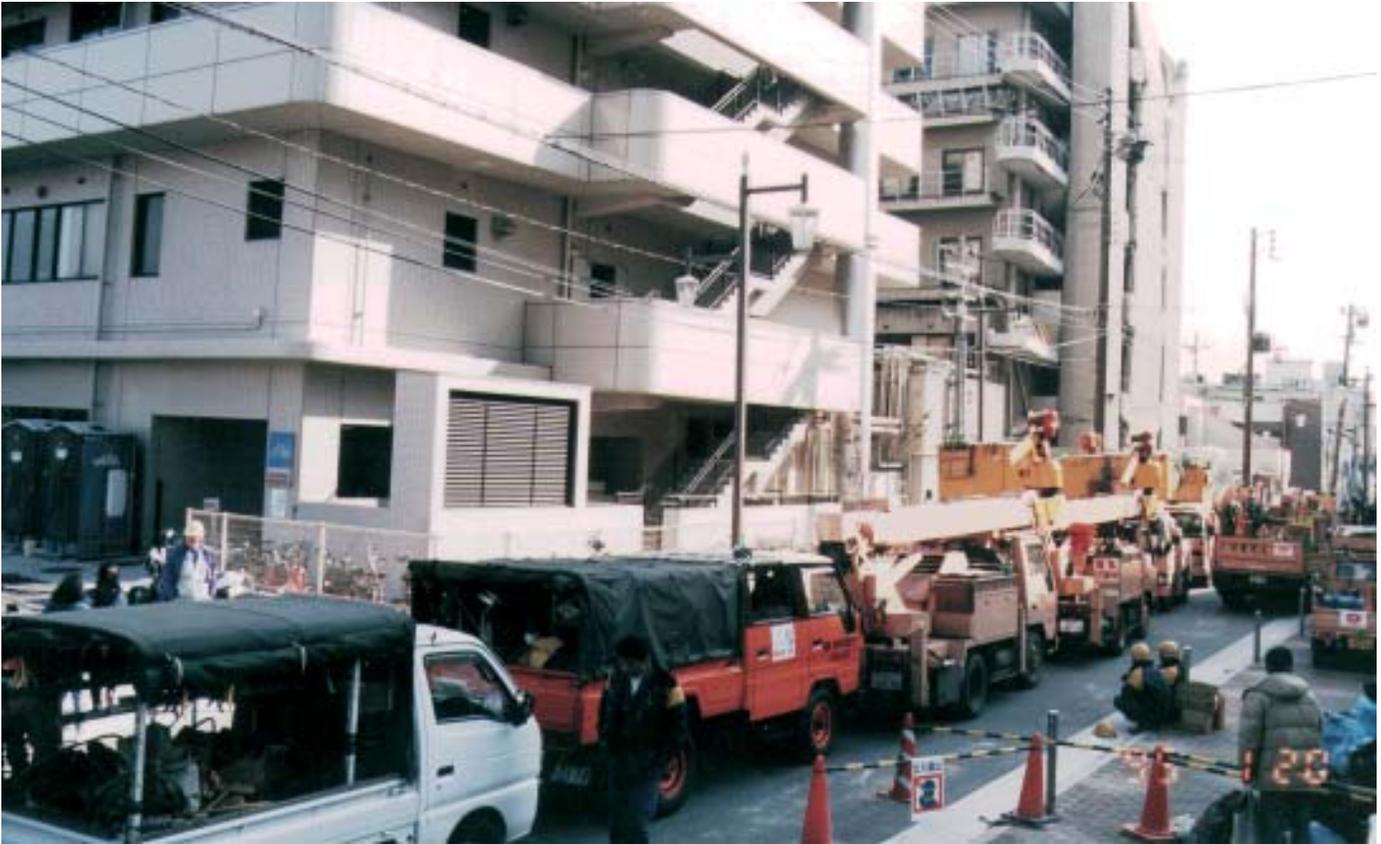
Lines of trucks bringing supplies to the populace, as well as equipment to start demolition and removal of damaged buildings.

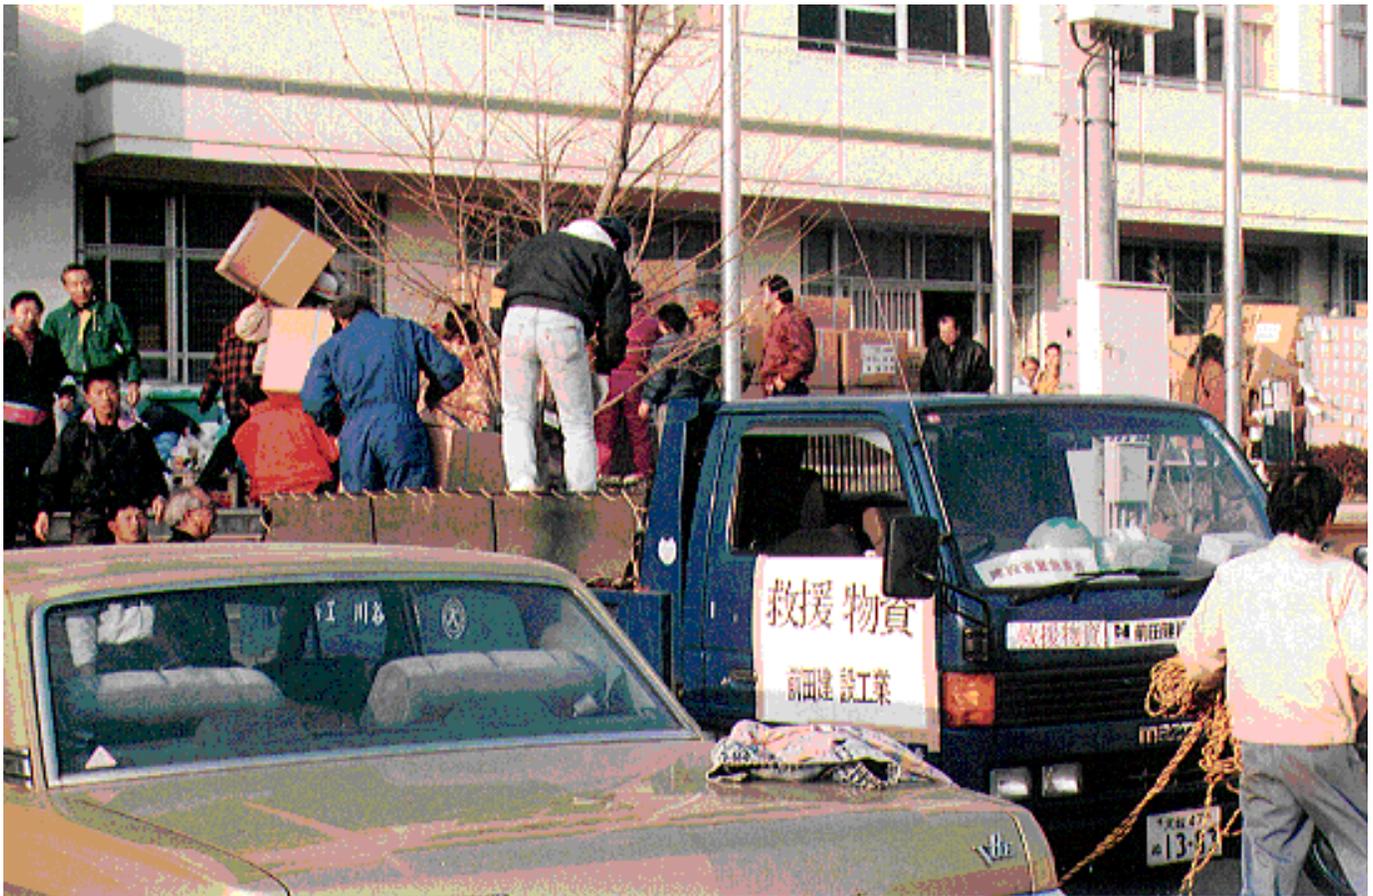
Relief workers unloading boxes of supplies at a refuge center in the Nada Ward.

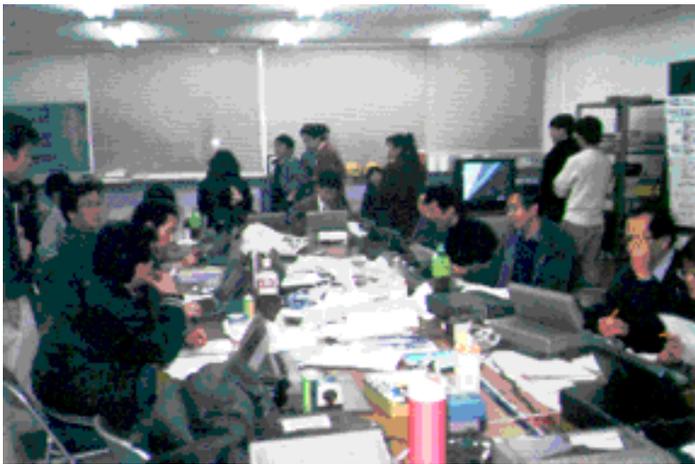
The temporary office of a Kobe newspaper on January 18, after the regular office was closed by damage.

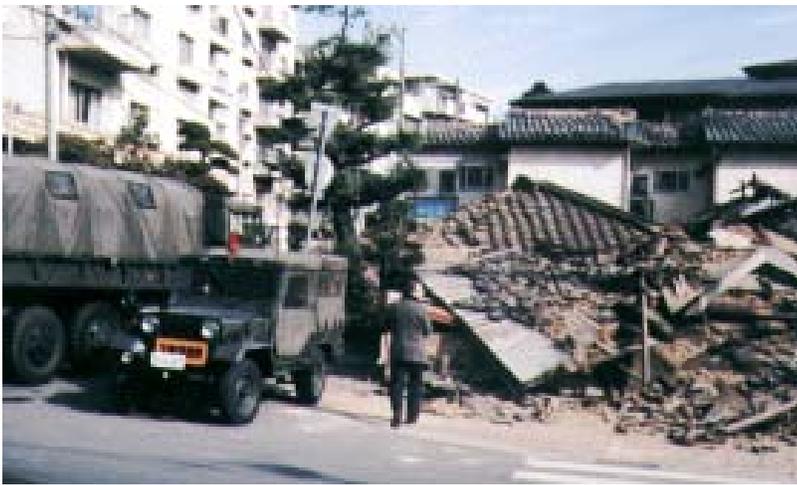
Post-earthquake relief scenes.
