Earthquake Damage to the Electric-Power Infrastructure- Substation

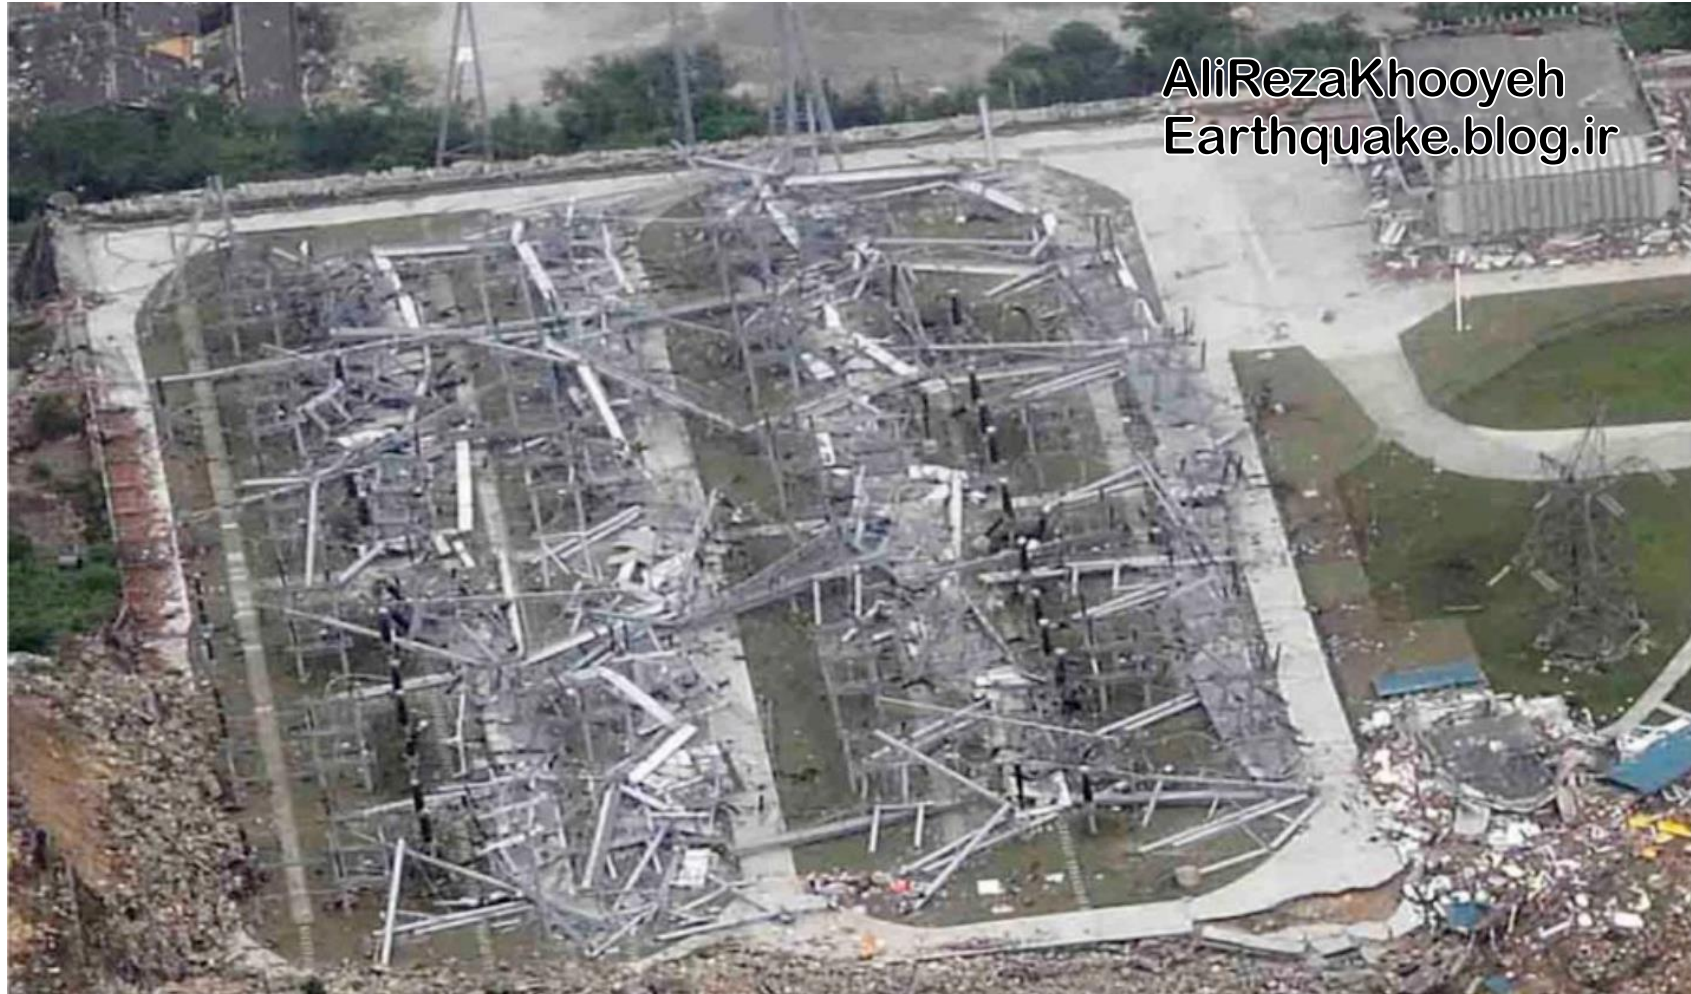
220 kV Ertai Substation, Yingzhou

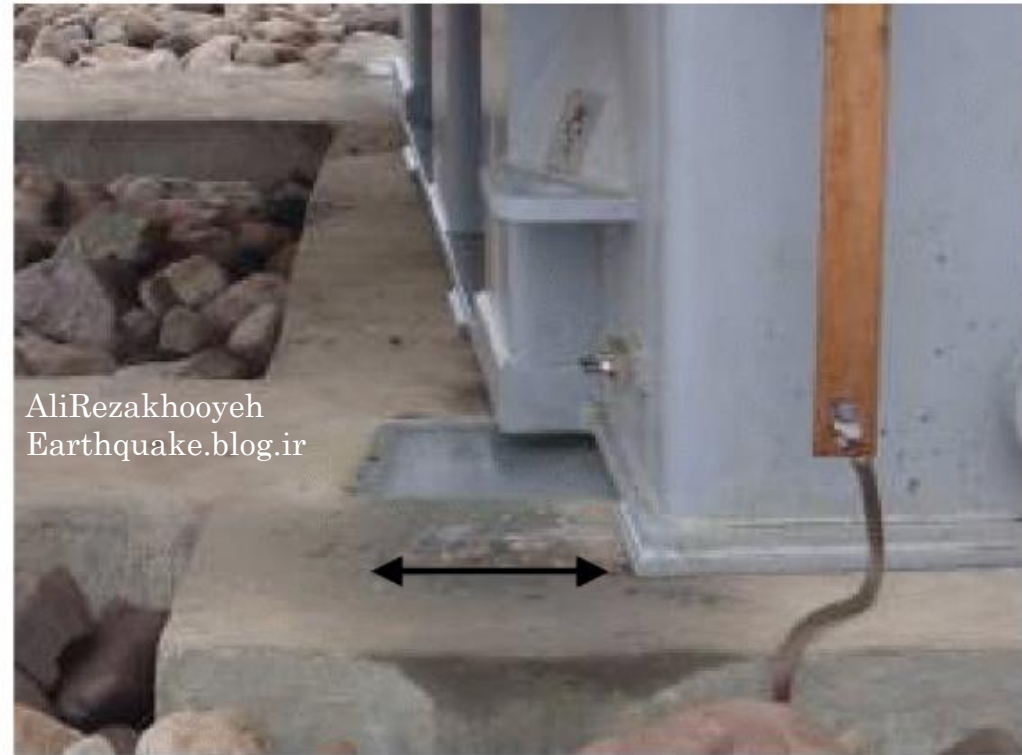
Figure 6: Pulled conductor

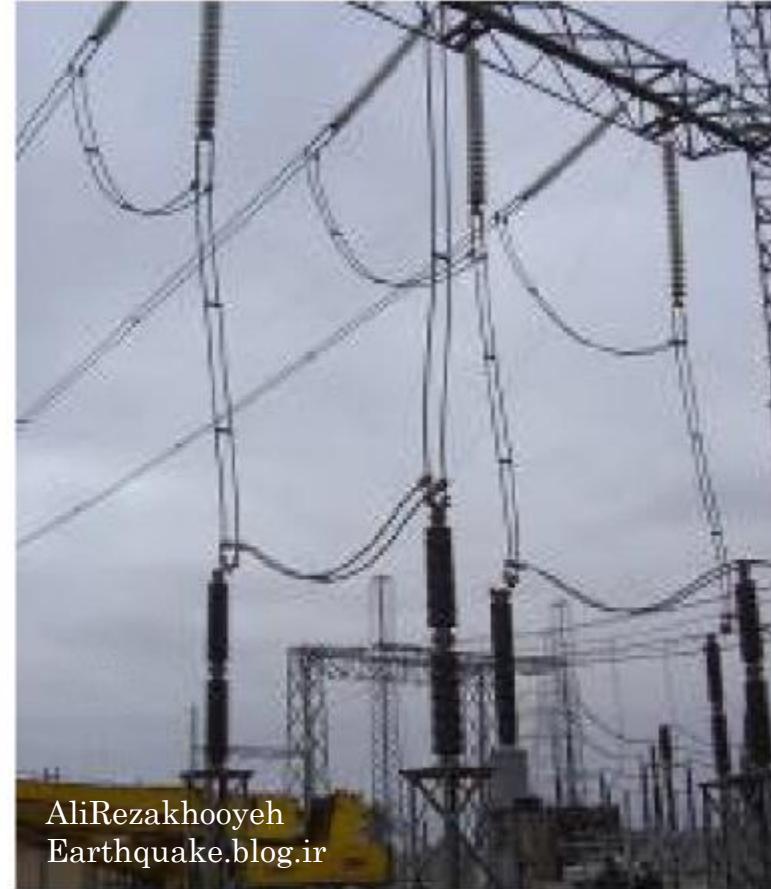
Figure 8: Broken surge arresters
