REPORT ON 1999 KOCAELI AND DÜZCE (TURKEY) EARTHQUAKES

MUSTAFA ERDIK

*Bogazici University, Dept. of Earthquake Engineering, 81220 Cengelkoy, Istanbul, Turkey
E-mail: erdik@boun.edu.tr*

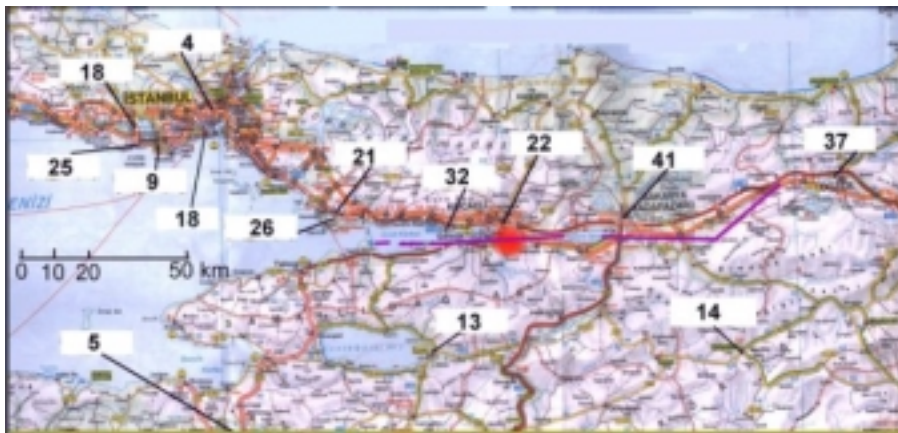
correct values in the near field for large magnitude events. Other reasons for low accelerations may be the smoothness of rupture and the relatively low stress drop in the Kocaeli earthquake. At distances greater than 20 km, the acceleration data from the Kocaeli earthquake are generally bound by the plus and minus two standard deviation predictions. As it has been observed in almost all past earthquakes, the ground motion amplitudes are larger for the soil sites (Yarimca, Düzce) than for the rock sites (Gebze, Izmit, Sakarya)

Figure 8. Peak horizontal ground accelerations recorded in the Kocaeli earthquake

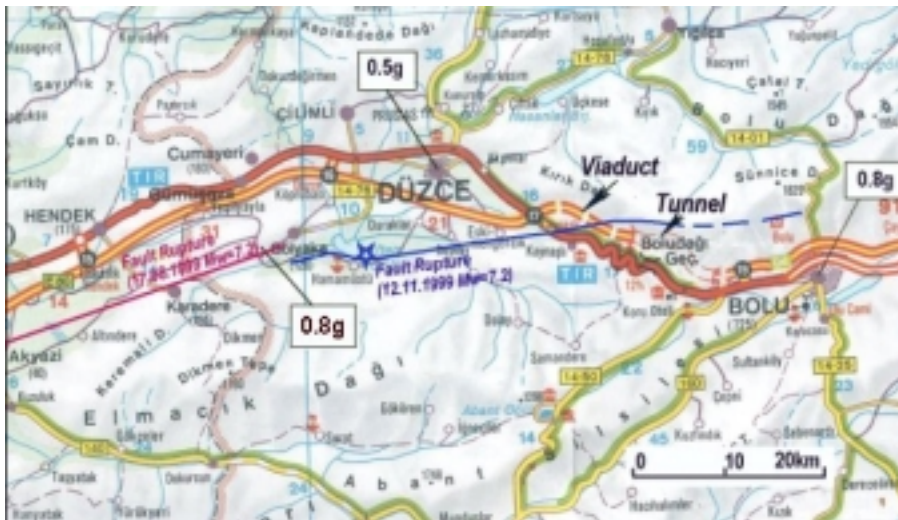
Figure 9. Peak horizontal ground accelerations recorded in the Duzce earthquake

The Duzce (DZC) record is the only record closer than 20 km that falls above the median prediction. This record was affected by rupture directivity. The Ambarli (ATS) site recorded unusually large accelerations (above the plus two standard deviation prediction for each attenuation relationship), possibly due to strong focusing and site effects.

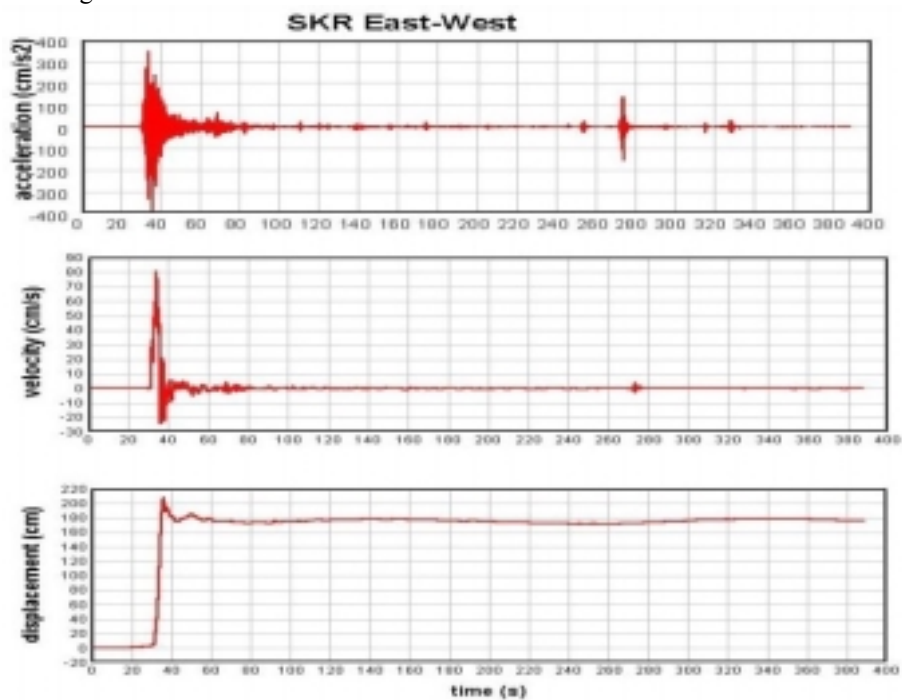
Figure 10. Acceleration, velocity and displacement traces associated with the Sakarya E-W record obtained during Kocaeli Earthquake.

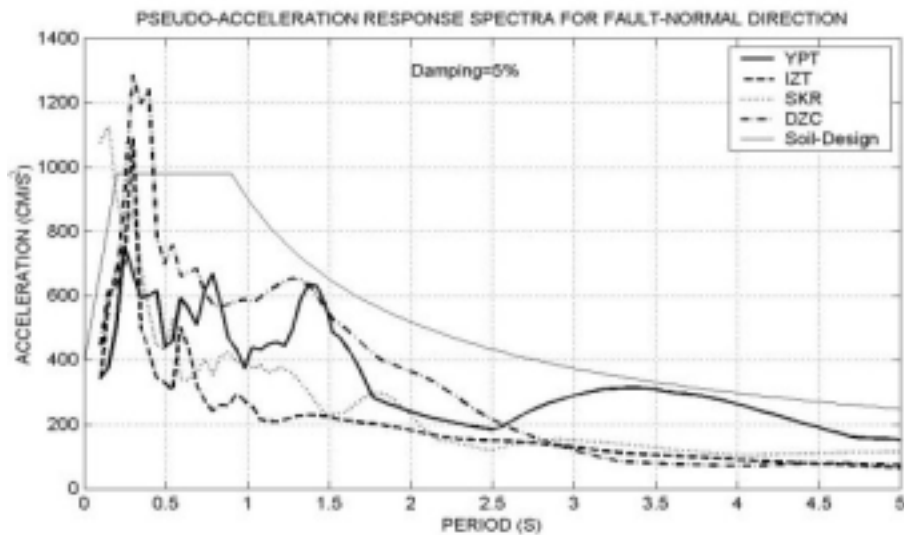
Figure 11. 5% damped linear response spectra for fault normal components of YPT, IZT, SKR and DZC records obtained during Kocaeli Earthquake and comparison with the code-based spectrum.

During the Kocaeli earthquake the Düzce (DZC) station was in the forward directivity direction of the eastern segment of the fault and as expected, the fault normal motion is dominant. The acceleration response spectra for the DZC motion exceed of the UBC design spectrum at periods less than 0.5 s and greater than 3.0 s. At longer periods the fault normal component is above the fault parallel component, as expected for forward directivity situations. Düzce earthquake generated two strong motion records in the near field from the stations operated by the General Directorate of Disaster Affairs. A mobile array installed in the Golyaka region (western terminus of the rupture) installed by Lamont-Doherty Observatory and French research team also recorded several accelerograms. The peak acceleration levels on these accelerograms are in the vicinity of 0.8g (Figure 9). The peak accelerations recorded in Duzce earthquake are more in line with the available attenuation relationships. The stress drop associated with this event is also at least

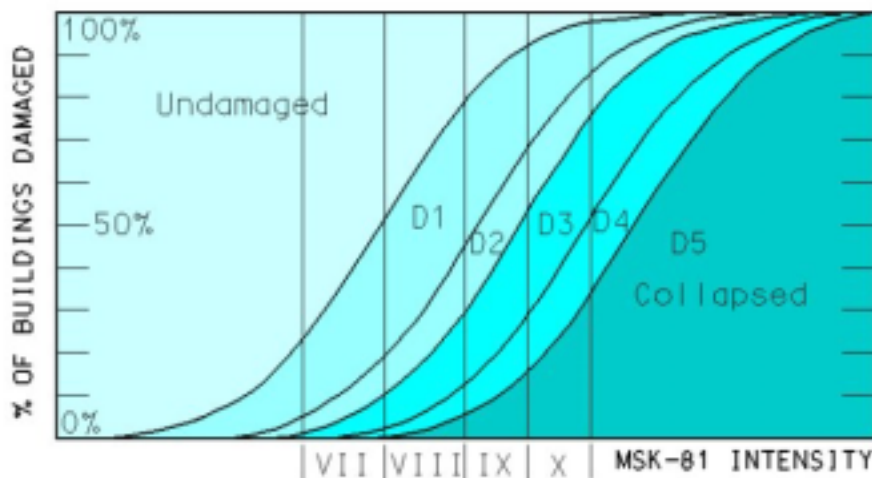
Intensity IX+ regions. This ratio is at least 4 times higher than what was observed in 1995 Kobe and 12 times higher than 1994 Northridge earthquakes. The general vulnerability relationship for mid-rise R/C frame buildings in Turkey is provided in Figure 19, where damages grades are indicated from D1 (slight) to D5 (collapse) following the EMS (European Macroseismic Scale) terminology.

Figure 19. Earthquake vulnerability relationship for general mid-rise R/C buildings in Turkey

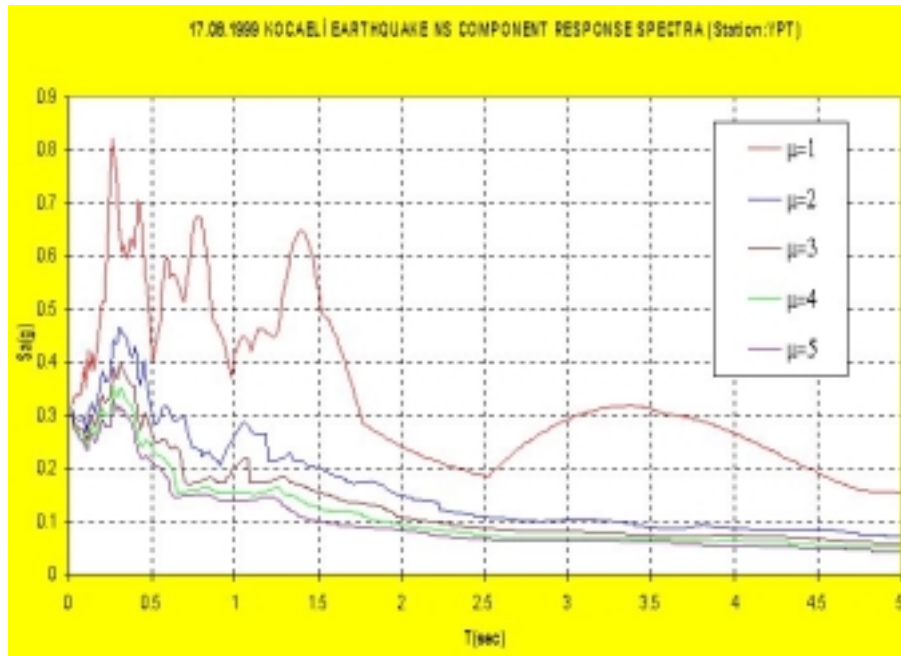
It should be of interest to analyze the recorded ground motion to assess whether the design basis ground motion levels foreseen in the earthquake resistant design codes has been exceeded. It is believed that almost 90% of the mid-rise buildings in the earthquake-affected area were built during the last 30 years. Thus their design were supposed to follow partly the 1961 and mostly the 1975 issue of the Turkish Earthquake Code. According to the 1961 issue of the code the lateral force coefficient applicable to the region was 0.10 for reinforced concrete framed structures up to 40 m high. This coefficient was 0.15 at maximum in the 1975 issue. Elastoplastic nonlinear response spectra of the near-fault ground motions recorded in the Kocaeli and Duzce earthquakes indicate that the spectral accelerations were in the range of 0.25-0.35g for ductility ratios between 3 and 5 and for periods that encompasses the fundamental vibration periods of mid-rise buildings (Figure 20). Since would be difficult, even for those buildings that are in conformity with the 1975 code, to supply adequate capacity for this demand, the main reason behind the good earthquake performance of some structures can be the over-strength supplied by the infill walls. It should be noted that these are very general statements since it is known that the ground motion has very high spatial variability in these period ranges and the difference of damage in seemingly identical might, at least partially, be a reflection of this variability. The answer to question should wait for the installation of dense strong motion networks in urban areas.

Figure 20. Elasto-plastic response spectra of YPT NS component for different ductilities (after Prof. N.Aydinoglu)

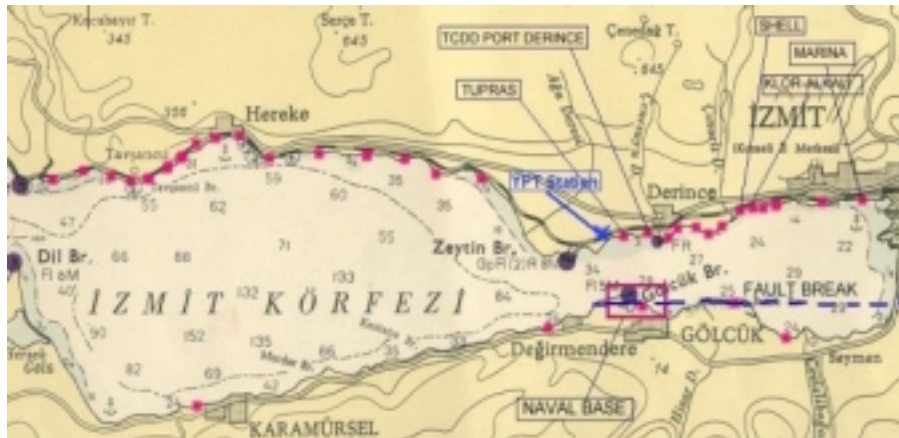
Most of the ports and jetties privately operated by industrial facilities in Izmit Bay sustained damage (Figure 28). Extensive damage was observed at Golcuk Navy Base due to fault crossings (Figure 29). Damage included failure of piers, mechanical equipment, piping and the collapse of cranes. The government owned Derince general cargo and grain port, which handles some 2 million tons of cargo annually, suffered heavy damage to docks, cranes and warehouses, including cracks and severe subsidence. Deince Port, which is of the concrete caisson type with shorefront length of about 1.5 km, shifted away from the wharf up to 0.7m horizontally and 1m vertically due to liquefaction-induced deformations, settlements and lateral spreading (Figure 30). Several rail mounted portal cranes and some old steel warehouses were damaged. A substantial number of the jetties at the industrial facilities were also damaged. These include Petkim facilities, Tupras Oil Refinery, Petrol Ofisi, Shell Oil, Trans Turk, Seka Paper Mill and UM Shipyard.

Figure 28. Location of affected ports and jetties in Izmit Gulf in the the Kocaeli Earthquake
