# Understanding Bridge Collapses

Björn Åkesson Consulting Engineer, Fagersta, Sweden

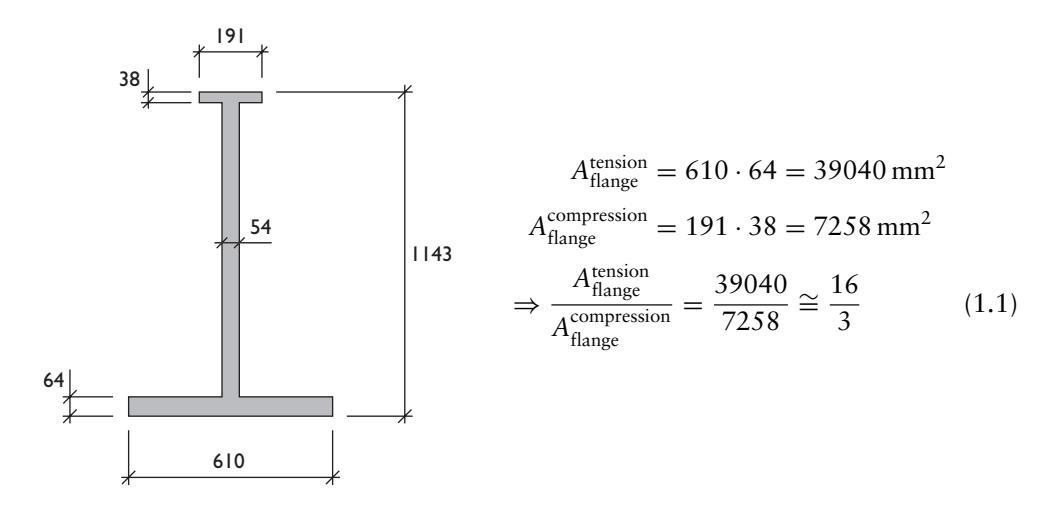
*Fig. 1.7* Cross-section dimensions of the mono-symmetrical l-girder. The lower flange was increased in relation to the strength of cast iron in compression relative to the strength in tension, in order to make up for the difference in strength.

Bridge – according to the designers of the time – was consequently a profile where the tension flange area was increased in relation to the compression flange with the inverse proportion (Fig. 1.7, Eq. 1.1).

However, something that was not taken into consideration was the fact that the neutral axis of this mono-symmetrical cross-section does not fall in between the flanges with the same relation (i.e. 3/16 of the girder depth). As the neutral axis of this

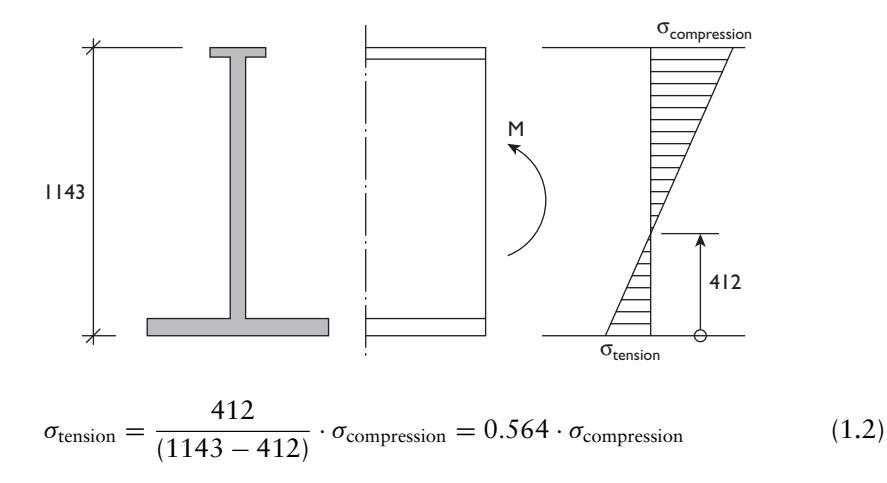
*Fig. 1.8* The relationship between the maximum tension stress and the maximum compression stress for pure bending of the *unreinforced* girder.

cross-section (without tension bars) is found at 412 millimetres up from the lower face of the tension flange, the stress relation becomes altered (Fig. 1.8, Eq. 1.2).

The maximum tension stress at bending will be 56.4% of the maximum compression, instead of the intended relation 3/16 (18.75%). Thus the maximum tension stress at bending was very much underestimated, despite having taken the difference in strength into consideration by shaping the I-profile with different flange sizes. However, as the girder – in addition to the mono-symmetrical shaping – also was strengthened by the applied wrought iron tension bars, there is perhaps reason to believe that the load-carrying capacity was heavily enlarged, especially as the wrought iron tension bars have twice as high modulus of elasticity as the cast-iron girder (wrought iron has a modulus of elasticity of about 200,000 MPa, i.e. in the neighbourhood of steel, while cast iron has a value of something like 100,000 MPa) (Fig. 1.9).

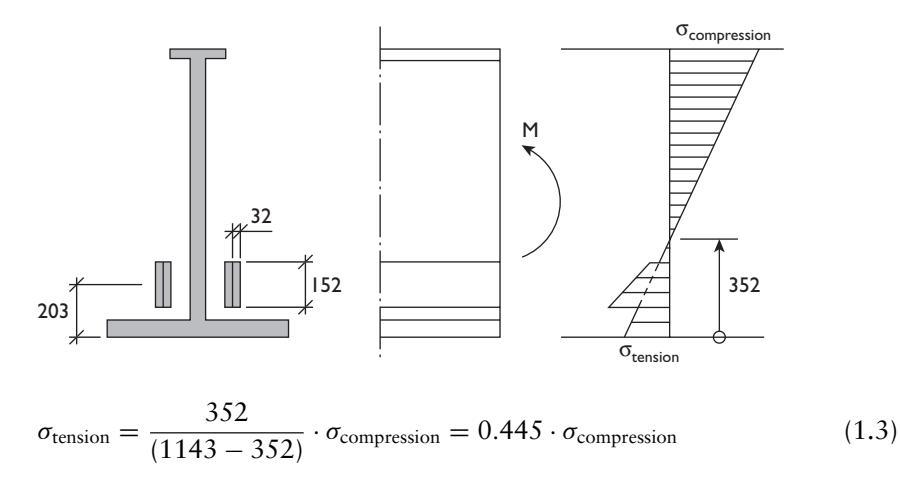
The girder was in the mid-span region part reinforced in the lower part with four wrought iron tension bars – each being  $32 \times 152 \text{ mm}^2$  in size – two on each side of the girder web (with a small free spacing in order to pass the upper flange for the anchorage at the ends). The stress relation is changed in a positive direction due to the fact that the neutral axis is lowered, however, not as much as one perhaps would expect, so the tension stresses are still being underestimated (Fig. 1.10, Eq. 1.3).

With respect to the load-carrying capacity – based on the section modulus for the lower part of the girder subjected to tension – it will increase with approximately 25% for the tension bar reinforced cross-section in comparison to the simple girder. However, as the magnitude of the tension stresses still is being underestimated the load-carrying capacity will still be insufficient. An assumed load test using the design load of that time (a 30 ton heavy and nine metre long locomotive) – three of those positioned close to each other on one of the girder spans – would result in a stress level on the tension side of about 80 MPa, which is on the level of the unreduced strength (read: the strength without any safety factors) for cast iron of *very* high quality. A load test was also performed, however, using less heavy locomotives, and that was lucky,

Fig. 1.10 The relationship between the maximum tension stress and the maximum compression stress for pure bending of the *reinforced* girder.

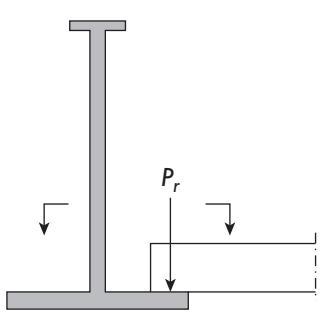
Fig. 1.13 The sleepers introduce an eccentric loading to the lower flange plate.

One of the most recent ideas presented is failure because of *fatigue*, due to the eccentrically applied loading on the lower flange from the sleepers (Fig. 1.13).

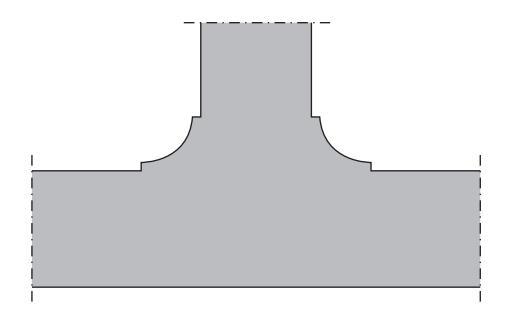
The suggested fracture scenario was that an initiated fatigue crack, in the transition area between the flange and the web in the lower part of the girder, gradually would have propagated to a certain critical length (with respect to brittle fracture) and thus caused the sudden collapse. However, we can see from the calculations above that the *maximum* stress range not the least is of such magnitude that the fatigue limit for cast iron would be exceeded, and this is still the fact despite that cast iron is having blisters and other impurities, which makes it weaker (and more brittle) than modern steel of today. There is also an additional stress raising factor to consider in the affected area, and that is the especially designed fillet transition between the flange and the web (Fig. 1.16).

Fig. 1.16 The fillet transition between the flange and the web acts as a stress raiser as this area is not smooth.

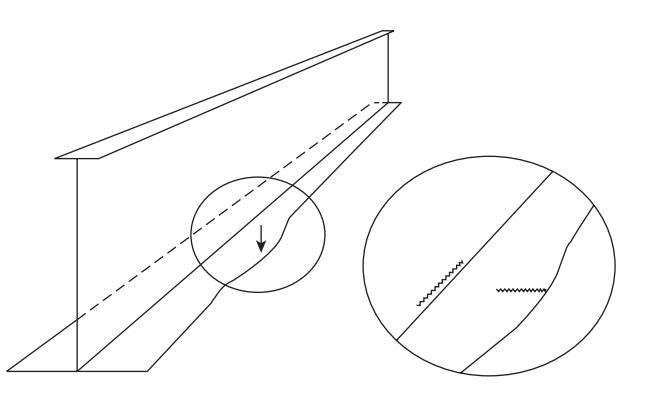
Fig. 1.17 Possible fatigue cracking locations due to local bending of the flange plate.

This decorative shaping is raising the local stress level, but not as much as for a similar welded detail (in steel), which have a fatigue limit that exceeds the stress range level calculated here. We must also not forget that the calculated stress range is for an assumed *maximum* axle weight, which is rather unlikely to occur, at least with regard to any large number of cycles. During the six months the bridge was in service the local stress reversals produced were not of any significant magnitude, and those stress cycles that did occur were still having a fairly low number of repetitions (due to the limited period of time together with the relatively low number of train passages per day). Consequently we could rule out the possibility of any fatigue cracking to occur. And if we – despite the fact that no fatigue cracking could have taken place – still imagine us a crack in the upper part of the fillet being initiated, then this crack would be *horizontal*, i.e. parallel to the normal stress direction due to the global bending of the girder. Such a surface crack - horizontal and single sided (i.e. not going through the thickness of the web plate) – does not constitute a direct threat to a possible brittle fracture risk, which transverse cracks do. For local bending of the flange there is, in a way, also a possible risk for a transverse crack to be initiated, however, the bending stresses here are much lower than those that arise in the web-to-flange transition, so for the case of the Dee Bridge a transverse crack is even less probable than a horizontal (Fig. 1.17).

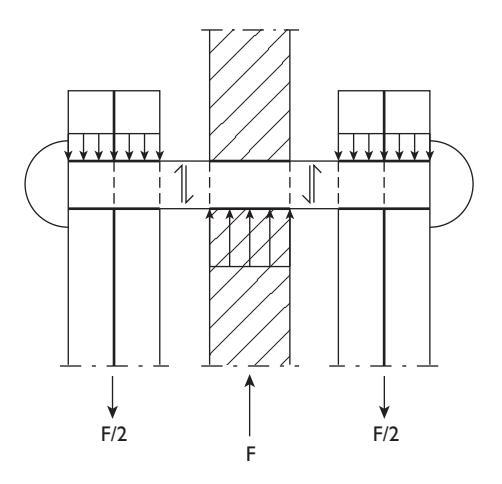
Fig. 1.18 Through shear in the pin bolts the elongation of the lower part of the girder (when subjected to bending) is restrained by the wrought iron tension bars.

What could instead be a possible cause of failure is a successive *ovalization* of the hole for the pin bolts that join the tension bars together (on either side of the web plate) to the girder. As the girder becomes subjected to bending it will elongate in the lower part, and through this elongation the horizontal tension bars will be forced to interact with the girder (visualized in the figure below for an imagined force F) – the tension bars are consequently acting as a constraint against this elongation (read: they unload the girder by supplying extra tension flange area) (Fig. 1.18).

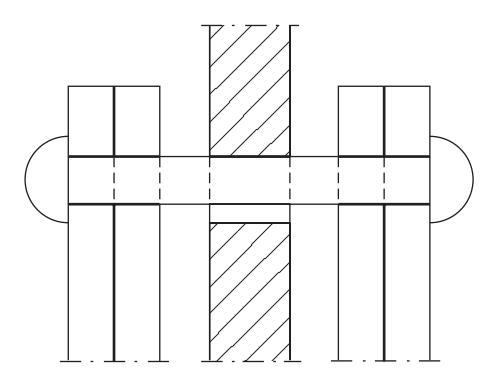
Fig. 1.19 Due to the repeated loading the bolt hole in the girder web becomes over time elongated (ovalized).

Because of the relative hardness of the tension bars and the pin bolt (in comparison to the softer cast-iron material in the girder, see Fig. 1.9) it will in time develop a localized deformation in the contact pressure area between the pin bolt and the web plate of the girder (the contact pressure here is also the largest). This will lead to an ovalization of the hole (read: remaining plastic deformation) – the hole has quite simply been elongated through wear and excessive local contact pressure (Fig. 1.19).

As the holes are more or less hidden behind the tension bars (as well as behind possible washers and girder reinforcements) they could be difficult to check even at a close inspection. However, what had been discovered was that the deflections of the girders were remarkably large – at most some 14 centimetres in midspan. If the deflection is calculated for a normal train load of that time – assuming full interaction between the tension bars and the girder – then the deflection will be approximately half of this registered value, and this indicates quite strongly that the composite action more or less had been lost.

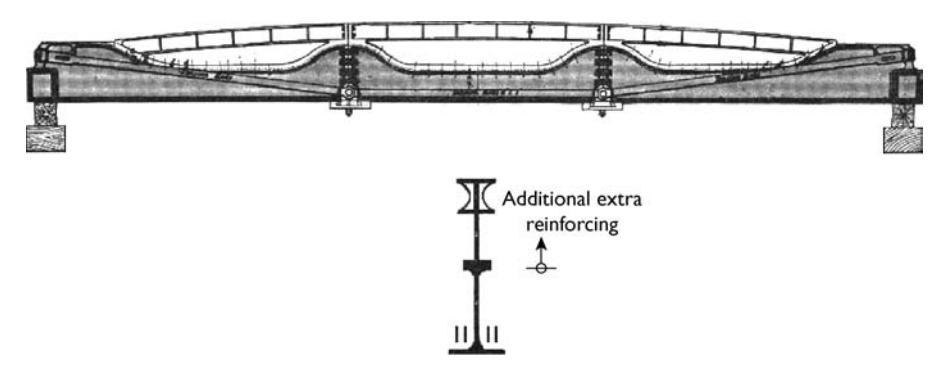
Fig. 1.21 As a consequence of the Dee Bridge collapse many existing cast-iron bridges had to be strengthened. (Berridge:The girder bridge after Brunel and others)

The collapse of the Dee Bridge had some large repercussions. An investigation did result in both that the choice of material, and the tension bar reinforced girder system as such, was blamed for the collapse and more or less doomed this bridge type for further use. Most of the already existing cast-iron girder bridges were either replaced or strengthened. An example of the latter was the 18 metre long and also tension bar stiffened girder bridge over Trent Valley, which was strengthened by the adding of extra plates and profiles in order to increase the girder depth (Fig. 1.21).

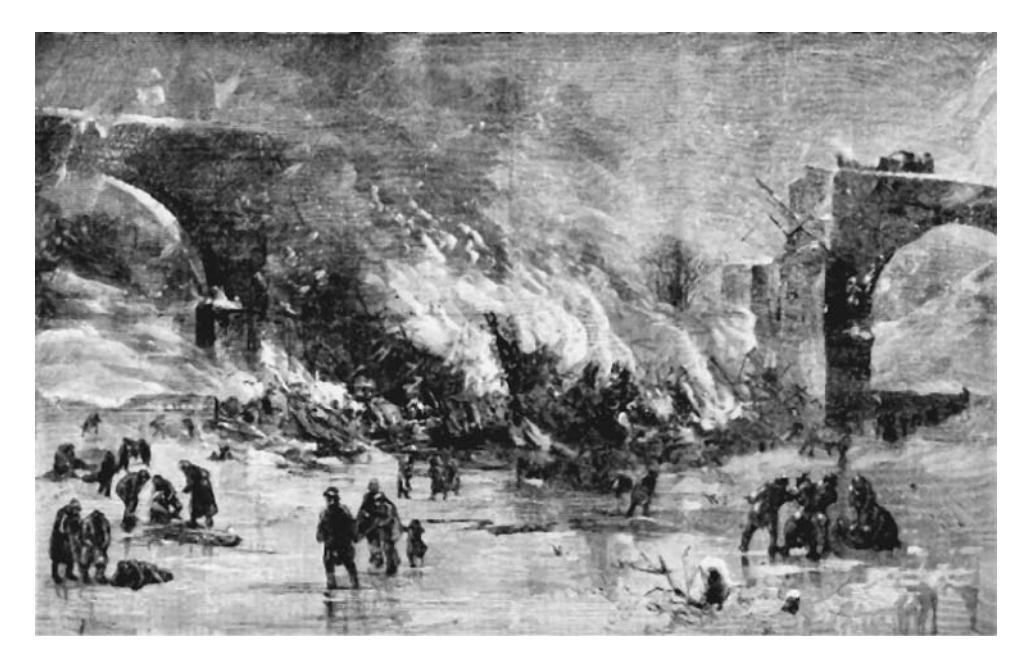
Although many people were estimated to have died instantly in the crash, several passengers also perished in the fire that followed, bringing a total of 92 casualties. The severe fire was a direct result of the fact that each carriage was heated by stoves, besides being lit by oil lamps (Fig. 2.3).

Fig. 2.3 A vivid drawing of the collapse scene (Harper's Weekly, 20 January 1877). (www.catskillarchive.com/rrextra/wkasht.html)

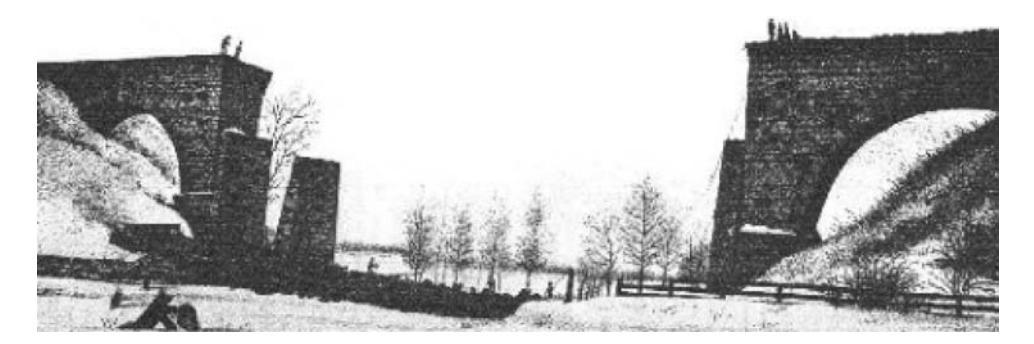
The following day the charred remains of the bridge and the train lay twisted beyond recognition in the river bed below (Fig. 2.4).

Fig. 2.4 The day after the collapse. The extra brick pier that is seen close to the left-hand abutment is from the earlier wooden bridge at this site. (http://home.alltel.net/arhf/bridge.htm)

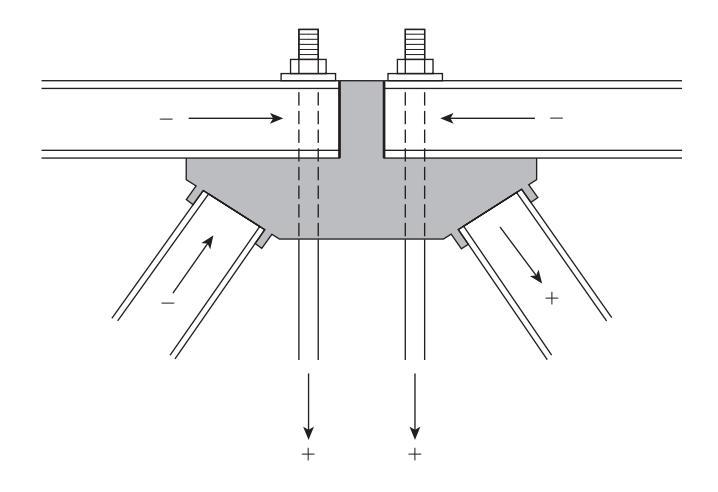
Fig. 2.10 The principal truss joint design of the Ashtabula Bridge – a cast-iron angle block in between the individual members (diagonals, verticals and horizontal chords).

As the diagonals in the Ashtabula Bridge were somewhat loosely fitted to the joints in the panels during assembly, they relied upon the prestressing (read: compacting) to function properly during loading of the truss. The tension diagonals could only carry load below the prestressing level (as a reduction of the compression), and were not able to withstand the full tension capacity of its members (due to the inadequate fastening to the joints).

The joint between the diagonals and the upper and lower chords had the following principal design – a cast-iron angle block supporting, and transferring the forces between the members in the truss (Fig. 2.10).

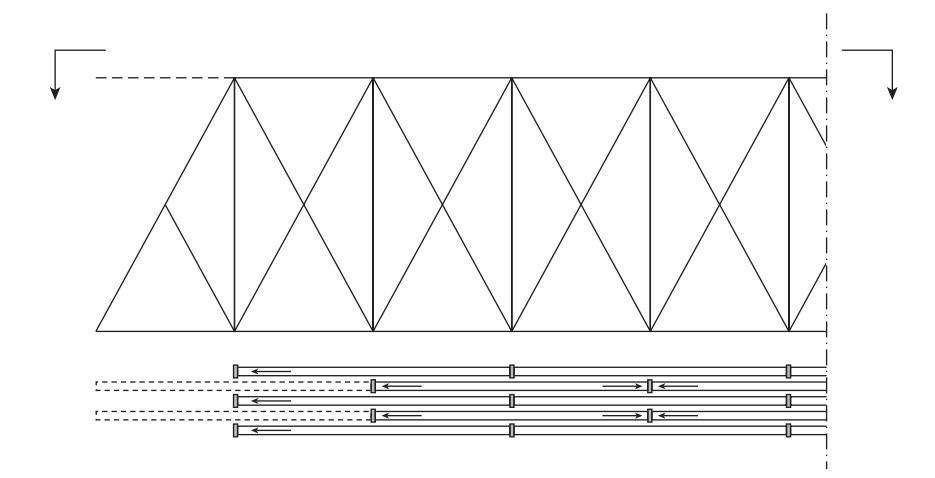
Even though the bridge was considered to be very strong and robust, it was judged "too experimental" by another involved engineer, Mr Charles Collins, and experimental it certainly was. Both the chords and the diagonals consisted of *separate* wrought iron I-girder elements (Fig. 2.11).

Fig. 2.11 The top (compression) chord of the Ashtabula Bridge.

In every other joint in the upper chord, the I-girders were fitted to the lugs on the cast-iron angle blocks by using shims – i.e. thin plates – to fill the small gaps there during the assembly (see Figs. 2.10 and 2.11). In a sense the entire bridge resembled more a gigantic model construction kit – such as a Meccano without nuts and bolts – rather than a normal steel truss of modern standards, which is having the members properly and securely fixed to the joints. Perhaps Amasa Stone had too much of his inspiration coming from the wooden Howe trusses.

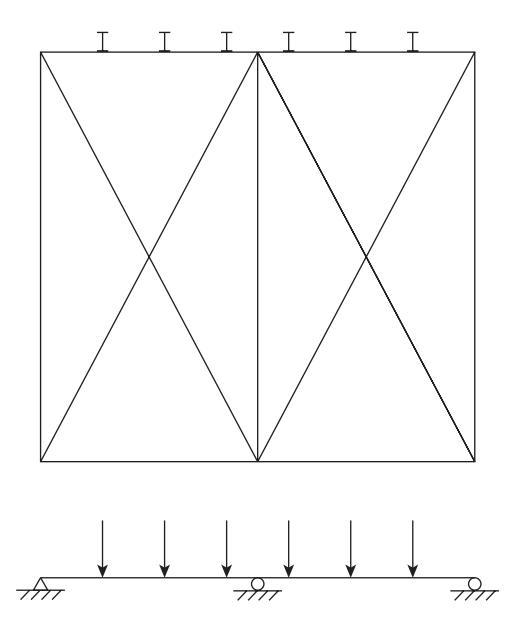
Also the transverse floor-beams (carrying the track) were of the same wrought iron I-girder profiles that were used for the truss members, and these floor-beams were just simply positioned every 1.12 m along the upper chord of the truss (Fig. 2.13).

Fig. 2.13 The upper chord of the trusses had to, besides carrying the normal compressive forces due to the truss action, also – as a continuous beam – carry, in bending, the floor-beams positioned in between the truss joints.

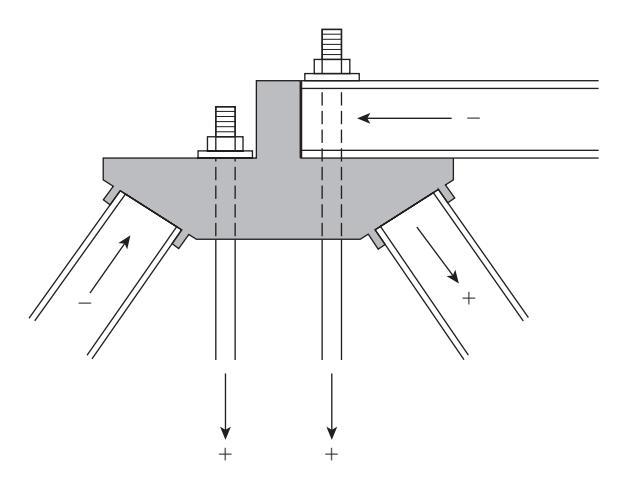
However, during the passage of the west bound train to Cleveland on the evening of 29 December 1876, the Ashtabula Bridge suddenly collapsed. An inquest was immediately summoned in order to find the answer to the collapse, and this investigation would last for more than two months. It was found that the bridge had been badly maintained, poorly inspected, and not properly designed with respect to the truss members (e.g. by applying load from the floor-beams to the upper chord between the truss joints, and by having relied upon separate elements to act as a unit), but above all, that the entire load-carrying capacity rested upon the small cast-iron lugs at the truss joint angle blocks. They discovered, after having salvaged some key parts from the wreckage of the bridge superstructure that one of the two lugs at the second upper chord joint had been broken off (Figs. 2.14 and 2.15).

There were five lugs at both ends of the upper compression chord that were having one-sided loading – the two in the second joint were having I-girder elements on either side, however, the two I-girders continuing to the abutment (see Figs. 2.5 and 2.11) are only "zero-bars" with respect to the truss action. The remaining lugs – all having

Fig. 2.15 The one-sided horizontal loading from the upper chord I-girder member to the cast-iron lugs at the ends (see also Fig. 2.10).

active members on both sides (see Fig. 2.10) – had only to transfer (by shear) the small difference in member forces between the horizontal I-girders. It was considered without any risk to choose cast iron for the angle blocks (containing the lugs), as they were to be subjected to compression only, however, the five lugs at the ends must have been somewhat overlooked in the design process. After eleven years of in-service loading one of the lugs broke, which resulted in an instant over-loading of the remaining I-girders in the chord. As the upper chord consequently became eccentrically loaded, it began to buckle outwards in the transverse lateral direction (first perhaps as separate units, and then finally as a complete "package"). There was limited capacity of the upper chord to withstand this excessive loading as the compression members of the bridge had been designed with respect to a stress criterion only, and not with respect to the risk of buckling. (Further, there is the simultaneous transverse vertical loading from the floor-beams.) One could also assume uneven load distribution in between the I-girder elements – prior to the breaking of the lug – due to difference in contact pressure to the lugs. The engine drivers had also for many years experienced a "snapping sound" when trains were passing over the bridge, indicating perhaps that even small gaps (due to the loss of shims) were present between certain compression elements in the bridge (upper chord as well as diagonals). There had also been inspection reports of misalignments – the girder elements were in many cases not meeting the lugs completely straight. Anyway, the upper chord failed in buckling, which resulted in the progressive failure of the entire second truss panel, transforming the inner statically indeterminate truss from a load-carrying structure to a complete mechanism (Fig. 2.16).

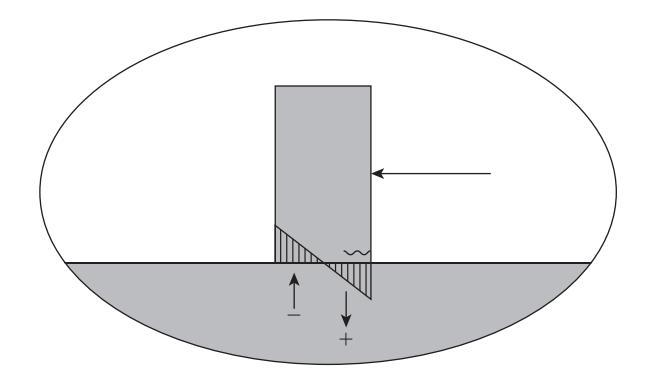
Fig. 2.17 A fatigue crack is formed perpendicular to the tensile stresses at the base of the lug.

have given uneven contact pressure zones, which could explain why some lugs were subjected to bending (and shear) rather than pure shear. When such a lug is repeatedly loaded – especially those at the ends (being loaded from only one side as they were) – a fatigue crack is eventually initiated, and this crack is then propagating horizontally (for every new loading cycle) until it reaches a certain critical length (with respect to brittle fracture of the net section) (Fig. 2.17).

The very low ductility of cast iron leads to small critical crack lengths, but still a crack has to be initiated and then propagate to give a final fracture (in a brittle manner). In addition, there was also the probability of sudden thrusts from the upper chord I-girders to the lugs if they were not exactly in close contact, and this would reduce the fatigue life of the lugs (read: reduce the critical crack length). Furthermore, at the evening of the collapse the temperature was low, which increased the brittleness (read: reduced the fracture toughness) of the cast iron material. There is one other parameter though, which is reducing the load on the lug, and that is the friction (between the I-girders and the horizontal face of the angle blocks), which is due to the pretensioning of the truss and the live load upon the floor-beams.

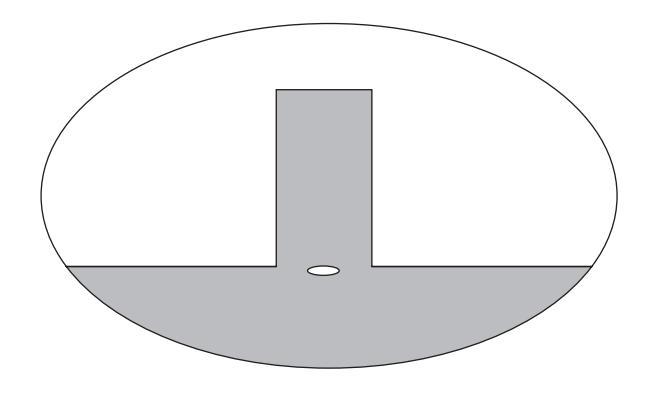
The inquest correctly pinpointed the broken lug as the initiating point for the collapse, but it was not until later that it was found – when examining the lug more in detail – that it contained a large flaw. An air hole (void) was found in the broken lug (Fig. 2.18).

Besides reducing the effective cross-section of the lug (not only the gross section alone, but also the net section after the initiation of the fatigue crack), the void also

Fig. 2.18 When the broken lug was examined a large embedded air hole was found.

acts as a stress raiser due to the stress concentration effect. The transition zone between the lug and the main body of the angle block is also a region where cooling is slow after casting – in such zones there is not only the risk of voids forming (due to "suctions" because of uneven shrinkage of the metal during solidification), but also the formation of large grains, the accumulation of slag inclusions and other impurities, which all result in extra brittle behaviour in such zones. Given this knowledge, it was just pure chance that the lug did not break at first loading.

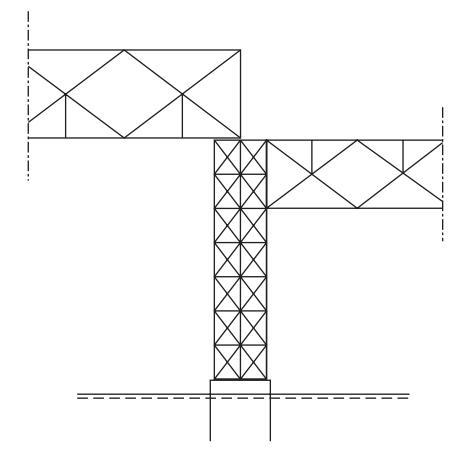
*Fig. 3.6* Additional vertical members – from the lower chord of the high girders and from the upper chord of the deck-spans – help to avoid bending in the chords.

very important secondary member was completely left out in the Ashtabula Bridge (see Chapter 2) (Fig. 3.6).

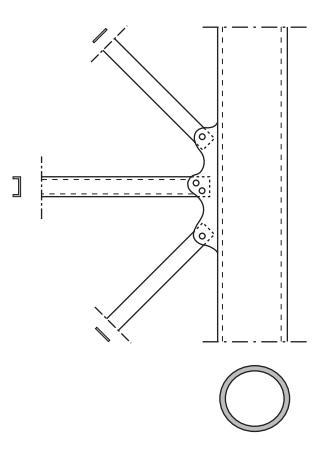
Concentrating on the truss columns in the continued discussion regarding the governing weakness of the bridge, we start with a brief description of the joint configuration. In each joint the wrought-iron horizontals and diagonals were attached (bolted) to the vertical cast-iron cylinders (the circular hollow profiles) through cast-iron gusset plates (lugs), which were cast in the same mould as the cylinder, as integrated parts (Fig. 3.8).

In order to allow for an easy erection of the truss members – especially the diagonals – one end was provided with an elongated hole (to allow for tolerances due to slight differences in length). At assembly the diagonals were fastened to the gusset plates, and then secured and tightened through small tapered cotters ("wedges") which were fitted in the over-lapping gap. It was these cotters that for some diagonals had worked loose (through the shakings and vibrations), making the function of these truss members heavily impaired – now more or less comparable to a non-active zero bar. But there were other circumstances that made this truss column weaker than perhaps was the intention. By choosing flat bars the diagonals of the truss column could not transfer compressive load due to the negligible buckling strength of these members. So here we had a structure comprising of diagonal elements:

- that easily lost their strength in tension, and
- that were more or less unable to carry any load in compression.

Fig. 3.8 The configuration of the truss column joints. The diagonals were simple flat bars and the horizontal was a U-channel bar (possibly a T-bar).

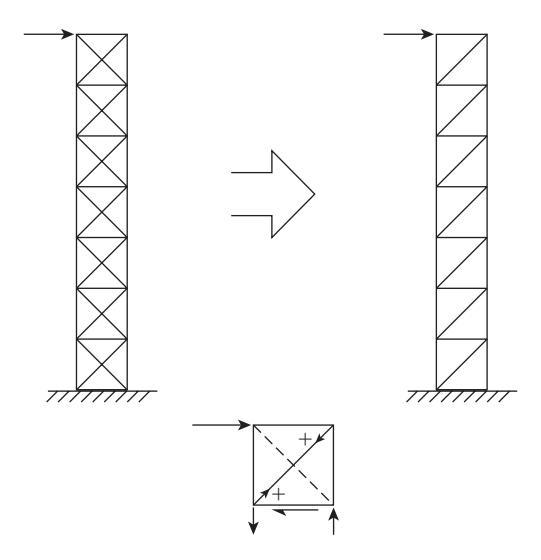
At a first glance the truss column has the appearance of an inner statically indeterminate structure, but which in fact is statically *determinate* due to the inactive compressive diagonals, and could be transformed into a "mechanism" with respect to the action of a true truss (when diagonals in tension also are lost). In comparison to the Ashtabula Bridge – where all members (in tension and in compression) were designed with respect to maximum stress, rather than taking the risk of buckling into account for the members in compression – the Tay Bridge design led to a utilization of the diagonals in tension to twice the intended value. In a truss having equally stiff crossing diagonals, the transfer of load is divided equally in between the diagonals. However, if we study the transfer of a horizontal load in a vertical cantilevering truss – having one of the diagonals in each panel unable to carry load in compression – the resulting action is that the load is transferred down into the base as a constant force (in tension) in only one set of the diagonals (Fig. 3.9).

Fig. 3.9 The resulting transfer of "shear" in a vertical cantilevering truss if one diagonal of each pair in the panels is unable to carry compression (because of a negligible buckling strength).

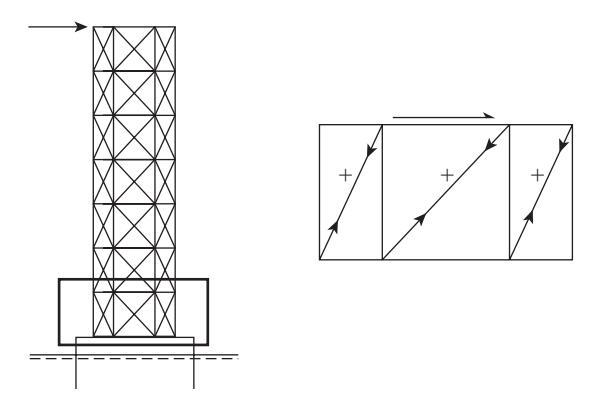
We study the set of panels closest to the base of the truss column (where the force in the diagonals are slightly higher than the panels above, given that we take into account the wind loading on the truss column itself) (Fig. 3.10).

Fig. 3.10 The resulting action of the bottom panels in the truss column (as well as every set of panels), considering that the diagonals in compression are inactive.

The major part of the horizontal load is transferred down through tension in the active diagonal of the inner panel, and if this diagonal is lost – having worked loose due to the loss of the cotters, or due to local failure of the connection – then all load has to be taken by the remaining two diagonals in the outside panels.

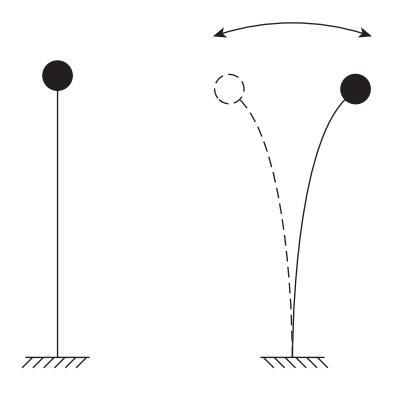
Fig. 3.12 A model of the Tay Bridge as a top-heavy cantilevering structure, which for sure it was.

Let us consider the weight of the bridge spans and that of the train as a concentrated mass on top of the cantilevering truss column (Fig. 3.12).

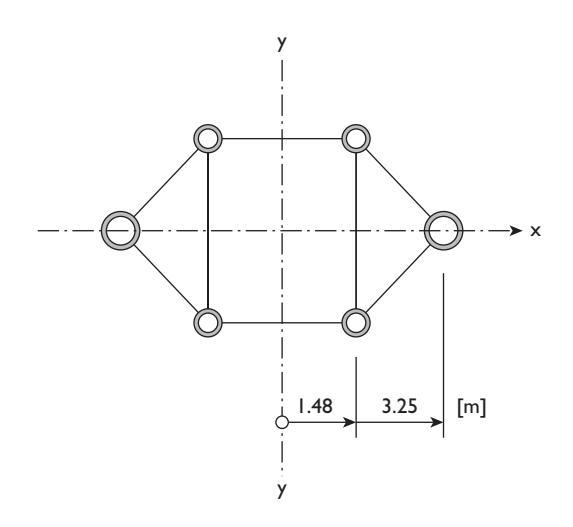
In order to determine the natural frequency of the truss columns for the high-girder bridge section of the bridge, we need first of all to find the second moment of area of the cross-section around the y-axis, as the deflection for the wind is along the x-axis (Fig. 3.13).

The thickness of these cylinders must be assumed, and the expected values to choose are 25 mm for the large cylinders and 20 mm for the small, giving the cross-sectional

Fig. 3.13 The cross-section of the cantilevering truss column (see also Fig. 3.5). As a qualified guess the two exterior cylinders are those having the diameter of 460 mm, and the four interior having the diameter of 380 mm.

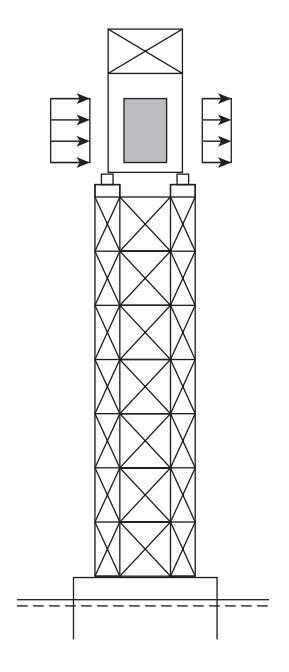
The wind was blowing very hard on the evening of the 28 December 1879 as the mail train approached the Tay Bridge from the south. The structure itself was of course subjected to the wind pressure, but the incomparably largest wind loading came when the train entered the bridge, and as it climbed towards the high-girder section the structure was strained to the utmost. Twenty-seven metres high up in the air – as a huge elevated signboard exposed to wind – there was pressure on the windward side of train as well as suction on the leeward side (Fig. 3.14).

Fig. 3.14 The wind loading on the train twenty-seven metres high up in the air.

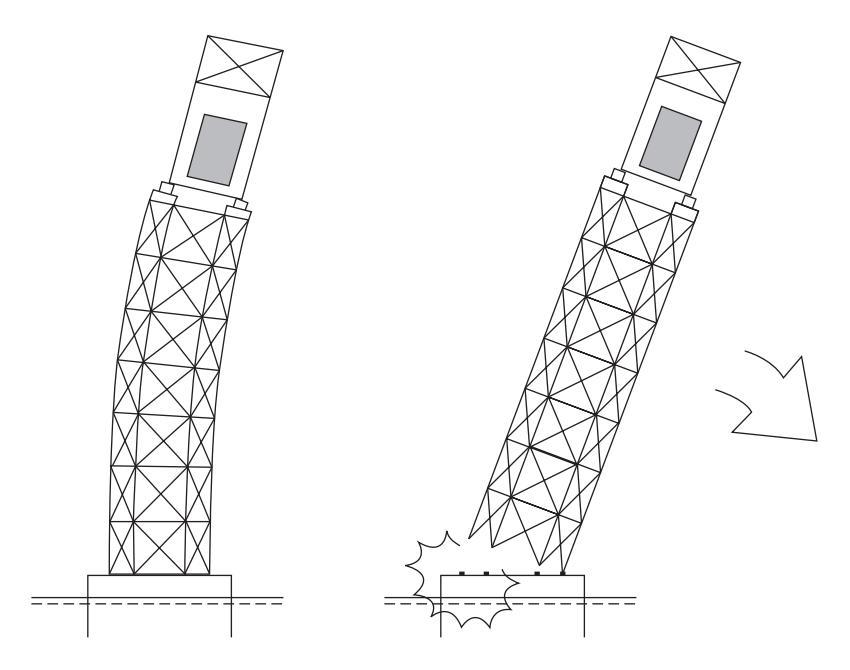
The maximum pressure came from the wind gusts, exerting not only a maximum deflection of the truss columns in the wind direction, but also, most probably initiating resonant vibration (swaying) which amplified the forces – at the base of the truss columns – and the deflections of an already weakened structure, which finally became too much for the bridge to carry (Fig. 3.15).

Fig. 3.15 The progressive failure of the high-girder section of the Tay Bridge.

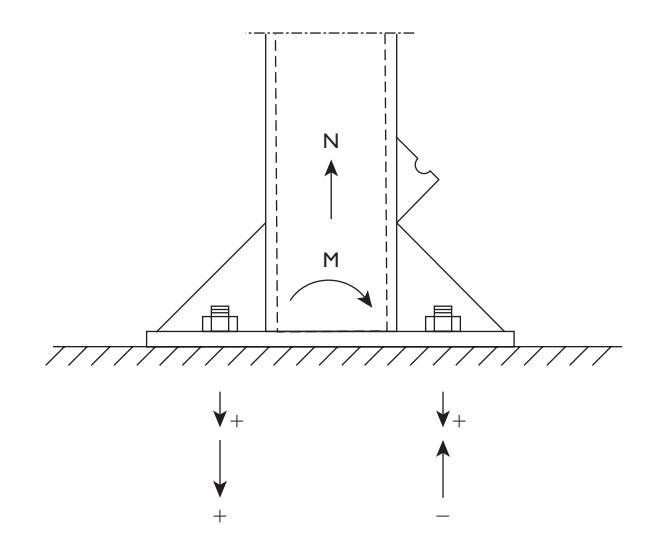
Ten out of twelve truss columns fractured at the base (to the piers) due to a sudden loss of anchorage (one after the other) and the remaining two fractured some few metres above the base. As the diagonals had lost their strength – during the eighteen months the bridge had been in service and during the final stages of the progressive collapse – the loading at the base of the cylinders changed from being pure normal forces to the combination of normal force plus bending moment, neglecting the shear force being present. Here only the action coming from the horizontal wind load is shown (not considering the vertical compression coming from the weight of the train) (Fig. 3.16, see also Fig. 3.11).

Fig. 3.16 As the diagonals were lost the loading at the base of the cylinders increased dramatically. Also shown above is the fractured gusset plate where the diagonal had been connected.

Afterwards, when the piers were examined, they found a large number of nuts and bolts together with broken-off pieces from the gusset plates (the outside parts after fracture of the net-section through the bolt holes – the missing parts of the gusset plates in Figs. 3.16 and 3.17).

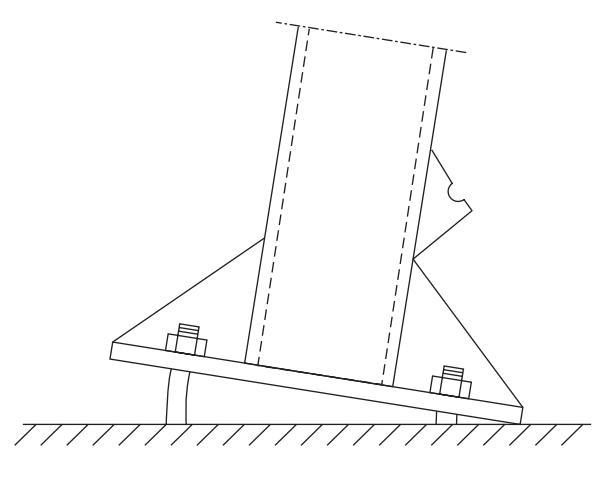
Fig. 3.17 Elongated and deformed anchorage bolt on the tension side of the cylinder base plate.

As a consequence the anchorage bolt at the tension side became overstressed (Fig. 3.17).

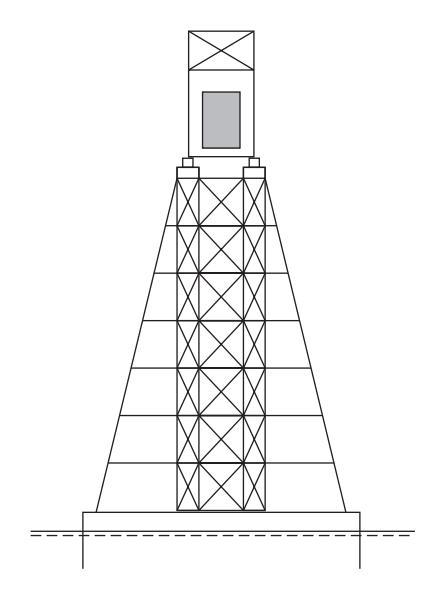
The Court of Inquiry concluded that "the fall of the bridge was occasioned by the insufficiency of the cross bracing and its fastenings to sustain the force of the gale", and indeed so it was. The high-girder section of the bridge would definitively have benefited from an extra pair of straddling legs (like the intuitive position of a human body expecting a horizontal thrust), stabilizing the truss columns and drastically lowering the strain due to severe winds (Fig. 3.19).

Fig. 3.19 An extra pair of straddling legs would most probably have saved the Tay Bridge.

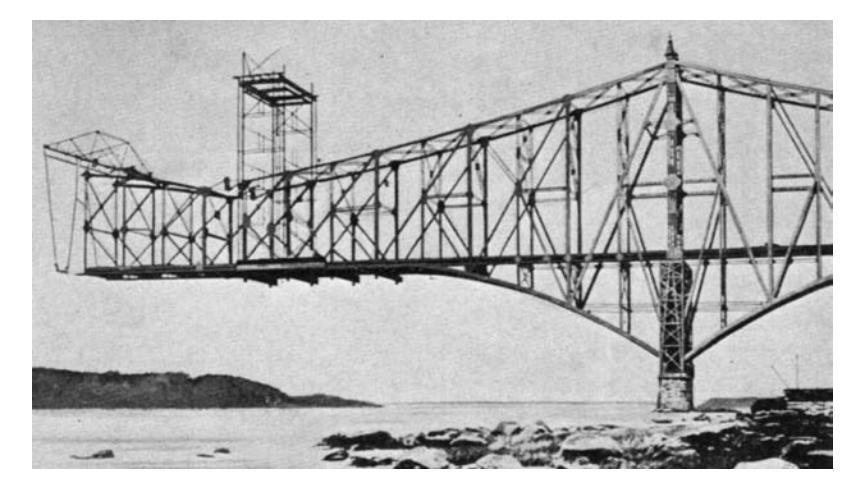
Fig. 4.8 The south cantilever arm and the first three panels of the suspended span of the Quebec Bridge extending 223 m out over the St. Lawrence River in late summer of 1907 (see also Fig. 4.9). In comparison to the massive Forth Bridge (see Fig. 3.23) this structure looks for sure anything but "bulky". (Hammond: Engineering Structural Failures – the causes and results of failure in modern structures of various types)

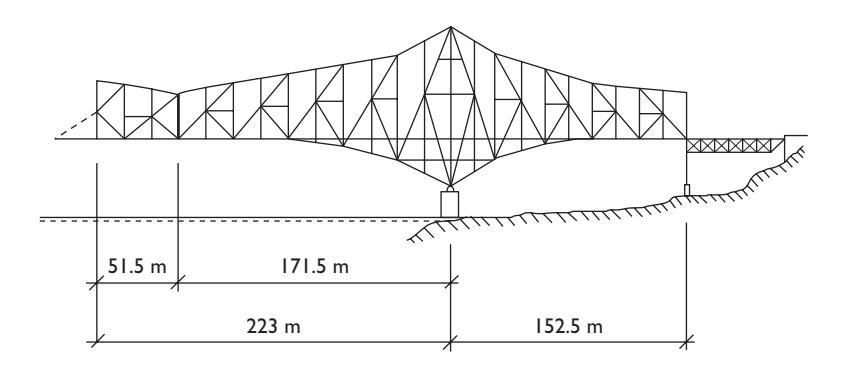
*Fig. 4.9* The south half of the Quebec Bridge extending 223 m out over the St. Lawrence River, balanced by the 152.5 m long anchor arm. Three panels are remaining (i.e. 51.5 m) of the suspended span to the mid-point of the bridge (see also Fig. 4.2).

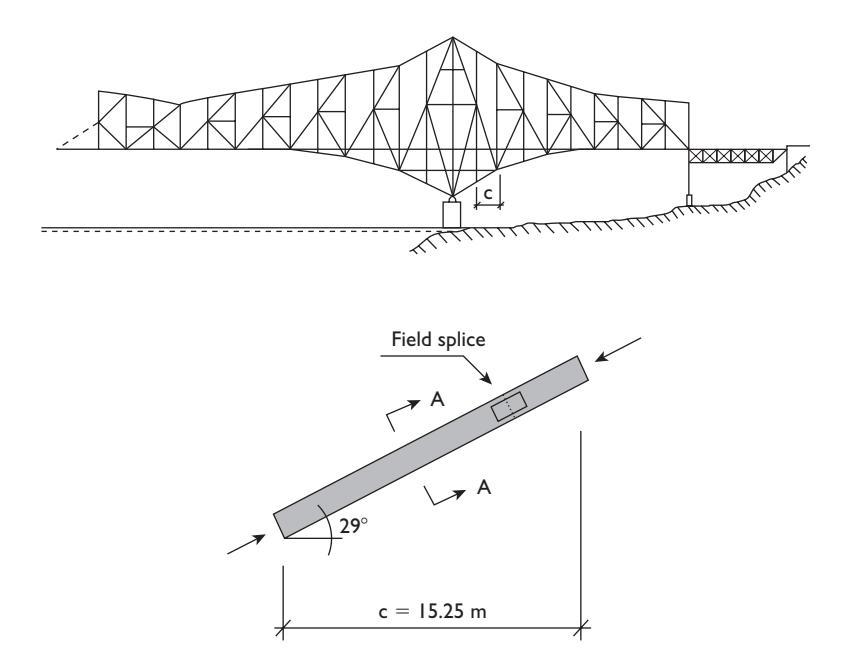
In mid summer of 1907 the first signs of distress in the steel superstructure began to show – a field splice in the ninth panel lower compression chord on the left-hand side of the anchor arm (member A9-L) had become distorted (Fig. 4.10).

Fig. 4.10 The lower compression chord in the ninth panel of the south anchor arm (member A9-L), where distortion of the field splice was detected in July 1907.

At the end of August - when the cantilever had been extended further out over the river, increasing the stresses even more in the truss members – it was found that the outof-plane bending of chord A9-L had increased from some 20 mm to alarmingly 57 mm. Even though this deformation – representing an out-of-plane deflection of L/305 (the length L of the member being 17.44 m) – is hard to detect by the naked eye, it was a clear signal that something was quite wrong. And visible signals were also given, as rivets for the transverse bracing members (the diagonal and horizontal L-profiles - see Fig. 4.12) began shearing off – a clear evidence of the excessive out-of-plane bending taking place. Realizing the danger McLure immediately travelled to New York on the 27 August to consult with Cooper (telephoning was judged to be too risky - there was always the possibility that the telephone operator would listen in and reveal the situation to the newspapers). Cooper, realizing the danger of the situation, wanting the construction to come to an immediate halt, telegraphed to the Phoenix Bridge Company: "Add no more load till after due consideration of facts". However, the contractor (i.e. the Phoenix Bridge Company) was under great pressure not to delay the construction, so the work continued by unfortunately moving an erection crane one step further out on the cantilever. If they had listened to the message from Cooper,

In late afternoon of 29 August 1907 – just some 15 minutes before the working day was over – the entire bridge collapsed (Fig. 4.13), starting with the buckling failure of the A9-L lower chord of the south anchor arm.

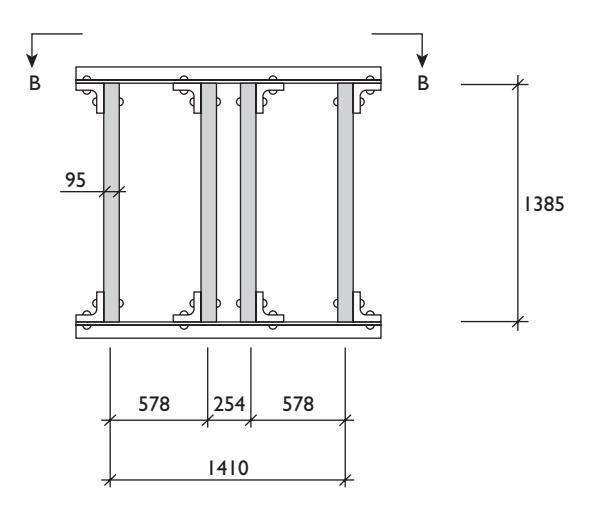
While the Forth Bridge had circular tubes the Quebec Bridge had riveted built-up rectangular truss members. The lower compression chord in panel nine of the south anchor arm consisted of four parallel steel plates,  $95 \times 1385 \text{ mm}^2$  (each consisting of four 23.8 mm thick plates being clamped together by rivets) (Fig. 4.11).

*Fig. 4.11* The cross-section of the anchor arm lower compression chord in panel nine (section A-A in Fig. 4.10).

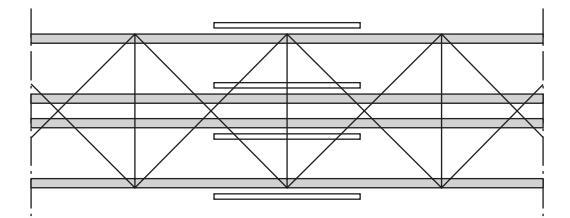
Close to the upper joint of the compression chord in panel nine (at a distance of some 20% of the member length) the web plates were spliced with cover plates (see also Fig. 4.10) (Fig. 4.12).

Fig. 4.12 The web splice (spliced in field and not in shop) of the lower chord in panel nine – section B-B in Figure 4.11, i.e. the top view (however, rotated 90°). Also shown are the stabilizing members in the transverse direction – crossing diagonals and horizontals of small L-profiles.

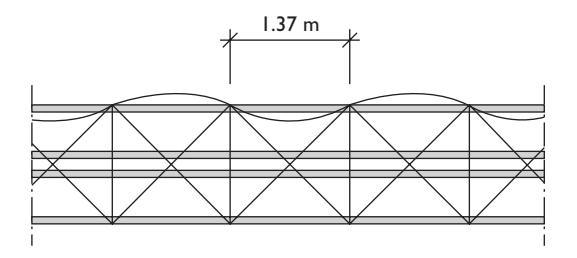
Fig. 4.14 The possible failure mode of an individual web plate buckling independently of the others.

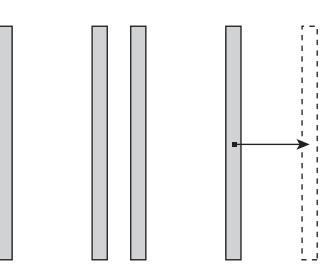
Fig. 4.16 The global buckling capacity of four web plates having no interaction whatsoever is almost equal to zero.

This latter result is equivalent to the case when the web plates are free to buckle individually of each other in the global out-of-plane direction – as four separate units – i.e. when there is no stiffening truss at all (Fig. 4.16).

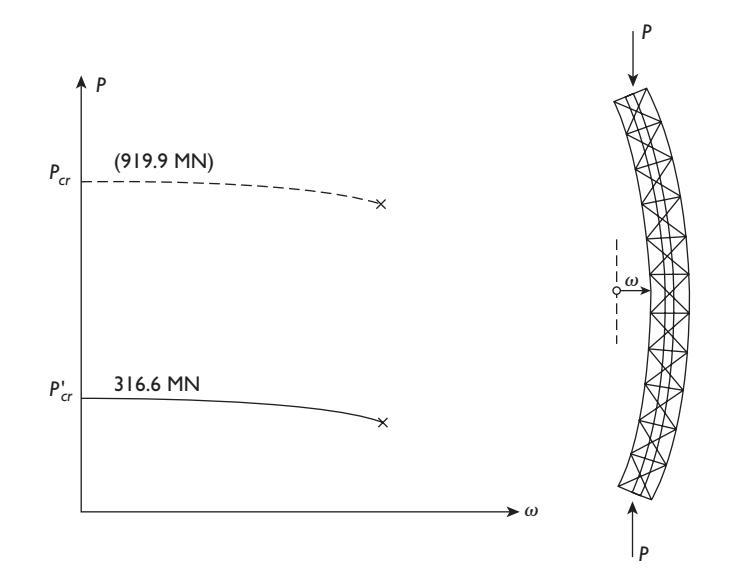
$$P'_{cr} = \frac{1}{\frac{1}{919.9} + \frac{1.97^3}{2.1 \cdot 10^5 \cdot 6452 \cdot 10^{-6} \cdot 1.37 \cdot 1.41^2}} = 316.6 \text{ MN}$$
(4.8)

Fig. 4.17 Load/displacement-diagram showing the critical buckling loads in the global out-of-plane direction for full and complete composite action ( $P_{cr}$ ) and for the case when the flexibility of the stiffening truss is taken into consideration ( $P'_{cr}$ ).

In a graph we could also visually see that the critical buckling load in the global out-ofplane direction has been reduced to almost one third of the value assumed by Cooper (Fig. 4.17).

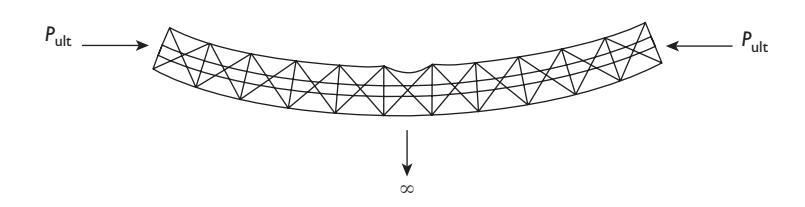
Fig. 4.21 Local buckling of the web plate on the concave side triggered most probably the collapse.

For the case of the built-up sections of the Quebec Bridge yielding of the web plate at the concave side (for out-of-plane bending) was probably not the triggering factor for the collapse of the chord, instead local (Euler) buckling in between the horizontals of the transverse stiffening truss was more probably the initiating cause – starting with the web plate on the concave side having the highest combined effect of normal force stresses and secondary bending stresses (besides the presence of the residual stresses) (Fig. 4.21).

As local buckling of the web plate on the concave side took place then there was nothing to stop the collapse of the chord (the remaining three web plates in the damaged panel were unable to carry the load as the eccentricity of the normal force increased drastically). The whole loading procedure was just like a gigantic full-scale load test until failure; a step by step increase in load and a simultaneous monitoring of the deformations, just as it is done in a laboratory – the only difference being that here it was performed in field conditions, in a real load-carrying structure. Starting with an already damaged (read: initially bent) chord there was a gradual increase in loading – and out-of-plane deflections – until the ultimate load-carrying capacity was reached (Fig. 4.22).

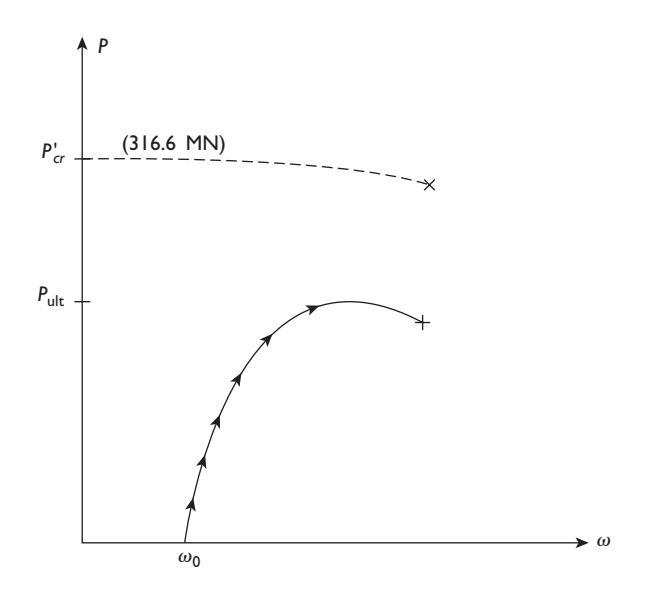
Knowing what we know today of the stability of built-up chords – and also knowing what we know of the outcome – the maximum design load-carrying capacity should only have been a fraction of the ultimate load, however, at that time when the Quebec Bridge was built Cooper was convinced that the capacity was sufficient (relying upon full composite action). The stiffening truss was expected of having adequate strength and stiffness, but instead it was its weakness and lack of rigidity that made the chord (and the bridge) to collapse. As the out-of-plane deflection of the chord increased the strain on the stiffening truss members increased. Each diagonal and horizontal had only a single rivet at each end, making the shearing stresses (as well as the bearing pressure) becoming high, as the loading and the deflections of the chord increased. Prior to the collapse there were also reports of rivets shearing off, and that decreased the load-carrying capacity (and the stiffness) of the stiffening truss even more. The final failure of the chord could also have been preceded by the rupture/buckling of some of the stiffening truss members.

Fig. 4.22 The true load/deformation-relationship (in principal), well below that of the theoretical response assuming an ideal and perfect chord. The actual loading procedure was just like following a gigantic load test until failure.

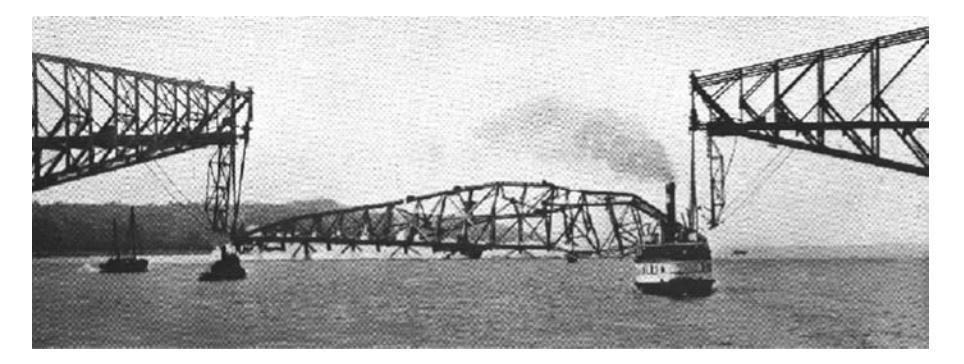
When the suspended span had been lifted 9 metres up above the water level there was a crash due to the sudden collapse of one of the corner bearings. Immediately the eccentric loading became too much for the remaining bearings to carry (more or less

Fig. 4.26 The second failure in September 1916 in the construction of the Quebec Bridge (quite a remarkable picture taken by a very alert photographer). (www.civeng.carleton.ca/ Exhibits/Quebec\_Bridge/intro.html)

twice the loading for the intact diagonal corner bearings), so the entire span crashed down into the river, twisted and deformed (Fig. 4.26).

but it was finally attributed to inadequate strength of the connection detail due to a faulty design.
