# Understanding Bridge Collapses

Björn Åkesson Consulting Engineer, Fagersta, Sweden

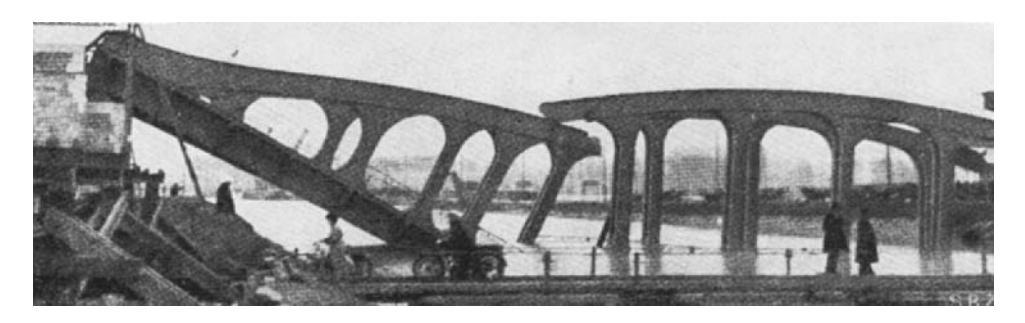
On a cold morning in March 1938, the Hasselt Road Bridge in Belgium suddenly and unexpectedly collapsed and fell into the Albert Canal, less than two years after its completion (Fig. 5.1).

Fig. 5.1 The collapse in March 1938 of the Hasselt Road Bridge over the Albert Canal in Belgium. (Stålbygge. Utdrag ur Stålbyggnad, programskrift 11)

When investigated it was found that collapse of the bridge was initiated by the fracture of the lower chord, starting with a crack originating from a transverse butt weld in the transition between the concave gusset (the haunch) and the horizontal lower chord (Fig. 5.3).

The Hasselt Bridge was an all-welded structure having box-girder sections for all the members, and the fracture had made the lower member crack in a brittle manner. A number of other small cracks in other parts of the bridge were also found. The primary cracking – making the tension chord to be severed – was most certainly starting from a small fatigue crack, originating from the butt weld in the joint – the failure came when the crack had reached its critical length with respect to brittle fracture.

Going back to the failure of the Hasselt Bridge in Belgium, this Vierendeel bridge concept was in a way quite provident, as the transition between the verticals and upper and lower chords was rounded, providing a smooth flow of forces (see Figs. 5.1 and 5.2). However, because of the framework action, large localized stresses were being formed due to the combined effect of bending and normal forces.

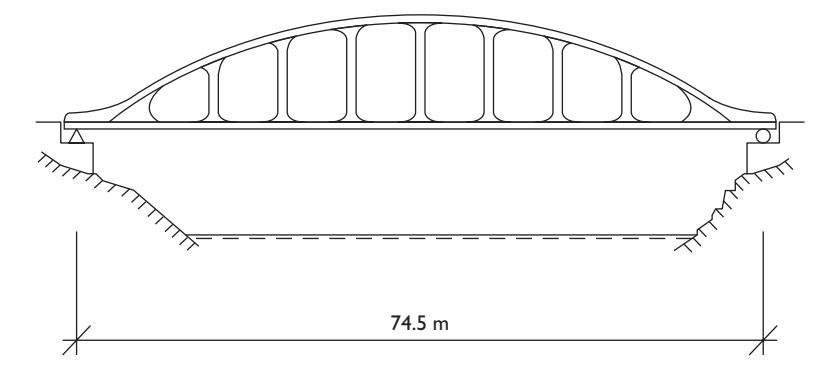
The bridge was of the Vierendeel type (invented by the Belgian engineer Arthur Vierendeel), having a span of 74.5 metres (Fig. 5.2).

*Fig. 5.2* The Vierendeel bridge over the Albert Canal near the city of Hasselt, close to the border of Germany, some 70 kilometres east of Brussels, the capital city of Belgium.

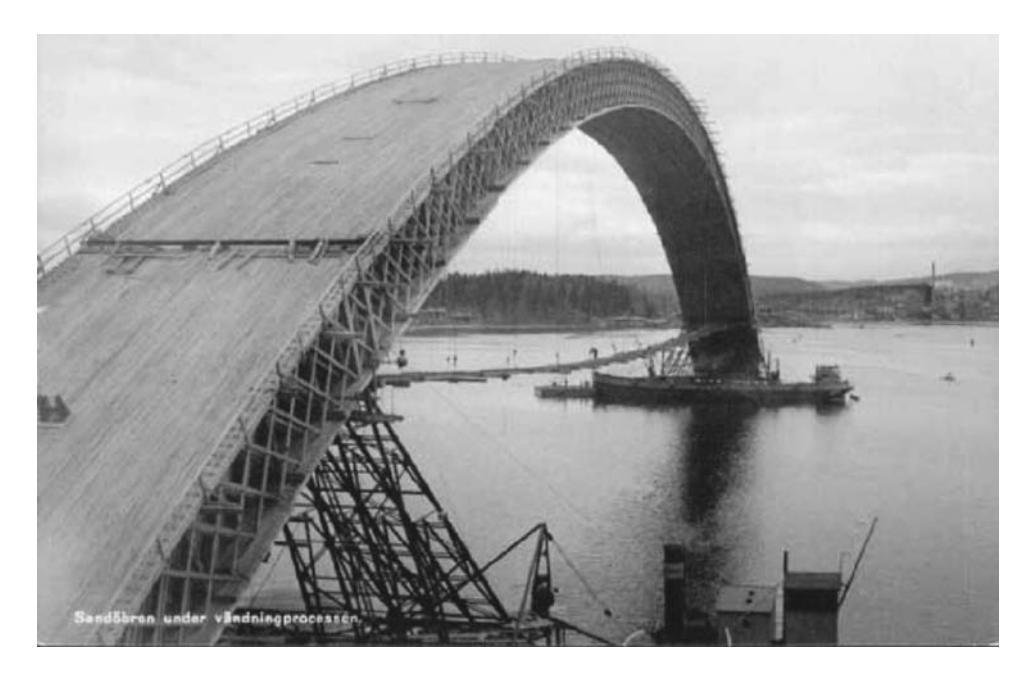
Fig. 6.2 The timber arch falsework being shipped into position. (www.famgus.se/Gudmund/ Gudm-Sandobron.htm, with kind permission of Leif Gustafsson)

Construction of the falsework began in April 1938, and this 247.5 metre long timber arch was to be a self-supporting formwork during casting of the concrete. In May 1939 the timber arch was completed and shipped into position (Fig. 6.2).

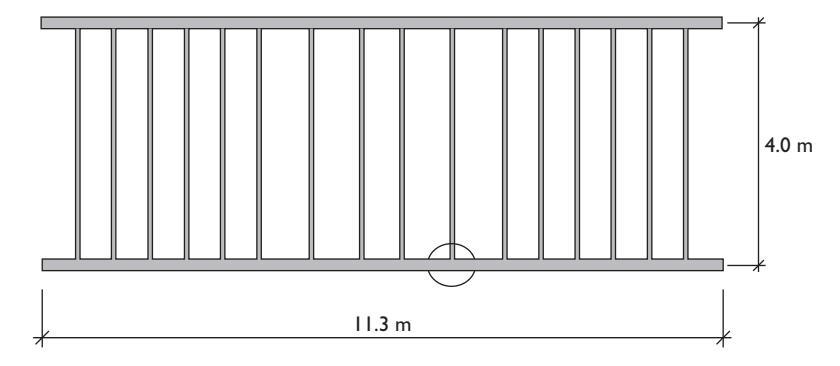
The  $11.3 \times 4.0 \text{ m}^2$  cross-section of this temporary timber bridge construction consisted of two compact timber flanges, separated by a large number of internal lattice walls (Figs. 6.3 and 6.5).

Fig. 6.3 The cross-section of the timber arch falsework for the Sandö Bridge.

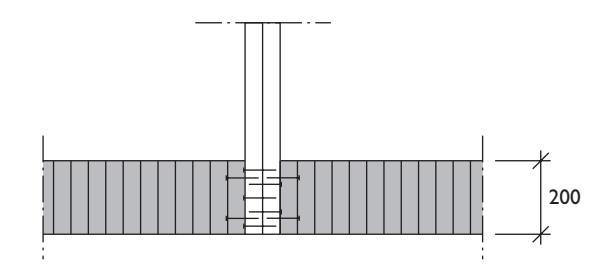
The timber lattice walls was connected and fitted to the flanges through nailing, and the flanges – also nailed together – consisted of more than 220 individual pieces of timber, each having the dimension of  $50 \times 200 \text{ mm}^2$  (Fig. 6.4).

Fig. 6.4 The built-up bottom flange and internal timber wall connection.

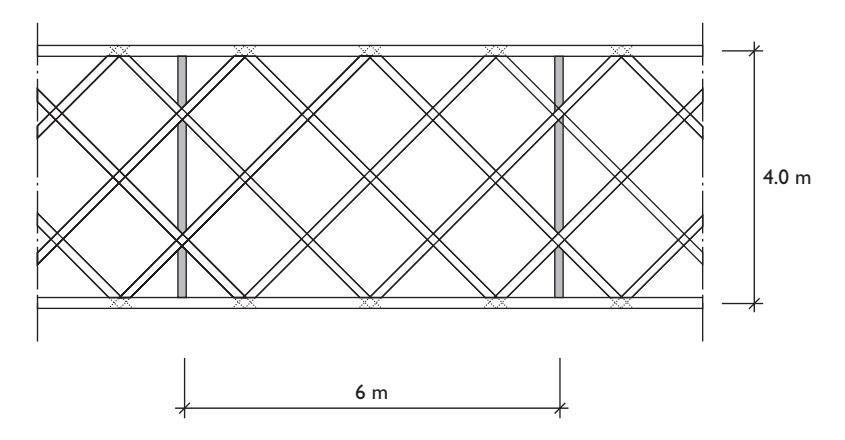
Every six metres the box was stabilized in the transverse direction through crossbracing walls (Fig. 6.5).

Fig. 6.5 Elevation of the timber arch.

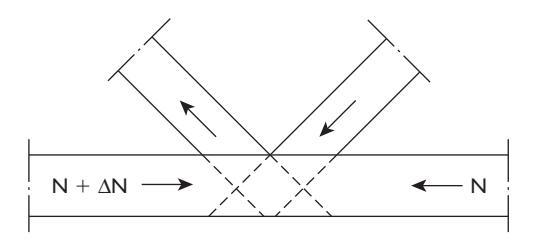
The lattice walls consisted of over-lapping timber elements,  $50 \times 150 \text{ mm}^2$ , and they were to function as diagonal elements in a regular truss system, ensuring equilibrium during bending between the normal forces in each joint (Fig. 6.6).

Fig. 6.6 The normal force equilibrium in each joint.

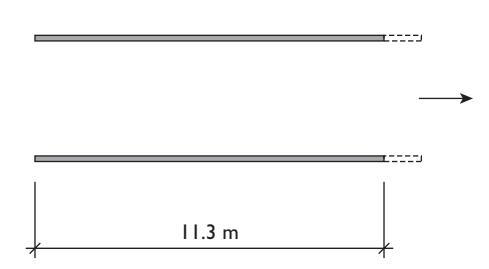
It was not until some 20 years later, in 1961, that the exact cause was put forward, and it was shown that Professor C. Forssell was correct in his assumptions. Professor Hjalmar Granholm, at Chalmers University of Technology in Göteborg, had devoted some time and effort in bringing light to the cause, and he could prove that the bending

Fig. 6.7 Buckling direction, i.e. in the stiff direction of the flanges.

stiffness of the built-up flanges were too weak to resist lateral buckling. If we – for the sake of discussion – start by calculating the bending stiffness of the two flanges (as a coupled pair) in order to find the critical buckling load, assuming *full interaction* between the joined timber parts, we find (Eqs. 6.1 and 6.2, Fig. 6.7):

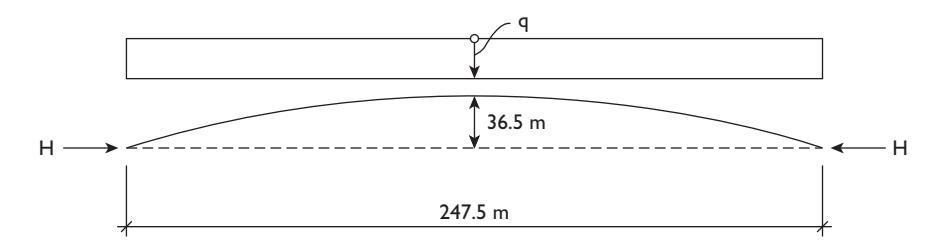
If we use the actual values for L and f (see Fig. 6.8), we finally have the critical buckling load, where we have assumed full interaction between the individual timber elements in the flanges (Eq. 6.4, Fig. 6.8):

$$q = \frac{(1000 + 3000) \cdot 9.81}{247.5} = 158.5 \,\mathrm{kN/m} \ll q_{cr} \tag{6.5}$$

Fig. 6.8 The span length and rise of the timber arch.

However, as there is nothing like full composite action in a built-up section – especially not for a nailed timber flange – the *true* second moment of area must be used. What we have is something like a glulam timber beam, however, without the glue. Granholm performed a large number of tests in order to establish the shear deformation characteristics of the nailed joints in a built-up timber beams similar to the Sandö Bridge timber arch flanges, and he found that the second moment of area is only some 13% of that of the unreduced value (where full composite action had been assumed) for immediate and *short-term* response. The true critical buckling load value therefore becomes (Eq. 6.6):

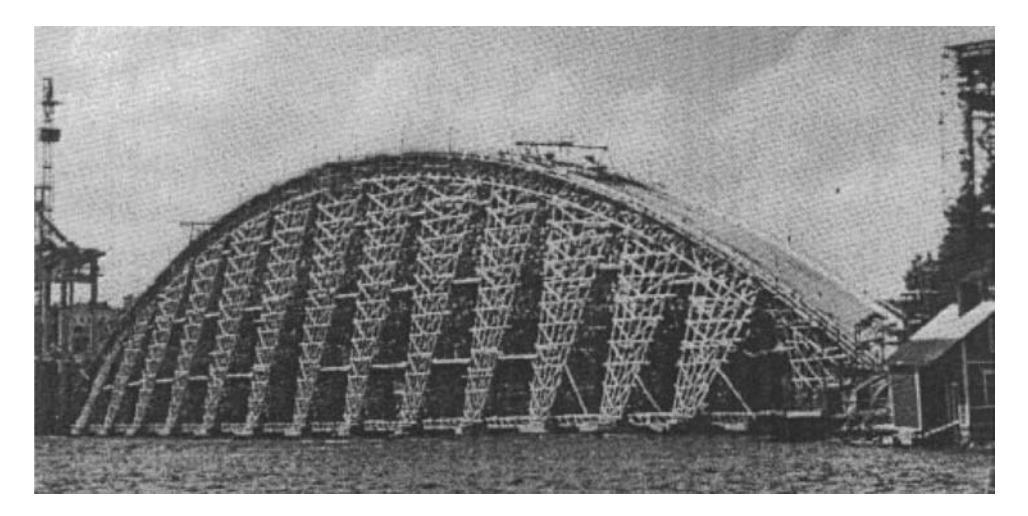
Fig. 6.10 The timber falsework used for the second (and this time successful) attempt to bridge the river Ångermanälven at Sandö.

The bridge was finally rebuilt in 1943, however, now using a timber falsework supported all along its length (Fig. 6.10).

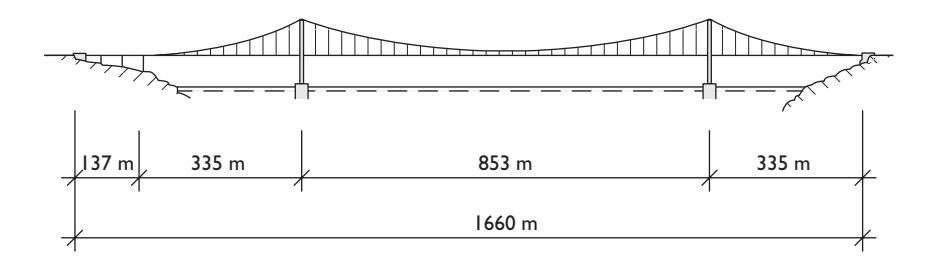
It was constructed as a 1660 metre long suspension bridge with a main span of 853 metres (see Fig. 7.2), the third longest suspension bridge in the world (and USA)

Fig. 7.2 Elevation of the Tacoma Narrows Bridge.

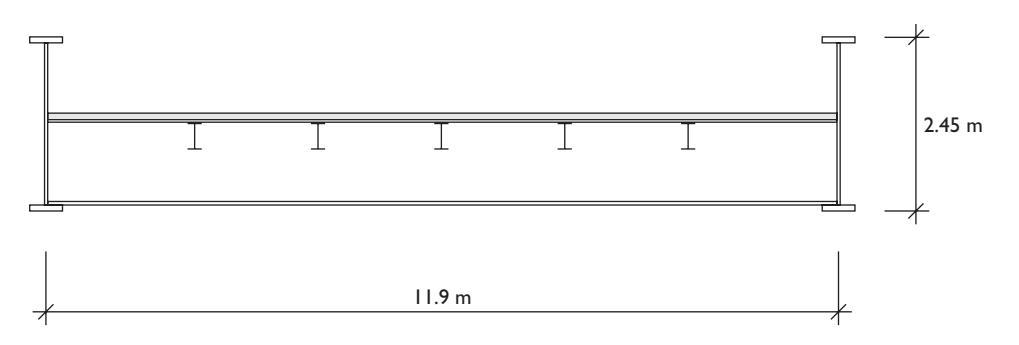
*Fig. 7.3* The stiffening girder (i.e. the bridge deck) of the Tacoma Narrows Bridge, which provided room for two traffic lanes and foot pavements.

at that time. The bridge deck was 11.9 metre wide, supported by two 2.45 metre deep plate girders (I-girders) (Fig. 7.3).

The *depth-to-span* ratio for the stiffening girder in suspension bridges, in the span range of 600–900 metres, was recommended to be above 1/90 (earlier even above 1/40), that is, with a depth of the stiffening girder of at least 1/90 of the span length. The Tacoma Bridge, with its 2.45 metre high girders (see Fig. 7.3), had a depth-to-span ratio of only 1/348. If they would have been to meet this recommendation then the stiffening girder depth should have been at least 9.5 metres (i.e. 853 m/90)! So it is very easy to conclude that the Tacoma Bridge had a very slender and flexible bridge deck, both in the vertical direction (for in-plane bending) and in the horizontal (out-of-plane) lateral direction – it was as if the ideals of Charles Ellet once again was accepted. Leon Moisseiff, the chief designer of the Tacoma Bridge (and the designer of the main cables for the Manhattan Bridge in 1909 – one of two bridges that were especially checked after the Quebec Bridge collapse, see Chapter 4), relied upon the weight of the long span to ensure stability in wind, having the opinion the longer the span the better (i.e. safer), the same opinion that Ellet also held about his Wheeling Bridge.

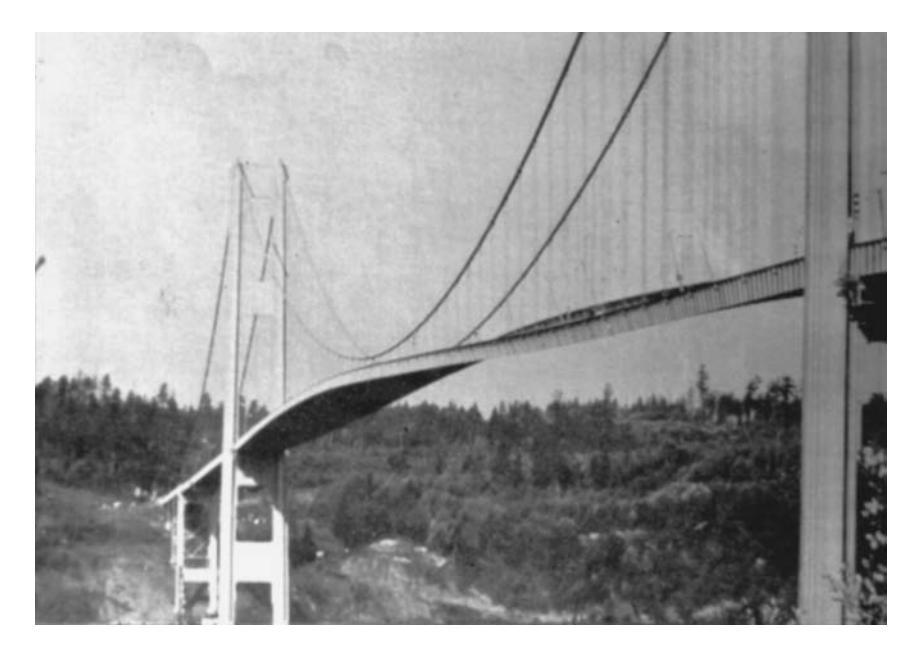
Fig. 7.4 The twisting motion of the main span. (University of Washington Libraries, Special Collections, UW 21413)

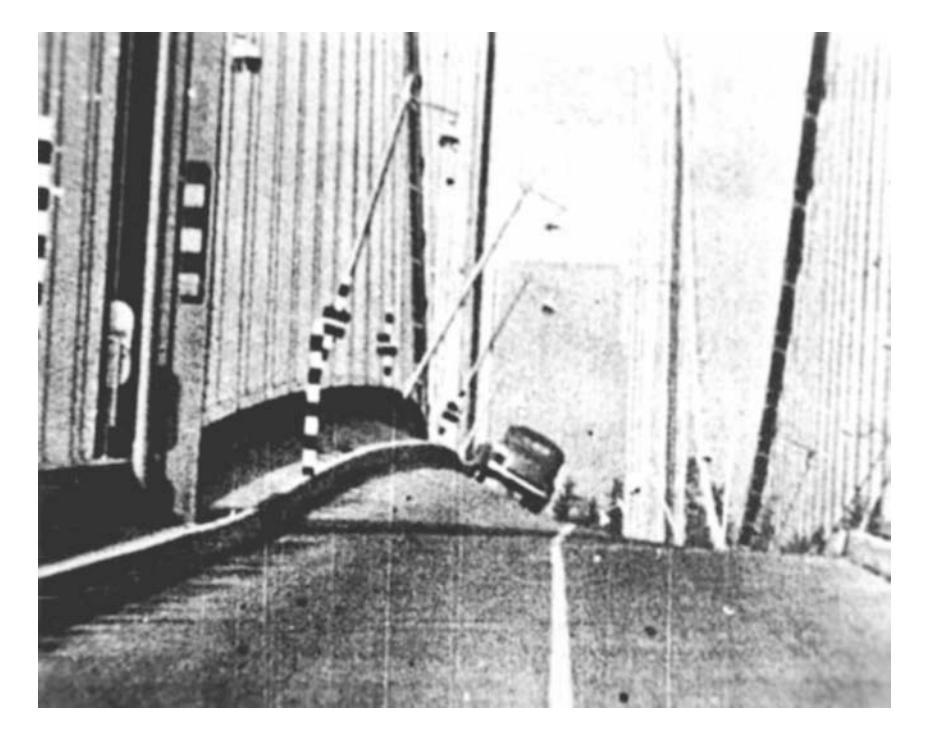
*Fig. 7.5* A still from a classic live film of the twisting span, showing a car left out on the bridge, abandoned by a newspaper reporter. (University of Washington Libraries, Special Collections, UW 21429)

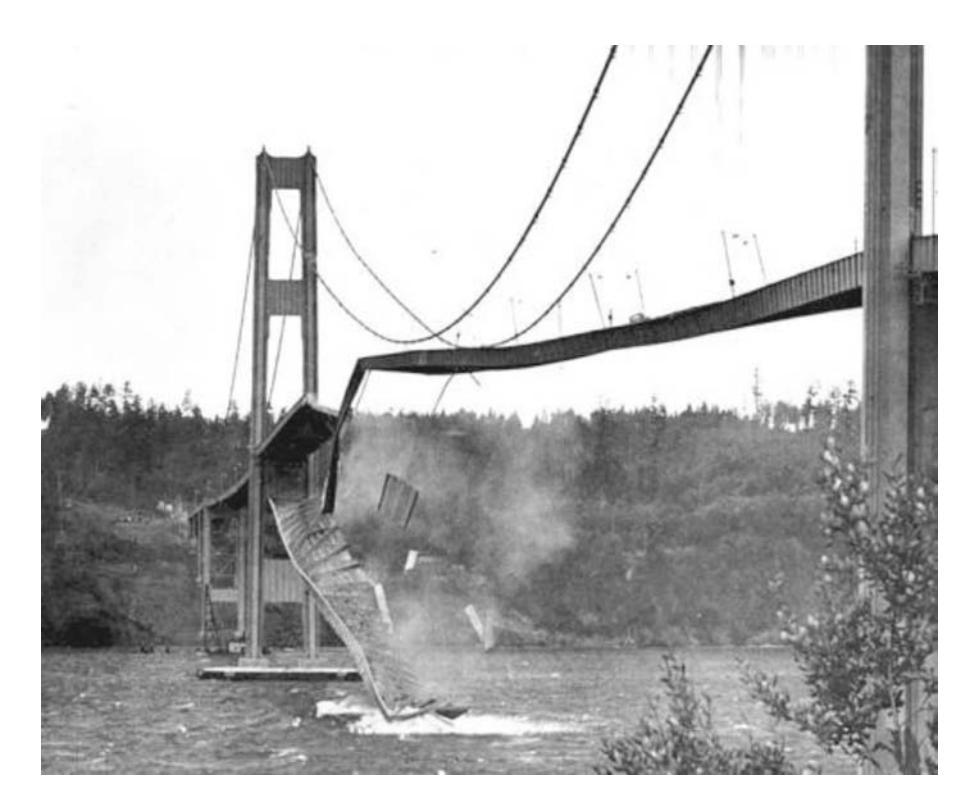
"For a half hour and more, the steelwork and concrete slab took this terrific punishment. Something was bound to give way. At 10:30 came the first break: one floor panel at mid-span broke out and dropped into the water 208 feet (63 m) below. The twisting, writhing motion continued. Spectators on the shores were herded to a safer distance away from the span. At 11 A.M. the real breaking up of the span occurred; 600 feet (183 m) of the main span near the west quarter-point tore away from the suspenders, the girders ripping away from the floor like a zipper; part of the falling bridge floor turned upside down before the entire falling mass hit the water, sending up spray to a great height." (Fig. 7.6).

Fig. 7.6 The first part of the collapse, where 183 metres of the main span tore away from the vertical hangers (suspenders) and fell into the waters below. (University of Washington Libraries, Special Collections, UW 21422)

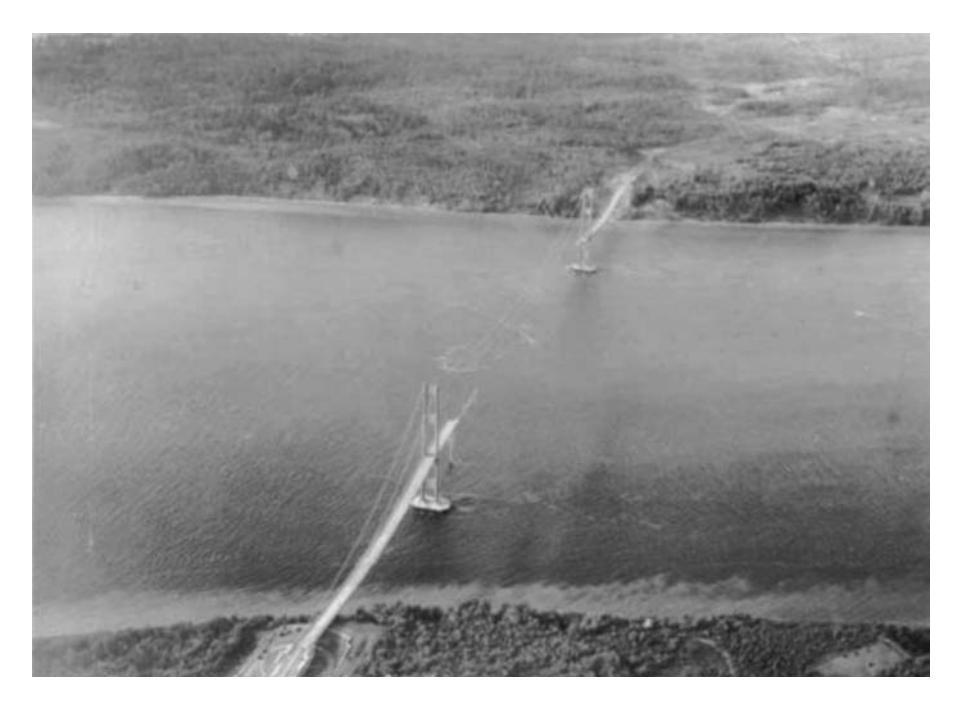
Apart from some short ends of the bridge deck only the two suspension cables remained of the main span (Fig. 7.8).

Fig. 7.8 The collapsed Tacoma Narrows Bridge – aerial view looking west, a rather sad and dreary sight. (University of Washington Libraries, Special Collections, UW 26818z)

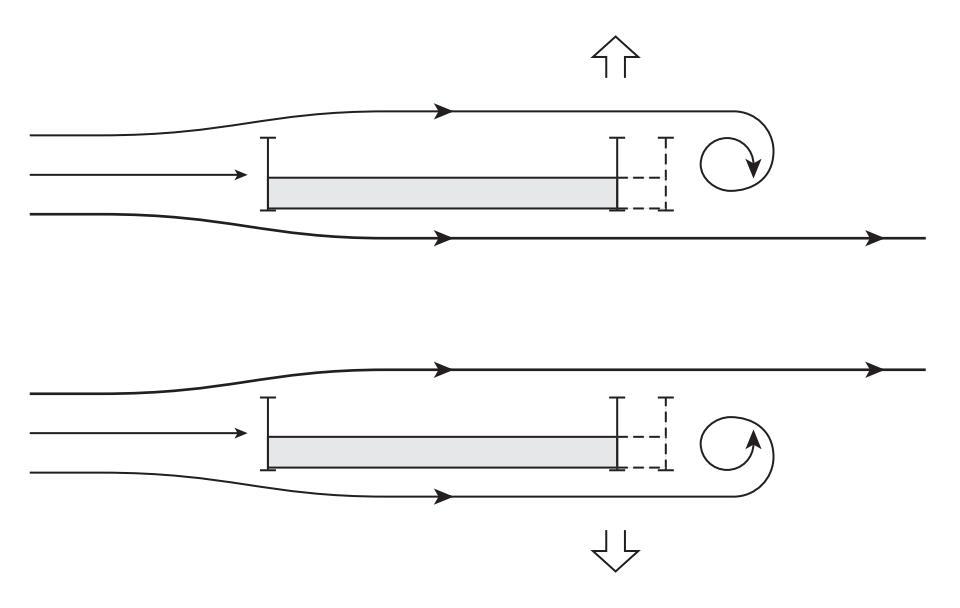
Fig. 7.9 Vortex shedding at a steady air flow.

The committee concluded that the bridge had been properly designed according to the present codes, and with adequate stiffness and strength for *static* wind pressure – for wind speeds close to three times more than the wind of that fatal morning in November 1940 – however, not taking into consideration the possibility of *aerodynamic instability*. Wind tunnel testing confirmed that the bridge was very susceptible to a phenomenon known as vortex shedding (at least known to aerodynamicists at that time). A cross-section such as the Tacoma Bridge deck – having a small width in relation to its length, and a very flexible stiffening girder, consisting of solid web plates – is especially sensitive to the formation of vortices (whirlpools) in a steady air flow, which appear at regular interval (i.e. at a constant frequency) at the back of the deck (on the leeward side). This phenomenon creates alternating suction in the transverse direction to the wind, perpendicular to the bridge deck, subjecting it to pulling forces up and down (in the vertical direction) at regular frequency, while, at the same time, the bridge is pushed horizontally by the steady wind (Fig. 7.9).

If the shedding frequency of these vortices coincides with the natural frequency of the body, then resonant vibration can be induced, creating excessive oscillations. In the case of the Tacoma Bridge – where the situation was a little bit more complex – these lift and drag forces were initially too small – i.e. to deflect the deck up and down – however, due to the sustained conditions the deflections not only were initiated, but also gradually grew, increasing little by little with time. The investigation committee

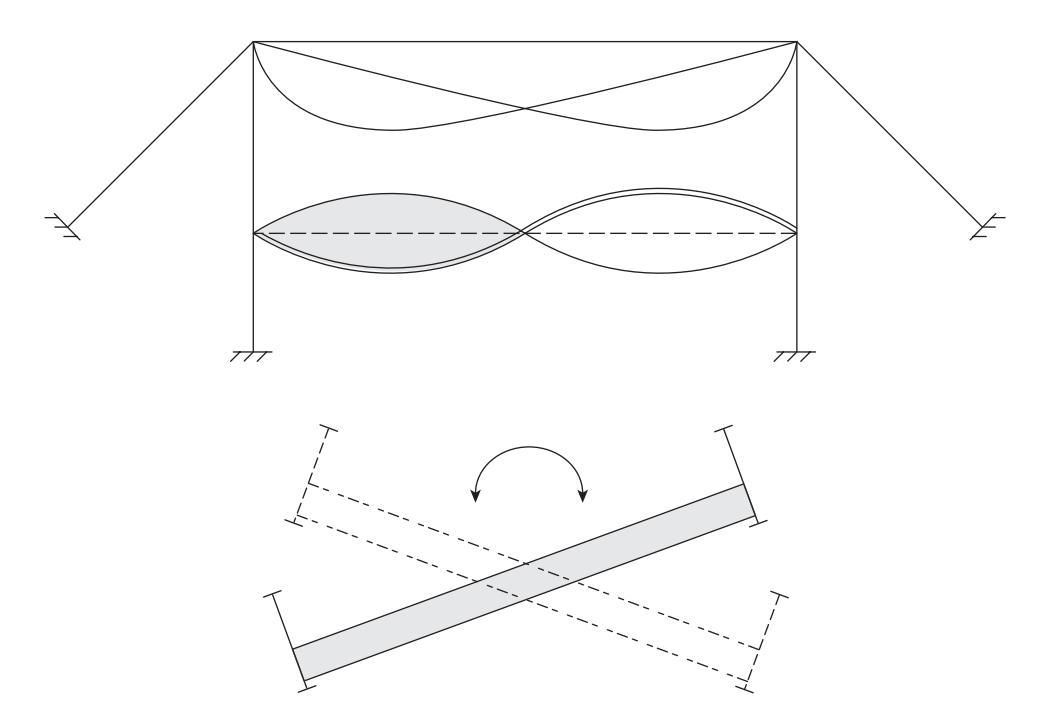
In addition to bending vibrations there is also torsional vibration (i.e. twisting) to consider. The first torsional mode of vibration is when one half of the bridge is rotating one way as the other half rotates the other (Fig. 7.13).

At the time of the collapse, the oscillations had started as bending vibrations, but "*when* something seemed to snap" (possibly the breakage of the cable locks at midspan) the vertical oscillations changed into twisting.

*Fig. 7.13* The first torsional mode of vibration of a suspension bridge deck (and the corresponding deformation of the main cables).

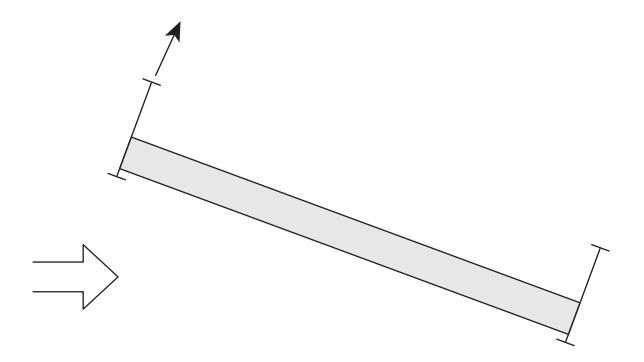
As the torsional deformation of the deck well has started then there is also a tendency of the wind acting as a driving force, as the surface of the deck is exposed (however, in the opposite direction the wind is stabilizing – pushing down instead of pushing up) (Fig. 7.14).

Fig. 7.14 Wind acting as a driving force with respect to torsional oscillation.

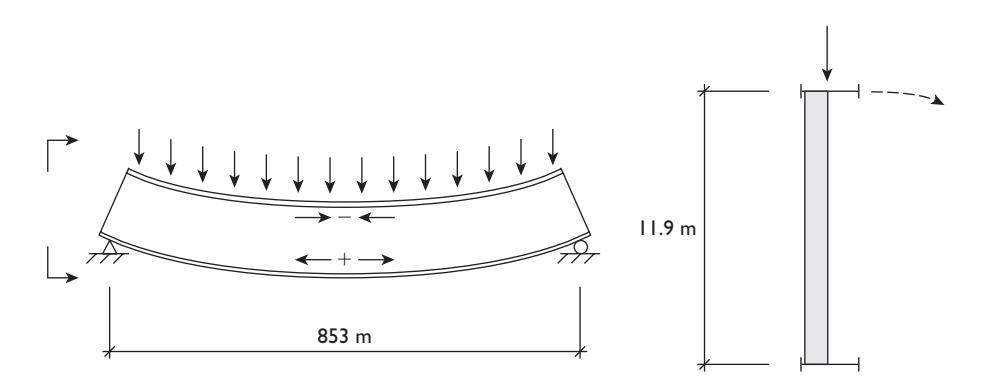
A triggering factor with respect to the torsional oscillations – besides vortex shedding – may also have been a phenomenon which is called lateral/torsional buckling. As the wind is pushing the bridge deck horizontally, the two end girders act as two flanges – separated apart by the deck – in a deep beam (which is on the flat). Compression stresses are formed in the end girder at the windward side and tension stresses in the other end girder at the leeward side, and the compression flange could buckle transverse to the wind loading direction (if the wind is strong enough that is) (Fig. 7.15).

Fig. 7.15 The 853 metre long bridge deck as a simply supported deep beam (should in fact be continuous in three spans), with possible lateral/torsional buckling risk.

The buckling direction of the compression flange would be upwards in the vertical direction (because of the least resistance from the cable), counterbalanced of course by the self-weight of the deck.

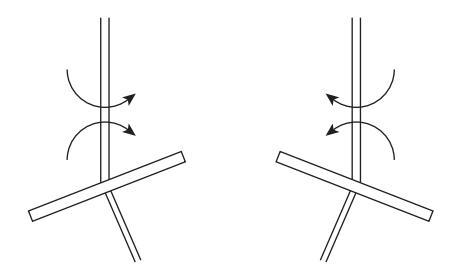
*Fig. 7.16* Local bending of the hanger connections as the bridge deck was twisting back and forth made the bridge eventually collapse – a typical case of low-cycle bending fatigue.

Then, what was it that finally made the bridge deck to break from the vertical hangers and fall into the water below? Of course the bending and twisting deformations of the deck itself were excessive (however, as the flexibility was low no destructive strains were produced), the key failure mechanism was instead the *local* bending of the connection detail between the hangers and the end girders (Fig. 7.16).

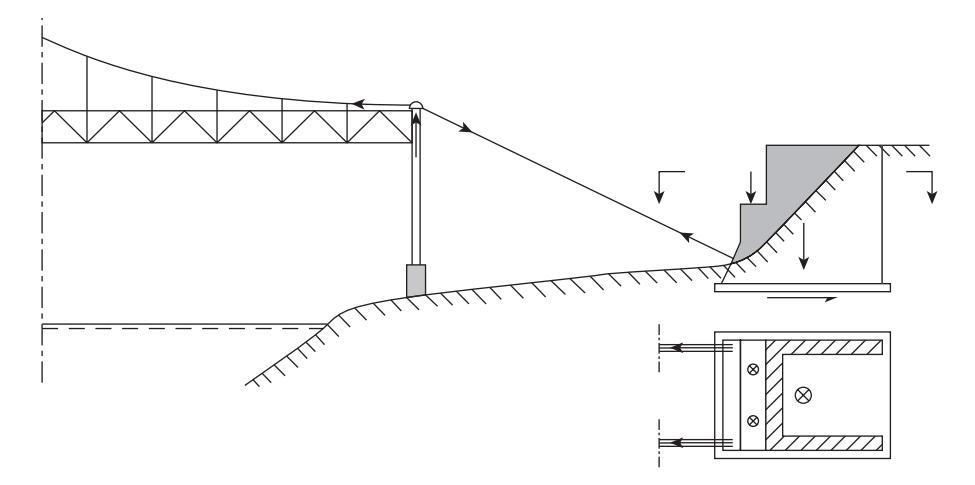
*Fig. 8.10* The pulling forces from the two main cables, which are anchored in the abutment, are counterbalanced by the weight of the concrete and the soil and the reaction forces coming from the roller bearings supporting the end span (the end span is not shown in the figure above because it does not contribute to the horizontal stability).

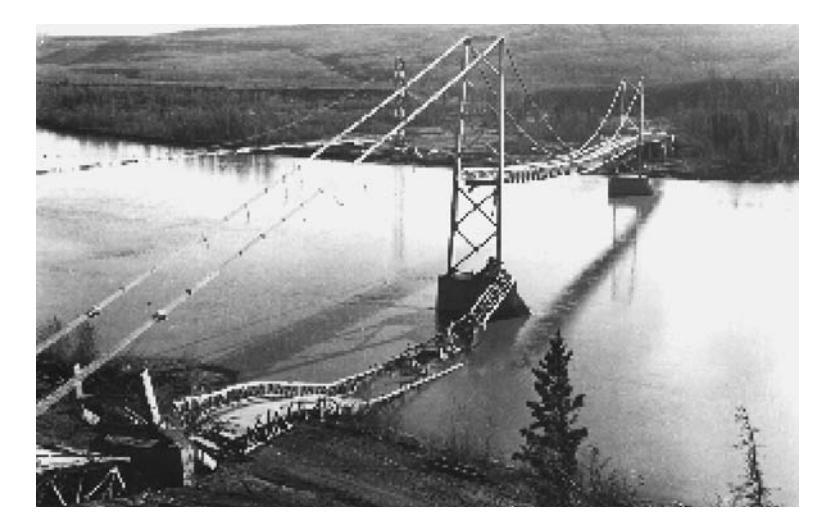
Early on the morning of 16 October 1957, an unexpected bump in the roadway was reported from one of the drivers crossing the bridge. It was discovered that a water line close to the north abutment had sprung a leak, and was pouring out huge amounts of water in the ground – visible signs of ground movement at the abutment was also discovered. Possibly a small initial slip of the abutment – indicating the major collapse

Fig. 8.11 The collapsed Peace River Bridge. (http://collections.ic.gc.ca/north\_peace/transport/ 02.07.html)

to come – had created the bump experienced by the drivers (as a misalignment of the deck either at the transition between end span and the suspended side span – i.e. at the cable bent – or possibly between the side span and the main span). The inspection personnel immediately realized the danger and closed the bridge to traffic. Just as the case was for the Tacoma Narrows Bridge the collapse of the Peace River Bridge came several hours later, so a large crowd of people could gather and witness the actual collapse. Suddenly, at approximately one o'clock in the afternoon, the north abutment slid towards the river some 3.5 metres and the end span and north suspended side span collapsed simultaneously (Fig. 8.11).

The end span could of course also have helped to push the cable bent forward – even though the end span is not shown in the figure above – as soon as it came in contact with the front wall of the abutment that is. The broken and deformed cable bent can be seen lying on the ground to the left in figure 8.11, leaning backwards supported by its plinth (and behind it the collapsed end span). In the same figure the deflected main span can be seen – it oscillated heavily at the time of the collapse, but was not

destroyed (opposite to the Tacoma Narrows Bridge, where the main span was destroyed while the end spans remained intact). Due to the slackening of the main cable – now straightened in between the tower top and the anchorage at the abutment – and the uneven loading on either side the north tower deformed in just the same manner as the cable bent, however without failing, thus saving the main span and the south side span and end span.

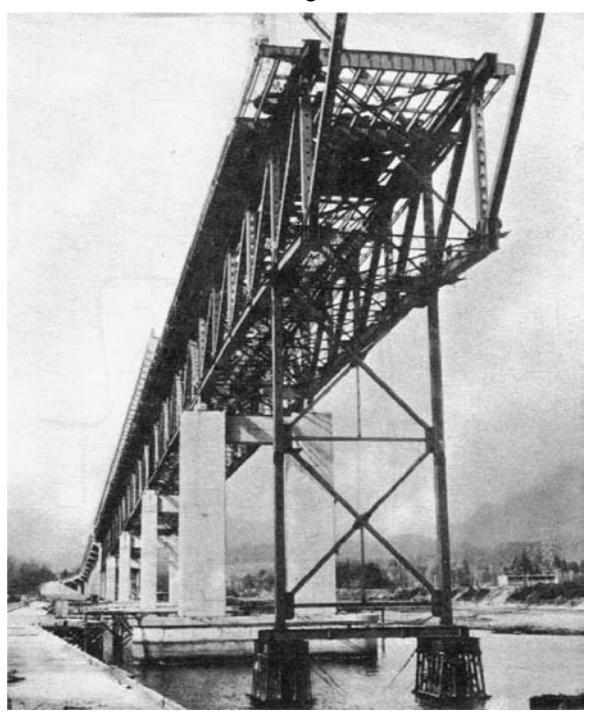
Fig. 9.3 The temporary truss (i.e. the falsework) supporting the north anchor span during construction. (McGuire: Steel Structures. With kind permission of Pearson Education Publications).

At the time of the collapse the north anchor span was being erected, and in order to reduce the maximum cantilever length a centrally located falsework support was being used. In contrast to the anchor spans of the Quebec Bridge back in 1907 – which were constructed using an all-span length falsework (see Fig. 4.6) – it was in this case decided to limit the amount of extra supports to just one because of the water (Fig. 9.3).

In figure 9.3 it is indicated that vertical web stiffeners *actually were* used, however, not directly under the load application points (and these indications could also very well be just bolting, holding the grillage tight together).

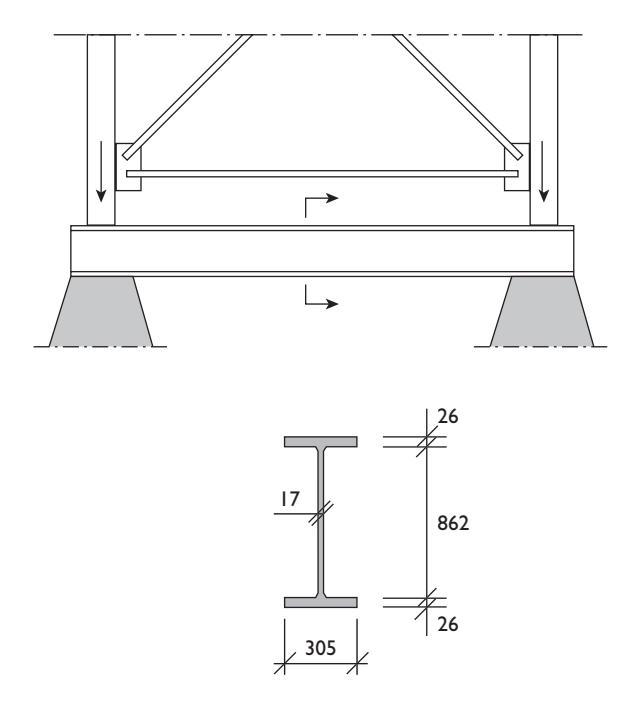
When the anchor span fell the adjacent span also collapsed, as it lost its support when the pier was pulled away. A total of 18 workmen and engineers were killed. A Royal Commission of Inquiry investigated the cause of the collapse and soon found the answer. It was not the buckling capacity of the temporary truss that was inadequate, as could have been expected; instead it was found that the lower transverse beam at the bottom of the falsework truss had failed. The purpose of this beam was to distribute the concentrated load – coming from the vertical members of the truss – in order to spread it over a larger area on top of the piles. The profile – or profiles, for there were probably more than one, lying parallel close to each other as a grillage – was a wide-flanged rolled standard steel girder (36 WF 160) (Fig. 9.5).

Fig. 9.5 Cross-section of the transverse girder.

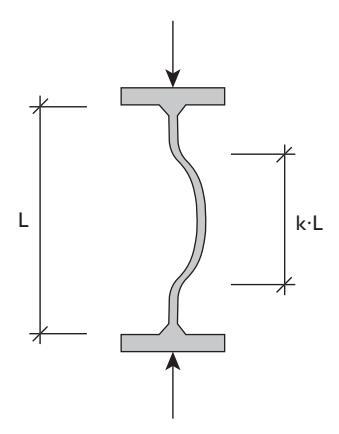
As the concentrated load is transferred directly through the web to the support there is no risk of web crippling (i.e. local buckling of the upper part of the web) as no shear force is present (i.e. the girder is not subjected to bending), instead the instability phenomenon to consider in design should be global buckling of the entire web – an instability phenomenon that is more or less similar to the Euler buckling case where both ends of a strut are fixed (Fig. 9.6).

Fig. 9.6 Overall buckling of the entire web when the load is transferred directly through the web (with a column effective length factor k equal to 0.5).

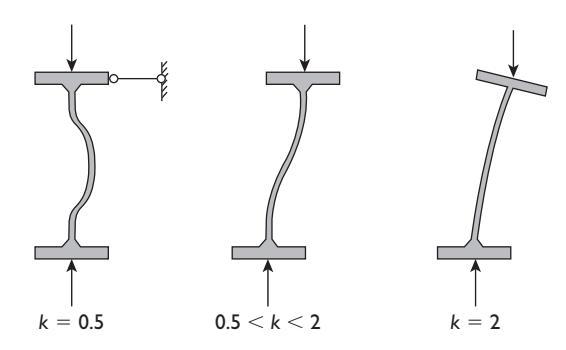
If the upper flange, though, is not fixed in the transverse direction, the effective length factor is somewhere in between fixed end conditions (k = 0.5) and that of a free-swaying cantilever (k = 2.0), which have the result that the capacity to carry concentrated loads is lowered even further (Fig. 9.7).

Fig. 9.7 The effective length factor k with respect to web buckling for different boundary conditions.

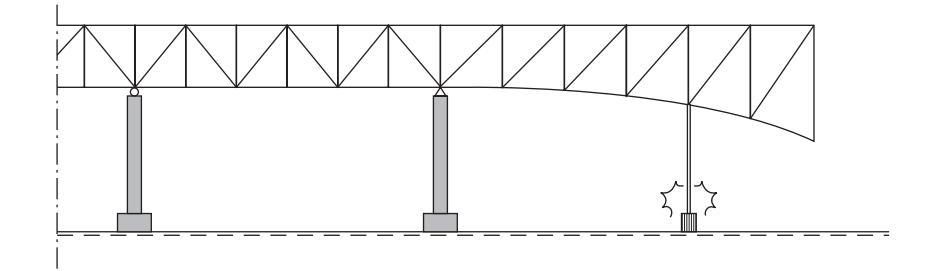
The exact conditions for the transverse girder(s) is difficult to ascertain in detail, but nevertheless, the capacity was far from being enough as the huge cantilever up above lost its temporary support and plunged into the water below (Fig. 9.8).

Fig. 9.8 When the web of the temporary transverse girder below buckled the entire weight of the cantilever above was transferred to the truss itself – which it had not been designed for – so it broke in bending and collapsed (see also Fig. 9.4).

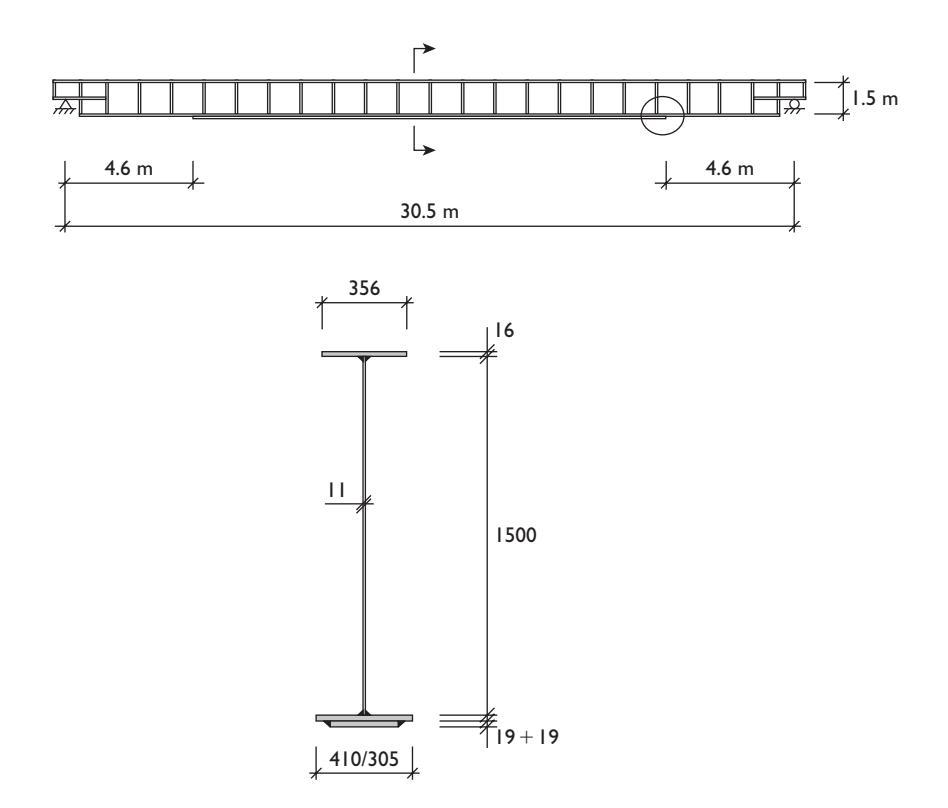
*Fig. 10.3* Elevation and cross-section of the *outer* girders of the second span on the south end of the bridge. The inner girders had 356 millimetre wide cover plates, which were terminated 5.3 metres (instead of 4.6 metres) from the ends.

winter's morning, as a 45-ton heavy vehicle was passing over the second span on the western carriageway – having approached the bridge from the south – this span broke and collapsed. The span was 30.5 metre long and the I-girders were reinforced by extra cover plates attached to the tension flange in the maximum-moment region (Fig. 10.3).

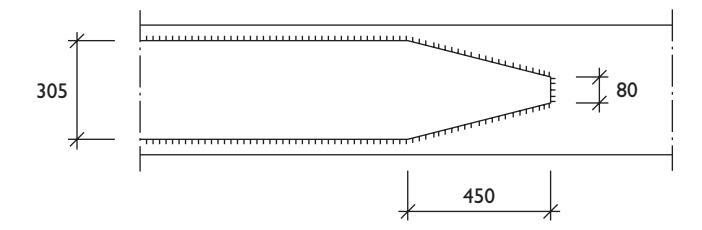
In order to achieve a smooth transition – rather than an abrupt change in stiffness – the cover plates were tapered (i.e. gradually reduced in width) at the ends (the south end encircled in Fig. 10.3) (Fig. 10.4).

Fig. 10.4 The cover plates were tapered over a length of 450 millimetres. Fillet weld dimension: 5 mm – automatic welding for the parallel sides, and manual welding for the tapering and the 80 mm transverse end.

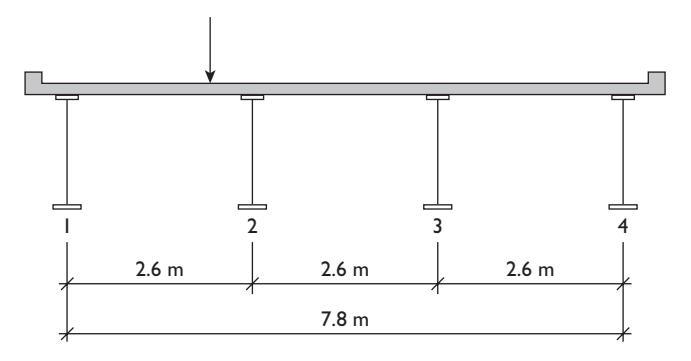
When the lorry passed over the second span on the western carriageway the position was in between girders number one and two (Fig. 10.5).

Fig. 10.5 Cross-section of the second span on the south end of the Kings Bridge, and the approximate position of the lorry that initiated the collapse.

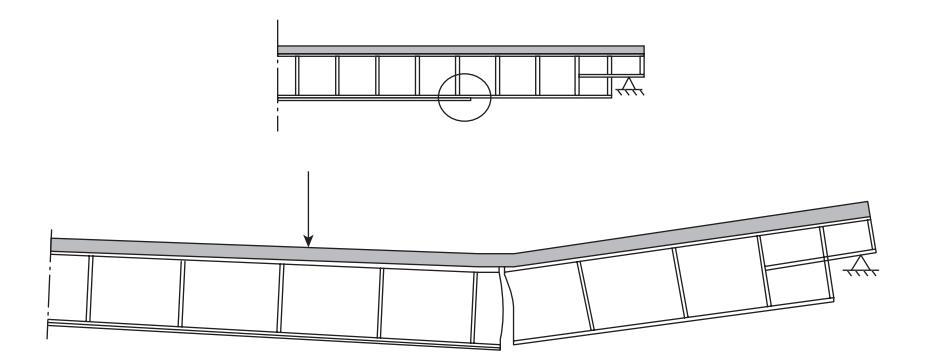
Fig. 10.6 The broken girders.

It was found that all four girders had fractured in a brittle manner in the position of the cover plate ends (Figs. 10.6 and 10.7).

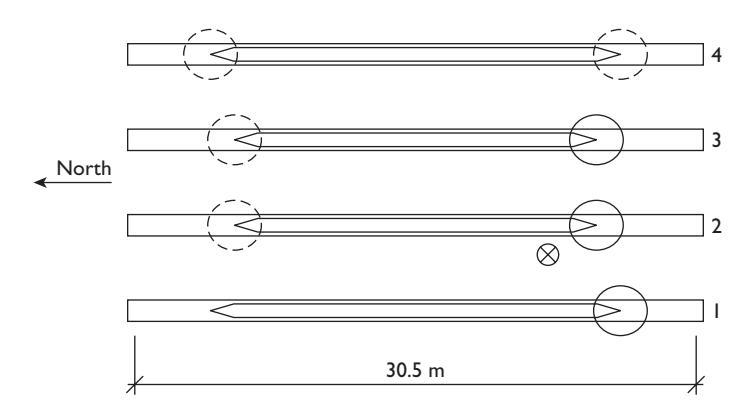
In three positions the crack was complete, i.e. had propagated across the entire depth of the girder (the south ends of girder No. 1, 2 and 3) and in four positions the crack had arrested in the web below the upper flange (the south end of girder No. 4, and the north ends of girder No. 2, 3 and 4) (Fig. 10.8).

*Fig. 10.8* Complete fracture in the south ends of girder No. 1, 2 and 3, and partial fracture of the south end of girder No. 4 and of the north ends of girder No. 2, 3 and 4. For the sake of simplicity the flanges have been turned upside down – the flange widths have also been enlarged (in relation to the span length).

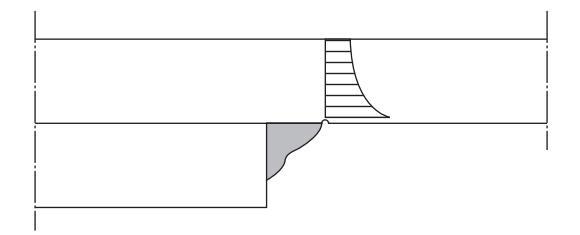
Fig. 10.10 Additional stress raising effects coming from the roughness of the surface, and, especially, melting ditches.

The roughness of the surface of the manual fillet weld, as well as melting ditches will increase this local stress raising effect even further (Fig. 10.10).

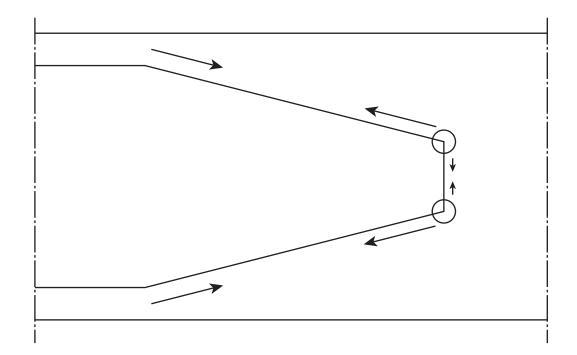
When the weld cools, and the contraction is restrained by the surrounding cold metal, small micro-cracks will form (as well as the forming of residual tensile stresses – counterbalanced by residual compressive stresses in the surrounding metal). One way of limiting the formation of these cracks (and the residual stresses) is to preheat the metal pieces to be joined; however, regions which still are especially prone to crack are corners, because of the combined effect of the start/stop-procedure of the welding and the restrained contraction thereafter during cooling (Fig. 10.11).

*Fig. 10.11* The corner regions, where the probability for crack initiation is the highest. Here the combined effect of residual tensile stresses in the transverse and longitudinal direction is the highest.

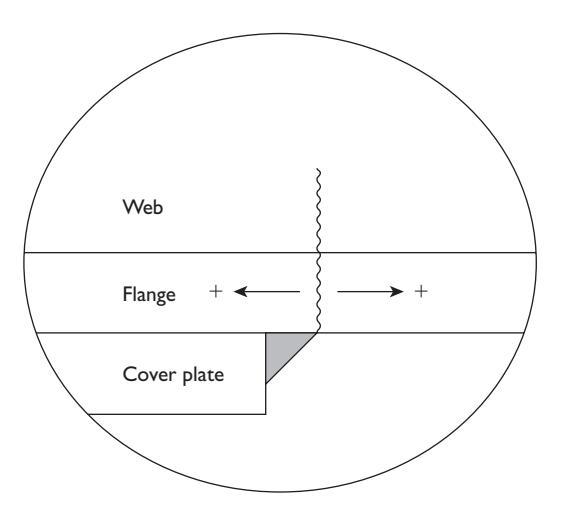
All these effects taken together make this region in the tension flange – at the cover plate end – very probable for the initiation and the following propagation of a *slow* fatigue crack (a small incremental increase in crack length for each new loading cycle) or a *fast* brittle fracture (the final failure starting from an existing crack for just one additional loading cycle). The crack will propagate *perpendicular* to the applied normal tensile stress, starting from the weld toe in the heat-affected zone (Fig. 10.12).

Fig. 10.12 A crack will initiate from the weld toe, in the heat-affected zone, and then propagate upwards into the web, perpendicular to the applied normal tensile stress.

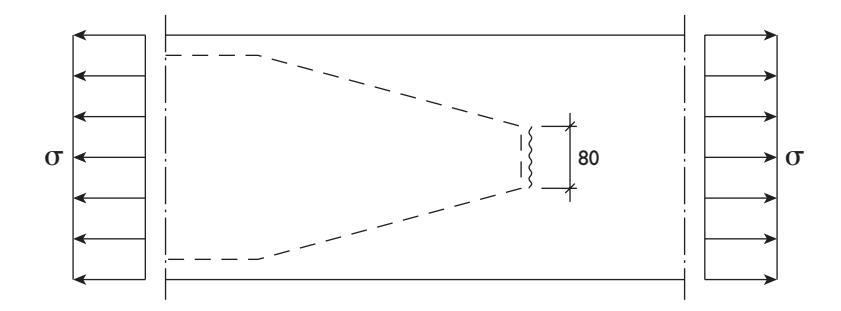
We assume a crack all along the length of the cover plate end (having a length equal to 2a = 80 mm) (Fig. 10.13).

Fig. 10.13 A centrally located crack all along the cover plate end.

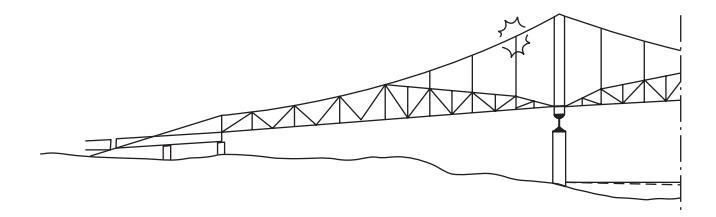
Fig. 11.7 The location of the fractured eye-bar chain joint.

Despite being unusual in design the bridge served its purpose well for almost 40 years, but on that fatal afternoon in December 1967 it was no longer capable of carrying the service load it was intended for. First the side-span on the Ohio side fell into the river, and then the main span and the other side-span followed almost instantaneously, and all cars on the bridge plunged down as well. After the first couple of days of chaos an investigation into the cause of the collapse commenced, where as many parts as possible of the bridge superstructure was salvaged from the river bed. A large number of probable causes were first considered (among them aerodynamic instability and sabotage), however, these were eliminated when a fractured eye-bar was found. The broken eye-bar was identified with respect to its original location, and it was found that it had been positioned in the second panel counting from the Ohio tower on the upstream north side, with its fractured end connected to the eye-bar in the first panel (Fig. 11.7).

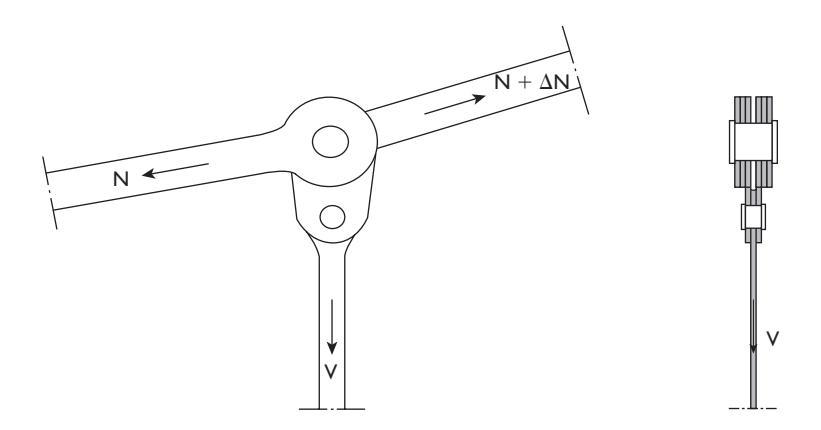
Fig. 11.8 Static equilibrium in the upper hanger joint.

In each chain joint a vertical hanger is attached, which is carrying a vertical reaction force, V, coming from the self-weight of the stiffening truss and deck and from traffic load upon the bridge. Vertical equilibrium in the joint is met by an increase in the normal force, N, in the eye-bar chain element closest to the towers (Fig. 11.8).

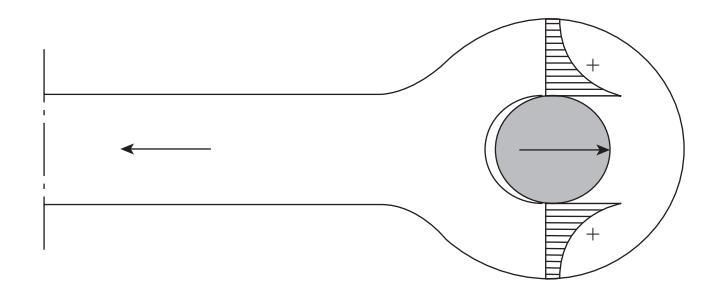
Fig. 11.9 Stress concentration effects in the eye-bar end.

to carry the gradual increase in loading (from 1928 to 1967) without exceeding the allowable stresses. However, it was soon realized that the actual loading of the eyebar hangers was high, as they were made out of high-strength steel (the higher the strength the higher the allowable loading). For the eye-bar shank it was not a problem, however, the tensile stresses in the end parts – taking the stress concentration effects into account – were found to be very high (Fig. 11.9).

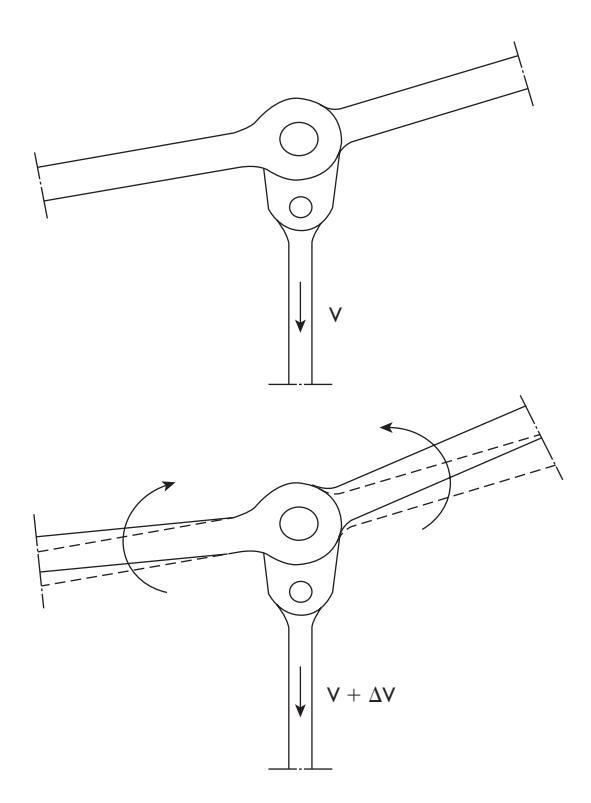
As the load from the traffic is transferred by the vertical hangers to the eye-bar chain it is followed by a rotation of the chain joints (and by a deflection down of the joint), as they are adjusting themselves to the new loading position and loading level (see also Fig. 7.10) (Fig. 11.10).

Fig. 11.10 Rotation of the joint as the load, transferred by the vertical hanger, is increased.

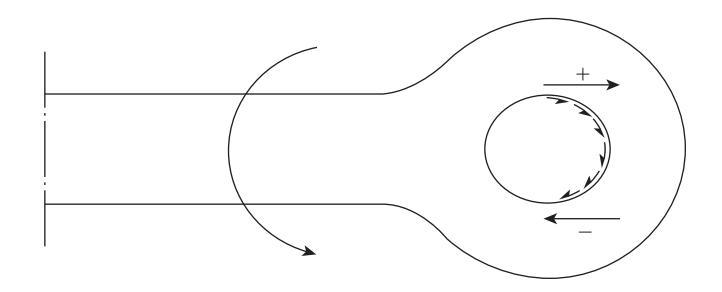
This rotation creates fretting due to the sliding friction between the pin and the hole edge, and at the ends of the contact zone it adds to the tensile stresses from the normal force, which drastically increases the probability of a fatigue crack being initiated at the surface (especially as the number of loading cycles equals that of the hanger). When the hanger is unloaded (with respect to the service load) the eye-bar chain elements rotate back, now creating sliding friction in the opposite direction (Figs. 11.11 and 11.12).

*Fig. 11.11* Sliding friction between the pin and the hole edge as the eye-bar chain element is rotating back to its original position. Due to the restraint a partial fixed end moment is introduced.

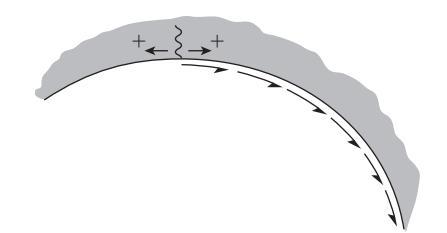
Fig. 11.12 At the end of the contact zone, on the upper side (as well as on the lower side), a fatigue crack could be initiated due to the combined effect of fretting and normal tensile stresses (see also Fig. 11.9).
