# Understanding Bridge Collapses

Björn Åkesson Consulting Engineer, Fagersta, Sweden

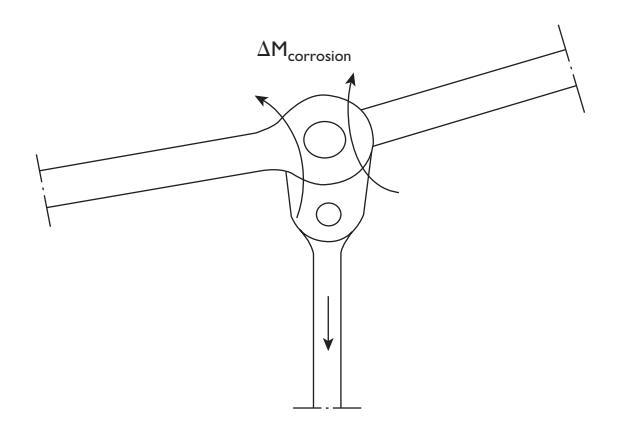
of the eye-bar elements would have been prevented, introducing secondary bending stresses into the joint (as well as to the eye-bars) as soon as traffic load was carried by the hanger (Fig. 11.13).

Fig. 11.13 Secondary bending stresses are introduced if the joint has rusted stuck.

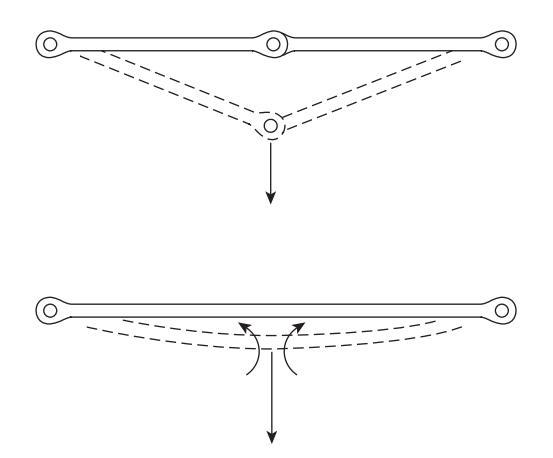
Fig. 11.14 The upper case where the eye-bar joint is free to rotate, and the lower extreme case where there is no rotational capacity at all, and therefore secondary bending stresses are being introduced.

case – where there is no rotational capacity at all left in the centre joint (and that is why it has been omitted) (Fig. 11.14).

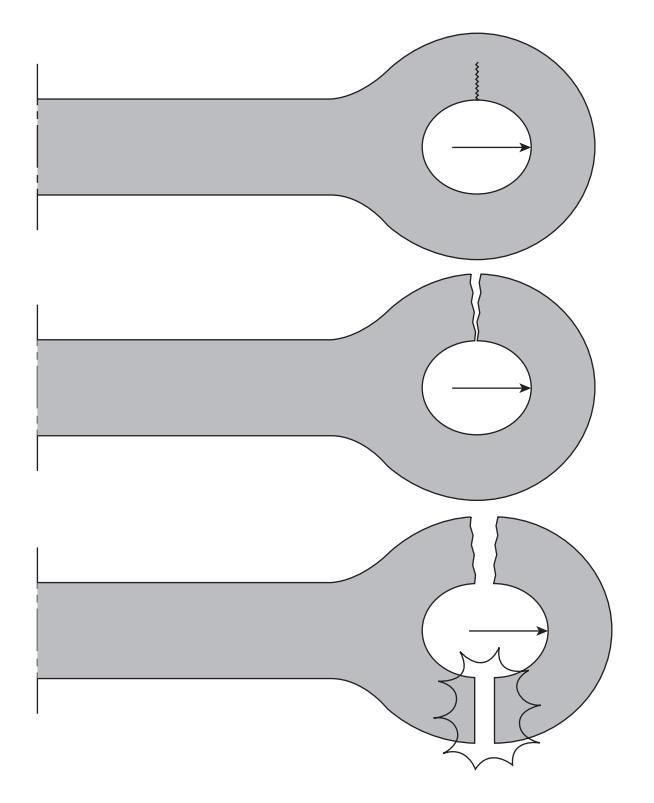
The most probable failure sequence was as follows; a fatigue crack in the upper portion of the eye-bar end (see Fig. 11.12) continued to grow upwards, perpendicular to the applied tensile stress (see Fig. 11.9), for each new loading cycle (of heavy vehicles passing the bridge) – gradually increasing the stress concentration effect (and hence the crack propagation rate) – until, finally, it reached a certain critical length and netsection (brittle) failure of the upper half occurred. The entire load was then carried by the lower portion, which deformed rapidly under the combined action of tension and bending, and broke more or less immediately in a brittle manner (Fig. 11.15).

Fig. 11.15 A probable failure sequence.

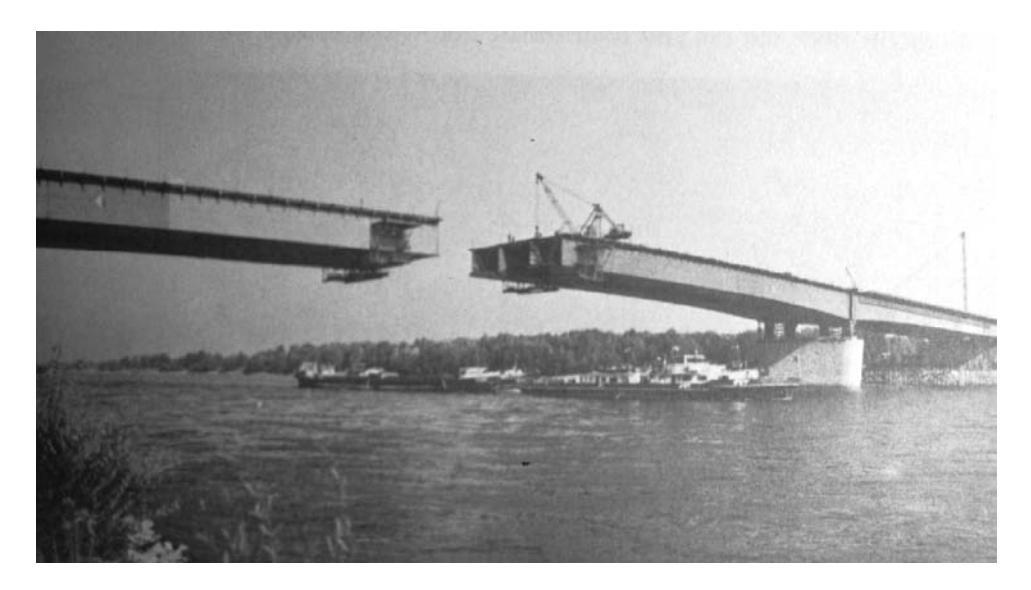
load-carrying capacity of the cantilevers. As the length of the cantilevers increased, the moment and shear over the inner supports also increased – stresses that exceed what is later the case for the final bridge (Figs. 12.4 and 12.5).

Fig. 12.5 Only a short gap remains before the final closing of the two cantilevers.

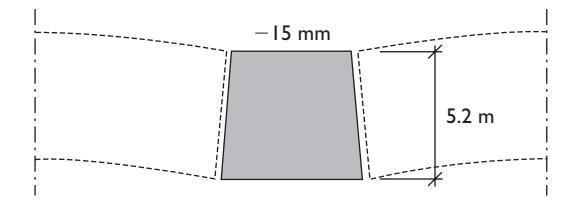
When the two cantilever ends met in the middle, the final section had to be adjusted due to the temperature deformations the bridge had been subjected to during the day. The weather had been sunny and warm, which made the bridge, in addition to the elastic bending deformations, to bend down a little bit extra. The final closing section had to be shortened 15 mm at the top (due to this additional temperature deformation) in order to fit into the gap between the cantilever ends (Fig. 12.6).

Fig. 12.6 The final closing section in the centre part had to be adjusted due to temperature deformations in the bridge.

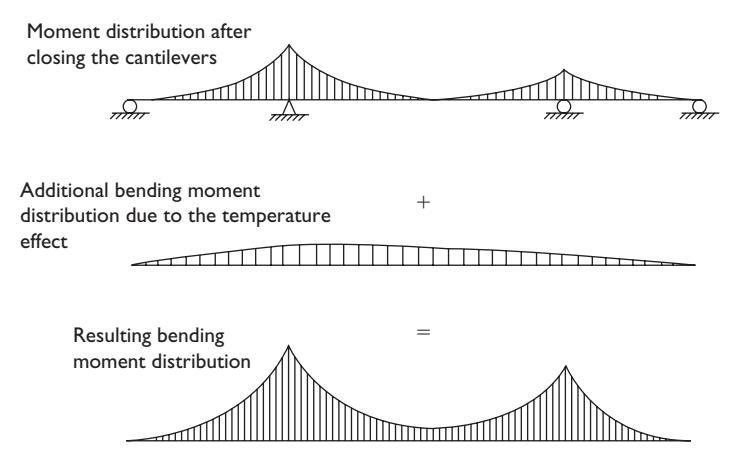
In the late afternoon, when the two cantilever ends had been joined, there was, however, not enough time left to lower the inner supports, instead it was decided to wait until the next working day. Due to the temperature deformations described above, there was a situation in the evening that had given an *increase* in the temporary moment distribution, instead of the desired decrease that would be the case if the supports had been lowered (Fig. 12.8).

Fig. 12.8 The resulting moment distribution due to the temperature effect (before the intended lowering of the inner supports).

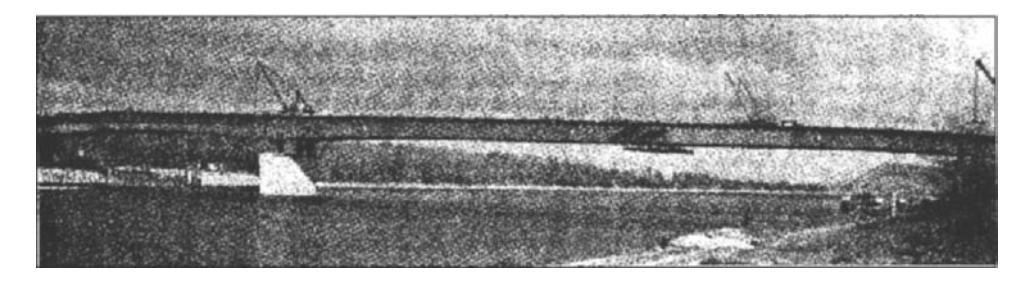
In the photo of the bridge below, the deformed and upwards bent outer span can be seen to the left, as well as the downwards deflected main span (compare this deformation to the mechanism in Fig. 12.14) (Fig. 12.11).

Fig. 12.11 The downwards deflected main span and the upward bent outer span (to the left). (Aurell/Englöv: Olyckor vid montering av stora lådbroar. Väg- och Vattenbyggaren)

Thanks to the inbuilt damage tolerance of the system (read: robustness) the bridge could be saved, even though it was heavily distorted, and was later taken into use again (after replacing the damaged parts). The rebuilt bridge, which today goes under the name of the Prater Bridge, obtained a permanent settlement of about 700 mm in mid-span of the centre span (read: a reduced camber) as a direct consequence of the damages.

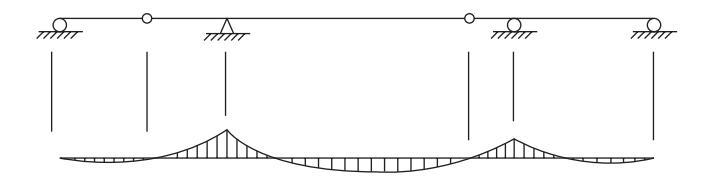
*Fig. 12.13* Bending moment distribution after buckling had occurred (in fact in principle similar to the intended after the planned lowering of the two inner supports).

Through this release of the inner constraint (i.e. the transformation from a statically indeterminate system to a statically determinate), the continuous girder system now received a moment distribution that was the originally intended after lowering of the supports (in principle) (Fig. 12.13).

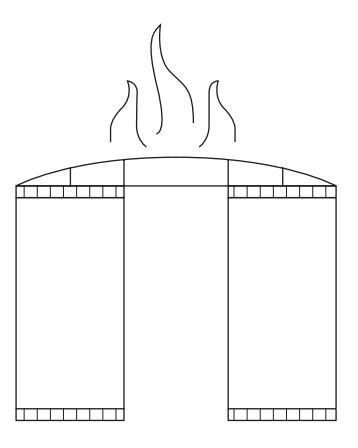
Fig. 13.12 The wooden roof, which protected the two tubes, was put on fire.

modern box-girder bridges were built, mainly in post-war Germany. The Britannia Bridge carried heavy and modern traffic loading without having to be strengthened, and continued to do so until 1970 (after 120 years of faithful service), when the wooden roof – which had been added to the original structure to protect against rain – accidentally was put on fire. On the evening of 23 May 1970, two boys, looking for bats close to the entrance at the south end of the bridge (at the mainland), dropped a burning torch which first ignited the tar-coated roofing felt, and then spread to the timber boards (Fig. 13.12).

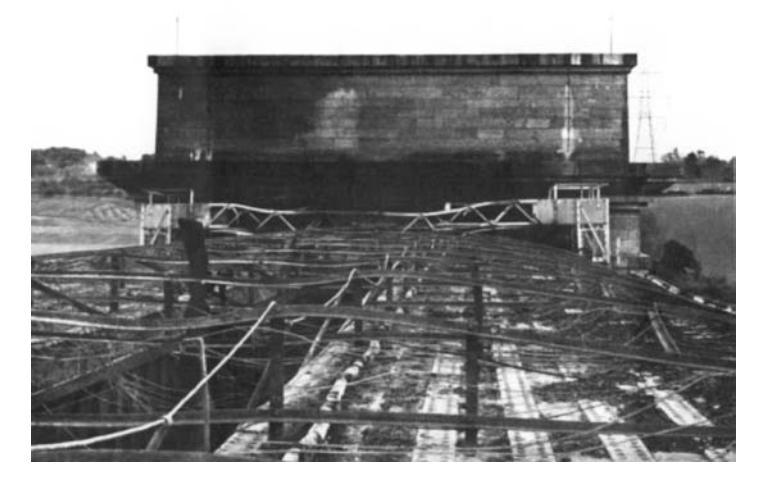
Fig. 13.13 The burnt-down roof of the Britannia Bridge. (www.2d53.co.uk/britanniabridge/ menu.htm)

All through the night the fire brigade tried in vain to extinguish the fire, but eventually they had to withdraw, accepting that the fire spread over the entire length of the bridge towards the Anglesey side (the north end). On the next day all that was remaining of the roof was the steel L-profiles (Fig. 13.13).

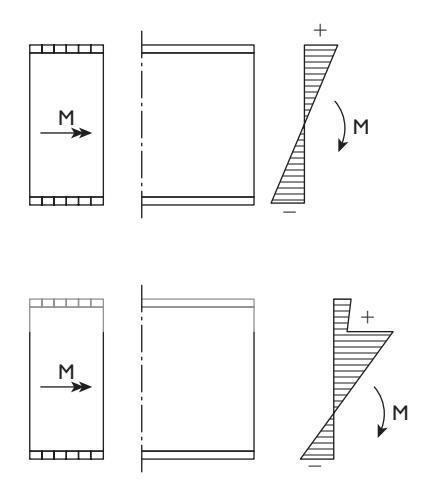
The two end spans had smaller deflections, but the two main spans were deflecting 49 and 71 centimetres respectively. The statically indeterminate system had been transformed into a statically *determinate* system (i.e. becoming four simply supported box girders, instead of the continuous system it originally was). Perhaps it was the decision by Stephenson in 1850 to prestress the tubes that saved the bridge from a total collapse (see Fig. 13.5). Possibly the sagging did not consist only of the spans being simply supported, but most probably irreversible plastic deformations due to the heating of the tubes contributed as well. As the upper part of the tubes (i.e. the top flange) was heated, the wrought iron material softened, resulting in a decrease in stiffness, which reduced the effective cross-section of the tubes as well as lowering the neutral axis. The stresses on the upper tension side (for the negative bending moment regions over the intermediate supports) thus increased markedly (Fig. 13.16).

As a result of this combined effect there is a high probability that the tension stresses exceeded the yield limit of the material, leaving irreversible plastic strain deformations in these parts. If the tension stresses were even higher it could also explain why these regions cracked open, but most certainly the cracking was due to restricted contraction during cooling (almost the same mechanism as why micro-cracks in welds are being formed). When the tubes became hot, and the deflections increased, this resulted in large tensile strains in the upper half of the tubes (over the supports). As the fire died out, and the wrought iron material wanted to contract, it was then restricted by

*Fig. 13.16* As the upper part was heated, and lost its stiffness, the tension stresses for the negative bending moment regions increased – both because of the reduced net-section and also because of the neutral axis being lowered.

The permanent deformations and the apparent risk that the tubes would loose their supports over the piers, made the authorities decide that the Britannia Bridge had to be rebuilt. Many different solutions to save the bridge were considered but, finally, it was decided upon to reconstruct the entire bridge completely, where the two main spans were being rebuilt as a truss arch bridge in steel. The choice of using truss arches was two-folded; first it was an idea that already back in the 1840's had been proposed by Stephenson, but rejected by the Admiralty because of the free sailing width requirements, and secondly it enabled for the rapid use of one of the two parallel tubes (being supported from beneath) for traffic, while the other tube (also that supported) was dismantled. The bridge was finally opened for regular traffic in 1974, and although being completely reshaped (using steel arches to carry a new concrete deck to support the railway track, the walls and roof of the existing bridge taken away) the original towers and abutments were used with only minor adjustments. The two end spans were constructed as steel girder bridges supported by two concrete frames each. To accommodate for highway traffic as well, a second deck (supported by steel frames) was constructed and put on top of the railway deck in 1980. The nearby Menai Strait Suspension Bridge from 1826 had over a long period of time created traffic congestions,

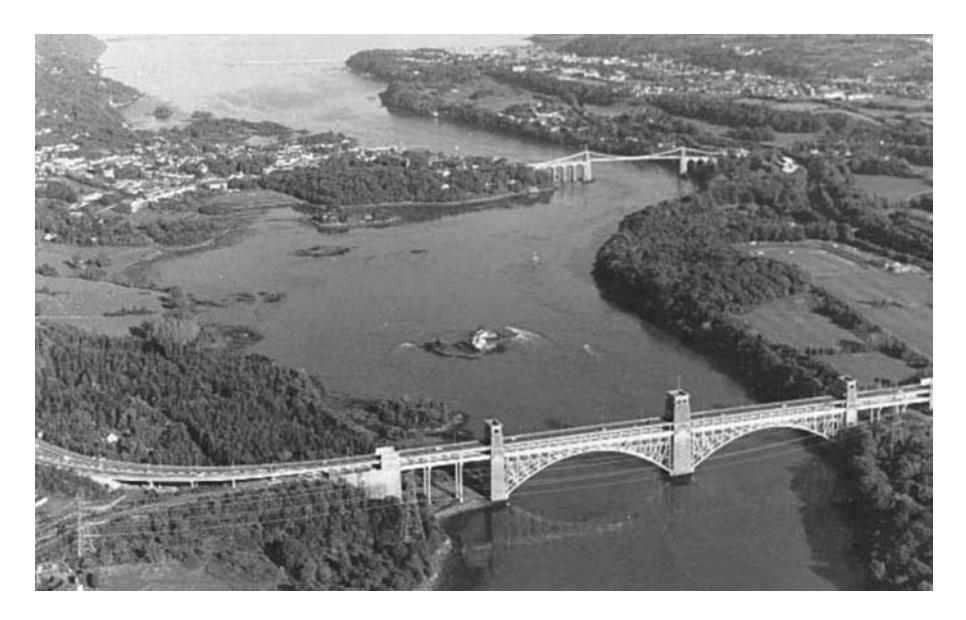
Fig. 13.17 Aerial view of the Britannia Bridge of today. In the background the Menai Strait Suspension Bridge built by Thomas Telford in 1826 can be seen. (http://vivovoco.rsl.ru/VV/E\_LESSON/BRIDGES/ BRIT/BRIT.HTM)

and it was therefore decided to transform the Britannia Bridge into a two-level bridge. So today the Britannia Bridge – in its new shape – is carrying railway traffic on the lower level, as it always have done, and highway traffic on the upper level (what earlier was the roof of the original structure) (Fig. 13.17).

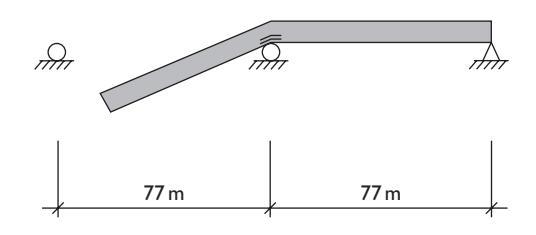
Fig. 14.4 Collapse of the second span on the south end of the bridge.

The designer, Freeman, Fox & Partners, had with great success a couple of years earlier used a trapezoidal cross-section at the construction of the Severn Bridge (a 988 metre long suspension bridge) and at the construction of the Wye Bridge (a 235 metre long cable-stayed bridge), and wanted to continue with this successful concept. The box-girder bridge cross-section of the Cleddau Bridge was – in contrast to the Fourth Danube Bridge – stiffened in the longitudinal direction by the use of more buckling stiff and torsion-rigid stiffeners. The assembly of the second span on the south end of the bridge, was just before the collapse cantilevering out 61 metres, and the final section (closing the gap of 77 metres) was just to be launched out as the bridge buckled over the inner support, and the huge arm fell 30 metres to the ground (killing four people) (Figs. 14.4 and 14.5).

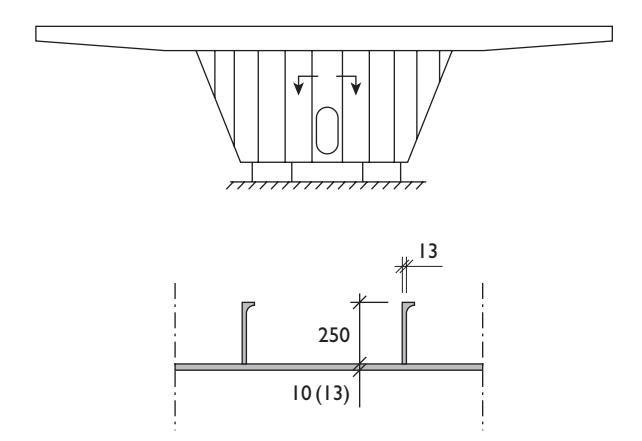
Diaphragms are made up of a solid plate in box-girder bridges (having for a centrally located manhole though, for the passage of inspection personnel), and these are positioned at a regular interval in the longitudinal direction (normally 8–12 m) in order to ensure a sufficient torsional stiffness of the cross-section. The diaphragms are stiffened, especially over the supports, as they are in these positions subjected to large concentrated forces. In the Cleddau Bridge, the diaphragm plate was stiffened with so-called bulb-flat stiffeners, having the dimension  $250 \times 13 \text{ mm}^2$ . The plate itself was 10 mm thick in between the bearings, and 13 mm locally over the bearings and for the inclined outer parts (Fig. 14.6).

Fig. 14.6 The stiffened diaphragm plate of the box-girder over the inner support.

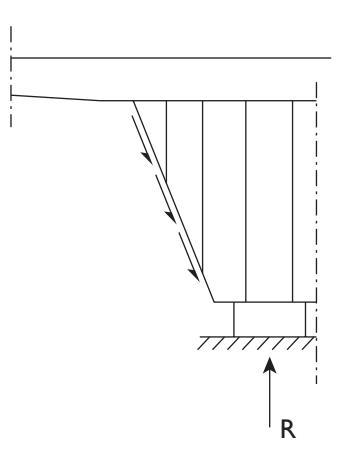
Fig. 14.7 The shear load from the inclined webs is transferred down to the bearings.

The first function mentioned above, means that the diaphragm has to act as a stiffening (transverse) girder – supported by the two bearings – which is loaded at the edges by the inclined shear force (Fig. 14.7).

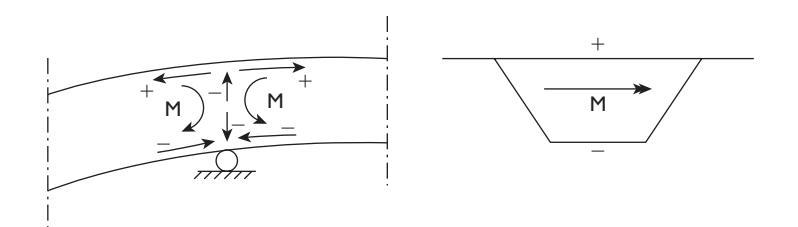
Fig. 14.11 Additional vertical reaction force (in the diaphragm plate) was induced due to the curvature effect.

Besides the two-axial stress state – due to the transfer of the shear force from the inclined webs – there were a number of other factors that even more increased the stresses over the support. There was, for example, the additional compression in the diaphragm plate caused by the curvature (coming from the bending deformations because of the deflection of the cantilever arm) (Fig. 14.11).

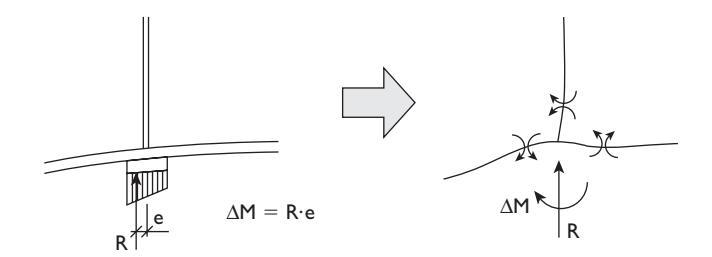
Fig. 14.12 Eccentric loading of the bearing pad induced local bending in the lower flange plate and in the diaphragm plate.

In addition, the 40 mm wide bearing plate also became eccentrically loaded as a local eccentricity was induced because of the curvature. This eccentricity made the lower flange plate (of the box-girder cross-section) and the diaphragm wall to become subjected to a bending rotation (Fig. 14.12).

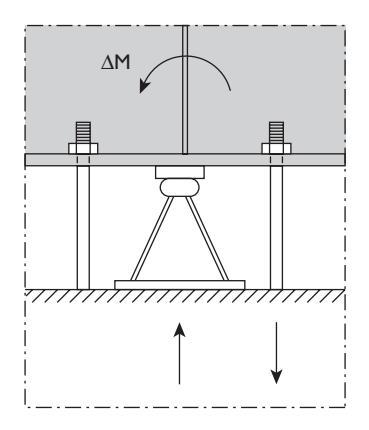
In the investigation it was also found that the "holding-down bolts" – which at a later stage of the erection (cantilevering of the third span) should prevent lifting of the bearings – had been tightened. The effect of this tightening probably made the supports becoming fixed, which additionally increased the vertical reaction force over the supports (Fig. 14.13).

*Fig. 14.13* Tightening the bolts (which were needed in holding down the box-girder bridge first when cantilevering out the *third* span) already at this early stage meant that an additional reaction force was introduced (due to the clamped condition).

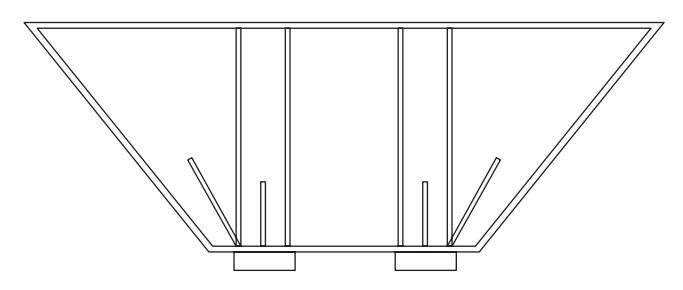
Fig. 14.14 The configuration of a modern box-girder bridge diaphragm plate, having extra stiffeners in the highly stressed regions.

All these effects taken together created excessive loading of the diaphragm locally over the supports, which made the diaphragm plate and its stiffeners buckle, followed by the buckling of the web plates, and ultimately the collapse of the entire cross-section. The design codes at that time was quite clearly inadequate with respect to proper construction of diaphragm plates, and the designers were also not fully aware of the complexity regarding the action of the same. Today the diaphragms are not only having larger thicknesses and stronger stiffeners, they are also locally provided with extra stiffeners where the stress concentrations are the highest (Fig. 14.14).

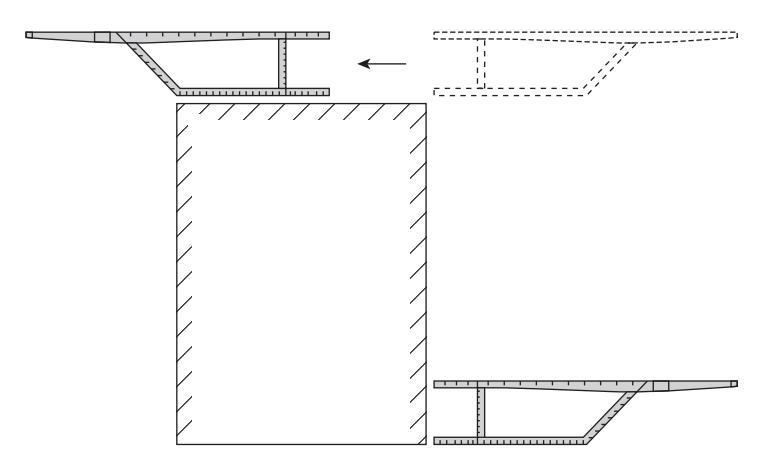
The time pressure made the contractor choose a somewhat unusual erection sequence though. In order to save time and reduce the weight for the lifting process, it was decided to build the girder spans in two separate halves. One half at the time was then to be lifted up by the help of hydraulic jacks, and then launched horizontally on a sliding girder into position (Figs. 15.4 and 15.5).

Fig. 15.4 The lifting procedure of the two separate halves.

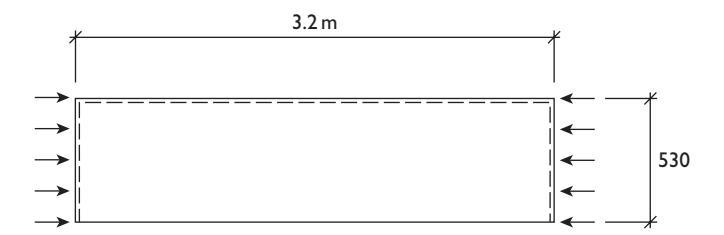
Let us now study the part of the stiffened flange that is closest to the free edge, having the remaining three edges supported by a longitudinal stiffener and two crossbeams (Fig. 15.8).

Fig. 15.8 The free flange plate in between longitudinal and transverse stiffeners.

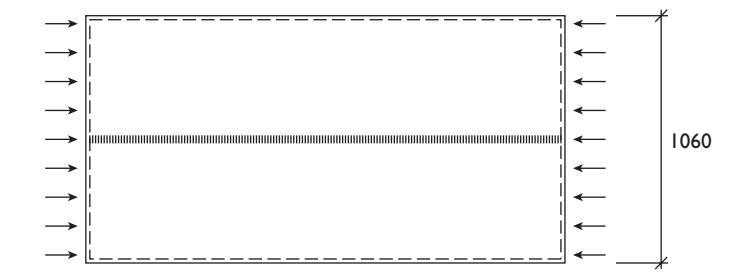
As the free edge will be joined with the opposite flange plate (from the other bridge half), the critical buckling stress will then *increase* (i.e. beneficial), even though the width has been doubled (Fig. 15.9 and Eq. 15.2):

If we compare the critical buckling stresses with each other, we find that the latter – the one with the doubled width – is 2.35 times larger than the former (Eq. 15.3):

The critical buckling stress became more than 50% reduced due to this temporary free edge of the flange, which also became apparent already on the ground. However, as has been mentioned earlier, they waited until the bridge was lifted into position before taking care of the buckles, even though the buckles were up to 380 millimetres in amplitude! The reason behind the large amplitudes was the fact that also the

Fig. 15.9 The width of the flange plate – in between the longitudinal stiffeners – will be doubled as the two bridge halves are joined together, but still the critical buckling stress will increase.

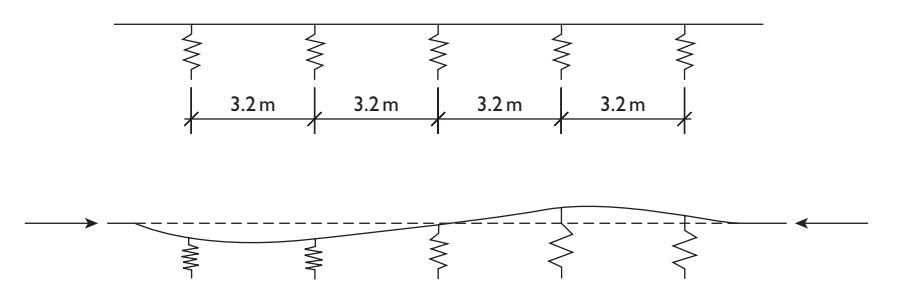
Fig. 15.10 Buckling of the longitudinal stiffener, being supported by flexible transverse crossbeams.

longitudinal stiffener (closest to the free edge) had buckled, due to the flexibility of the transverse cross-beams (which did not act as rigid supports, as they were flexible cantilevers) (Fig. 15.10).

This flexibility of the transverse cross-beams made the longitudinal stiffener have a buckling length longer than the distance between the cross-beams. The deflections of the cross-beams were 50–75 millimetre, and it was this flexibility that contributed to the buckling of the plate edge, and also explains why the deflection of the same became as large as 380 millimetre. In addition, a weak splice of the longitudinal stiffener also contributed to the reduced buckling strength. Each 16 metres the longitudinal stiffeners were spliced by using a simple single-lap joint, having a rectangular plate  $100 \times 12.5 \text{ mm}^2$  overlapping the two bulb-flat stiffener edges. By this choice of configuration a local weakness was inserted – the overlapping plate was not only smaller in dimension (than the bulb flat stiffeners), it was also eccentrically positioned, and last, but not least, not welded to the upper flange plate, which made it less strong in the transverse out-of-plane direction (the same applies for the deck plate). This detail had thus a markedly reduced strength in transferring axial load from one end of a longitudinal stiffener to the other (Fig. 15.11).

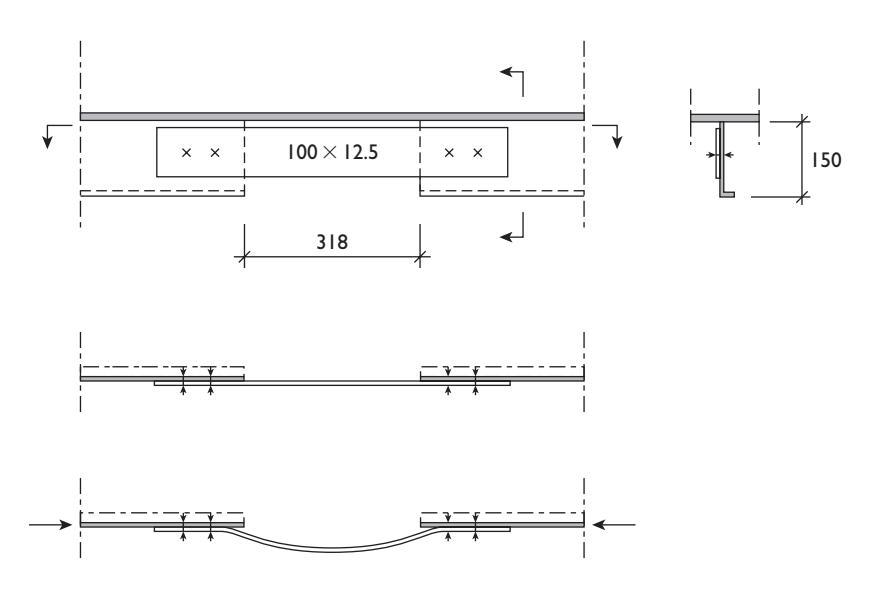
Fig. 15.11 The rather weak detailing of the longitudinal stiffener splices (each 16 metres).

This choice of configuration created a free vertical distance of 25 millimetre between the inserted profile and the flange plate, which unfortunately did show to be the direct reason why buckling was initiated. Almost the same type of splice had been used at the West Gate Bridge (see Fig. 15.11), however, not being the "triggering factor" for the collapse (as it did show to be here).

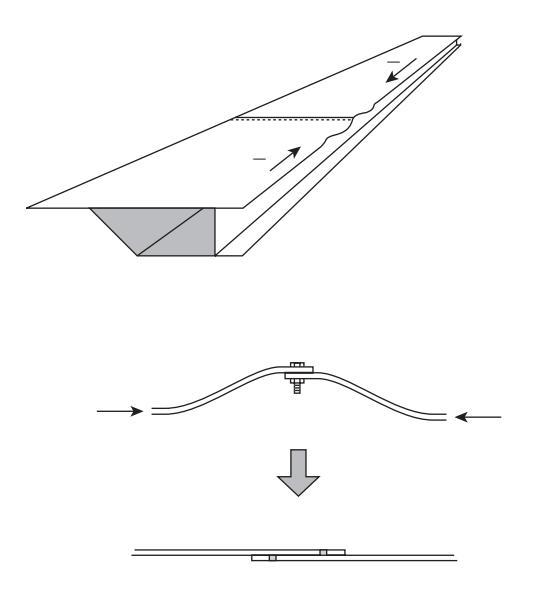
Fig. 15.12 By removing the bolts in transverse splices (of the deck plate) the buckles were removed when the plates slipped under each other.

order to "relieve" the inbuilt stresses, which were the cause of the buckling – the plates would then slip under each other, and by doing so straighten out the buckled plate. This was a step that worked quite satisfactorily for the east span (Fig. 15.12).

New holes had to be drilled – or the enlargement or re-drilling of already existing – in order for the bolts to be inserted again (note that the size of the buckle and consequently the slip between the plates is heavily exaggerated in the drawing above).

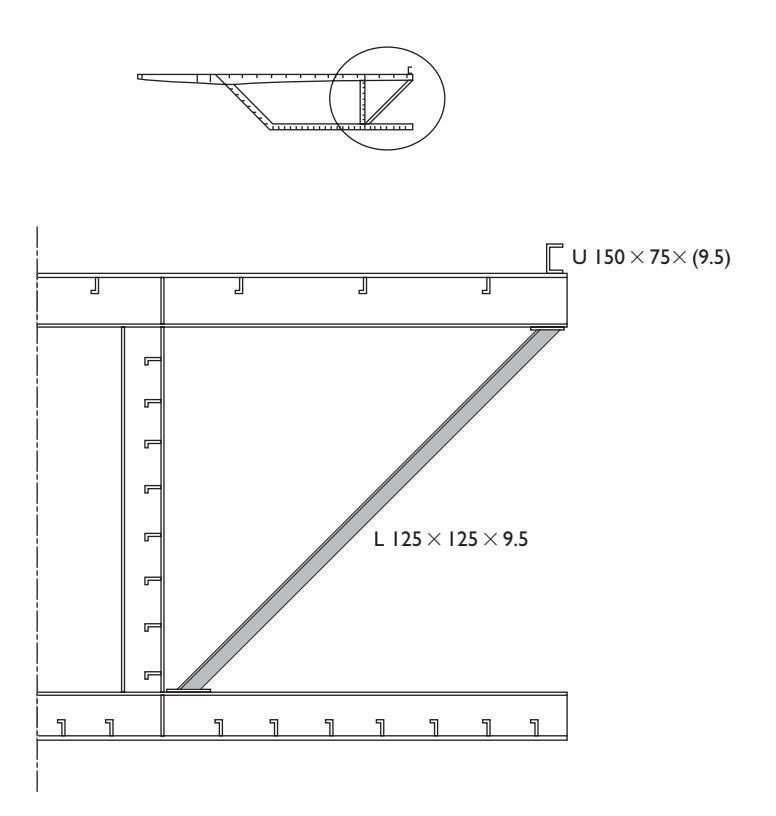
Fig. 15.13 The upper flange edges of the bridge halves on the west side were stiffened by an extra longitudinal, and the transverse cross-beams were supported by an additional diagonal.

For the continued assembly of the bridge halves on the *west* side, the free flange edges were stiffened with an extra longitudinal, and each cross-beam was supported by a diagonal – all due to the lessons made from the buckling of the east girder span (Fig. 15.13).

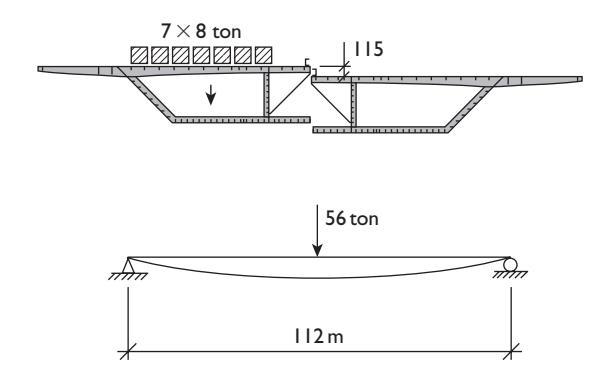
At the assembly of the west girder halves in the air, this extra reinforcement proved to be efficient, and there was initially no problem with buckling of the upper flange. Instead another problem arose when the two halves were to be joined together – due to tolerances that were exceeded, and a difference in deflection, there was a vertical gap of 115 millimetres in mid-span between the two halves. There had been a similar problem also for the east span, however, due to a smaller distance the discrepancy was evened out by the help of jacks. A distance of 115 millimetres was too much for jacks to even out, so they had to come up with another idea this time. Unfortunately then somebody suggested that heavy concrete blocks were to be placed in mid-span on the girder half to be deflecting down (Fig. 15.14).

The extra strengthening of the free edge – that showed to be sufficient for loading coming from self-weight alone – showed to be *insufficient* for the additional loading coming from this temporary loading of the concrete blocks (the bending moment in

Fig. 15.14 An extra loading of 56 tons was put on one of the girder halves to even out the difference in deflection.

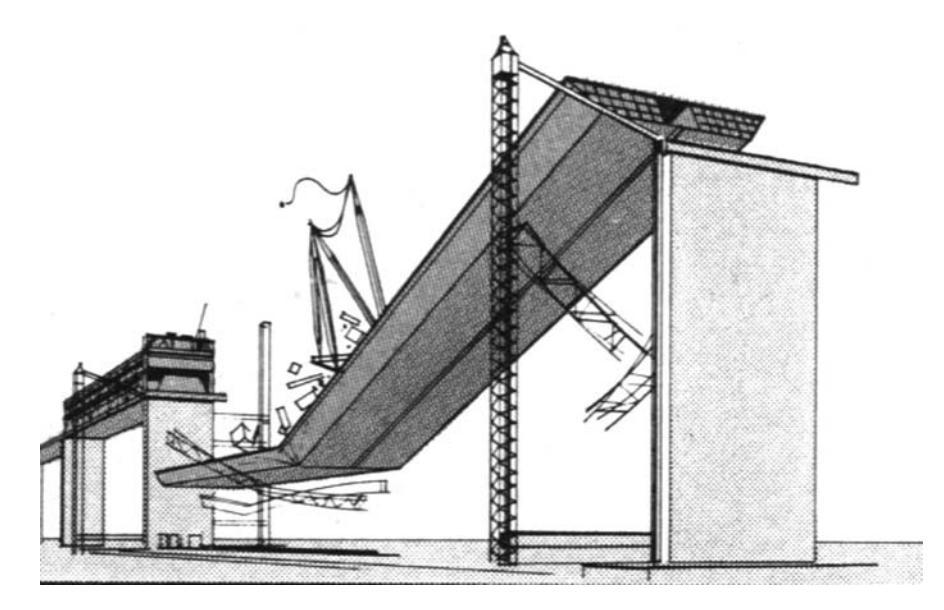
Fig. 15.17 A vivid drawing of the actual collapse. See also the back cover illustration. (Paul: När den stora bron rasade. Det Bästa 1972)

as the case was for the Cleddau Bridge in Milford Haven – where the buckling of the diaphragm produced a hinge that transformed the statically determinate system into a mechanism – this "man-made" hinge made the simply supported girder span of the West Gate Bridge collapse to the ground (the clearly visible hinge – as folding of the upper flange – can also be seen in the photo in Fig. 15.18) (Figs. 15.16, 15.17 and 15.18).

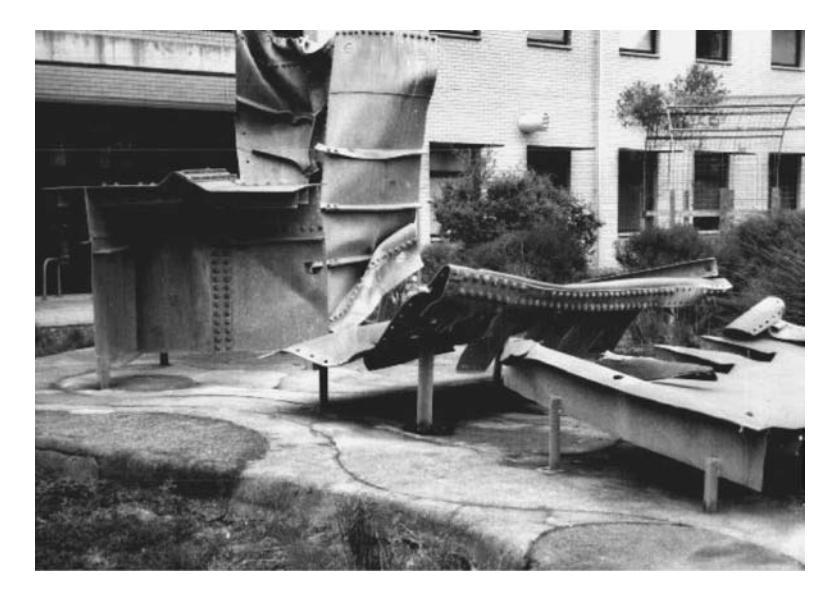
Fig. 15.20 Some removed and saved parts from the collapsed West Gate Bridge at Monash University in Melbourne, Australia. (With kind permission of Bo Edlund)

If you ever visit The Monash University, Department of Civil Engineering, in Melbourne, then take the opportunity to study some of the remaining parts from The West Gate Bridge. Some "scrap pieces" have been saved there, outside the building, as a reminder of the importance of remembering bridge failures, and to learn from the mistakes made. On the left in the photo one can, for example, see the buckled deck plate at the longitudinal stiffener splice (Fig. 15.20).

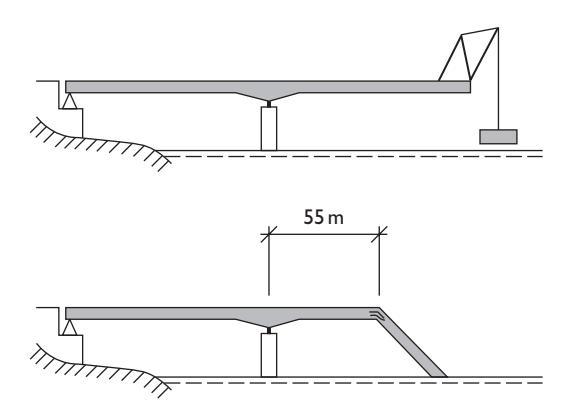
Fig. 16.4 During erection of the main span – using the free cantilevering technique – the cantilever arm buckled approximately half-way out and fell into the River Rhine.

In order to minimize the obstruction to boat traffic, it was chosen to cantilever out the centre span from both directions (just as for the Danube Bridge). The cantilever arm was about 100 metres long, and it was only the erection of the final section remaining (an 18 metre high lift of a 16 metre long and 85 ton bridge element from the water level), as the cantilever arm collapsed approximately halfway out (Figs. 16.4 and 16.5).

The negative bending moment in the cantilever arm, because of the loading coming from from the self-weight of the girder, the weight of the crane, and the new girder element (plus the additional inertia forces as the cantilever arm must be assumed to have been set in swaying), created too much compression for the lower flange to carry, which buckled and transformed the statically determinate system into a mechanism.

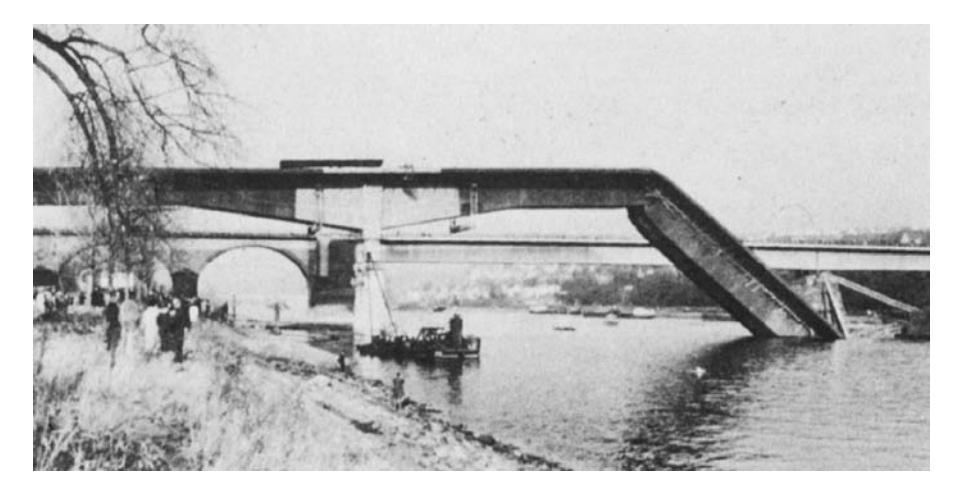
Fig. 16.5 Photo taken just after the collapse (see also Fig. 16.4).

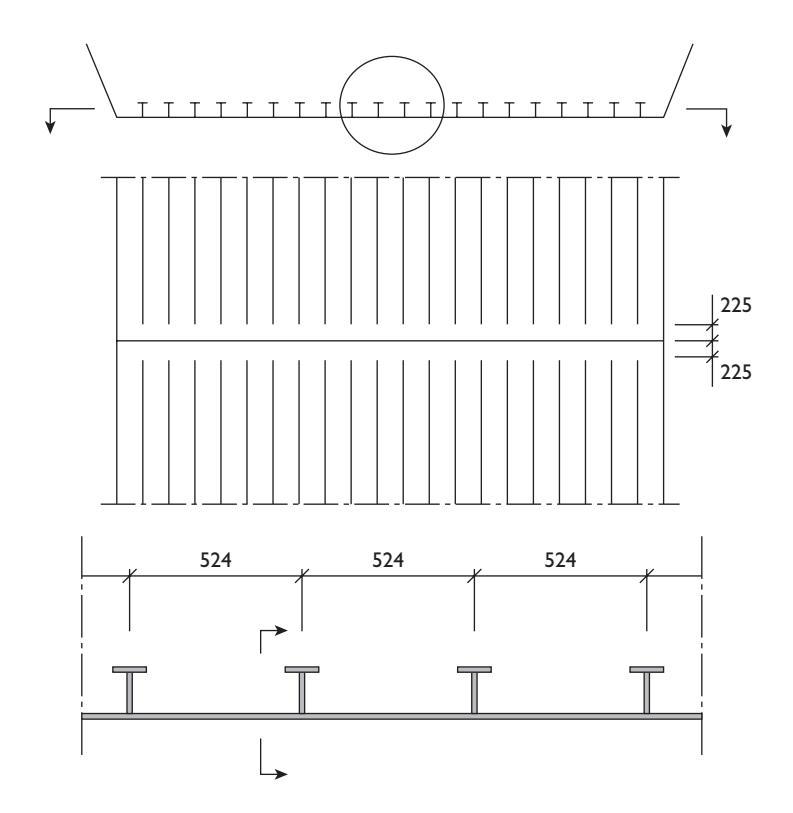
When two girder elements were to be joined together, there was a horizontal gap of 225 millimetres from each edge to allow for automatic welding in the transverse direction of the elements (without having to be interrupted by the many stiffeners) (Fig. 16.6).

Fig. 16.6 The longitudinal stiffener configuration of the box-girder bridge lower flange.

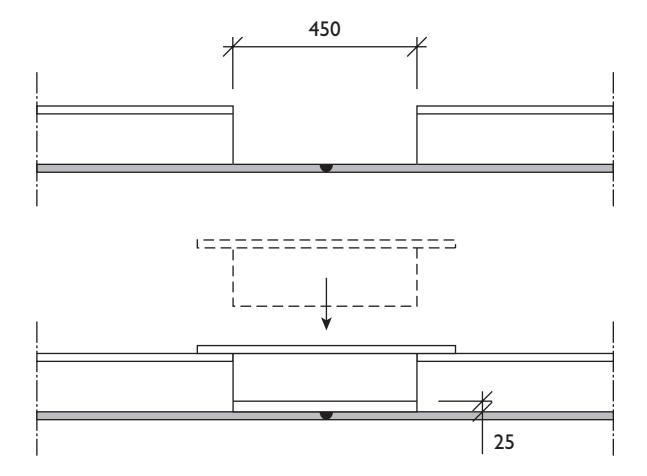
As the longitudinal stiffeners were to be made intact again (i.e. continuous over the joint), the choice was to "hang" a T-profile on to the edges of two adjacent stiffeners, instead of filling the gap with an exact profile. The intention was (and quite rightly so, looking at the problem from one point of view) to avoid crossing welds which is a weakening factor concerning fatigue and brittle fracture strength (Fig. 16.7).

Fig. 16.7 The unfortunate choice of splicing longitudinal stiffeners.

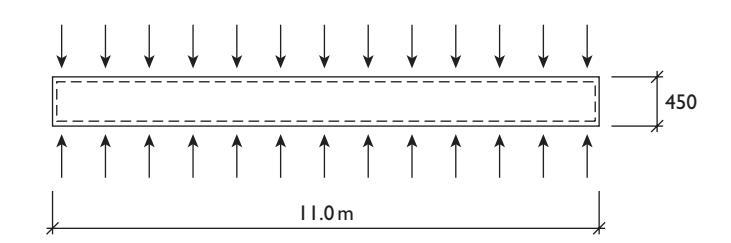
Fig. 16.8 The unstiffened part of the lower flange plate in between the longitudinal stiffener ends.

We will in the following study and analyze the load-carrying capacity of the lower flange plate in this more or less unstiffened zone. We lack information about the thickness of the plate and the yield strength of the steel material, however, as a qualified guess we assume t = 10 mm and  $f_y = 360$  MPa. The flange plate is 11.0 metre wide and 450 millimetre long (in between the stiffener edges), and we assume simple supports along the four edges of the plate (Fig. 16.8).

In relation to the stiffened parts on either side, the capacity has been reduced to only 64% in the spliced zone (4.99/7.78) – a major decrease, that to an almost certainty was not taken into consideration.

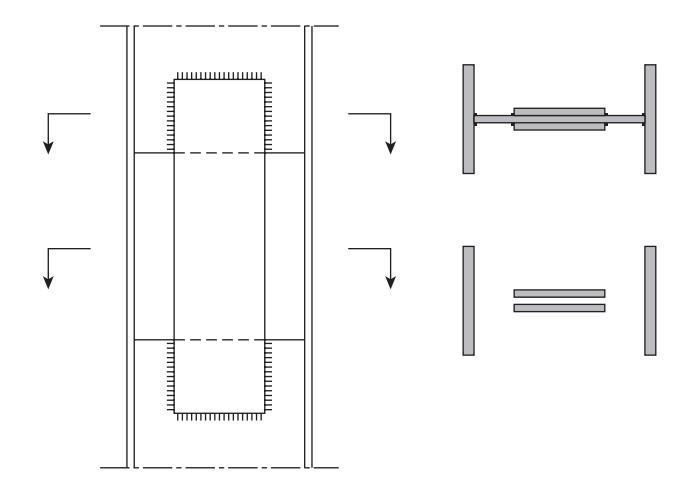
Fig. 16.9 A simplified model that could be used to explain and to understand the behaviour of the weak splicing of the longitudinal stiffeners in the box-girder bridge bottom flange – an axially loaded column having the web spliced with two cover plates over a free gap.

cross-section. As a similitude one can consider a column, that has a very special splice where the web is missing, and that the web has been replaced with two separate cover plates (Fig. 16.9).

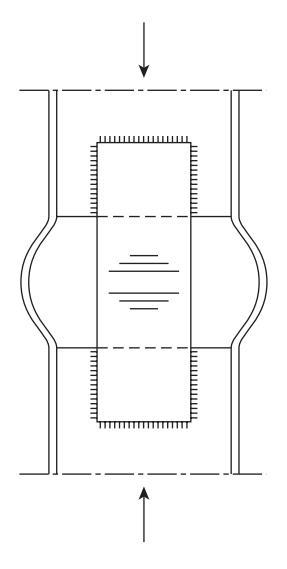
Fig. 16.10 Local buckling of the column having the web spliced.

For such a weak splice it is not difficult to imagine the scenario at the first heavy loading – the flange plate of the column, and the cover plates, will for sure buckle out (as the splice more or less also can be regarded as an initial hinge) (Fig. 16.10).

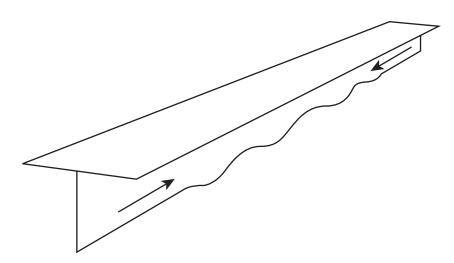
Fig. 16.12 The free and unstiffened lower edge of the inserted T-profile (in the gap) was a weak part with respect to normal stress buckling.

An additional effect, that also most certainly was not considered, was the weakness of the inserted T-profile, which had a an outstanding vertical part that was free and unsupported, and this made it prone for normal stress buckling along its lower edge (just as the case was for the free flange edge of the West Gate Bridge girder halves) (Fig. 16.12).

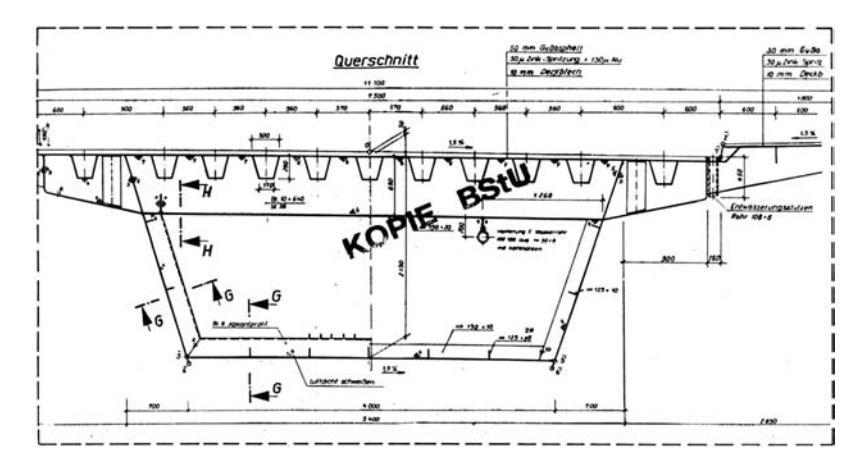
There was no exact and detailed explanation given in the Stahlbau article of the reason for the collapse, but still we will in the following give it a try to analyze the bridge cross-section to see if we can, somehow, prove that the bridge was inadequate in its design. The structural drawing, showing the cross-section of the box-girder, was the following (Fig. 17.6).

Fig. 17.6 Cross-section of the Zeulenroda Bridge, as given in the structural drawings. (Ekardt: Die Stauseebrücke Zeulenroda. Ein Schadensfall und seine Lehren für die Idee der Ingenieurverantwortung. Stahlbau. With kind permission of Karl-Eugen Kurrer)

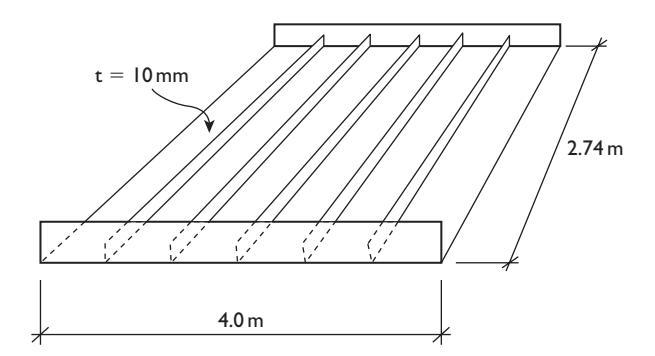
The lower flange, that shall carry a compressive stress of 212.5 MPa, is stiffened in the longitudinal direction by five flat steel bars and in the transverse direction by a stiffener each 2.74 metres (Fig. 17.11).

Fig. 17.11 Transverse and longitudinal stiffeners in the lower flange.

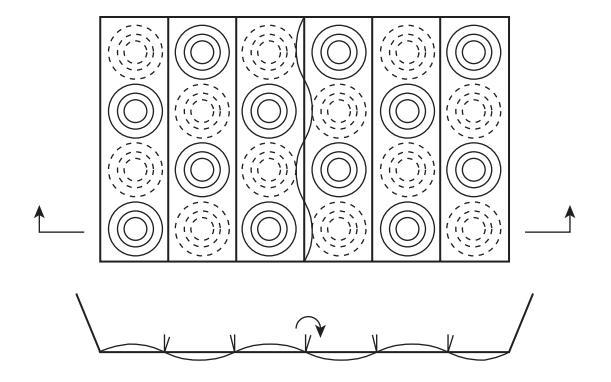
*Fig. 17.14* The sine-wave buckling pattern in the flange plate has the effect on the longitudinal stiffeners that they tend to rotate in a sine-wave pattern as well.

From the results we see that the longitudinal stiffeners also were given too small dimensions, so the bridge was quite clearly doomed to fail during erection. And even if consideration is made regarding a more refined global buckling model – where for example the influence of the stiffening effect from the flange plate in the transverse direction is taken into consideration – there are more reducing effects that have to be considered which *lower* the load-carrying capacity. In order for a longitudinal stiffener to function as a rigid nodal point at buckling of the flange plate, it has not only to be sufficiently stiff in the out-of-plane direction (i.e. in the vertical direction relative the plane flange plate), but also be torsional stiff in order not to deform in the transverse direction due to the plate buckling (Fig. 17.14).

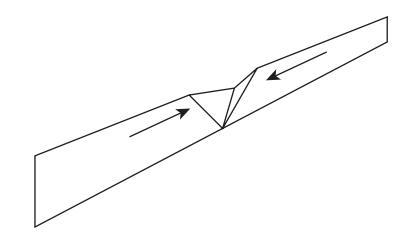
Fig. 17.15 Possible "folding" mechanism of a longitudinal stiffener due to a local damage.

Flat steel bars as stiffeners are "torsional soft", which make them susceptible to welding deformations, and this increases the tendency even more for lateral deformations. In addition, there is also the probability of hits and damages during transport, handling, and assembly. A local damage can make the stiffener lose most of its load-carrying capacity with respect to the global buckling resistance (Fig. 17.15).

Thus, the advice is never to choose flat bars as longitudinal stiffeners (as was done not only in the Zeulenroda Bridge, but also in the Fourth Danube Bridge, see Chapter 12) because of the above-mentioned reasons. Besides a negligible rotational (torsional)

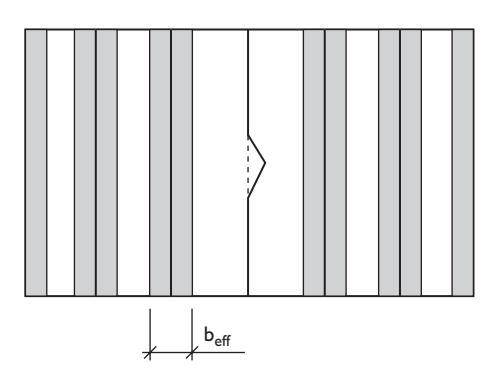
And if one longitudinal stiffener is eliminated, it also means that the total loadcarrying capacity of the flange plate is reduced (as the effective width of the plate decreases) (Fig. 17.16).

Fig. 17.16 The negative effect on the overall ultimate load-carrying capacity of a stiffened plate because of a locally damaged stiffener.

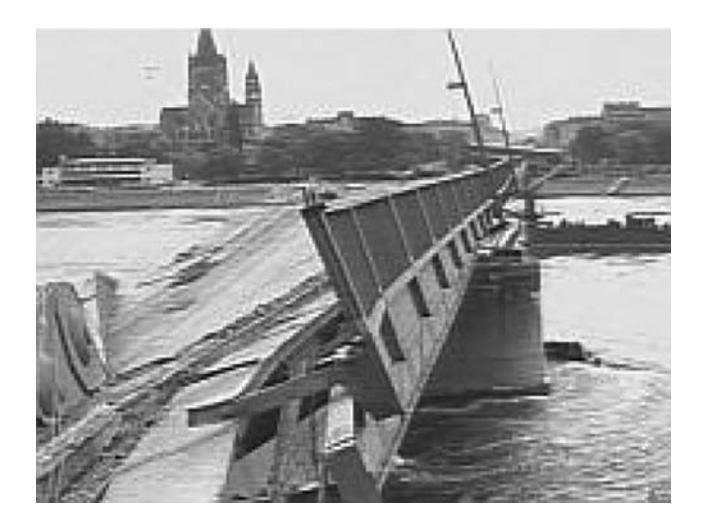
At first the authorities suspected a terrorist sabotage and had the other Danube bridges in Vienna guarded by police – a suspicion which is quite understandable as the collapse had occurred when there was more or less no traffic load on the bridge – but soon it became evident that the collapse had been initiated by the failure of the river pier (Fig. 18.6).

An expert commission was summoned to investigate the reason behind the collapse, and after a few months they presented their results. It was confirmed that the failure was due to the fracturing of the river pier, consisting of unreinforced concrete as it was. The effects of creep and shrinkage were also said to be contributing factors. The failure could not have been predicted the commission said. Knowing the fact though that the bridge piers were *unreinforced* indicates a long-term deterioration because of a gradual change of the inner stress state of the same. We will in the following consider a probable failure sequence.

Fig. 18.6 The end span supported by the collapsed river pier (to the bottom right in Fig. 18.5 above). (www.reichsbruecke.net/geschichte\_e.php)

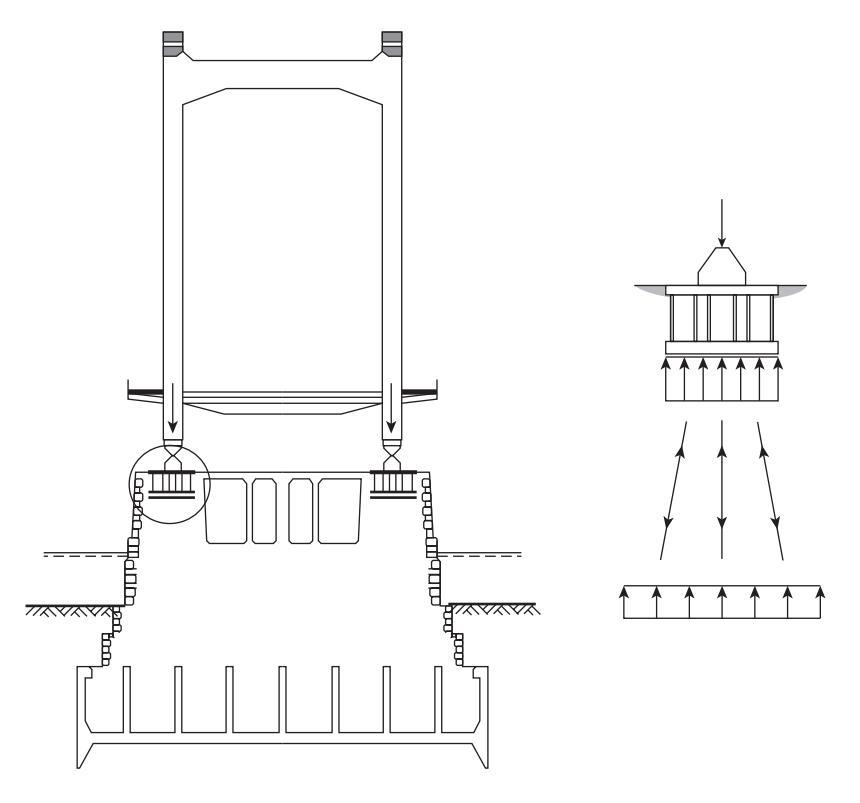
The vertical load from the bridge tower is distributed and dispersed into the pier (Fig. 18.7).

Fig. 18.7 Cross-section and load distribution and dispersion under the tower foot. (Left-hand figure: first published by IABSE in Reiffenstuhl, H.: Collapse of the Viennese Reichsbrücke: Causes and Lessons. IABSE Symposium, Washington 1982)

As the time-dependant phenomenon of creep makes the stiffness of the concrete to decrease over time, more and more load is gradually transferred to the granite stone wall cladding (Fig. 18.7) – which is, in contrast to concrete, not susceptible to creep – thus increasing the inclination of the outer strut (in our strut-and-tie model), and thereby also increasing the need for a balancing horizontal tensile force (Fig. 18.9).

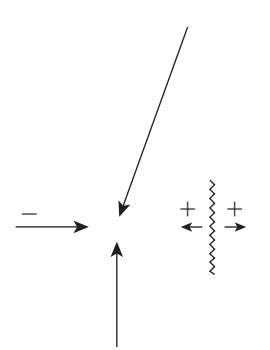
When the tensile strength of the concrete is exceeded a vertical crack, perpendicular to the applied tension, is formed in the interior of the bridge pier – a failure mode which goes by the name of splitting. The inclined strut has now to be balanced by horizontal *compression* exerted by the granite wall (Fig. 18.10).

Fig. 18.10 Vertical cracking (splitting) increases the horizontal pressure on the granite wall.
