# Understanding Bridge Collapses

Björn Åkesson Consulting Engineer, Fagersta, Sweden

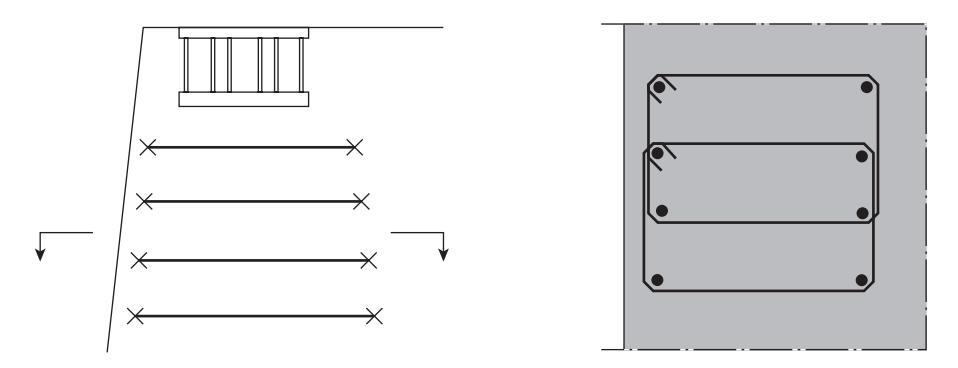
Fig. 18.13 Configuration and position of horizontal stirrups that would have prevented the collapse. (The vertical bars are not shown in the figure to the left)

Back in the 1930's creep and the possibility of splitting failure was not known phenomena, but the designers should anyway have been well aware of the low tensile strength of unreinforced concrete and added some minimum reinforcing bars locally under the tower feet. Some horizontal stirrups would readily have carried the stabilizing force (i.e. acting as a strong tie) (Fig. 18.13).

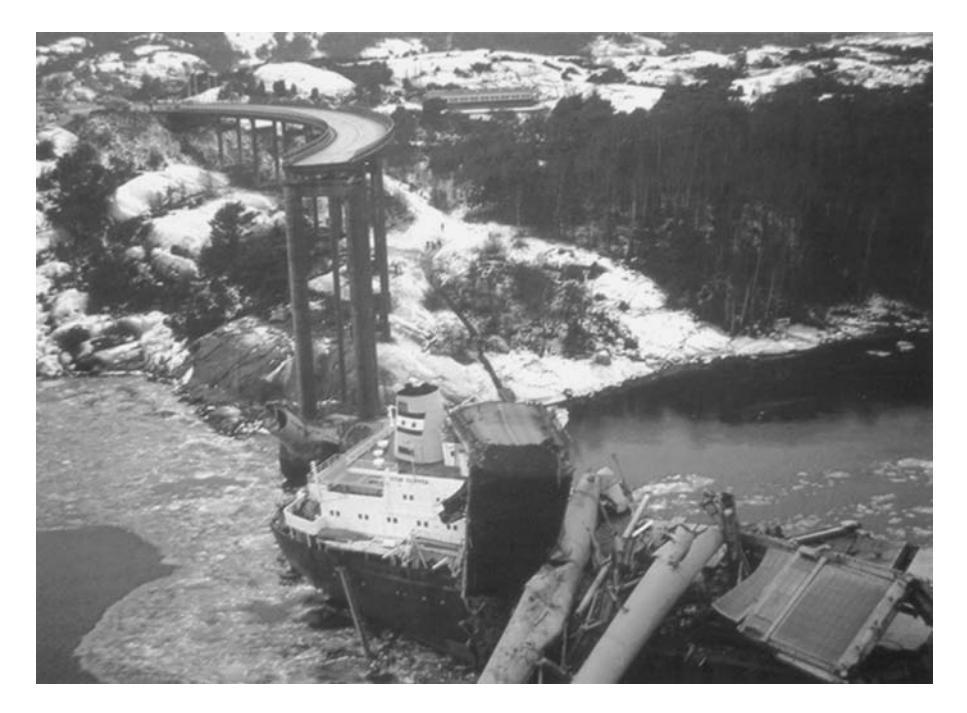
Uddevalla, hit the bridge only some 35 metres from the west abutment (i.e. on the Almö side) (Fig. 19.8).

To the despair of the ship's crew seven cars went over the edge before the traffic was stopped – the personnel tried in vain to warn the motorists by shooting signal rockets. Eight people died, and no one survived the fall into the water.

Fig. 19.8 The collapse of the Almö Bridge. (Tjörnbron. The Swedish National Road Administration. With kind permission of Lennart Lindblad)

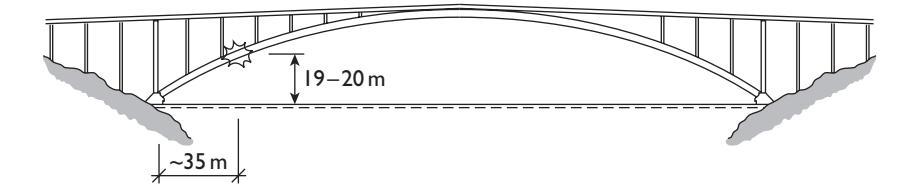
Fig. 19.9 The location where the bridge was hit by the Star Clipper gantry crane.

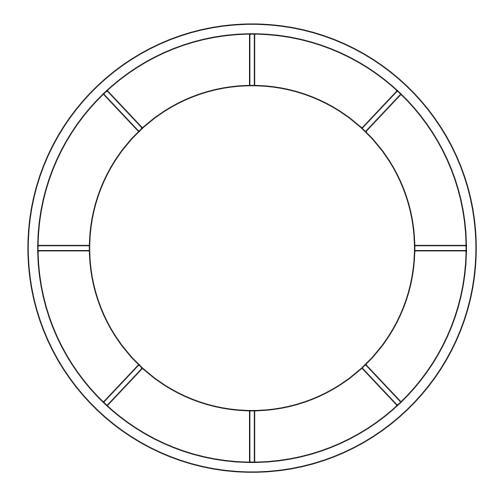
Fig. 19.16 Longitudinal stiffeners in between the ring stiffeners would markedly have increased the stability of the membrane.

Perhaps it is somewhat rude to compare the Almö Bridge arch to a giant beer can, but then again it is inexcusable by the designer to *propose* and for the bridge owner/authorities to *accept* such a "collision-prone" structure, which, in addition, was so sensitive even to very small damages. The unstiffened cross-section (beside the ring stiffeners at the load-application points) was for sure too optimal for its own good. Would longitudinal stiffeners have been applied inside the tube then the load-carrying capacity would not only have increased but, most importantly, also the resistance to horizontal blows as well (Fig. 19.16).

Buckling of the shell in between the longitudinal stiffeners – if such are applied – no longer results in the collapse of the entire cross-section as the damaged zone now is "confined". As a matter of fact, there is also a capacity for post-critical reserve effects to develop as the edge zones close to the longitudinal stiffeners are able to carry load above the critical buckling load. Would the Almö Bridge tubes have been stiffened in the longitudinal direction then perhaps the bridge would have survived the collapse (just as the case would have been for a truss arch bridge, which normally consist of

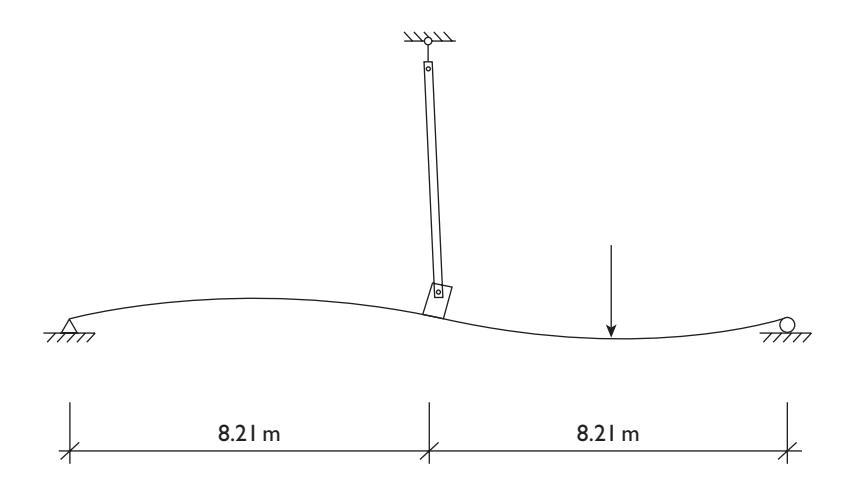
There are two local actions to consider when the hangers are forced to rotate (besides global bending deformation of the arch). First there is the effect coming from unsymmetrical loading taking the flexibility of the *stringers* into account (Fig. 20.8), and secondly, there is the effect from the flexibility of the *hanger* itself (Fig. 20.9).

Fig. 20.8 Rotation of the hanger due to unsymmetrical loading.

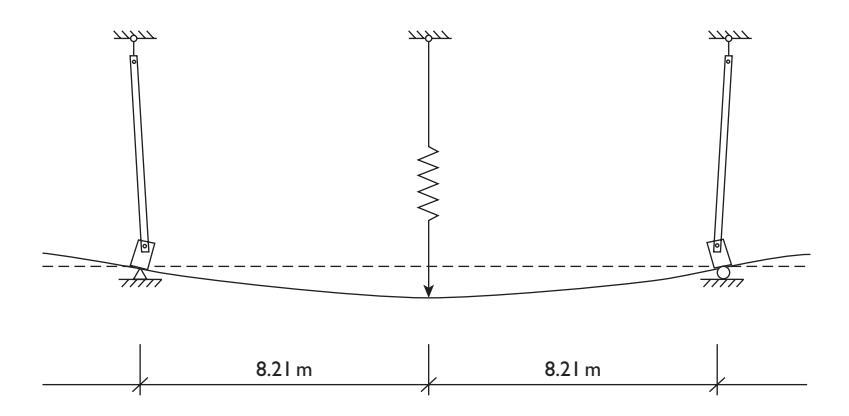
Fig. 20.9 When a floor-beam is subjected to a concentrated load, the difference in deflection makes the adjacent hangers rotate. For the sake of simplicity the adjacent hangers have been kept rigid in the description above, which, of course, they are not.

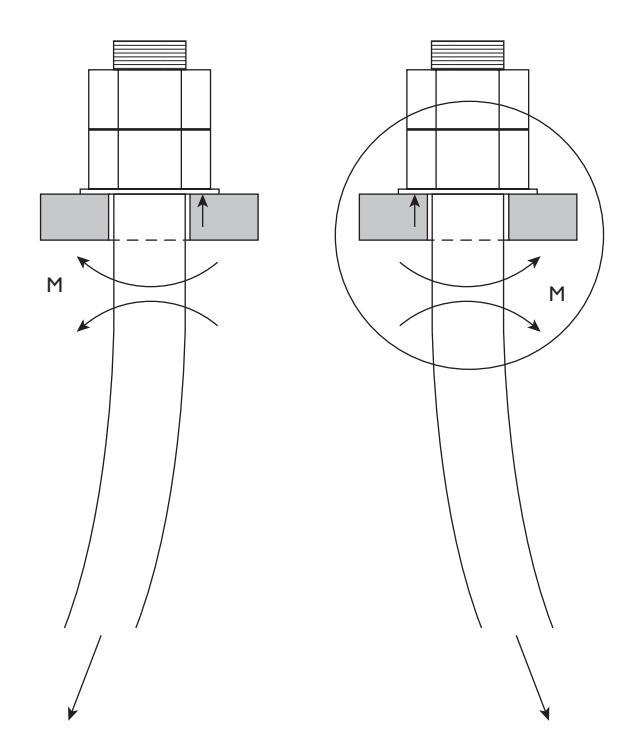
Fig. 20.10 Secondary bending of the hangers due to the inability of the pin joints to rotate.

to the arch, and as the hangers always were "vertical" there could not be any problem, could it? But, the inability of the pin joints to adjust to the rolling load on the bridge deck, led to back-and-forth bending deformations of the hangers (Fig. 20.10).

Would the connection to the arch have been a true hinge then there would not have been any problem, however, as the reaction force became eccentrically applied – the contact pressure of the washer moving from side to side – this connection acted more or less like a fixed end. The stiffness of the hanger itself is very small, but close to the connection to the arch the rigidity increases dramatically (because of the "fixedend condition"). Possibly there was also additional secondary bending produced in the transverse direction because of bending deformations of the floor-beam, but most probably these stresses were negligible in comparison to the longitudinal effect.

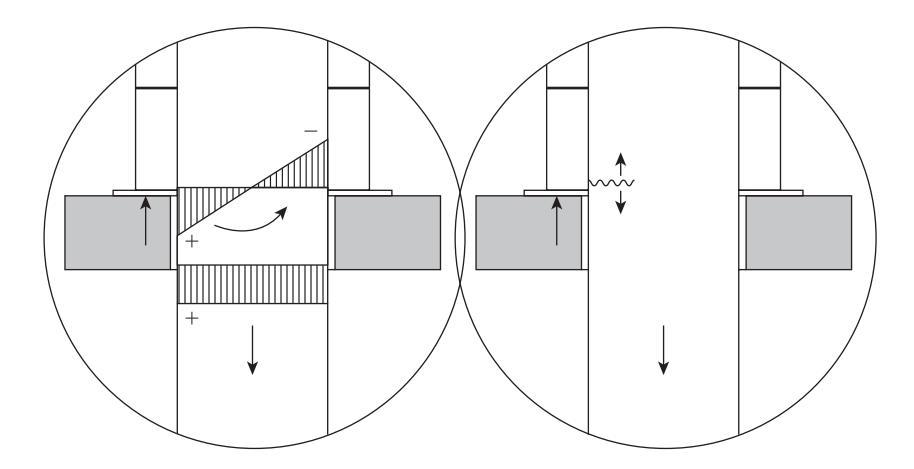
It is true that these secondary bending deformations (in the longitudinal direction) were very small, but over the long run (read: after a sufficient number of loading cycles, perhaps several millions) a fatigue crack was initiated in one of the hangers (Fig. 20.11).

If such a crack is left unattended (and it is impossible in this case to do anything else, as this connection is "enclosed" and hidden inside the arch) then it will propagate until the critical crack length is reached and the net-section will fracture in a brittle manner. And it would not have mattered if the steel would have been more fracture tough (read: ductile, being of a more modern standard) it would still have failed, the process taking just a little longer time.

Fig. 20.11 Secondary bending stresses, in addition to the normal tension stress, will eventually initiate a fatigue crack (see also Fig. 20.10).

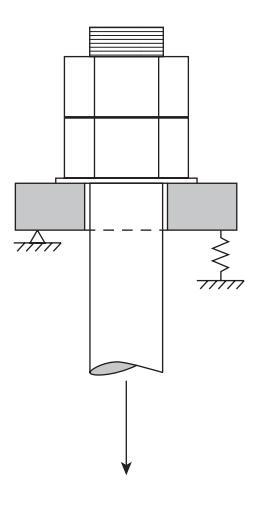
Fig. 20.12 The support conditions – a difference in stiffness due to the single diaphragm plate (see also Fig. 20.7).

It was the hanger closest to the abutment of the northwest corner of the bridge that failed first, being the shortest (i.e. more axial stiff then the rest of the hangers), thus experiencing more dynamic effects than the longer and softer hangers. The rolling load coming from north (or south for that matter) will also produce a more type of "shock loading" to the first hanger than the ones more centrally located in the bridge where the load is more evenly distributed and transferred in a more gradual manner. In addition to these dynamic effects, there was also a small defect present in the threaded part of the rod where the crack had originated from. Most likely the difference in stiffness of the support plate "bearings" also contributed to the initiation of the crack, probably then starting from the stiffer side at the diaphragm plate (Fig. 20.12).

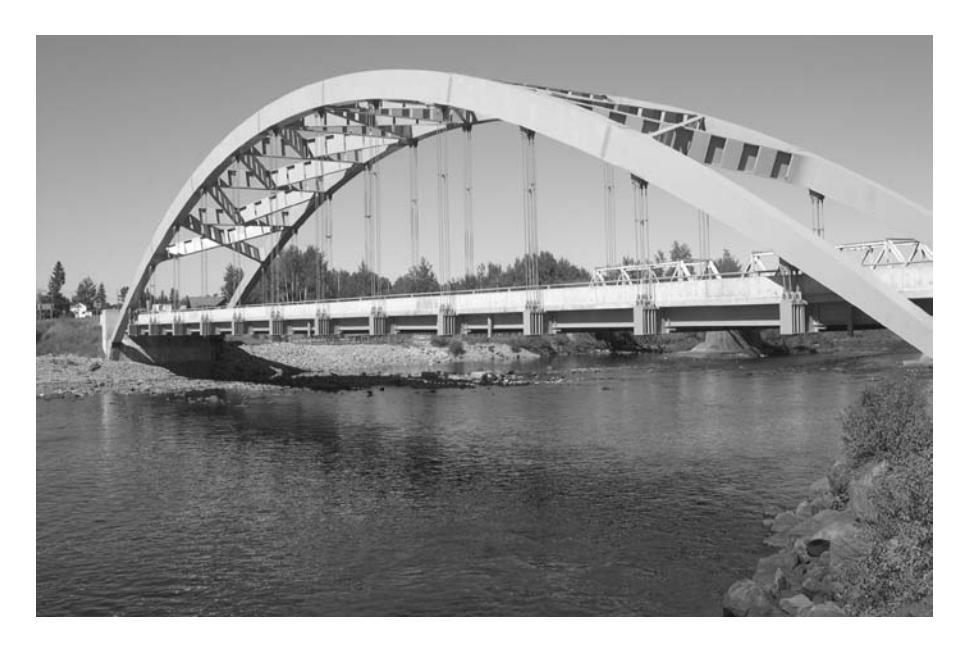
Fig. 20.17 The rehabilitated Aubrey Cosens Bridge at Latchford, September 2007 (with kind permission of Cameron Bevers, photographer and copyright holder).

The Aubrey Cosens Bridge was eventually repaired and again taken into service in 2005, this time using four cable wires in each hanger location instead of a bending stiff rod (Fig. 20.17). The use of several parallel cables (instead of a single thick one) is also a good choice with respect to safety and robustness – the loss of one wire would not mean the entire failure of the hanger as the remaining wires would take over the load.

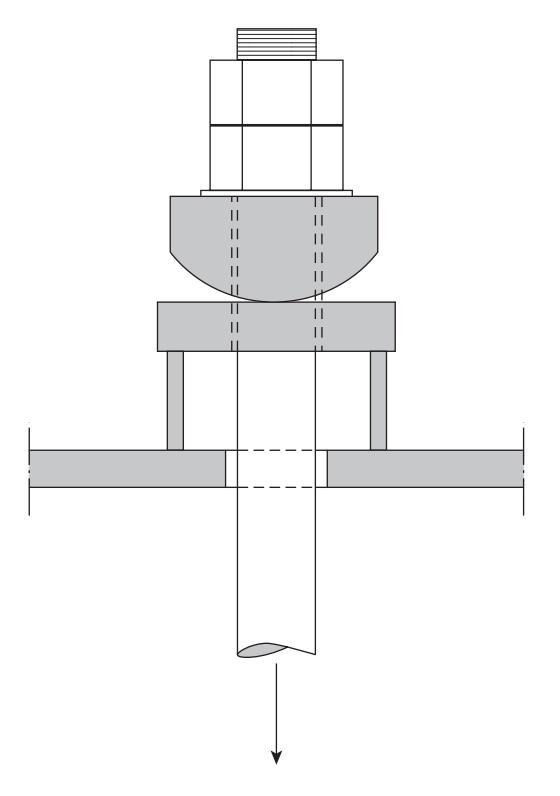
Fig. 20.18 A rocker bearing as an alternative design.

As an alternative to the connection detail at the top to the arch in the *old* bridge – as it was originally designed – the use of a *rocker bearing* (a true one) would most probably have saved not only the Aubrey Cosens Bridge, but also the Kusfors Bridge. However, if the pin joints of the hangers would have been properly inspected and maintained then a rocker bearing solution is superfluous. But as a safeguard to any hidden friction problems, the upper pin joint – of the original design – could be omitted and a rocker bearing at the top be used instead, as a safe life solution (Fig. 20.18).
