# REDESIGN OF A HIGH SPEED COMPRESSOR DRIVE STEAM TURBINE TO OVERCOME CAPACITY, EFFICIENCY, AND RELIABILITY ISSUES

## ABSTRACT

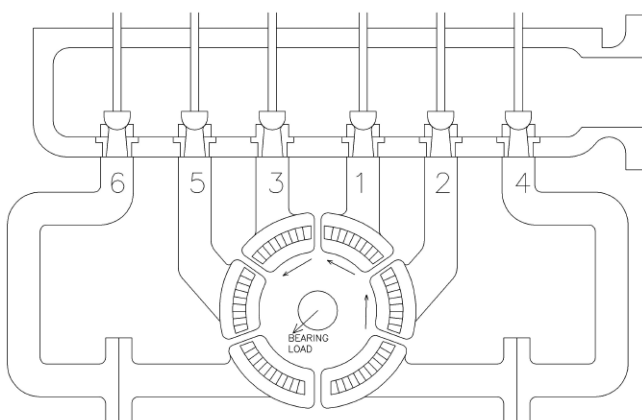
Figure 9. Revised Valve Opening Sequence.

The redesigned turbine was installed and run at part load for an extended period of time. The high pressure journal bearing temperature was very high and continued to climb as steam flow to the turbine was increased. The elevated bearing temperature was determined to be the result of steam forces from the partial arc of nozzles on the first stage pushing the HP end of the rotor into the side of the bearing resulting in elevated reaction and undesirable loading angle on the HP journal bearing. Figure 8 shows the configuration of the first stage nozzle arcs and valve opening

sequence. With the first three valves open, the steam force exerted on the stage one wheel pushes the turbine rotor down and to the left. This steam force coupled with the rotor gravity load results in a very high load on the HP journal bearing, which caused the elevated bearing temperature. A new V1 camshaft assembly was installed with revised opening sequence as shown in Figure 9. With this opening sequence, the maximum bearing load was reduced and the unit was able to increase load without exceeding bearing temperature limits.
