# CORROSION ATLAS

Case History 01.01.01.001

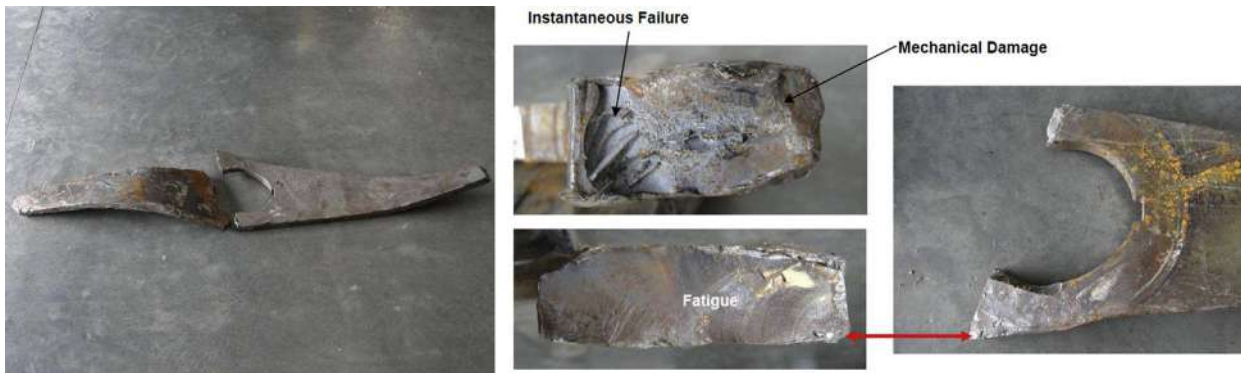
**Part** Pellet

**Phenomenon** Fatigue cracking

**Time in Service** Corrosion occurs in 11 months, but the part was designed to last 5 years.

**Cause** The ingress of a foreign object which had either cracked or introduced a severe stress concentration in the profile cut HAZ. Subsequently fatigue cracking had propagated under normal operating conditions
