# Case History

Experience with API Plan  
53B

Pressurized Dual Seal  
Systems

Roger Jones, Ken Savoie & Zhou DaLi

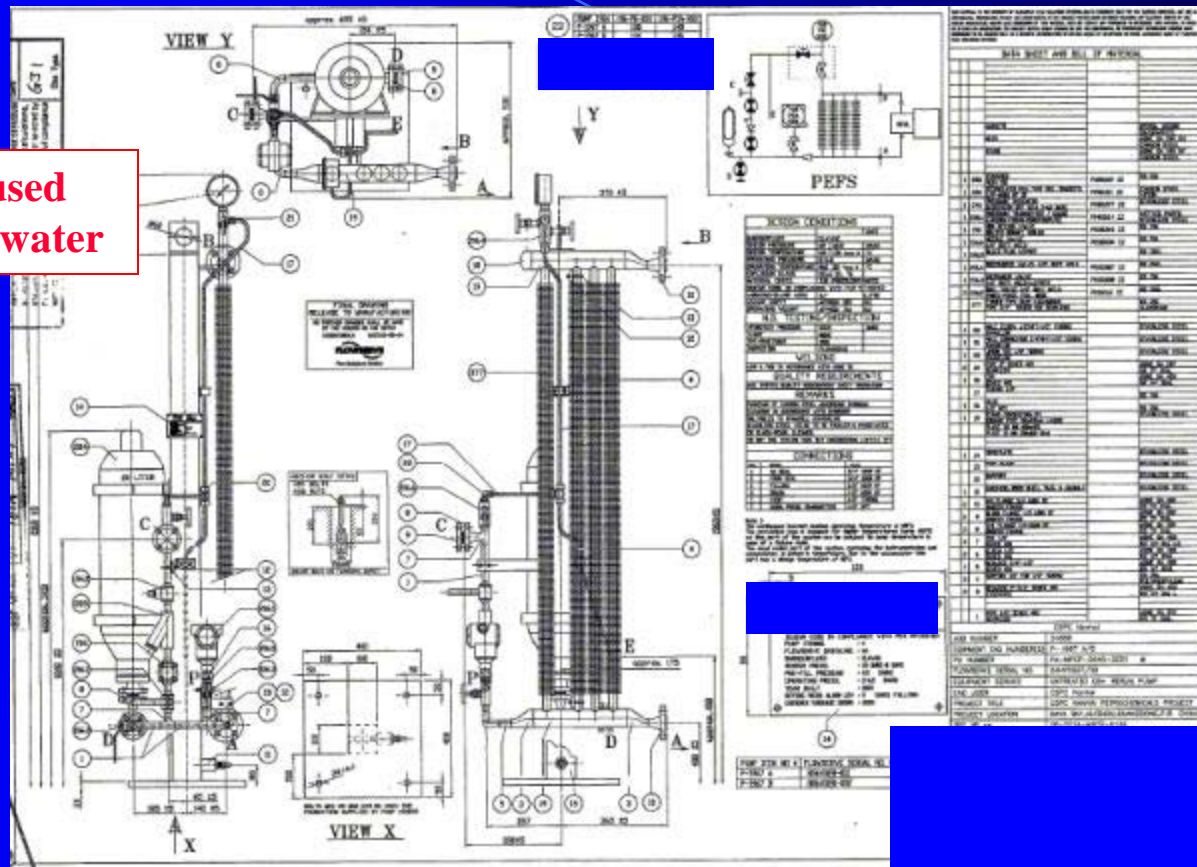
# P&ID and GA for Plan 53B

Project mostly used air coolers; few water

All mechanical seals leak. It is the leakage across the faces that lubricates the seal. The manufacturer can tell you the leakage rate. The bladders were sized for a minimum of a months leakage.
