RELIABILITY IMPROVEMENTS TO A HIGH PRESSURE, HIGH TEMPERATURE, THIRTEEN STAGE CHARGE PUMP

Dave A. Johns

Shell Oil Company

Norco, Louisiana

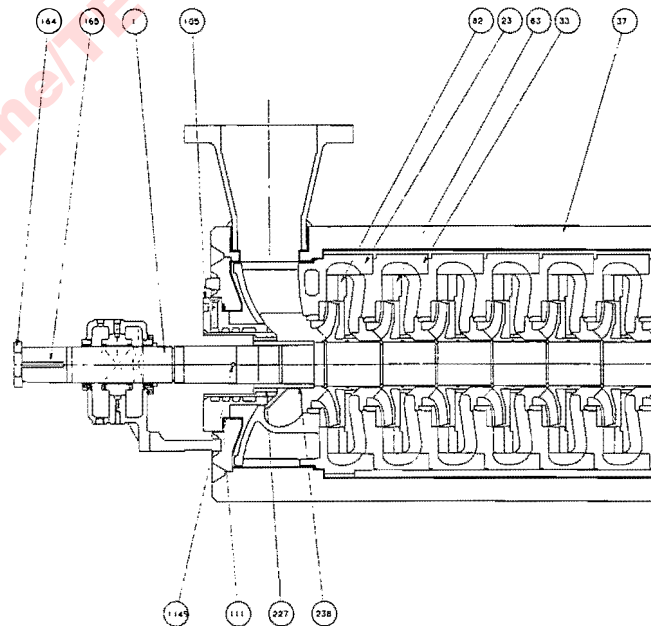
Figure 1. Pump Assembly.

Since installation in 1965, this pump has had a record of poor reliability with several seal failures resulting in fires. Previous

attempts to improve reliability have made some progress, but the pump was never able to run from turnaround to turnaround. The majority of the seal failures were on the coupling end and most of the failures occurred during pump startup.

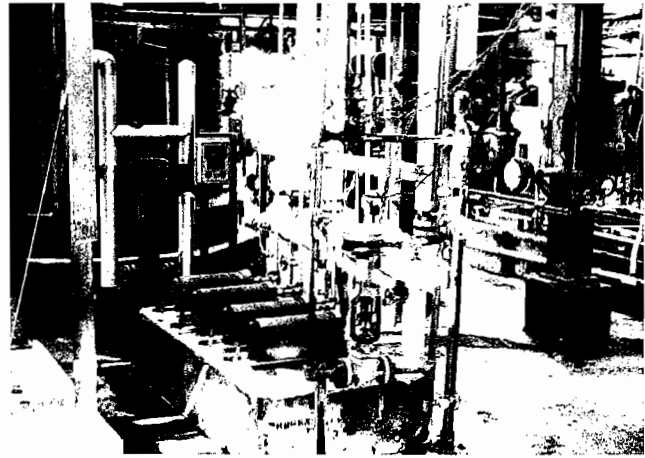
Figure 7. Water Cooled Seal Flush Coolers.

Seal flush piping is per API Plan 21 for normal pump operation. When this flow is not available, flush is provided from an external source per API Plan 32. Cooling is provided by a bank of natural convection fin tube exchangers and four shell and tube water cooled exchanges (Figure 7). Seal flush flow is maintained at 4.0 to 5.0 gpm per seal, via manually controlled needle valves. Desired temperature range is 200 to 250°F. The seals are quenched with low temperature steam.
