ROOT CAUSE ANALYSIS OF FIVE COSTLY CENTRIFUGAL PUMP FAILURES

Heinz P. Bloch

Process Machinery Consulting

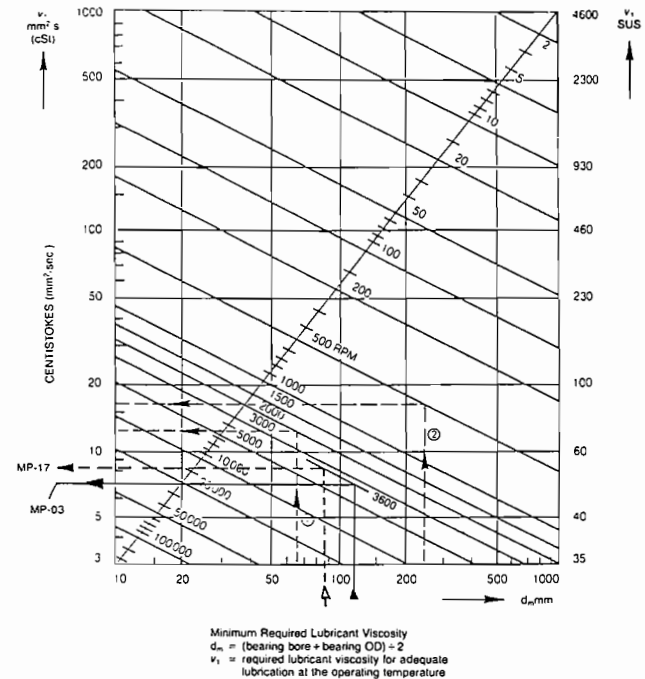
The chart in Figure 7 was used to determine the viscosity required to adequately lubricate the MP-17 bearings. At a mean diameter of 87.5 mm and a speed of 3570 rpm, a minimum lubricant viscosity of 8.3 cSt is required. As shown in Figure 8, maintaining this minimum viscosity is possible only if operating temperatures do not exceed 130°F. Newly installed duplex and double row thrust bearings will, however, experience temperatures well in excess of 130°F. Although a superior grade oil mist lubricant was supplied to these particular pump bearings, the mist lube could not overcome the diluting effect of the inferior low viscosity oil which was present in a "trough" formed by the bearing outer race at the six o'clock position. The existence of this "trough," or minisump explains why oil mist lubricated bearings in horizontally arranged pumps and drivers generally survive for periods of eight or more hours after the oil mist supply has been turned off. Unfortunately, if the minisump is filled with a dilutant, the beneficial effects of applying highly viscous lubricants cannot come into play until the damage is done.

Figure 8. Oil Viscosity Requirements Plotted vs Mean Bearing Diameter and Shaft Speed.

It should be noted that plotting the temperature-viscosity relationship of this penetrating oil on an ASTM chart (Figure 8) could be considered the equivalent of analytical calculations. Calculations are very often superior to conjecture and guesswork when attempting to find the root causes of pump failures.

As to the basic agent of this bearing failure mechanism, it was quite obviously temperature. Pre-lubrication with a much more viscous oil was initiated and there have not been any similar failures since.

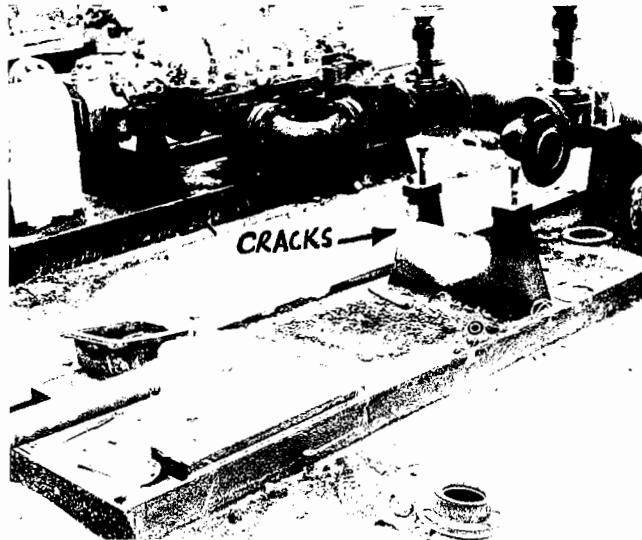
One of the more tragic pump failure incidents occurred at a hydrocarbon processing plant in the U.S. Gulf Coast area in 1982 (Figure 11). It involved the pump shown in the foreground of Figure 12.

Figure 12. Broader View of Pumps in 1982 Hydrocarbon Processing Plant Accident.

When a pump malfunction was detected by control room personnel at this plant, two operators went to the area and realized from the dimensions of a propane vapor cloud that the pump had to be shut down. As they approached the equipment, the vapor ignited causing both men to suffer extreme burns. One of the two operators later died.
