# MATERIALS PROBLEMS AND SOLUTIONS—A METALLURGICAL PERSPECTIVE

**Colin McCaul**

**Senior Consultant Materials Technology  
Ingersoll-Dresser Pump Company  
Phillipsburg, New-Jersey**

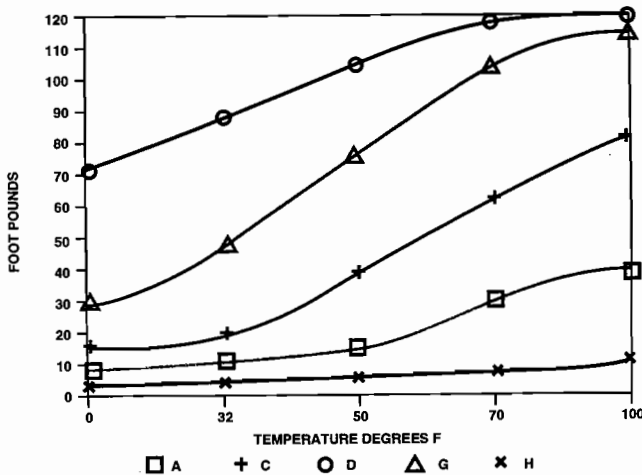
**RAVENSWOOD CHARPY IMPACT TESTS**

The fractured shaft shown in Figure 11 is typical of this class of failures. Failure occurred after only 2.5 months of service in a five stage boiler feed pump operating at 3580 rpm, 230°F, and 1100 psi discharge pressure. In the previous 30 years that the pump had been installed, there were no reported incidents of premature shaft failure. Metallurgical analysis was conducted and it was determined that the failed shaft met requirements of the applicable material specification and had no significant flaws or defects. It was fabricated to drawing requirements and apparently not subject to misuse in service. Failure initiated in the keyway at some superficial scratches that occurred when the key was inserted, Figure 12. Root cause was found to be improper heat treatment that embrittled the material, making it highly susceptible to crack initiation and propagation. This was determined by Charpy impact testing, which showed the material to have absorbed energy of 6 ft lb, lateral expansion of 2 mils, and zero percent shear at 70°F. These results are very low, but within the wide range possible, as shown in Figure 13 for 410 stainless that exhibits tremendous variation in the ductile to brittle transition temperature as a function of slight variation in heat treatment parameters.

employed during outages reveals that shafting may experience severe loading at much lower temperatures. Charpy testing is a good indicator of material embrittled by heat treatment, a condition that is not easily detected in any other way. Type 410 stainless must be tempered at 1100°F minimum to avoid potential embrittlement and susceptibility to cracking.

Figure 13. Energy Absorbed, as a Function of Temperature for 410 Stainless Steel with Minor Variations in Heat Treatments.
