# FAILURES IN CONCRETE STRUCTURES

Case Studies in Reinforced  
*and* Prestressed Concrete

Robin Whittle

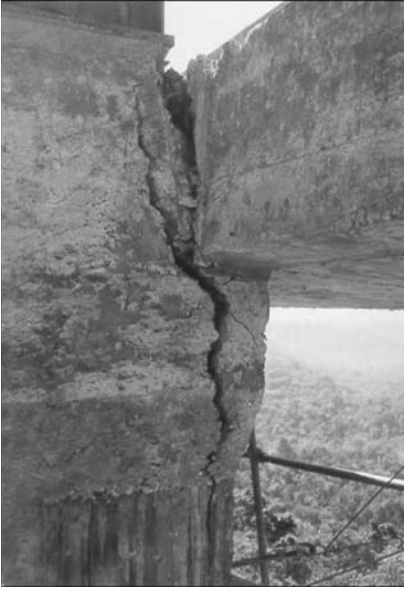
A collapse occurred involving the connection of a heavy concrete gutter (1 m wide) to the supporting columns. The structure consisted of a series of reinforced concrete edge columns supporting steel trusses that spanned the width of the building. Edge beams spanned between the columns to support the concrete gutter. Figure 1.1 shows the collapse of the gutter. Although the edge beam had been designed and detailed to resist the full load from the gutter (bending moment, shear, and torsion), this had not been carried through to the joint. Figure 1.2 shows where the edge beam just started to tear away from the column and Figure 1.3 shows the top of a column where the edge beam has separated and fallen off.

*Figure 1.2* Edge beam starting to separate from column.

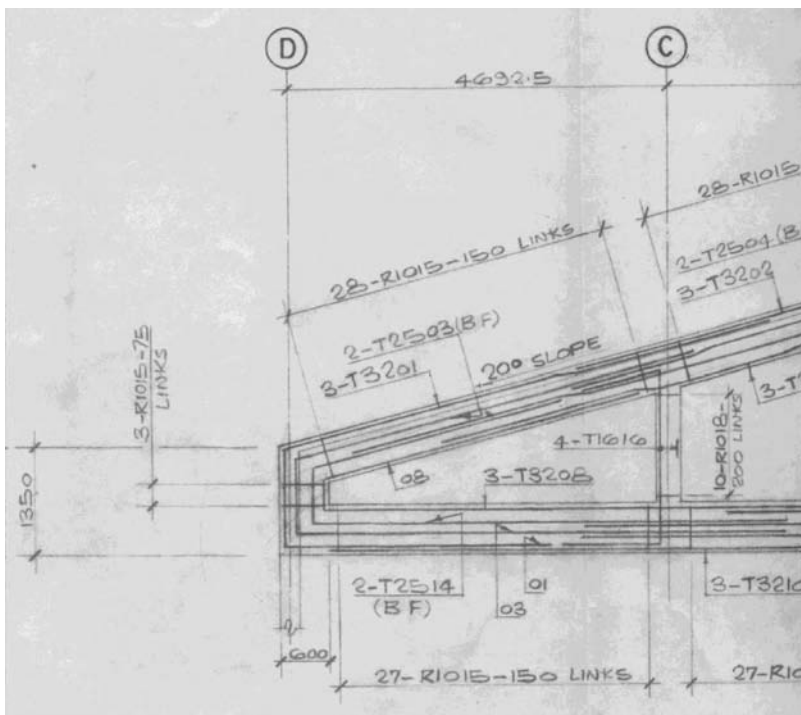
Figure 1.6 Detail of part of truss.

A project team requested a second opinion about the design of the bottom boom of a 19 m span reinforced concrete truss. The project team considered that the tension would cause unsightly cracking. A drawing (see Figure 1.6 showing the detail of part of the truss) and the analysis of the truss were provided. Much attention had been given to this design and special care had been taken to ensure that the stresses in the concrete were low.

It was also apparent that the detailing required some changes. Figure 1.6 shows the main T32 bars, drawn as if they could be bent with sharp corners when in fact the minimum inner radius of bend required ( $3.5 \times$  diameter of bar) is 112 mm. When drawn to scale, it became clear that the concrete would fail in two places as shown in Figure 1.8.

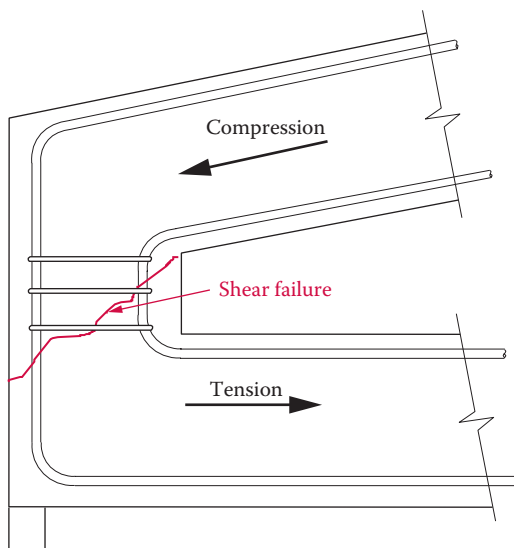
Figure 1.7 Shear in vertical post at end of truss.

The request was to check the design of the bottom boom. This check was carried out and it became apparent that the shear strength of the end vertical post connecting the top and bottom booms (see Figure 1.7) was inadequate. The section dimensions were  $b = 230$  mm and  $d = 460$  mm.

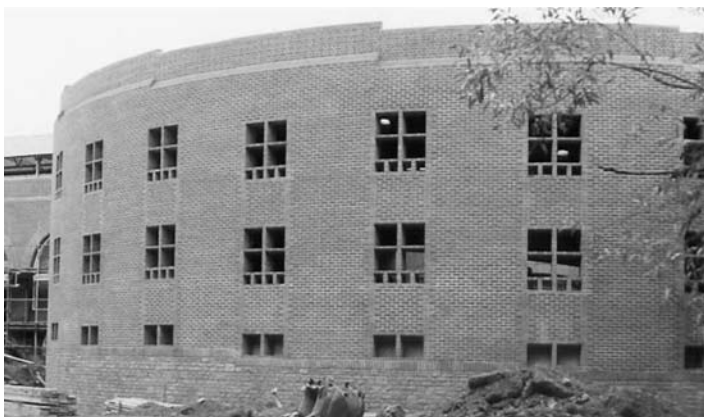
*Figure 1.9* Car park with circular ramps.

The construction of this car park (see Figure 1.9) was nearly complete. The parapet and slab of the circular ramps were supported on two columns diametrically opposite each other. The torsion and cantilever effects of the loads caused wide cracks in the supporting columns. Although these columns were damaged with shear cracks, it was considered that if the cantilever and torsional effects from the ramp could be reduced, then the columns could be repaired without risk that the cracks would return. This was achieved by inserting steel circular columns half way around at every level throughout the height of the structure (see Figure 1.10). In order to ensure that these new columns would take the correct load, flat jacks were introduced at each floor level (see Figure 1.11).

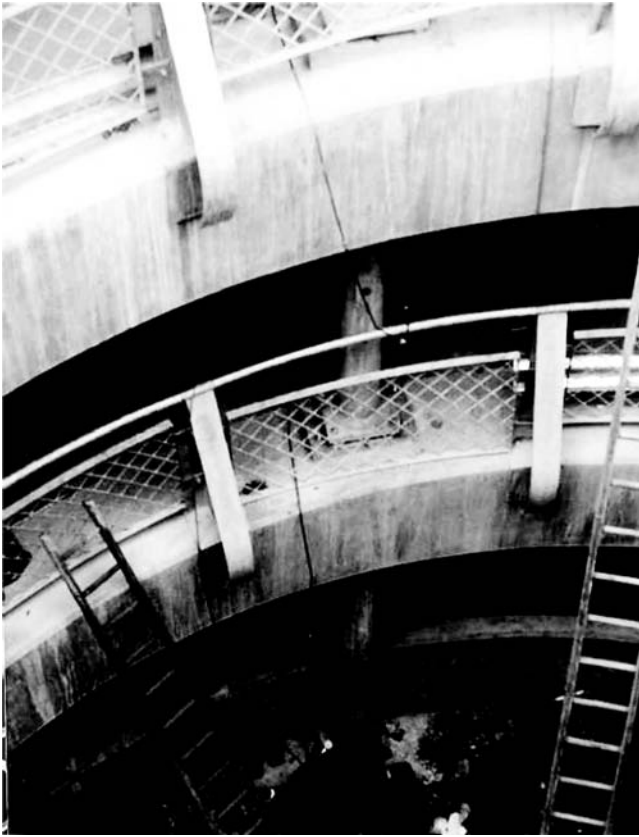
*Figure 1.10* Additional steel columns.

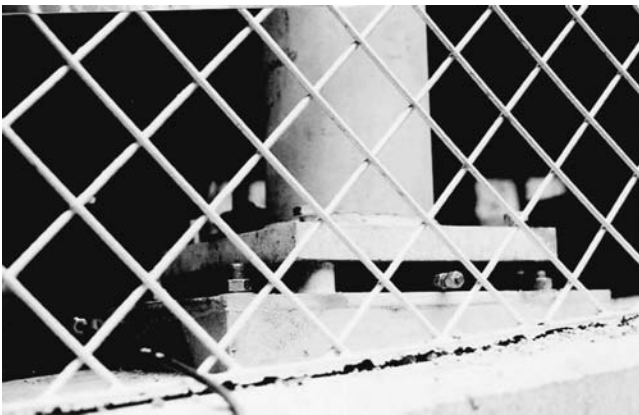
*Figure 1.11* Flat jacks fitted under each new column.

All the flat jacks were connected up to a single pump and pressure gauge. Epoxy resin was pumped into each of the flat jacks at the correct pressure and allowed to harden. This ensured that the correct load had transferred to the new steel columns at each level.

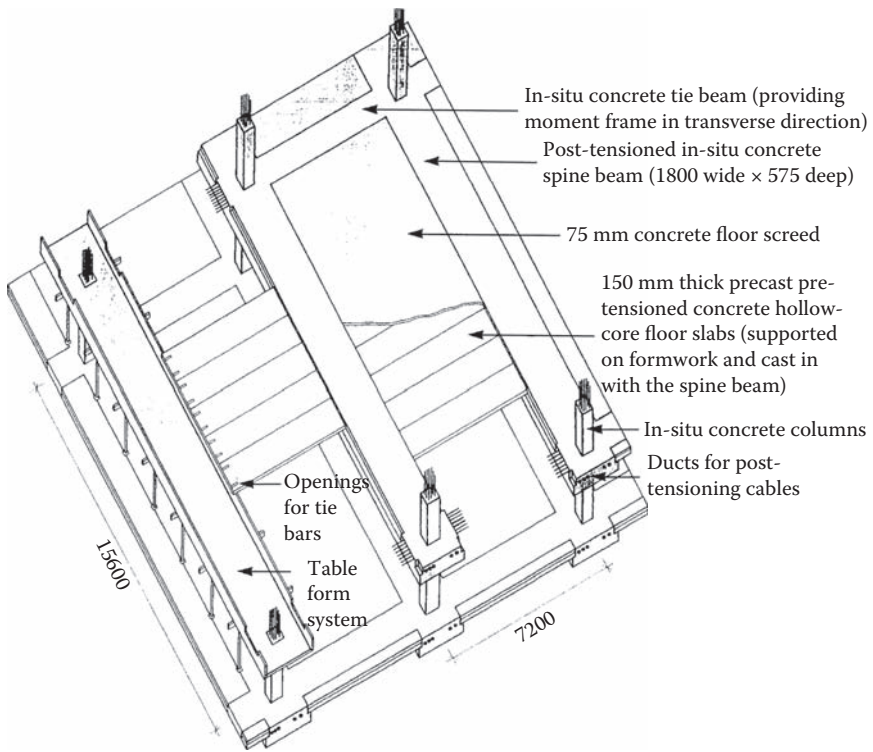
Figure 1.12 Layout of structural members.

The design of a five-storey car park incorporated long post-tensioned beams. These formed part of an unbraced concrete frame supported by 600 m square columns; floor-to-floor height was 2.7 m. The beams included six 15.6 m spans that were cast in one pour. They were stressed at 3 days to the full required prestress. The beams were 575 mm deep and 2000 mm wide, with rebates in the top corners to take 150 mm deep hollow core units. The hollow core units spanned between the beams which were at 7.2 m centres. Figure 1.12 shows the arrangement.

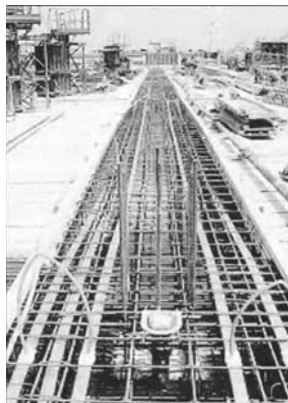
Figure 1.13 Typical beam under construction.

The construction period for the car park was extremely short (8 months) and hence all the prestressing work was carried out under a very tight schedule. Figure 1.13 shows a typical beam under construction.

Unfortunately, 5 to 6 days after the transfer of prestress for the first set of beams, cracks appeared in many parts of the frame. The cracking was

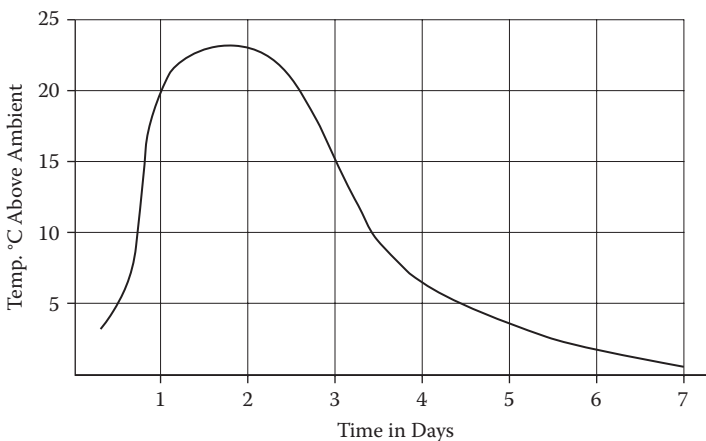
**Figure 1.15** Typical early temperature rise and fall in concrete beam.

peak temperature since the beams tried to expand while heating up. A typical curve for one of the beams, giving the temperature rise and fall over time, is shown in Figure 1.15.

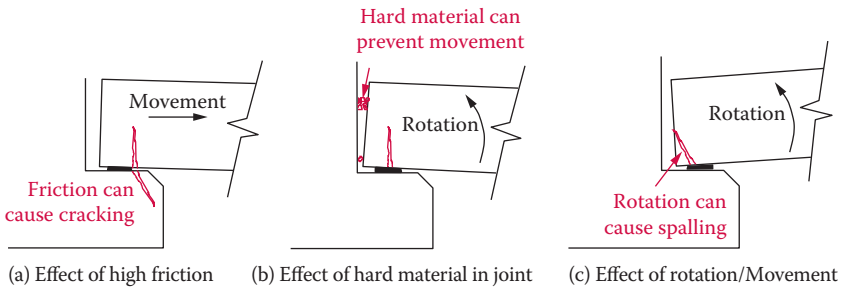
Figure 1.22 Examples of potential failures at movement joints.

more than 5 years. Figure 1.22 describes different mechanisms that can occur even where a structural topping has been used.

In general, if the bearing material creates large friction forces, these can lead to large tension stresses in both the support and the precast slab or beam (see Figure 1.22a). Neoprene bearings or similar should be used to avoid this.

If the space between the precast slab or beam and the face of the supporting member is not adequate for the required movement or it fills with hard material over time, cracking will occur (see Figure 1.22 b). If the effects of movement and/or rotation cause the line of action to move too close to the edge of the support, local spalling can occur (see Figure 1.22c).

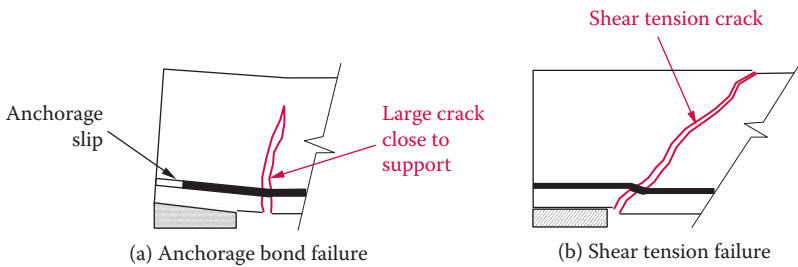
Figure 1.23 Types of end failure of hollow core units.

A further problem arises where hollow core units are used. Any cracking that occurs close to their ends is likely to cause anchorage bond or shear failure of the unit (see Figure 1.23). Anchorage bond failure may occur because the cracking close to the support does not allow the full anchorage resistance to develop and the prestressing strands start to slip. This causes the crack to grow until the unit fails (see Figure 1.23). Hollow core units are inherently vulnerable to the effects of cracking close to the support as their shear resistance relies on the tension strength of the concrete. Unlike a solid section, a cross section available for shear resistance of these elements is much reduced due to the presence of the cores.

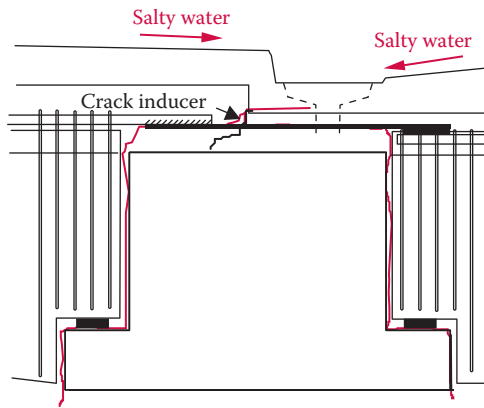
Figure 1.27 Section through completed deck.

The structural screed laid over the whole deck was designed with a step over the welded plate above the spine beam. The final screed, incorporating a waterproof membrane, was laid to falls. The drainage points were situated at the ends of the spine beams. Figure 1.27 shows the final arrangement through a section. The step in the screed created a crack inducer for the tension stresses at the top of the cantilever and water draining off the

car park was likely to permeate it. In winter, this water was likely to be combined with de-icing salts. The risk of corrosion of an important part of the structure was high. By the time this problem was realized, it was considered too late to change the design and form of construction. Instead the depth of the waterproofing membrane was increased.

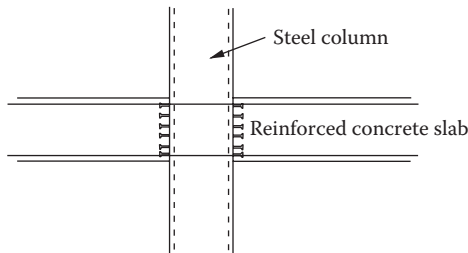
Figure 1.32 Junction between steel column and concrete slab.

The designer's proposal was to use shear studs welded to a steel column to transfer the load from the concrete flat slab to the column (see Figure 1.32). However, with this configuration, a punching shear failure could occur with only the bottom row of studs providing any shear resistance. All the other shear studs would remain in the cone of concrete attached to the column (see Figure 1.33). To avoid such a failure, two options provide sensible solutions:

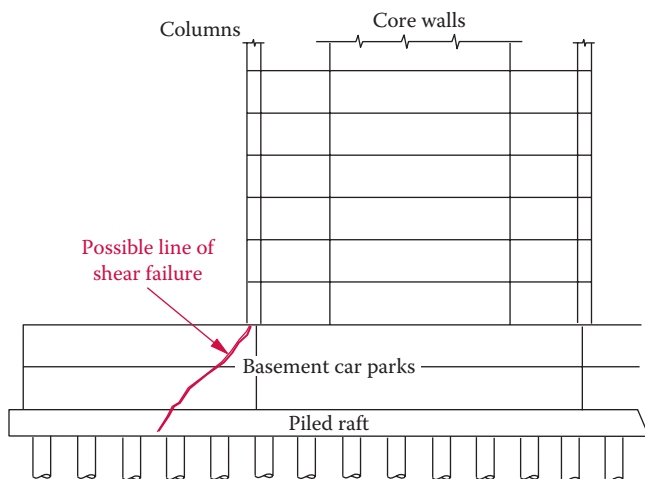
Figure 1.36 Arrangement of piled raft and basement car parks.

The design of the raft assumed that the walls of the two-level basement car park would act with the raft over the piles to transmit the shear and bending forces to the outer piles. The walls of the basement had almost full height openings, placed one above the other, and contained only nominal reinforcement. The combined strength of these walls plus the 1.5 m thick slab was inadequate to transmit the loads (see Figure 1.36).

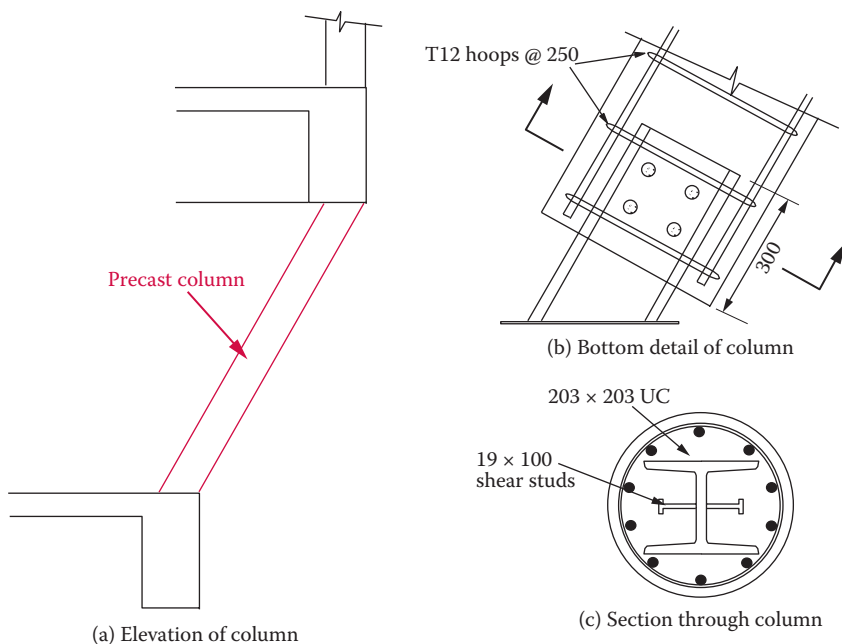
Figure 1.38 Sloping precast column.

into the bottom of the precast element to simplify the connection detail to the beam below. During construction, it was realised that the design of this connection was unsafe due to insufficient bond capacity and anti-bursting steel.

The short stub consisted of a  $254 \times 254$  UC section that extended into the column about 300 mm. The stub had four  $19 \times 100$  shear studs welded to each face of the web (see Figure 1.38b). The links surrounding the stub column were T12 hoops at 250 mm pitch. No other anti-bursting reinforcement had been provided.

No calculations had been carried out to determine the required embedment length of the UC stub column. Bond and end bearing should have been considered.

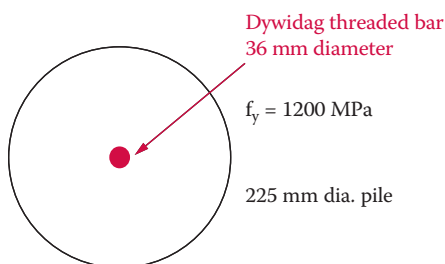
**Figure 3.3** Proposed pile with Dywidag bar as reinforcement.

An engineer was hoping to reduce the number of piles required for a building by providing reinforcement with much higher strength than required for normal high yield bars. Figure 3.3 shows a section through a 225 mm diameter pile with a proposed Dywidag threaded bar 36 mm in diameter (Dywidag Systems International, Munich). The yield stress  $f_y$  of such a bar is 1200 MPa.

Before going into production it was decided to check the load carrying capacity with a test pile. The result was that the pile failed at a similar load to that of a pile with normal reinforcement with  $f_{yk}$  of 460 MPa.

After some thought, the reason for the unexpected low pile strength became apparent. The actual concrete compression stress–strain diagram is similar to that given in Part 2 of *BS 8110*<sup>1</sup> and Figure 3.2 of *BS EN 1992 (EC2)*<sup>2</sup> and differs in shape from that used in ULS design in that, instead of having a plateau of maximum stress, it peaks at about 0.002 strain. This strain is close in value to that of the yield strain of normal reinforcement ( $500/200000 = 0.0025$ ). This means that the maximum resistance of the concrete occurs at the same strain when the reinforcement reaches its yield stress (maximum resistance).

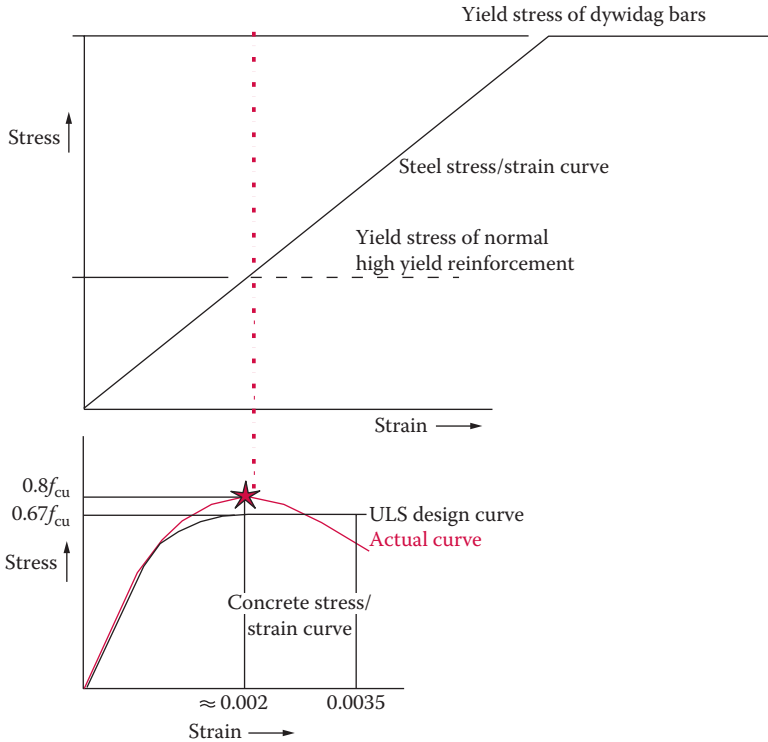
Figure 3.4 Stress–strain curves for concrete and steel.

The yield stress of a Dywidag bar is about 1200 MPa which corresponds to a yield strain of  $1200/200000 = 0.006$ . This compares with the ultimate strain of the concrete of 0.0035, so the concrete will fail in a compression test long before the Dywidag bar reaches its yield strain or stress. Figure 3.4 shows this graphically.

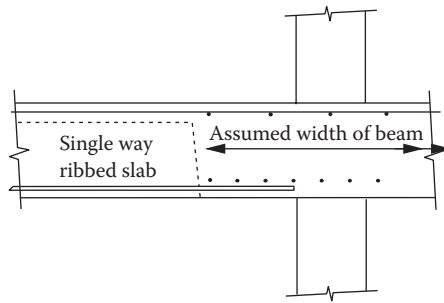
Figure 4.2 Section through broad beam.

The depth of the broad beam was the same as the trough slab and the design wrongly assumed that it could be considered a one-way slab and therefore did not require links (see Figure 4.2).

In order for the edge of the beam to be considered in the design as the support face, the vertical force from the load on the ribbed slab had to be

transferred to the top of the beam. Vertical reinforcement should have been provided for this. Links in the broad beam (in addition to any links necessary for shear resistance) could have provided sufficient resistance.

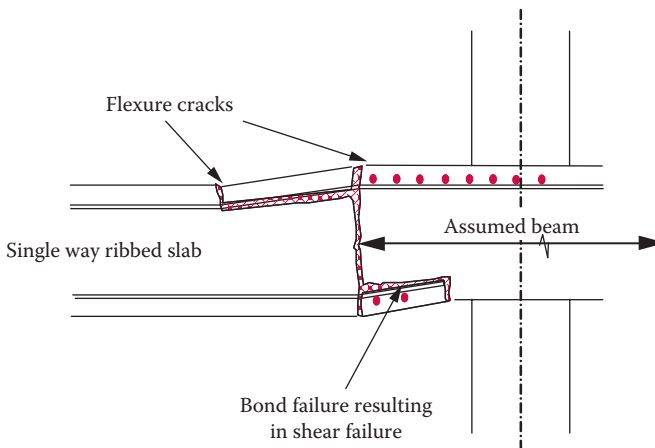
Figure 4.3 Section through ribbed slab at failure.

Failure of the ribbed slab occurred at the support with the broad beam (see Figure 4.3). Complete collapse was avoided by immediate temporary propping. The sequence of the failure was likely to be:

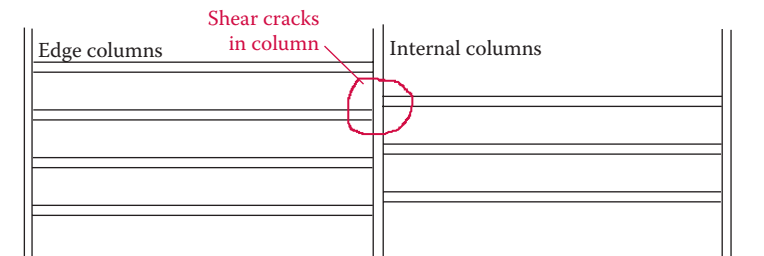
Figure 4.4 Structural elevations of beams and columns of car park.

Figure 4.4 shows the beams on the sides of the internal columns. They are stepped to allow ramping between levels (as is often the case). The internal columns were much stiffer than the edge columns and in consequence the support moments and shear forces within the column were high compared with the edge columns. The column shear forces caused large shear cracks (up to 2 mm) within many of the columns.

Although a failure mechanism was not present, a problem occurred from repairing the cracks. As soon as the car park filled with vehicles after the repair, the cracks reopened and eventually the deterioration of the column concrete could have led to a collapse.

The design had been carried out to the existing code of practice of the time which did not have specific clauses for shear in columns. By the time remedial work was carried out, new code clauses in place required shear checks of columns. The design of this particular joint was inadequate to the new clauses. The insurance company required remedial work to be carried out so that the building would comply. This was considered to be so costly that the decision was made to demolish the existing structure and replace it with a new design.

**Comment** — Although the existing design code did not cover this particular situation, the designer should have been aware of the problem and taken action in the design to prevent overstressing within the joint. This is an example of common practice in the 1960s and 1970s when many engineers extrapolated the existing clauses of the codes of practice for situations outside the scopes of the codes.

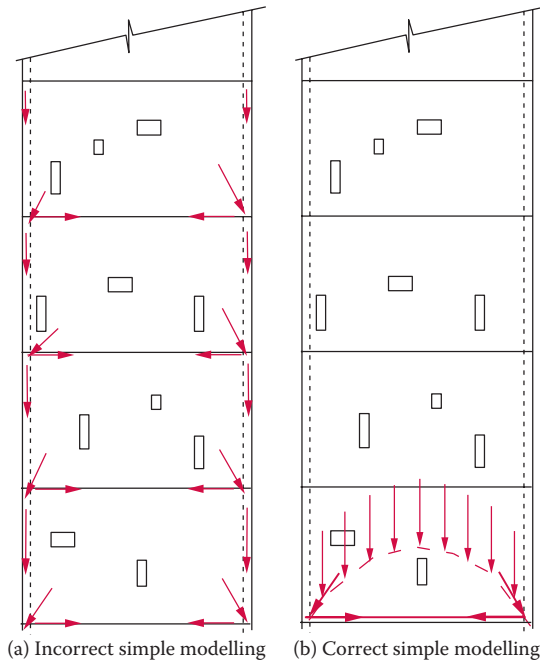
Figure 5.4 Multi-storey shear wall.

A multi-storey shear wall required so many openings (windows, doors, etc.) that the load path became very complicated. The designer assumed that the load would flow to the corners and then track vertically down the edge of the wall (see Figure 5.4a). In fact, since the wall was built in situ as a homogeneous structure, strain compatibility caused the load to flow back into the full width of the wall. The result was that several storeys of load

were supported by a deep beam that transferred the load to its end supports (see Figure 5.4b).

The limiting height of the natural arch of a deep beam ( $0.6 \times \text{span}$ ) was not considered (see Figure 5.4b) and this resulted in the omission in the design of much of the reinforcement needed for the bottom tie. Construction had reached several floors up by the time the mistake was recognised and this led to a redesign of the wall during construction and heavy remedial work. Each part of the wall required careful re-appraisal. This led to the requirement of much more reinforcement at each floor level. The bottom corner reinforcement details required special attention to ensure that the junction between the tie and compression struts was adequately designed.

**Comment** — The consequence of missing this simple principle of deep beam behaviour before construction reached such an advanced state meant that it required the redesign of the structure and reprogramming of construction which were extremely costly.

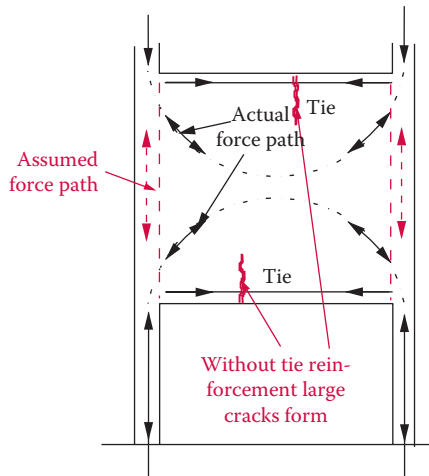
Figure 5.5 Modelling deep beams.

Figure 5.5 shows in a simple diagrammatic form how the force paths automatically flow out and back again. The assumed force path down the edges would not require ties at top and bottom, but without these the actual force path would cause large cracks to open up from the top and bottom surfaces. Even after cracking, the angle struts would still exist and so would the consequential horizontal component. Without sufficient tie force to resist, the support joint would move outward and eventually failure would follow.

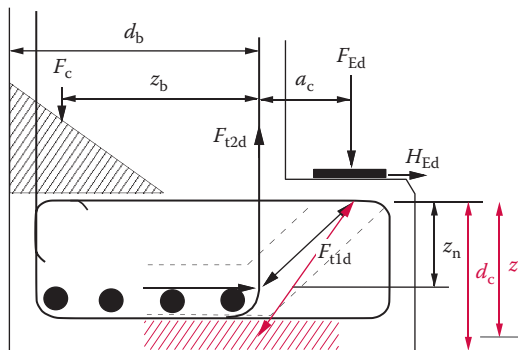
Figure 5.6 Nib attached to bottom of a beam.

The conventional assumption for a short cantilever of  $d_c$  and  $z_c$  (shown in red in Figure 5.6) is unsafe for such a nib. The design compression zone for such a model would be close to the bottom face of the beam and likely to fall outside the beam reinforcement (both the links and main reinforcement). Strut-and-tie modelling is helpful to explain why this is so. The strut (shown in red in Figure 5.6) would just cause the cover to the reinforcement to spall off. The strut must be supported mechanically by the reinforcement of the supporting beam (shown in black in Figure 5.6). The effective lever arm becomes much smaller and the tension force in the nib top reinforcement much larger than assumed by the short cantilever approach.

It should also be noted that the force in the supporting links of the beam,  $F_{t2d}$ , is likely to be much greater than the applied load on the nib,  $F_{Ed}$ , to satisfy equilibrium. For the situation shown in Figure 5.6, it is conservative to assume the compression acts at the centroid of a triangular compression stress block. Hence the force in the link, in addition to any shear, may be calculated as follows:

**Comment** — There are probably many nibs of this type that have been designed incorrectly and survive because of built-in safety factors and the fact that the load assumed in the design has not occurred.

The error described in this case study was found in the design of a nib for a very prestigious project. It was very fortunate that it was discovered before construction started.

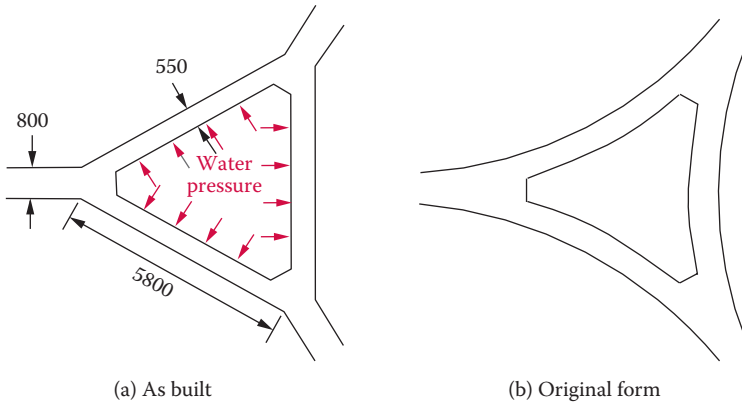
Figure 6.3 Detail of tri-cell.

Figure 6.3 shows a detail of the tri-cell wall that was designed to resist the water pressure when the cellular base was submerged. Figure 6.3b shows the original form of the cells with cylindrically shaped walls. The natural arch action provided by that geometry was not present in the modified form shown in Figure 6.3a.

The analysis of the cell structure was carried out using a finite element software package. The accuracy of the analysis was reduced as the arrangement of the quadrilateral elements meant that those in the region of the tri-cell corners were distorted from the ideal square shape. This led to errors in the results. It was realised after the failure that the shear stress results from the analysis were in error on the unsafe side.

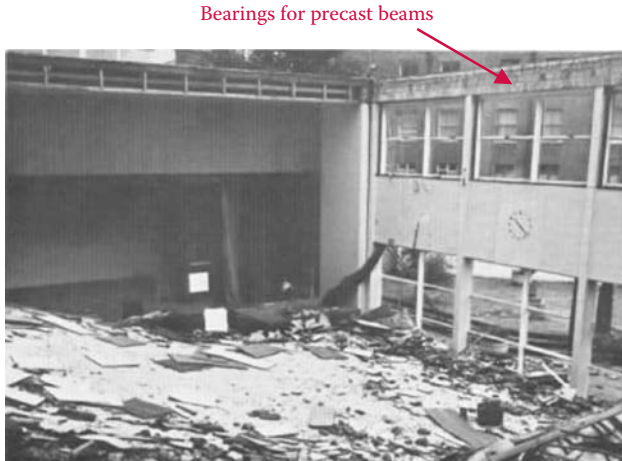
The principal cause of the collapse was inadequate bearing for beam seatings and deterioration of concrete at beam ends. The hall was one of the first buildings found to have suffered from the effects of high alumina cement (HAC; see Section 7.4).

**Comment** — This was an example of inadequate design and poor detailing of the end bearing nibs built into the supporting beam for the precast beams. The reduction in strength caused by HAC left no margin for temperature effects. The combination was likely to have triggered the collapse.

**Figure 6.5** Assembly hall showing edge beam that supported the precast beams. (From Scott, G.A., *Building Disasters and Failures*, Construction Press Ltd., Lancaster, 1976. With permission.)

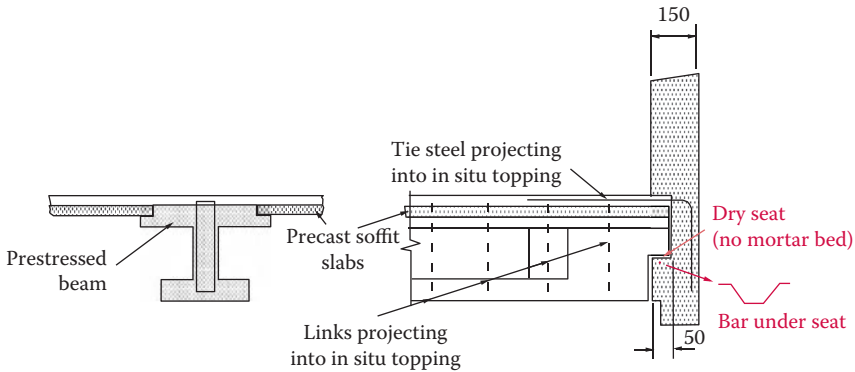
Figure 6.8 Prestressed beam and support.

The roof was constructed of prestressed precast concrete beams made with HAC spanning 12.6 m, supporting precast concrete slabs acting as permanent formwork for an in situ concrete topping (see Figure 6.8). The outer ends of these beams rested in 50 mm deep pockets cast into the vertical inside faces of the edge beams. In addition to these, the edge beams had recesses just below their seatings. These encroachments on the already narrow section led to the adoption of a reinforcement arrangement that had no main steel under the seating pockets for the prestressed beams.

The cause of this collapse was a disastrous combination. The columns and edge beams were precast as T units (with webs facing outward). The architect had, in order to obtain a dark colour, specified HAC concrete to be made with aggregate that was highly alkaline. The specification had been mistyped or misread to call for one part HAC to four parts sand to two parts aggregate (these mix proportions were confirmed by analysis after the event). Cores drilled from one of the T units after the collapse revealed strengths as low as 7 MPa and some could not be extracted in one piece.

The depth of seating for the pretensioned roof beams satisfied the code requirement for bearing pressure, but left no margin for erection tolerances or temperature effects. There was inadequate reinforcement detailed under the beam seatings, and as the T units were cast with external faces down, even that reinforcement was displaced downward, away from the seating ledge.

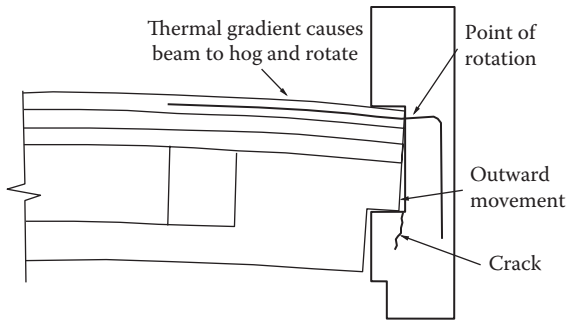
Figure 6.9 Detail at support.

The actual mechanism that led to the failure was found to be thermal hogging of the prestressed beams. The tie steel projecting from the edge beam into the in situ topping acted as a hinge, and the end rotation accompanying the thermal flexure between the two extremes corresponded to a horizontal movement at the level of the seating of approximately 2 mm. This caused cracking of the bearing nib as shown in Figure 6.9. The tension stress in the concrete support reduced its shear resistance sufficiently to cause the failure. The prestressed beam had been made with high alumina cement and although it aggravated the situation it was *not* the cause of the failure.

On another building, an identical detail was found, but the edge beams were constructed with ordinary Portland cement concrete. In that case, a crack similar to the one shown in Figure 6.9 was found, but presumably the reinforcement had not been badly displaced, as full collapse had not occurred. This did, however, demonstrate that HAC was not the primary cause of the collapse of this roof, but accelerated the cracking until collapse had become inevitable.

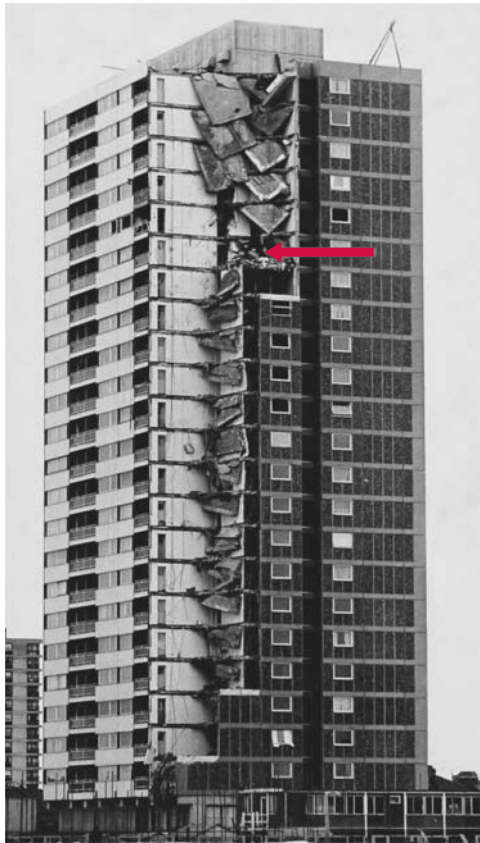
In the early hours of 16 May, 1968, a gas explosion in a bathroom on an upper floor shook a building, resulting in the instantaneous collapse of part of one wing (see Figure 6.10). Four people were killed. Figure 6.11 shows a closer view of the upper floors after the explosion.

*Figure 6.10* Progressive collapse showing point of explosion. (Ronan Point building collapse, May 16, 1968, London. Courtesy of Building Research Establishment.)

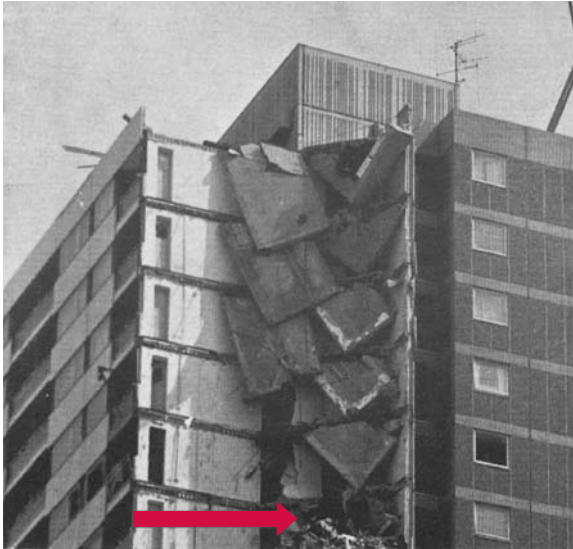
*Figure 6.11* Closer view of upper floors showing point of explosion. (Ronan Point building collapse, May 16, 1968, London. Courtesy of Building Research Establishment.)

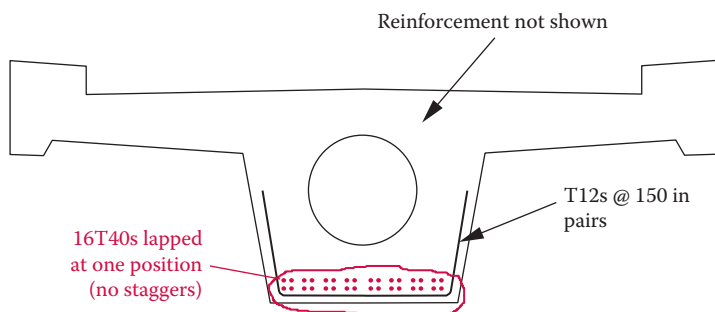
Figure 6.12 Section through footbridge.

A footbridge was being constructed over a motorway. The bridge had two spans with an in situ concrete T-section deck (see Figure 6.12). The span lengths were 20 and 40 m. After removing the formwork and props, two large transverse cracks (2 and 3 mm) appeared in the sides and soffit of the longer span. The cracks occurred at the positions of the laps of the main bottom reinforcement.

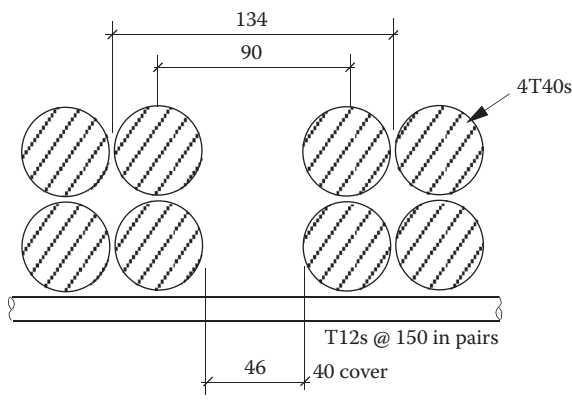
Figure 6.13 Layout of bars at laps.

The reinforcement had been detailed so that all the main bars in the bottom, 16 T40s, were lapped at positions of high stress. It is generally considered poor detailing practice to lap bars in positions of high stress and lapping

all the bars in a congested situation compounds the error. The bars were cranked to allow them to be as close as possible (see Figures 6.13 and 6.14). Links, T12s @ 150 in pairs enclosed all the main bars. No extra links were provided at the laps or cranks.

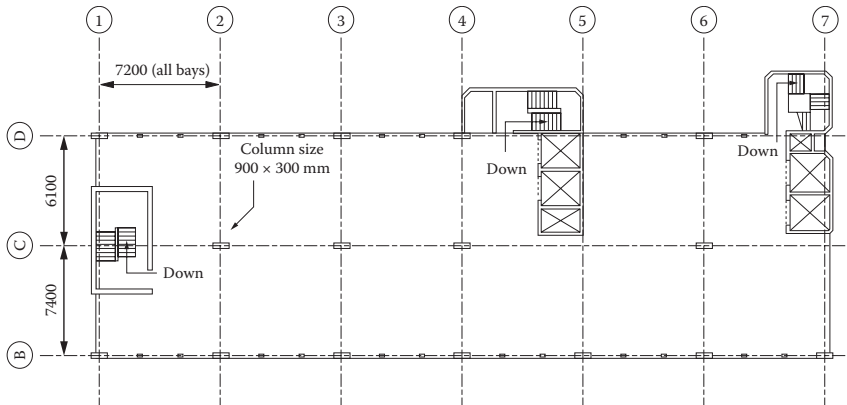
Figure 8.1 Structural layout of hotel floor.

Figure 8.1 shows the structural layout of a typical flat slab floor. The depth of the slab was 250 mm. The spans along the building were 7.2 m and across the building were 6.1 and 7.4 m. The top surface of the slab was very uneven and did not appear to have been levelled (by hand or power float). In some places, boot marks had been left. Cracks (generally not larger than 0.3 mm width) occurred on the upper surface radiating from the corners of the columns with one or two small cracks running tangentially. Large cracks (up to 1 mm width) appeared at some of the construction joints. The deflection of one of the slab bays of an upper floor was large—over 75 mm.

**Excessive deflection** — In order to understand how the excessive deflection had come about, it was necessary to check not only the design, but the in situ concrete strength, reinforcement details, and cover to the reinforcement as built. This check found that the only factor not as specified was the top cover to the reinforcement near the column supports. This was found to be on average 30 mm more than specified. This reduced the moment of

resistance at the support. However, after reasonable moment redistribution was included in the calculations, there was sufficient overall moment capacity in the slab without requiring any reduction to the design safety factors.

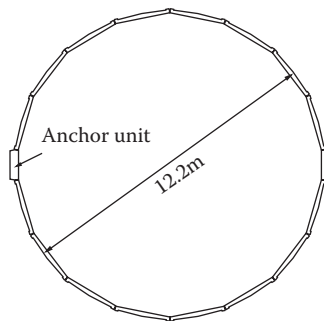
Figure 8.5 Precast elements of tank.

A liquid storage tank was constructed with precast wall panels. The diameter and height of the tank were 12.3 and 7 m, respectively (see Figure 8.5). The vertical panels were held in place by unbonded prestressed tendons threaded through horizontal PVC ducts embedded in the concrete and fully encircling the tank at set levels throughout the height. The tank collapsed without warning within 2 years of construction. Failure was caused by a number of separate mistakes.

**Water tightness** — In order for the tank to be watertight, each precast vertical panel had to butt up to the adjacent panel evenly throughout the 7 m height. A rubber strip was inserted within the joint between each set of adjacent panels and incorporated holes through which the prestressing tendons were threaded. The prestressing was intended to create uniform compression throughout the height of the tank. However, to achieve

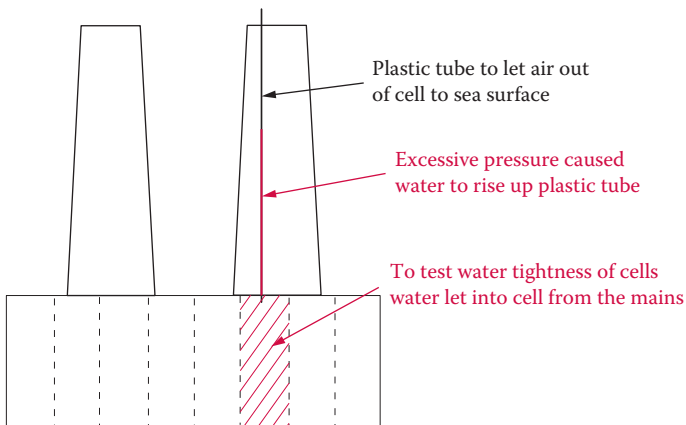
Figure 8.12 Water tightness test during construction.

were made during construction to test the water tightness of the cells. The intention was to fill each one of the cells to its top only. Each cell was constructed with a plastic tube that led to the top of the shafts to allow air to escape from the cell when it was filled during the final installation. The main water supply used to fill cells was capable of providing a pressure much more than that required, and the water level was allowed to rise up the plastic tube (see Figure 8.12).

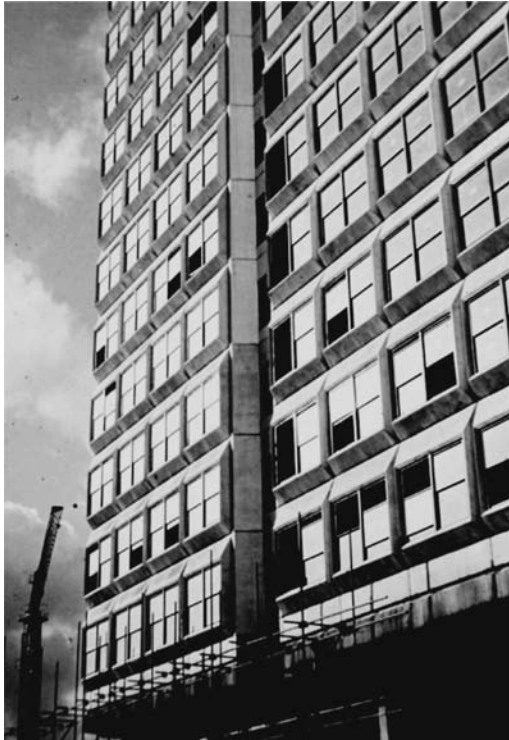
*Figure 8.16* Office block with sculptured panel facades. (Courtesy of Poul Beckmann.)

The facades of a tall office block were made of precast concrete sculptured panels (see Figure 8.16) and incorporated load bearing mullions. The horizontal panels and mullion joints were about 600 mm above the floor level. It had been specified that the panels be levelled by means of steel shims and then mortar beds be laid to a level just proud of the shims. The panels with the mullions attached would then be lowered down onto the beds with the intention that the load would be shared between the mortar and shims.

**Comment** — This joint detail might have worked had hardwood plywood been used for the shims instead of steel. The E value would have been close to that of the set mortar and, if pre-soaked, the shims would have shrunk as they dried, thus transferring the load to the mortar.

The repair work included inserting a set of steel columns at every floor (see Figure 8.19). To ensure the correct load was taken by each column, flat jacks were inserted at each floor level. Each jack was inflated with resin that was allowed to harden once the correct pressure was attained.

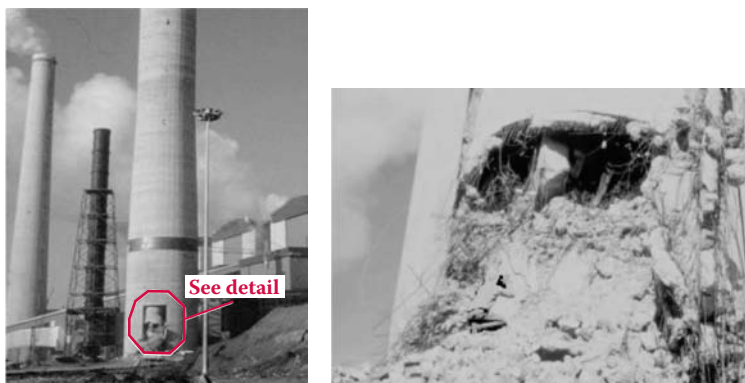
**Figure 8.20** Debris from collapsed flue. (Courtesy of Alan Steele.)

Above the roof slab at the top, the flues were also clad externally with brickwork. The bricklayers had just finished capping the last flue when a fracture lower down caused the top half of one of the flues to slide down, disintegrate, and fill the bottom of the wind shield with debris that spilled out of the portal for that flue. One worker was killed (see Figure 8.20).

It was still possible to enter the chimney space through one of the other portals, and the inside of one of the intact flues could be examined. A substantial horizontal crack was found on part of the wall surface; inserting a knife blade into the crack indicated that the fracture surface sloped upward. Subsequently, more cracks of a similar nature were found on the inside of the wind shield.

The fracture surfaces on the concrete fragments in the debris seemed more square and sharper than expected. This was later explained as a feature of sudden disintegration of high-strength concrete by impact, as opposed to the slow failures observed in laboratory tests. Cores were taken

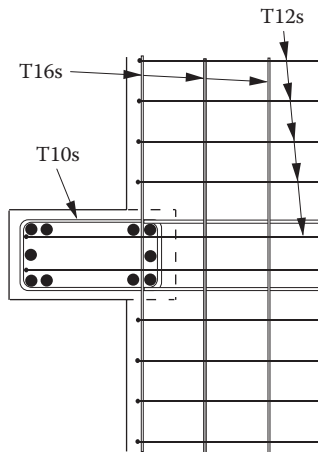
Figure 9.2 Intended layout of reinforcement.

The reinforcement arrangement intended for this joint is shown in Figure 9.2. Construction reached the second floor when a young graduate visited the building to gain some site experience. He reported back his concern about the reinforcement layout along the edge of the slab that was about to be concreted. Figure 9.3 shows what he saw. There was no mechanical link between the slab and the column reinforcement! It was immediately realised that not only had this occurred at all edges of the slab on the second floor, but also on the first floor that was completed several weeks earlier.

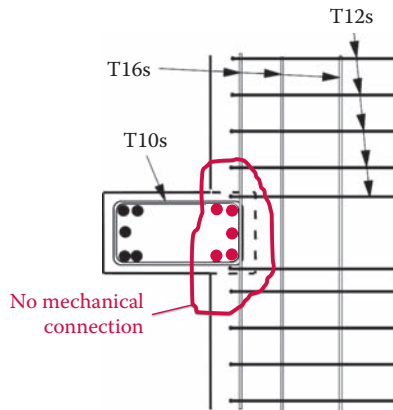
Figure 9.3 Actual layout of reinforcement.

**Comment** — One of the reasons this situation occurred was that no check had been made in the design office to ensure that a mechanical link could be made. In fact, when the cover and the actual size of bars were taken into account, it was clear that the reinforcement could not fit as intended. The fabricator of the reinforcement fitted the bars as close to the correct position as possible without thinking that a mechanical link was essential.

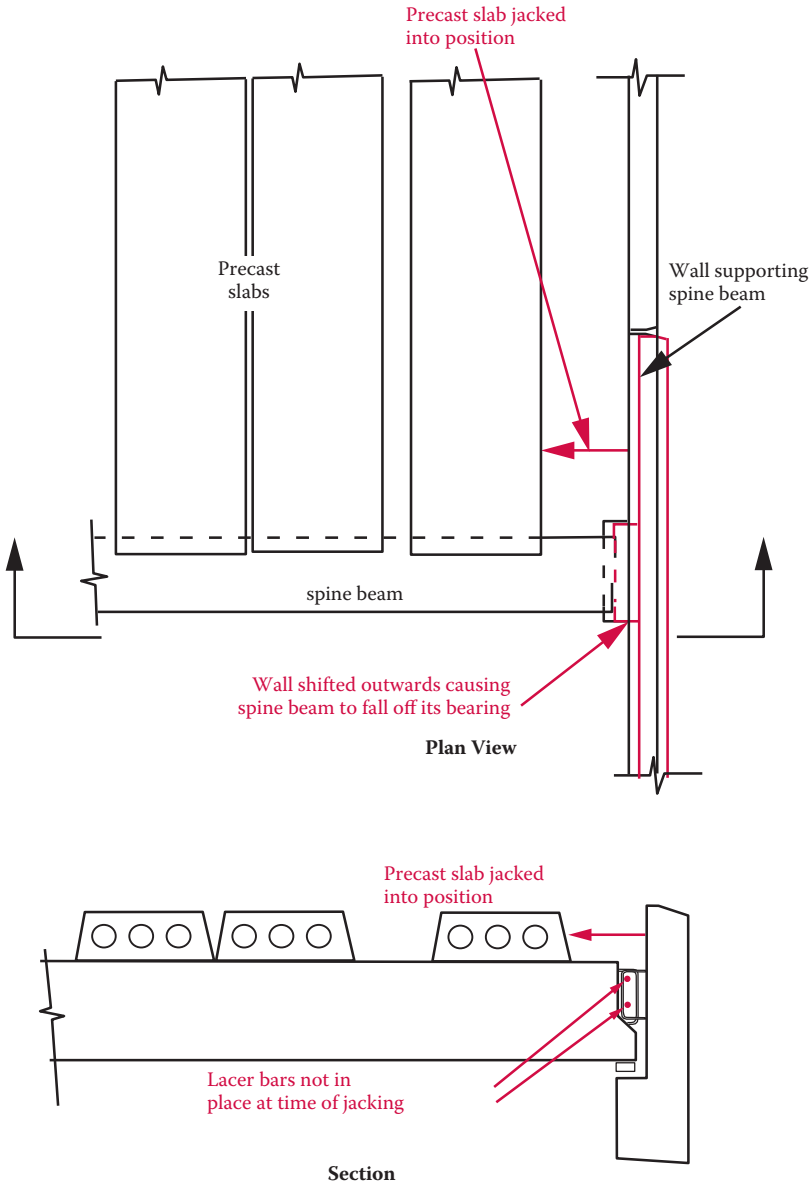
Figure 9.5 Adjusting positions of precast planks.

A spine beam carrying precast planks lost its bearing because a labourer trying to jack one of the final planks into position actually levered out

the wall panel supporting the end of the spine beam (see Figure 9.5). This caused the spine beam to lose its bearing and led to the collapse of the floor. The connection between the spine beam and the wall panel had been designed to have two overlapping U bars locked together with lacing bars threaded through the space between them. These lacer bars had not been inserted at the time of erecting and laying of the floor elements. If they had been in place, they would have prevented the wall panel from moving away from the spine beam.

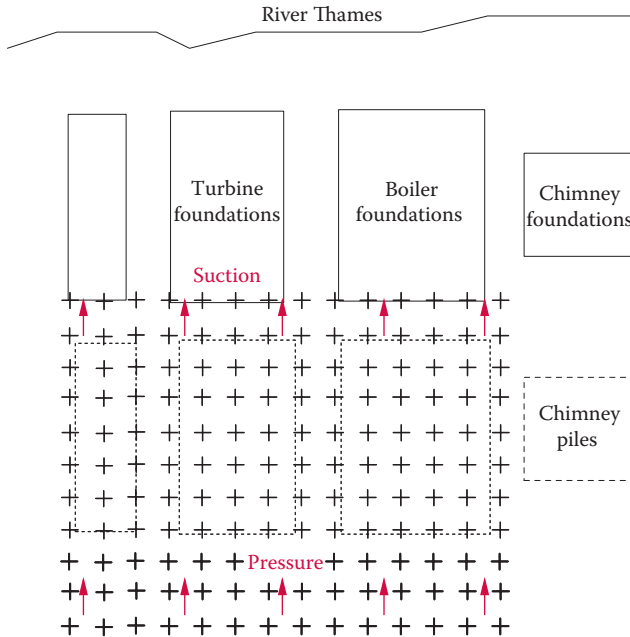
Figure 10.3 Diagram showing cause of movement.

A year after the start of piling, when concreting of the foundations progressed about a third of the way along the site, it was discovered that the tops of the piles that were still exposed were moving. *Measurements showed that the movement was up to 1.5m!*

The first major concern was to check whether the piles were still intact. One pile was extracted. It came out straight and appeared undamaged. On close examination, fine cracks could be seen throughout its length. This indicated that it had bent evenly over its full length.

It took some weeks to fully understand what had happened. Figure 10.3 shows a plan of the site and attempts to demonstrate the situation. The steady addition of piles into the ground built up ground pressure. This pressure was applied increasingly from one direction. At the same time, the excavation for the foundations of the structure closest to the river released any ground pressure that built up. The combination of these two major actions caused the movement.

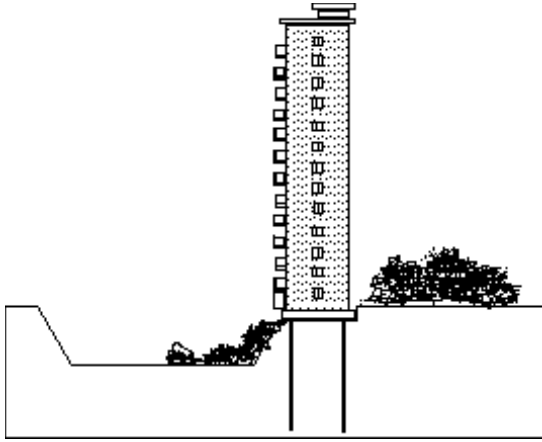
Figure 10.4 Diagrammatic view after excavation.

An underground car park was to be added to one of several residential tower blocks. Excavation commenced on the south side of the block and the excavated soil was piled on the north side to a height of 10 m (see Figure 10.4). A heavy rainfall occurred some time after the excavation finished and it increased the lateral ground pressure on the piles. The building began to move sideways toward the excavation. This caused the piles to fail as their shear resistance was exceeded (see Figure 10.5). The building became unstable as it moved toward the excavation and eventually fell over (see Figure 10.6).

**Comment** — There appears to have been no engineering planning to prevent the combination of excavation and piling up of the soil on opposite

sides of the building. Some hand sketches showing the intentions of the plan would have helped identify the likely problem.

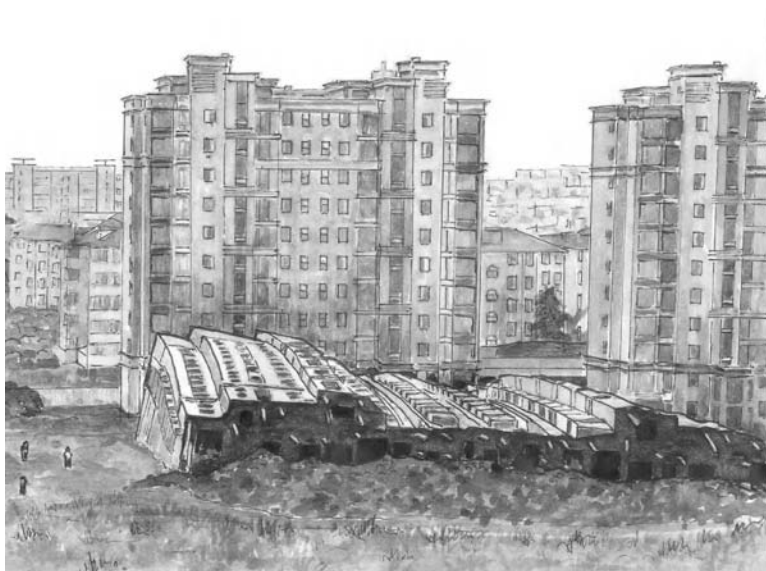
*Figure 10.7* View of underside of collapsed building. (Courtesy of Gillian Whittle; redrawn from Reuters, <http://www.telegraph.co.uk/news/worldnews/asia/china/5685963/Nine-held-over-Shanghai-building-collapse.html>.)

It was very fortunate that the other tower blocks were not close enough to cause a domino effect. Figures 10.7 and 10.8 show how close this tower block was from its neighbours. Figure 10.8 shows a close-up view of the piles that failed in shear. The piles were made of circular hollow unreinforced concrete. They were constructed with short lengths at the top with solid reinforced sections (see Figure 10.9).

It was probably reasonable for the piles to be designed for compression only since the loading to which the foundations were subject was beyond the scope of the design.
