# FAILURES IN CONCRETE STRUCTURES

Case Studies in Reinforced  
*and* Prestressed Concrete

Robin Whittle

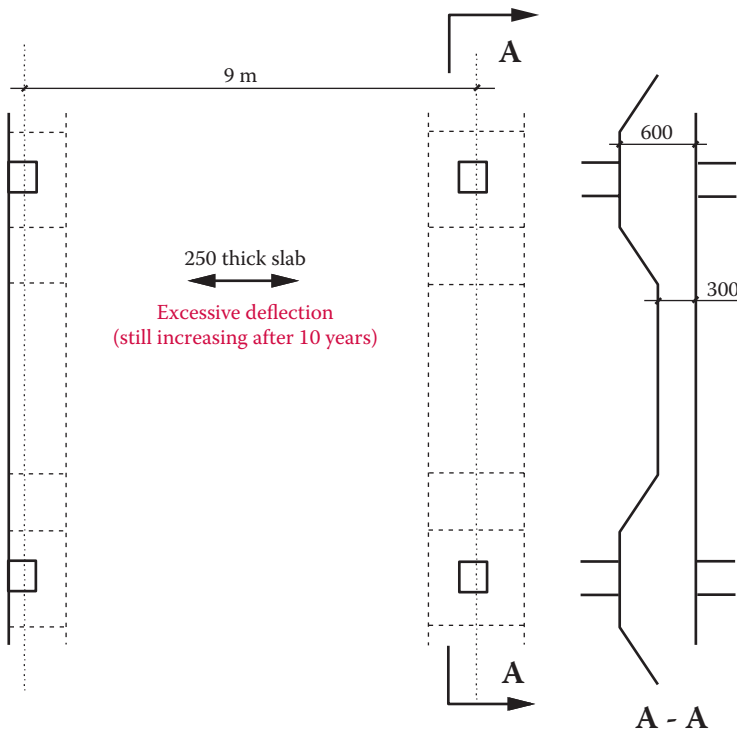
Figure 11.1 Plan and section of typical end bay.

The building in question was a telephone exchange built in the mid-1970s, 10 years earlier. Figure 11.1 shows a plan and section of a typical end bay. The slab had been designed as single way spanning between two shallow haunched beams. The design included a span of 9 m with a slab only 250 mm thick which many engineers would consider too thin.

The visit to site included the inspection of the slab close to a column. The screed had been removed to expose the top surface of the structural slab. On close inspection, the reinforcement appeared to be badly rusted and breaking through the top surface. As a crude check of the hardness of the concrete surface, it was scratched with a penknife. Quite unexpectedly, the blade of the knife penetrated into the concrete surface right up to the hilt! A further check of the soffit of the slab gave a similar result.

An additional interesting feature of the soffit was the presence of a number of shallow disc shaped ('flying saucer') pieces of concrete (150 mm

diameter) that were separating from the surface. One such piece came away as it was being examined. Although the slab had been designed to span one way, the supporting beam was sufficiently flexible for the slab to behave more like a flat slab. The ‘flying saucers’ appeared in the compression areas of the soffit and were considered to be the effects of spalling. It was clear that the slab in question required immediate additional support and the rest of the building required core testing.

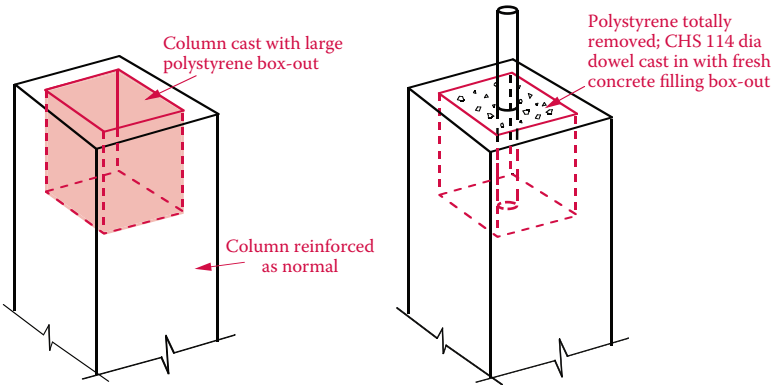
Figure 11.3 Intended construction of top of in situ column.

The construction of the in situ columns should have proceeded as shown in Figure 11.3. The central circular hollow section (CHS) dowel was cast into the top of the in situ column ready to receive the precast column.

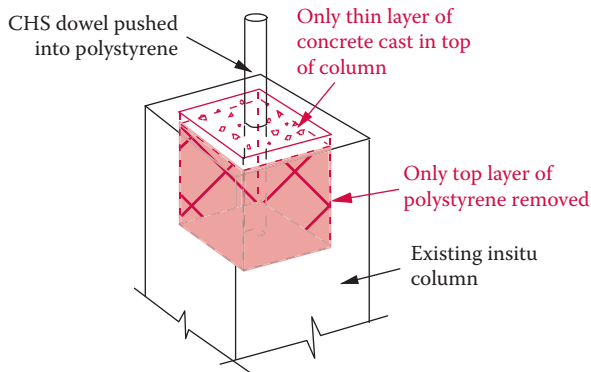
Figure 11.4 Actual construction of top of in situ column.

In order to check that the concrete in the box-out was in place as intended, holes were drilled through each face. It was discovered that the polystyrene had been left in and only a thin layer of concrete had been placed at the top (see Figure 11.4).

The load in the precast column from seven floors above transferred to the outer rim of the in situ column. This load was intended to be taken by the whole section of the in situ columns. However, the thin layer of concrete at the top of the box-out and the polystyrene below were quite incapable of taking any significant load. The outer shell of in situ concrete that had to take the load became overstressed and consequently cracked, providing the first sign of imminent failure (see Figure 11.5).

In order to repair the tops of the in situ columns, the load from the precast building had to be removed. This was achieved by providing props and

jacks close to the existing precast columns at each floor level and creating a new load path to the ground. This released the load on the in situ columns below and allowed the required remedial work—reconstruction of the tops of the in situ columns—to take place.

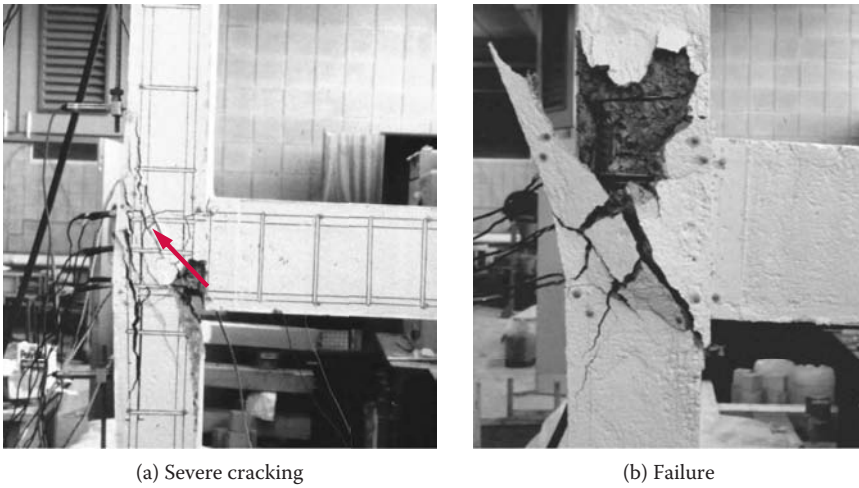
Different arrangements of reinforcement were detailed and tested. One important result showed that if the beam top bars were bent upward in the column, with gravity loading on the beam, the joint resistance was drastically reduced compared with the bars bent down. The reason is that the high compression force created within the joint was not resisted by the enclosing bar as shown in Figure 13.3a.

Figure 13.3 Loading column joint to failure. (Courtesy of Richard Scott.)
