CO₂ CORROSION ON NATURAL GAS COMPRESSORS: CRITERIA AND GUIDELINES

Liquid water and CO₂ can easily lead to carbon steel corrosion, especially at high pressures. Corrosion can happen either during normal running or during pressurized standstill conditions. The present paper describes three real cases of gas lift compressors operating in offshore platforms that suffered internal damage due to the formation of carbonic acid and unfavorable process conditions. The damages found were slightly different on each machine due to specific design characteristics (such as the presence or not of inlet guiding vanes), different manufacturers and process conditions. Full description of the failure mode and relevant root cause analysis as well as the modifications implemented to solve the issue are provided. Additionally, a review of the monitoring tools used to diagnose internal corrosion will be presented, including typical responses that can be expected in compressors subjected to CO₂ corrosion. Finally, detailed criteria to define CO₂ corrosion potential are proposed as well as comprehensive guidelines on material selection to avoid similar problems.

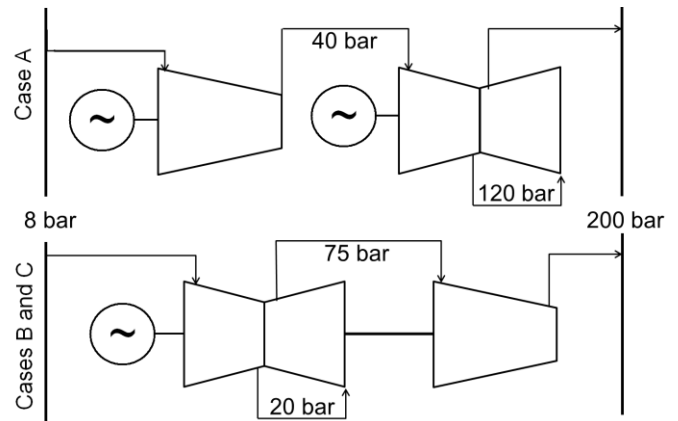
Figure 1. Natural gas compression system.

Each system contains three compressor trains, each divided in three compression sections, to raise natural gas pressure from 8 bar to 200 bar. Gas coolers and scrubbers are provided at each section inlet. On case A, one casing is dedicated to the first section, in a straight-through arrangement, while a second casing combines second and third sections in a back-to-back arrangement. Each casing is driven by a dedicated electric motor. On cases B and C, the first two sections are on a back-to-back casing and the third section on a straight-through casing, with both sharing the same electric motor. Figure 1 presents a schematic description of the systems.
