Hull Structural Breakdown - Bottom

2. Bottom

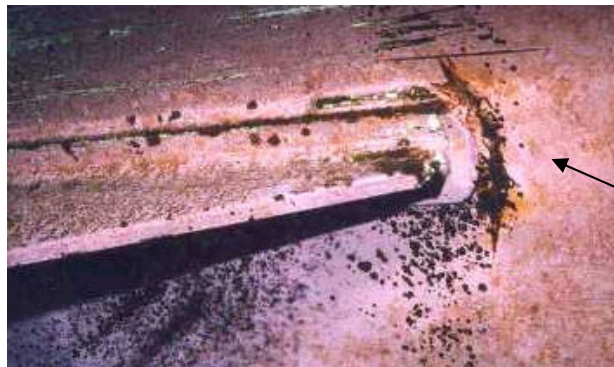
Oil Tanker
285,690 DWT built 1990
Crack in hull plating i.w.o. bilge keel terminations

Crack in hull plating in way of bilge keel toes

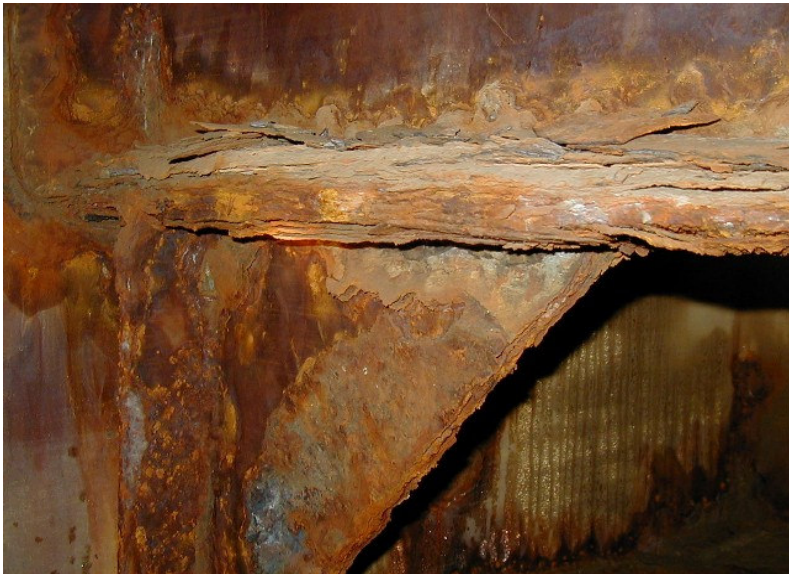
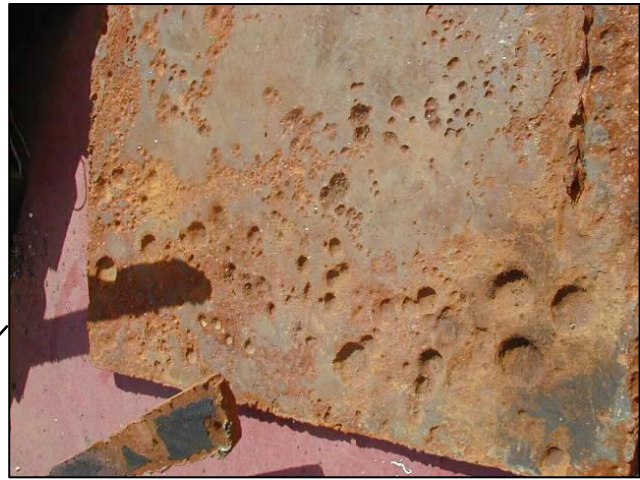
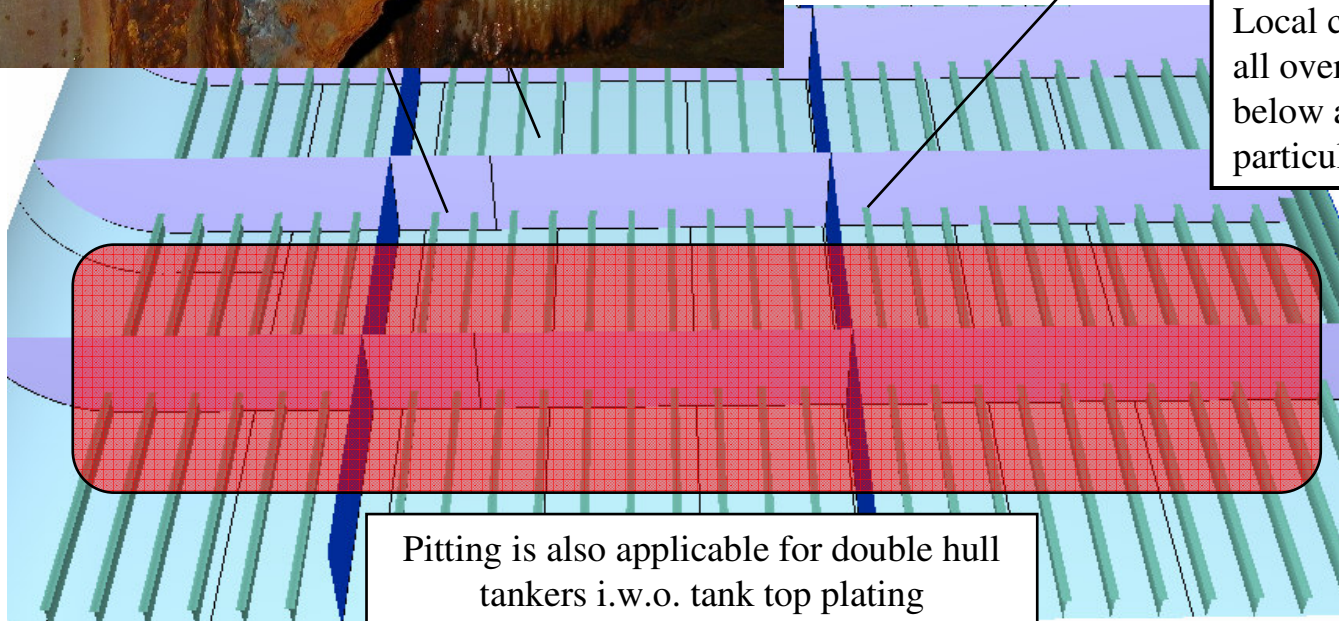
Corrosion of bottom structures

Local corrosion (pitting): may occur all over the bottom plating, but area below and around bell-mouth is particularly exposed

Pitting is also applicable for double hull tankers i.w.o. tank top plating
