Hull Structural Breakdown - Transverse bulkhead

4. Transverse
bulkhead

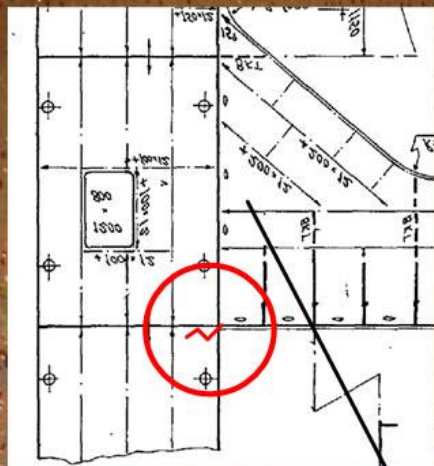
Crack in stringer connection to inner side at transverse bulkhead

Crack experienced in longitudinal bulkhead at stringer connection (2nd stringer). Important focus area during hull approval!
