# Hull Structural Breakdown - Deck

# Structural build up of deck

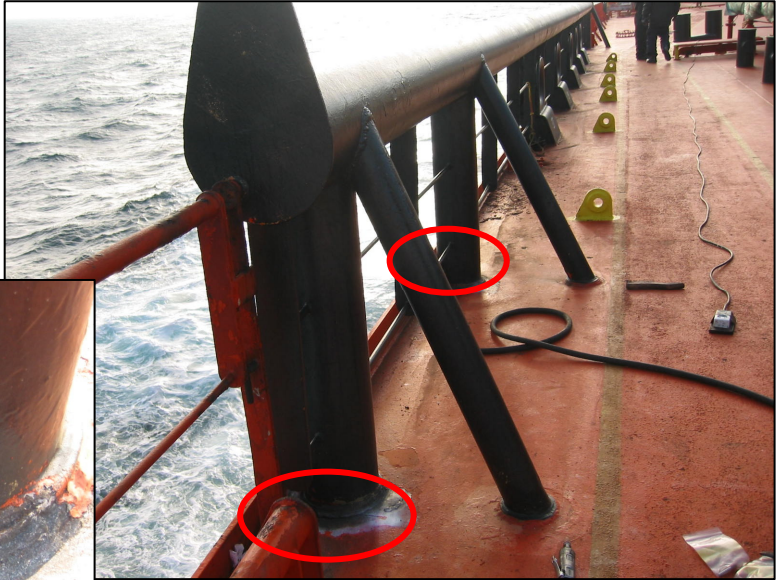
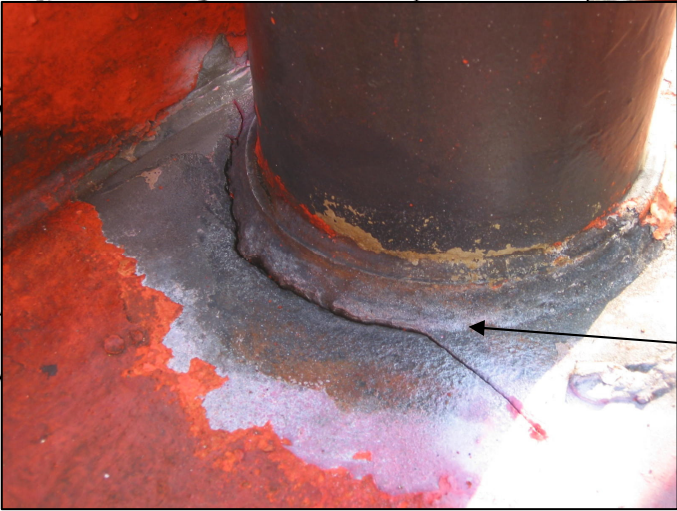
Tanker for Oil  
99328 DWT  
built 1996  
Crack in deck plating

Crack in deck plating at hose saddle support (midship area)

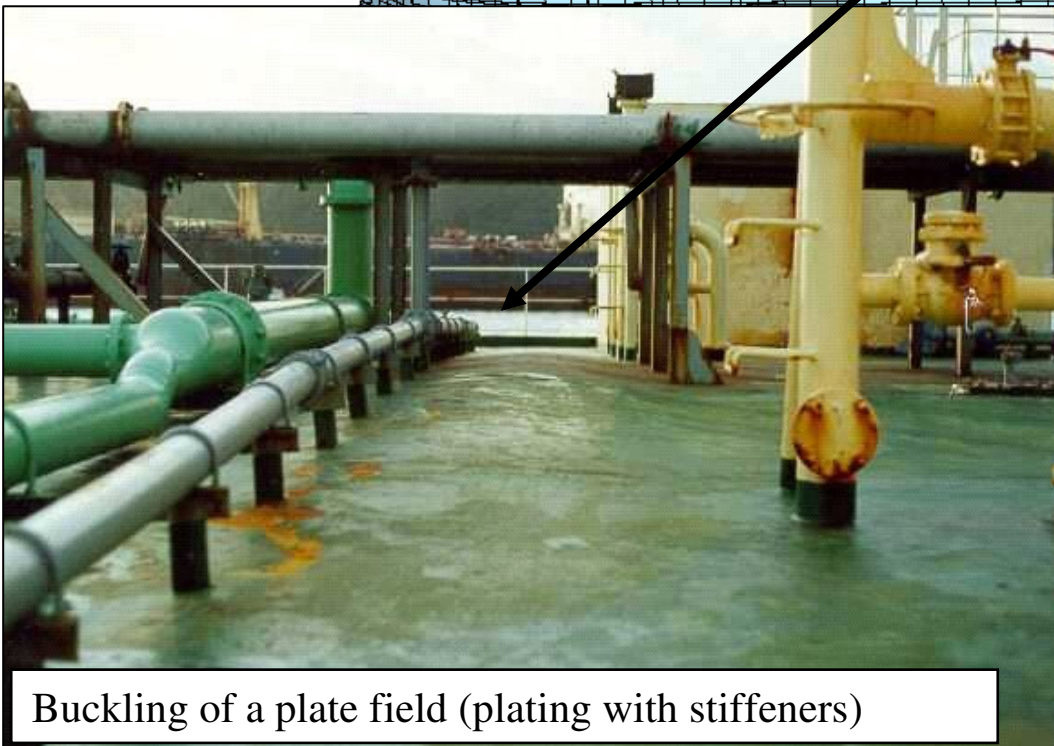
Buckling in deck is most likely to occur in the midship region where the hull girder bending moment is at its maximum

Buckling of a plate field (plating with stiffeners)

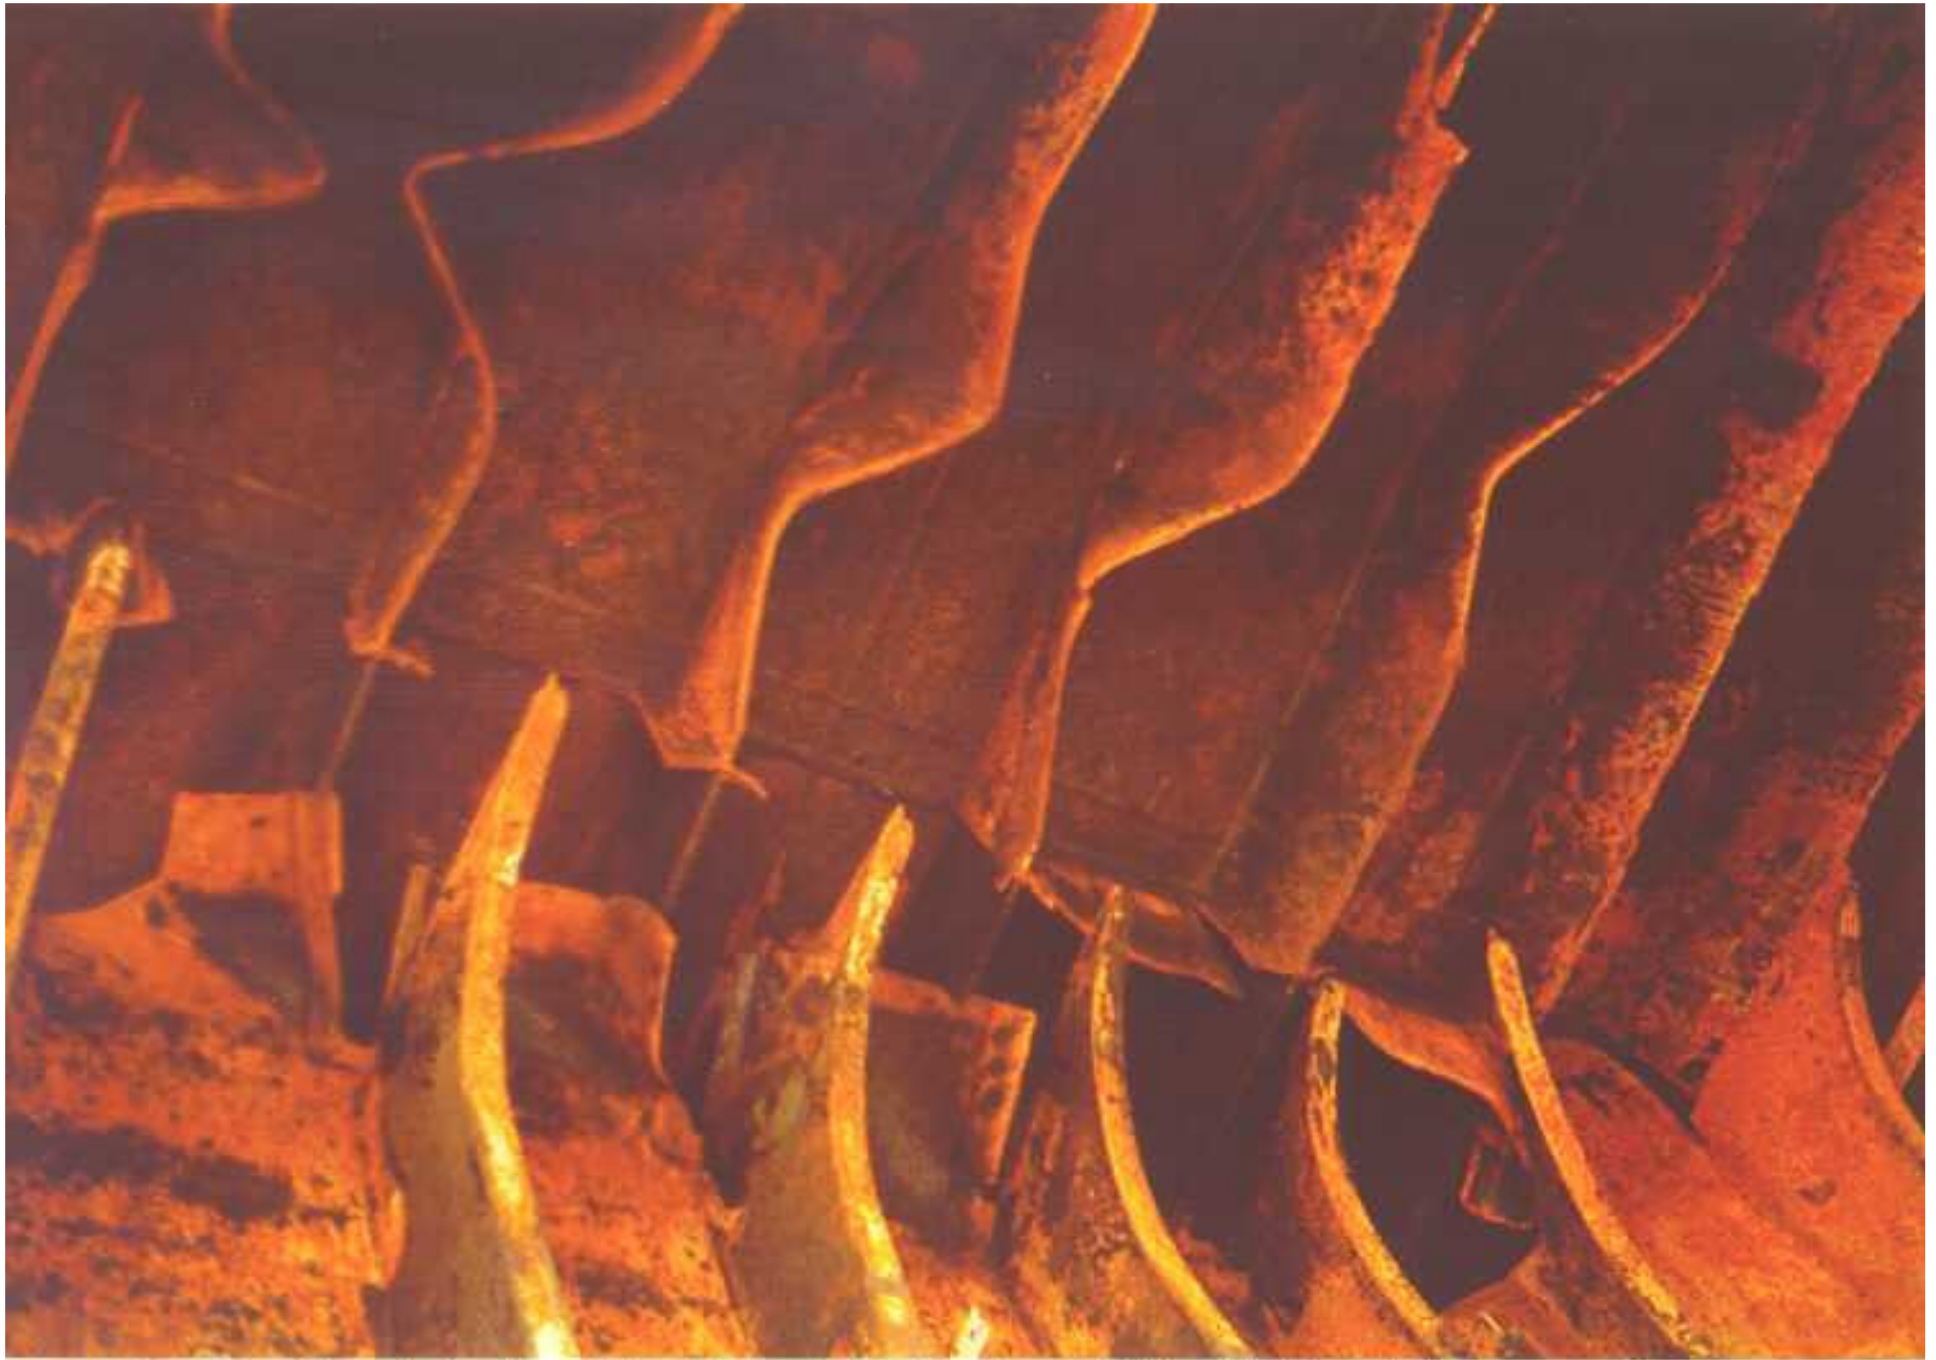
No. 17 — shows the buckling of the deck longitudinals in the port PBT and the forward displacement of transverse bulkhead 79. It will be noted that the deck longitudinals in the No. 3 wing tank are not buckled.
