# VIBRATION FIELD PROBLEM RESOLVED WITH ANALYTICAL DIAGNOSTICS APPROACH AND INNOVATIVE IMPELLER DESIGN

Several pump units of the same design installed in various locations in the USA with different duties exhibited high vibrations above API limits with process fluids ( $SG = 0.5$  to  $0.6$ ) from rated point down to minimum continuous flow.

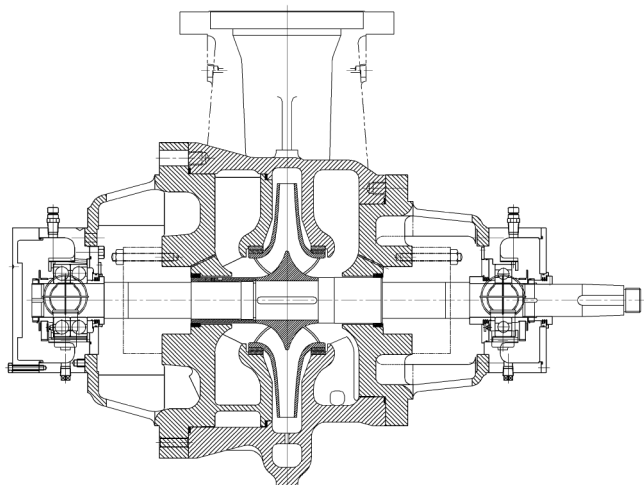
Figure 1. Pump Cross Section.

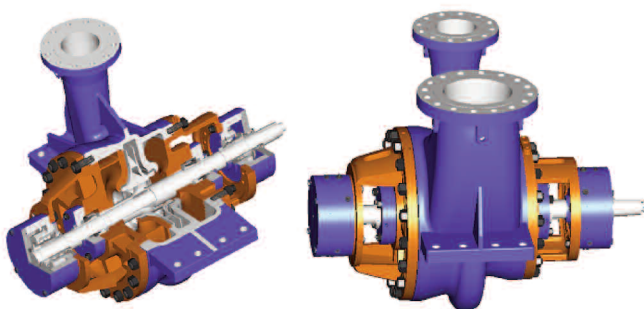
Figure 2. Pump Cut Views.

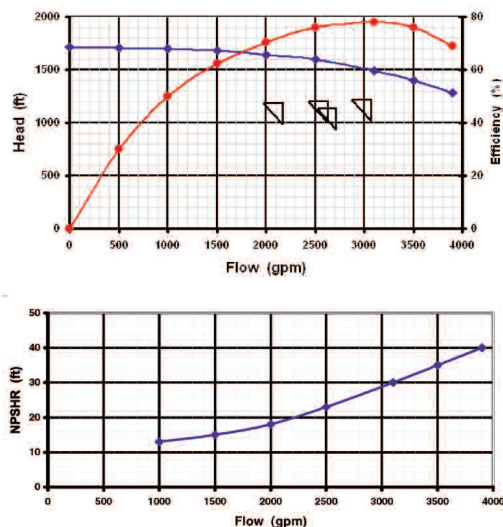
Figure 3. Pump Curve Characteristics.

During 2004 a common vibration problem was experienced in four different plants (refineries) in the USA with the same pump type/size operating apparently with different conditions of services. The pump type/size is an API 6 inch discharge pump with top-top configuration, double suction impeller, double volute, antifriction bearings configuration, center mounted (BB2). The cross section of the pump is given in Figure 1 and two cut views are shown in Figure 2. The pump overall characteristics at design speed ( $N_{des} = 3565$  rpm) and impeller maximum diameter ( $D_{2des} =$

19.09 inch) are given in Figure 3. The best efficiency point (BEP) is at  $Q_{BEP} = 3100$  gpm and  $H_{BEP} = 1490$  ft, which give a specific speed  $N_S = 828$  US (using total flow). Moreover:  $NPSHR_{BEP} = 30$  ft, which gives a suction specific speed  $S_{eye} = 10,950$  US (using half capacity). The impeller has five vanes and an eye diameter  $D_{eye} = 6.4$  inch. The nominal operating speed at site is  $N_{oper} = 3545$  rpm for all pumps, which gives a peripheral eye velocity  $U_{eye} = 99.0$  ft/s. The key operating data at rated capacity for each installation are presented in Table 1 and also shown in Figure 3. The impellers are trimmed with different duty diameter (Table 1). The diameter of the two volute cutwaters is the same for all four cases with  $D_3 = 20.51$  inch.

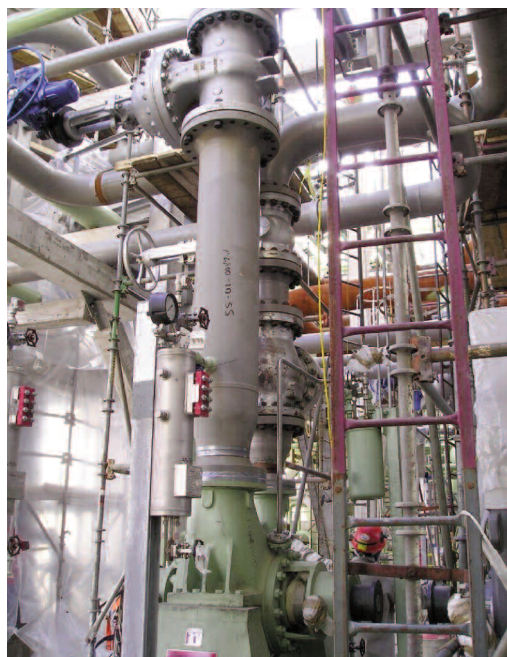
Figure 4. The Pump in the Field (Case 4).

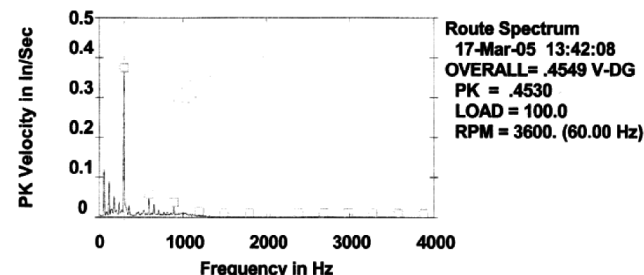
For Case 1 and 2 the level of bearing vibration at site with actual fluid (SG = 0.569 and 0.560) was exceeding the API limit 0.12 ips overall. These two pumps were tested in the shop at 2950 rpm (in 2002 to 2003) with cold water (SG = 1.0) and did not show any critical vibration level. In two cases (Case 3 and 4) the pumps were installed (Figure 4) but not yet operated and the solution that was identified and herein described was later implemented as a preventive action. For Case 1 and 2 the highest overall level at site (Figure 5) was at the drive end (DE) (DEV slightly higher than DEH) from 0.16 up to 0.45 ips at rated capacity. Experience was suggesting that further increasing vibrations could be expected below the rated flow toward minimum continuous stable flow (MCSF) (contractual value: 1000 gpm). The analysis of the vibration spectra clearly pointed out:

- Dominant vane pass frequency (around 300 Hz, five vanes)
- Relevant contribution of low frequencies in a broad band range

Figure 5. Field Vibration Spectra at DEV (Case 2,  $Q_{rated} = 3070$  gpm).

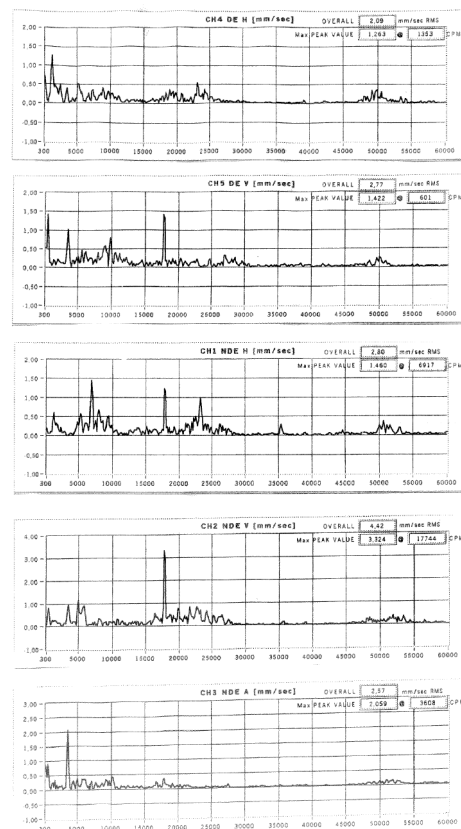
Figure 6. Shop Test Spectra at 1750 GPM.

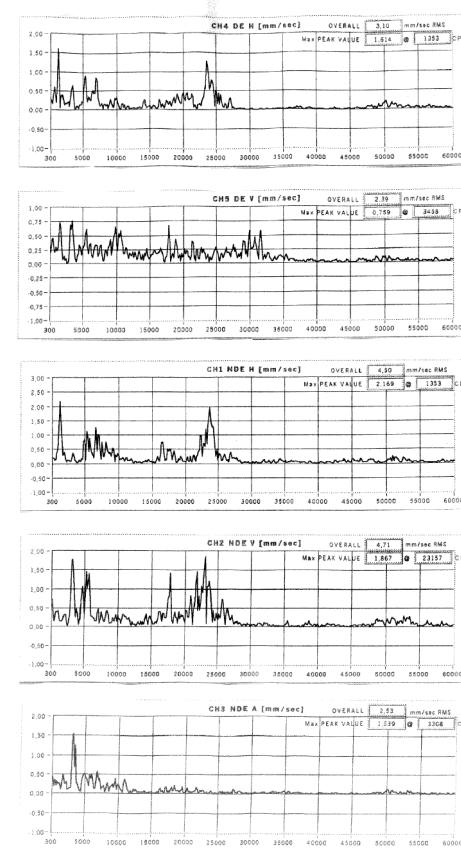
Figure 7. Shop Test Spectra at 2690 GPM.

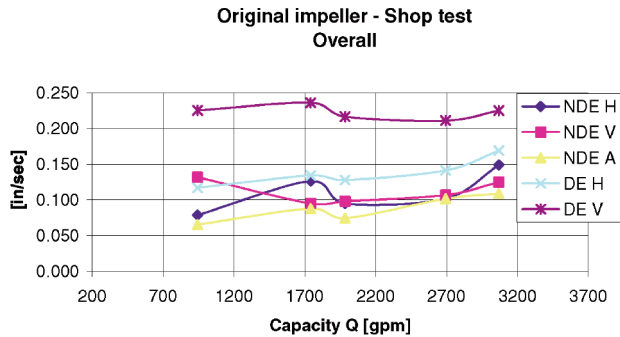
The trend of vibration levels (overall,  $1\times$ , and  $5\times$  or VPF) versus capacity is shown in Figures 8, 9, and 10. It is evident that the overall level exceeds the vibration limits of 0.12 ips (preferred operating range) and 0.15 ips (allowable operating range, including MCSF) for the DE bearing housings, especially for the vertical component, which is high in the full capacity range, from design flow down to MCSF. Also the  $1\times$  and VPF are high for DEV.

Figure 8. Shop Test Vibration Readings—Overall.

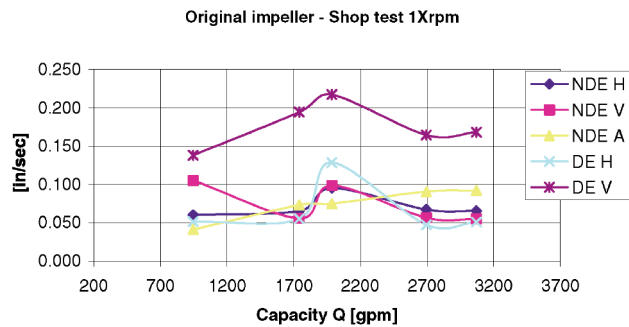
Figure 9. Shop Test Vibration Readings— $1\times$  RPM.

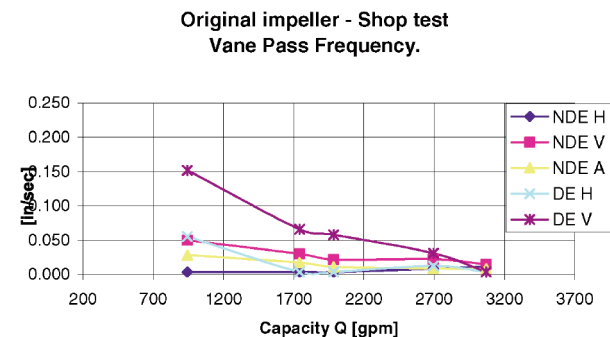
Figure 10. Shop Test Vibration Readings—Vane Pass Frequency.

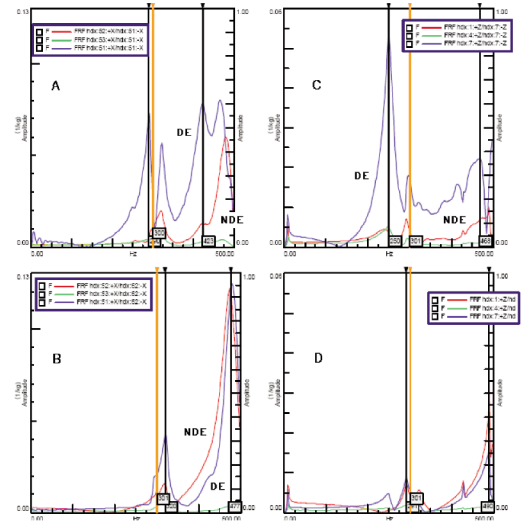
An experimental modal analysis was performed in order to determine the structural response of the pump and particularly identify possible resonance frequencies of the bearing housings. A hammer test was performed with the pump suspended in the air to avoid superposition of stand effects. The transfer function of the signal measured on each bearing housing in the horizontal and vertical position is illustrated in Figure 11. Then the following natural

frequencies (Table 2) appeared to be close to the VPF frequency (297 Hz) for both the DE and NDE bearing housings (first natural frequency). An attempt to modify the resonance characteristics of the pump bearing housings was performed by adding selective mass to each bearing housing. The corresponding transfer function of the signal measured on the bearing housing in the horizontal and vertical position is illustrated in Figure 12. The associated natural frequencies are indicated in Table 3. It appears that all the first natural frequencies were only marginally shifted to lower values, still remaining close to the VPF. However the vibrations were measured to see whether the pump under running conditions would show any improvement. The trend of vibration levels (overall,  $1\times$ , and  $5\times$  or VPF) versus capacity is shown in Figures 13, 14, and 15. The vibrations were reduced for the DE bearing housing, but increased for the NDE one, in agreement with the new natural frequencies.

Figure 11. Modal Analysis—Pump in the Original Configuration.

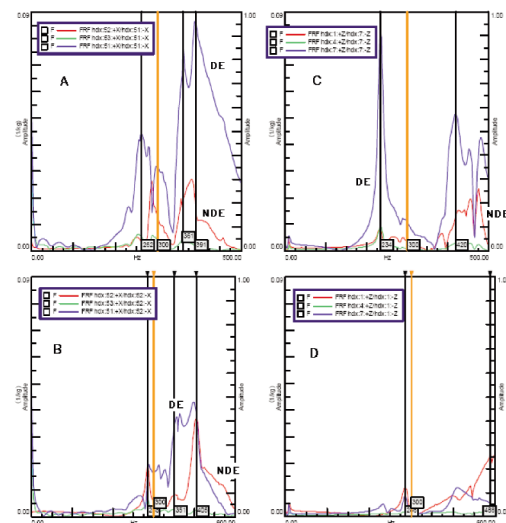
Figure 12. Modal Analysis—Pump with Modified Configuration.

The approach of lowering the natural frequencies by adding mass to the bearing housing seemed promising and a new attempt was made in the same direction by using a greater mass for the NDE one. There was only some improvement but the overall vibrations and VPF for NDEV at lower capacities (including MCSF) remained higher than API limit. These modifications of the bearing housings, which produced partial improvements near the rated capacity, were envisaged as possible short term solutions with limitations of the pump operating range.

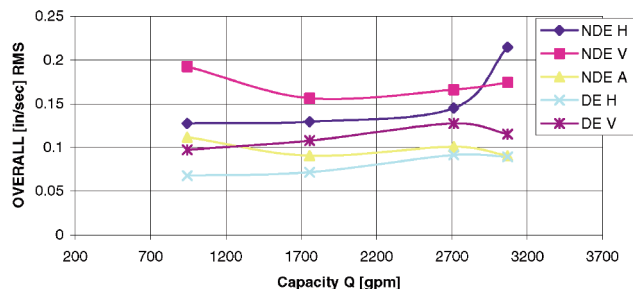
Figure 13. Shop Test—Modified Pump—Overall.

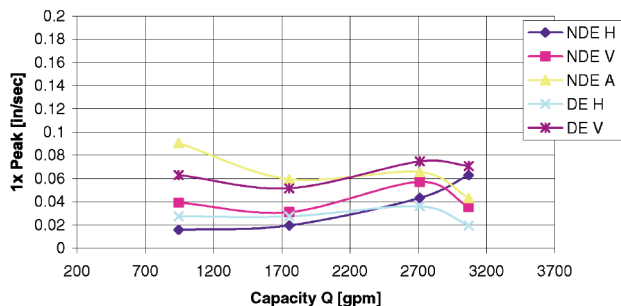
Figure 14. Shop Test—Modified Pump—I x RPM.

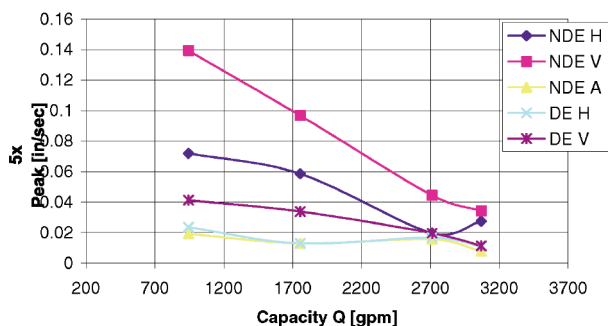
Figure 15. Shop Test—Modified Pump—Vane Pass Frequency (Mass Added to the Bearing Housings).

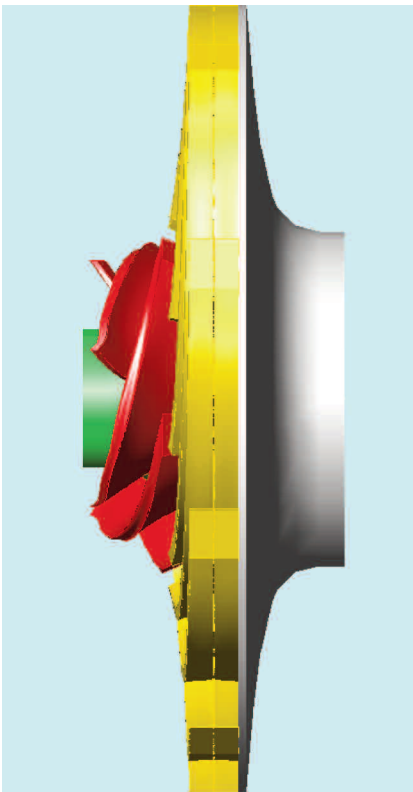
Figure 16. New Design Impeller (Side View).

The above design requirements led to conflicting choices for the vane geometry (number and shape) between the inlet and outlet of the impeller geometry. Then an innovative impeller geometry was selected with a double row of vanes (Schiavello, et al., 1997). The solid model of this impeller, which also represents the master pattern, is shown in Figure 16 (front view) and Figures 17 and 18 (top view, outboard and inboard), which presents the key elements, i.e., first blade row (red), second blade row (brown), central rib (green), and one shroud (gray). The vanes are not staggered at the exit because of small impeller width that would prevent cleaning of casting. Moreover, a full diameter central rib would drastically impair the efficiency.

output electronic files are used for automatic generation of the impeller hydraulic layouts and also the corresponding solid model (Figures 16, 17, and 18). The impeller solid models were created for various impeller variants, which were used for evaluating the manufacturing feasibility/constraints with pattern maker, foundry, and machine shop. The impeller castings were made by using a conventional ceramic core process.

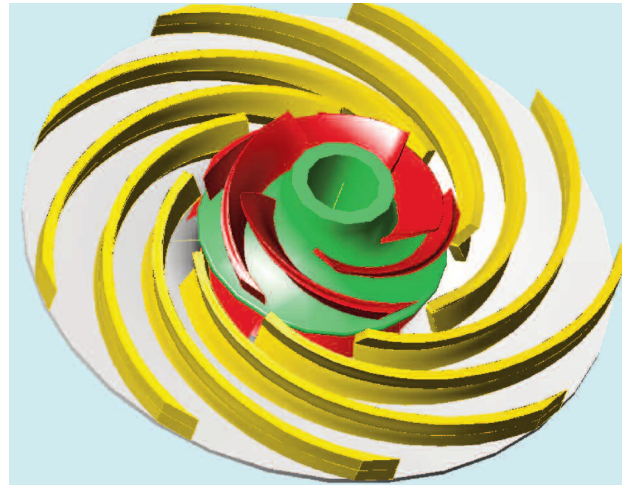
Figure 17. New Design Impeller (Front View—Outboard).

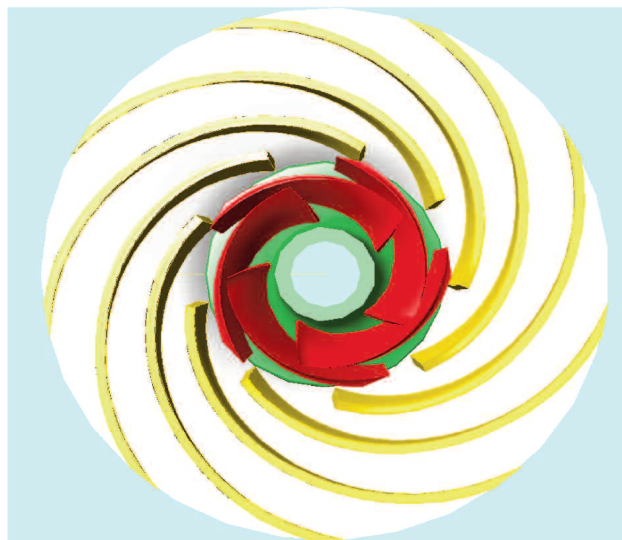
Figure 18. New Design Impeller (Front View—Inboard).

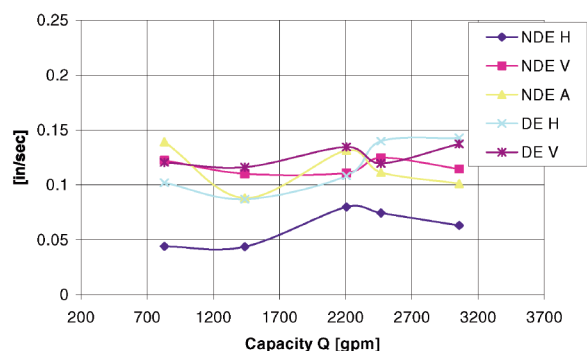
Figure 19. Shop Test—New Design Impeller—Overall.

The vibration shop test (3565 rpm, SG = 1.0—cold water) revealed a drastic reduction of all vibration components below API acceptance limits keeping the original design bearing housings (DE and NDE). The trend of these vibration levels versus capacity is shown in Figures 19, 20, and 21. The overall vibration level (Figure 19) was markedly reduced for all components, particularly for DE-bearing (by a factor 3 or plus) and brought within API limit. The Figure 20 presents the vibration level at the synchronous frequency  $1 \times \text{rpm}$  for all components (at DE and NDE) in the full operating range. It appears that this frequency (largely influenced by mechanical rotor unbalance) gives the major contribution to the overall amplitude. Moreover the relation with capacity for each component is very similar between  $1 \times \text{rpm}$  and overall level, showing limited and even irregular change (second order). The vibration levels at vane pass frequency for exit vane number (new impeller  $Z_2 = 9$ , VPF = 531 Hz) resulted nearly negligible (Figure 21) and well below the API limit of 0.08 ips in the whole operating range from BEP capacity down to MCSF. It is worthy noticing that the B gap for this shop test was 7.2 percent. Also the shop vibration spectra showed very low level at 5 V frequency (297 Hz), which is the VPF for the first row of blades from BEP to MCSF.

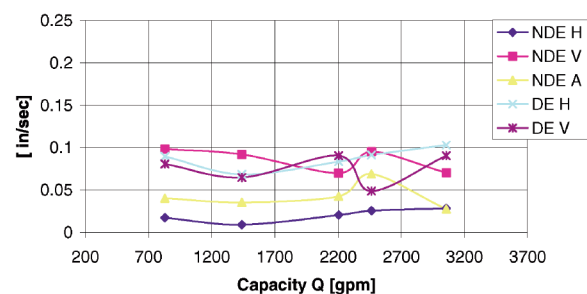
Figure 20. Shop Test—New Design Impeller— $1 \times \text{RPM}$ .

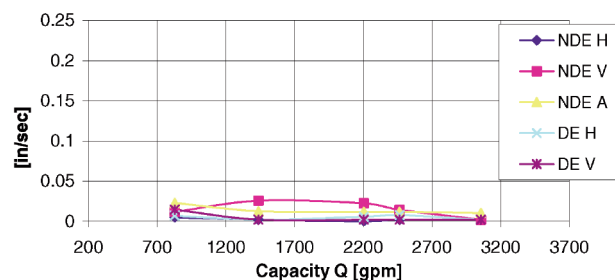
Figure 21. Shop Test—New Design Impeller—Vane Pass Frequency.

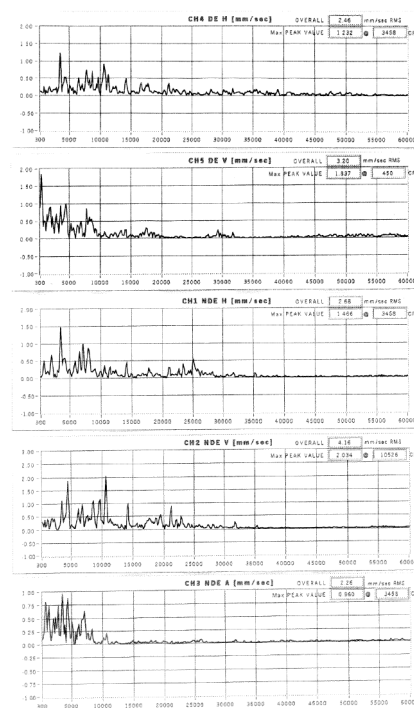
One shop vibration frequency spectrum with the new impeller is shown in Figure 22 for the capacity of 2690 gpm (close to rated one), which is also indicative for the other capacities. The corresponding shop vibration frequency spectrum with the old impeller is shown in Figure 7. By comparison it appears that the bandwidth of frequencies with peaks below  $0.5 \text{ mm/s} = 0.02 \text{ ips}$  is reduced by a factor 2 for each vibration component.

Moreover the frequency activity is negligible with the new design impeller above 250 Hz (15,000 cpm) compared to 550 Hz (35,000 cpm) for the old design impeller.

Figure 22. Shop Test Spectra at 2690 GPM—New Impeller.

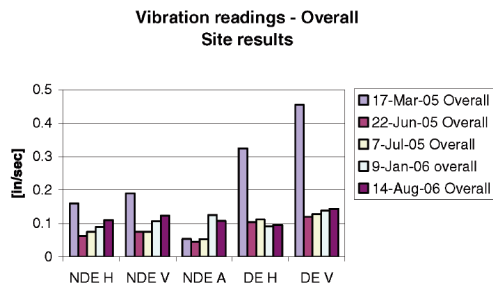
Figure 23. Field Data—Comparison—Overall (Case 2,  $Q_{rated} = 3070$  GPM).

Starting in June 2005 the new impellers were installed in all pumps (Case 1 to 4). The field vibrations and operations were in full compliance with specs meeting the customer's expectations in all four plants. Actual field vibrations are presented in Figures 23, 24 and 25 for Case 2 at the rated capacity of 3070 gpm ( $N = 3580$  rpm,  $SG = 0.56$ ) by comparing the last vibration data with the old impeller (17 March, 2005) and a series of vibration data with the new impeller (from 22 June, 2005 to 14 August, 2006). The overall vibration amplitude is compared in Figure 23, which shows that vibration level was exceeding the API limit of 0.12 ips for all radial components particularly at DEV and DEH. The new impeller has brought all vibration components within API limits with drastic reduction by a factor 3.5 of the highest values (DEV, DEH). Moreover the new vibration levels are consistently stable for more than a year of pump operation. The vibration at the synchronous frequency  $1 \times$  rpm is compared in Figure 24: the pump with the original impeller presented higher vibration response at DEV-NDEV and much lower values for the other components, while the response with the new impeller was more even and in general low for all components. The vibration at  $1 \times$  rpm can be related to both a mechanical unbalance of the impeller and also a hydraulic unbalance from casting deviation (e.g., blade angle at impeller outlet). It is hard to separate the two causes for interpreting this different vibration behavior. In principle it can be expected that an impeller with high vane number and lower vane loading (i.e., smaller pressure gradient at impeller outlet between the pressure side and the suction side of adjacent blades) is less sensitive to hydraulic balance due to geometry deviations.

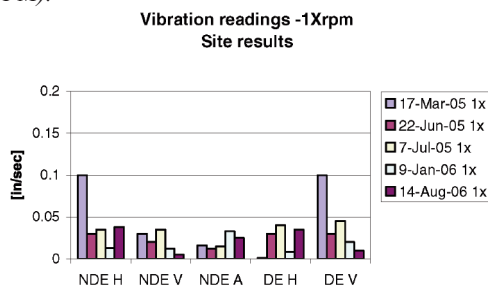
Figure 24. Field Data—Comparison— $1 \times$  RPM (Case 2,  $Q_{rated} = 3070$  GPM).

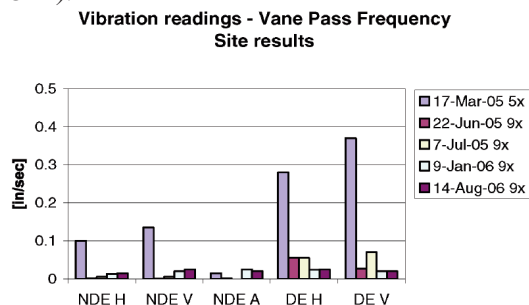
Figure 25. Field Data—Comparison—Vane Pass Frequency (Case 2,  $Q_{rated} = 3070$  GPM).

In Figure 25 the comparison between the old and the new impeller is made for the key vibration frequency at vane pass with reference to the vane number at impeller outlet, where the largest fraction of the head generation takes place (i.e., five and nine vanes for old and new impeller, respectively). It is fully evident that the VPF radial vibrations at bearing housings are drastically reduced with the new impeller geometry by a factor 7 (at NDEV) up to 12 (at DEV) as exclusive effect of the hydraulic design optimization and innovative impeller geometry. It is worthy noticing that both the impellers have the same duty diameter with  $D_{2duty} = 17.72$  inch and the same B gap = 16 percent, which is not playing any role in this drastic reduction of the VPF vibration. Then the reduction of the intensity of the hydraulic excitation forces as related with the impeller design appears as a primary factor for lowering the VPF vibrations. On the other hand the structural response of the bearing housings, which was not modified, has the highest natural frequencies (Table 2—second mode) below the VPF hydraulic excitation frequency (531 Hz). This is a second key factor contributing to the abatement of the VPF vibration.

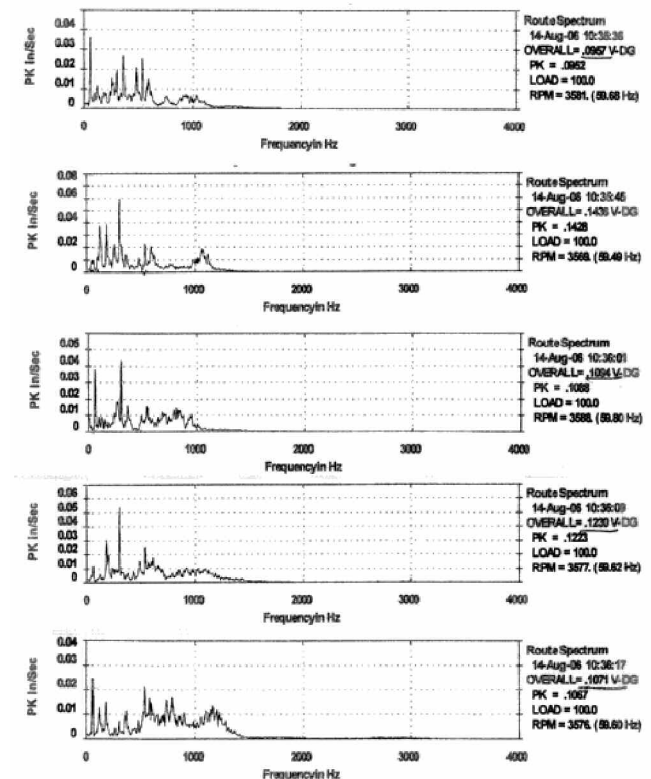
One field vibration frequency spectrum with the new impeller for Case 2 (14 August, 2006) is shown in Figure 26 at the operating capacity of 2690 gpm (88 percent  $Q_{rated}$ ) and 3580 rpm,  $SG = 0.56$ . The corresponding shop vibration frequency spectrum with the new impeller is shown in Figure 22 ( $D_2 = 19.09$  inch,  $SG = 1.0$ ). By comparison it appears that the drastic reduction of the VPF vibration is confirmed in the field also at this reduced capacity (refer to Figure 25 for 3070 gpm). However both the bandwidth of active frequencies is more enlarged up 1200 Hz (250 Hz in the shop test) and also the overall vibration level is increased (still remaining within the API limits) even with smaller diameter impeller ( $D_{2duty} = 17.72$  inch) and lighter fluid ( $SG = 0.56$ ). The most likely reason is that some degree of cavitation is present in the field as the ratio  $NPSHA/NPSHR = 1.30$  (Table 1, Figure 3) is surely insufficient to eliminate cavitation at part flows with impeller eye peripheral velocity of 100 ft/s ( $N = 3580$  rpm) (Schiavello, 1993).

Figure 26. Field Test Spectra at 2690 GPM—New Impeller (Case 2).
