Earthquake Damage to the Electric-Power Infrastructure- Substation

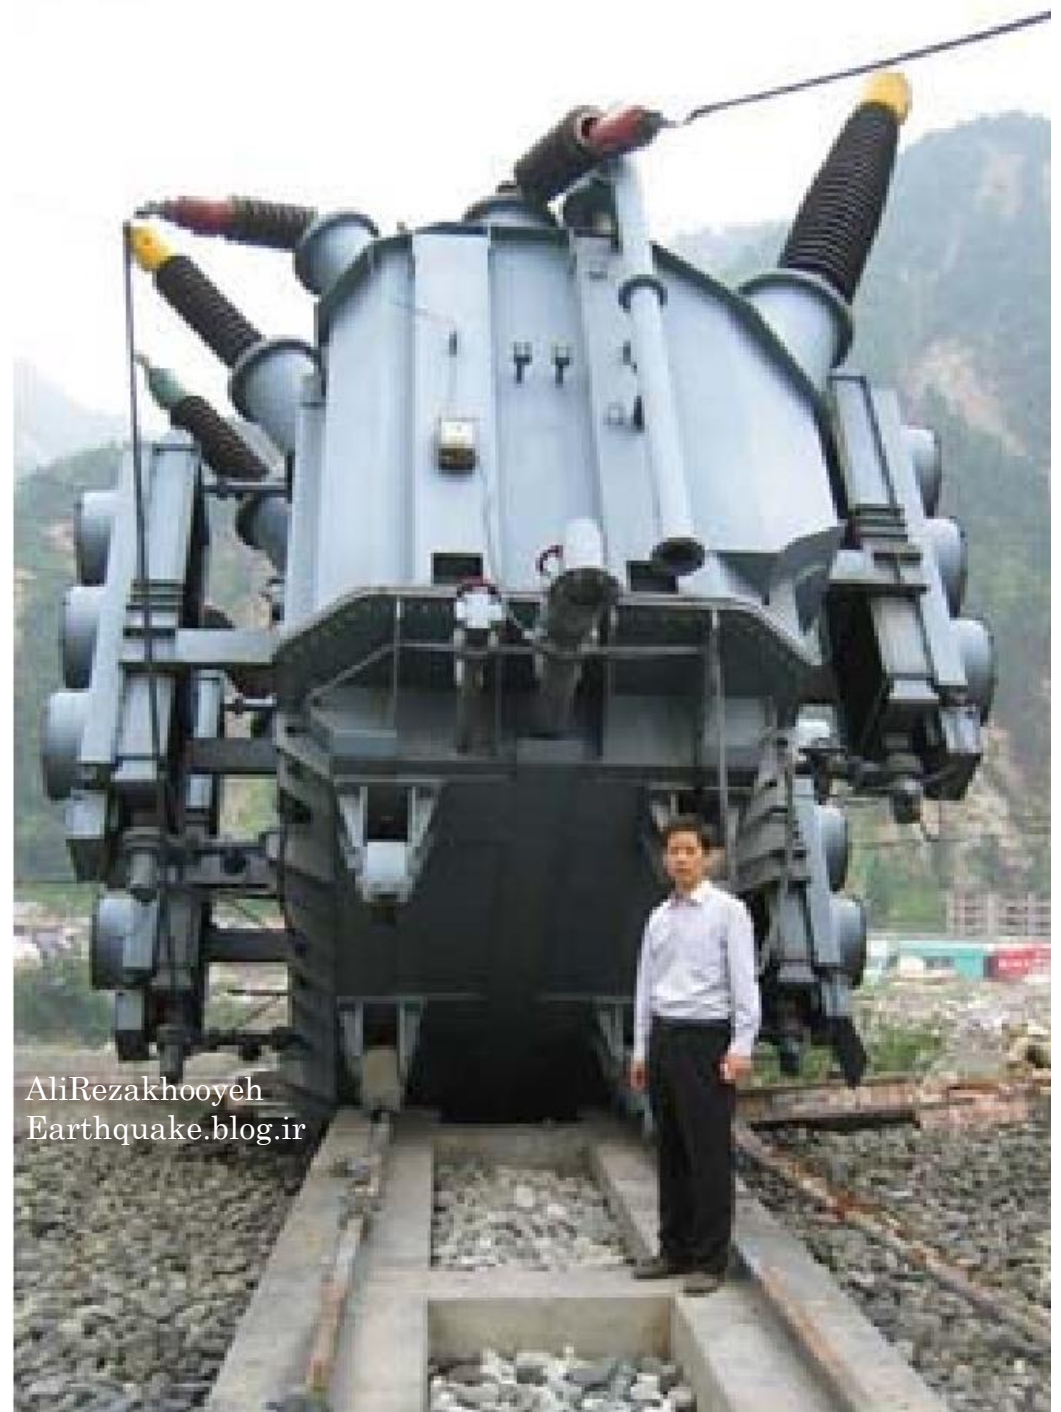
Overturning of 110kV transformer

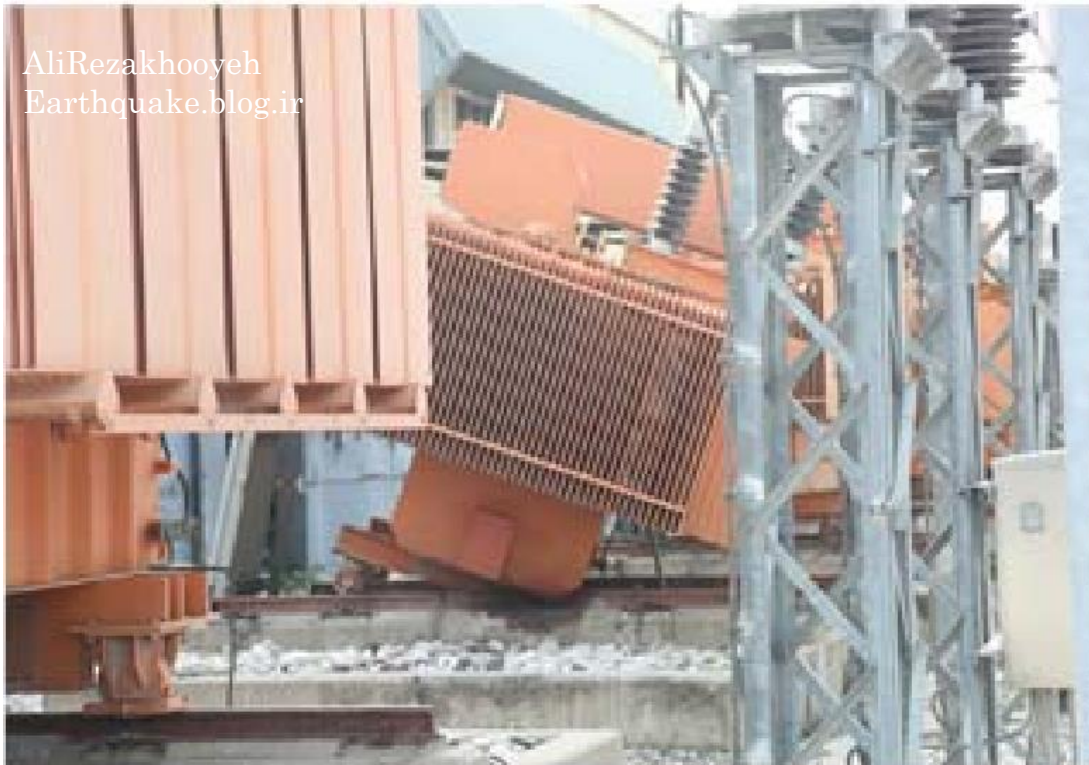
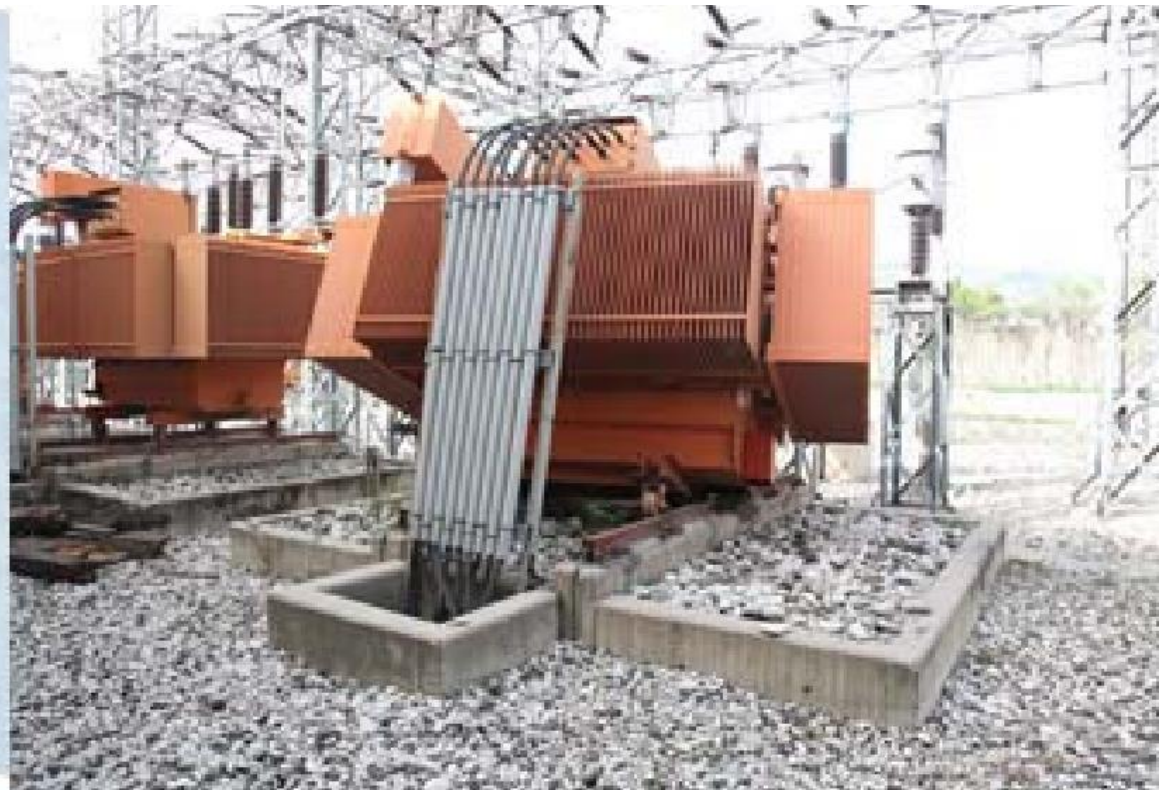
A transformer in Haiti earthquake (left image – side view and right image – rear view)

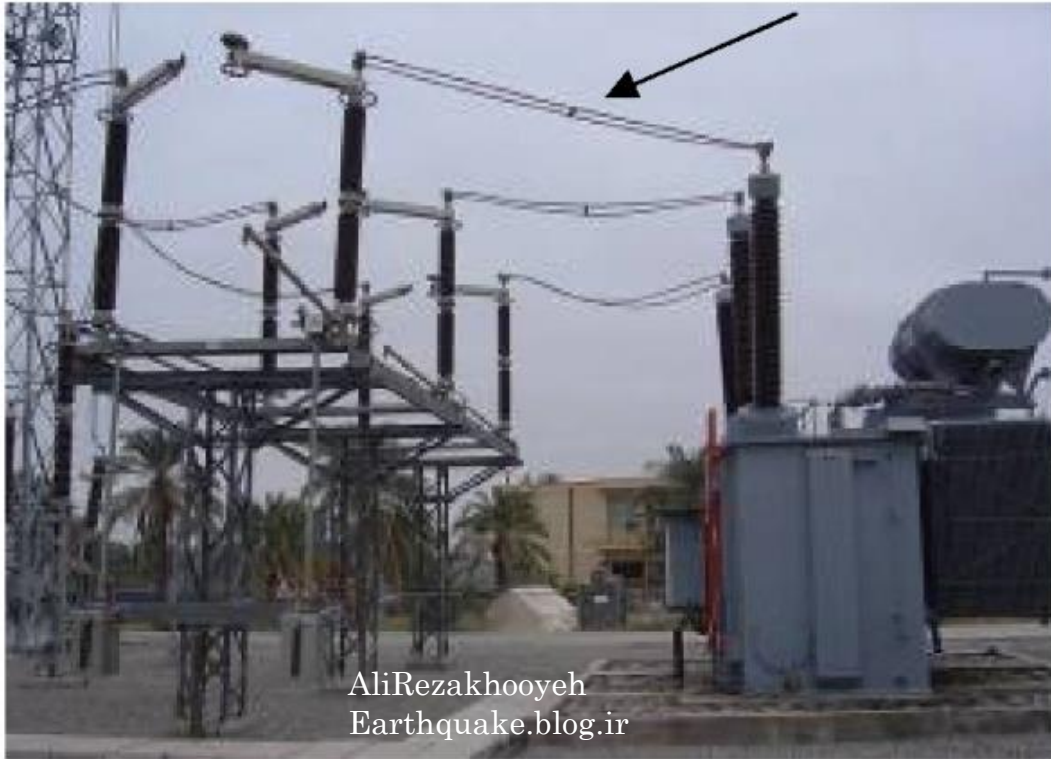
Figure 3: Fallen adjacent equipments

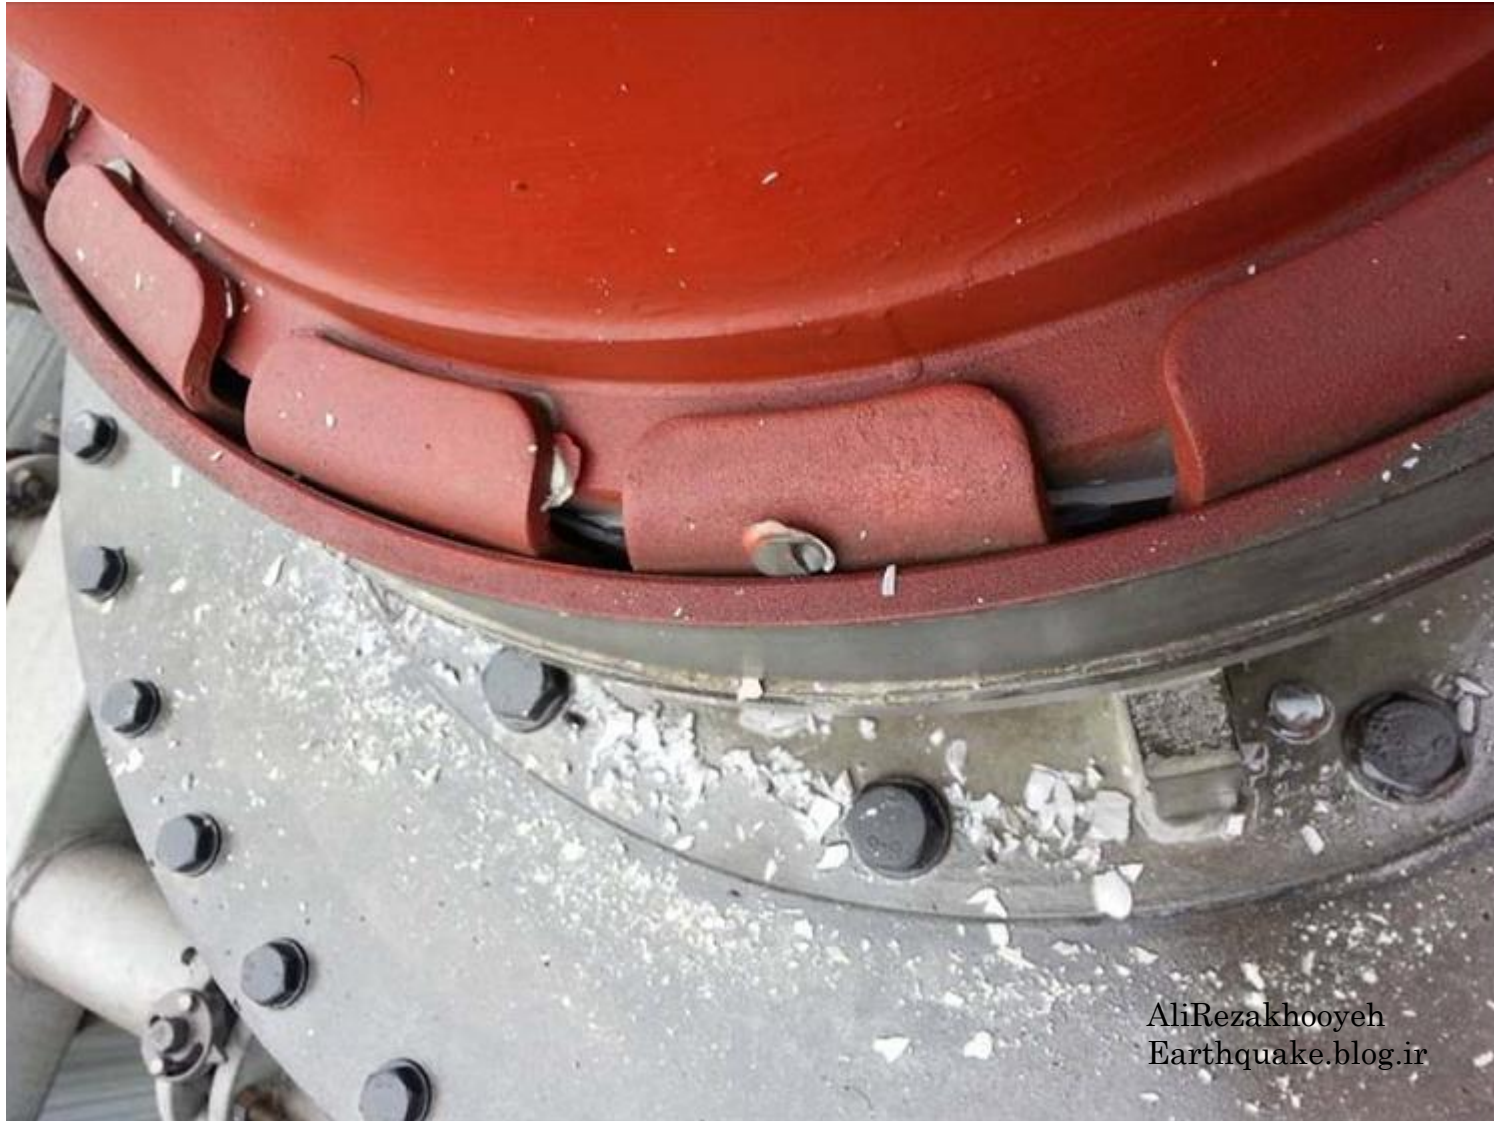
Oil Leakage Due to Ceramic envelope Breakage

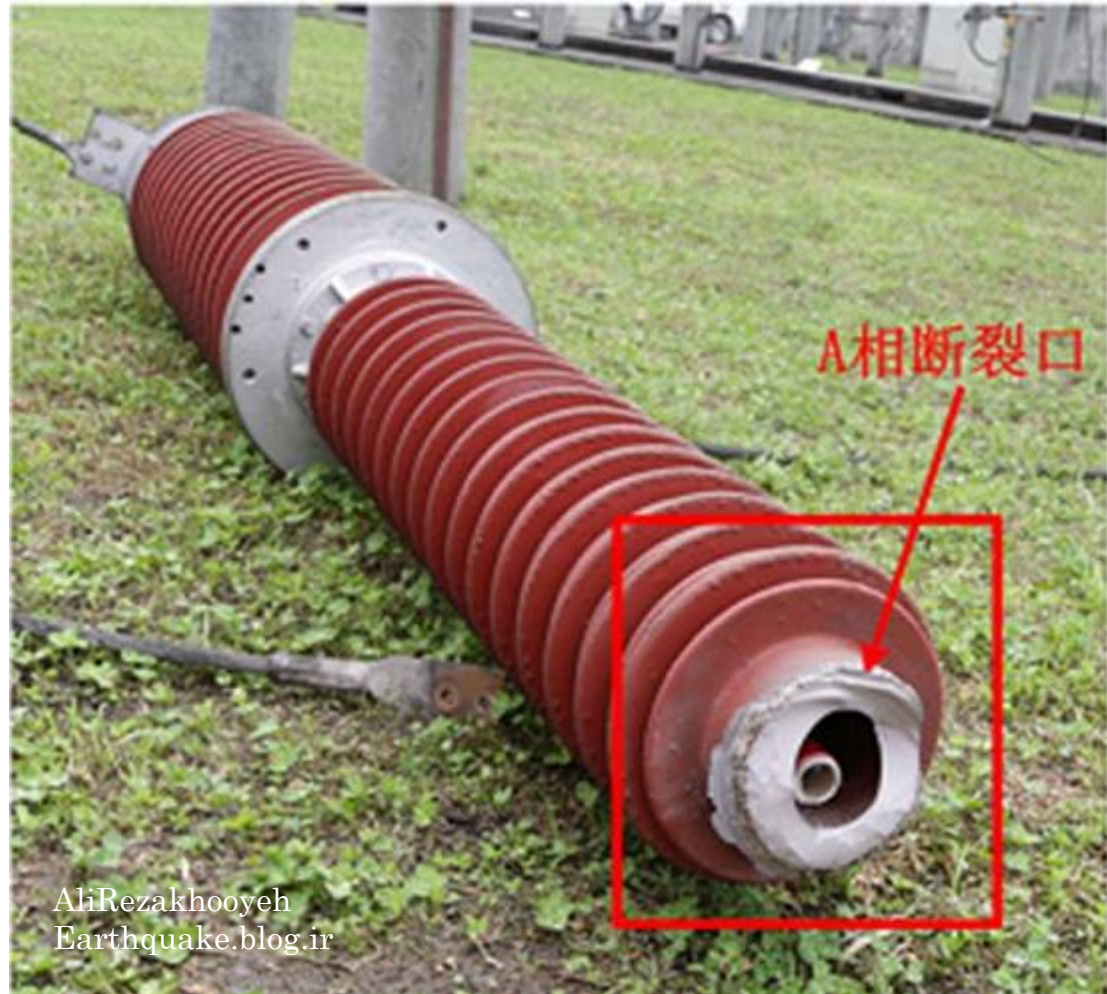
Damage of Circuit Breakers

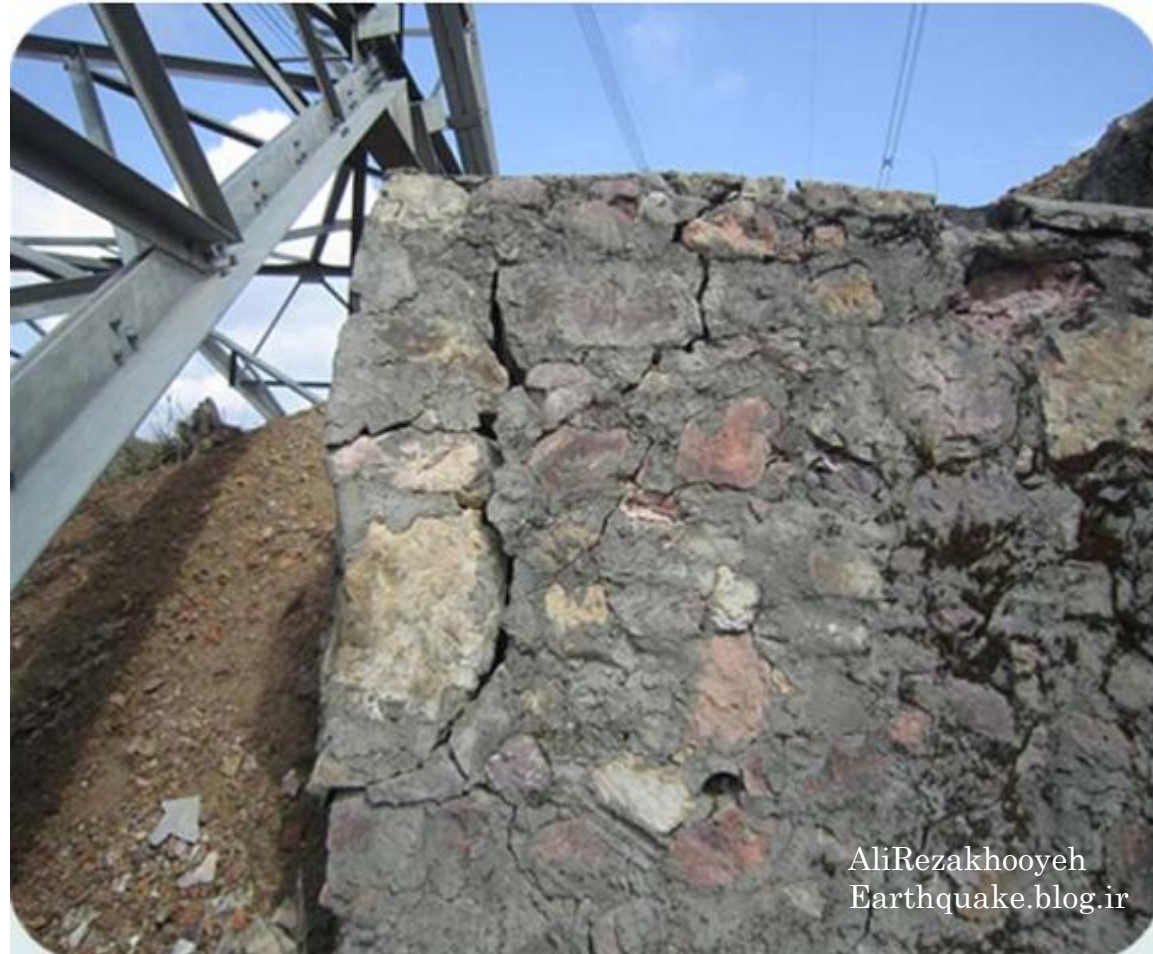
Crack of Tower Base and Slope Protection

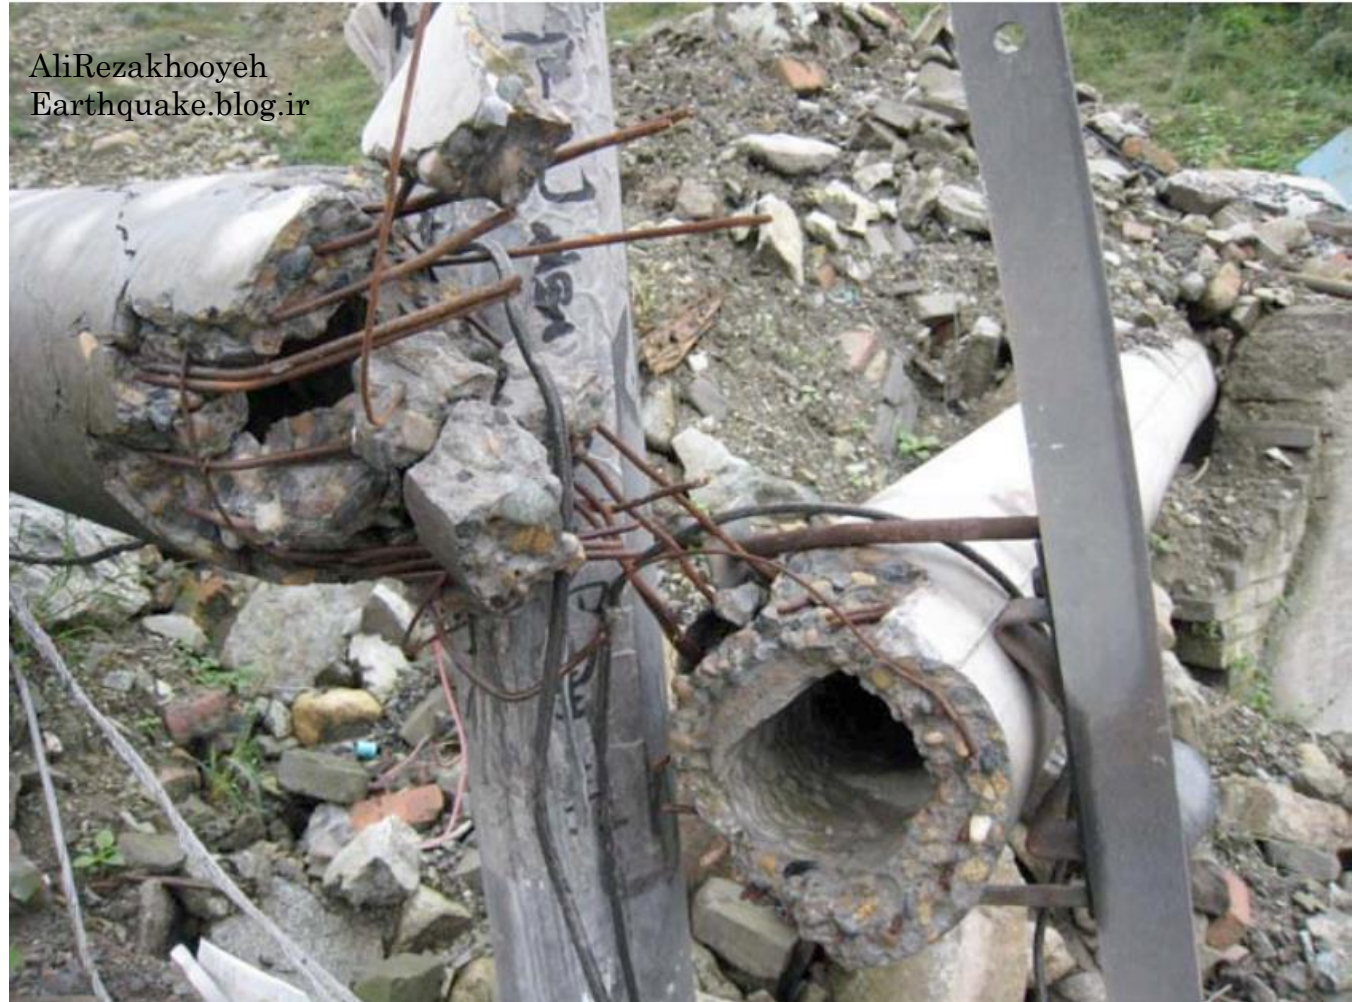
Collapsed 10 kV Distribution Pole (10 inch diameter, 2.5-inch wall thickness)

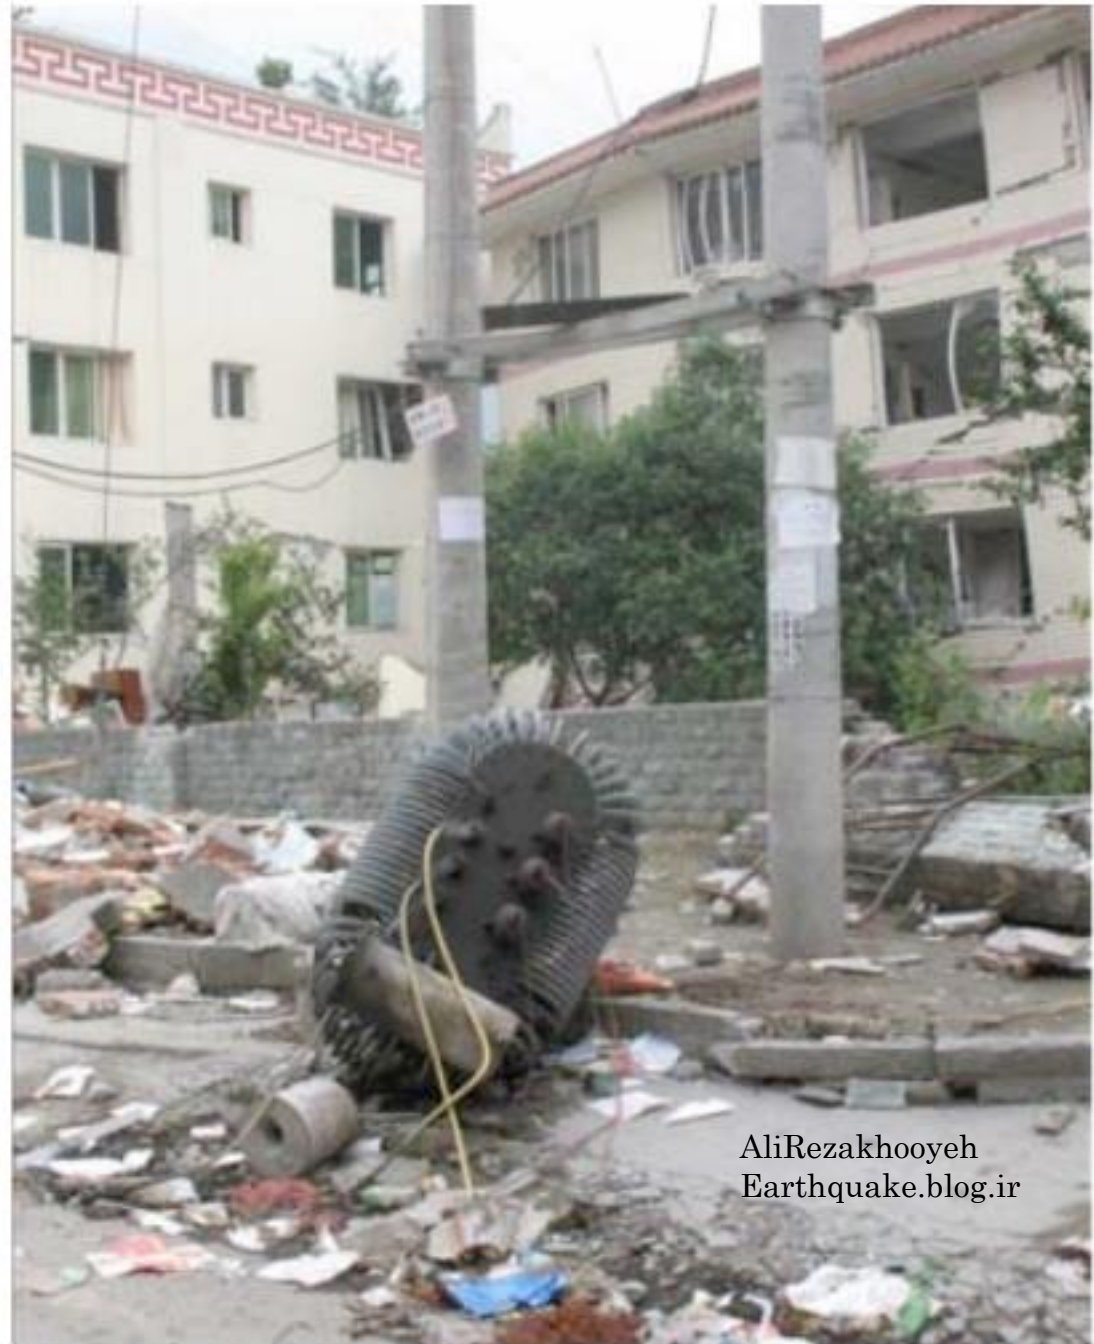
Fallen Distribution Transformer
